TORNADO OUTBREAK *of* **2011**

IN ALABAMA, GEORGIA, MISSISSIPPI,
TENNESSEE, AND MISSOURI

6 Observations on Critical Facility Performance: Schools

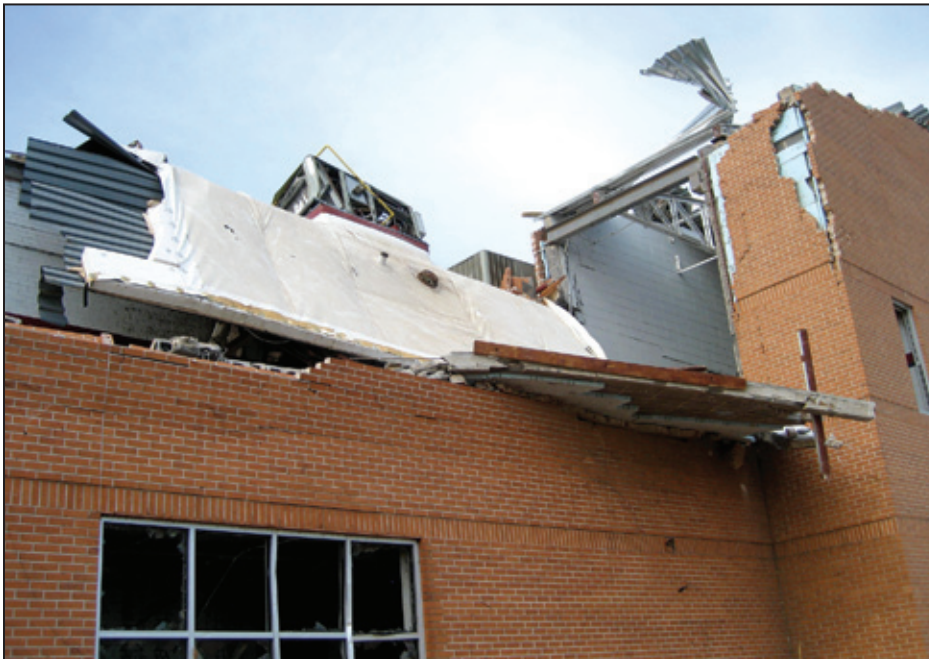
Figure 6-52:
Collapse of the exterior brick
veneer/reinforced CMU wall
and roof assembly into the
corridor at the north end of
the north classroom wing
(Joplin, MO)

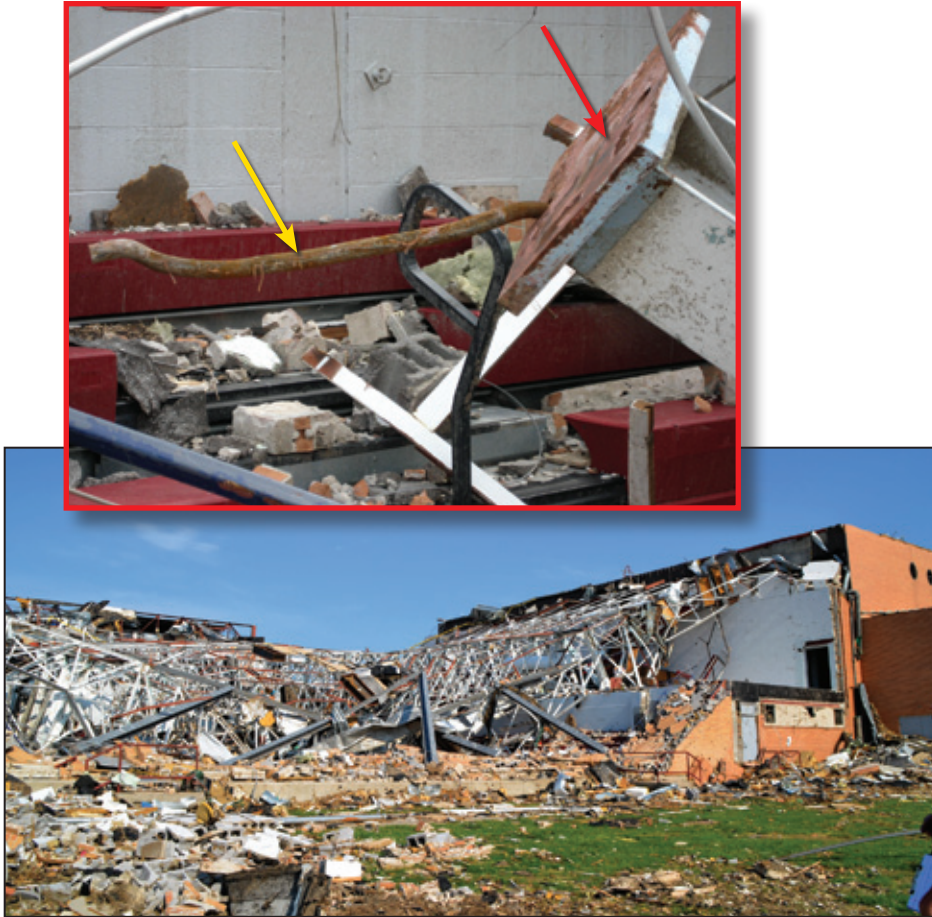
Primary gymnasium: The gymnasium shown in Figure 6-54 collapsed. The west wall was approximately 37 feet tall—it fell into the gymnasium. The connection between the pilasters and columns that supported the roof girders failed. The columns were connected with two 1½-inch diameter bolts, each 3 feet long, as shown in the inset at Figure 6-54. Most of the steel roof deck blew off. Only a small portion of it remained within the gymnasium space. Collapse of the brick veneer/unreinforced CMU end wall and blow-off of the roof decking caused the failure. Once the integrity of the load path was disrupted, there was a progressive failure.

Figure 6-54:
View of the collapsed gymnasium. The inset shows the base plate (red arrow) and an anchor bolt (yellow arrow) that connected the girder support column to the pilaster (Joplin, MO).

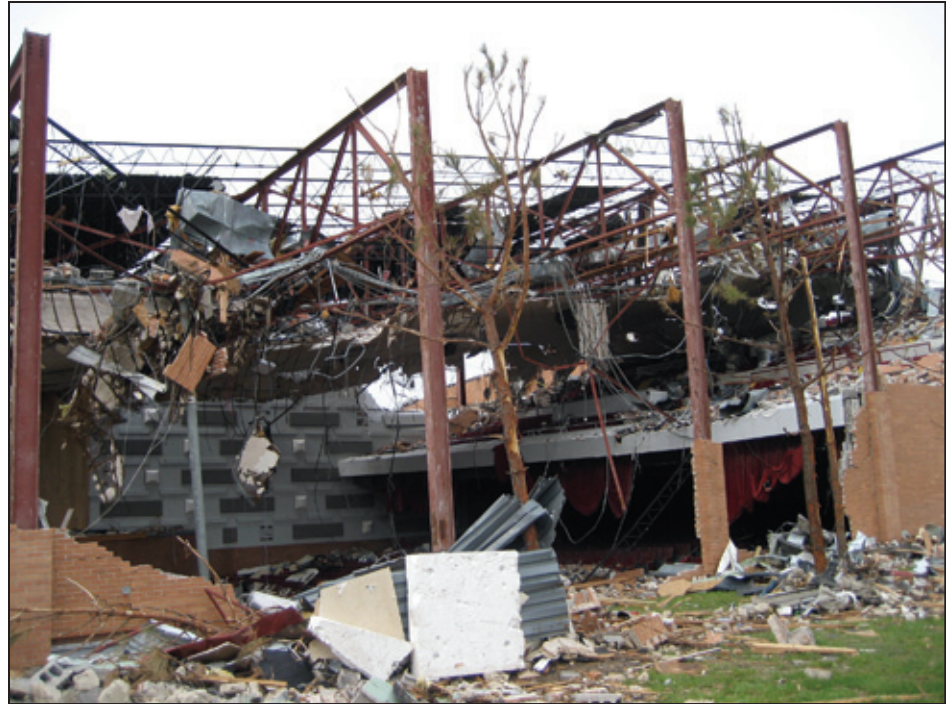
Figure 6-57:
South wall of the
auditorium, showing
collapse of the masonry
infill wall (Joplin, MO)
