TORNADO OUTBREAK *of* 2011

IN ALABAMA, GEORGIA, MISSISSIPPI,
TENNESSEE, AND MISSOURI

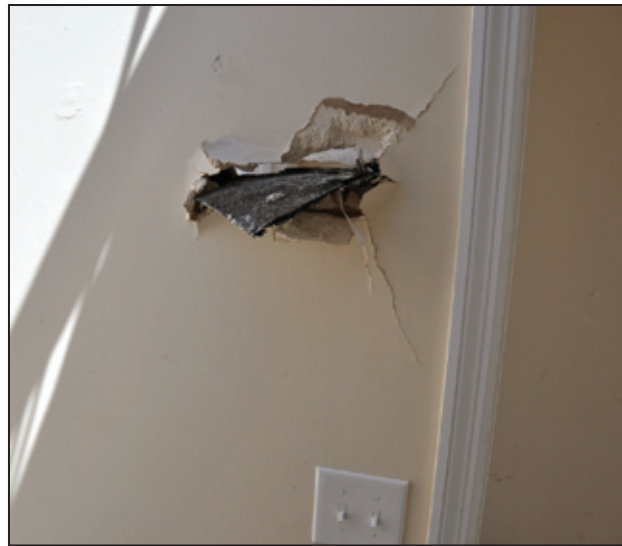
The second group of damages addressed—glazing damage and garage doors collapse inward, or DODs 3 and 4—often accelerate the disintegration of the structure through wind pressurization of the interior. Whether the result of wind-borne debris shattering glazing or wind pressure causing garage doors to collapse, a breach in the building envelope subjects it to increased pressurization and allows the intrusion of wind-driven rain. Other common building envelope vulnerabilities include, but are not limited to, soffits, doors, and gable end walls.

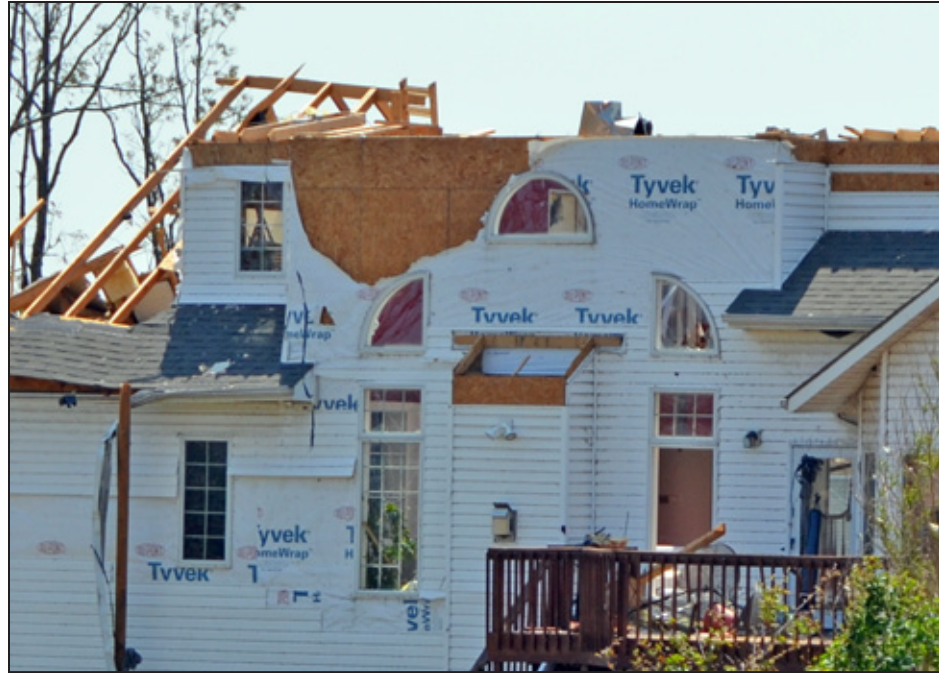
4.1.4 Glazing Damage (DOD 3)

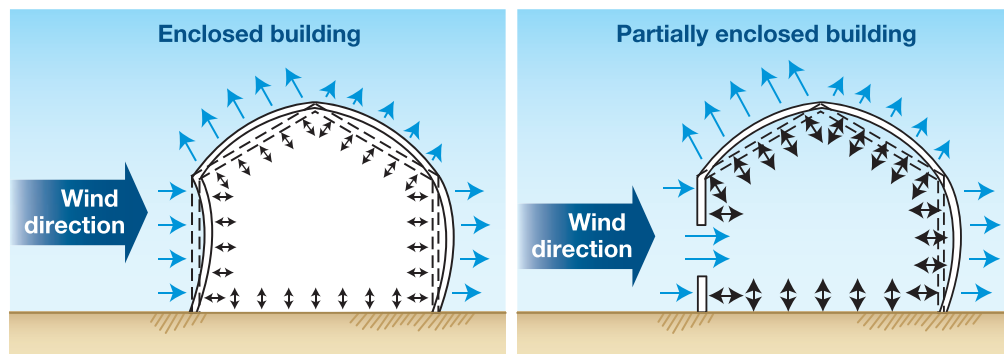
The MAT observed some buildings that benefitted from the installation of insulated glazing units (i.e., double-paned windows), where the outer pane was sacrificed but the inner pane remained intact, as illustrated in Figure 4-6. Energy code changes that require increased efficiency are leading to more double- and triple-paned glazing units in new residential construction. However, most windows of this type were not designed to provide extra protection from wind-borne debris and were breached on impact, as shown in Figure 4-7.

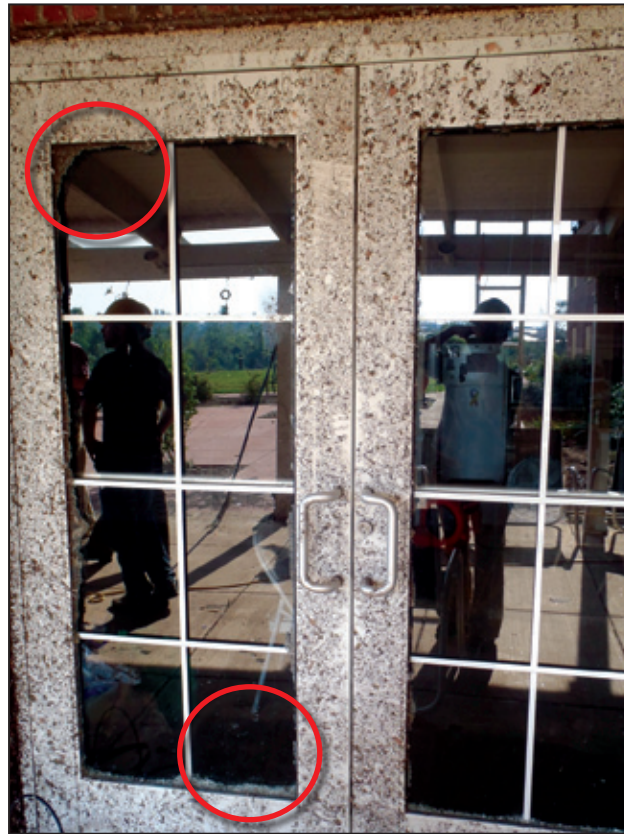
Figure 4-6:
Double-glazed window with outer pane sacrificed (remaining fragments are circled in red), leaving the inner glazing intact (Mercy Village, Joplin, MO); refer also to Section 4.2.3 for a case study of Mercy Village

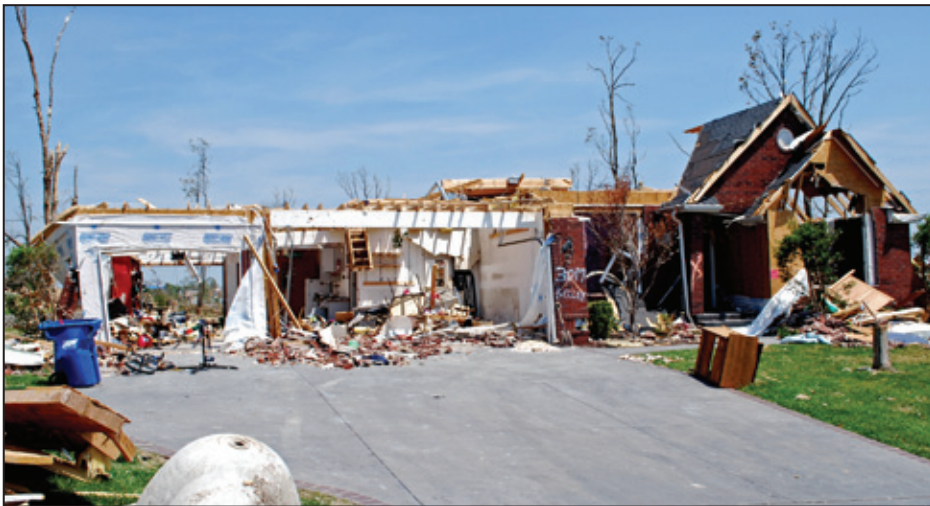
Figure 4-9:
Example of damage including loss of large sections of roof (DOD 6) apparently initiated from garage door failure (DOD 4) (Joplin, MO) [MAT EF Rating = 2]

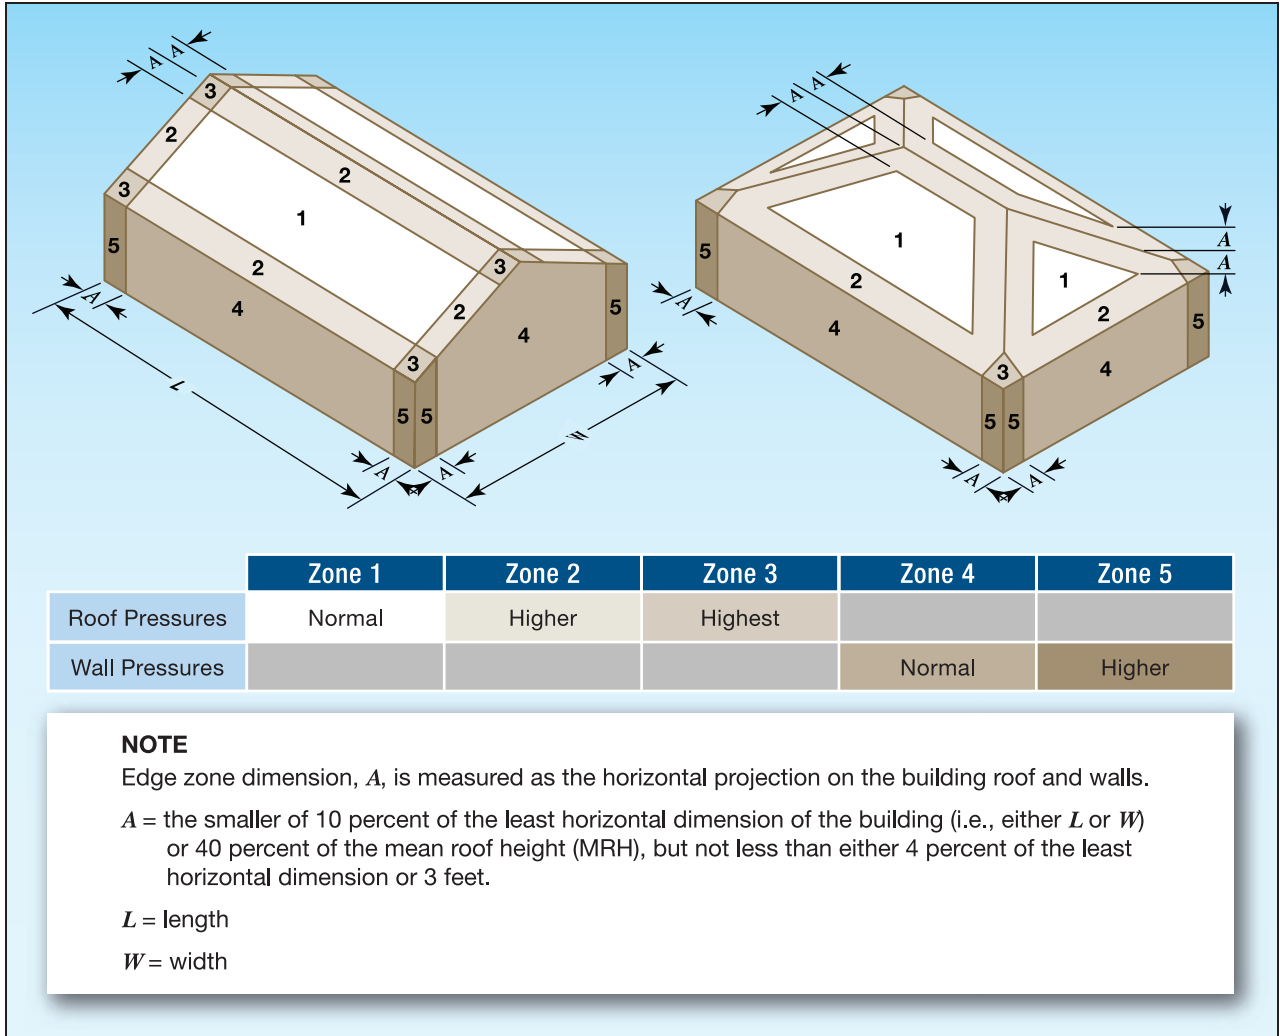
Figure 4-12: Component and cladding wind pressures

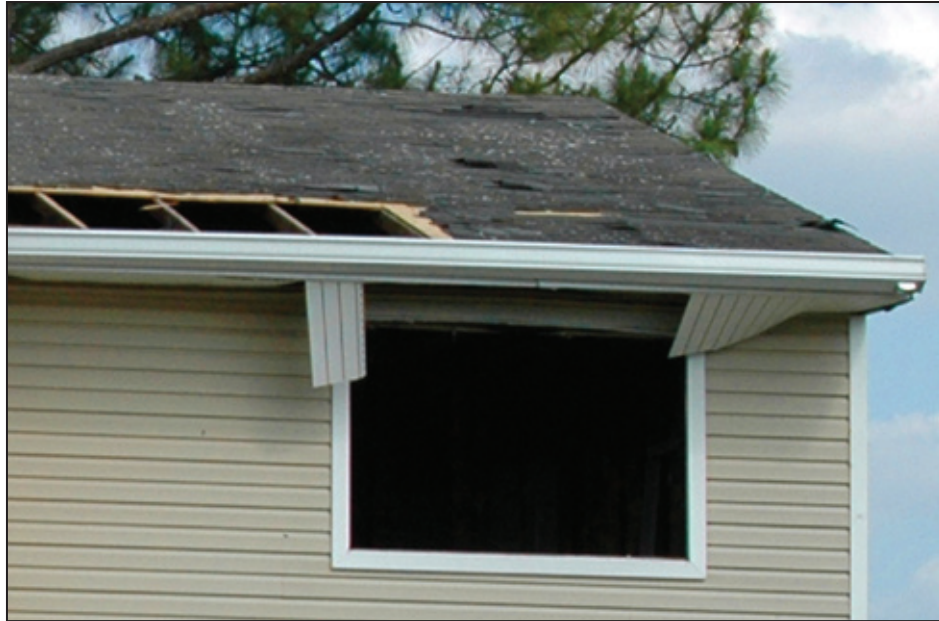
Figure 4-14:
Example of DOD 4 showing roof decking removed at wide eaves on hip roof (Phil Campbell, AL) [MAT EF Rating = 1]

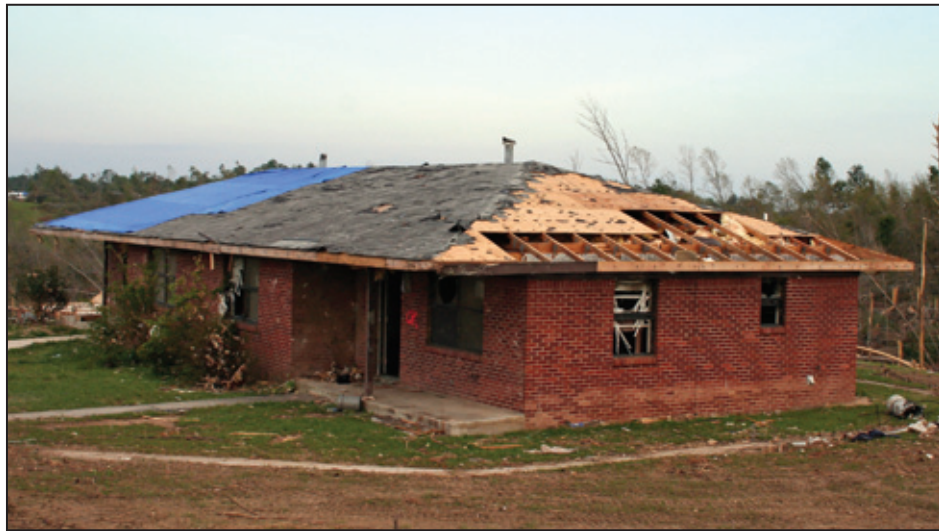
Poor construction methods can also decrease resistance to wind uplift. Figure 4-15 shows a residence where at least one of the roof deck nails along the panel edges failed to penetrate the rafter below. The expected performance is subsequently rendered weaker than intended by the building code or design professional. Improper spacing of fasteners and the use of improperly sized fasteners result in the same effect.

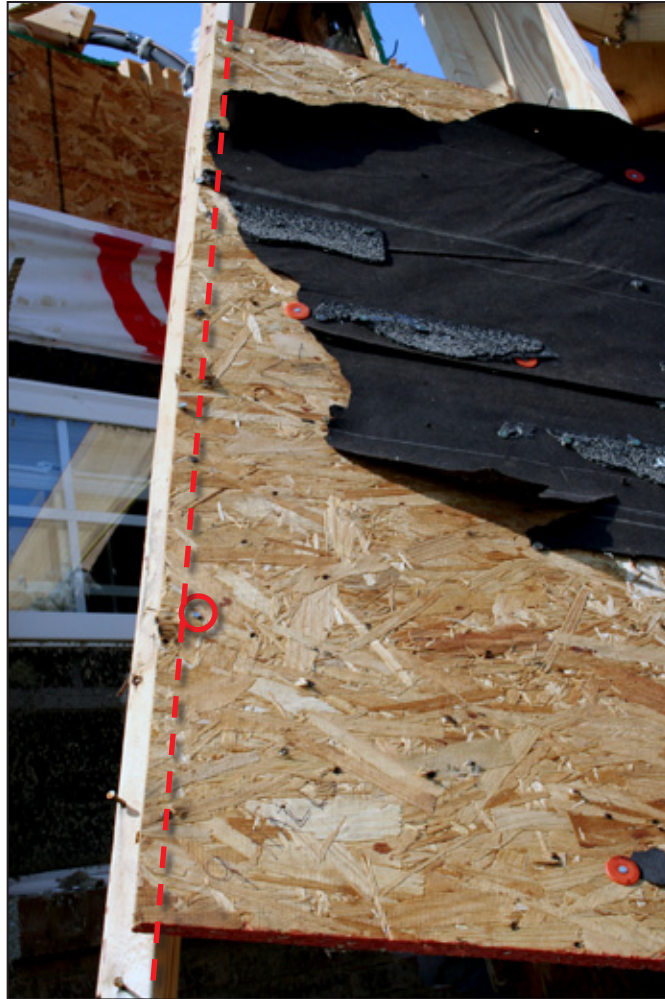
Figure 4-15:
Red circled roof deck nail not
connected to rafter (edge
shown with red dashed line)
(Harvest, AL)

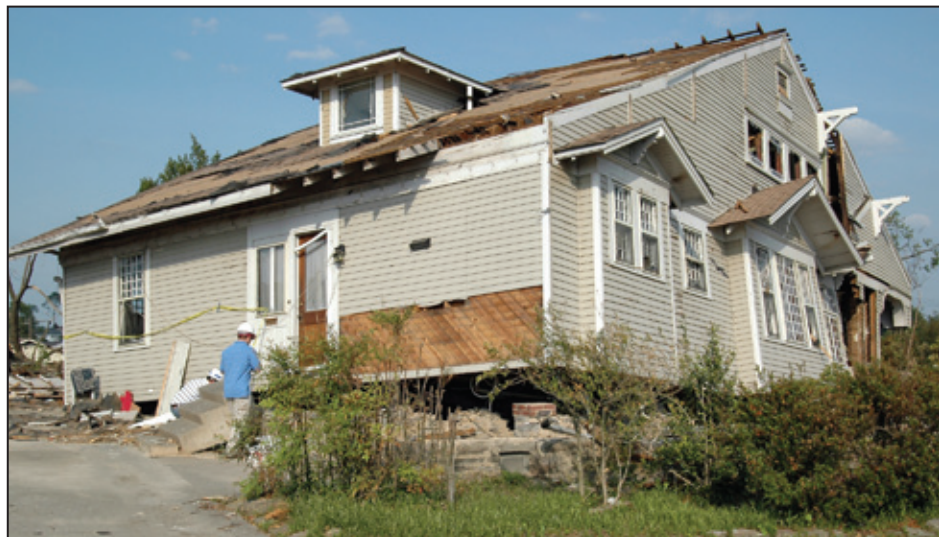
4.1.9 Roof Structure Removed (DOD 6)

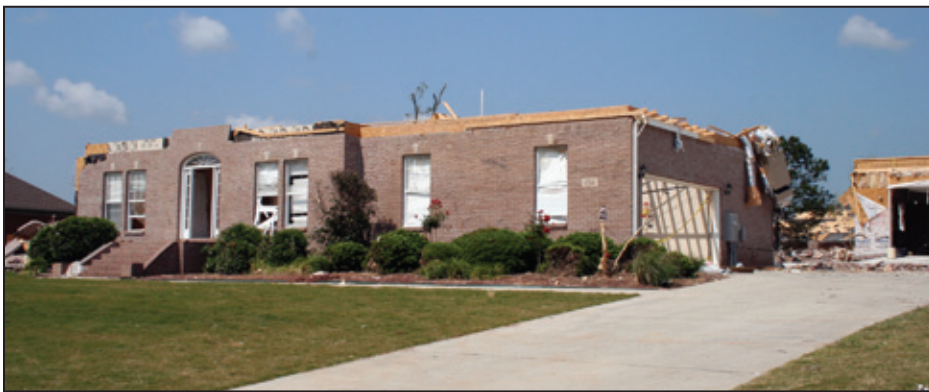
Figure 4-18:
Example of DOD 6 showing failed roof-to-wall connections that resulted in loss of roof structure (Harvest, AL)
[MAT EF Rating = 2]

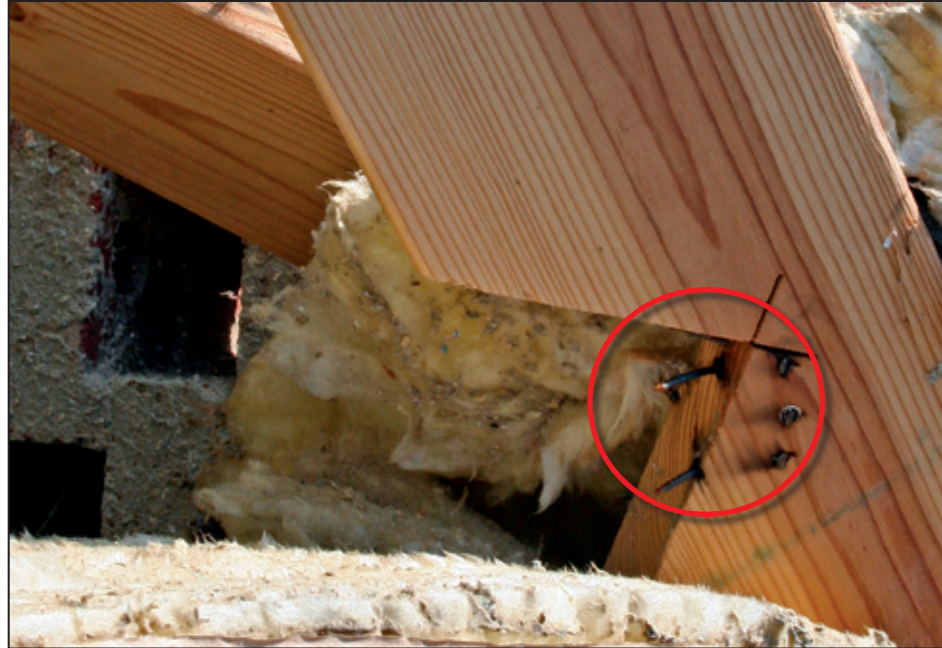
Metal connectors designed to transfer uplift forces from the rafter or truss to the wall below greatly enhance connectivity and were observed to outperform toe nail-only connections. In order to transfer uplift and lateral loads consistent with their maximum design capacities, metal connectors must be installed per the manufacturer's instructions.

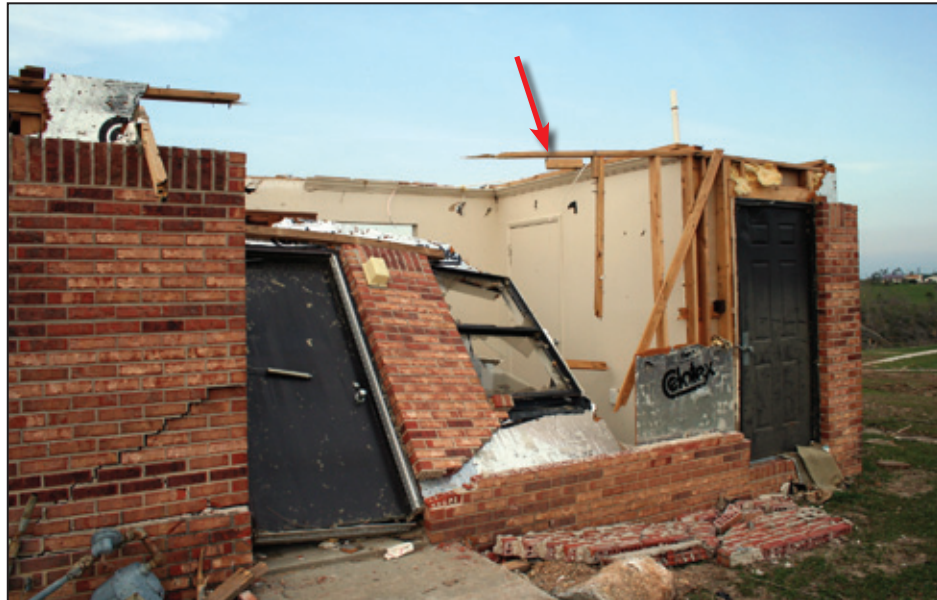
The floor system above the garage shown in Figure 4-24 separated from the framed exterior walls, allowing both the floor and walls to collapse. As shown in the inset to Figure 4-24, the double top plate of the garage entry wall was pulled away either with the fallen floor system or collapsed portion of the garage entry wall. The deeper floor system above the garage, which was installed to span the garage without intermediate support, appeared to be framed onto a lower top plate that interrupted the continuity of the top plate and weakened the connection to the adjacent walls.

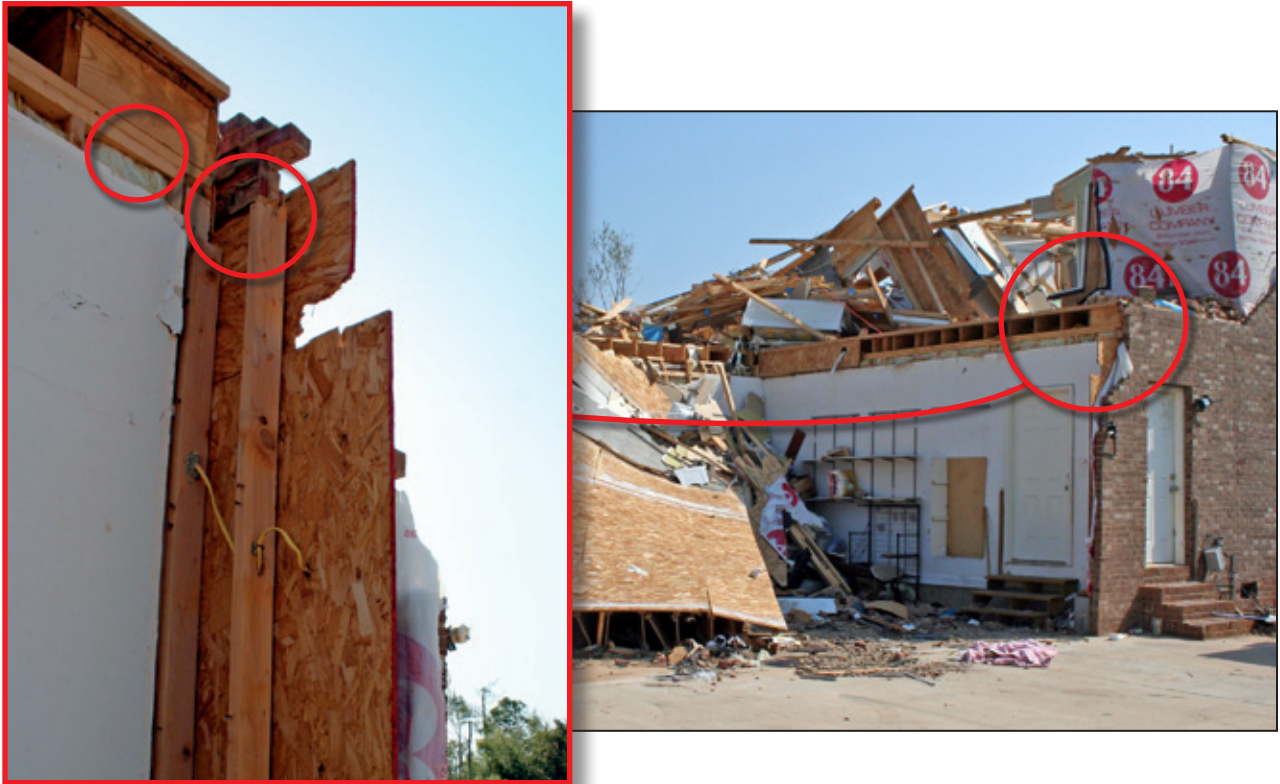
Figure 4-24: Example of DOD 6 showing pressurization of this garage from failure of the garage door/wall removed the support for the second story floor system (red circle). Inset shows where top plate of garage entry wall separated with floor or wall (red circles). Note former location of entry wall top plate—separated and missing from top of studs—is lower than the interior wall top plate due to deeper floor system (Harvest, AL). [MAT EF Rating = 2]

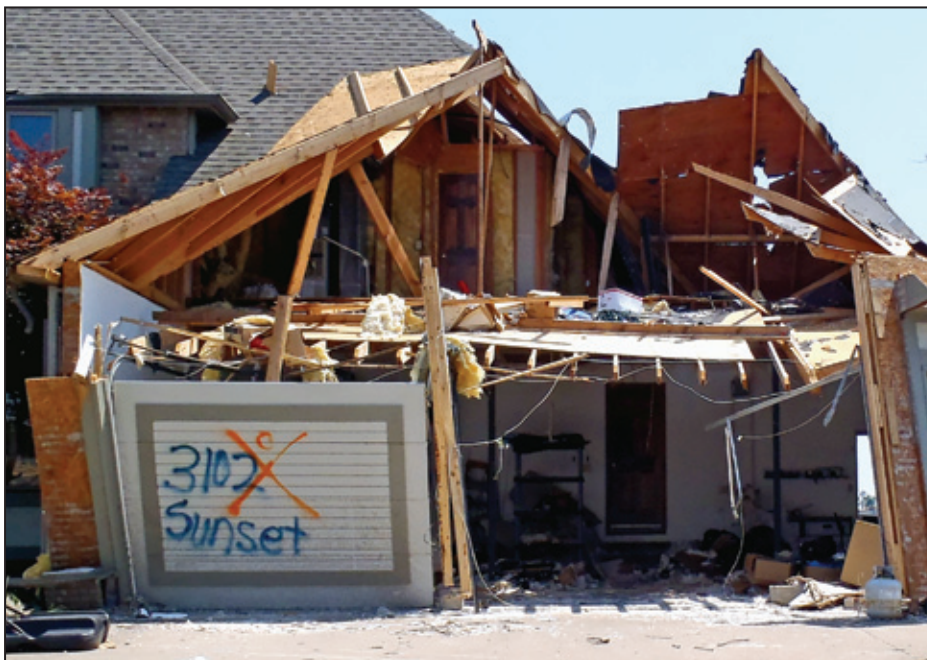
Figure 4-25: Example of DOD 6 where most walls remained standing, but under-braced garage entry wall failed (Joplin, MO) [MAT EF Rating = 2]

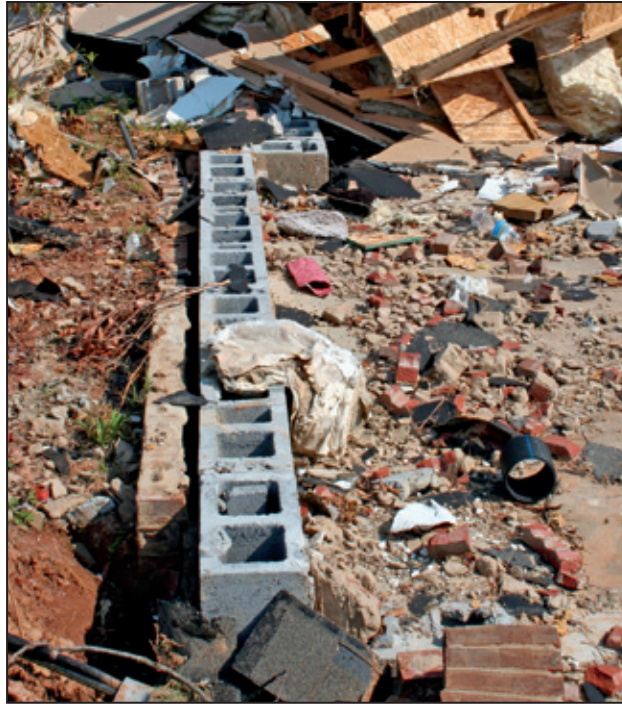
Figure 4-27:
Example of wall framing-to-foundation connection failure. Wall and bottom plate separated from foundation where anchorage of collapsed framed wall failed because anchors lacked embedment in grout. Note CMU wall with no reinforcement or solid grout (Harvest, AL).
[MAT EF Rating = 2]

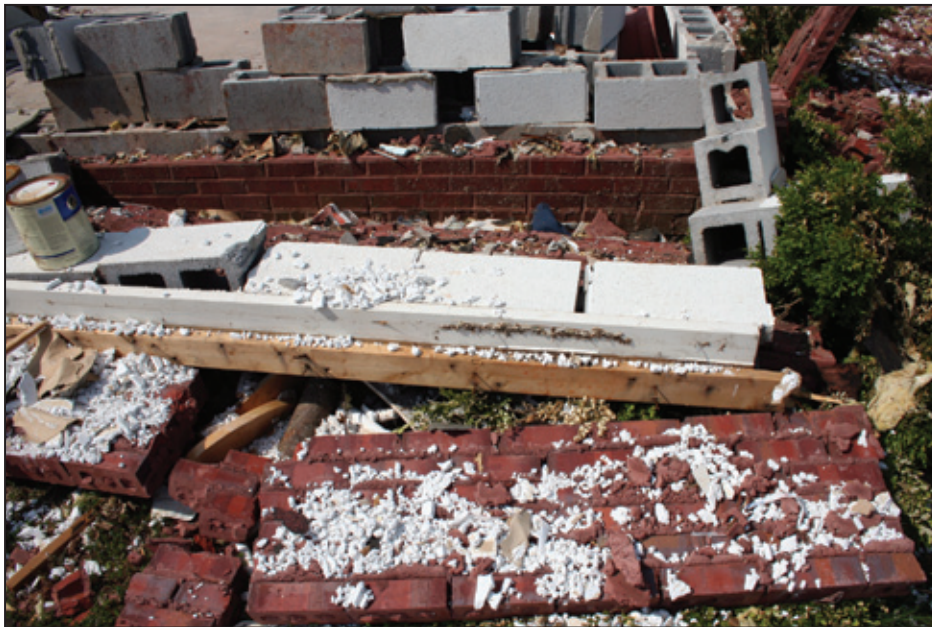
Figure 4-28:
Example of wall framing-to-foundation connection failure. Bottom plate remains connected to top row of CMU, but CMU wall failed due to lack of reinforcement for continuous load path (Harvest, AL).
[MAT EF Rating = 2]

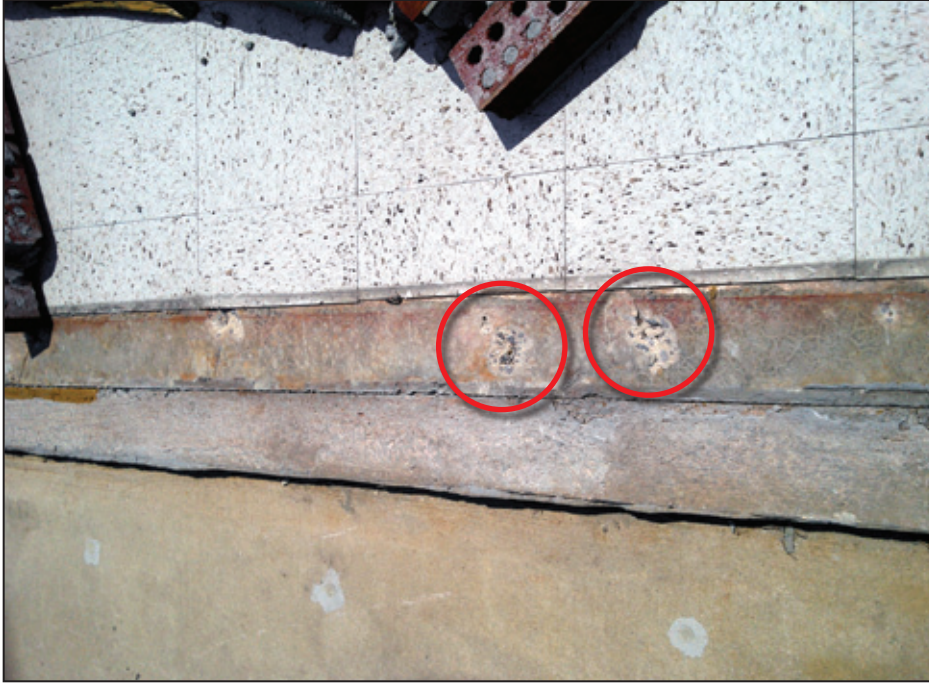
Figure 4-30:
Wall-to-foundation failure where bottom plate and concrete nails were pulled out by high winds. Shallowly embedded concrete nails pulled small cones of concrete up with bottom plate (red circles) (Hackleburg, AL).
[MAT EF Rating = 3]

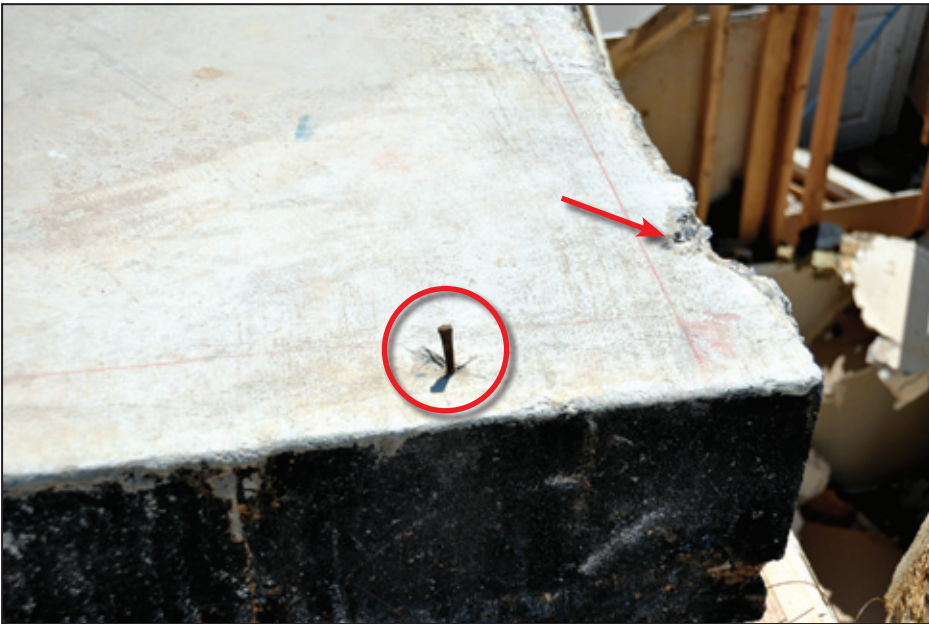
Figure 4-31:
Wall-to-foundation connection failure. Note slab failure along right edge where the bottom plate separated and the nail was removed (red arrow). A remaining cut nail is indicated by the red circle. (Tuscaloosa, AL).
[MAT EF Rating = 4]

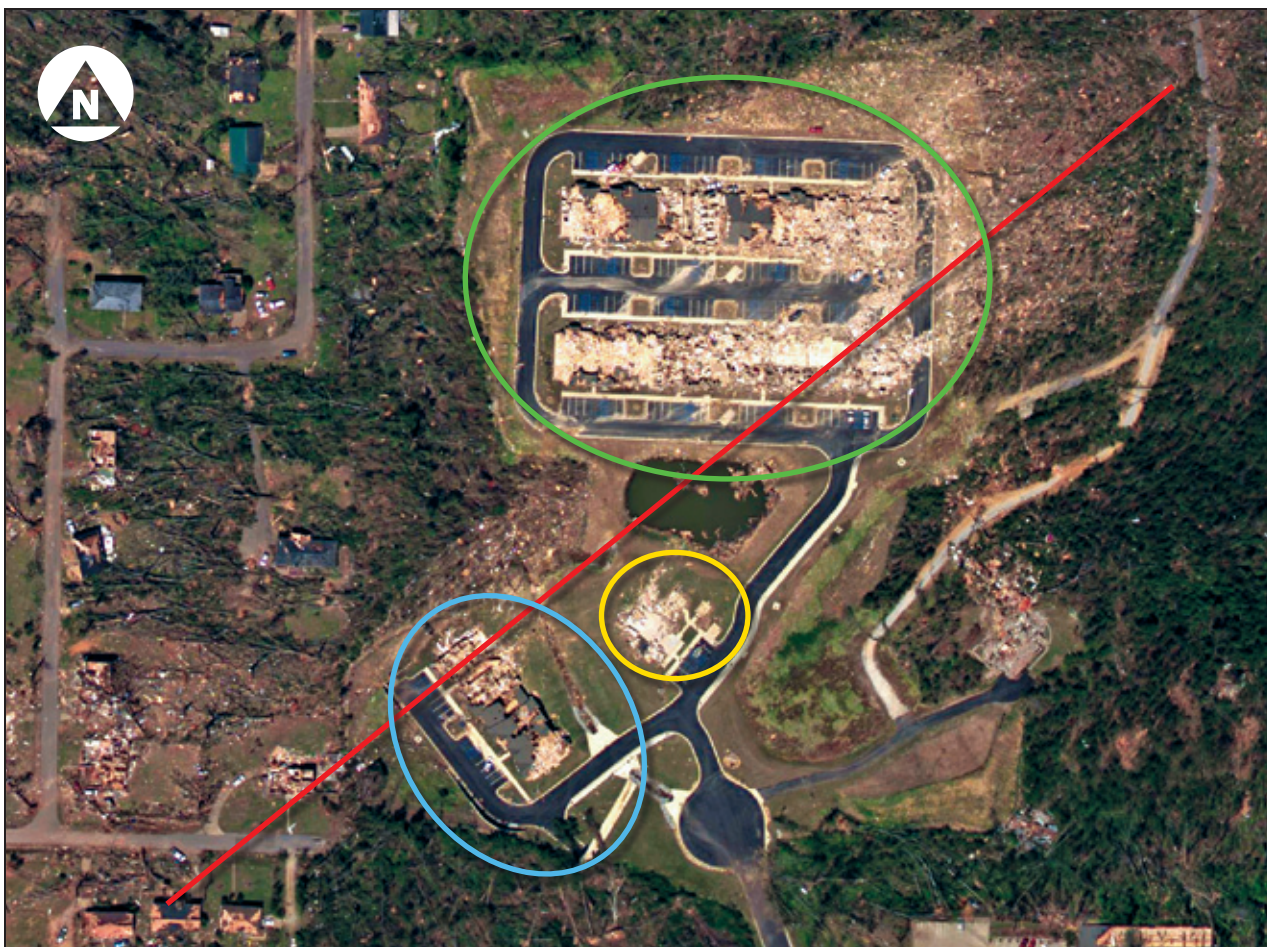
Figure 4-32: Aerial view of Chastain Manor Apartments in relationship to the approximate centerline of the tornado damage swath (red line).⁶ The green circle indicates the two-story apartment buildings, the yellow circle shows the location of the leasing office, and the blue circle shows the location of a one-story apartment building (Tuscaloosa, AL). SOURCE: ALL AERIAL PHOTOGRAPHS ARE FROM NOAA IMAGERY ([HTTP://NGS.WOC.NOAA.GOV/STORMS](http://ngs.woc.noaa.gov/storms)) UNLESS OTHERWISE NOTED

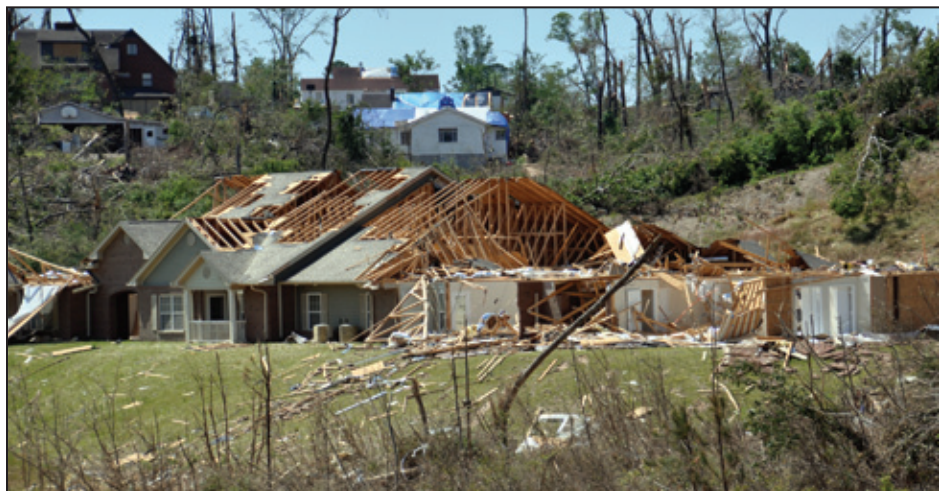
Figure 4-33:
One-story Chastain Manor Apartments suffered damage varying from roof decking uplift to collapse of roof structure

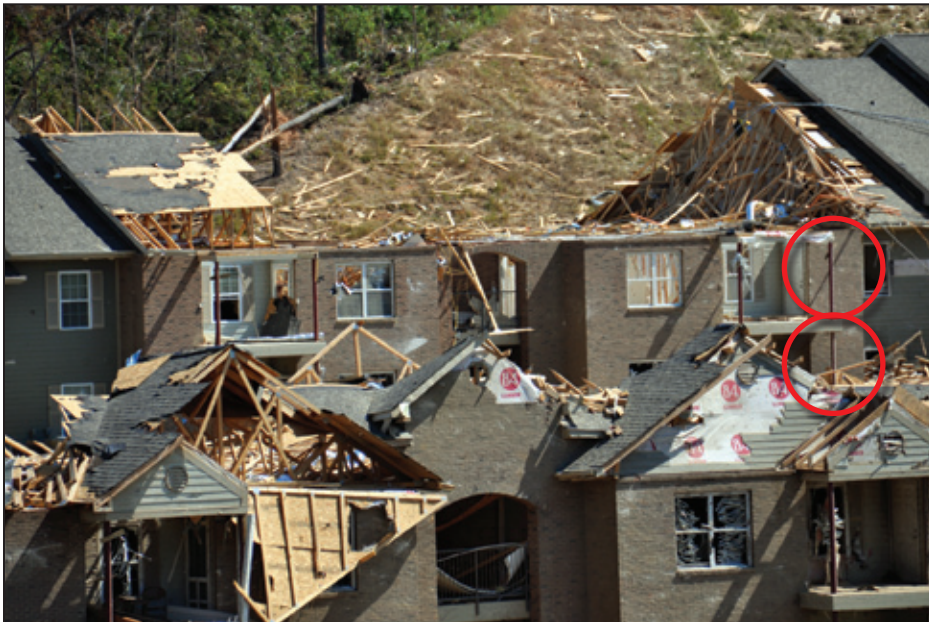
Figure 4-35:
Example of DODs 3 and 4
showing two-story Chastain
Manor Apartments with
varying roof damage. Note
upper and lower steel pipe
porch columns (red circles).

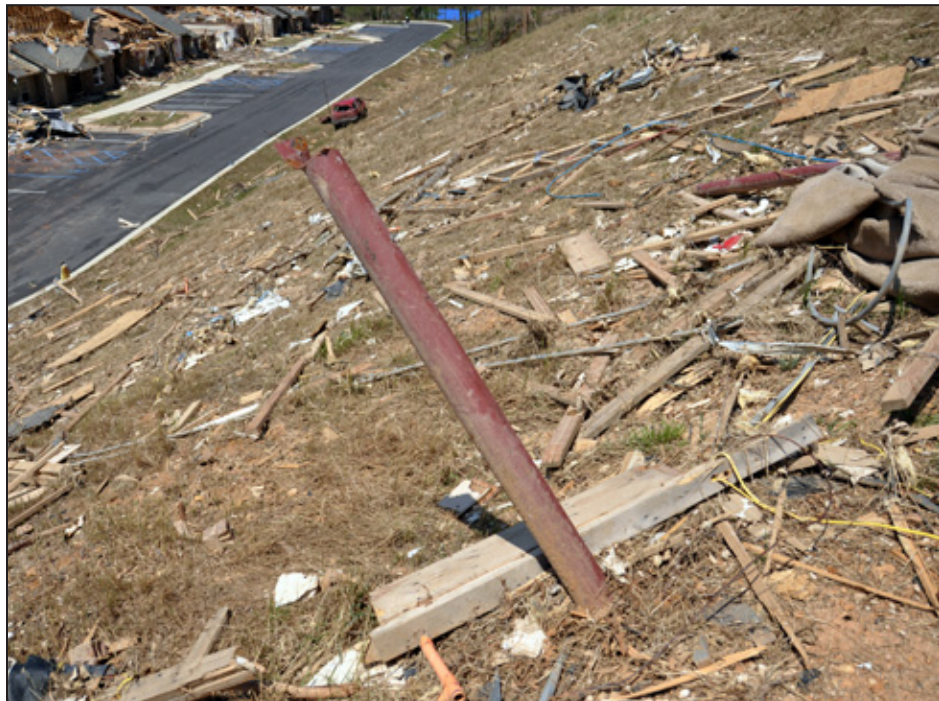
Bottom plates in the leasing office (Figure 4-38) and two-story apartment buildings (Figure 4-36) were removed from the thickened slab foundation in multiple locations. In some areas, the bottom plates were stripped away from the foundation, leaving the anchor bolts embedded in the foundation with washers still attached (Figure 4-39). The washers used between the anchor nut and plate were 1 inch in diameter. While the washer size for the bottom plate anchor is not specified in Section 2308.6 of the 2012 IBC, high-wind areas along the coast are required to use 3-inch-square washers, which significantly increase resistance to plate uplift.

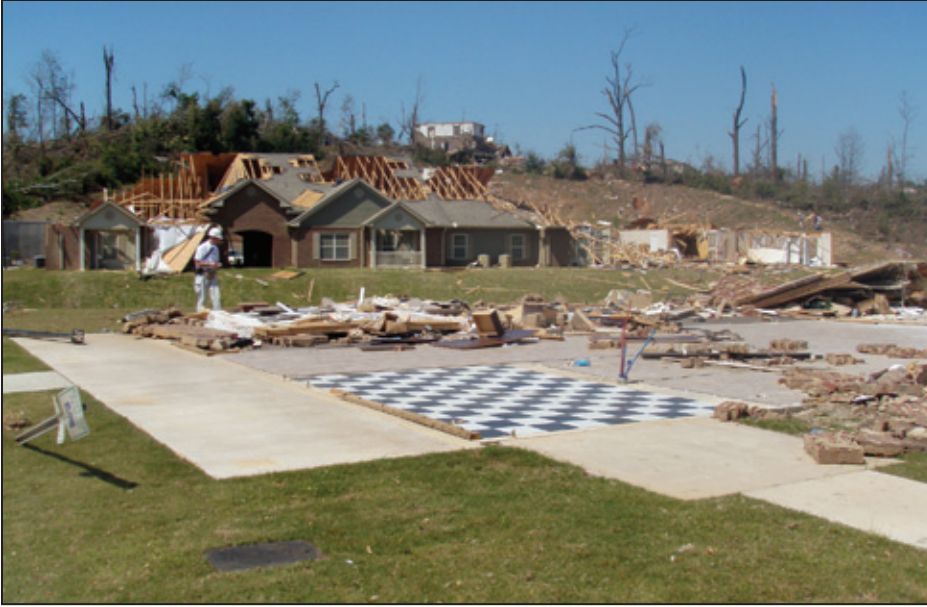
Figure 4-38:
Most of the bottom plates
were blown off the Chastain
Manor leasing office

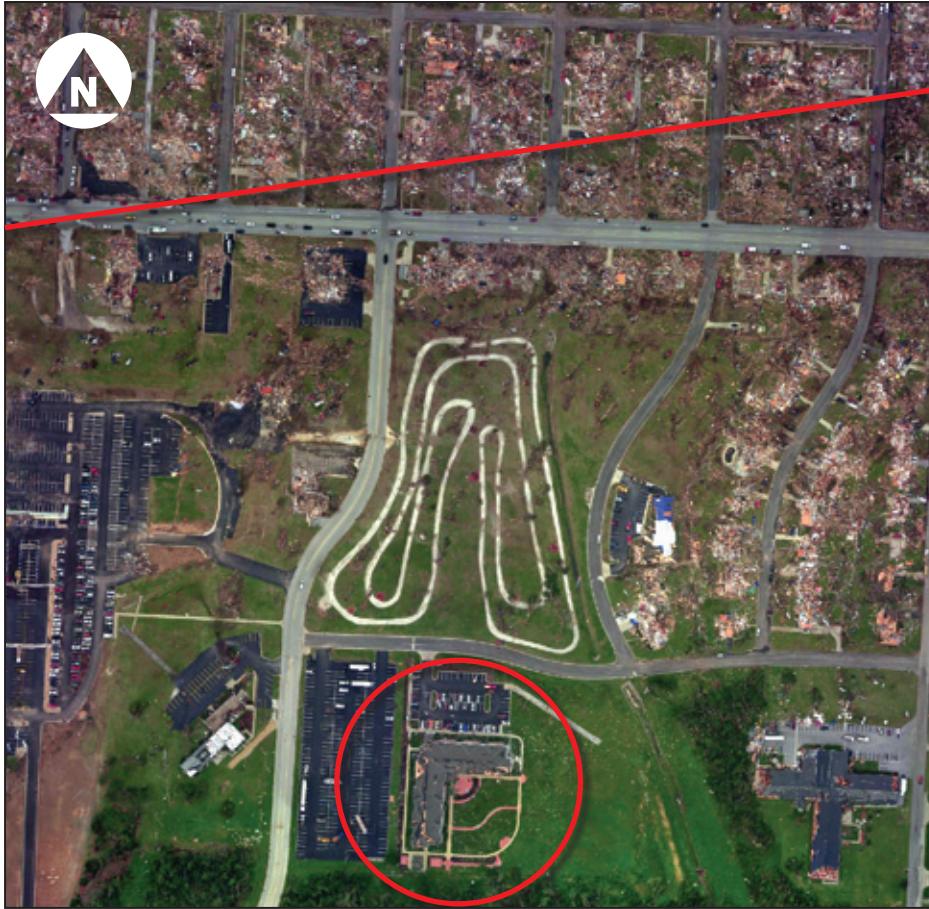
Figure 4-41:
Aerial photograph of Mercy Village (red circle) after the tornado; red line indicates the approximate centerline of the tornado damage swath (Joplin, MO)

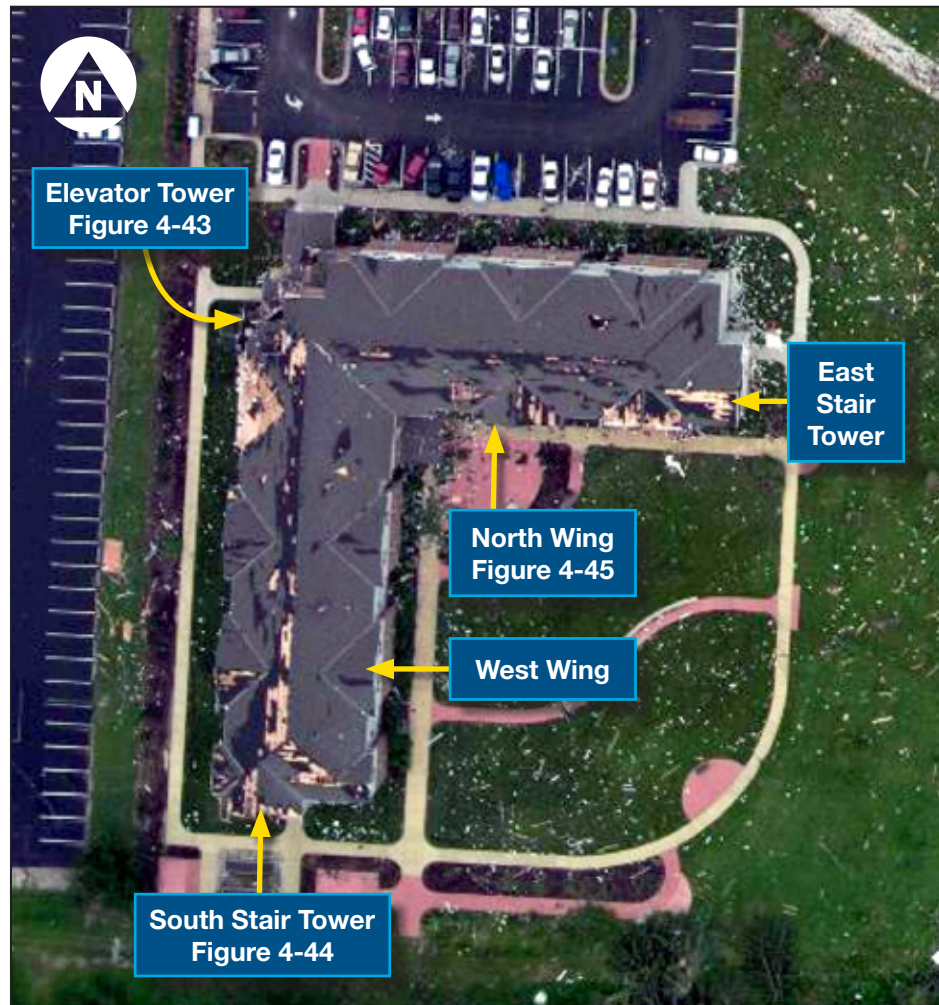
Sections of brick veneer fell off the elevator tower and caused damage to the single-story roof sections around the main entrance, maintenance room, and bathrooms, as shown in Figure 4-43. Aside from the elevator tower, damage to the brick veneer was minimal. The observed brick veneer damage was likely caused by debris impact and did not appear to indicate building movement relative to the foundation (or any significant movement of the building below the third floor). The brick veneer was attached with adjustable wall ties at 16 inches on center vertically and 32 inches on center horizontally as specified.

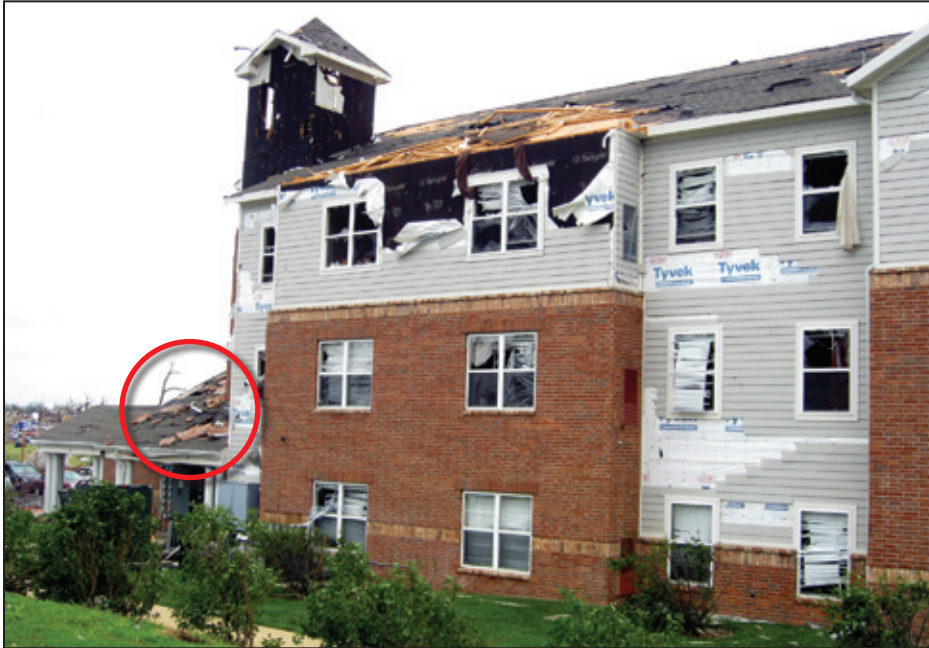
Figure 4-43:
West wall and elevator tower where brick fell off and damaged one-story roof (red circle)
