TORNADO OUTBREAK *of* **2011**

IN ALABAMA, GEORGIA, MISSISSIPPI,
TENNESSEE, AND MISSOURI

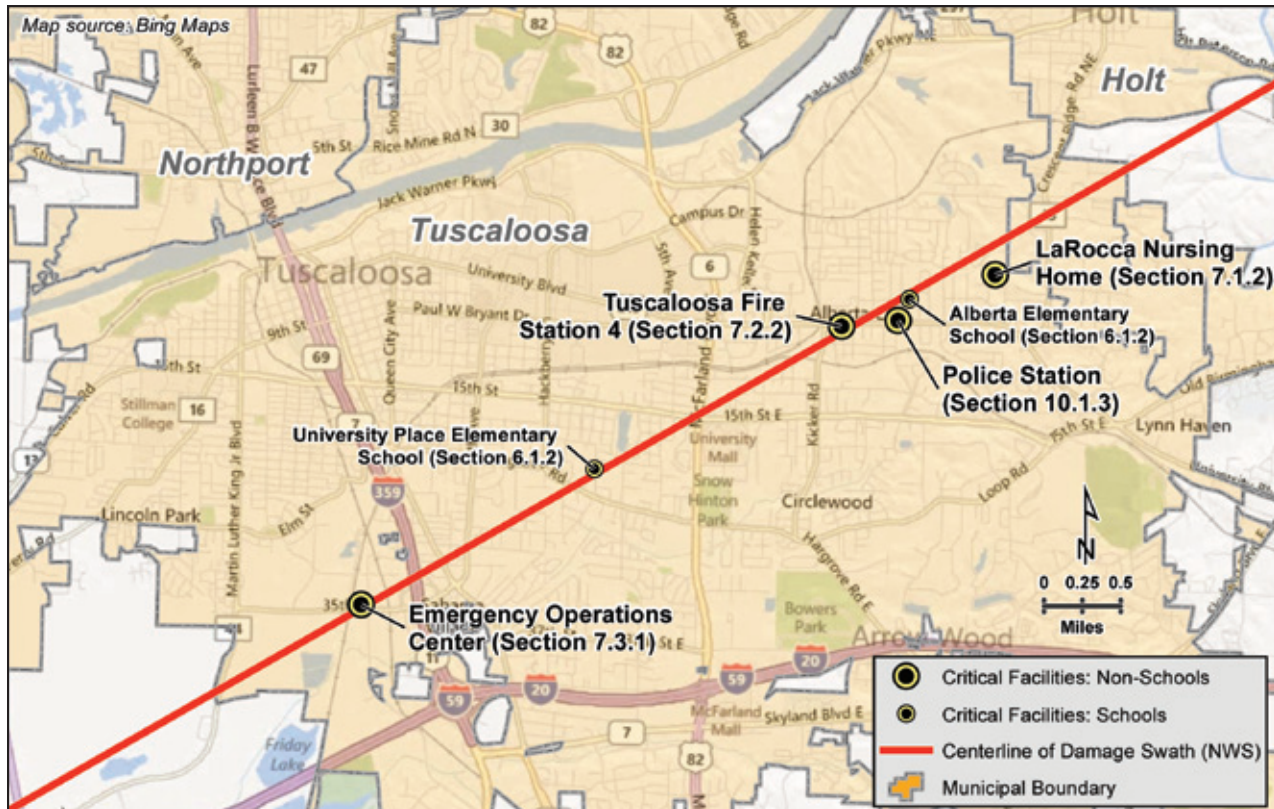
Figure 7-1: Location of Tuscaloosa, AL, critical facilities described in Chapters 6 and 7. The EOC (southwestern end of tornado damage swath shown, red line) is approximately 4.7 miles from the LaRocca Nursing Home (northeastern end of tornado damage swath shown).

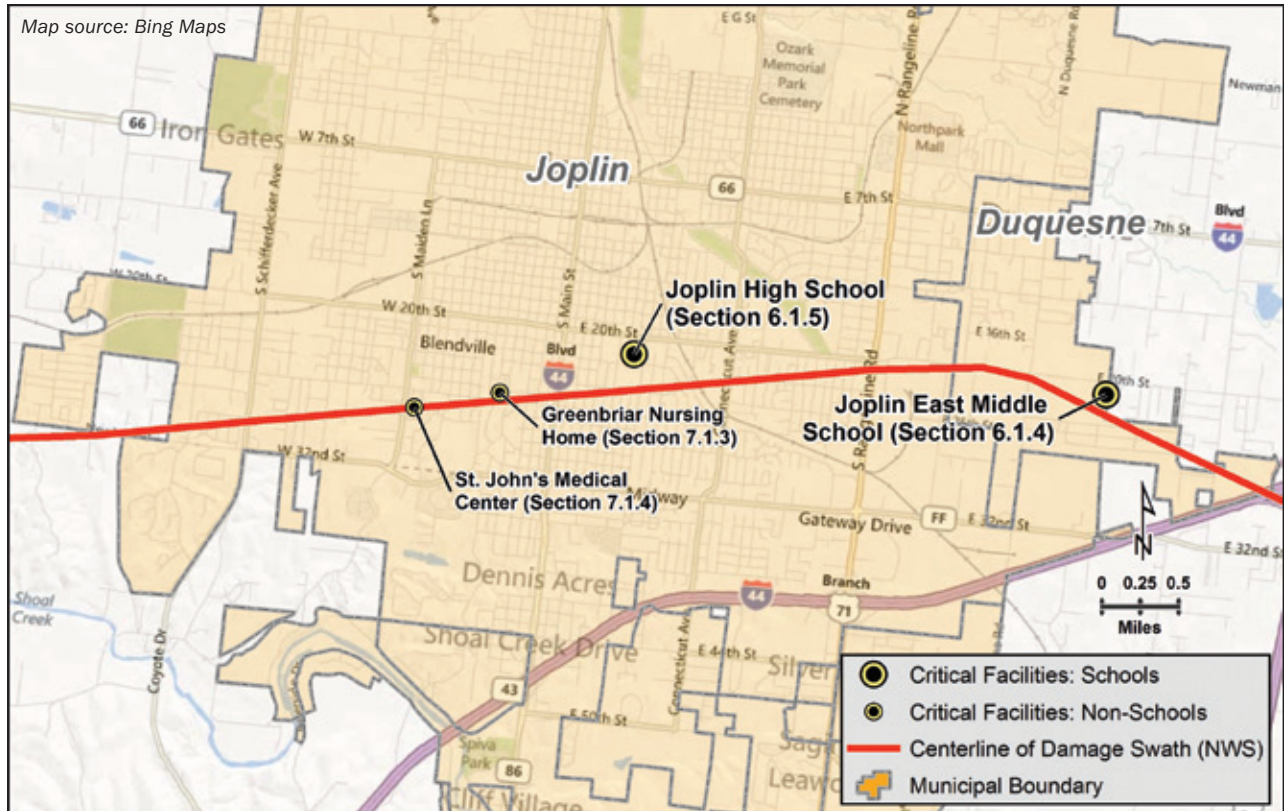
Figure 7-2: Location of Joplin, MO, critical facilities described in Chapters 6 and 7. The St. John's Medical Center (western end of tornado damage swath, red line) is approximately 4.5 miles from the East Joplin Middle School (eastern end of tornado damage swath).

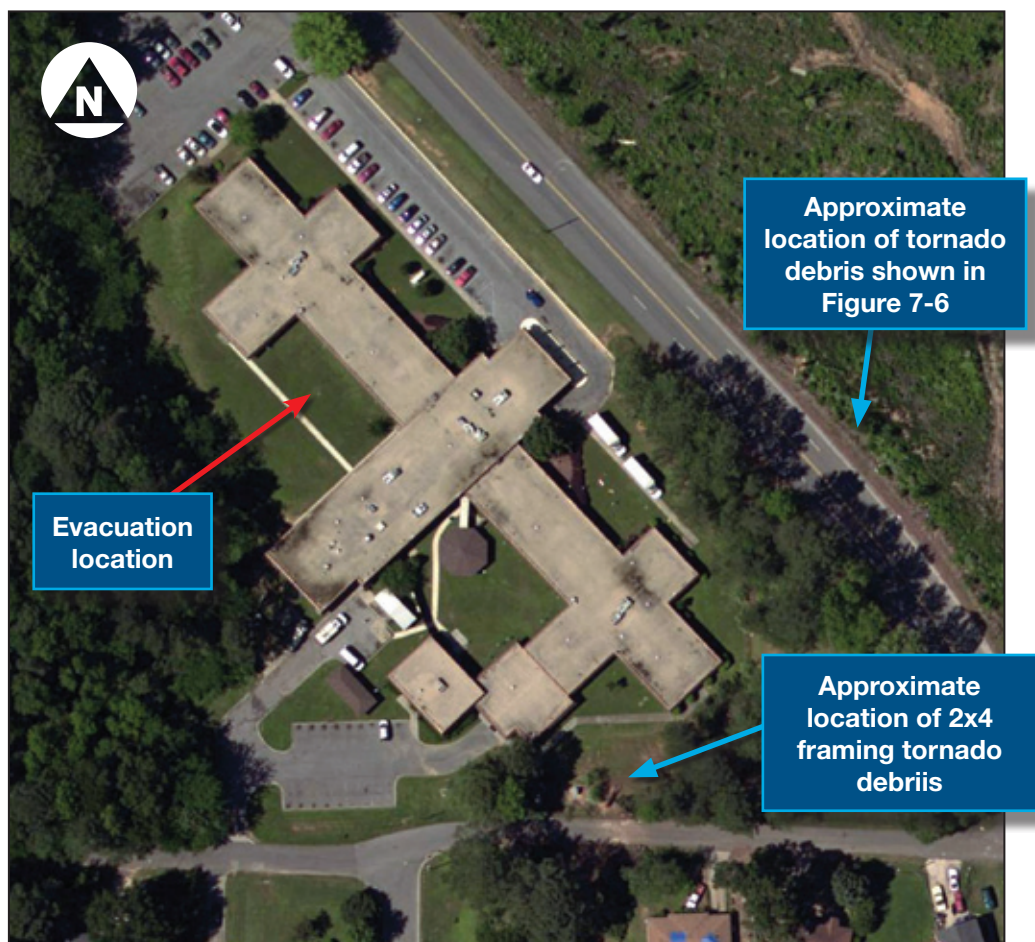
Soon after the facility was evacuated, the facility director realized that a tornado was nearby and on an apparent intercept path with the nursing home (Figure 7-4). The occupants were moved back into the facility corridors, which were designated as the tornado refuge areas for the facility (Figure 7-5).

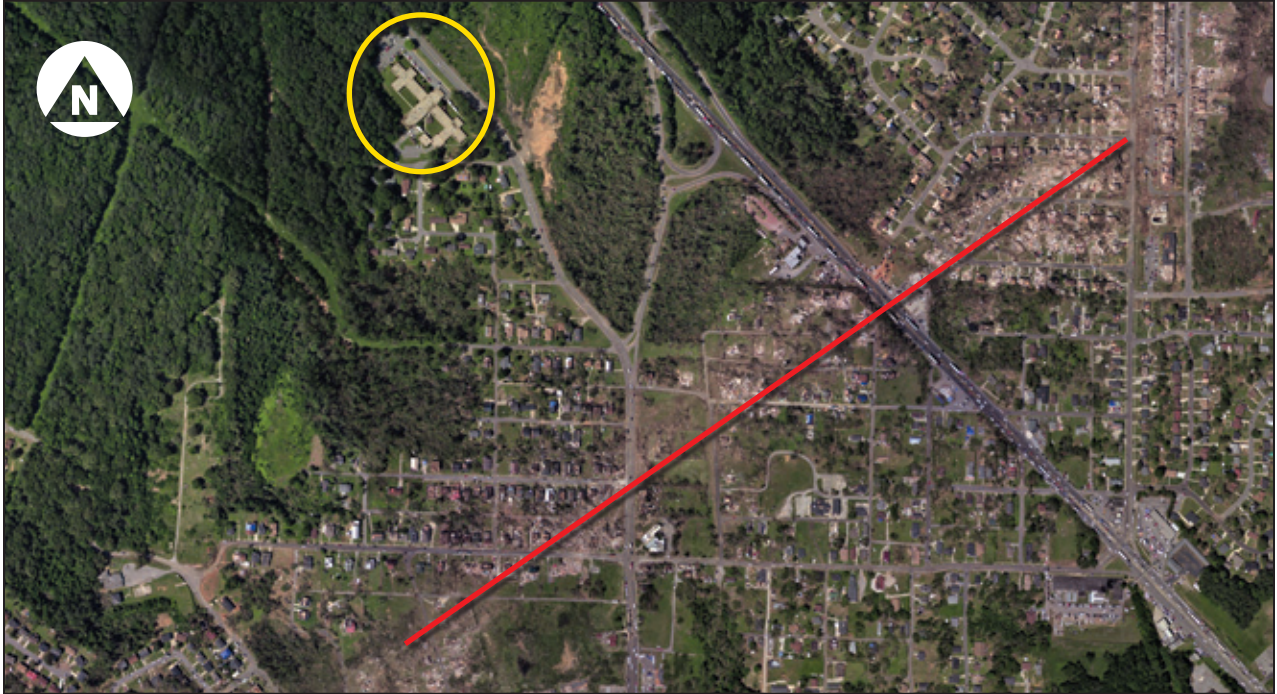
Figure 7-4: Aerial view of the nursing home (yellow circle) in relation to the approximate centerline of the tornado damage swath, shown by the red line¹ (Birmingham, AL)

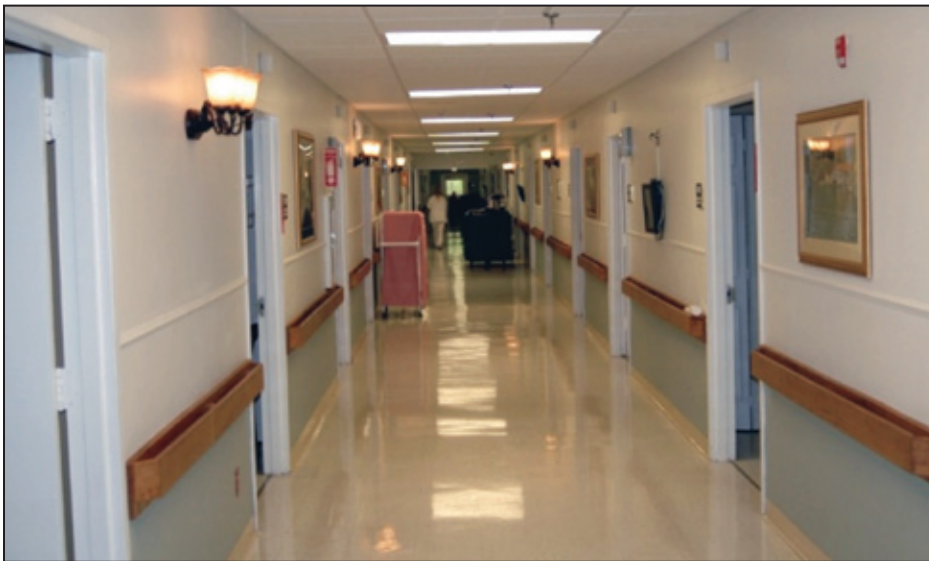
EF contours were not developed by NWS for sites in Birmingham, Tuscaloosa, and Fultondale, AL, and Smithville, MS, described in Chapter 7.

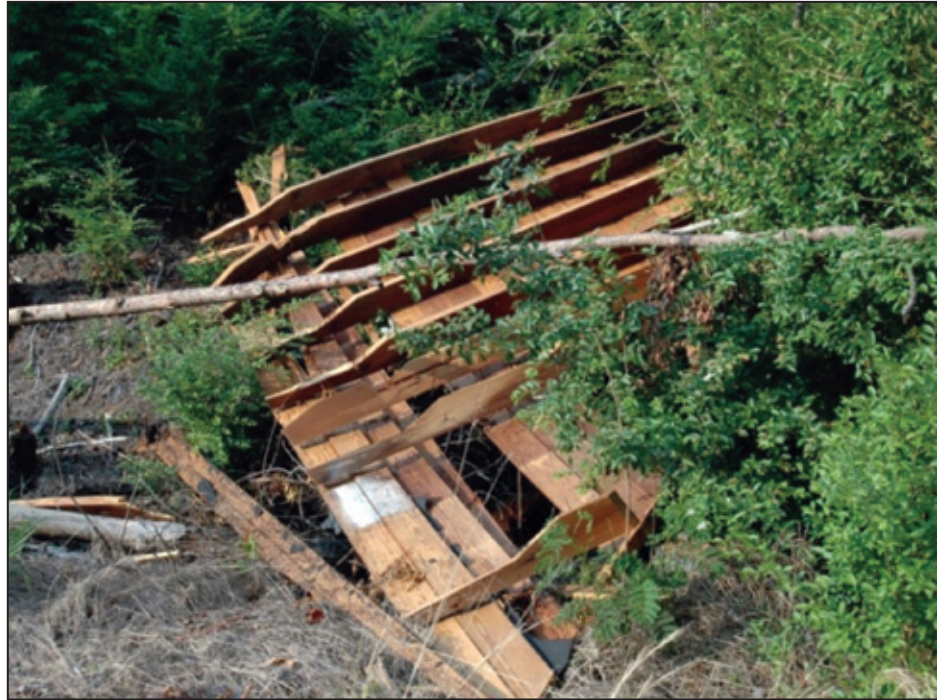
The nursing home had an emergency generator that was located outdoors (Figure 7-7). Although it was not damaged during this event, the generator was susceptible to tree fall and wind-borne debris damage.

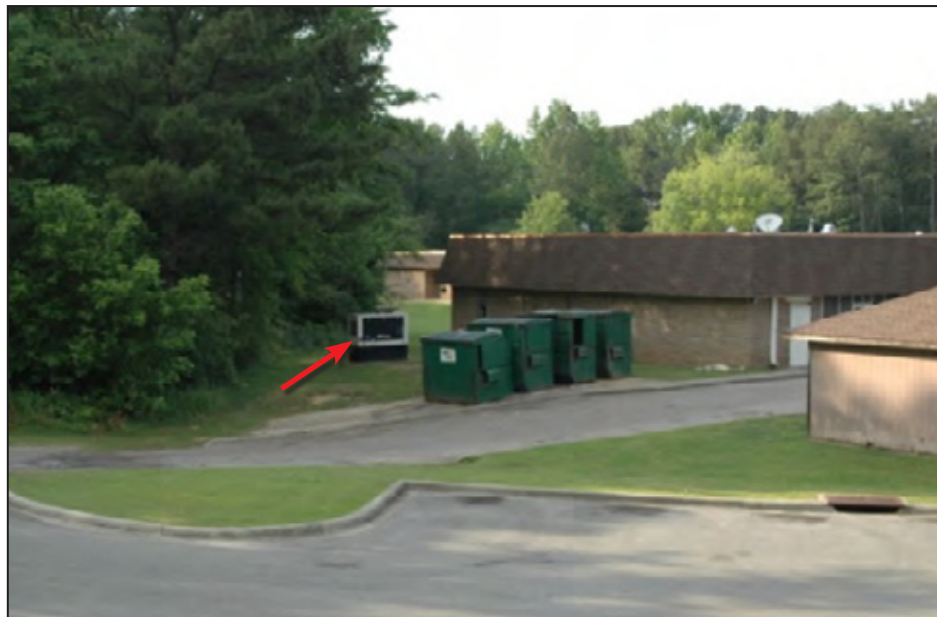
7.1.2 LaRocca Nursing Home (Tuscaloosa, AL)

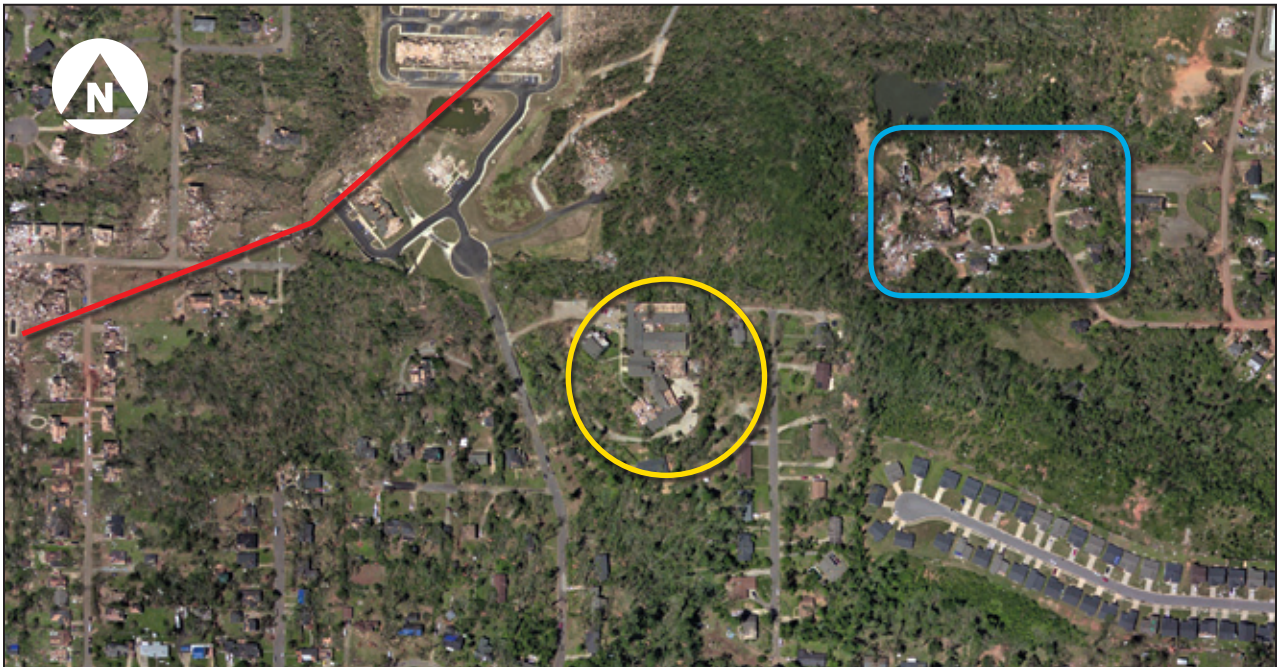
Figure 7-8: Aerial view of the track in the vicinity of the nursing home (yellow circle). The center of the damage swath is approximated by the red line. Inflow damaged the nursing home and buildings within the blue box (Tuscaloosa, AL).

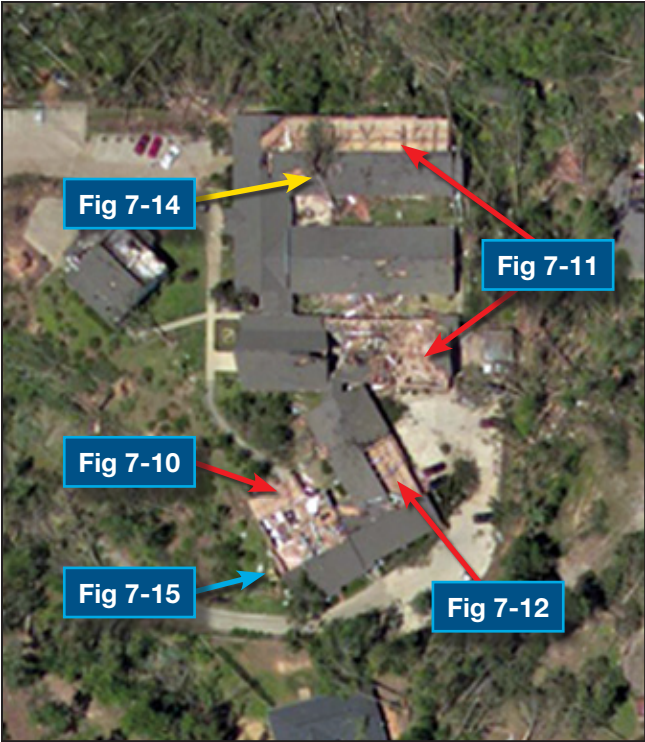
Figure 7-10:
Roof structure and brick veneer were blown off the nursing home (Tuscaloosa, AL)

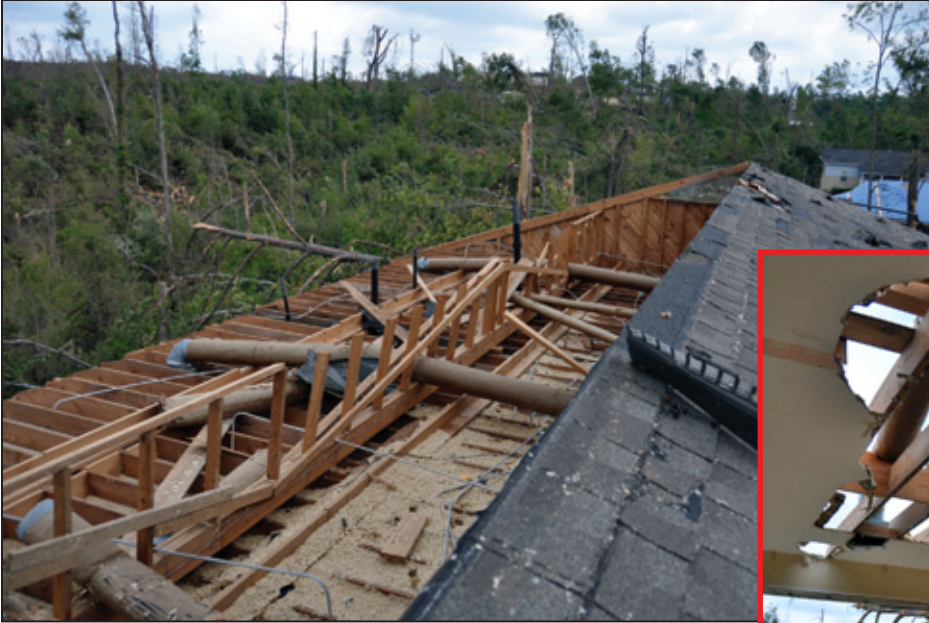
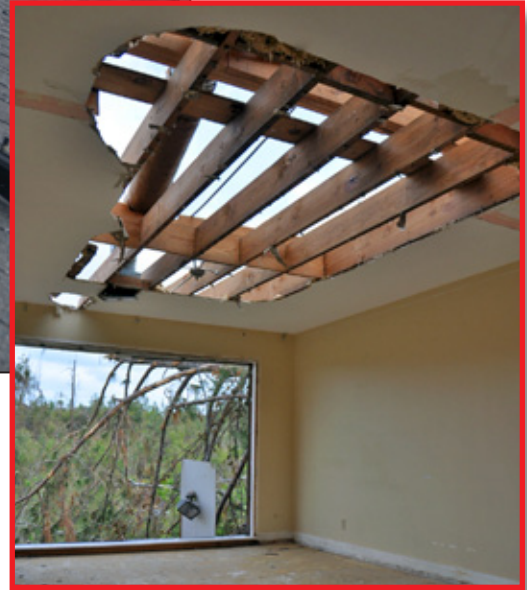
Figure 7-11: Roof structure blown off over resident rooms. The inset is a view from within one of the rooms. The window was broken. (Tuscaloosa, AL).

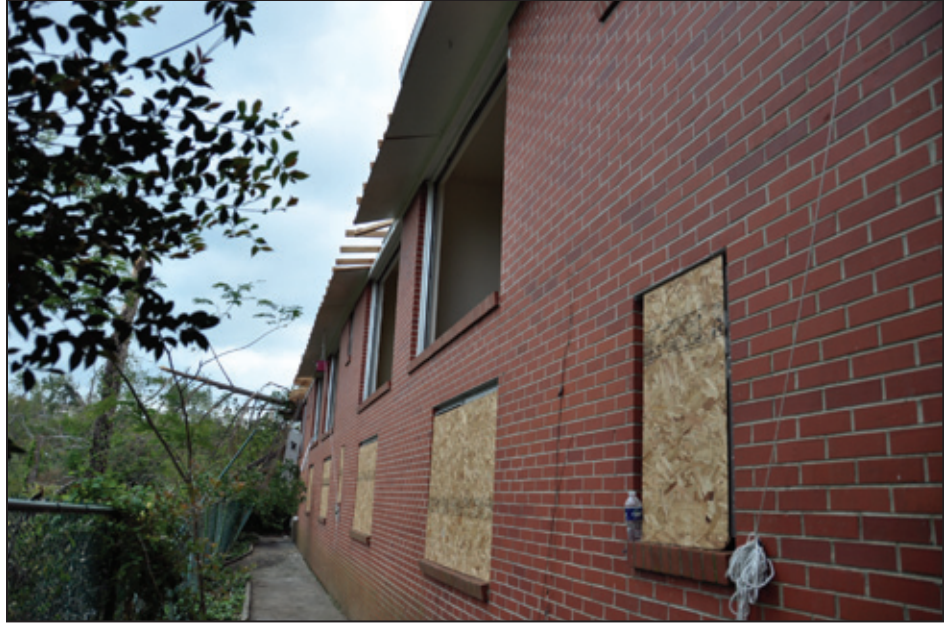
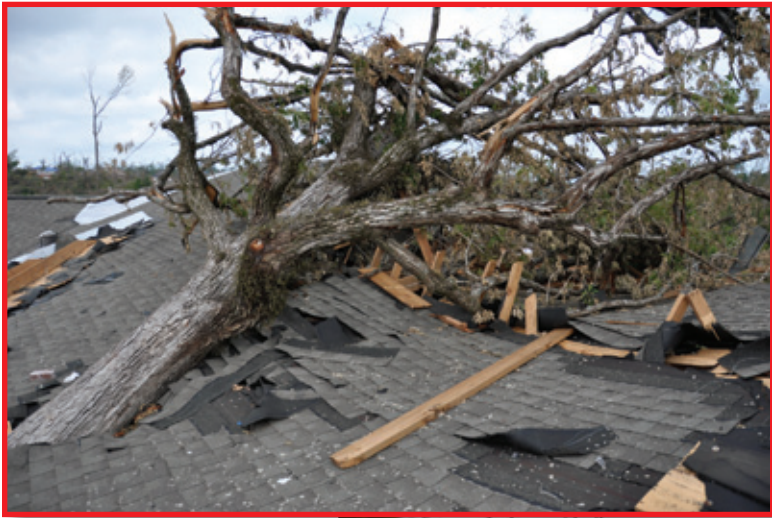
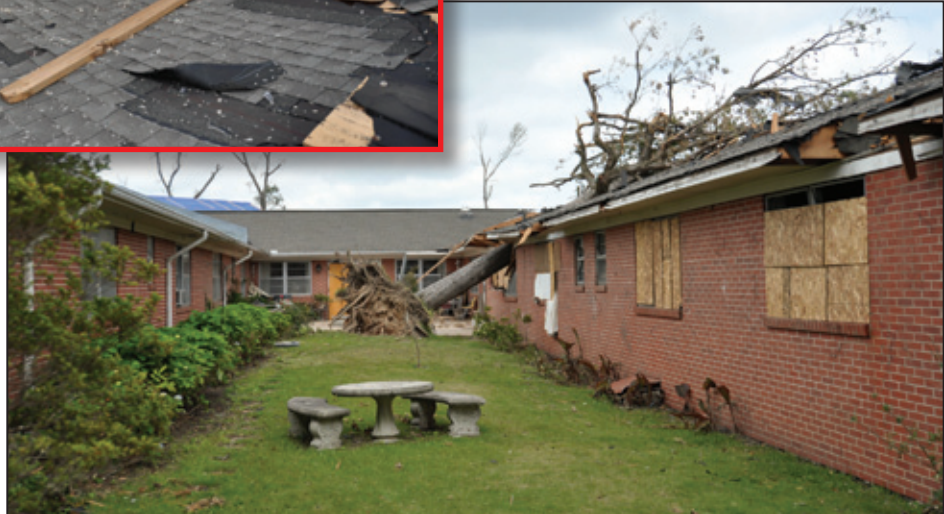
Figure 7-14:
Tree-fall damage. Note the boarded-up broken windows. The inset shows a close-up of the tree-fall damage (Tuscaloosa, AL).

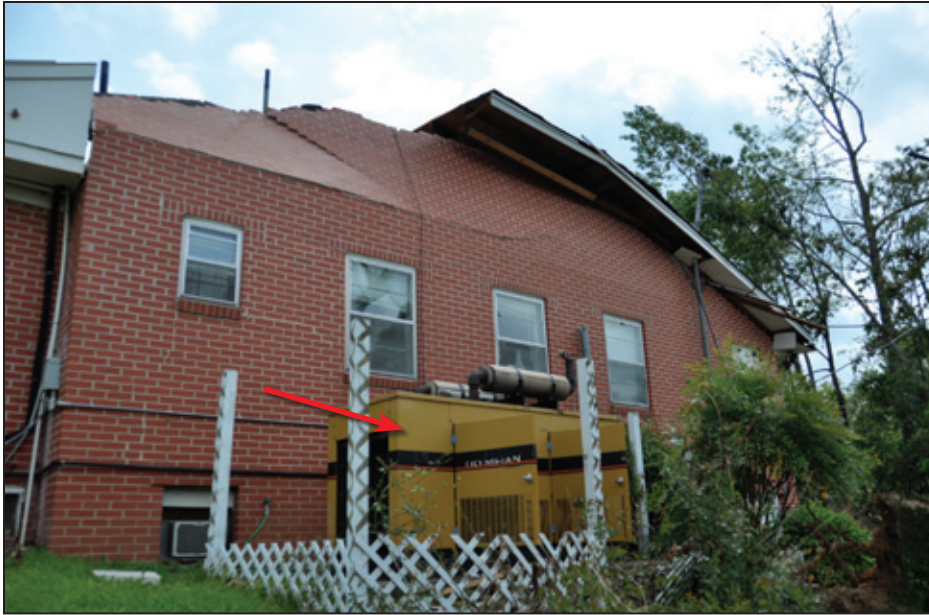
Figure 7-15:
Generator at the southwest side of the facility (red arrow). Note the roof structure blow-off and wall collapse (Tuscaloosa, AL).

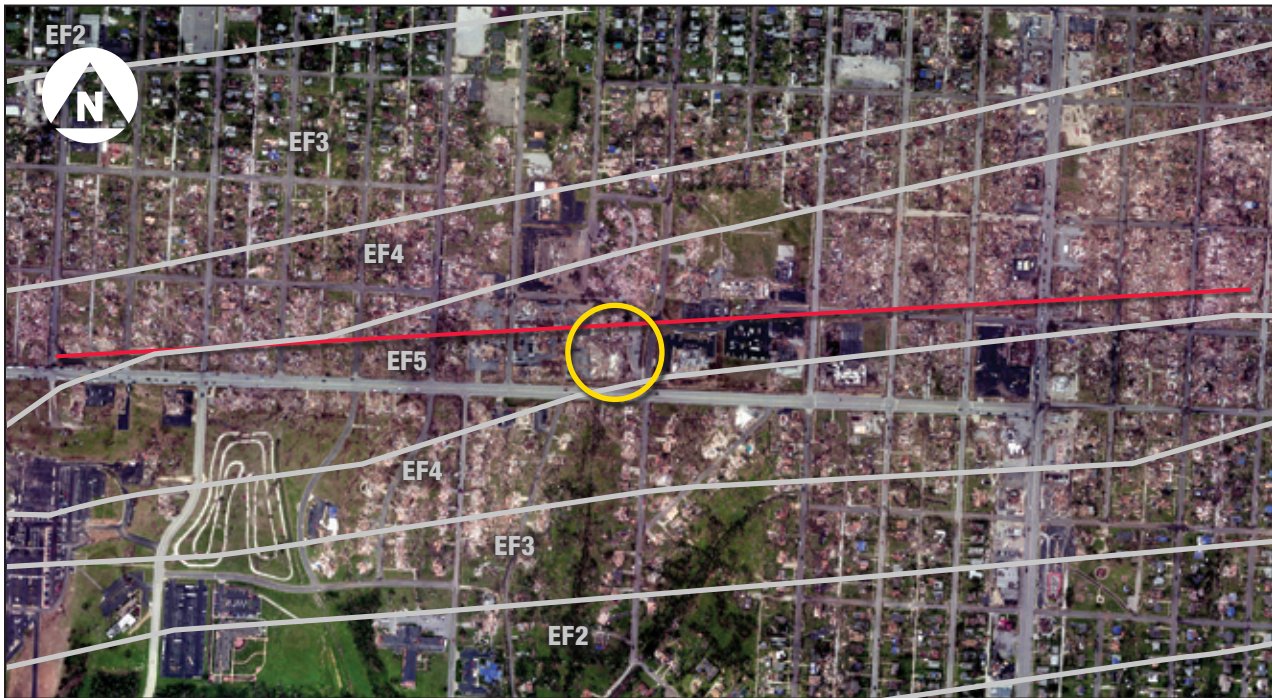
Figure 7-16: Aerial view of the track in the vicinity of the nursing home (yellow circle). The center of the damage swath is approximated by the red line (Joplin, MO).

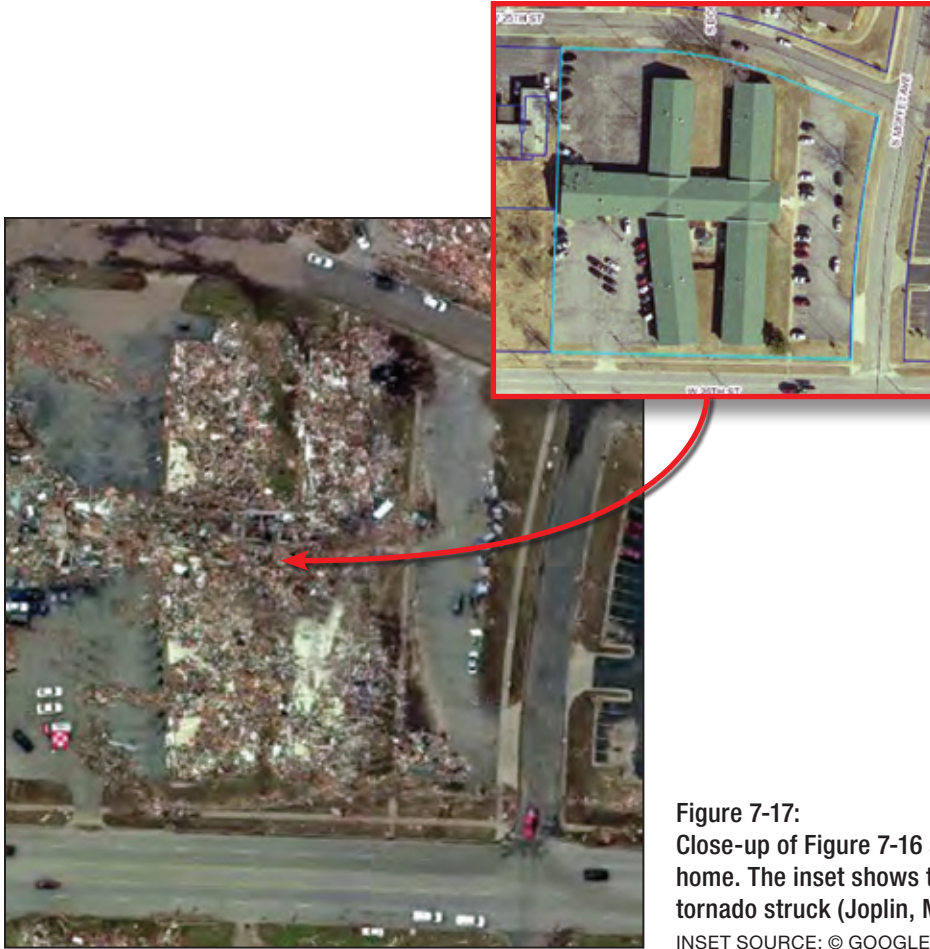
Figure 7-17:
Close-up of Figure 7-16 showing the damaged nursing home. The inset shows the nursing home before the tornado struck (Joplin, MO).

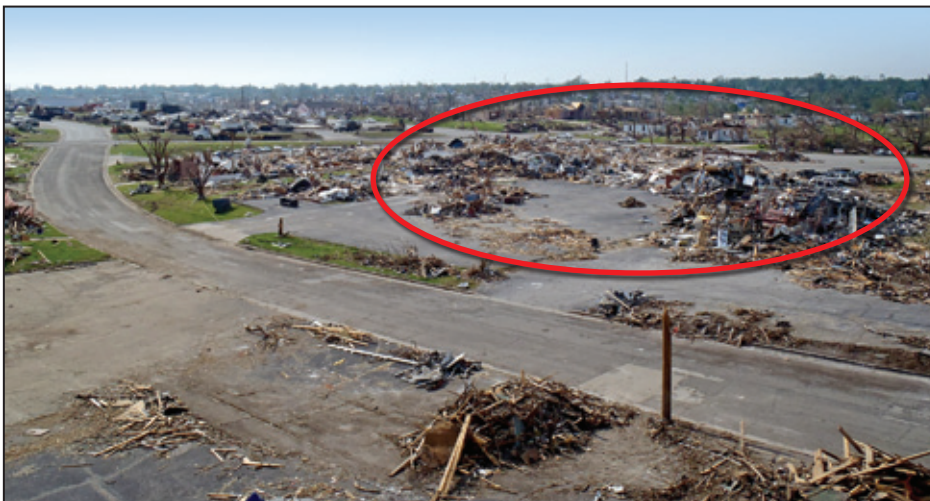
Figure 7-18:
Aerial view of the nursing home (red oval) after the tornado (Joplin, MO)

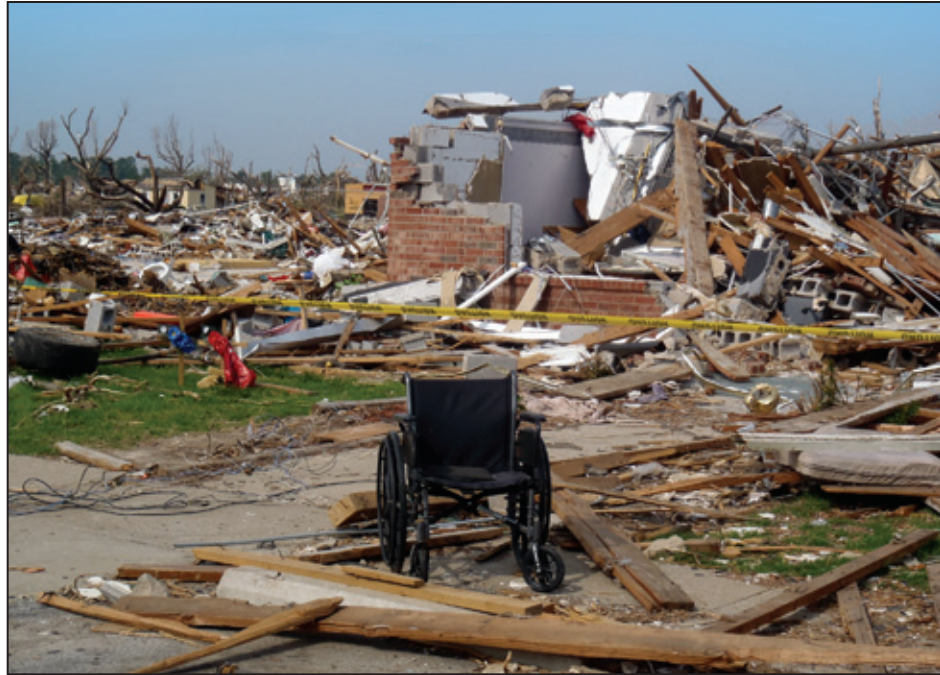
MAT EF Rating: Using DI 9 (Small Professional Building),³ the MAT selected DOD 9 (“total destruction of entire building”) for this facility. Considering the building age and observed damage, the MAT assessed the wind speed as between the expected and lower-bound wind speeds for DOD 9. Hence, the MAT derived the tornado rating as EF3 (136–165 mph) based on damage to this building. Therefore, the estimated wind speed experienced by the building was substantially above the current basic wind speed of 90 mph.

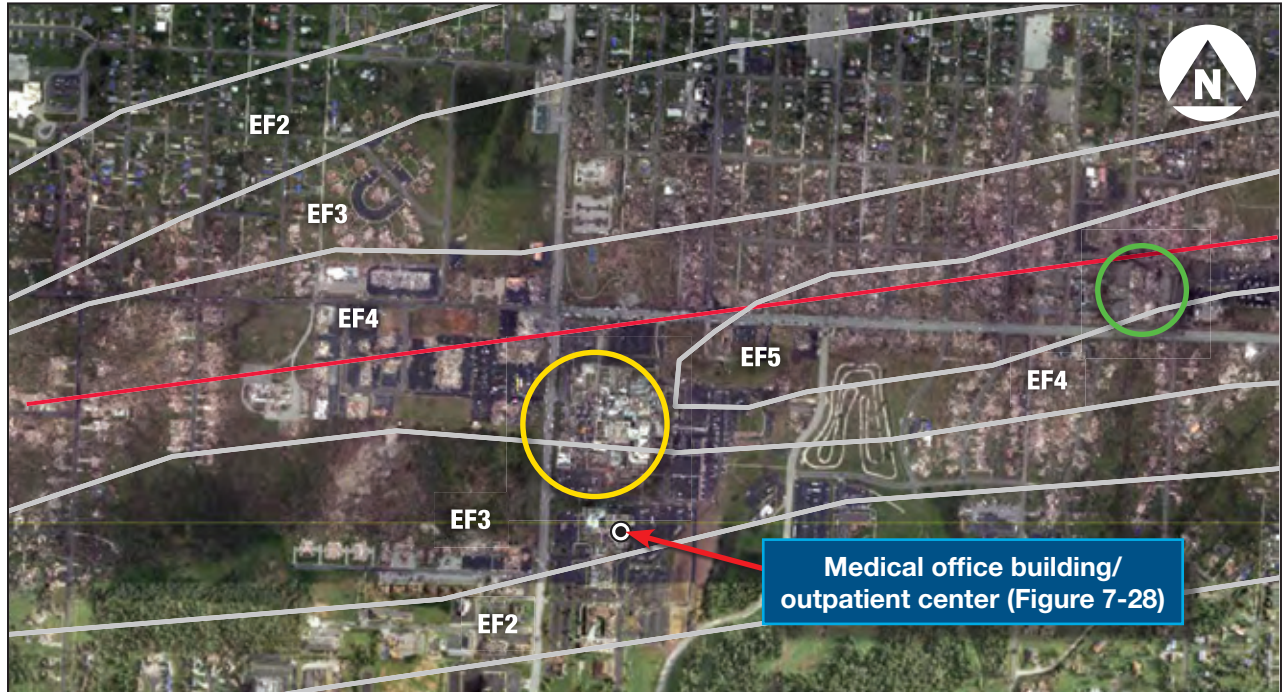
Figure 7-20: Aerial view of the track in the vicinity of the St. John's Medical Center (yellow circle). The blue arrow indicates the medical office building/outpatient center (shown in Figure 7-28). The center of the damage swath is approximated by the red line. The location of Greenbriar Nursing Home (Section 7.1.3) is indicated by the green circle (Joplin, MO).

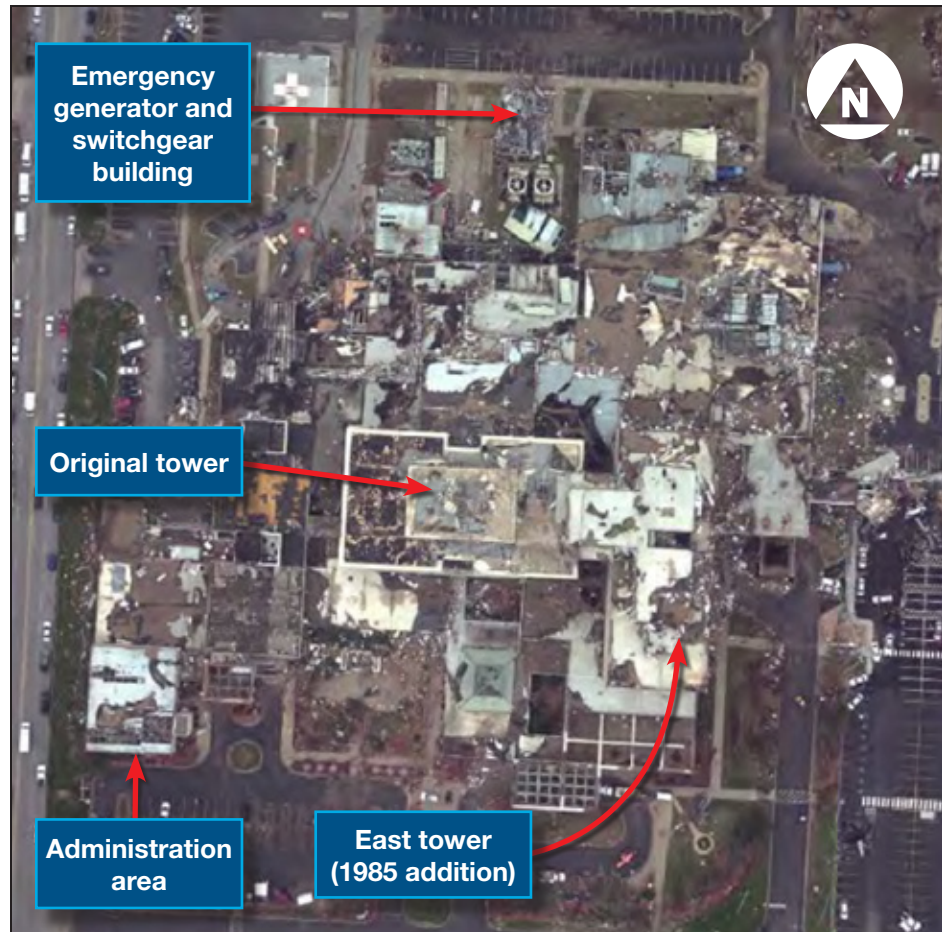
The hospital did not have a tornado safe room or storm shelter. The hospital's tornado procedure entailed moving patients into corridors, except in the ICU, where patients and hospital personnel were to remain in the unit and seek protection to the extent possible. Evacuation sleds were available to help move patients down stairwells and corridors during an emergency in the event elevators were not working.

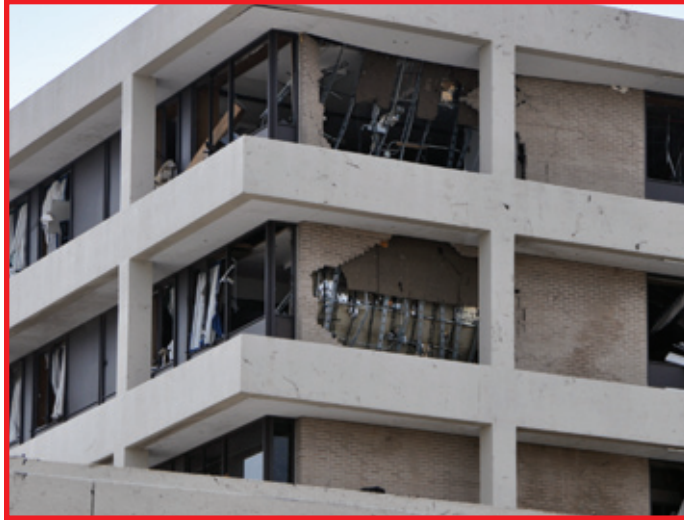
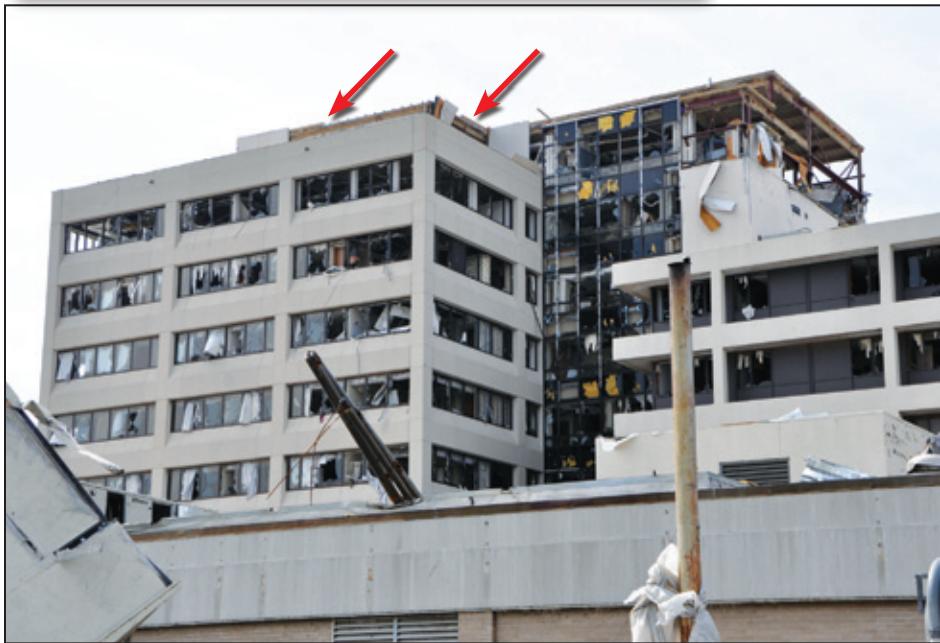
Figure 7-24:
Collapse of a portion of the exterior metal composite foam wall panels at the East Tower addition (red arrows). The inset shows collapsed brick veneer at the Original Tower. Most of the glazing shown in this photograph was broken (Joplin, MO).

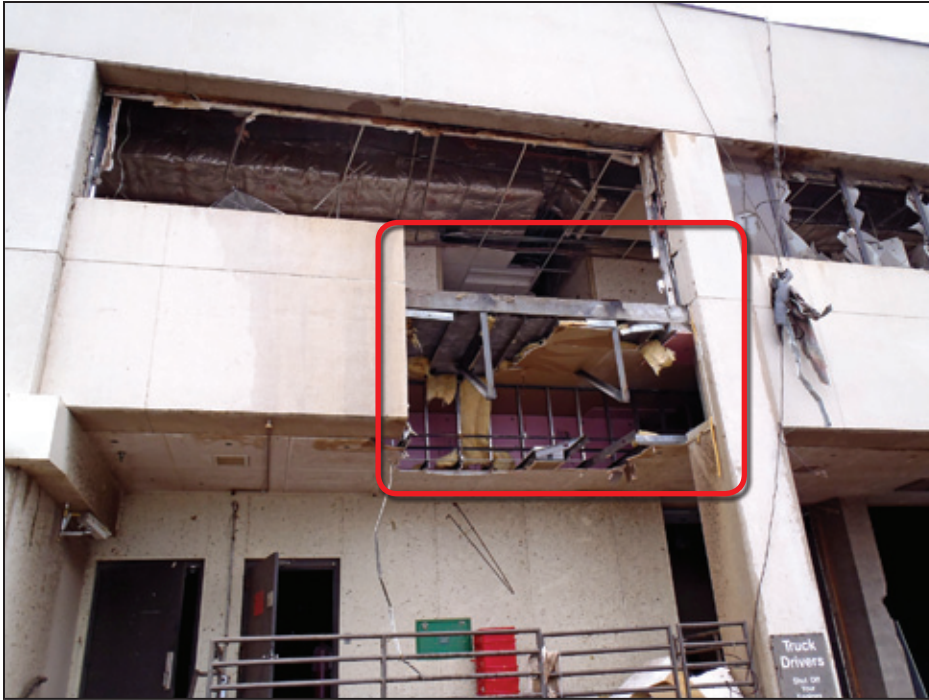
Figure 7-25:
View of a missing precast
concrete wall panel (red box)
at the loading dock
(Joplin, MO)

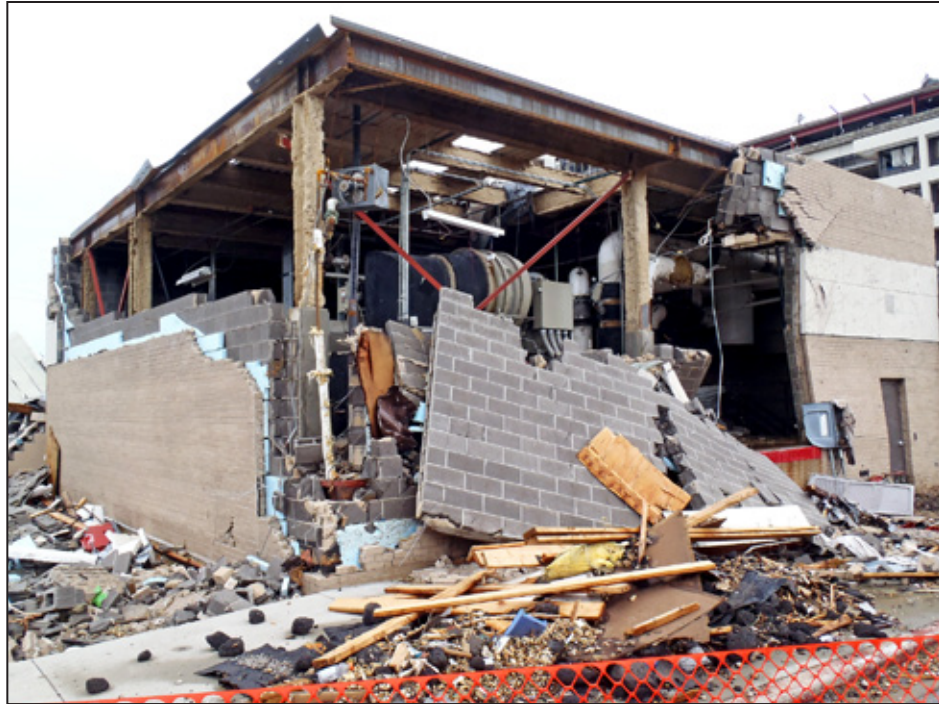
The water main and natural gas lines had been labeled at some point prior to the tornado and were closed soon after the event, thereby avoiding flooding, fire, and explosion.

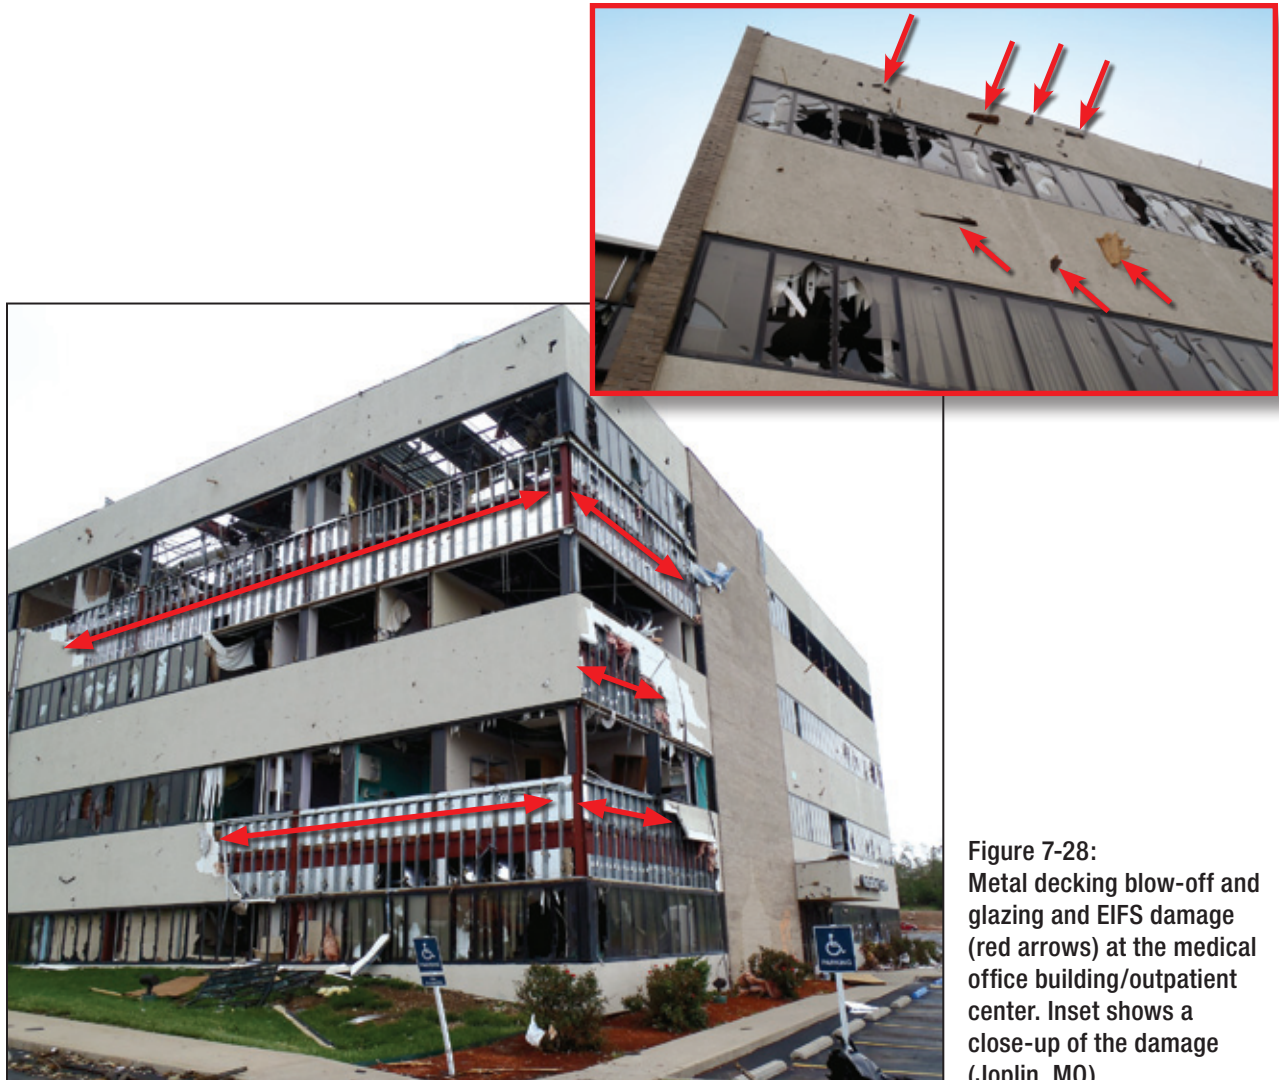
Figure 7-28: Metal decking blow-off and glazing and EIFS damage (red arrows) at the medical office building/outpatient center. Inset shows a close-up of the damage (Joplin, MO).

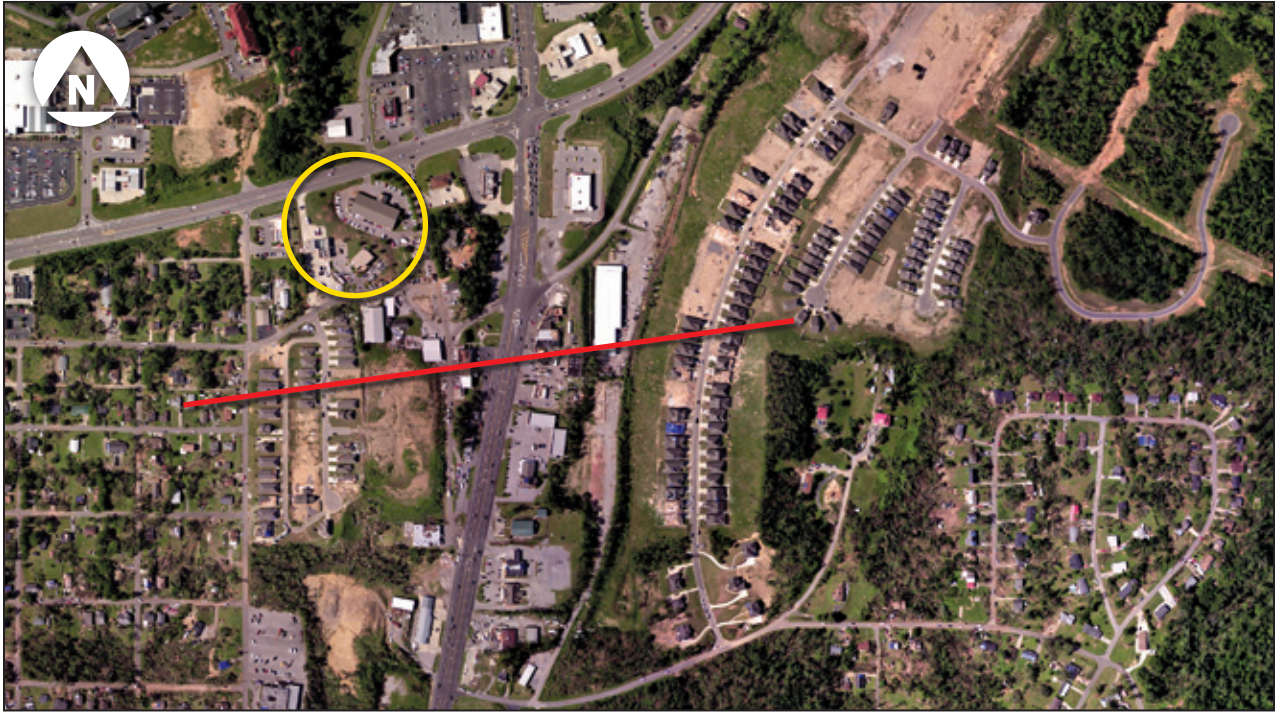
Figure 7-29: Aerial view of tornado track in the vicinity of Fultondale Municipal Complex in Alabama (yellow circle). The center of the damage swath is approximated by the red line (Fultondale, AL).

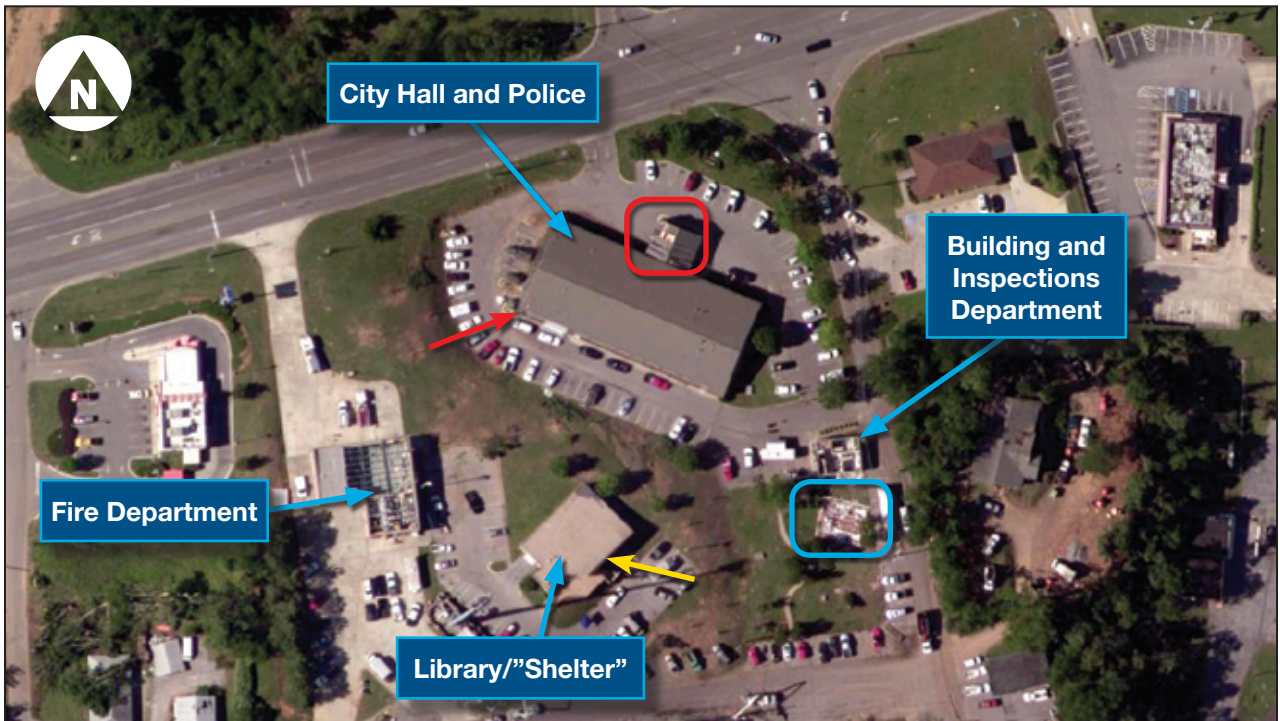
Figure 7-30: Tornado winds damaged an emergency generator (red arrow) and a roof (red box), and lifted a roof (final location shown by blue box). Yellow arrow shows the “shelter” entrance (Fultondale, AL).

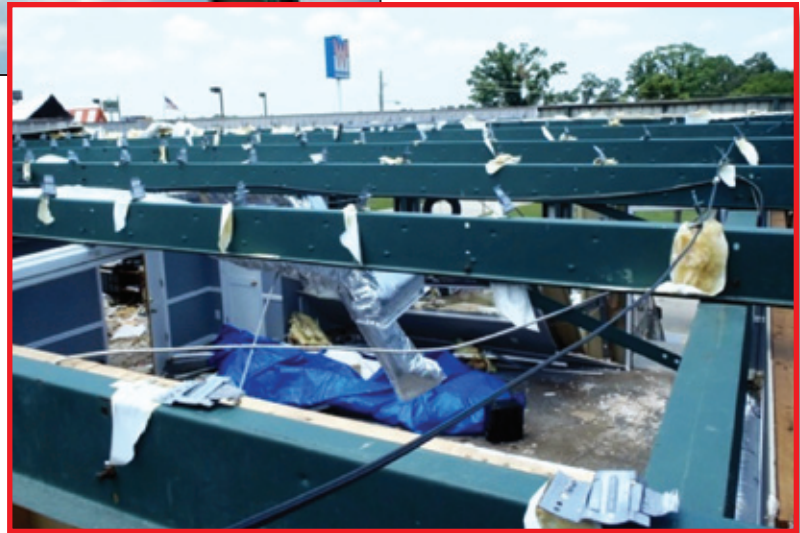
7.2.1.2 Library and “Shelter”

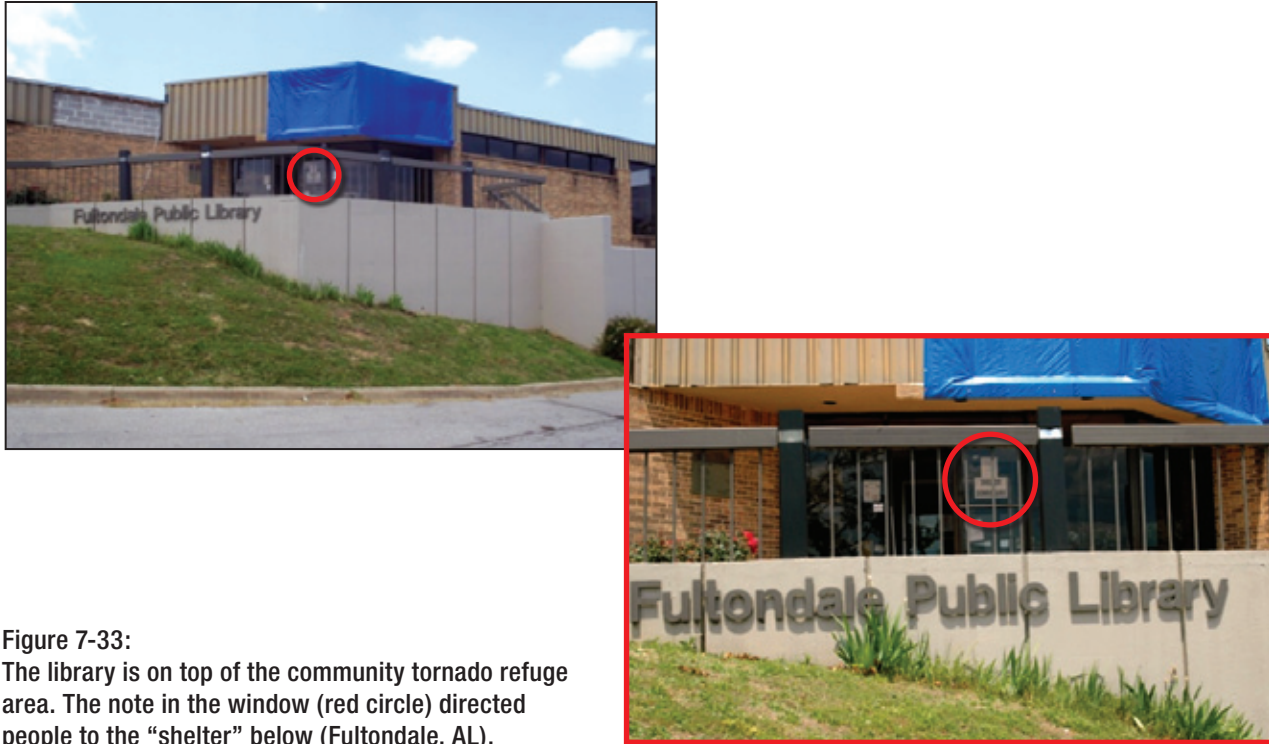
Figure 7-33:
The library is on top of the community tornado refuge area. The note in the window (red circle) directed people to the “shelter” below (Fultondale, AL).
