TORNADO OUTBREAK *of* **2011**

IN ALABAMA, GEORGIA, MISSISSIPPI,
TENNESSEE, AND MISSOURI

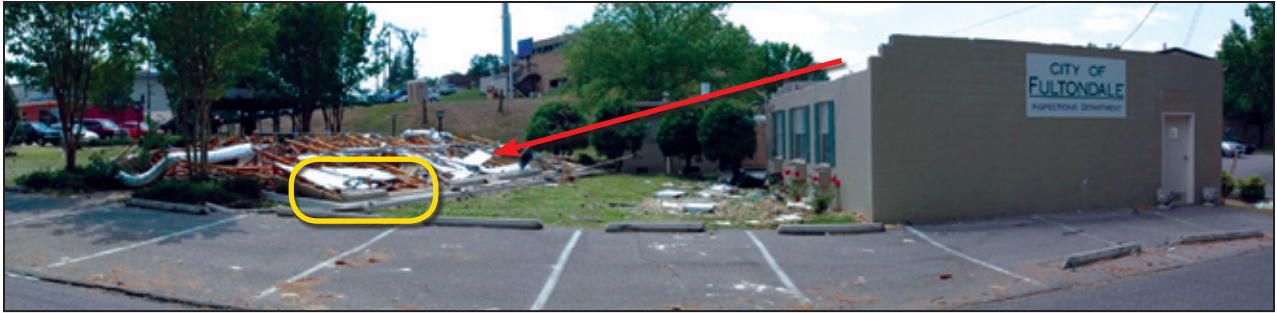
Figure 7-34: The roof structure of the Buildings and Inspections Department building blew off in one complete section (red arrow). The yellow oval area is shown in Figure 7-35 (Fultondale, AL).

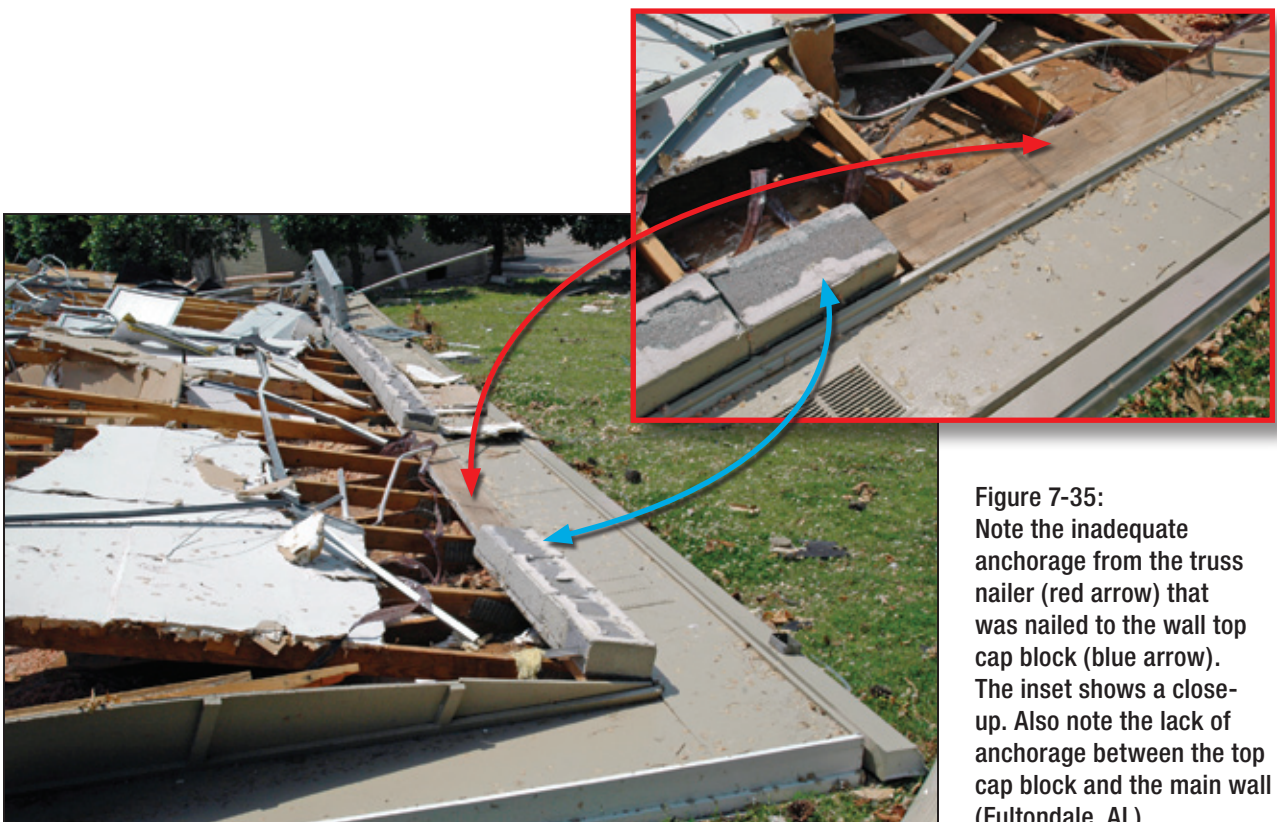
Figure 7-35: Note the inadequate anchorage from the truss nailer (red arrow) that was nailed to the wall top cap block (blue arrow). The inset shows a close-up. Also note the lack of anchorage between the top cap block and the main wall (Fultondale, AL).

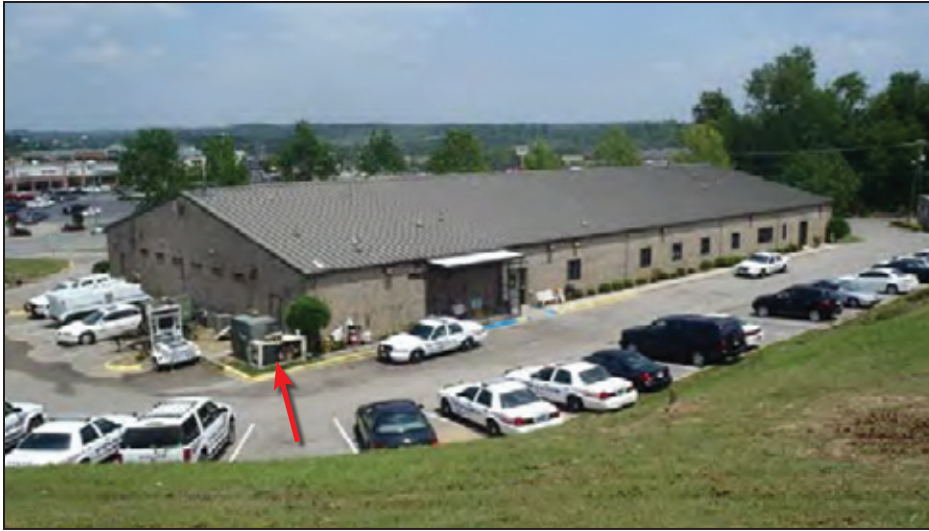
Figure 7-37:
Back of the City Hall. The red arrow points to the generator that was disabled by a fallen tree (Fultondale, AL).

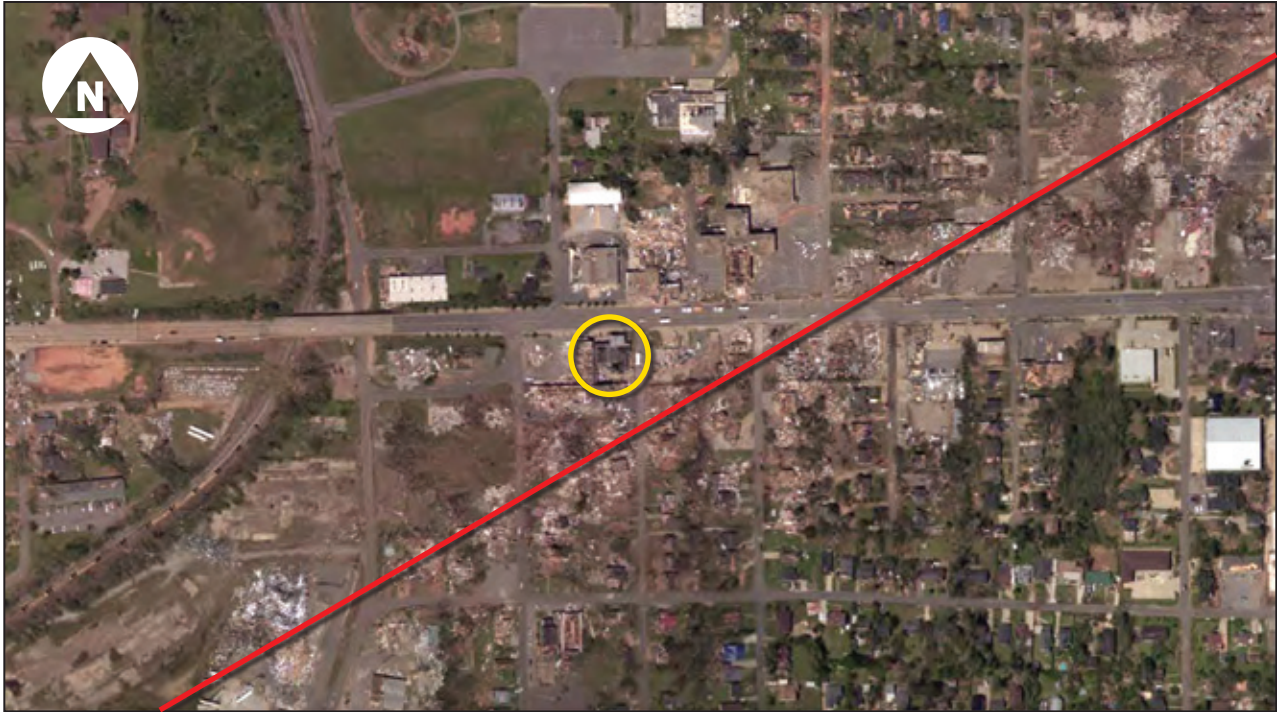
Figure 7-38: Aerial view of the track in the vicinity of the fire station (yellow circle). The center of the damage swath is approximated by the red line (Tuscaloosa, AL).

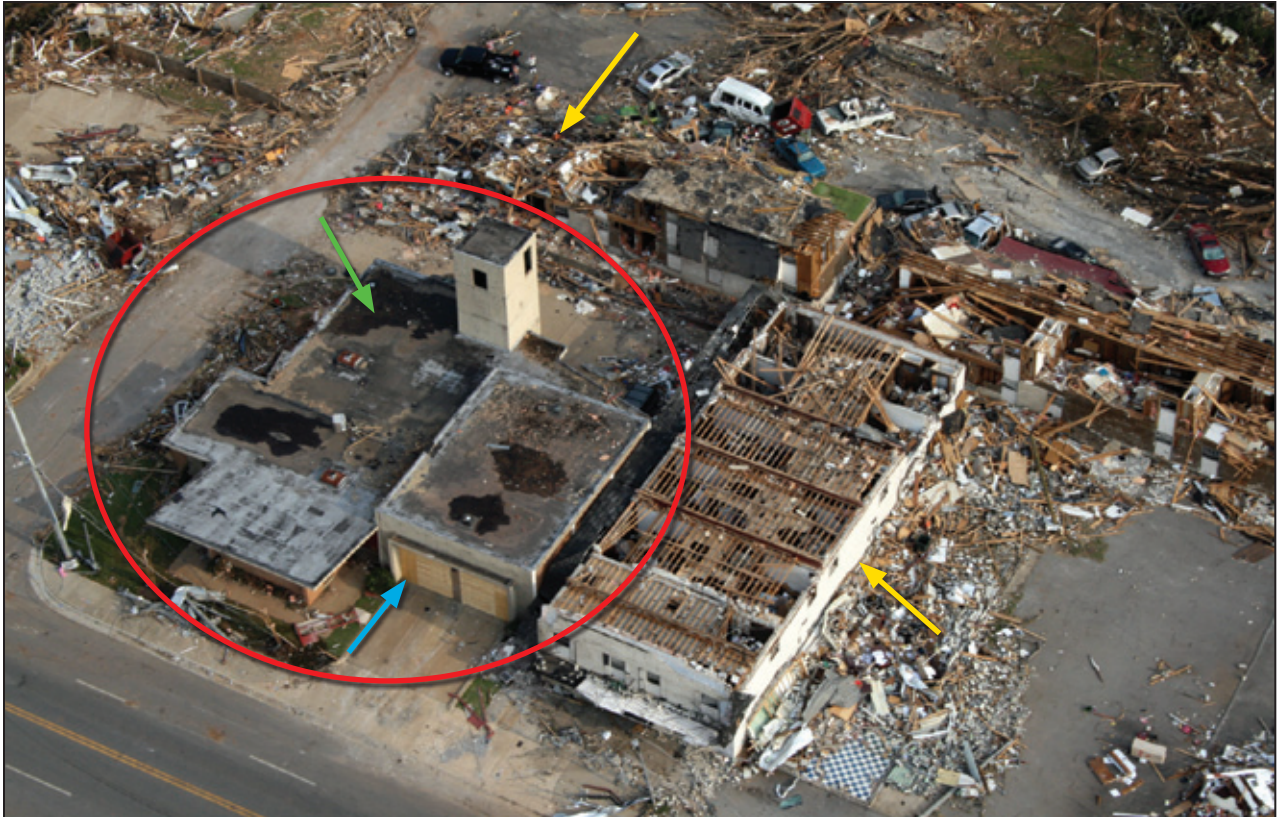
Figure 7-39: The fire station is within the red circle. The apparatus bay is indicated by the blue arrow, and the living quarters are indicated by the green arrow. The yellow arrows indicate the nearby heavily damaged apartment buildings (Tuscaloosa, AL).

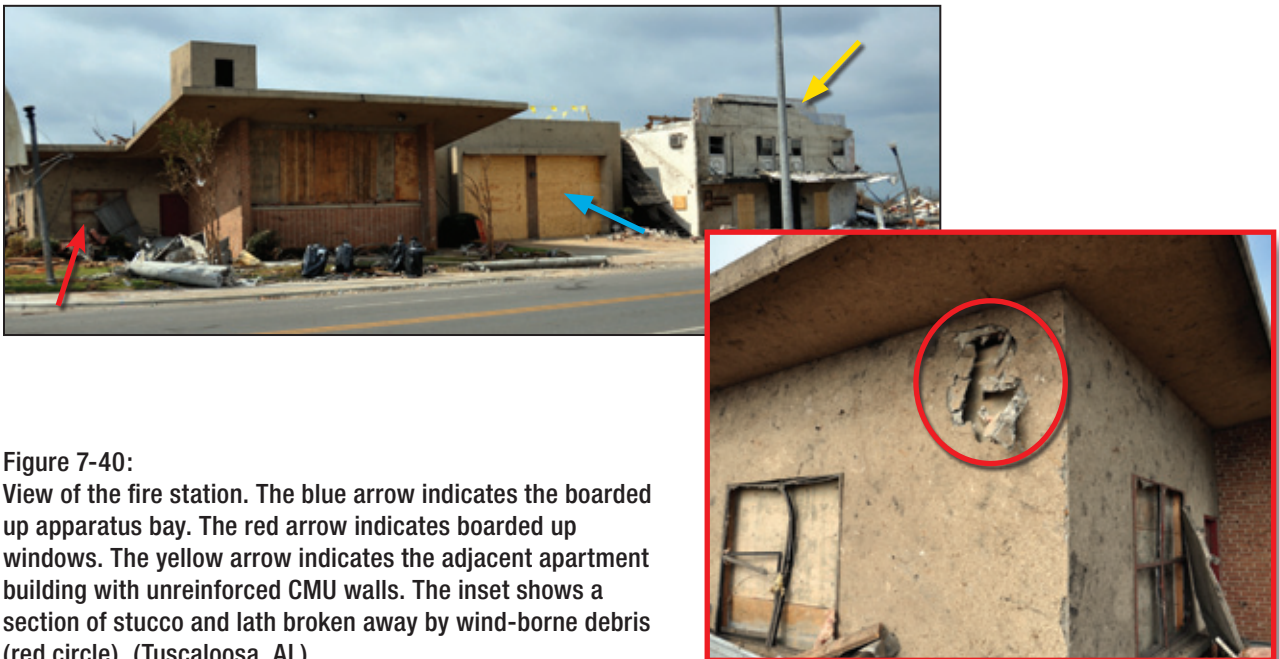
Figure 7-40: View of the fire station. The blue arrow indicates the boarded up apparatus bay. The red arrow indicates boarded up windows. The yellow arrow indicates the adjacent apartment building with unreinforced CMU walls. The inset shows a section of stucco and lath broken away by wind-borne debris (red circle). (Tuscaloosa, AL).

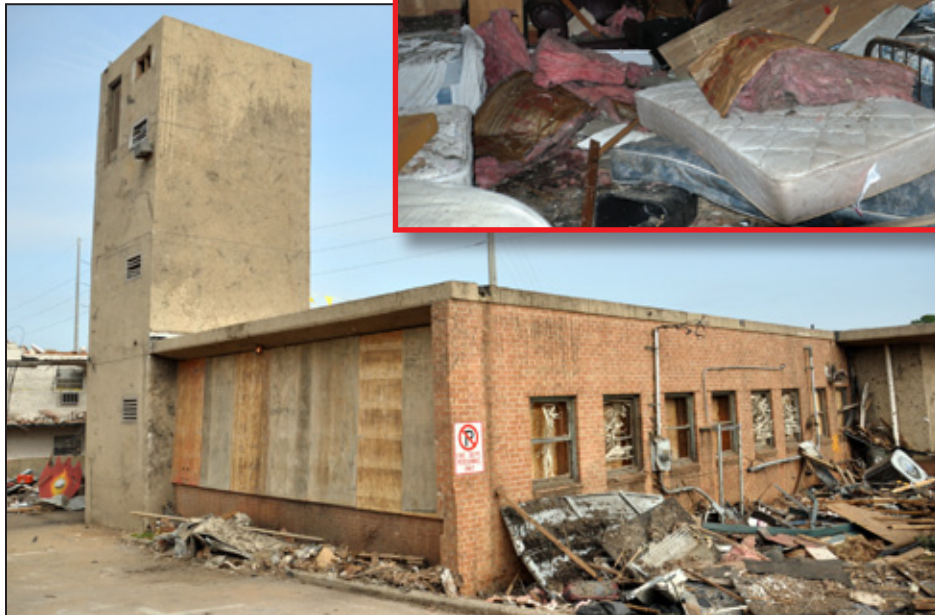
Figure 7-42:
View of a restroom toward the center of the fire station where occupants took refuge. Note the mattress that was taken into the room for additional protection (Tuscaloosa, AL).

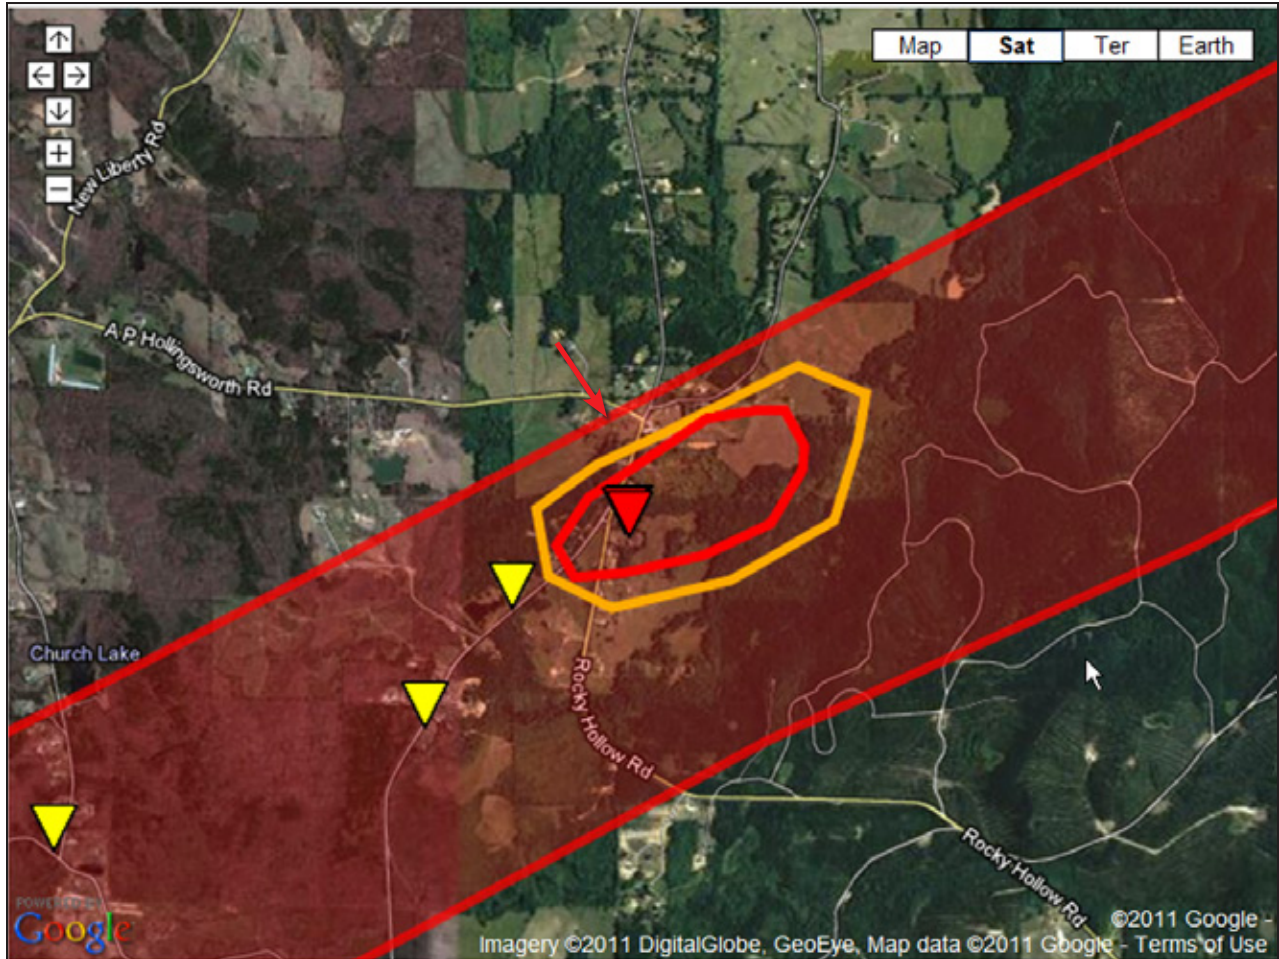
Figure 7-44: View of the Webster's Chapel Volunteer Fire Department (red arrow) in relation to the tornado.⁶ The red triangle indicates the location of two houses where NWS rated the tornado as EF4. The yellow triangles indicate the locations of houses where NWS rated the tornado as EF2 (Wellington, AL).

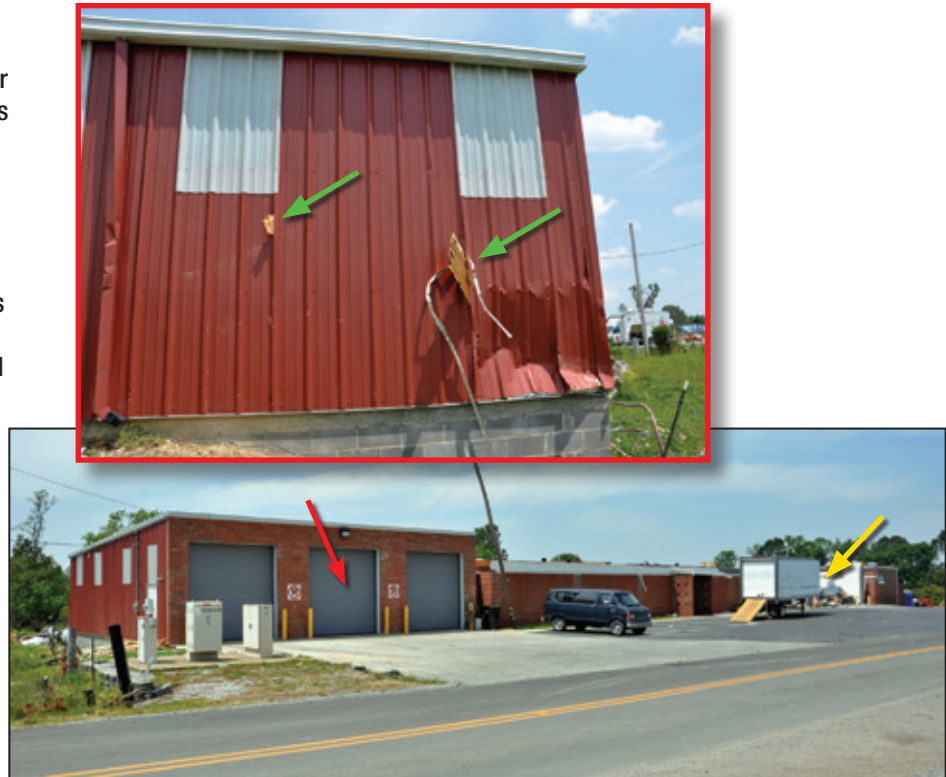
Figure 7-46:
View of the old apparatus bay of the Webster’s Chapel Volunteer Fire Department. The multipurpose room is indicated by the red arrow (Wellington, AL).

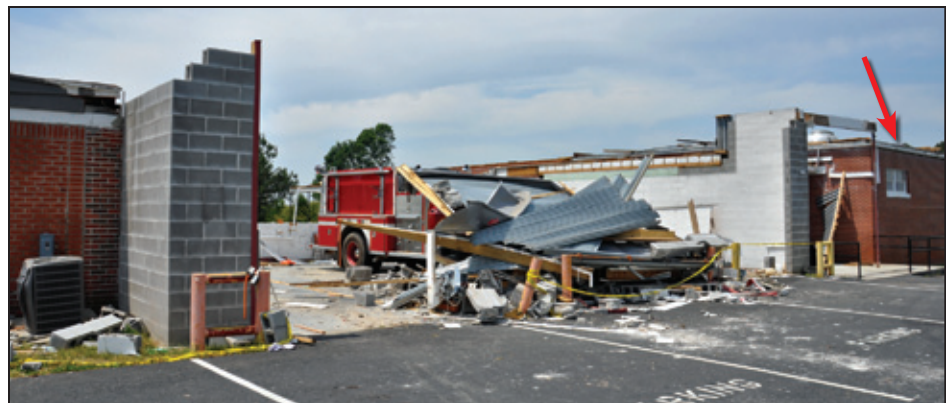
Figure 7-47:
View of the back of the building. The old apparatus bay is shown by the yellow arrow and the new bay by the red arrow. Roof structure and wall damage occurred within the red box. The debris in the foreground is from the multipurpose room roof and the old apparatus bay (Wellington, AL).

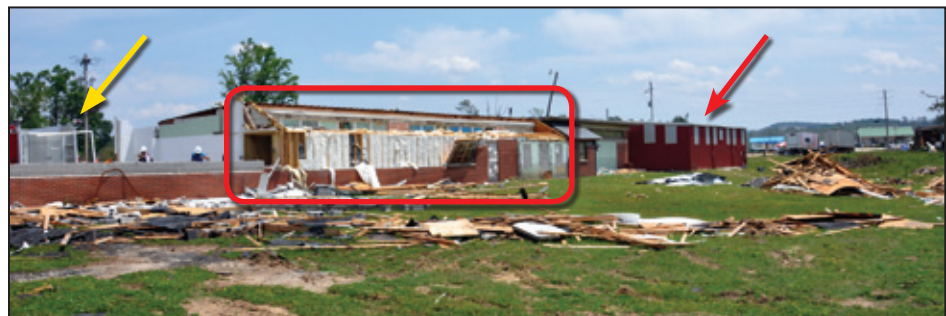
MAT EF Rating: Only the old apparatus bay portion of the facility was rated. Using DI 14 (Automobile Service Building),⁷ the MAT selected DOD 6 (“uplift or collapse of roof structure”) for this facility. Considering the facility age and observed damage, the MAT assessed the wind speed as near the lower-bound wind speed for DOD 6. Hence, the MAT derived the tornado rating as EF1 (86–110 mph) based on damage to this building. Therefore, the estimated wind speed experienced by the building was not substantially above the current basic wind speed of 90 mph.

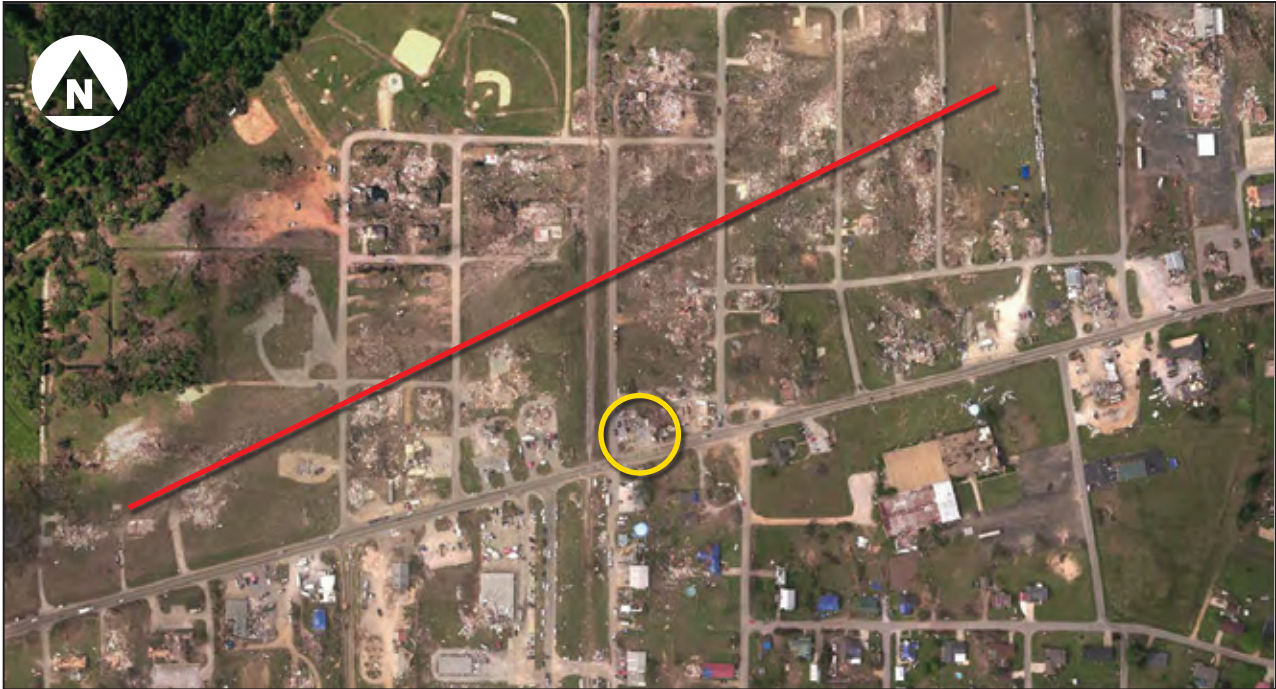
Figure 7-48: Aerial view of the tornado track in the vicinity of the Smithville Police Department (yellow circle). The center of the damage swath is approximated by the red line (Smithville, MS).

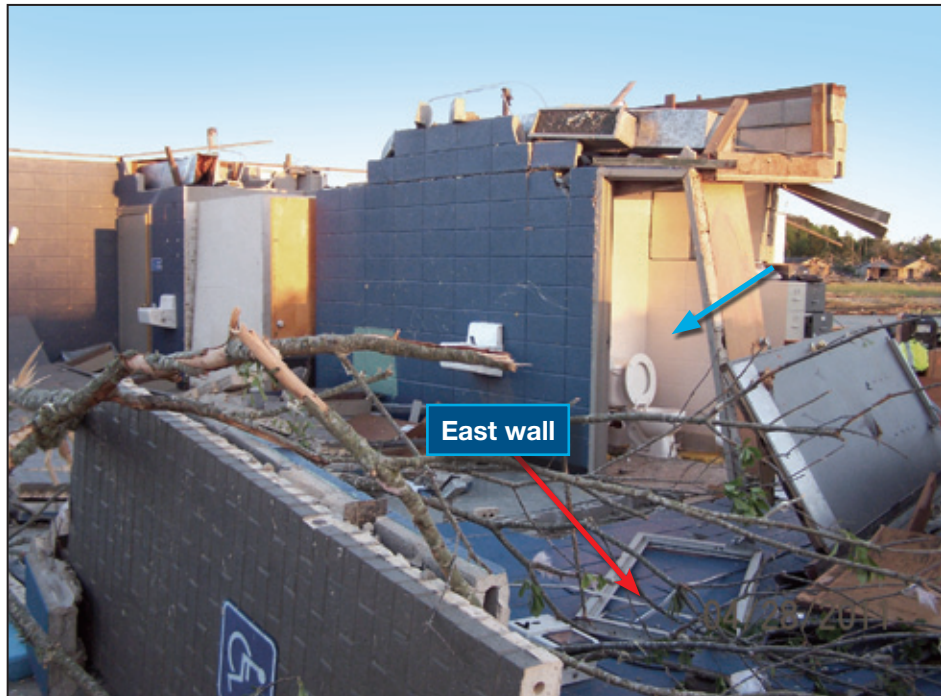
MAT EF Rating: Using DI 9 (Small Professional Building),⁸ the MAT selected DOD 8 (“collapse of exterior walls; closely spaced interior walls remain standing”) for this facility. Considering the building age and observed damage, the MAT assessed the wind speed to be between the expected and lower-bound wind speeds for DOD 8. Hence, the MAT derived the tornado rating as EF2 (111–135 mph) based on damage to this building.⁹ Therefore, the estimated wind speed experienced by the building was above the current basic wind speed of 90 mph.

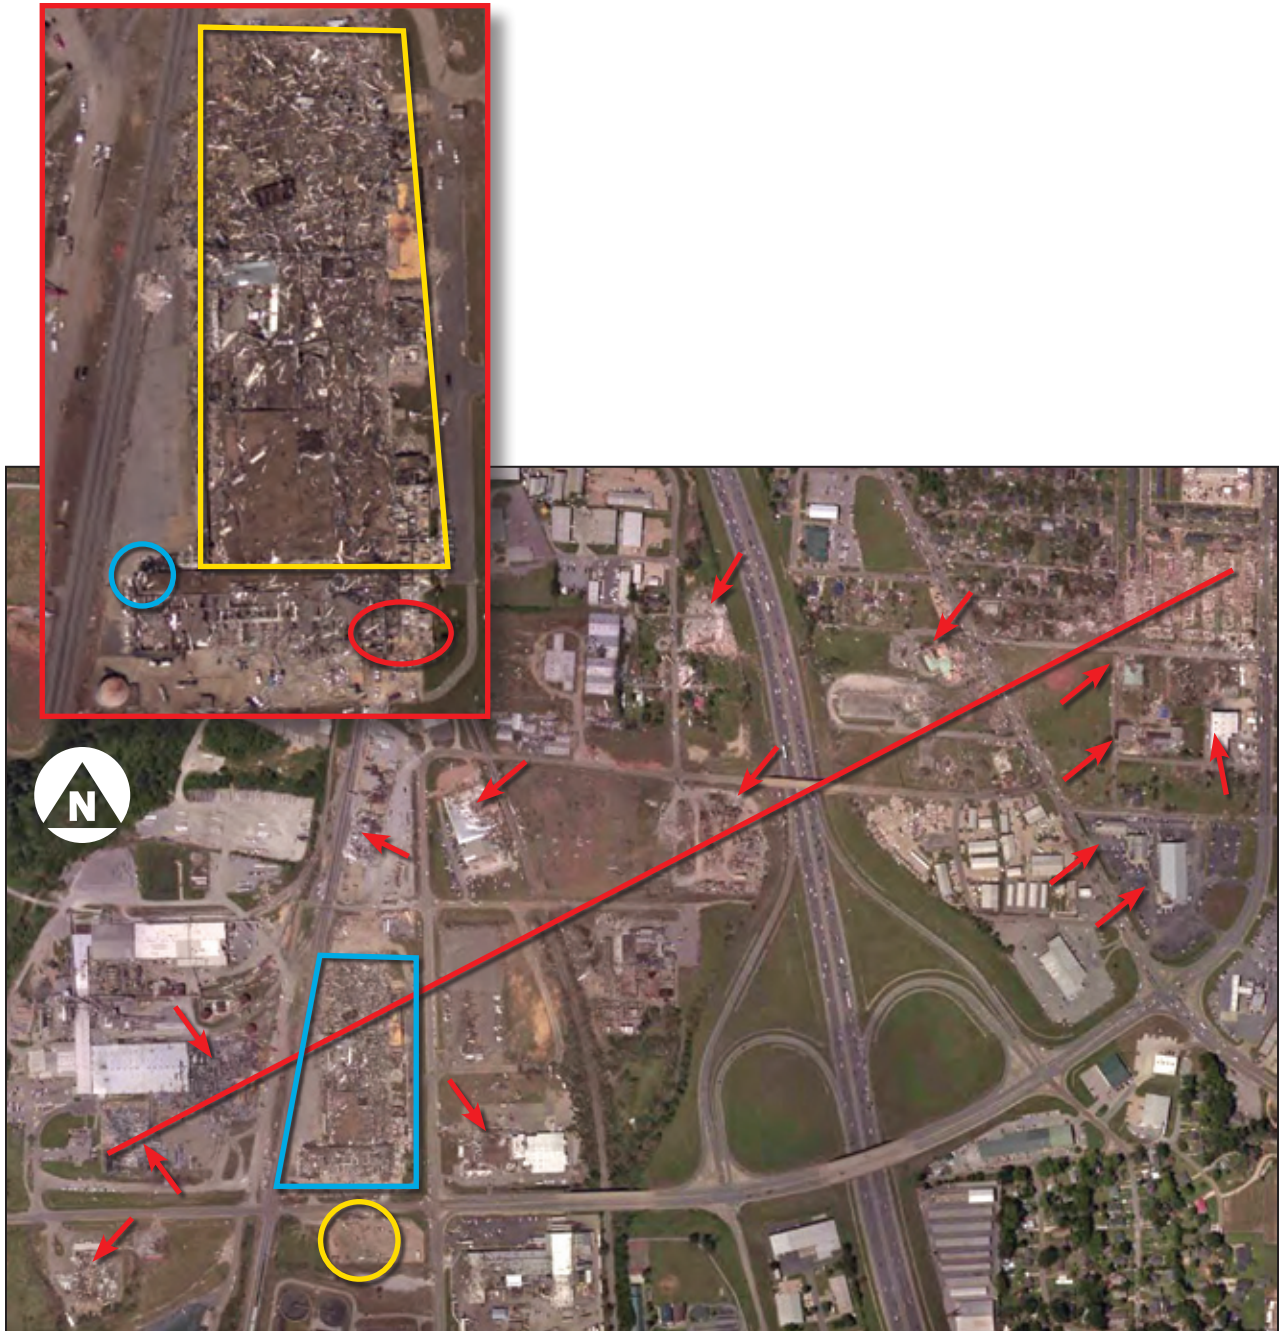
Figure 7-54: Aerial view of the track in the vicinity of the Curry Building city complex (blue rectangle). The center of the damage swath is approximated by the red line. The yellow circle indicates the EOC's collapsed communications tower. The red arrows indicate damaged buildings. In the inset, the red oval shows the EOC and the blue circle shows a tornado refuge area. Most of the area in the yellow rectangle collapsed (Tuscaloosa, AL).

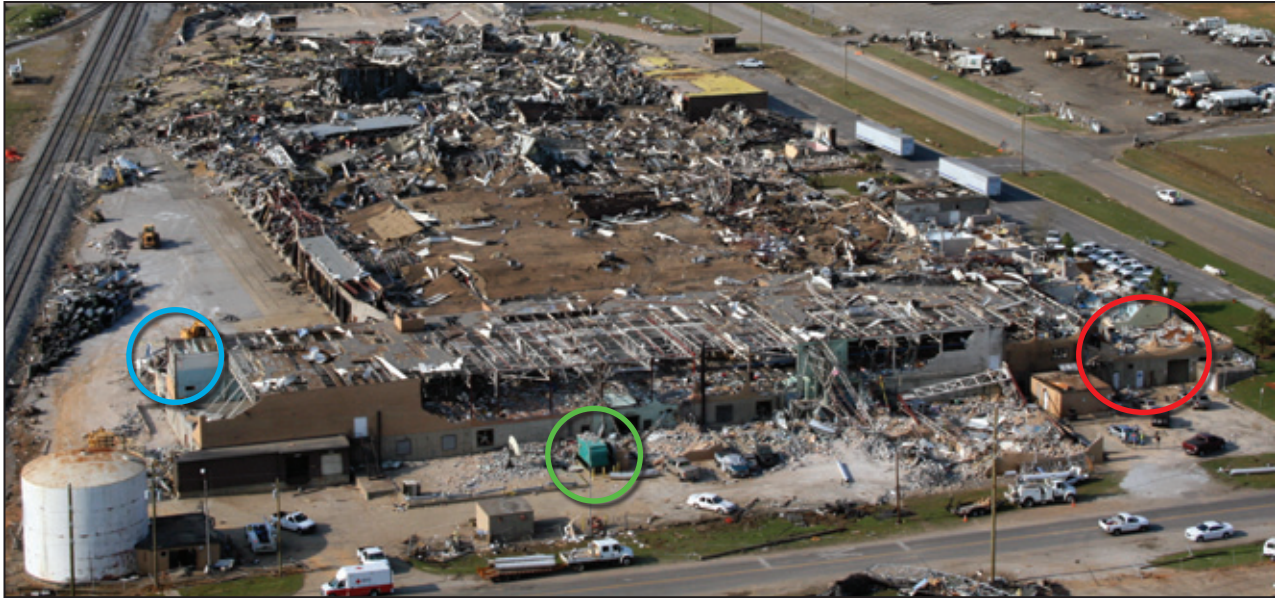
Figure 7-55: Oblique view of Figure 7-54 showing the Curry Building. The green circle indicates the EOC's emergency generator. The red circle shows the ground floor of the southeast corner, the location of the EOC. The blue circle shows the tornado refuge area.

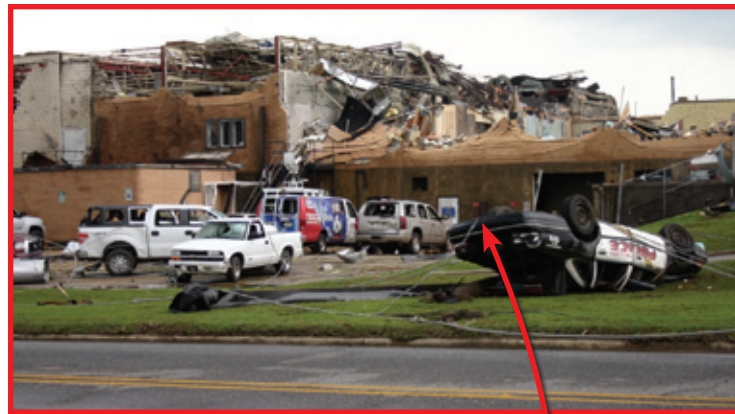
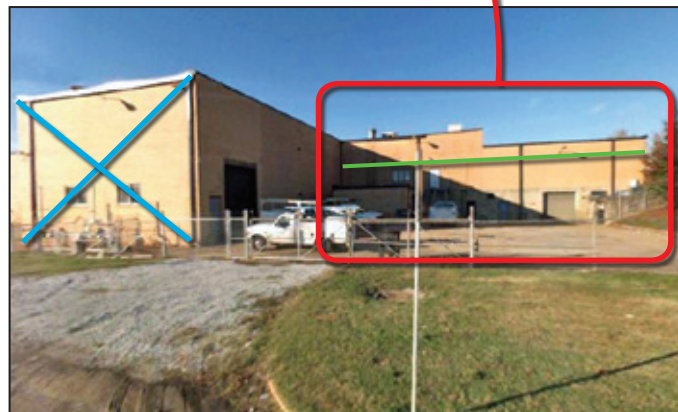
SOURCE: © GOOGLE EARTH

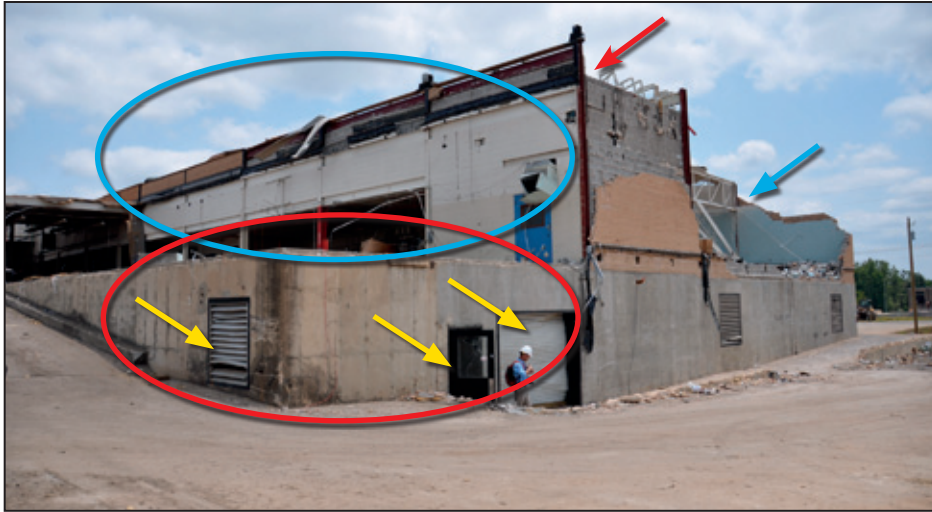
Figure 7-59:
View of the refuge area (red oval). Note the rolling door, personnel door, and louver wall openings (yellow arrows). The floor above the refuge area (blue oval) collapsed and the roof decking in the adjacent area (red arrow) blew off. A portion of the roof structure and exterior wall collapsed (blue arrow) (Tuscaloosa, AL).
