# Tornado: Moore, Oklahoma, May 20, 2013

Safe Room Performance, Observations, and Conclusions

*FEMA P-1020 / August 2014*

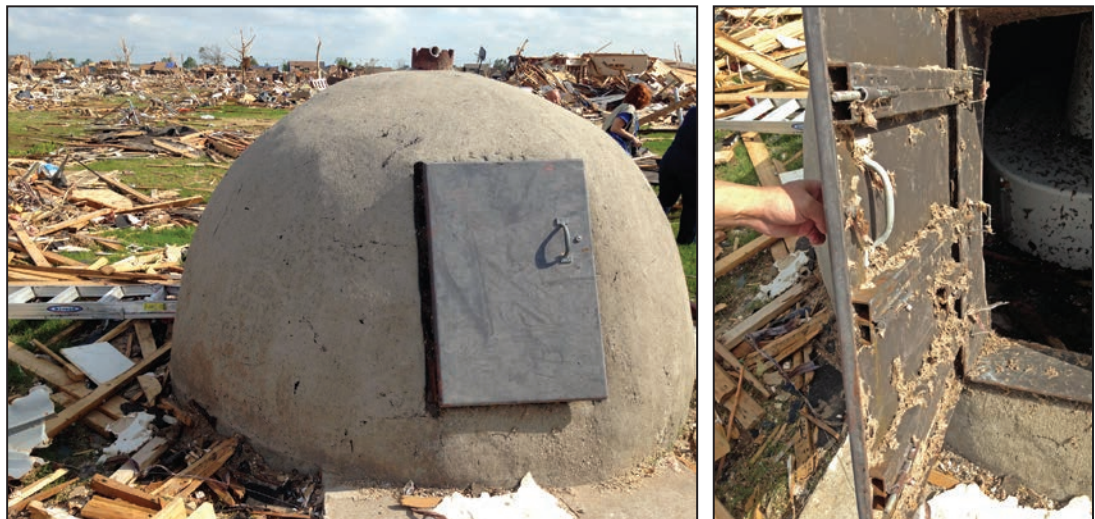
**Observation 2:** This shelter (Figure 3 left) was located in Oklahoma City in an area of heavy damage. No owners were present at the time of the investigation. It was approximately a 4 to 6 inch-thick concrete dome. It appeared to be an older structure, possibly from the post-1999 tornado reconstruction, though it could not

be determined if it had been constructed to any design criteria. The door was visibly damaged, and debris such as insulation, mud, and dirt were found inside the shelter (Figure 3 right). It was not clear whether anyone had taken refuge within it.

**Figure 3.**  
**Observation 2:** Dome structure within the path of the tornado (left), the inside of the dome structure door was covered with small debris (right) (Oklahoma City, OK)

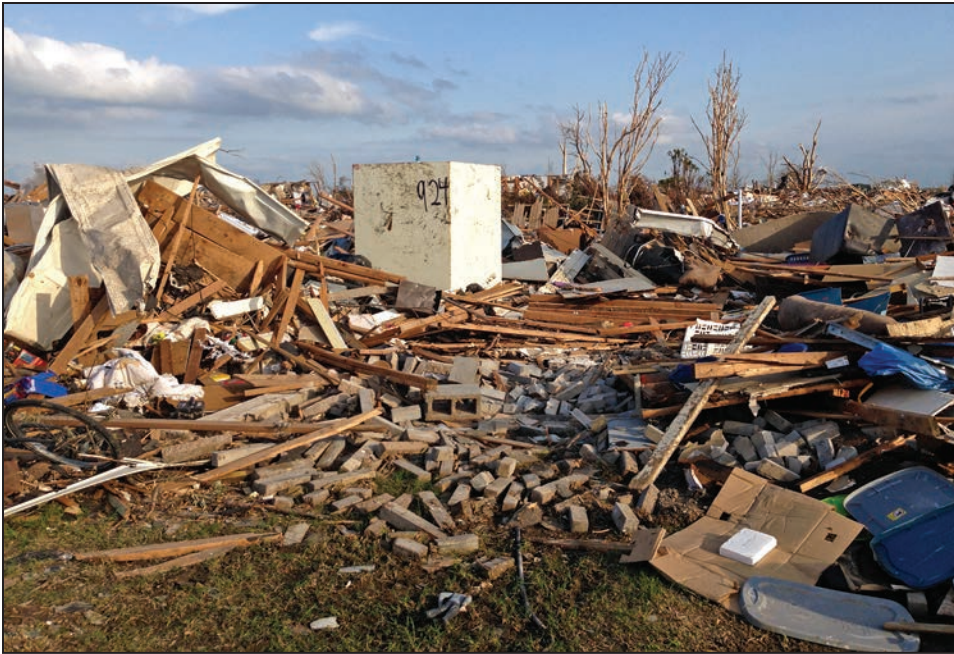
**Observation 3:** This metal above-ground shelter was located near Plaza Towers Elementary in a heavily damaged area of Moore, OK (Figure 4). There was nothing left of the home or nearby homes. The homeowner was not present at the time of the visit and

the door was locked. It appeared to have been installed in the garage of the home on a thick concrete slab. The side of the structure showed numerous marks from where wind-borne debris had impacted it, but it was otherwise in good condition.

**Figure 4.**  
**Observation 3:** Above-ground shelter located near Plaza Towers Elementary School (Moore, OK)

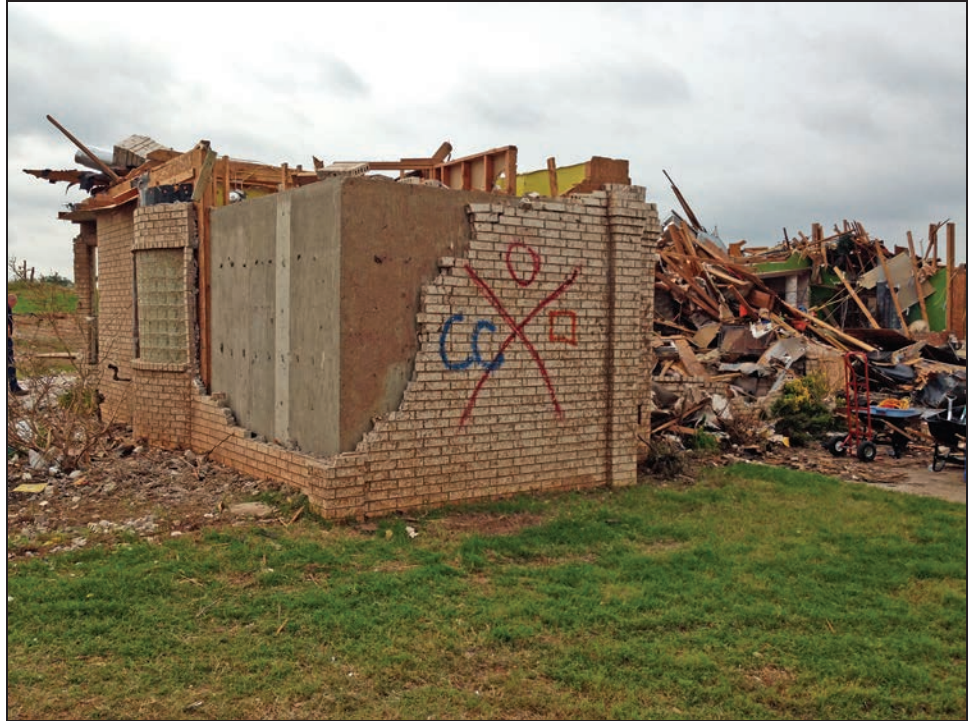
Figure 5.

**Observation 4:** This above-ground, concrete shelter (Figure 5 and Figure 6) was located in a newer neighborhood of Moore, OK, with many of the homes built in the early 2000s or later. No owner was home at the time of the visit. Most of the neighborhood was not in the direct path of the tornado and was not heavily damaged. This structure was one of the few site-built shelters the team found. Interviews with nearby neighbors indicated that the builder who constructed a number of homes in the neighborhood had included these shelters, although not every homeowner was aware of this. A nearby neighbor indicated that he had taken refuge in his garage, which experienced some breaching, and was unaware that the builder had

The neighbors did not know whether anyone had used the shelter in Observation 4 for refuge. The shelter's exterior was exposed due to loss of the building around it, allowing the team to observe more of the structure. The shelter was also a master bedroom closet and appeared to have at least a 6-inch thick concrete roof slab (see Figure 6). The shelter performed well although it had small debris particles and mud inside, which had entered through the inadequately screened ventilation holes.

**Observation 4:** Above-ground shelter that was also a walk-in closet for the master bedroom (Moore, OK)

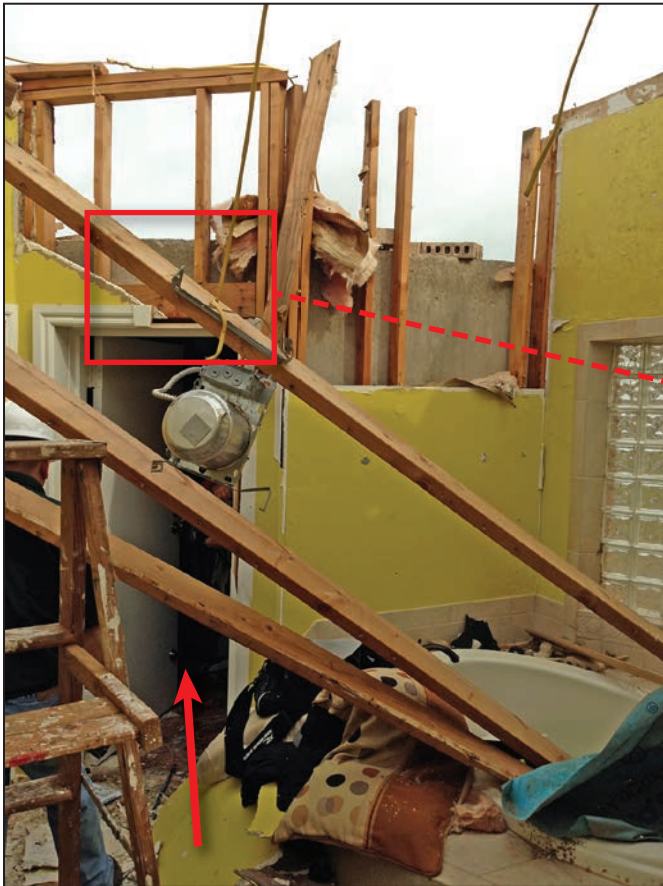
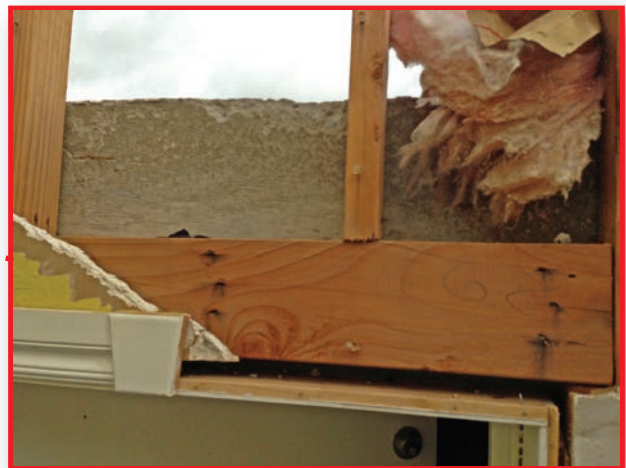
Figure 6.

**Observation 4:** Red arrow pointing to the entrance of the shelter (left) and a close-up of the concrete roof slab (right) (Moore, OK)

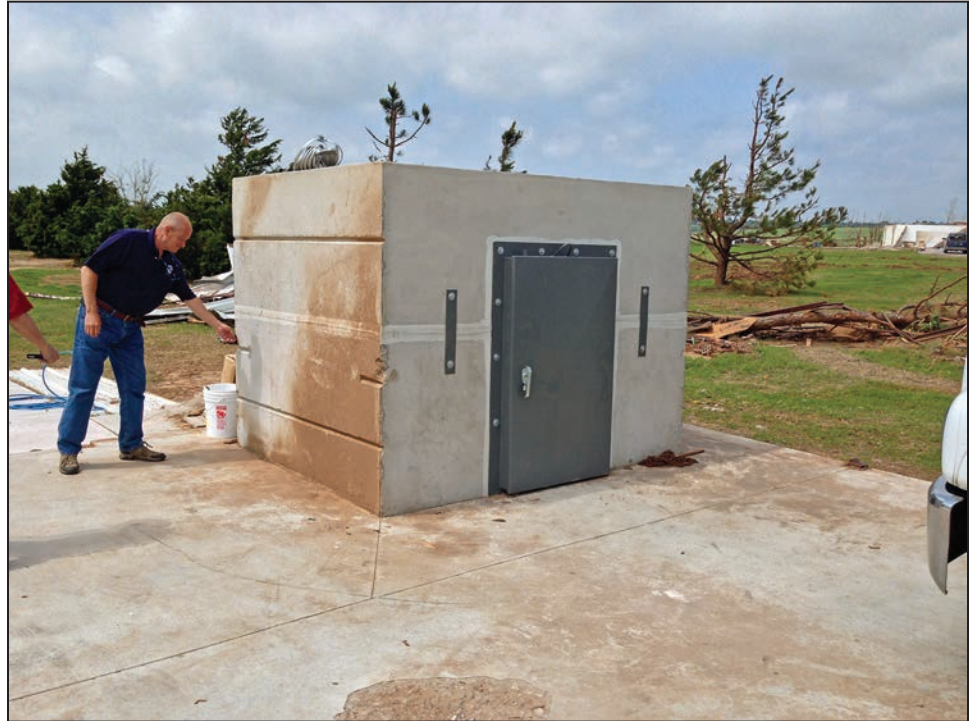
Figure 8.

**Observation 6:** This shelter (Figure 8) located in the Newcastle area was in the garage of a home and used by the homeowner during the 2013 tornado event. While the team was not able to speak with the homeowner,

the neighbors indicated the garage had collapsed around the structure and they had helped remove debris to rescue her.

**Observation 6:** Concrete shelter in the garage of a home that was completely destroyed; the site was already bulldozed at the time of the investigation (Newcastle, OK)

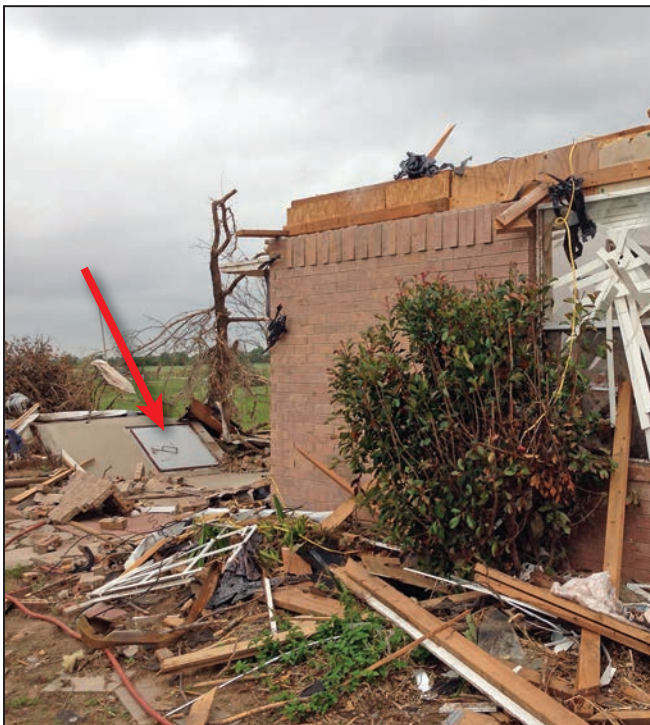
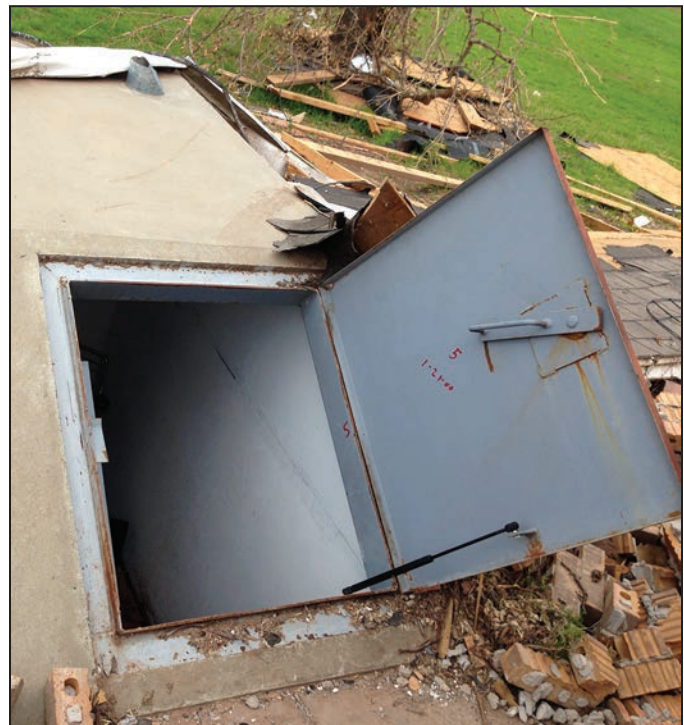
Figure 11.

**Observation 9:** The team traveled to the area of the 2013 tornado track that overlapped with the 1999 tornado in Oklahoma City. According to a neighbor, this clam-style safe room built outside the home (Figure 11) was installed shortly after the 1999 tornado, so it was not impacted by the 1999 event. It was installed with financial assistance from OEM/FEMA. This safe room was equipped with an exterior vent that sustained damage but was still attached to the shelter. Many of the outdoor shelters with exterior vents had been either seriously damaged or completely blown off, leaving a

6-inch hole at the top of the shelter. Vents should be special impact-resistant models, or baffles should be provided to prevent missiles, rain, and debris from entering the shelter.

The neighbor interviewed by the team said there were six occupants in the safe room when the tornado struck, including the 92-year-old owner, a woman who was 9 months pregnant, and her 18 month old daughter. The owner was able to make it in and down the narrow stairs safely. The safe room performed well.

**Observation 9:** Below-ground safe room (red arrow) installed after the 1999 tornado; the door of the clam-style safe room had only one lock, but newer standards require more than one lock (Oklahoma City, OK)

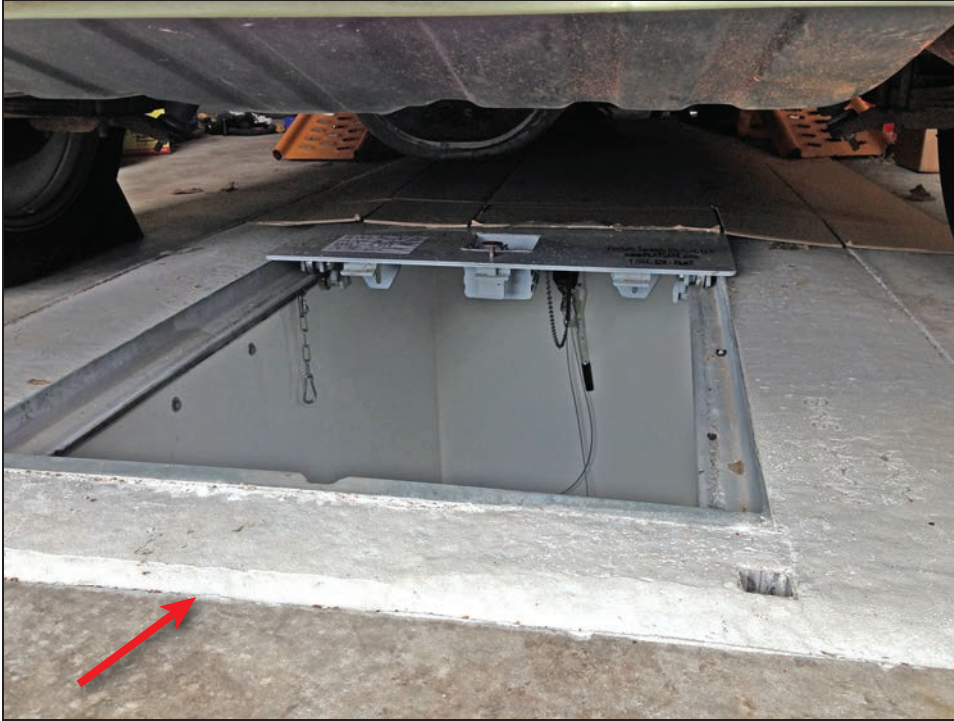
**Observation 10:** This below-ground shelter was located in the garage of a home (Figure 12) in a relatively newer neighborhood in Moore, OK. The owner was present at the time the team arrived. His home was not badly damaged, but nearby homes had moderate damage. The man and his mother had taken refuge in the shelter. There was a classic car the homeowner was restoring parked over the shelter during the tornado; the car had no tires and was raised on cinder

blocks. The homeowner and his mother had to climb underneath the car to access to the shelter. The homeowner shared with the team that he realized the need to be better prepared, as his car could have been blown off the cinder blocks and fallen on top of the shelter, trapping them. He was unaware that he could submit the GPS coordinates and address of his shelter to the local fire department to be one of the first places they would check for survivors trapped in shelters.

Figure 12.  
**Observation 10:** Shelter underneath a car in a garage (Moore, OK). The red arrow shows where the raised lip can help prevent water penetration from minor flooding.

**Flush-to-ground shelters** pose a risk of flooding. Shelters with a 1- to 2-inch lip at the surface entrance provided better protection from water run-off entering the shelter.

**Recommendation:** Conduct outreach to educate consumers and manufacturers regarding the residual risk of flooding (including flash flooding) and the placement of safe rooms in flood-prone areas.
