Conclusions

7.1 General Conclusions

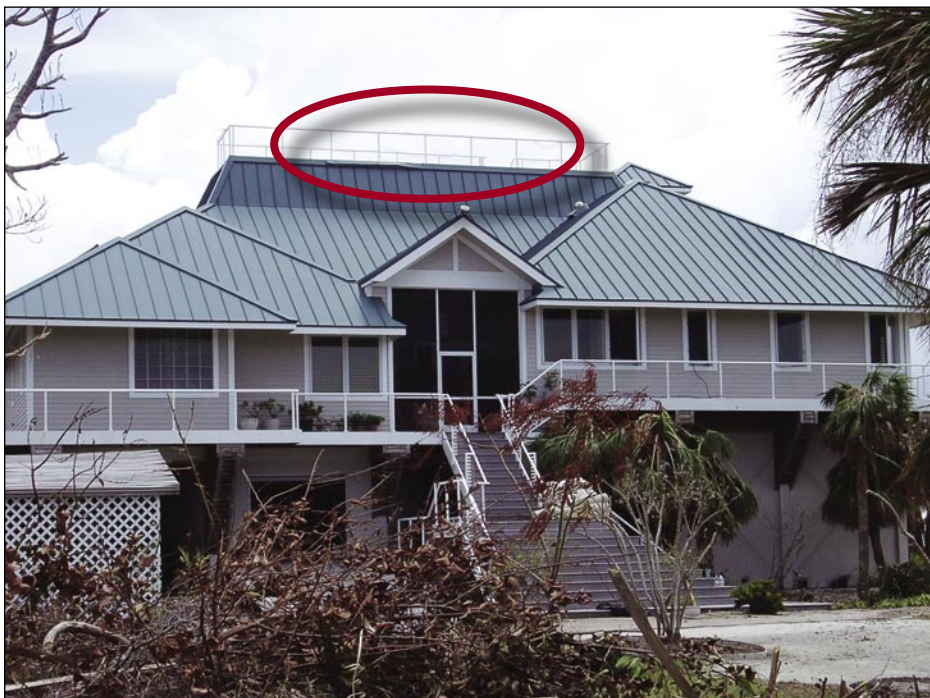
Two examples of well-executed mitigation against flood and wind were observed. First, on North Captiva Island, where Hurricane Charley battered buildings with estimated winds in excess of the 130 mph (3-second peak gust) winds required by the 2001 FBC, many homes withstood the winds with minimal damage. Figure 7-1 shows a residence constructed to the design requirements of the 2001 FBC. This building had a well-secured standing seam metal roof that performed well and only experienced some light trim damage (shown in the center of the photo). The windows and doors were protected with a combination of impact resistant, laminated glazing products and shutters. In addition, the residence was elevated above the predicted 100-year flood level on an open pile foundation.

Figure 7-1. Residence constructed to the design requirements of the 2001 FBC performed well and only experienced some light trim damage (shown in the center of the photo) (North Captiva Island).

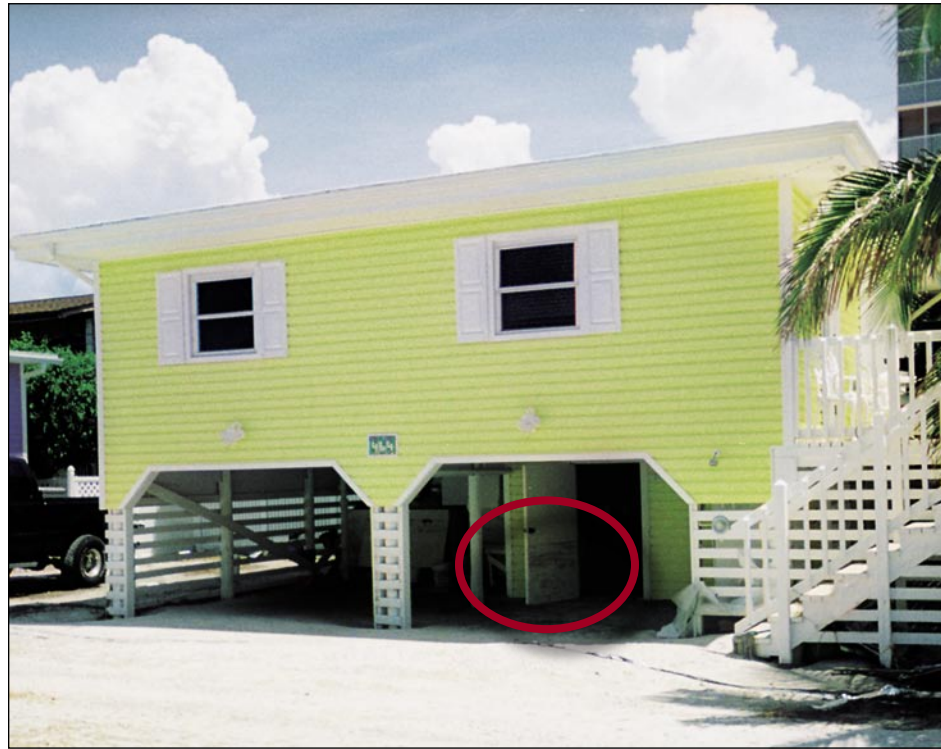
Second, many residences and businesses on the north end of Fort Myers Beach have been elevated on pile foundations to allow water to pass beneath these V-zone structures. In one of the few areas investigated by the MAT that experienced flooding and overwash, Fort Myers Beach experienced storm surge from Charley. The house in Figure 7-2 is one of eight residential units located along the beach in this small development. During Charley's storm surge, water approximately 2 to 3 feet deep washed through the development (see water mark on door of enclosure below house). These older residences, however, were atop pile foundations that allowed the floodwaters to pass safely beneath the houses. As a result, only minor damage to enclosures and access stairways was experienced. This success illustrates the use of best practices on older homes that has been recommended by FEMA in publications such as FEMA 55, *Coastal Construction Manual*.

Figure 7-2.
Older residence atop
pile foundation that
allowed floodwaters to
pass safely underneath,
resulting in only minor
damage to enclosures
and access stairways
(Fort Myers Beach)

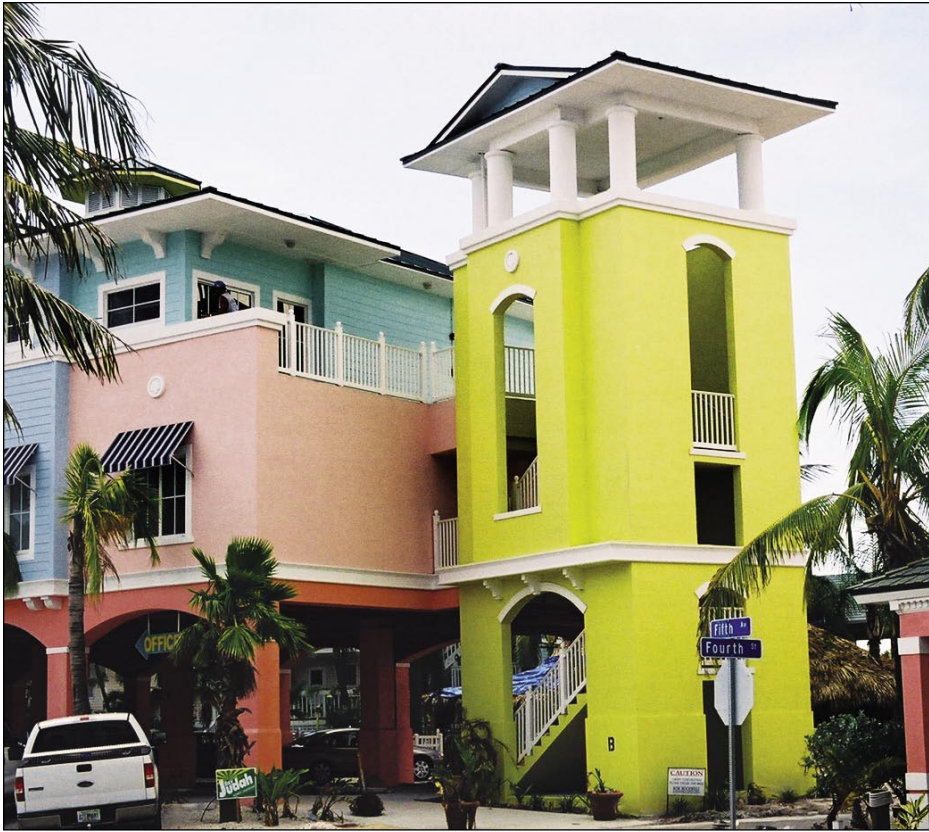
When Hurricane Charley hit Fort Myers Beach, the Lighthouse Resort Inn and Suites shown in Figure 7-3 remained dry, undamaged, and full of customers, while other hotels and motels on the island were damaged or flooded, and closed. In the past, the Lighthouse Resort would also have been closed. Over the last two decades, seven hurricanes have caused flood and wind-related damage to the resort, resulting in nearly \$100,000 in repair costs per event. The resort, which sits 200 feet from the beach, had been elevated as part of a joint State of Florida, Federal, and local mitigation project. In approximately 1 year, the owners have saved nearly \$200,000 in repair costs alone, almost 50 percent of their mitigation investment.

Figure 7-3.
Exterior view of the elevated Lighthouse Resort Inn and Suites, which remained dry and undamaged after Hurricane Charley (Fort Myers Beach)

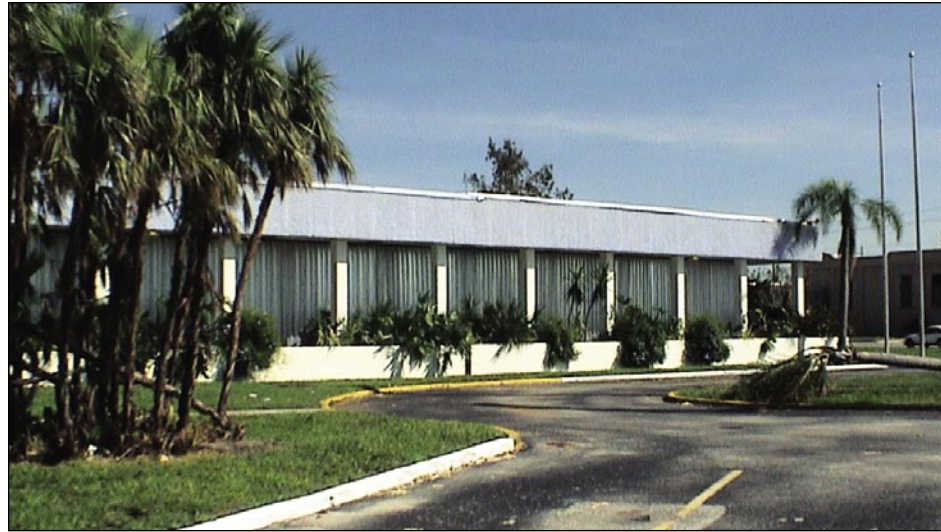
At the Charlotte County South Annex building, significant damage and loss of function was prevented when new shutters were installed to protect the building during Hurricane Charley. The galvanized metal shutters were funded in part by a grant to the State of Florida under FEMA's Hazard Mitigation Grant Program (HMGP). With the shutters in place, the Annex suffered only minimal damage. An investment of less than \$10,000 saved the taxpayers over half a million dollars in losses avoided in just one hurricane event.

Only one shutter was damaged. Hit hard by flying debris, the shutter panel was dented, breaking the glass behind it, but remained in place and prevented the wind from penetrating the building and causing major wind and water damage. Although windborne debris damaged the roof, creating some leaks and damaging some of the building's contents, this damage was minimal in contrast to other buildings according to Charlotte County Facilities Manager, Michael Sheridan.

Figure 7-4.
Exterior view of the
galvanized shutters that
protected the Charlotte
County South Annex
(Punta Gorda)

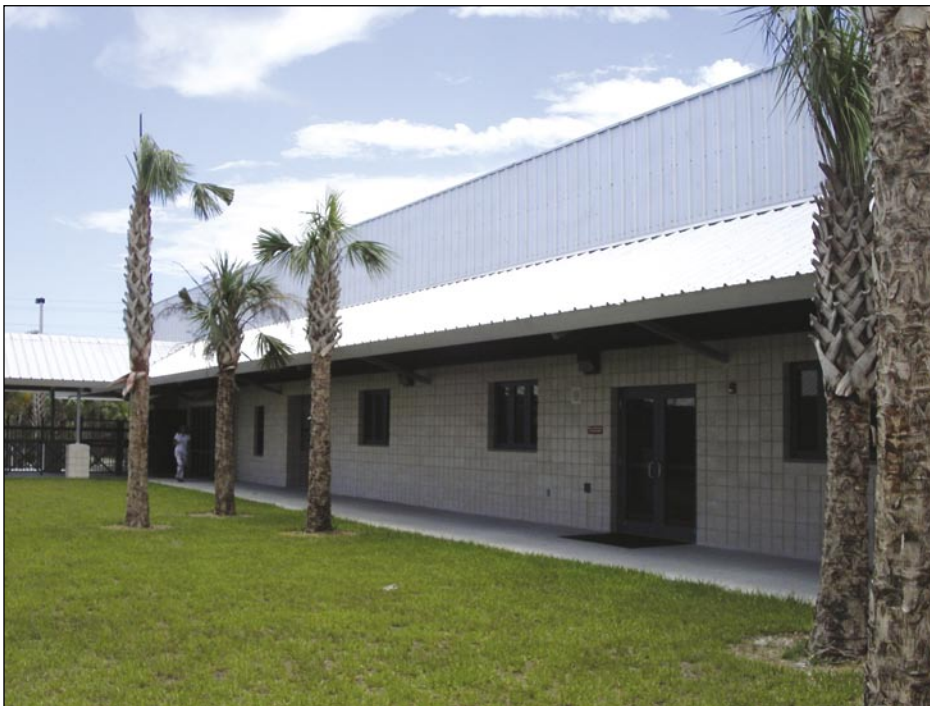
A success in school design and construction that resulted in no loss of function was observed at the Sanibel School on Sanibel Island (Figure 7-5). Dedicated on August 10, 2004, less than a week prior to the landfall of the storm, this school was designed and constructed to the 2001 FBC. Although the school building likely experienced wind speeds that were below the 130 mph (3-second peak gust) design wind speed

Damage at the school was limited to loss of gutters on the east side of the building and some wind-driven rain issues. At the time of the MAT visit, the school was preparing for an on-time school opening and did not experience a loss of function as a result of the hurricane. In addition to avoiding significant damage to the school building itself, the successful performance of the design allowed residents of Sanibel Island to move forward with their rebuilding process because the school was functioning.

Figure 7-5.
Courtyard of the newly constructed Sanibel School that was operational immediately after Hurricane Charley passed
