Building Envelope Performance

5.1 Doors

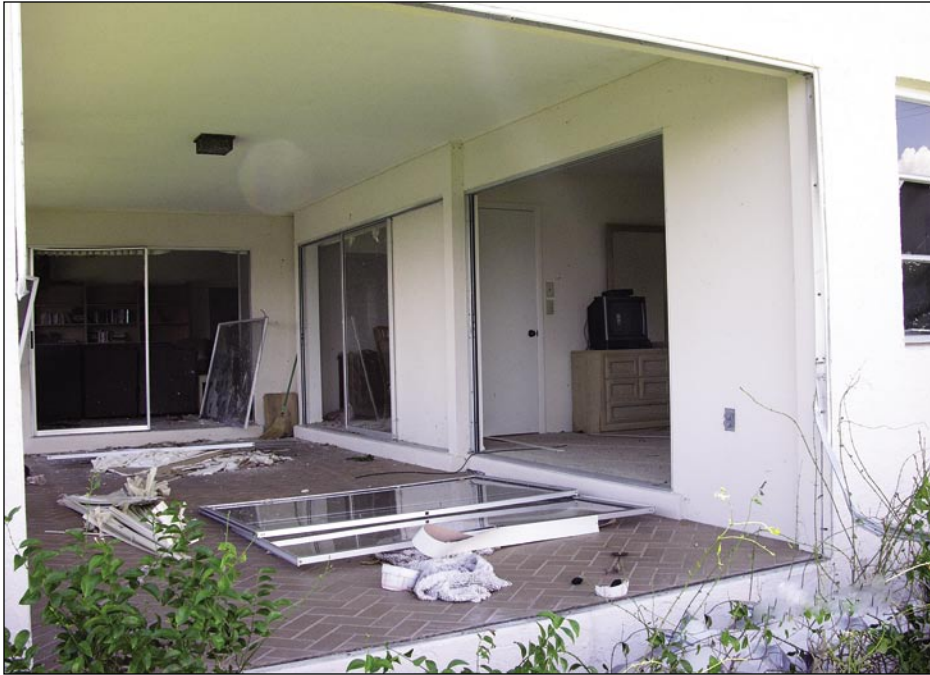
Figure 5-1.
Sliding glass doors blown out of their tracks (Punta Gorda Isles)

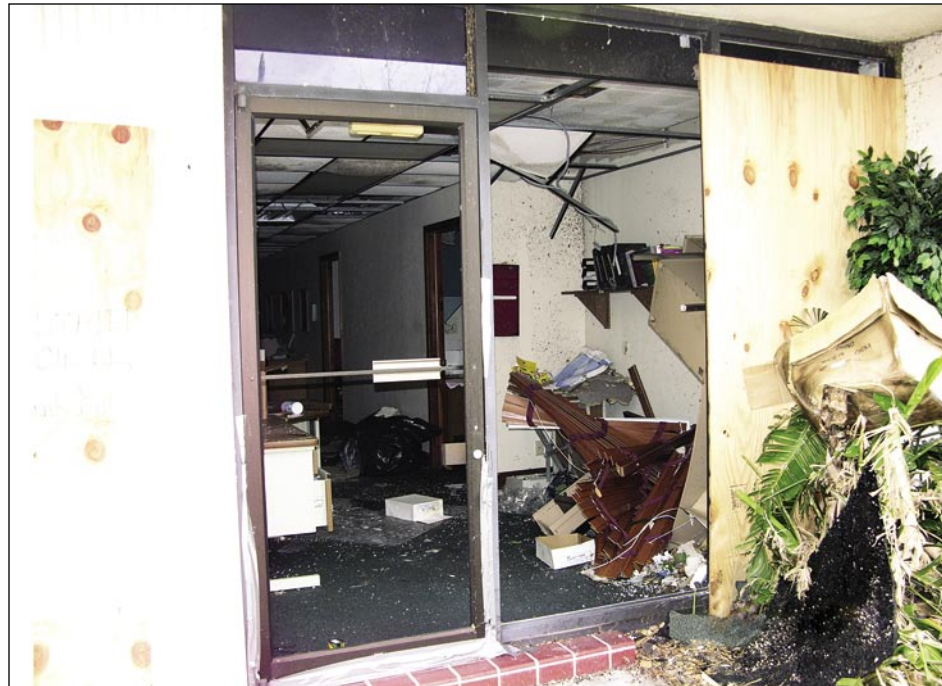
A limited number of buildings with personnel door damage were observed in commercial and critical/essential facilities. Observed damages included broken window panes (caused by missiles as shown in Figure 5-2) and disengagement of doors from their frames (likely caused by over-pressurization). At one school being used as a shelter, a pair of exterior gym doors reportedly blew open. People pulled the doors shut and held on to the horizontal exit hardware bars for the duration of the hurricane. The right leaf had top and bottom vertical rods, and the left leaf had a horizontal bolt. Therefore, at the latch edge, the door on the right was attached to the frame at the top and bottom of the door. However, the door on the left was attached only at mid-height, where it bolted into the right door (Figure 5-3). If the left door had also been equipped with top and bottom vertical rods, it may not have blown open.

Figure 5-2.
Tempered glass in office
building entry door and
side windows broken by
missiles (Punta Gorda)

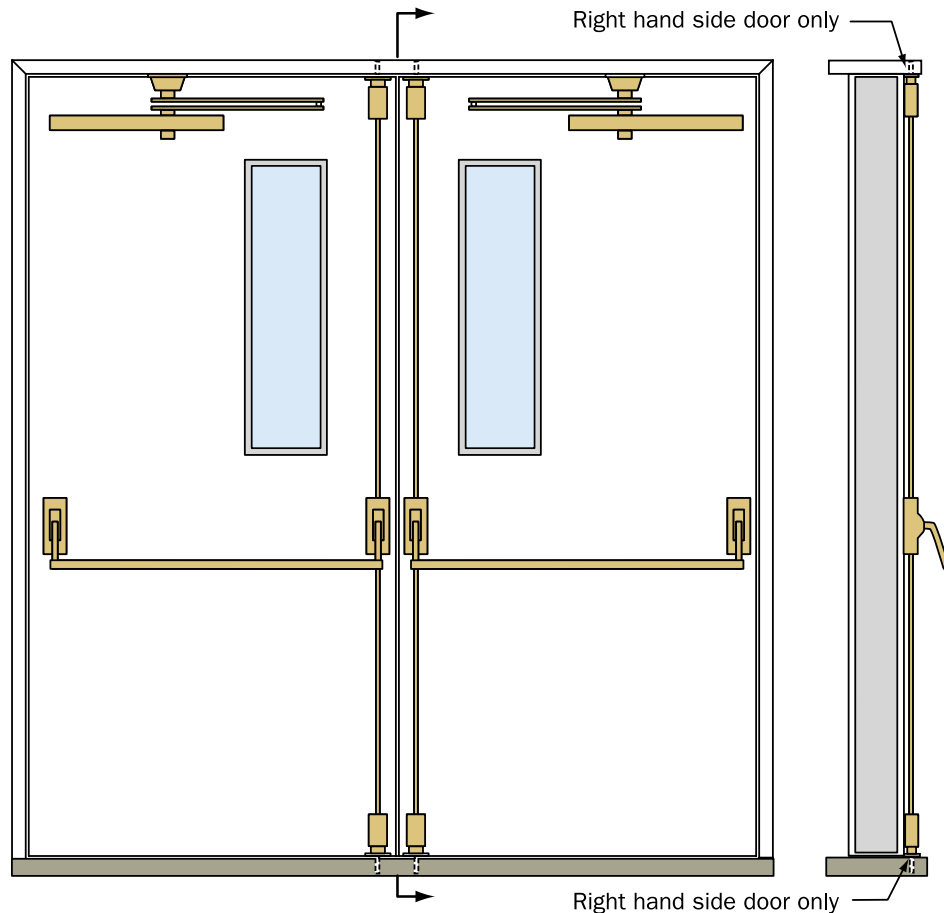
Figure 5-3.
Improper attachment of
doors

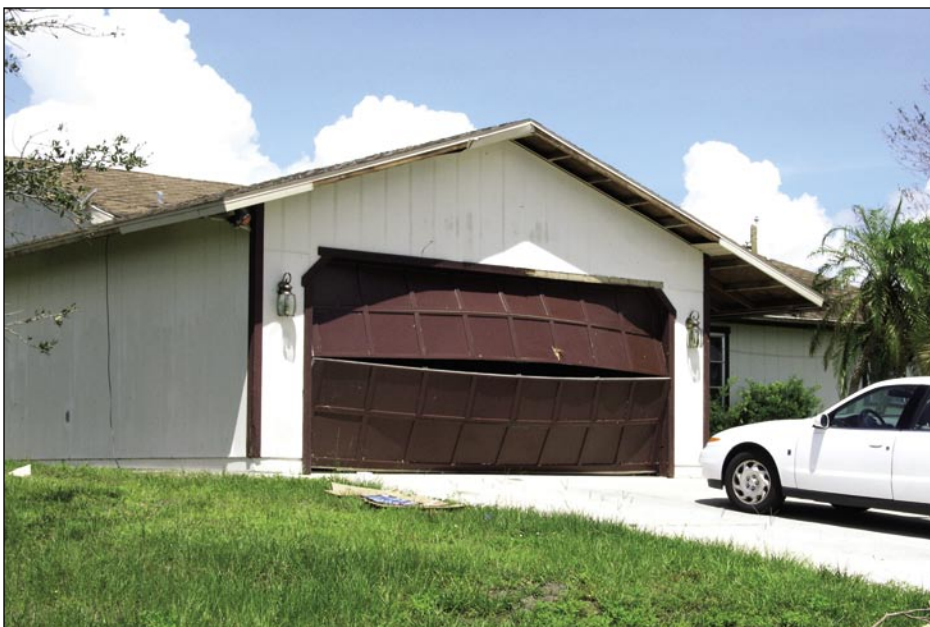
Damaged garage doors were observed throughout the Port Charlotte and Punta Gorda areas. In some instances, the doors buckled and were pulled outward (suction failures), as shown in Figure 5-4. In other instances, the doors were pushed inward (positive pressure failures), as shown in Figure 5-5. The home in the center of Figure 5-5 had a 5V-Crimp metal panel roof that performed well. Many of the other houses in this area (which typically had asphalt shingle or tile roofs) had roof covering damage. Many of the failures occurred because the doors had inadequate wind resistance. In these cases, the doors buckled inward or outward, and the rollers were often pulled out of the tracks. Other failures were caused by use of weak tracks or inadequate attachment of door tracks to the buildings. It was clear that most of the double car garage doors in older homes were not high-wind or debris-impact rated. In a number of the newer homes, the doors had improved bracing, but the metal gauge was much thinner than that used in Miami-Dade County approved impact-resistant garage doors. In addition, where door failures were observed, the tracks were not of the heavier gauge or braced according to high-wind recommendations. The garage doors approved by Miami-Dade County are constructed of thicker gauge material because they must meet different performance criteria for debris impact than is required by the 2001 FBC in other counties in Florida.

Figure 5-4.
Door lacked sufficient strength to resist the suction load (Deep Creek)

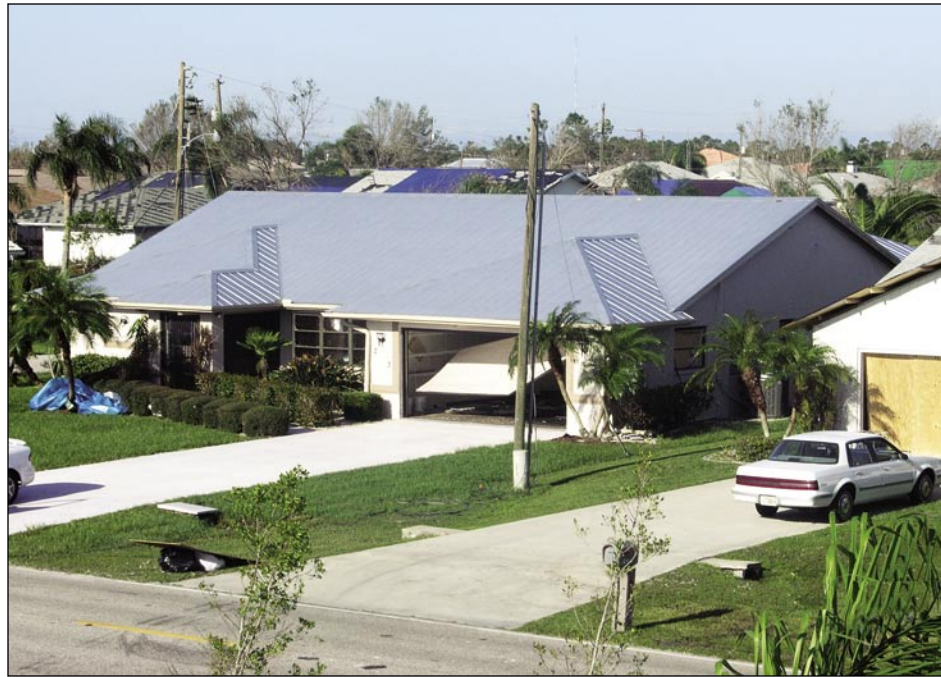
Figure 5-5. Garage door at the home in the center buckled and the rollers pulled out from their tracks; garage door at the home on the right also failed (Deep Creek).

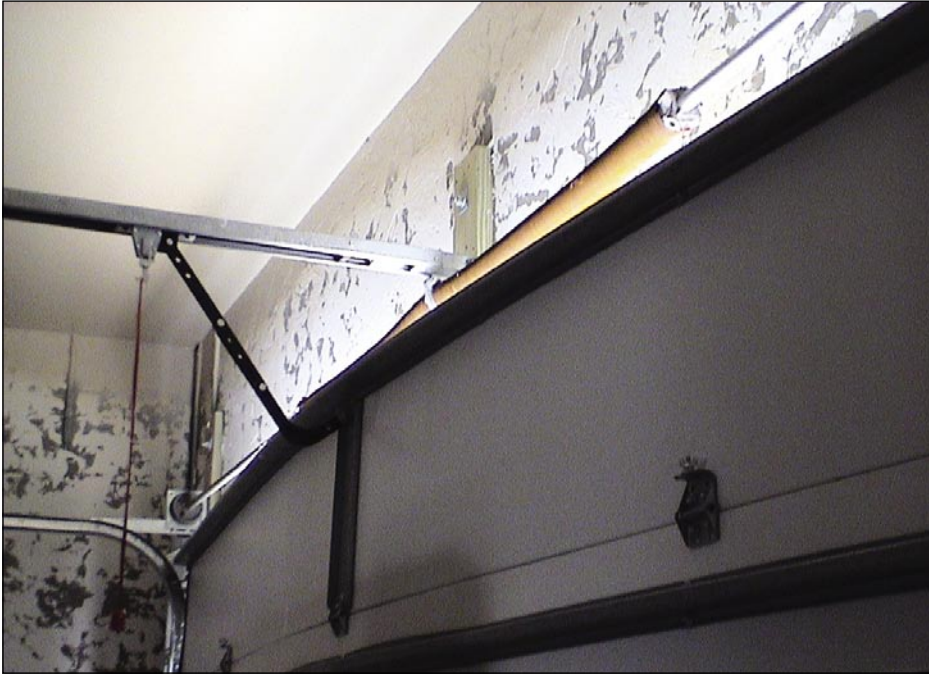
Some garage doors observed were designed with removable stiffener bars. One garage door with this type of design at a post-2001 FBC residence did not have the stiffener bar in place at the time of the hurricane, and it was damaged by wind pressure (Figure 5-6). There were instances where owners had left their homes for the summer season and had neglected to put into place the stiffener posts required to make their garage doors resist winds as they were designed.

Figure 5-6. Garage door failed because the removable stiffener bar was not in place at the time of the hurricane (Punta Gorda Isles).

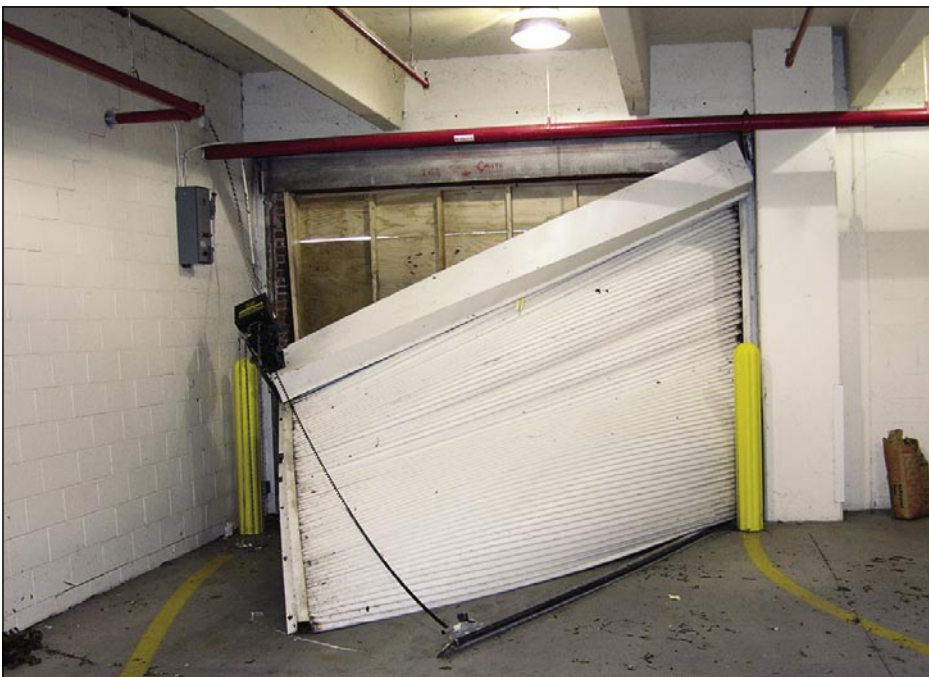
Damage to rolling and sectional doors (e.g., service garage doors and loading dock doors) was observed. Newer doors generally performed well. However, in one instance, a new door failed (the drawings were dated 1997), resulting in the failure of an interior partition wall, as shown in Figures 5-7 and 5-8. The failed door shown in Figure 5-7 was attached with 1 $\frac{3}{4}$ -inch long by $\frac{3}{8}$ -inch diameter expansion bolts into concrete that spalled at the bolt locations, likely due to the placement of the bolts too close to the edge. There were no ties between the wall itself and the end wall (Figure 5-8). The drawings indicated continuous angles on each side of the wall, but they were not installed. Another sectional door around the corner and perpendicular to the door shown in Figure 5-7 failed after the door in Figure 5-7 failed. The buildup of internal pressure exerted a positive load on the other door, which was also loaded in suction on its outer surface. One of the

expansion bolts along the right track sheared off, and the concrete spalled at the other bolts. The bolts were typically 2 feet on center, but some were closer.

Figure 5-7. New door that failed. Non-load bearing CMU wall at the left tilted (see Figure 5-8) (Punta Gorda).

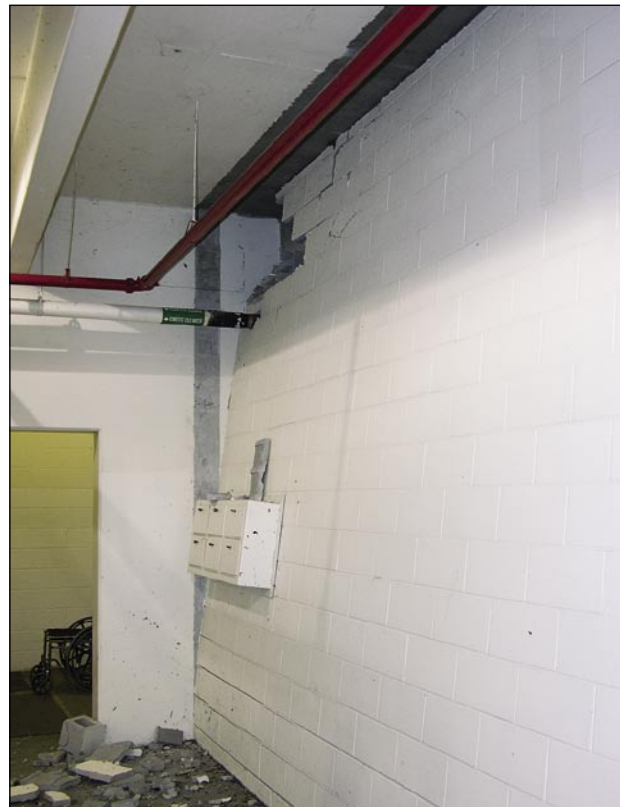
Figure 5-8.
After the door shown in Figure 5-7 failed, buildup of internal pressure tilted the wall (Punta Gorda).

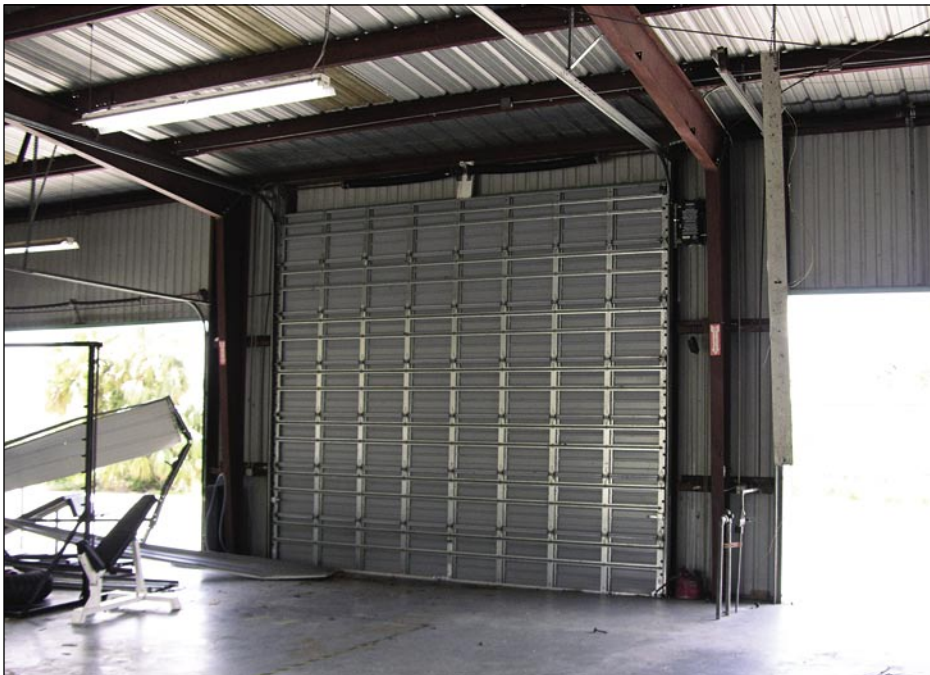
Figure 5-9. Windward side of a fire station; two doors blew inward, but the newer center door remained intact (Punta Gorda).

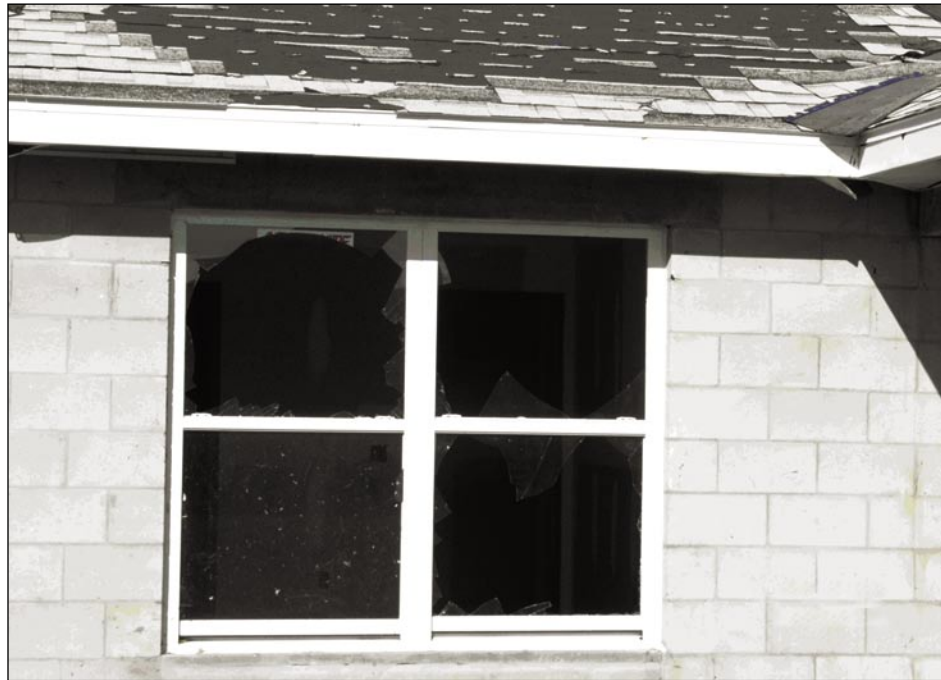
Figure 5-12.
Three of four panes
broken by windborne
debris; other windows
in this house also broke
(Deep Creek).

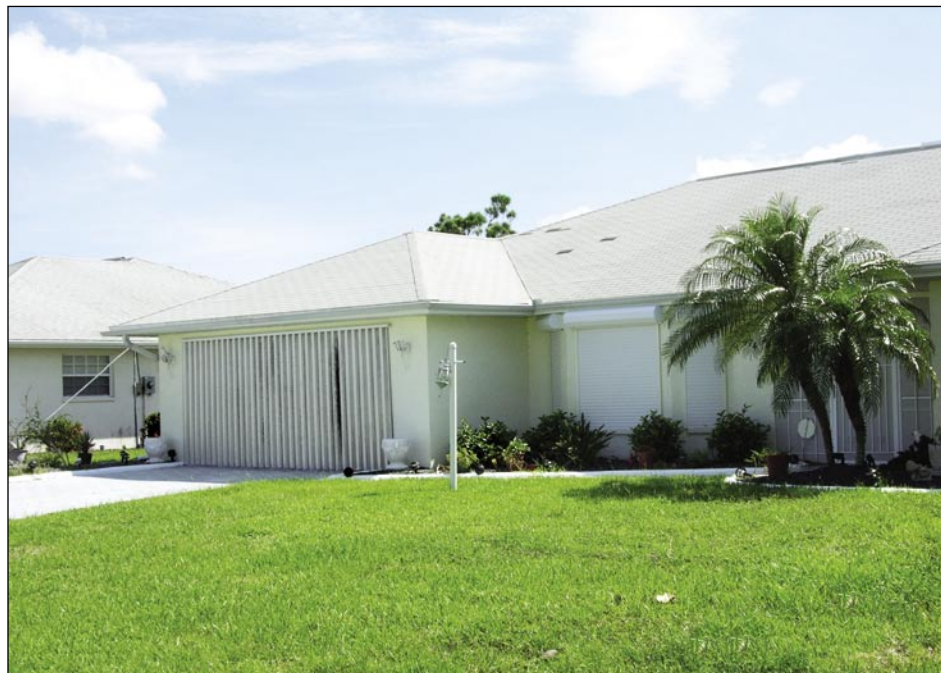
Figure 5-13.
This house, which
appeared undamaged
from windborne debris,
had roll-up shutters at
the windows and metal
panel shutters at the
garage (Deep Creek).

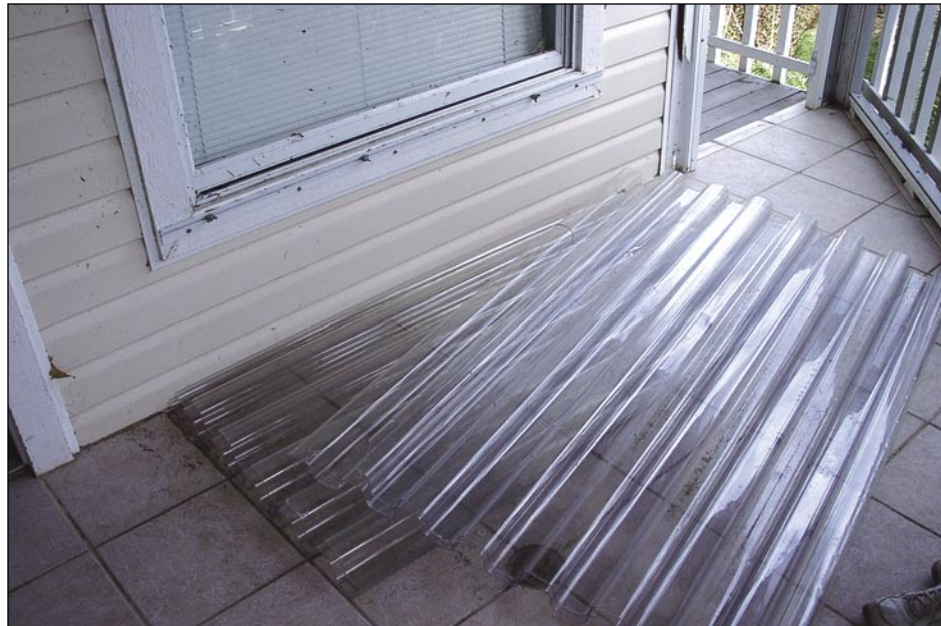
Some of the shutters did not have the strength to withstand the forces of the wind or the impacts of windborne debris. Others may have had sufficient strength, but were improperly installed. Figure 5-15 shows a house that used plastic shutters that blew off.

Figure 5-15. All of the windows on this house were covered by plastic shutters, many of which were blown off during the hurricane, resulting in several broken windows (North Captiva Island).

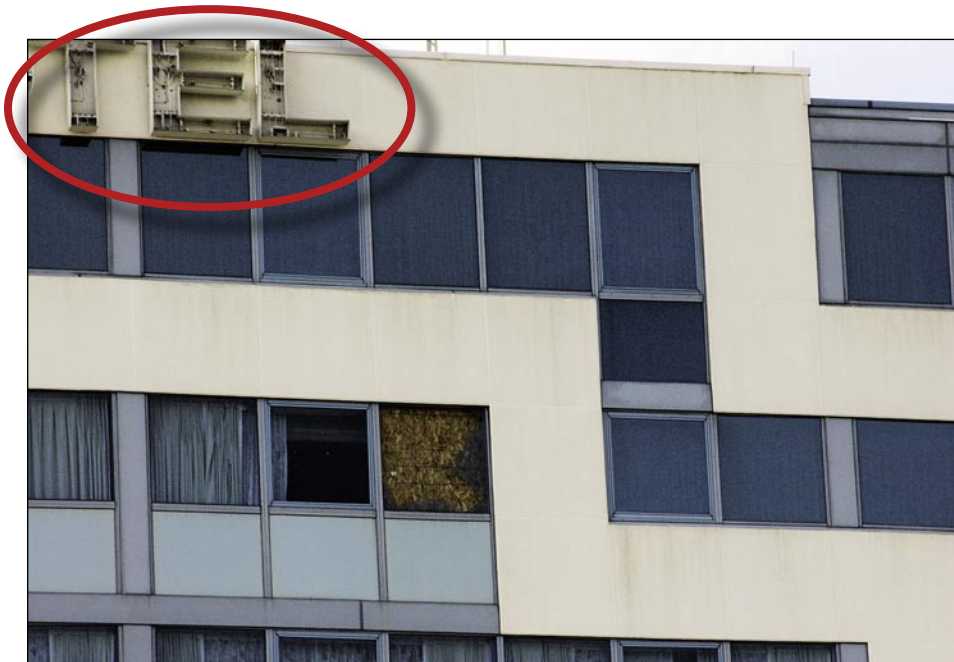
Window damage was observed on commercial buildings and critical/essential facilities throughout the impact area. Figure 5-16 shows a broken window in a mid-rise hotel in the Orlando airport area. Two windows on the same floor were likely broken by the missing plastic lens covers on the hotel sign. Figure 3-33 also showed glass breakage near the Orlando airport. In the Wauchula central business district, windborne debris broke glass in several adjacent buildings (Figure 5-17). The estimated wind speed in this area was 100 to 115 mph. In Punta Gorda, tempered glass in a door and several windows were broken by windborne debris (as shown earlier in Figure 5-2) and a nearby three-story office building had very extensive glass breakage on all sides of the building (Figure 5-18). At least some of the breakage in both buildings was caused by aggregate from a nearby built-up roof (BUR) (Figure 5-19). Other types of windborne debris also impacted the three-story building (one missile penetrated the stucco and underlying metal lath). All of the glazing, including glass spandrel panels, was broken on the long side of the building shown in Figure 5-18.

Figure 5-16.
Window most likely broken by missing plastic lens covers on hotel sign (see top of building) (Orlando airport area)

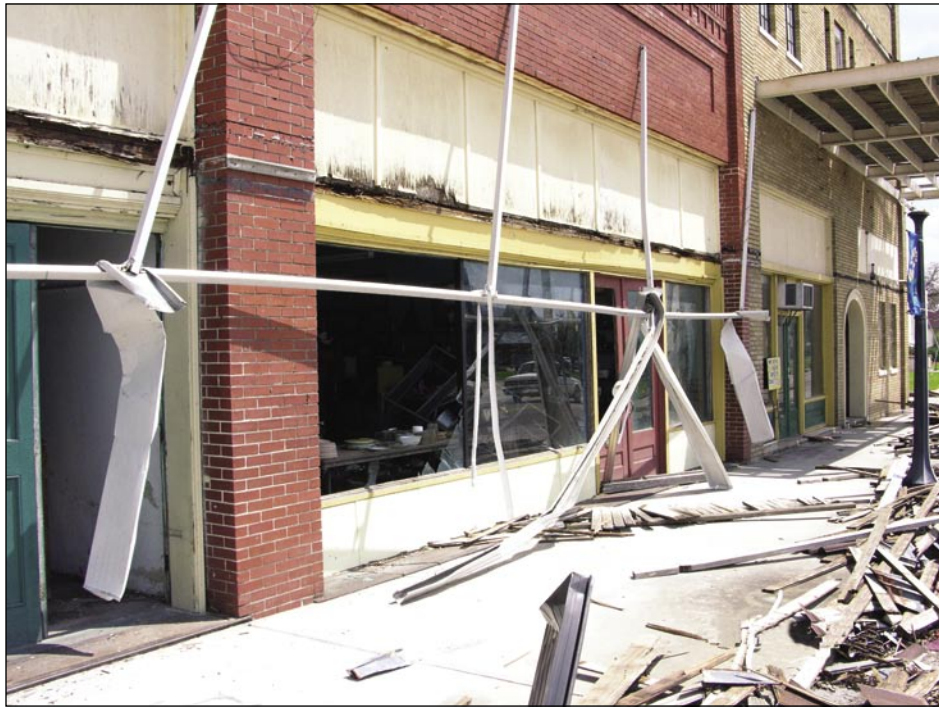
Figure 5-17. Broken glass in windows and doors in this building. Buildings across the street also had several broken windows caused by windborne debris (Wauchula).

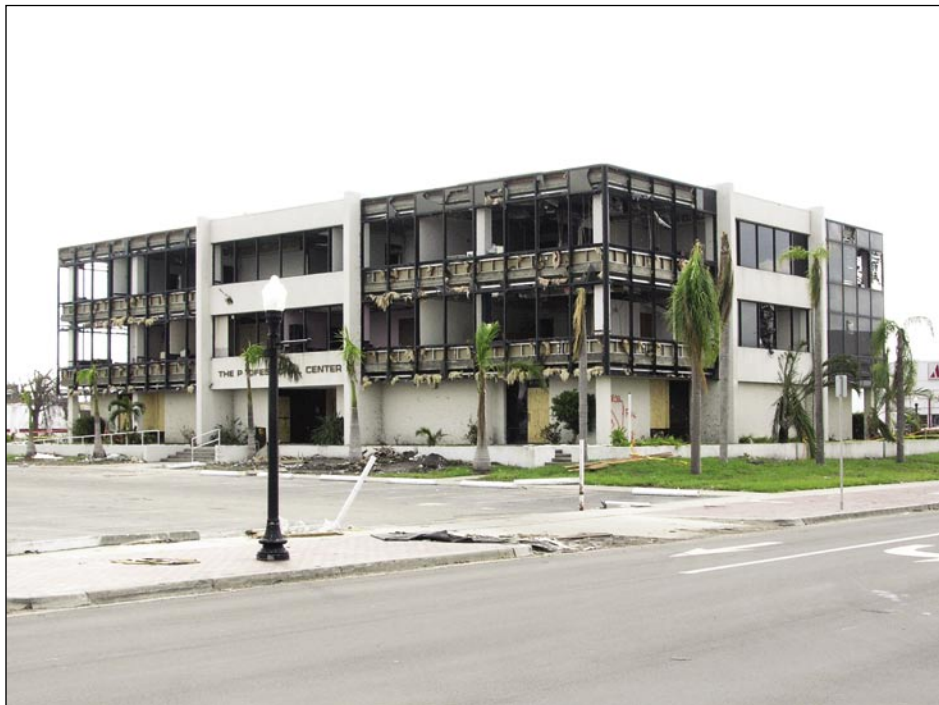
Figure 5-18. All of the glazing, including glass spandrel panels, was broken on the long side of the building (Punta Gorda).

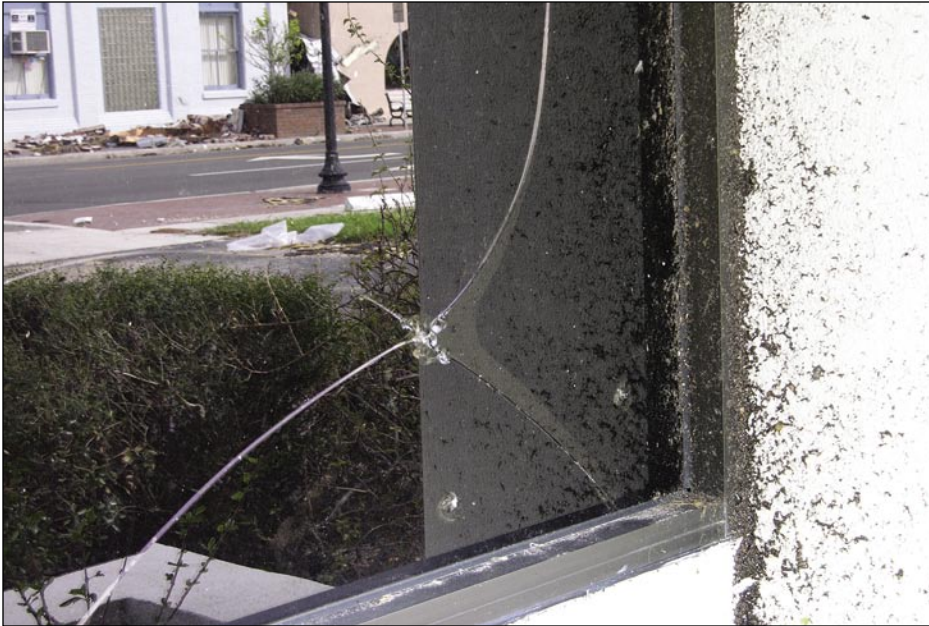
Figure 5-19. Windows broken by aggregate from a nearby BUR. Besides impact at the crack intersection, aggregate chipped the glass in three other locations (Punta Gorda).

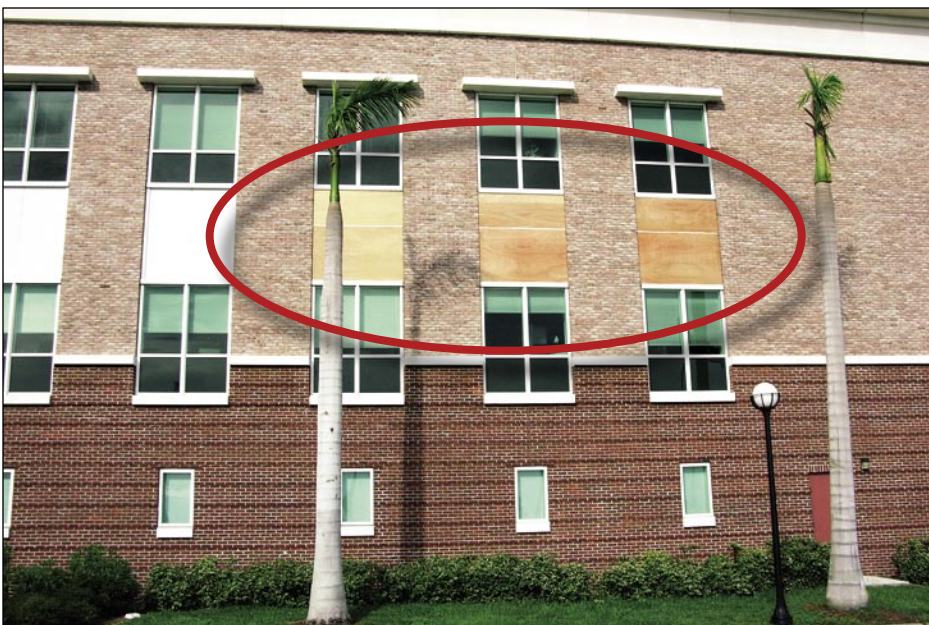
At a Charlotte County government building in Punta Gorda, a few of the windows were broken by windborne debris. Figure 5-20 shows missing spandrel panels; in other locations, the glass was broken. The windows extended from the floor to the ceiling, so tempered glass was used for personnel protection. Had laminated glass been used instead, any damaged glass would likely have stayed in its frame and would have provided wind and water protection. Glass broken by windborne debris was also observed at a hospital in Arcadia (Figures 3-41 and 6-8) and some of the fire stations in Port Charlotte and Punta Gorda.

Figure 5-20. Plywood panels installed where aluminum spandrel panels were blown out of the curtain wall (Punta Gorda)

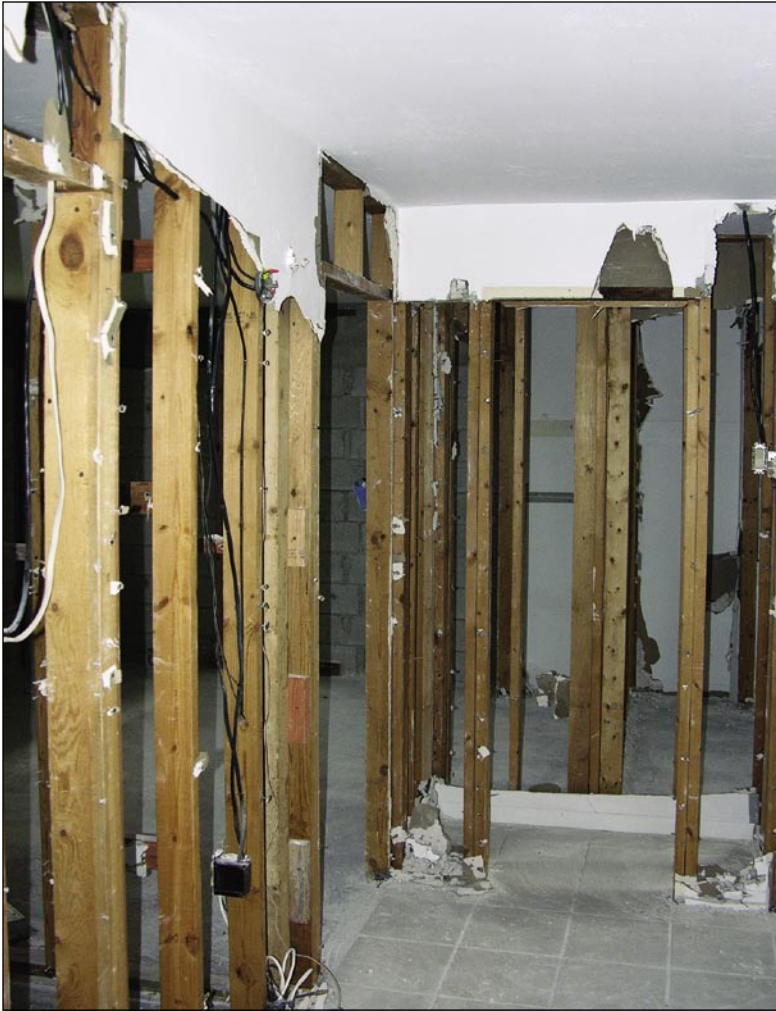
Figure 5-21.
After the attic vent failed, water entered this residence. Wet carpeting and a substantial amount of wet gypsum board had to be removed (Punta Gorda Isles).

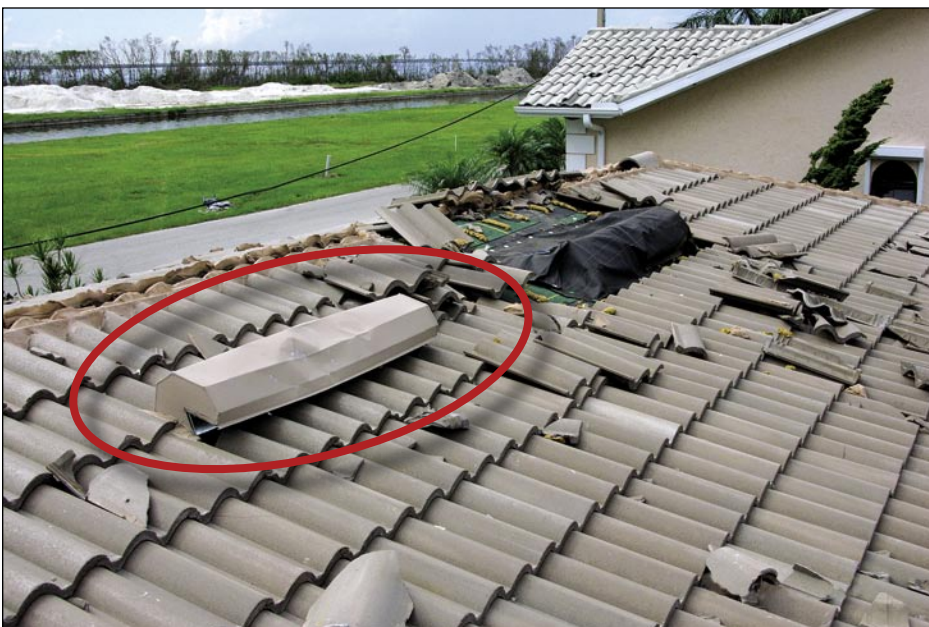
Figure 5-22.
The attic vent to the right (temporarily covered with felt) on this foam-set tile roof lifted during the hurricane and allowed water to enter the residence shown in Figure 5-21. The failed vent is like the one on the left (Punta Gorda Isles).

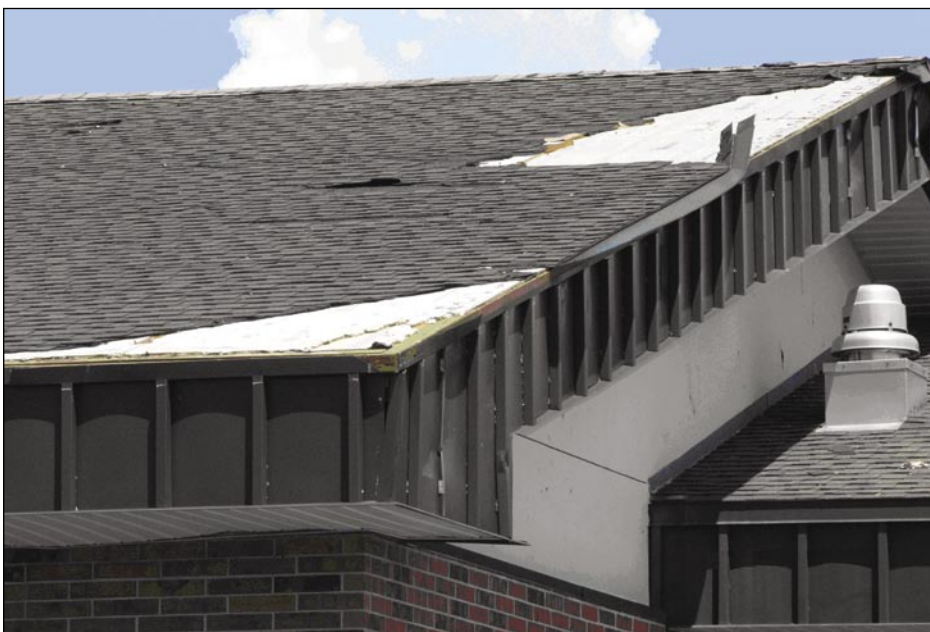
Figure 5-29.
Edge flashing that caused a progressive failure of the shingles (Deep Creek)

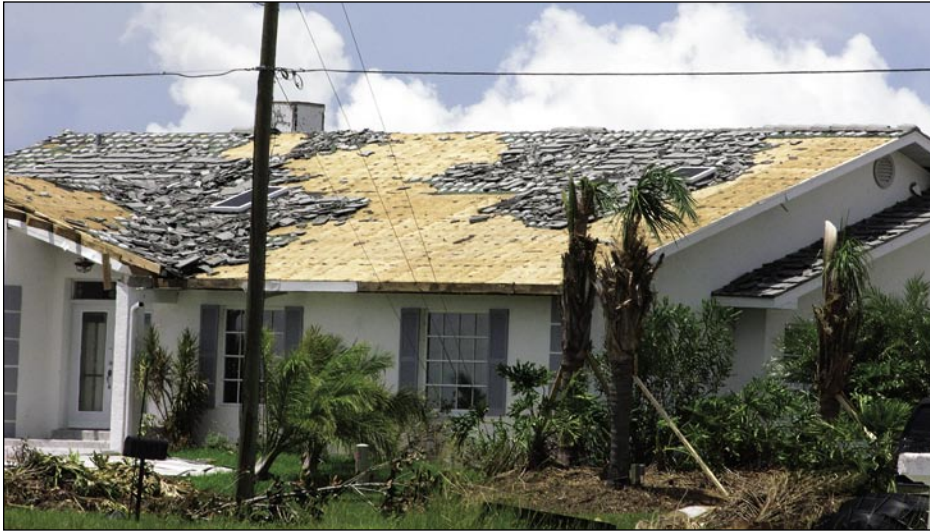
Figure 5-30.
A large area of underlayment at this mortar-set flat tile roof blew away. The loss of tile underlayment was atypical (Punta Gorda).

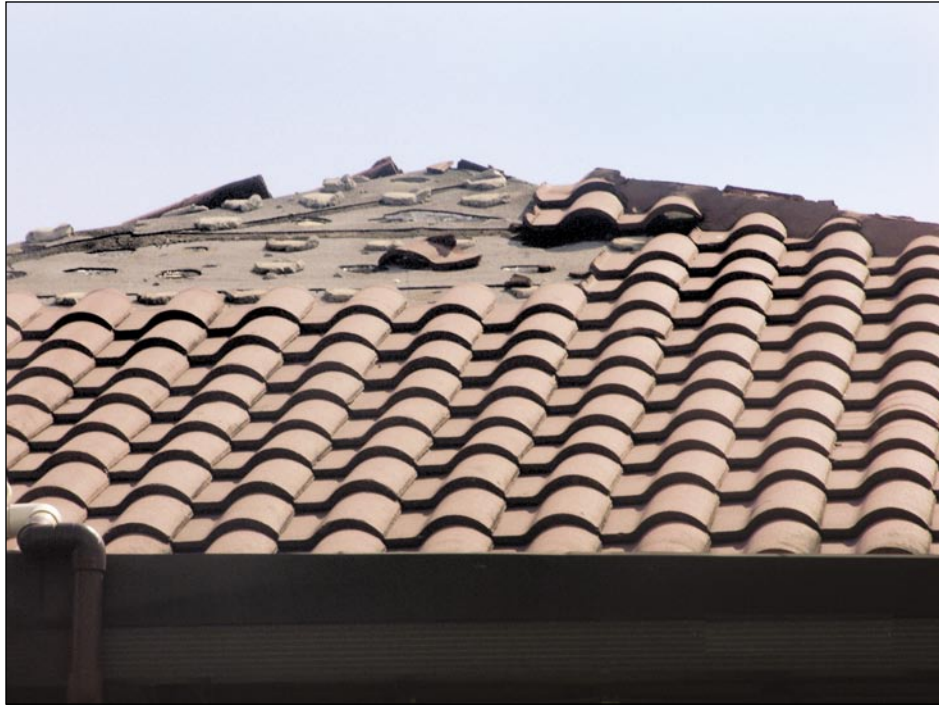
On the roof shown in Figure 5-32, most of the mortar-set hip and ridge tiles blew off. Some of the mortar-set flat tiles were also blown off, and other field tiles were broken by windborne debris (likely other tiles from this roof). Figure 5-33 shows three tiles from the roof shown in Figure 5-32. The mortar paddy on the left debonded from the underlayment. For the other two tiles, the underlayment tore away. The paddies were incorrectly located near the head of the tiles, which offers reduced uplift resistance.

Figure 5-32.
Most of the mortar-set
hip and ridge tiles blew
off this house (Port
Charlotte).

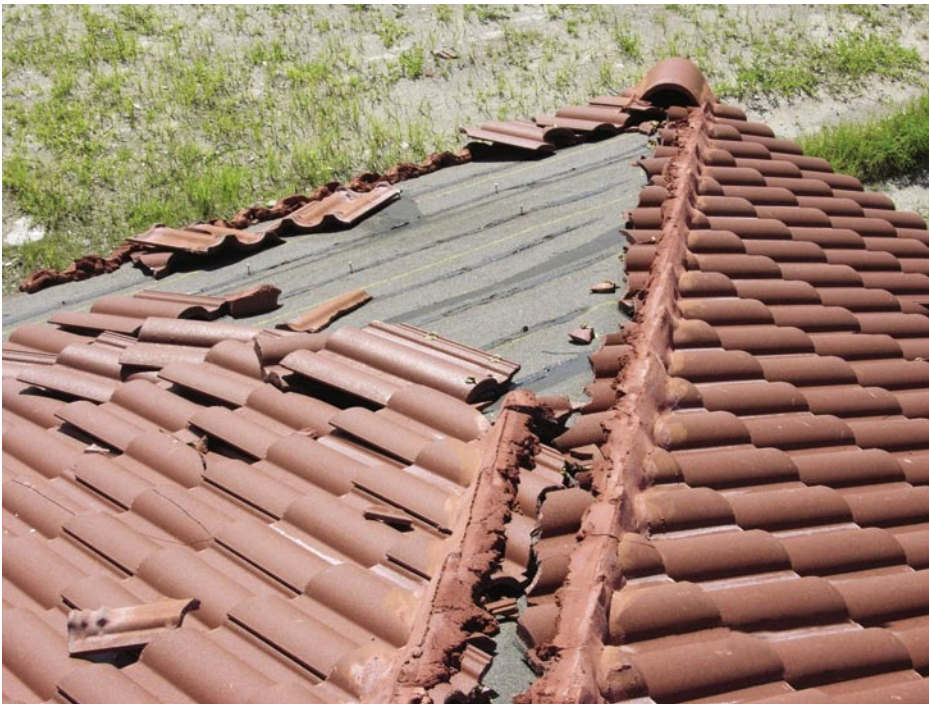
Figure 5-36. Loss of mortar-set hip tiles and several of the field tiles. Some of the screws remained in the deck, while others had been pulled out (Deep Creek).

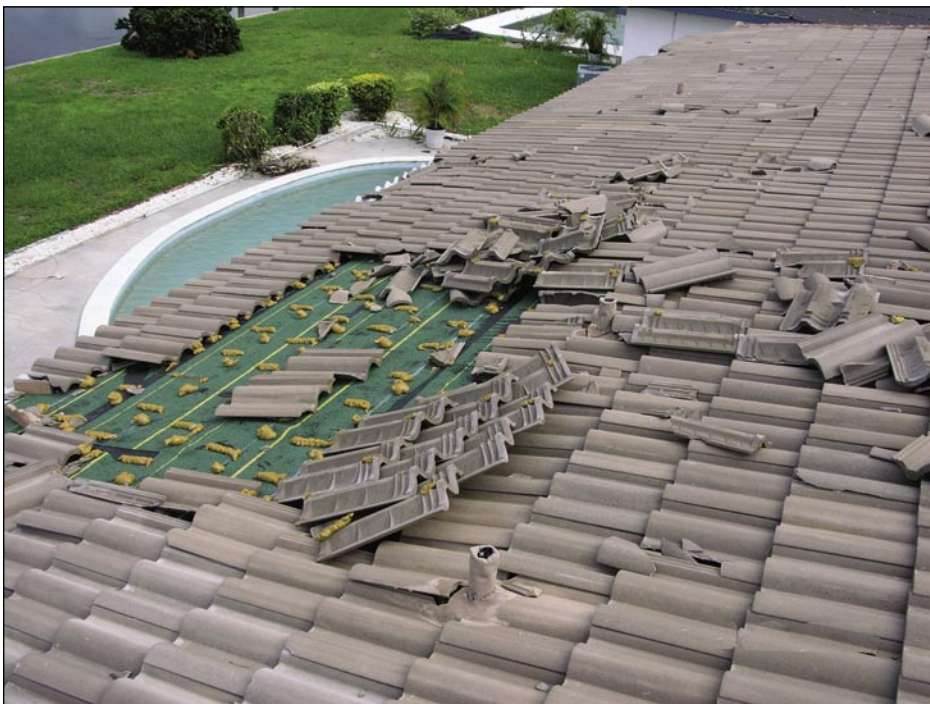
Figure 5-38. In addition to the damage shown in this photo, this one-story roof lost virtually all of the hip and ridge tiles (see Figures 5-22, 5-39, and 5-40) (Punta Gorda Isles).

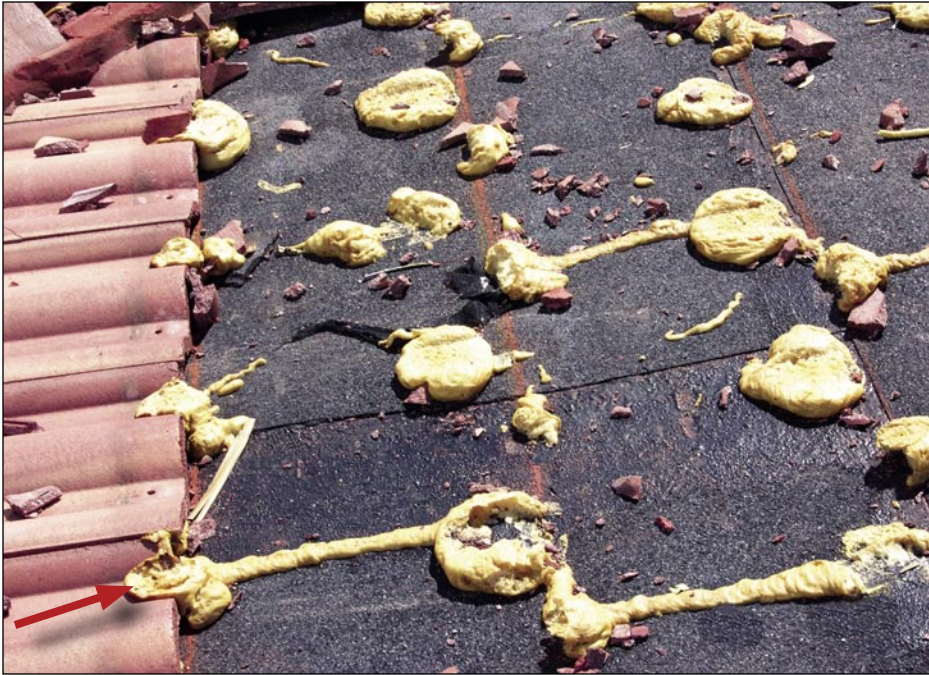
Several foam-set tiles were blown off a one-story bank (Figures 5-43 through 5-45), primarily due to insufficient contact area of the paddies. To meet the small paddy placement criteria, the paddies should have provided approximately 8 to 9 square inches of foam contact with the tile near the head. The paddies were observed to be about the correct size, but they did not achieve the required contact area. The paddies were also typically located too close to the upslope end of the tile. Though not required, a very small paddy was placed at the tile overlaps (red arrow in Figure 5-43). The tiles typically debonded from the paddies, but the two paddies shown at the bottom of Figure 5-43 debonded from the cap sheet. Many mortar-set hip and ridge tiles were also blown off. The bank was located in an area identified in the code with a basic wind speed of approximately 125 mph. Assuming the intent was to provide a small paddy placement, according to the foam manufacturer's literature, this attachment would have been suitable for a basic wind speed of 135 mph (assuming proper application). The estimated speed at this location was in the range of 125 to 140 mph. Therefore, had the foam paddies been properly sized and located, according to the manufacturer's literature, the tiles should not have blown off.

Figure 5-43.
This photo clearly shows insufficient contact area of foam-set paddies on the bank's roof (Punta Gorda Isles).

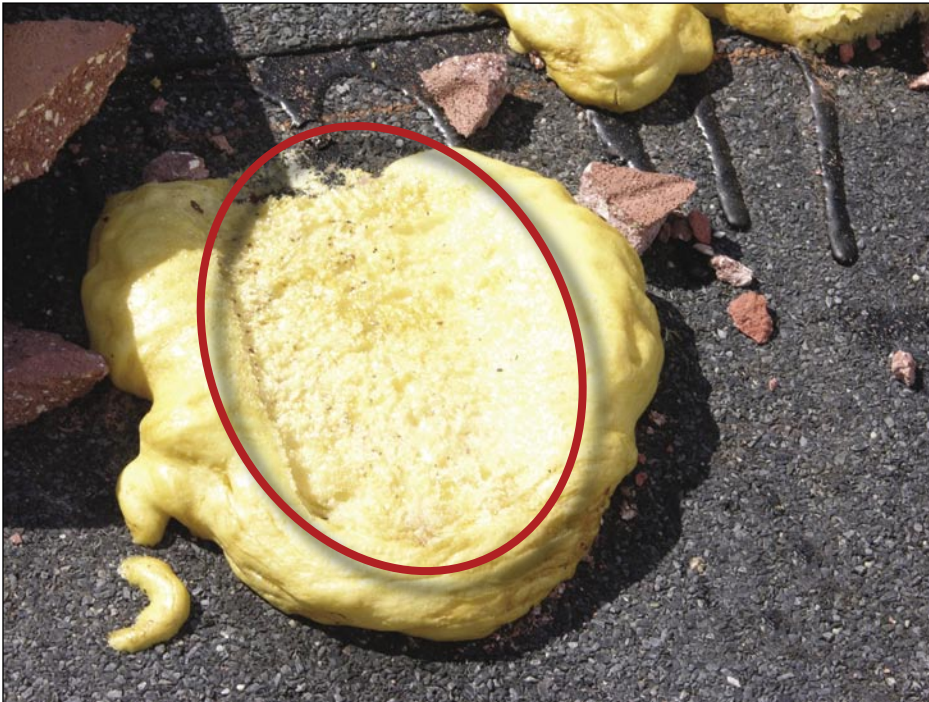
Figure 5-44.
In this photo, the portion of the paddy that made contact with the tile is clearly visible (Punta Gorda Isles).

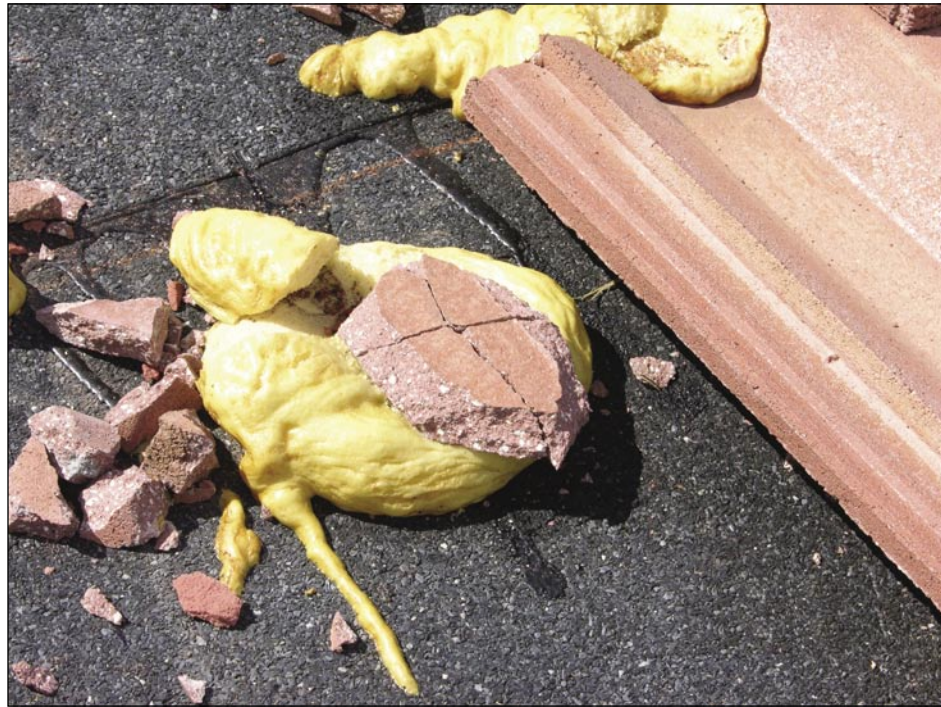
Figure 5-45. Tile remained bonded to the paddy, but, except where bonded, the tile blew away. A large portion of the paddies shown in Figure 5-43 and this figure failed to make tile contact, which was a typical observation (Punta Gorda Isles).

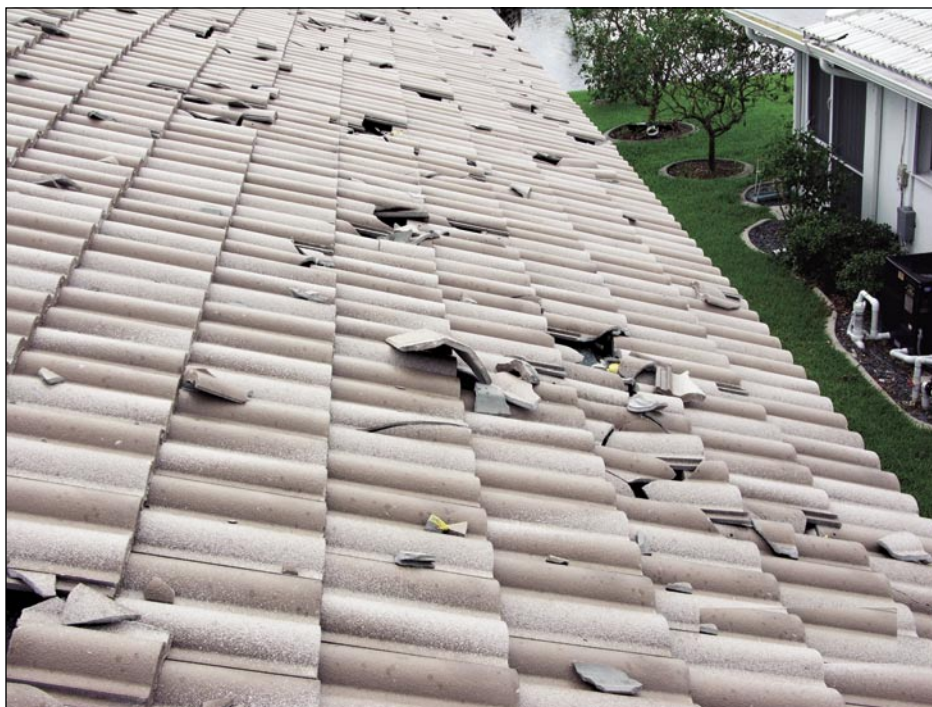
Figure 5-49. A view of the roof on the back side of the residence shown in Figure 5-41. Tiles (including a hip tile) from the front garage roof landed in this area and broke several field tiles (Deep Creek).

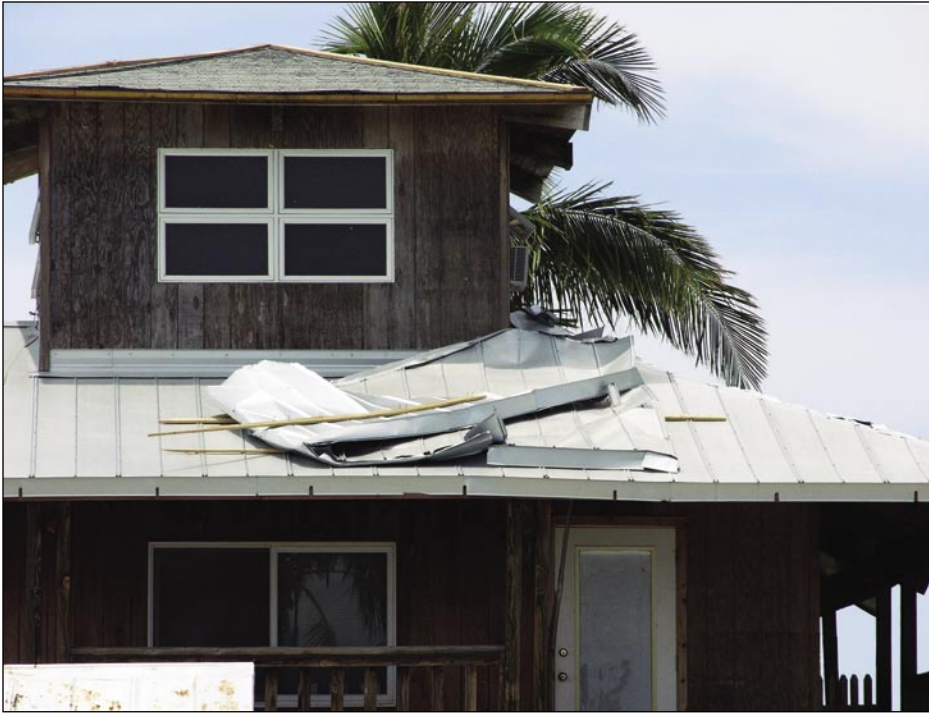
Figure 5-51. These panels blew off the upper roof and landed on the lower roof of this house (Bokeelia, north end of Pine Island).

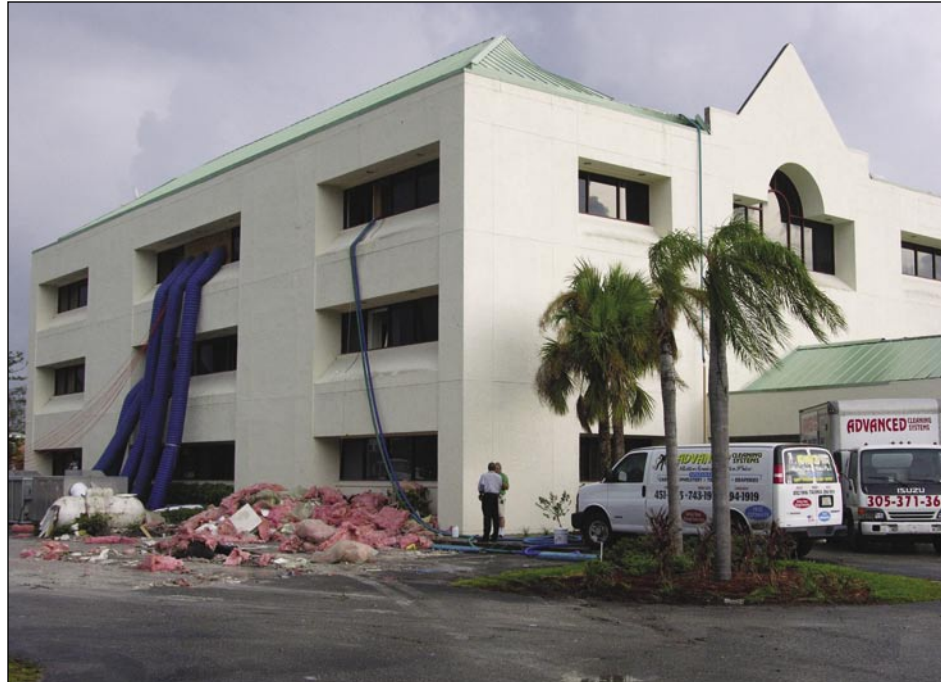
Figure 5-53.
The wood and metal
framed superstructure
blew away and exposed
the lightweight
concrete roof deck (Port
Charlotte).

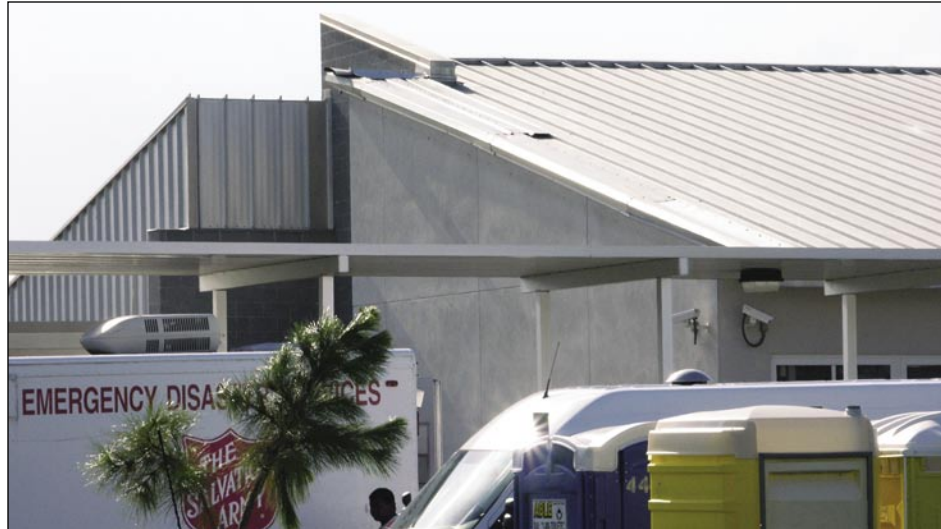
Figure 5-56. Several of the architectural panels and hip flashings blew off this fire station (Deep Creek).
