Building Envelope Performance

5.1 Doors

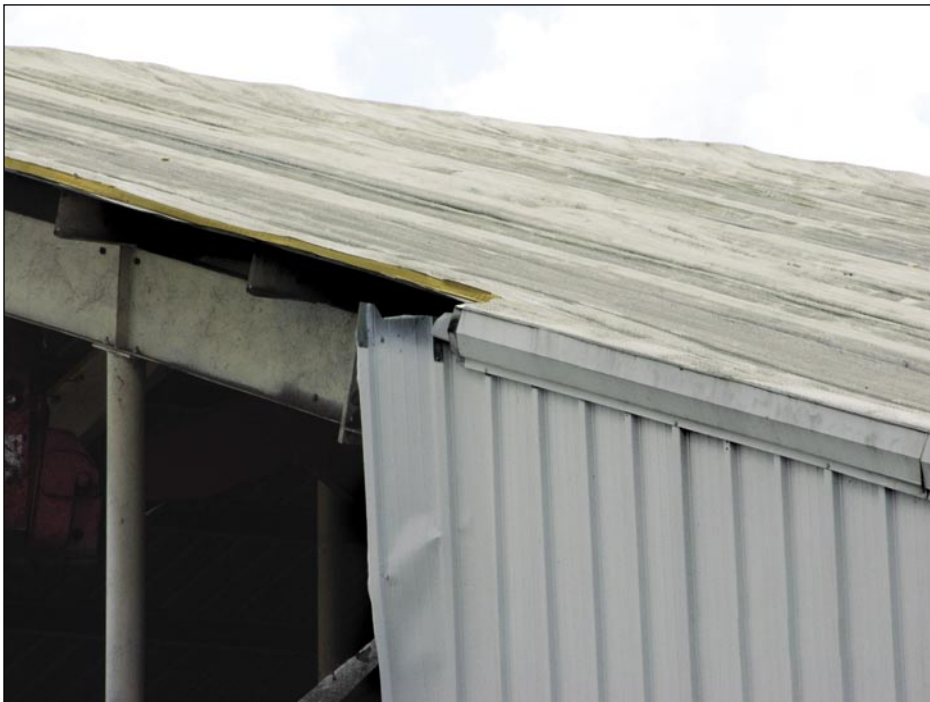
Figure 5-58. The metal wall panels and metal edge flashing on this building blew away, but the exposed fastener R-panels with an SPF covering did not progressively fail (Wauchula).

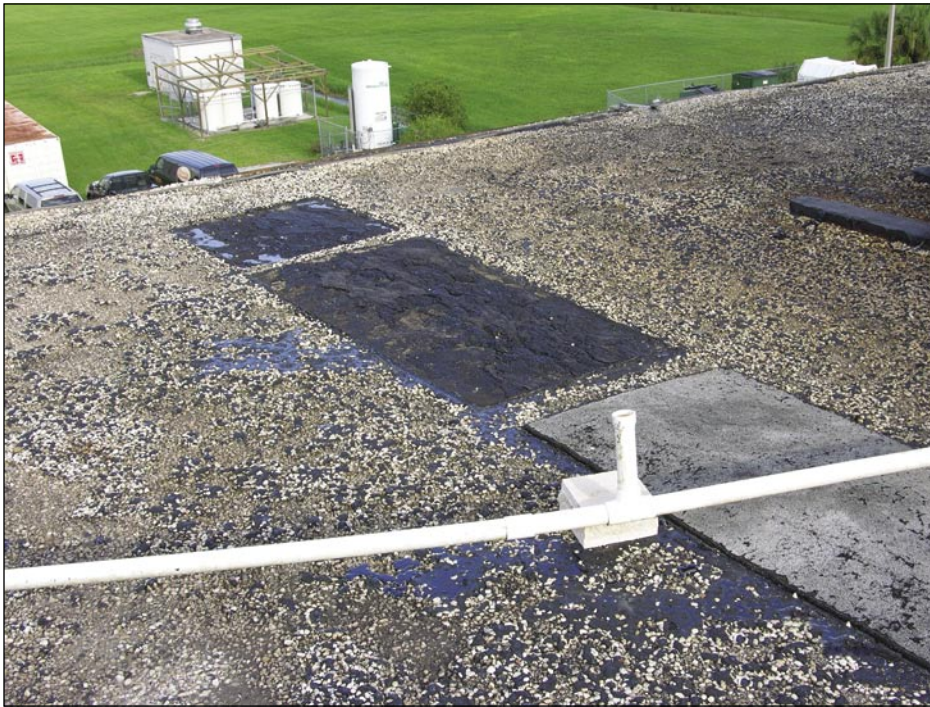
Figure 5-60. This view of the back side of the upper roof of a hospital (see Figure 6-8) shows that the missing gutter and asphalt plank walkway pad were blown away (Arcadia).

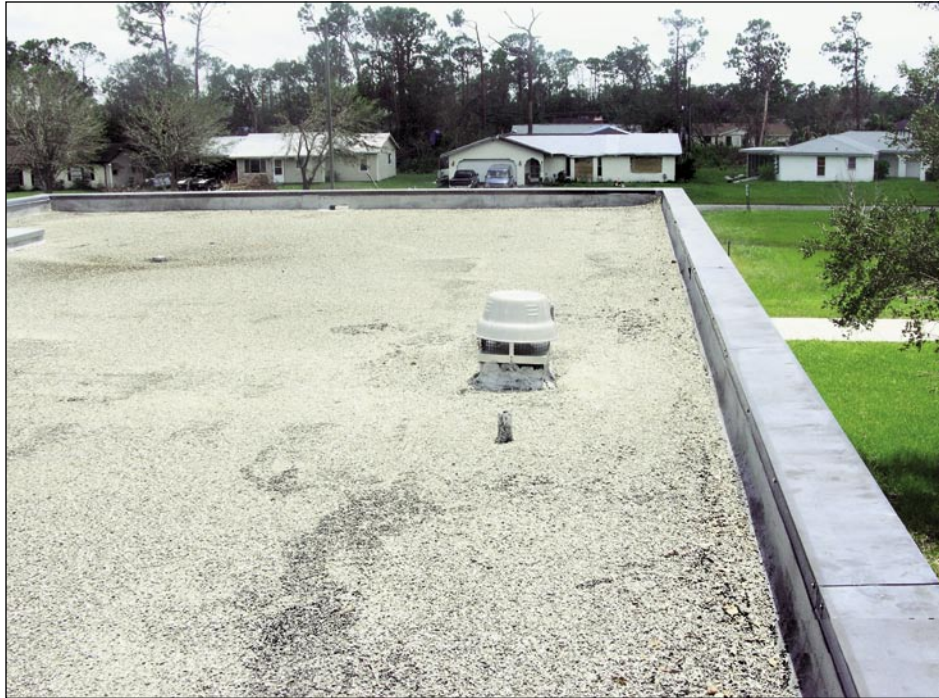
Figure 5-62.
The edge flashing at this mineral surface cap sheet roof lifted (Port Charlotte).

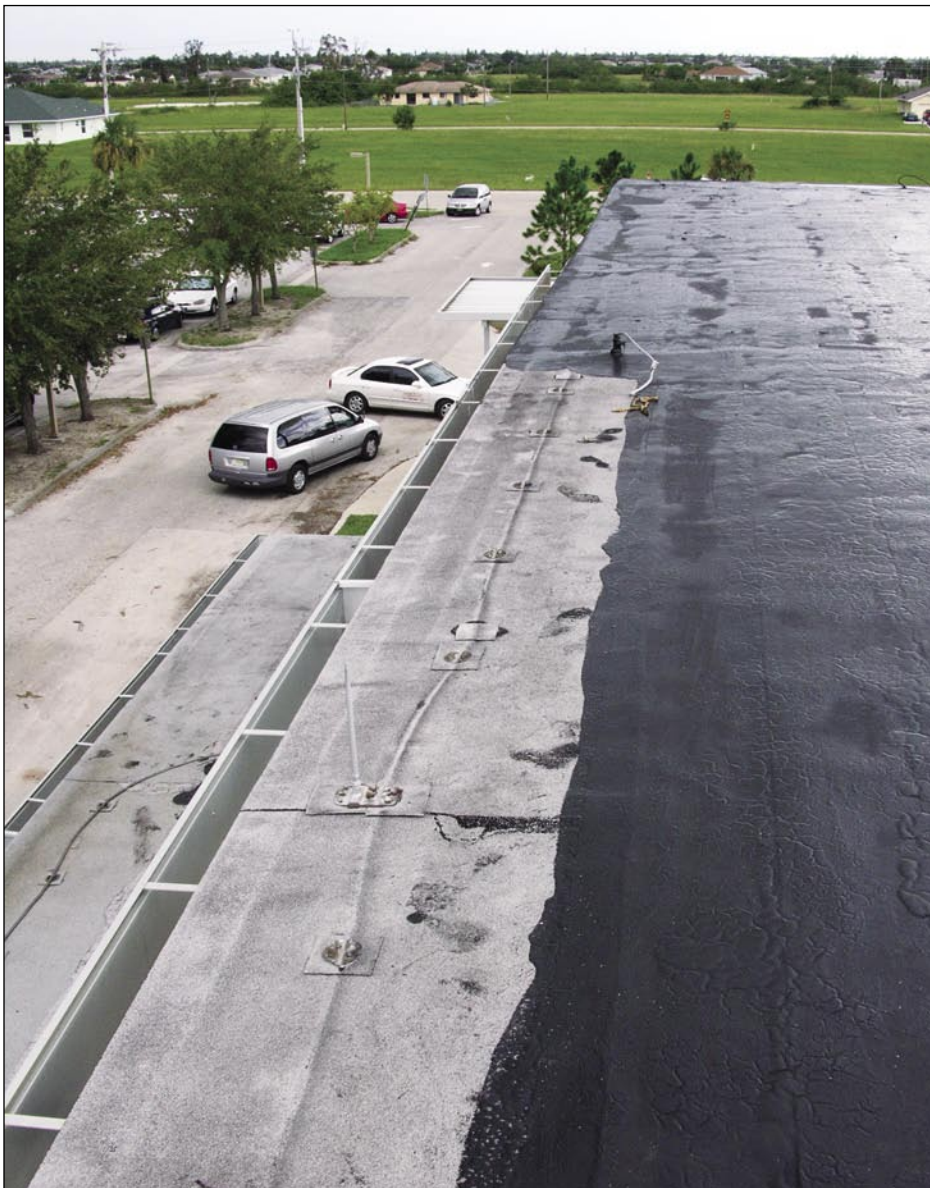
An edge flashing failure also occurred at a middle school in Cape Coral, first occupied in 1998 (Figure 5-63). This metal edge flashing had also been improperly installed underneath the membrane. The flashing should have been installed over the modified bitumen cap sheet and then stripped in to clamp the edge of the membrane. Wind lifted the gutter and metal edge flashing and peeled the modified bitumen membrane. The gutter was not designed for uplift resistance. A portion of a middle school in Port Charlotte also had a mineral surface BUR cap sheet roof, and the metal edge flashing had also been improperly installed underneath the membrane. However, none of the edge flashings lifted. Except for some missile damage, the BUR on this roof performed very well.

Figure 5-63. The edge flashing had a 2-inch vertical flange that extended into the gutter. The flashing was not cleated (Cape Coral).

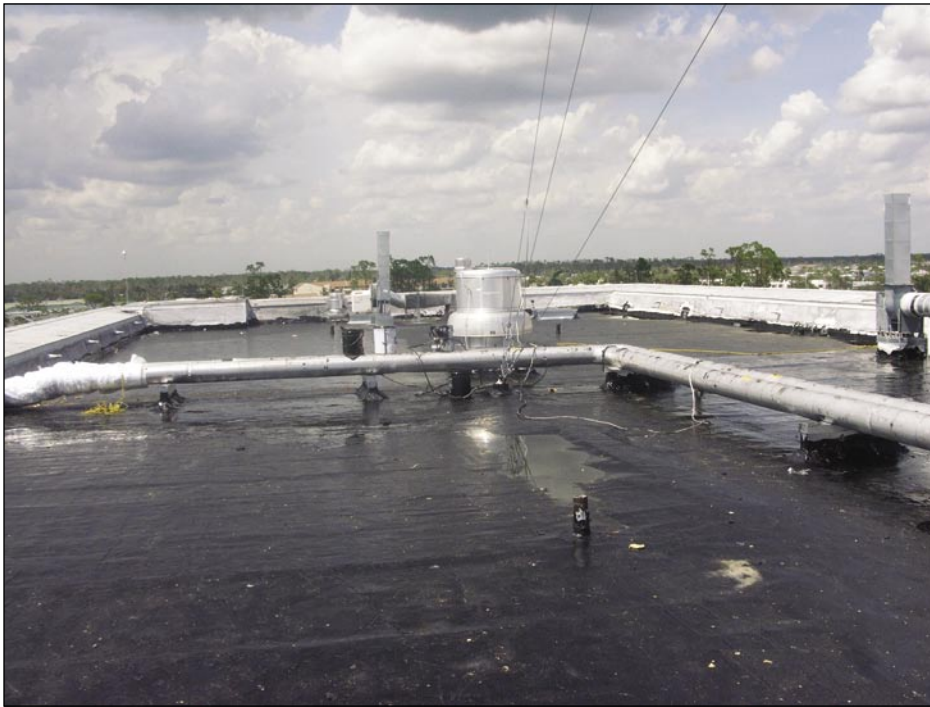
Figure 5-64. View of a portion of the fourth floor roof of a hospital after installation of an emergency roof (the black area). The deck was concrete (Port Charlotte).

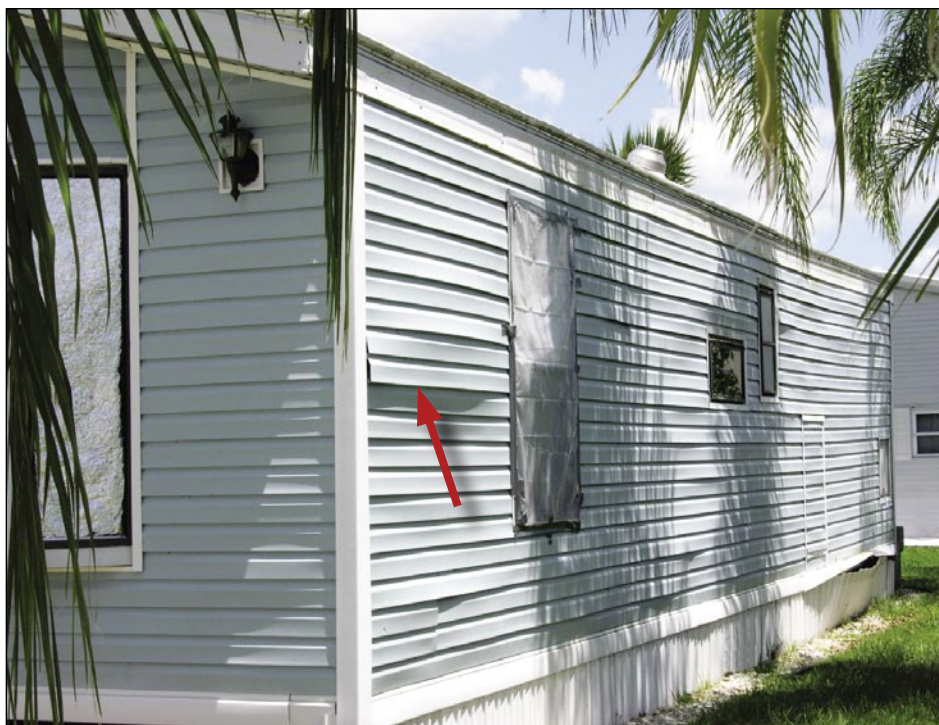
Figure 5-65. The vinyl siding panel with the red arrow is unlatched. The panel above and several others are also unlatched (Zolfo Springs).

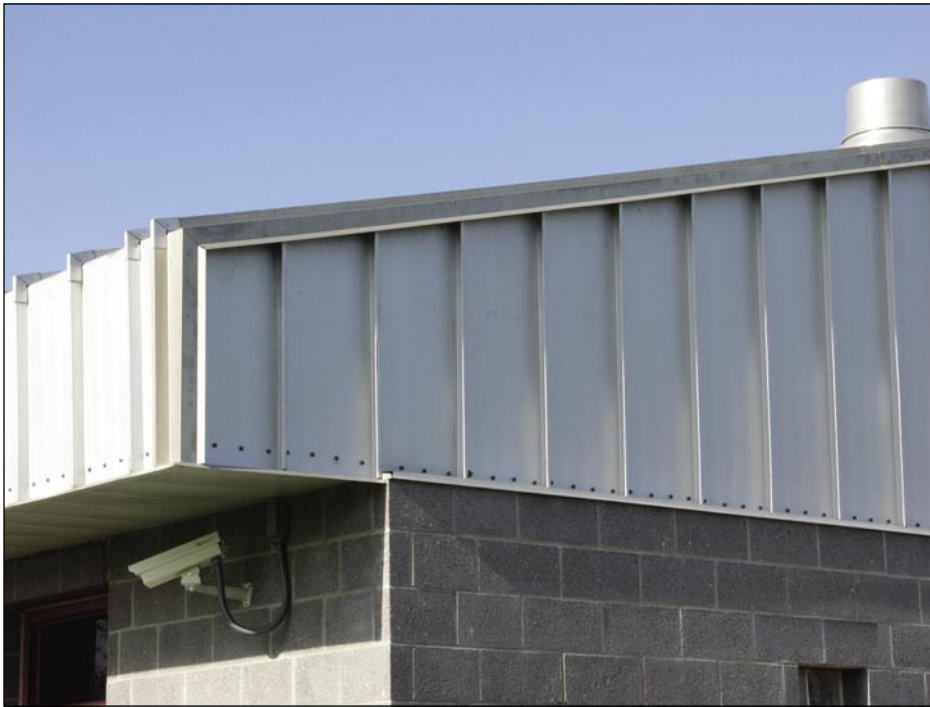
Figure 5-67. Standing seam metal panels with a 16-inch rib spacing were used at the fascia and secured with closely spaced exposed fasteners (Arcadia).

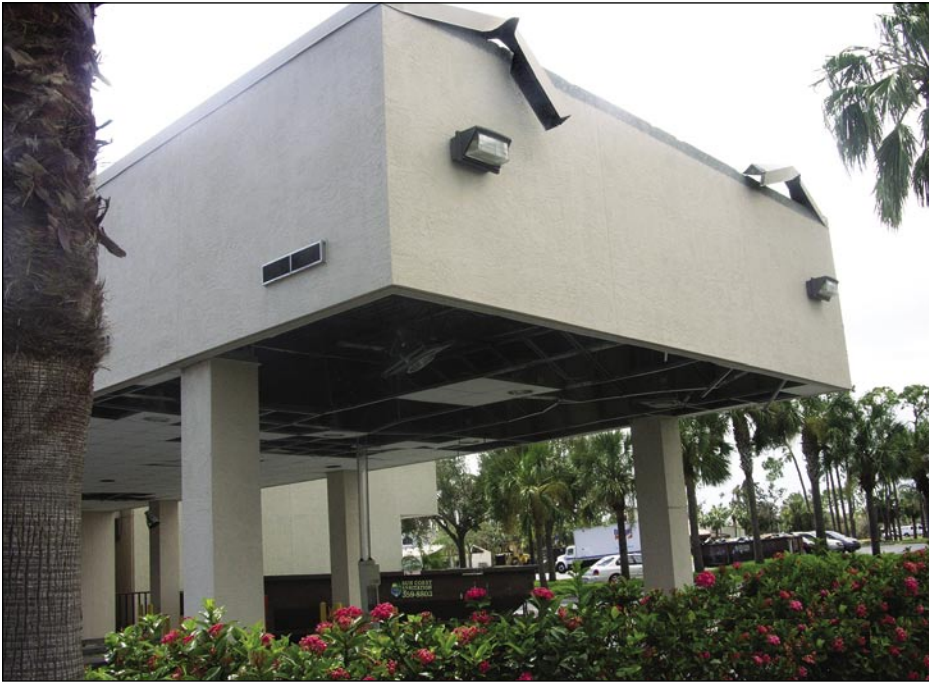
Figure 5-70 shows a damaged soffit at a bank drive-through canopy. Figure 5-71 shows damaged soffits at the Aquí Esta Fire Station. Most of the gutters and downspouts at the fire station blew away, but the 5V-Crimp metal roof had only minor damage at a hip flashing lap. The soffit panels were connected to the building only at their ends. A substantial quantity of wind-driven rain blew into the attic space and caused ceiling boards to collapse. Because of the water infiltration, this station was taken off-line after the storm.

Figure 5-70. Loss of soffit at a bank drive-through. Note the coping damage (Port Charlotte).

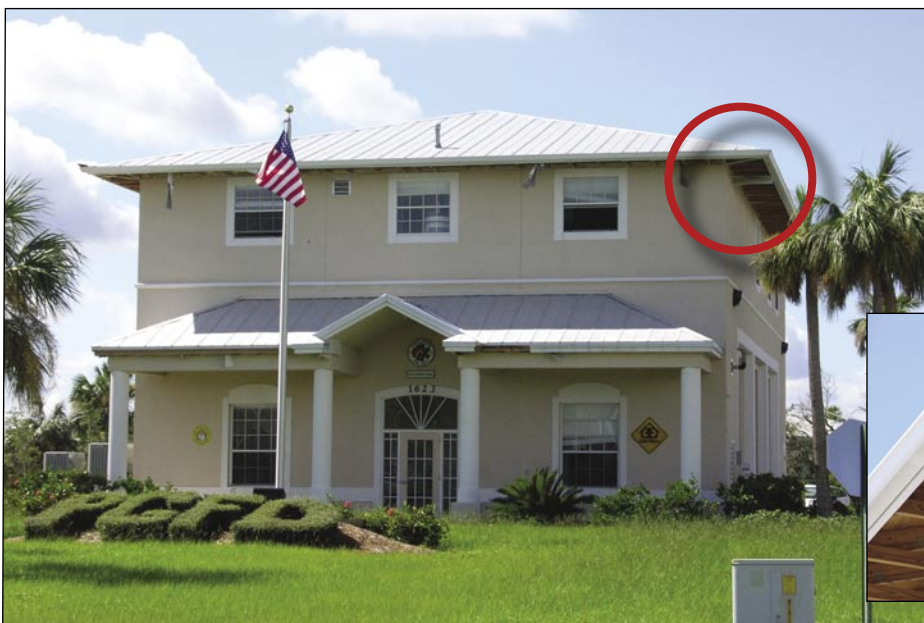
Figure 5-71. Essentially all of the perforated aluminum soffit on this fire station was blown away (Aquí Esta, east of Punta Gorda Isles).

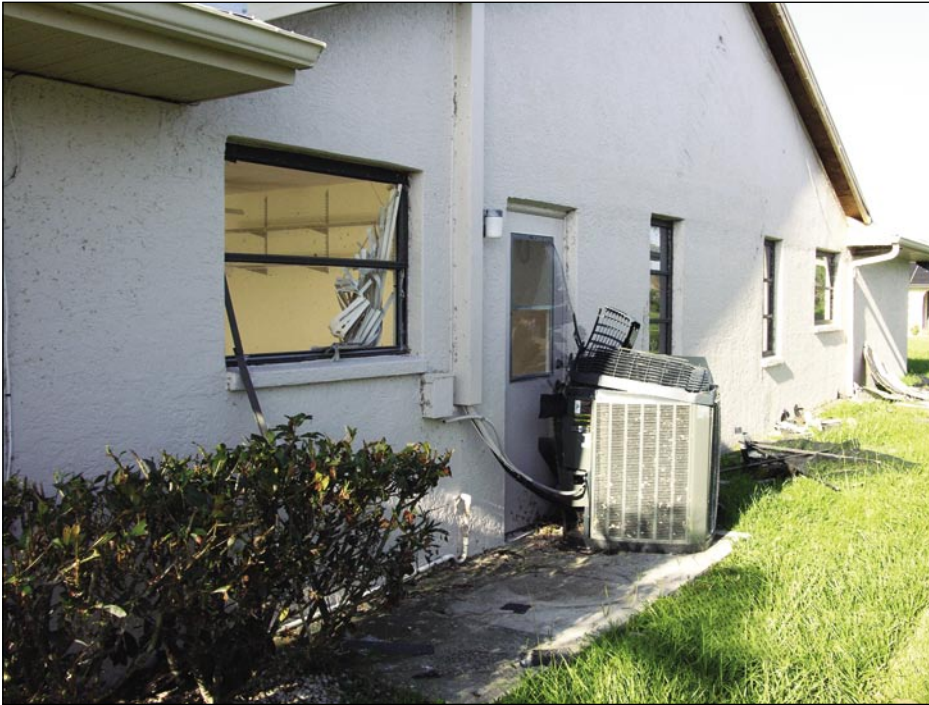
Figure 5-72. This condenser was not anchored to the concrete pad. The electrical and copper tube connections kept it from blowing farther away (Deep Creek).

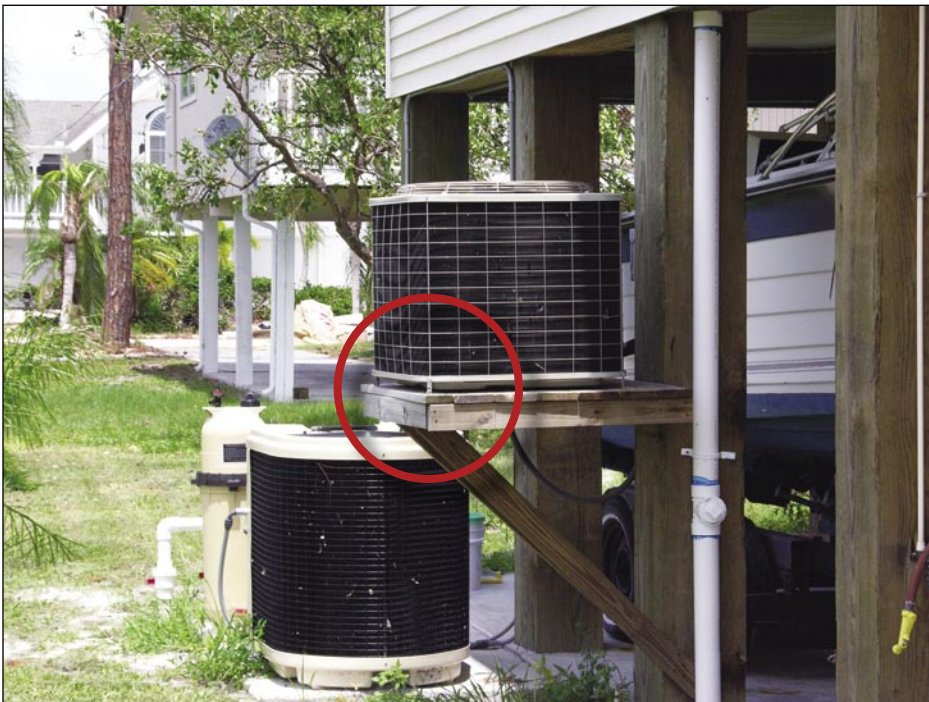
Figure 5-73. Condenser on the elevated platform attached with four angle brackets. The other condenser, located adjacent to it on the ground, should also have been on an elevated platform to account for storm surge (Pine Island).

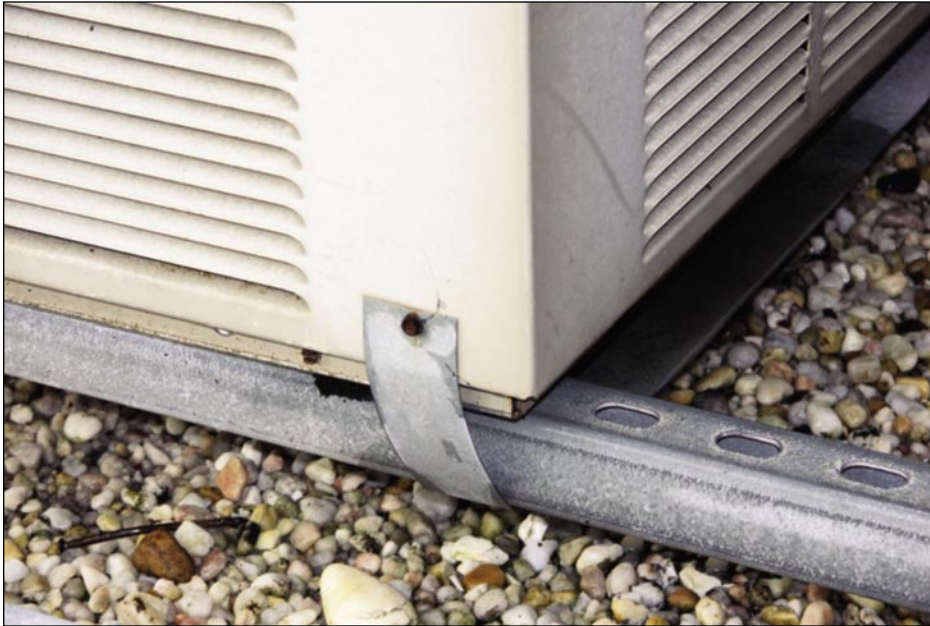
Figure 5-75. Rooftop condenser anchored to a support rail, but with only one small screw (which was corroded) used to connect the strap (Port Charlotte).

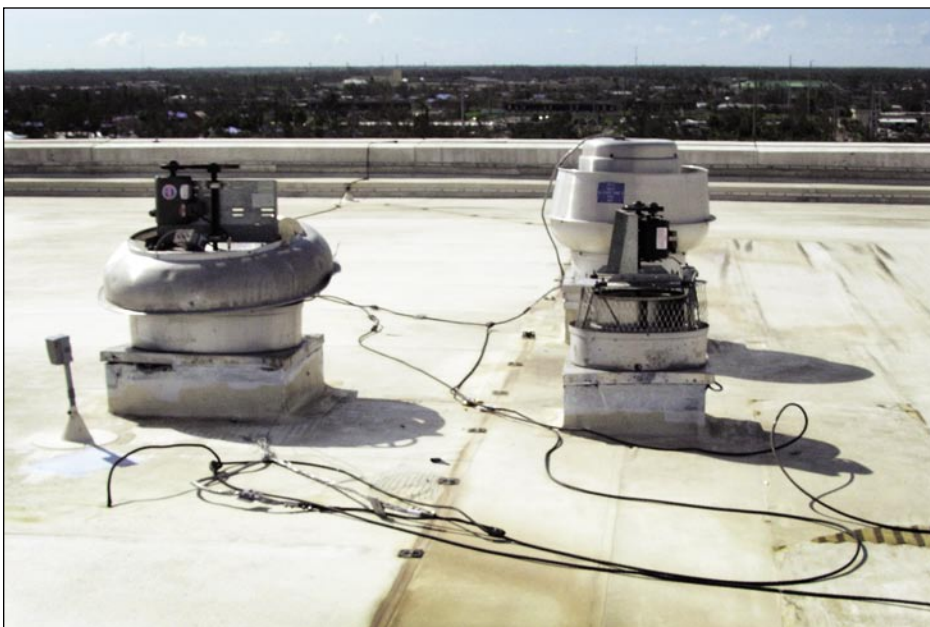
Figure 5-76. Cowlings blown off two exhaust fans in the foreground. Note also the loose LPS conductors and missing walkway pad (Punta Gorda).

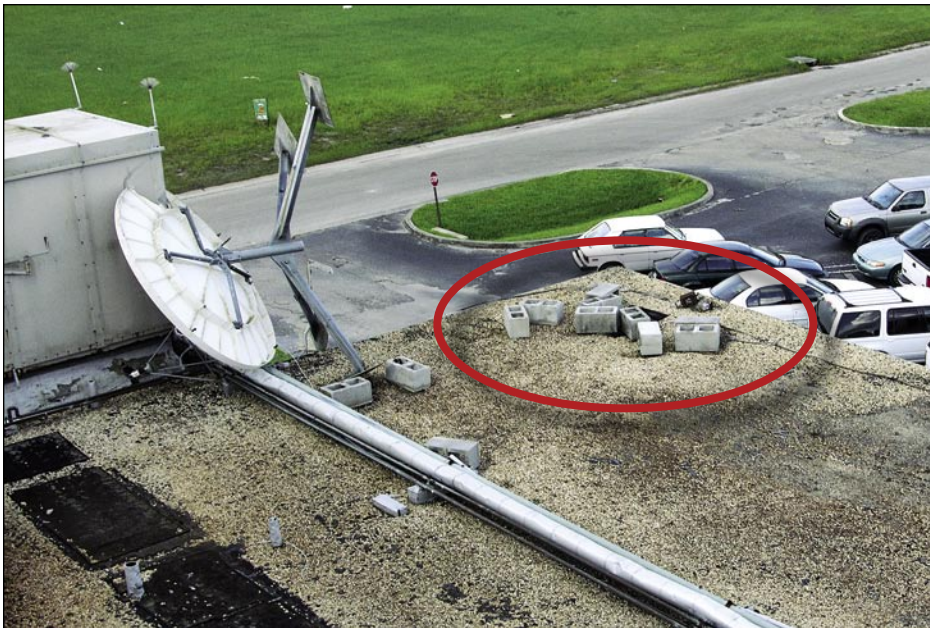
Figure 5-79. This satellite dish at a hospital was held down only with CMU. Note the loose LPS conductors and displaced air terminal at the corner (Arcadia).

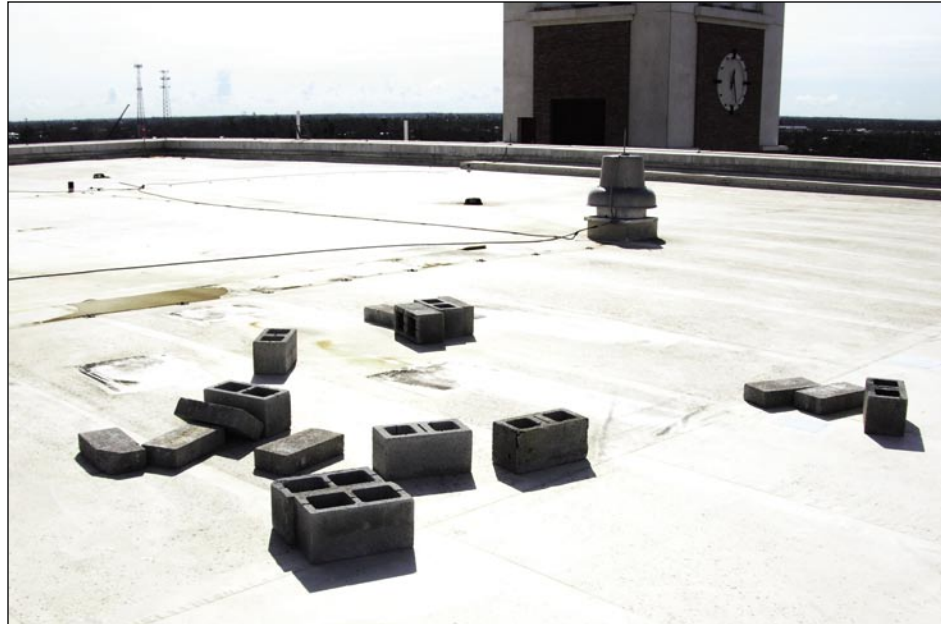
Figure 5-81.
The LPS conductor on this hospital blew away, but the air terminal was still attached. A lightning strike to this air terminal would not be safely dissipated (Port Charlotte).

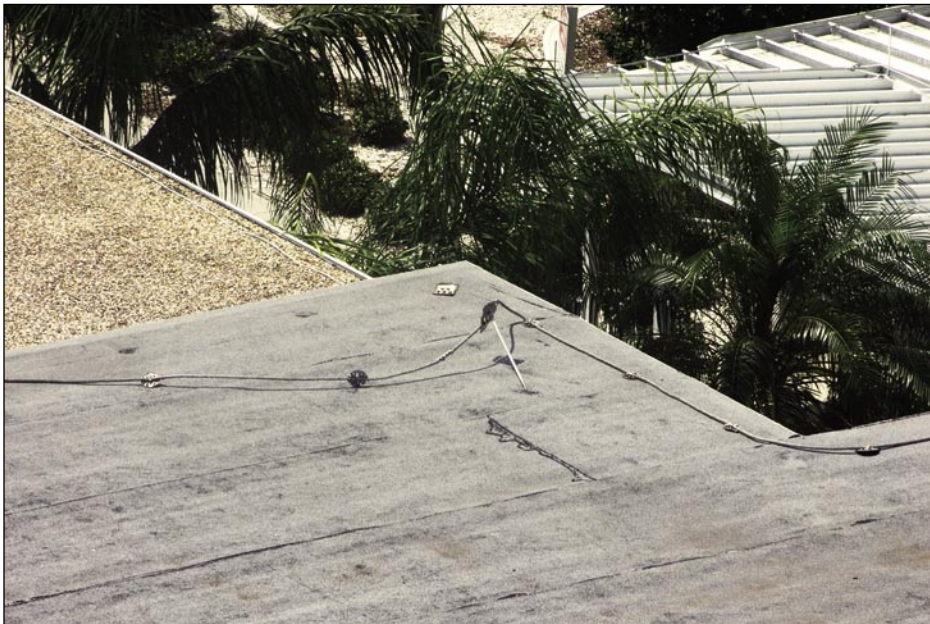
Figure 5-83.
The conductor connectors detached from the cap sheet on a hospital's BUR. The air terminal was also displaced (Port Charlotte).

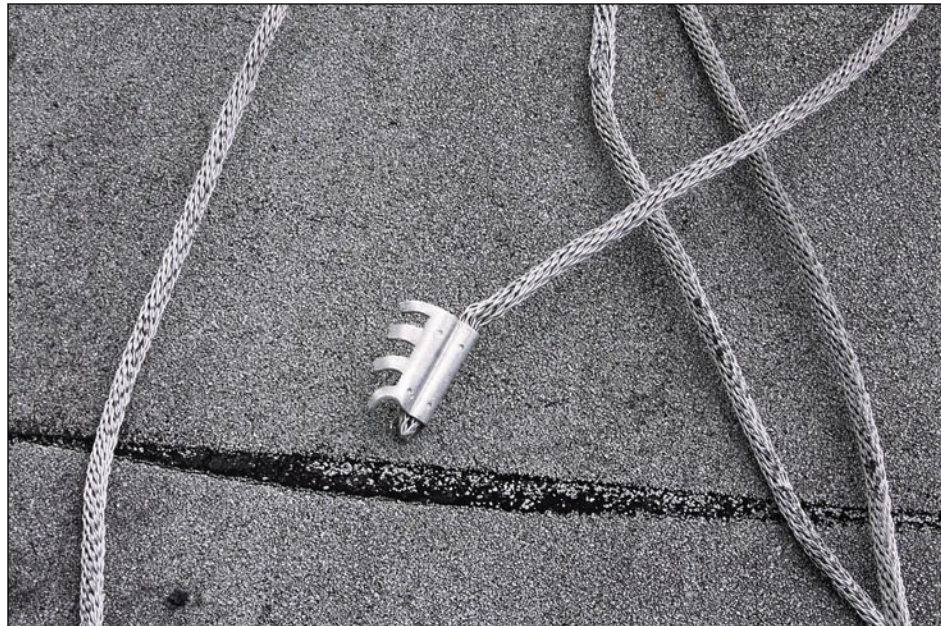
Figure 5-85.
When LPS conductors detach, the conductor ends can whip around and puncture and tear the roof membrane. The patch near this frayed conductor is likely a repair of damage caused by a whipped conductor (Punta Gorda).
