*Mitigation Assessment Team Report*

# Hurricane Charley in Florida

Observations, Recommendations,  
and Technical Guidance

*FEMA 488 / April 2005*

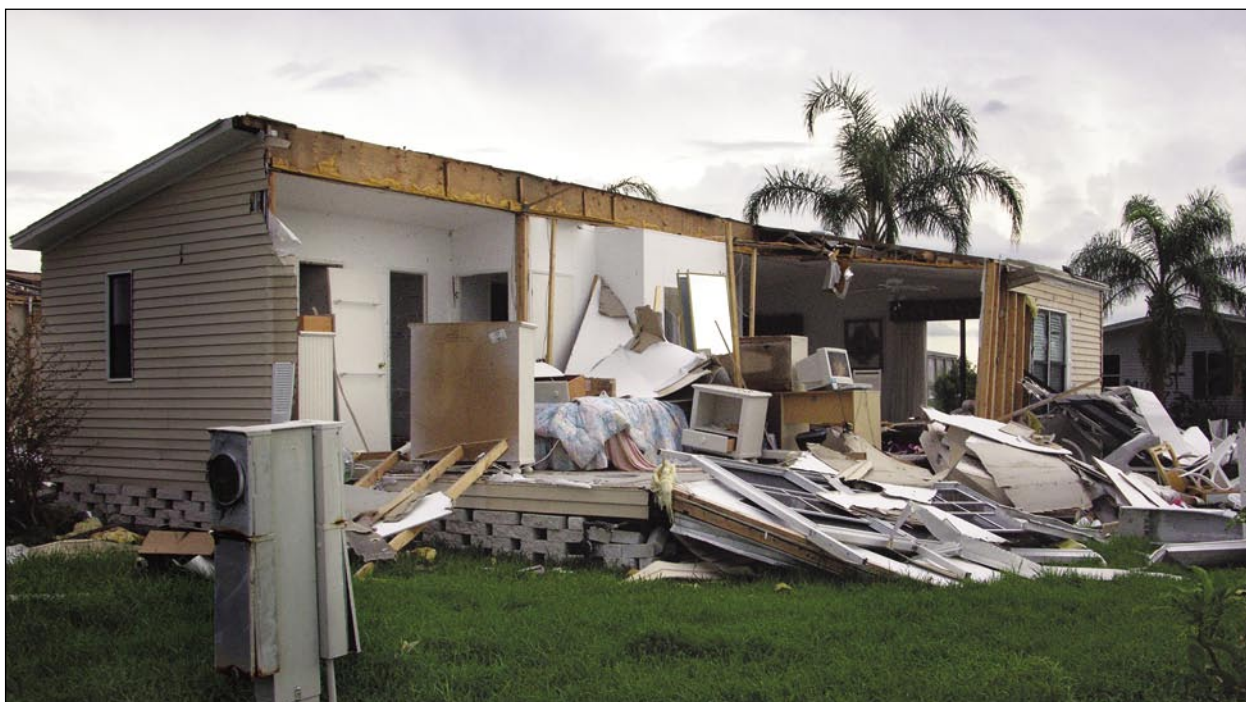
Figure 3-8 experienced extensive structural damage from 3-second peak gust winds in excess of the range of 110 to 130 mph.

Figure 3-8. Post-1994 manufactured home with major roof and wall failure (east of Port Charlotte)

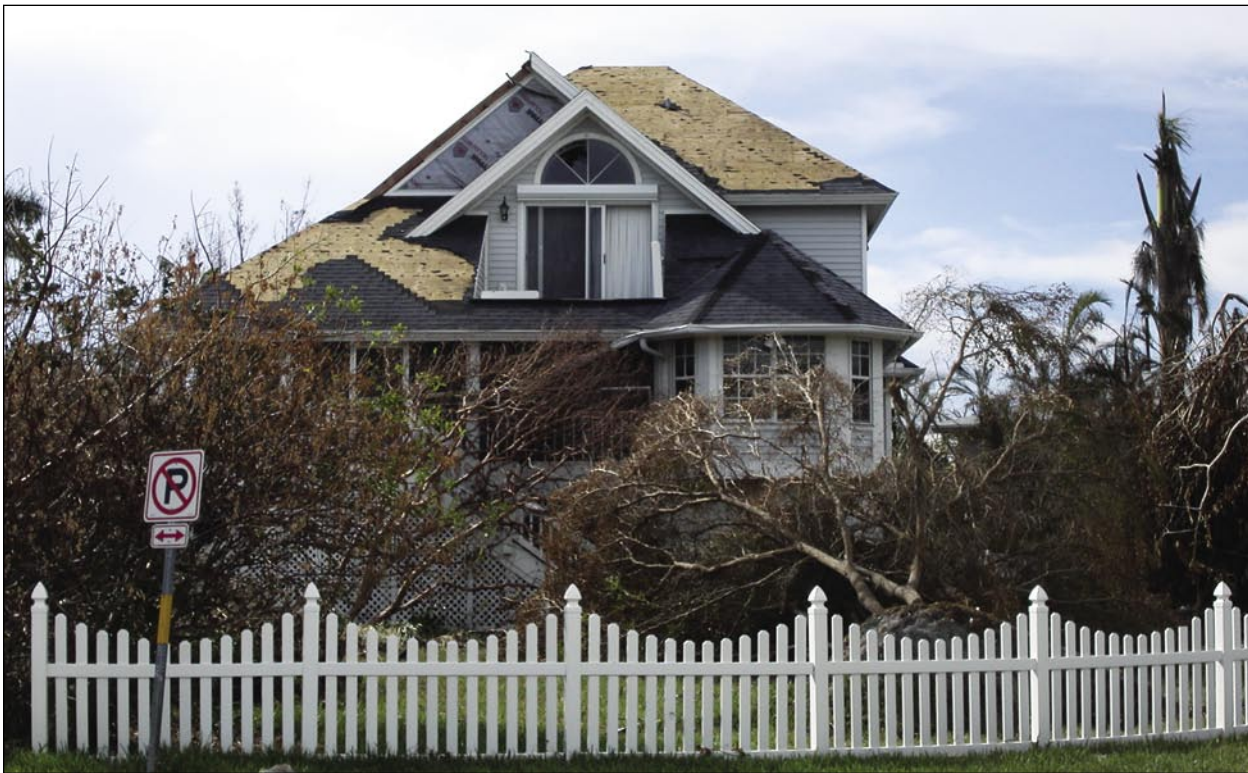
Figure 3-15. Typical asphalt shingle roof covering loss on elevated, two-story house (Captiva Island)

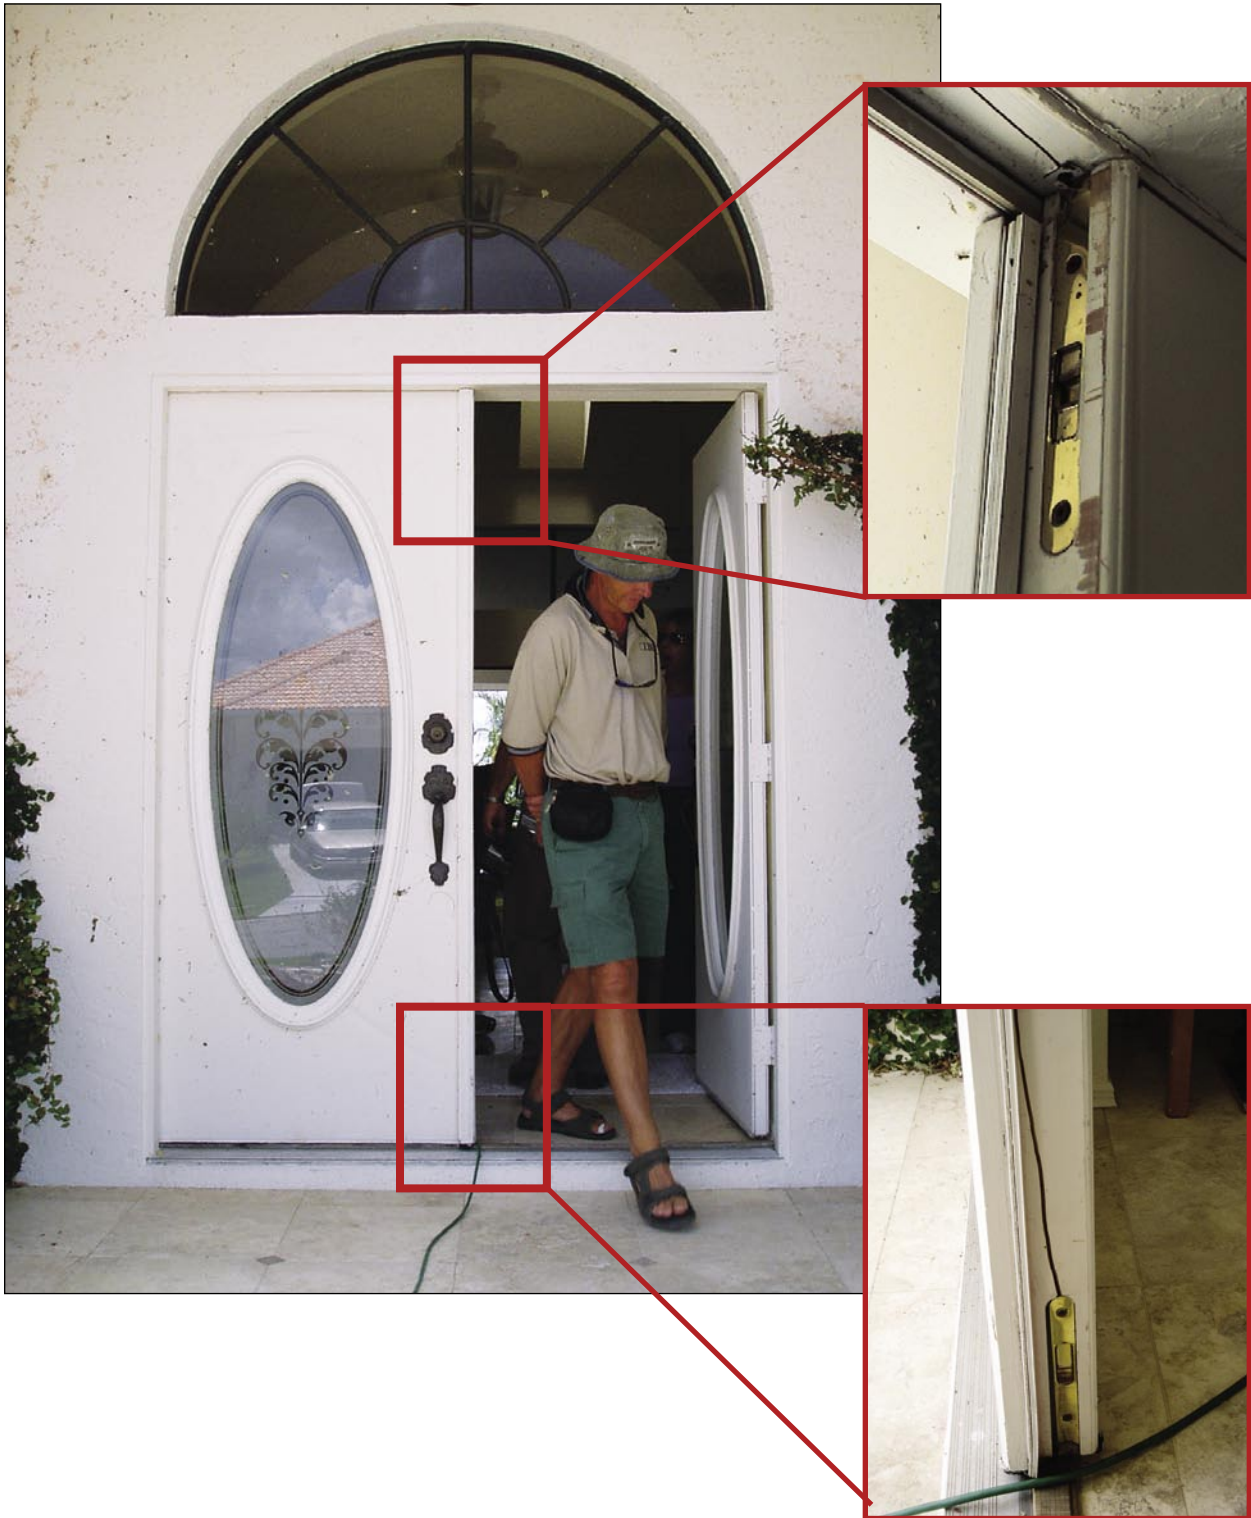
Figure 3-20. Double-entry door that failed under wind pressure. Upper inset shows close-up of crack in door frame at top latch. Lower inset shows crack in door emanating from bottom latch (Punta Gorda).

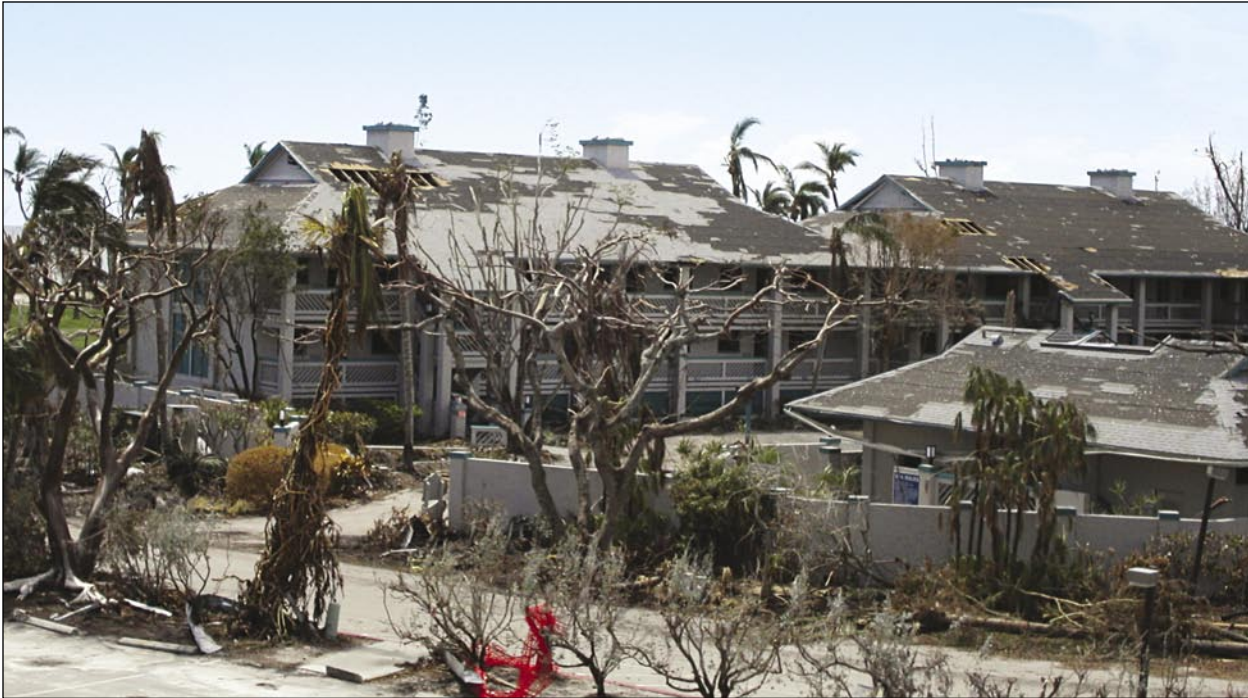
Figure 3-23. Roof covering loss. Note dark areas on roof are exposed underlayment (Captiva Island).

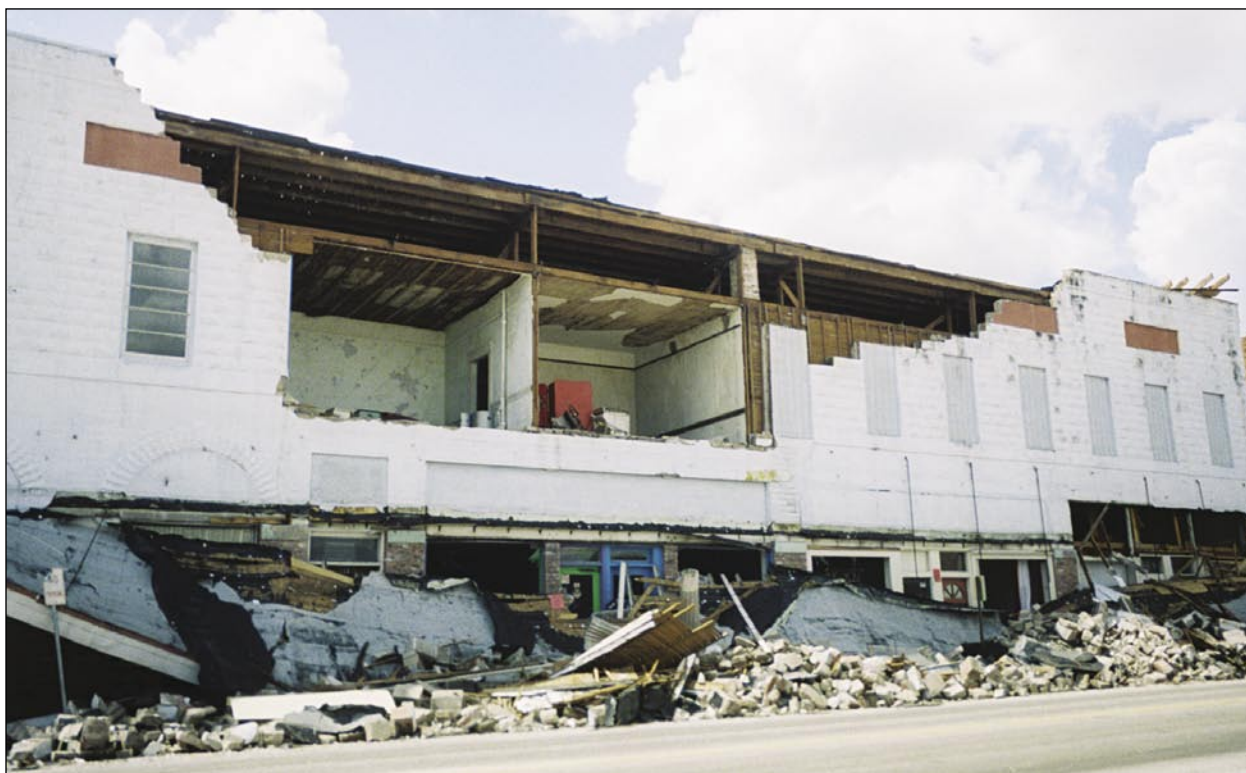
Figure 3-25. Example of unreinforced masonry wall and parapet collapse due to breaching of roof (on opposite side of building) (Wauchula)

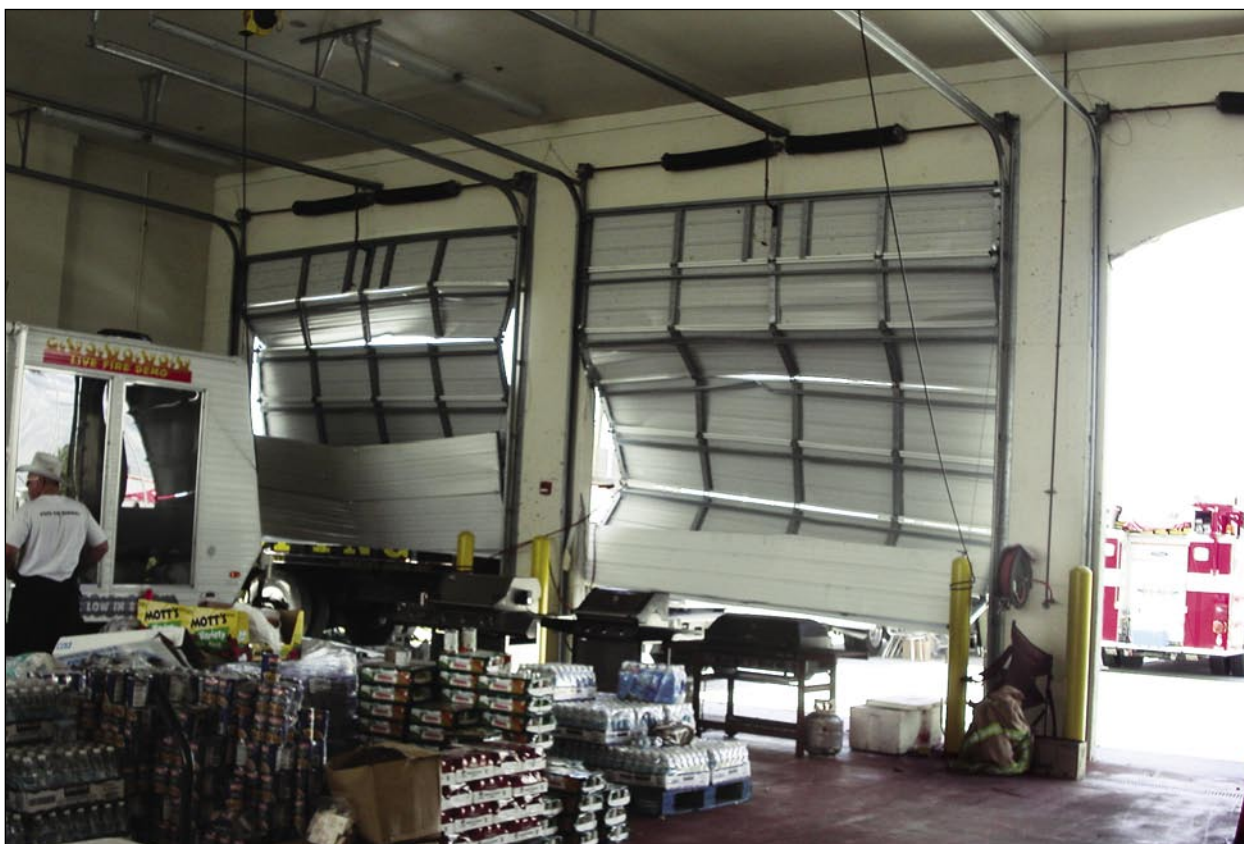
Figure 3-28. Damage to large rolling and sectional doors at Fire Station No. 1 (Punta Gorda)

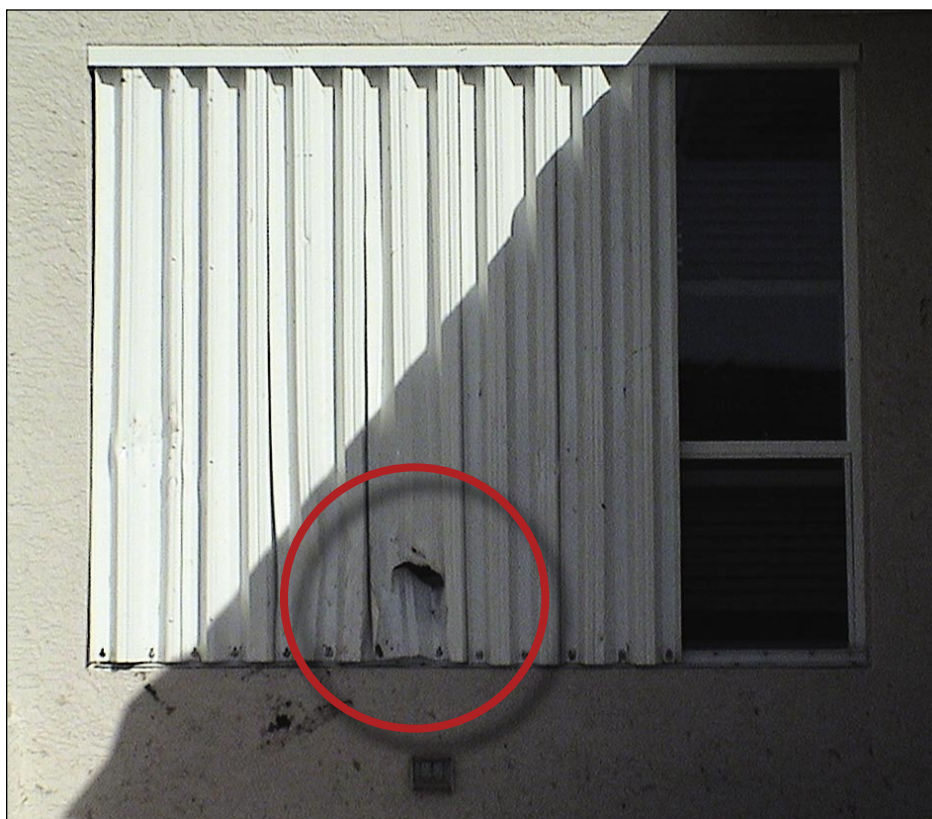
Figure 3-32.  
A roof tile punctured  
this Miami-Dade  
County-approved  
shutter (Punta Gorda)

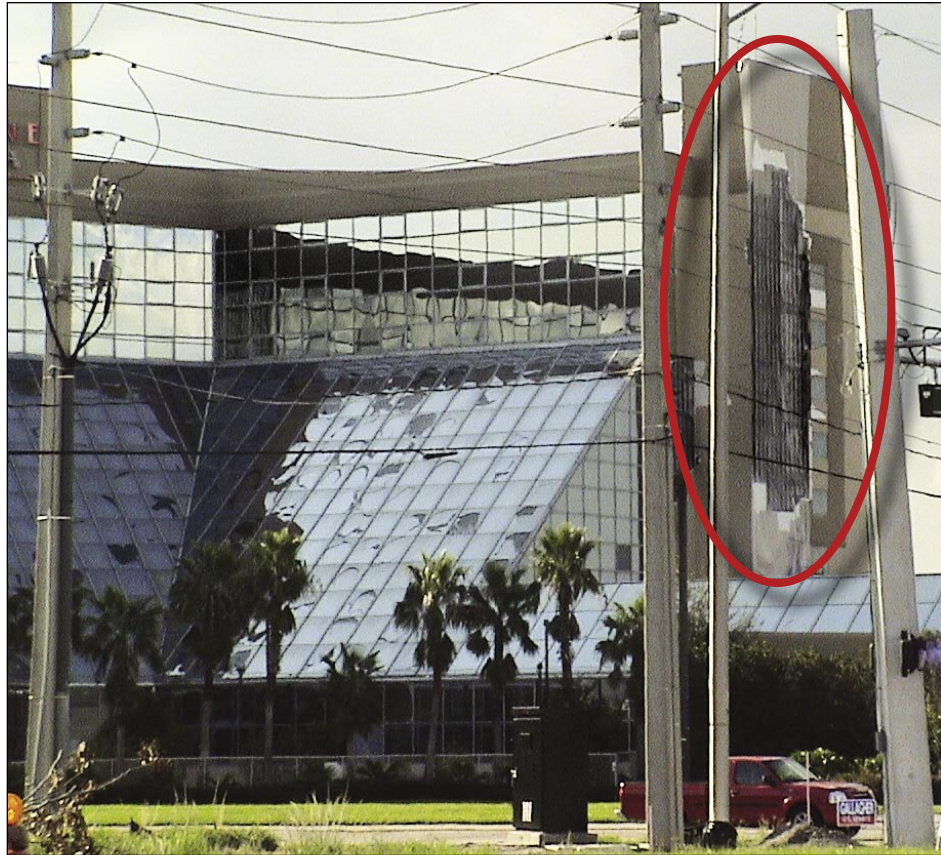
Figure 3-34.  
Edge impact of an  
asphalt shingle on  
decorative column  
(Punta Gorda)

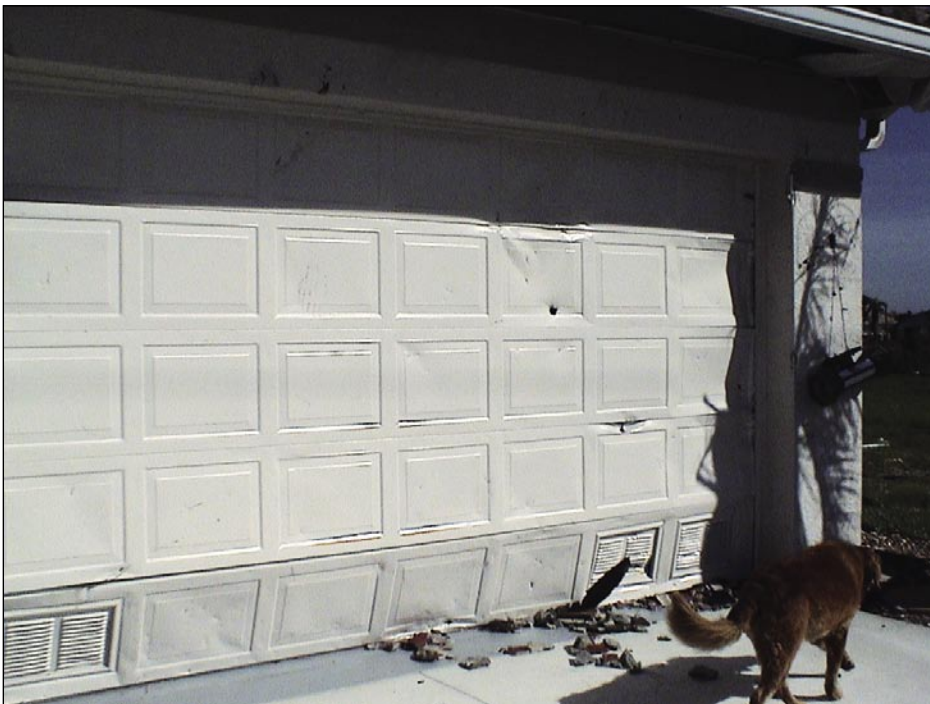
Figure 3-36. Tile damage to a metal-panel garage door (Punta Gorda)

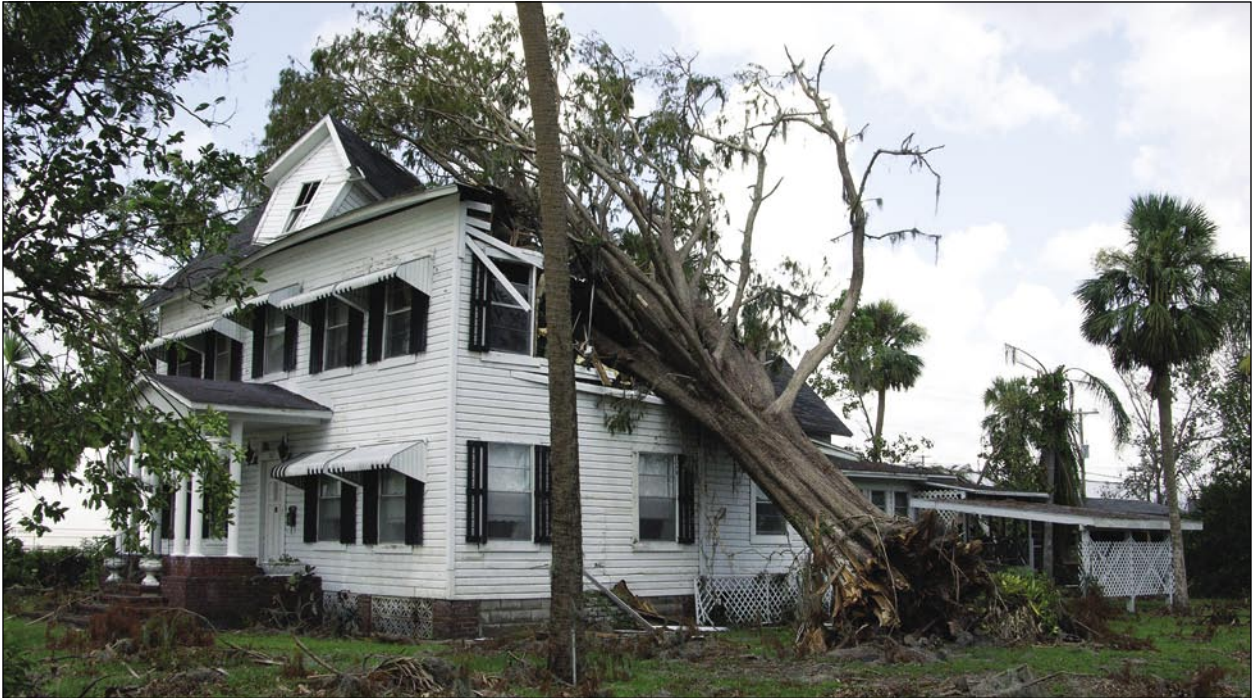
Figure 3-42. Damage to three-story home from tree impact (Wauchula)

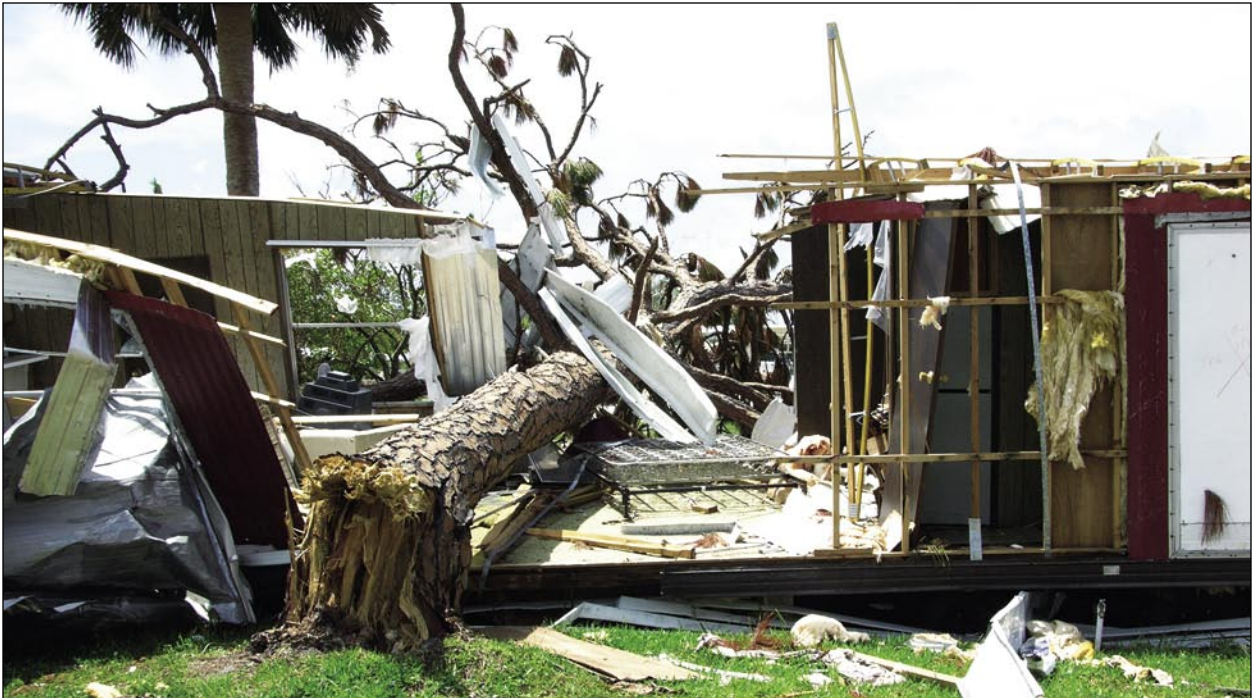
Figure 3-43. Damage to manufactured home from tree impact (Pine Island)

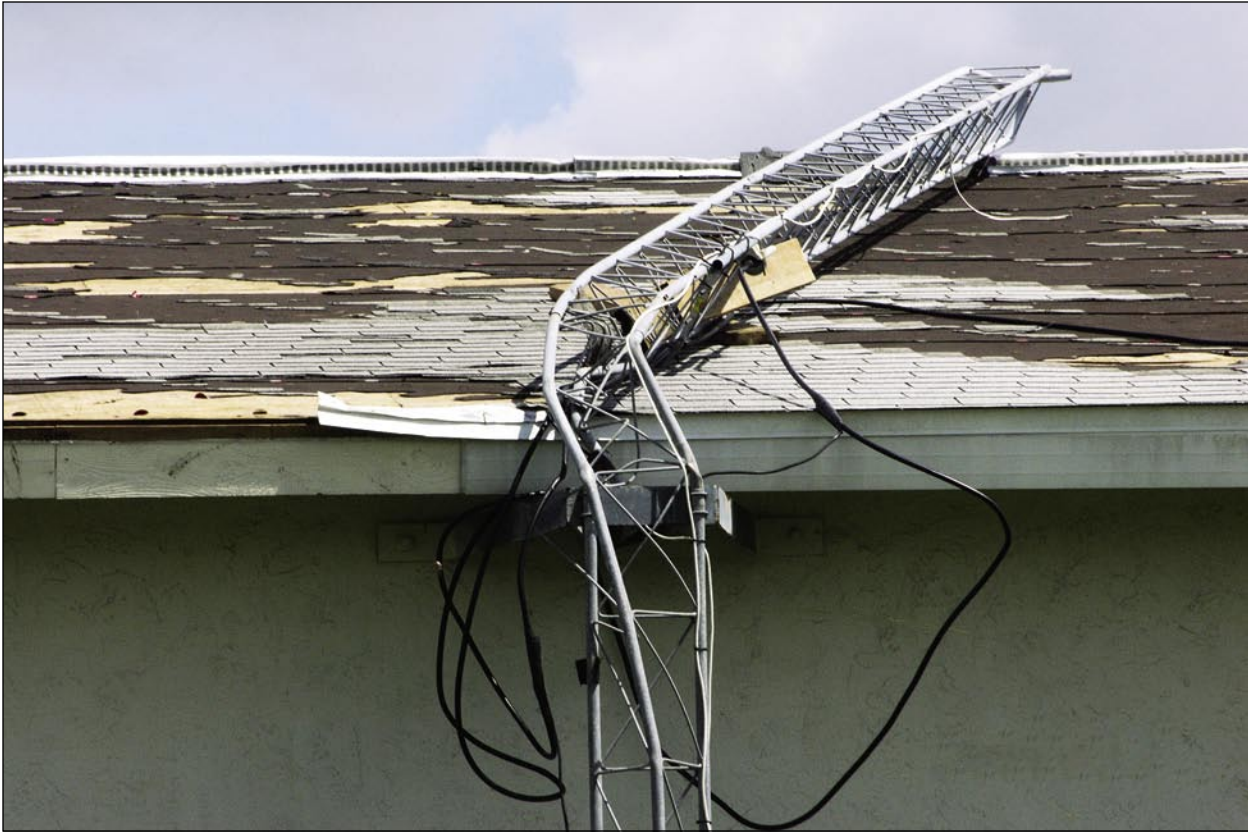
Figure 3-44. Fallen communications tower (Aqui Esta, east of Punta Gorda Isles)

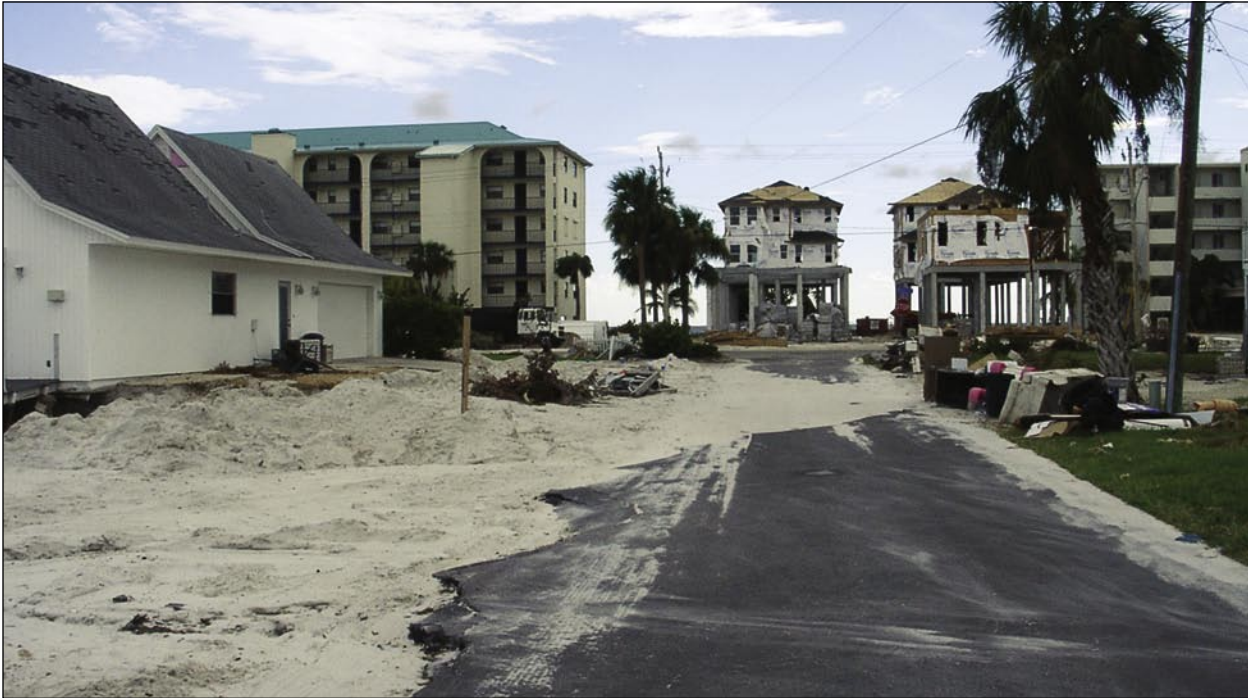
Figure 3-55. Storm surge caused scouring of the road and damage to the infrastructure (i.e., water main) (Fort Myers Beach)

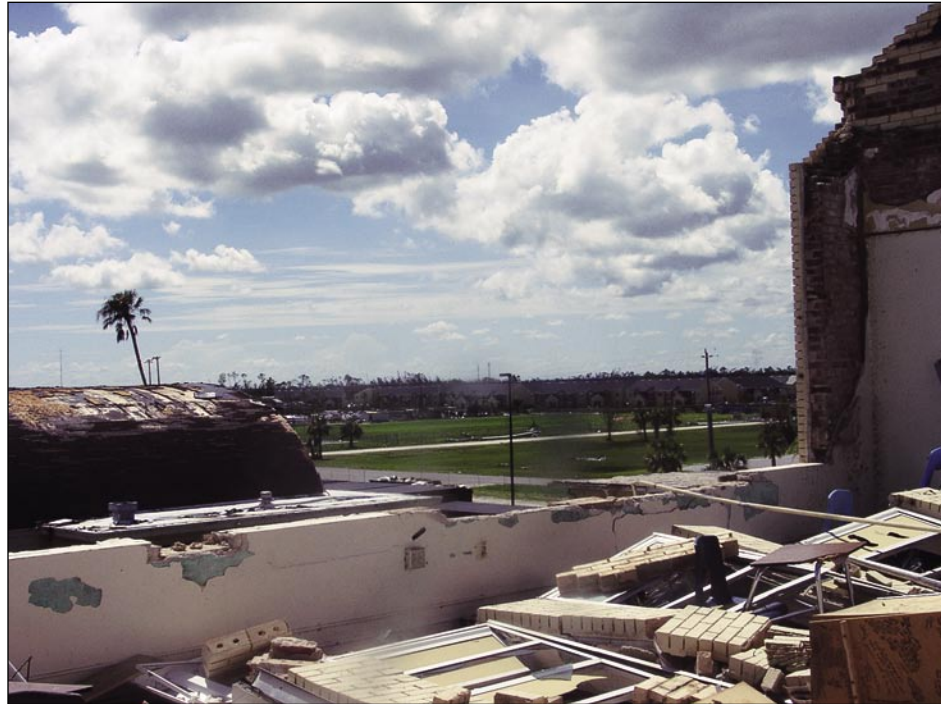
**Figure 4-14.**  
Partial failure of an unreinforced concrete masonry commercial structure (Port Charlotte)

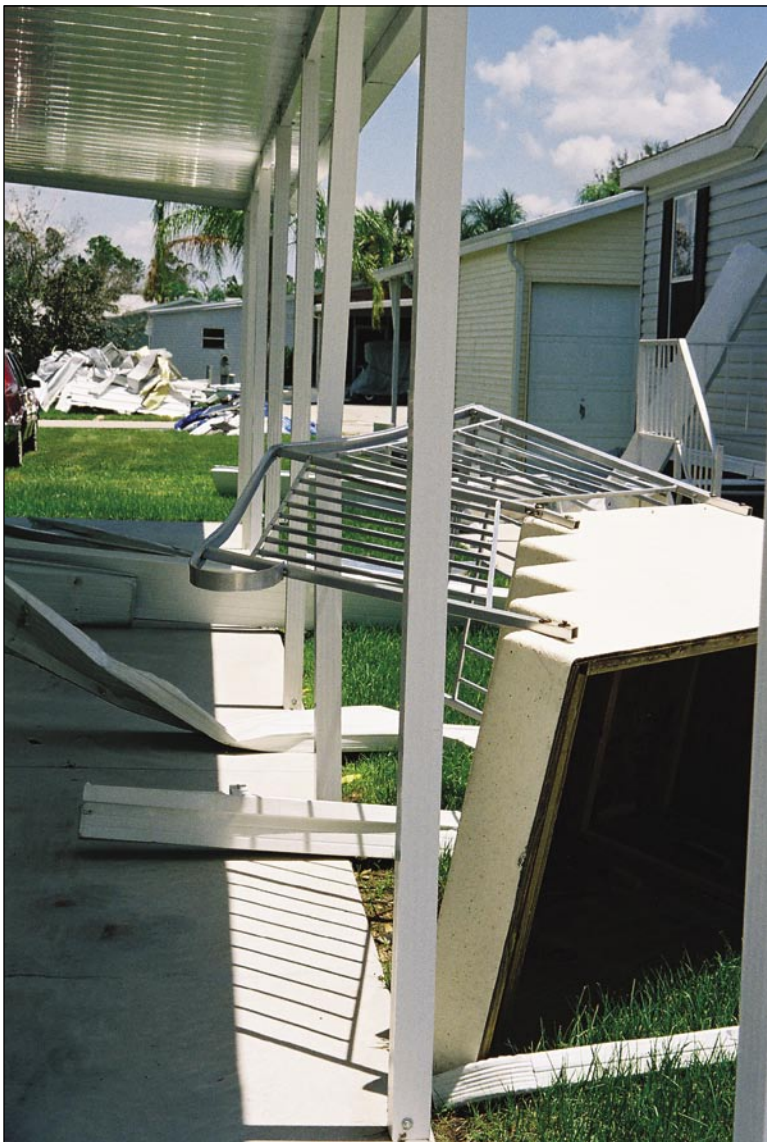
Figure 4-24.  
Stairway blown into a post of an  
aluminum carport accessory structure  
(Zolfo Springs)

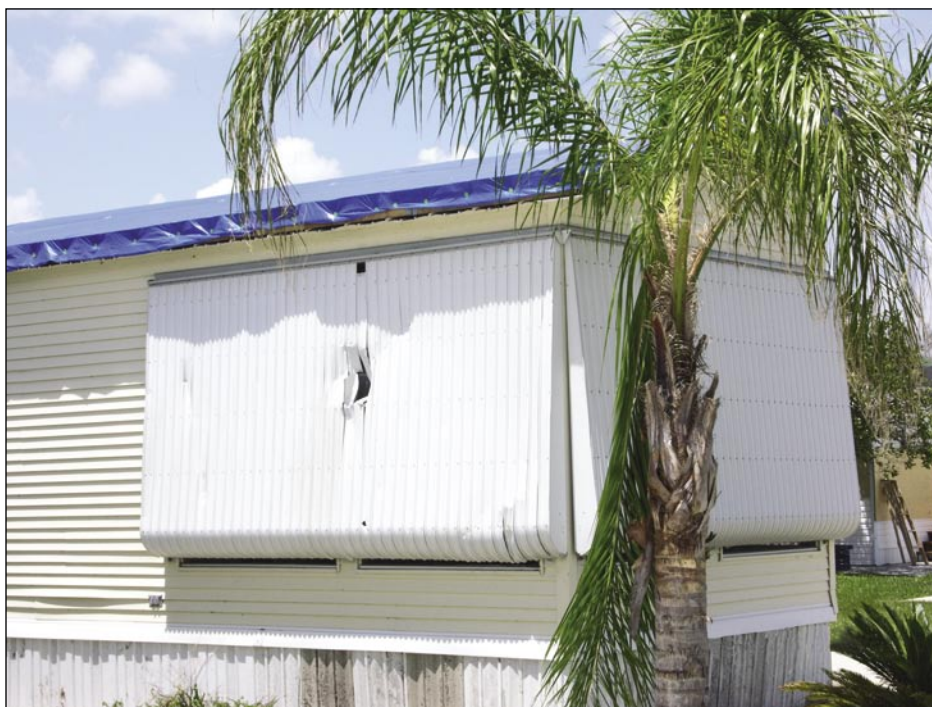
Figure 5-14.  
Metal awning shutter  
penetrated by a missile  
(Zolfo Springs)

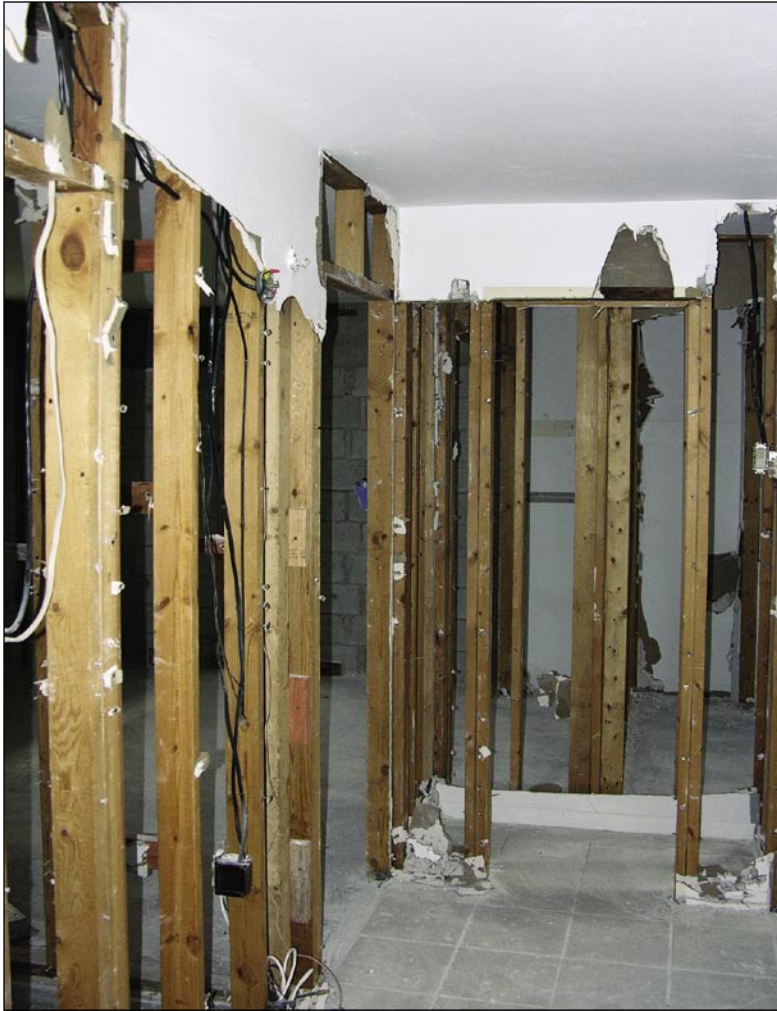
Figure 5-21.  
After the attic vent failed, water entered this residence. Wet carpeting and a substantial amount of wet gypsum board had to be removed (Punta Gorda Isles).

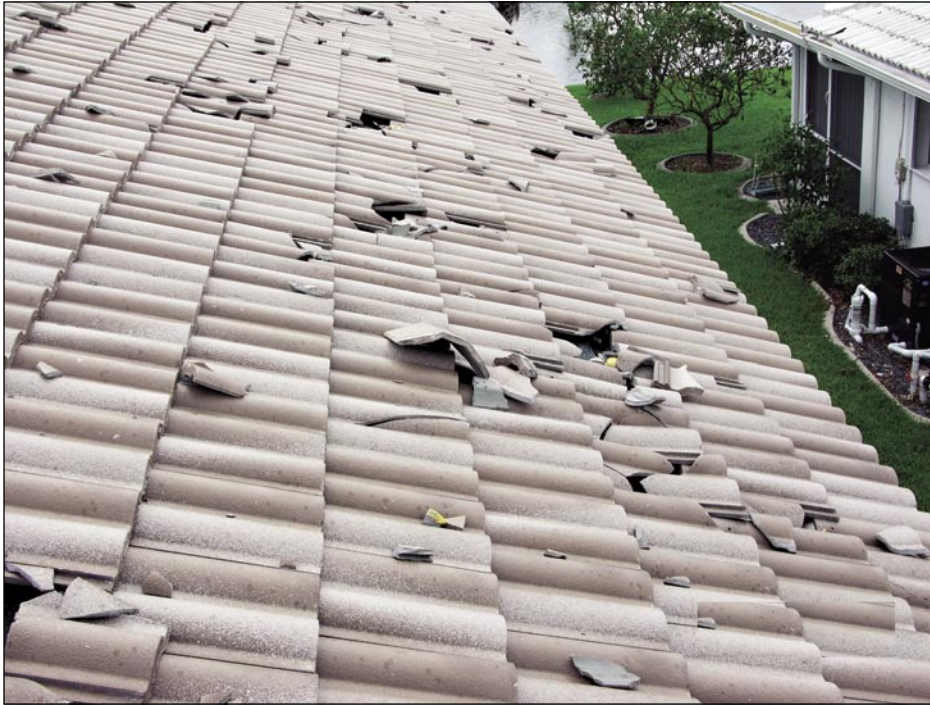
**Figure 5-49.** A view of the roof on the back side of the residence shown in Figure 5-41. Tiles (including a hip tile) from the front garage roof landed in this area and broke several field tiles (Deep Creek).

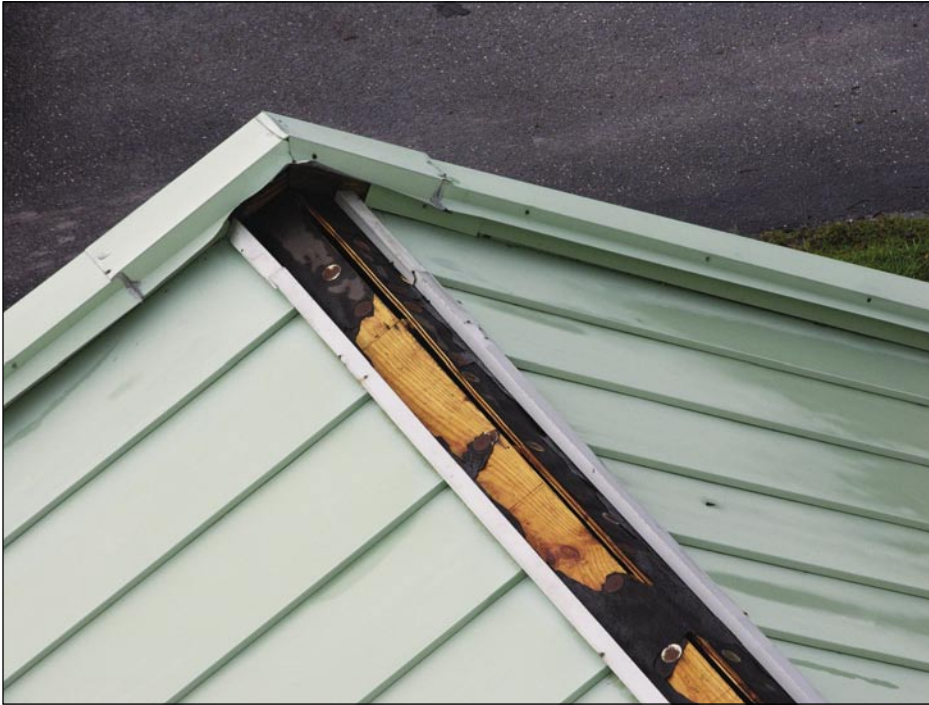
**Figure 5-54.** View of the canopy ridge at the building shown in Figure 5-52. The ridge flashing fasteners were placed too far apart. A significant amount of water leakage can occur when ridge flashings are blown away (Port Charlotte).

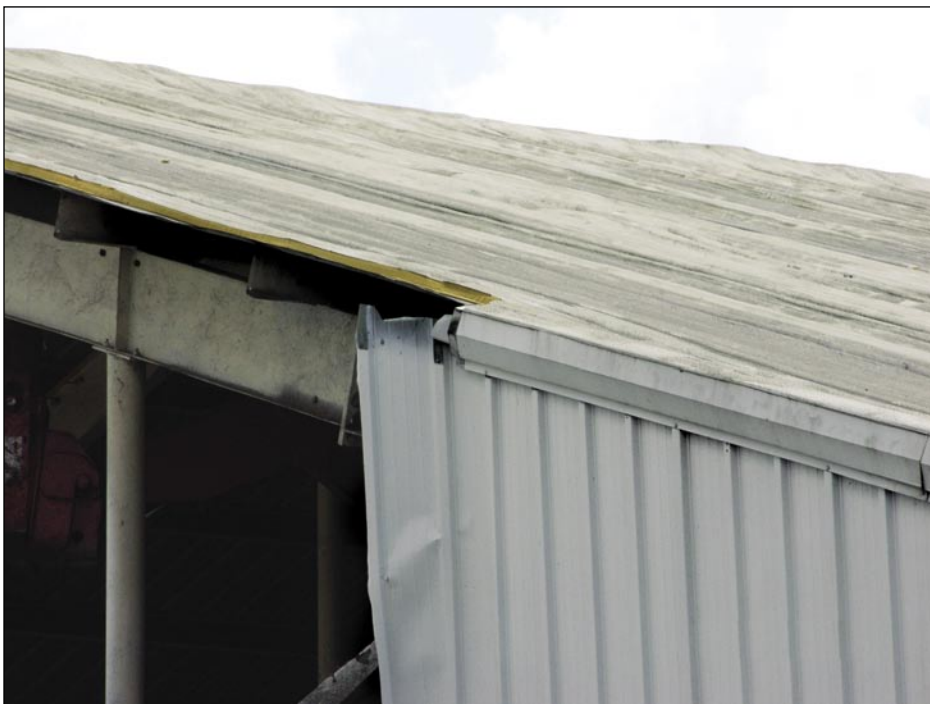
Figure 5-58. The metal wall panels and metal edge flashing on this building blew away, but the exposed fastener R-panels with an SPF covering did not progressively fail (Wauchula).

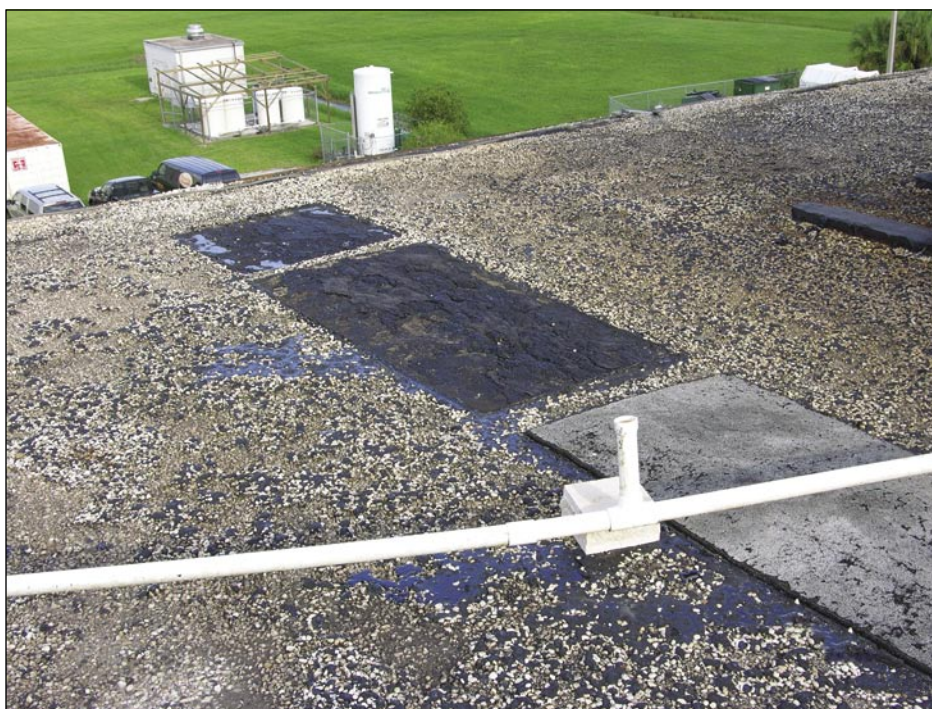
Figure 5-60. This view of the back side of the upper roof of a hospital (see Figure 6-8) shows that the missing gutter and asphalt plank walkway pad were blown away (Arcadia).

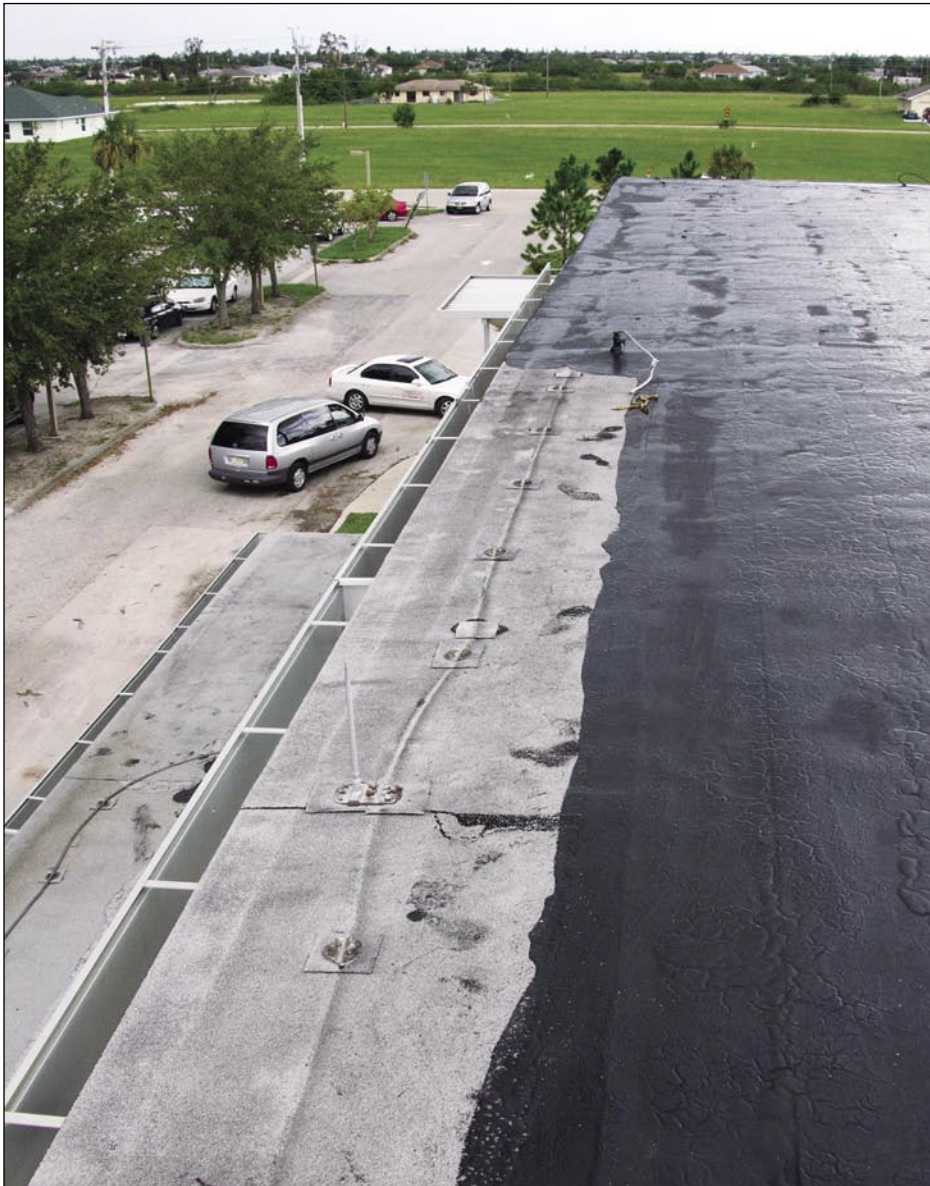
An edge flashing failure also occurred at a middle school in Cape Coral, first occupied in 1998 (Figure 5-63). This metal edge flashing had also been improperly installed underneath the membrane. The flashing should have been installed over the modified bitumen cap sheet and then stripped in to clamp the edge of the membrane. Wind lifted the gutter and metal edge flashing and peeled the modified bitumen membrane. The gutter was not designed for uplift resistance. A portion of a middle school in Port Charlotte also had a mineral surface BUR cap sheet roof, and the metal edge flashing had also been improperly installed underneath the membrane. However, none of the edge flashings lifted. Except for some missile damage, the BUR on this roof performed very well.

**Figure 5-63.** The edge flashing had a 2-inch vertical flange that extended into the gutter. The flashing was not cleated (Cape Coral).

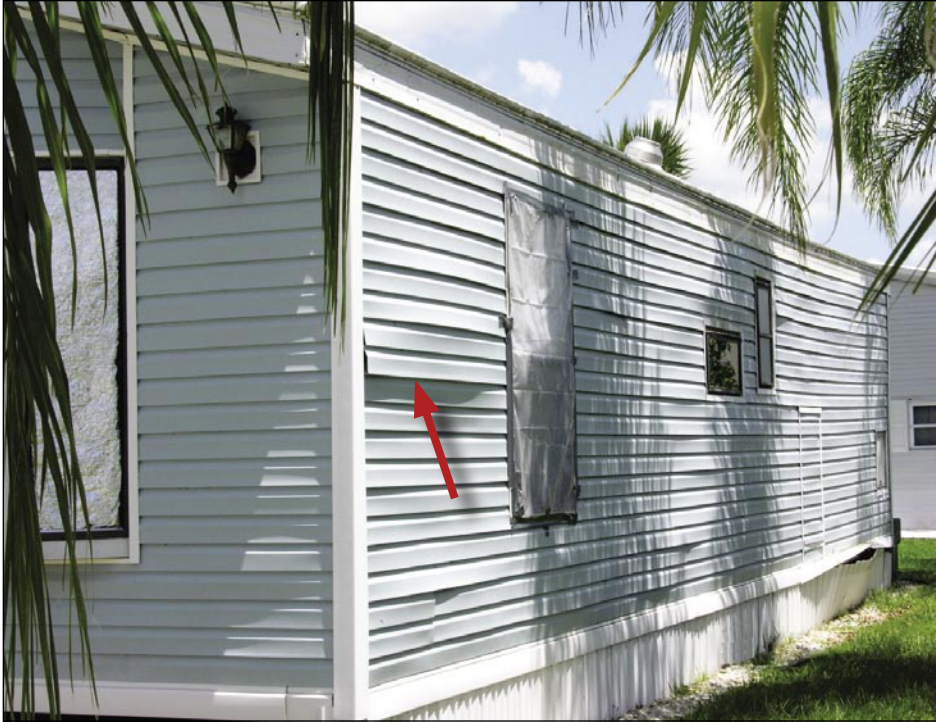
Figure 5-65. The vinyl siding panel with the red arrow is unlatched. The panel above and several others are also unlatched (Zolfo Springs).

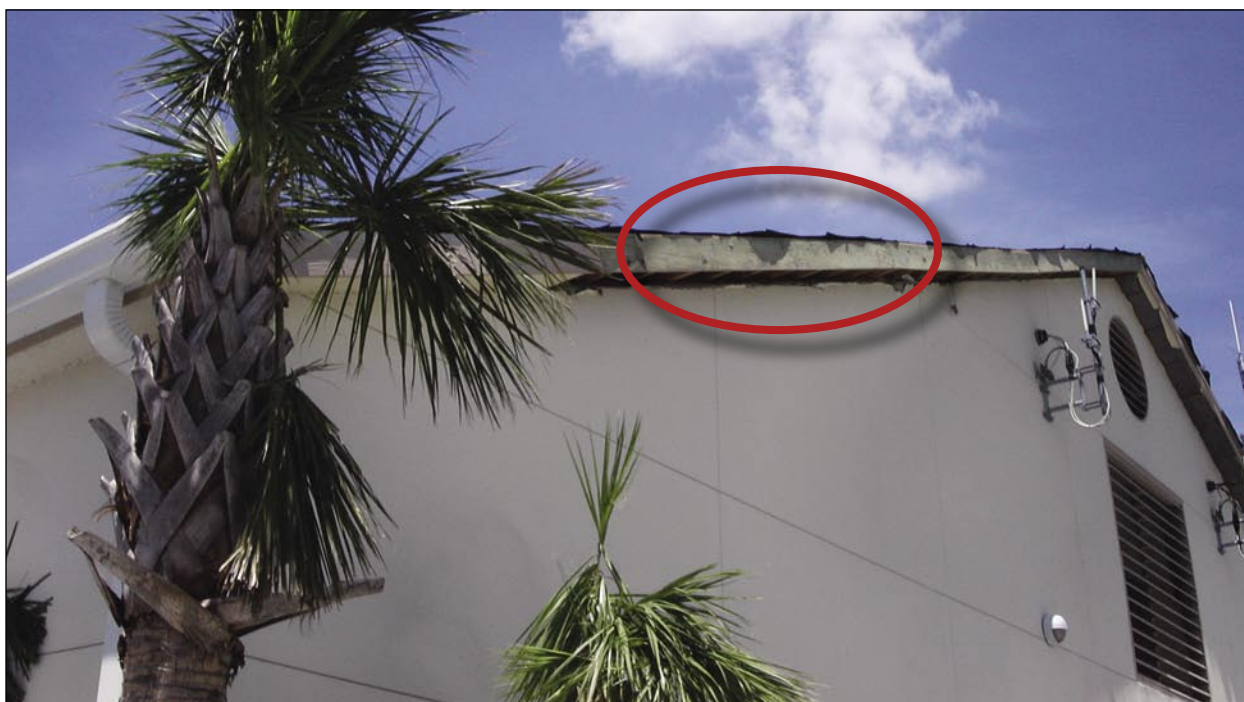
Figure 6-7. Damaged soffit at Punta Gorda Public Safety Complex
