Structural Systems Performance

4.1 Wood-Frame Buildings

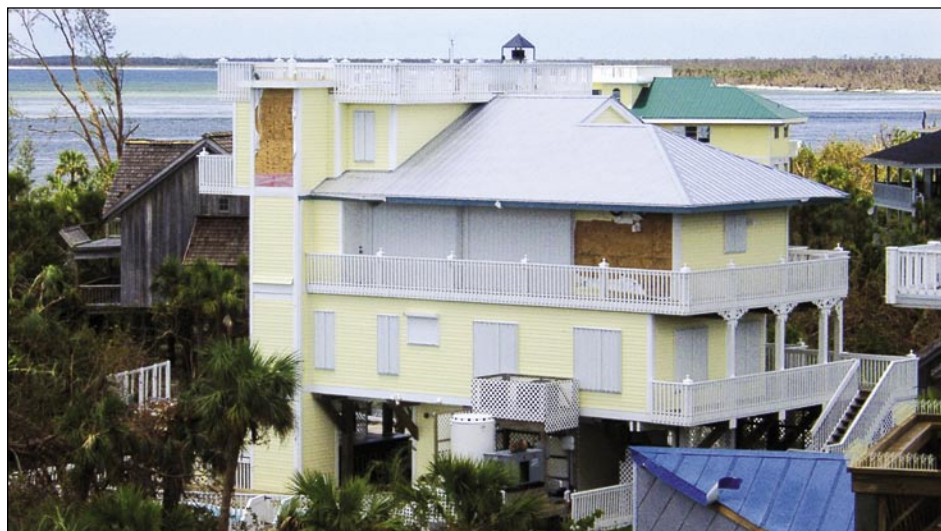
Figure 4-1.
No structural damage was observed to new buildings built to the 2001 FBC standards (North Captiva Island).

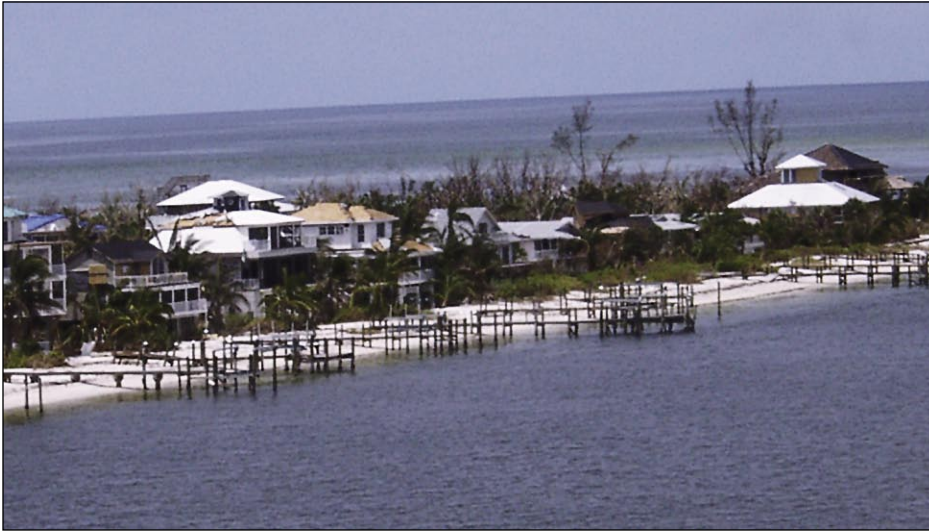
Newer wood-frame houses, built in accordance with the 2001 FBC, generally performed well structurally. Most of the newer wood-frame houses observed by the MAT were along the Gulf Coast on Sanibel and North Captiva Islands; these buildings were typically two stories on wood pile foundations. The relatively new building stock located in areas of North Captiva Island was impacted by the northeast eyewall, which contained some of the strongest winds of the storm, with winds over 150 mph (3-second peak gust); the houses survived very well from a structural standpoint (Figure 4-2).

Figure 4-2.
Newer single-family
wood-frame residences
that demonstrated good
structural performance
(North Captiva Island)

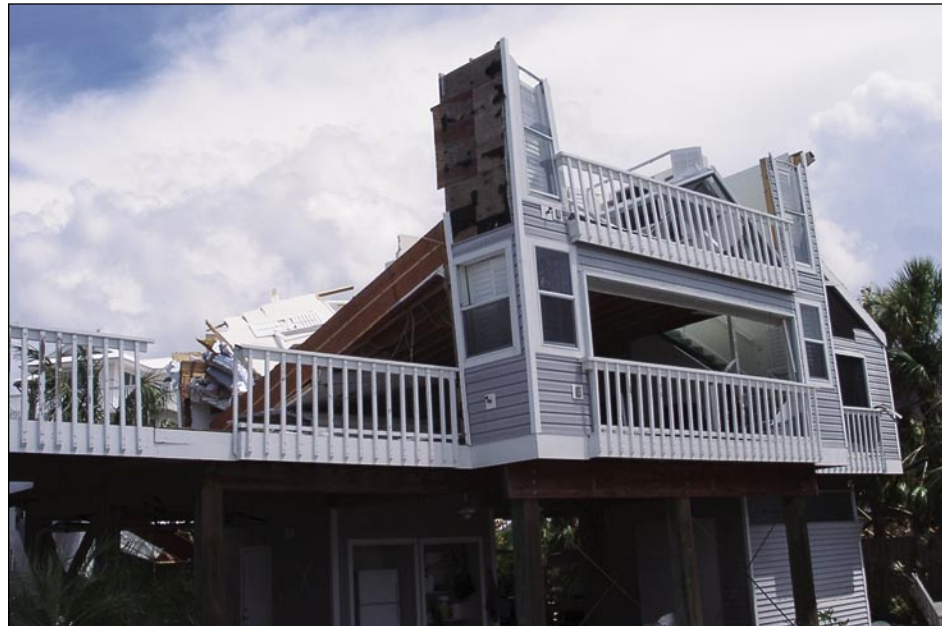
A number of the older residential buildings on North Captiva Island experienced structural collapse as shown in Figure 4-3 and were not designed with the continuous load path concept in mind, which consists of following the loads from the point of load application to the foundation; this is essential for stability. Newer building codes and standards specify that design and construction be performed with the load path concept in mind, which is resulting in better structural performance of buildings.

Figure 4-3. An older building that was renovated for architectural improvements a few years ago collapsed due to limited load path connections (North Captiva Island).

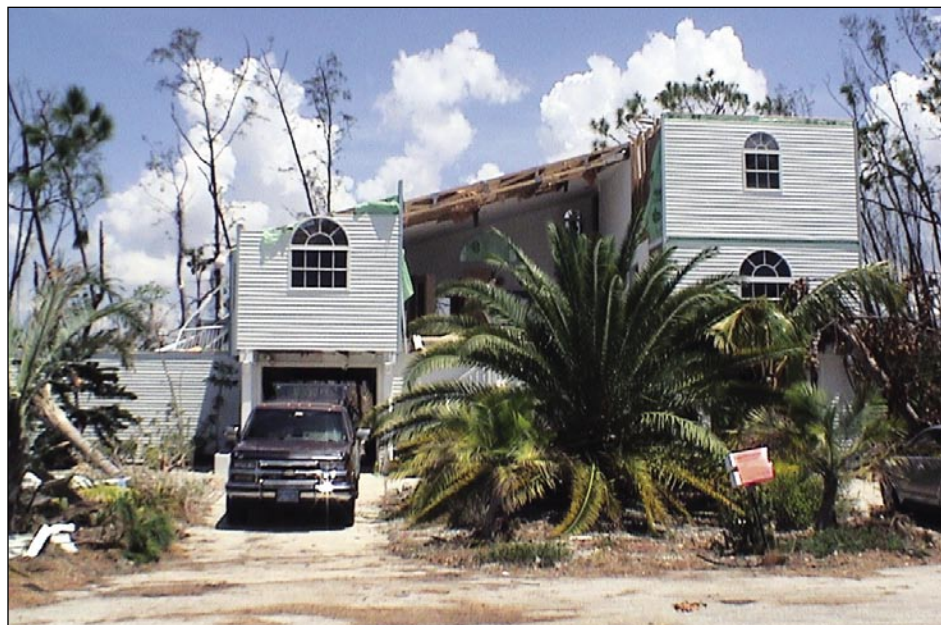
In the areas that experienced code level winds, the MAT observed a number of residences, presumably designed to be “partially enclosed,” with missing garage doors or broken windows (even when those windows were large) that survived without structural failure. The successful performance of these buildings seems to attest to the validity of the “partially enclosed” design practice. Figure 4-5 shows an example of a building not designed for internal pressure (not designed according to “partially enclosed” parameters) that resulted in major structural roof failure.

Figure 4-5.
Failure of the roof over
a cathedral ceiling from
pressurization of the
house when the window
failed on the windward
face (Pine Island)

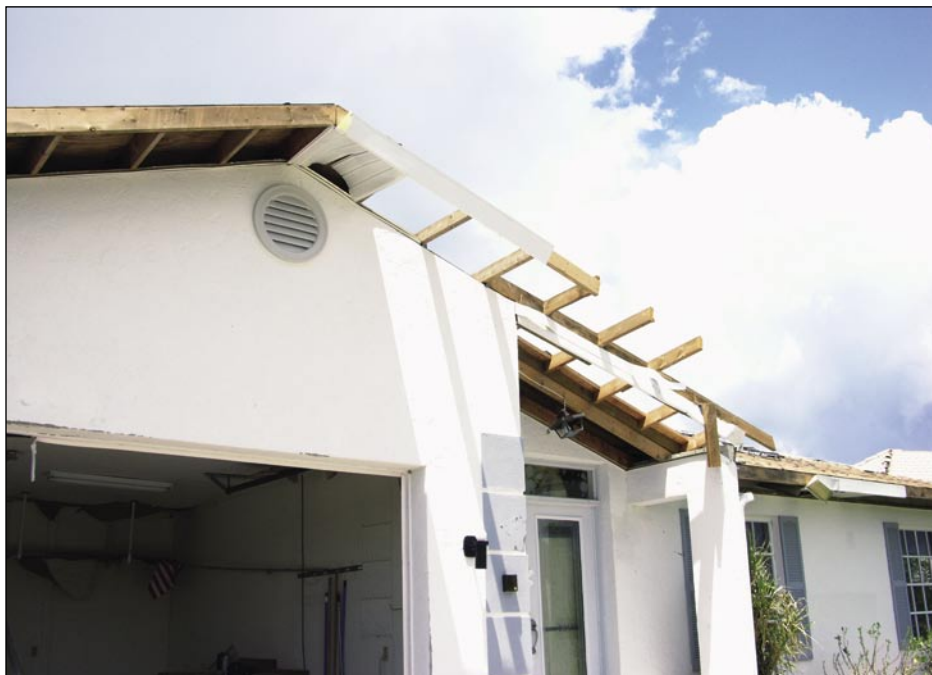
Damage to roof sheathing, though not widespread, was observed (Figure 4-6). This damage was observed by the MAT on older homes most likely designed prior to improvements in the C&C design criteria discussed in Chapter 2.

Figure 4-6.
Roof decking failed
due to uplift (Deep
Creek)

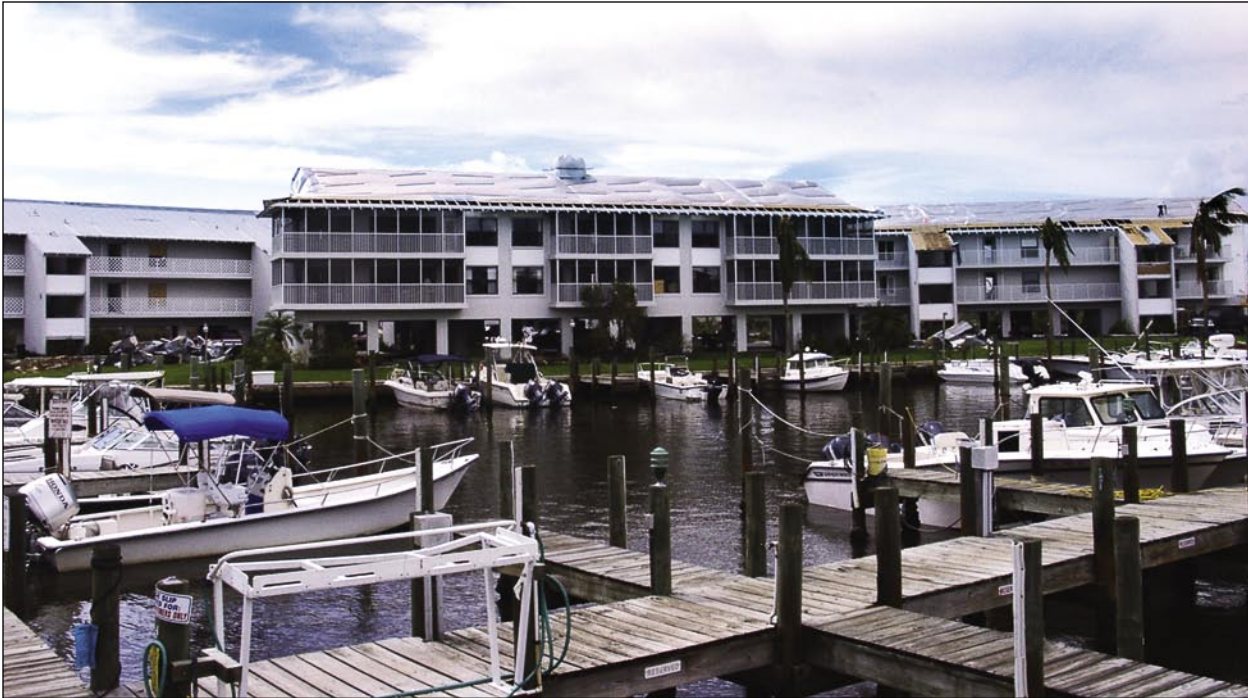
Figure 4-7. Multi-family residential building that performed well structurally, although it had severe roof covering and some sheathing failure at the overhangs, allowing water intrusion (Pine Island)

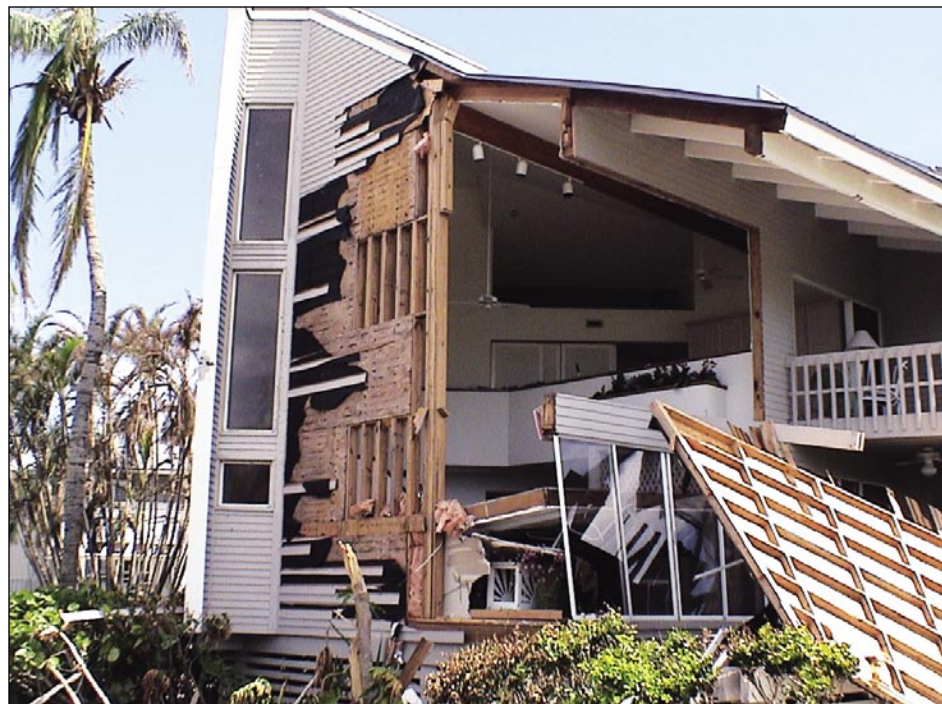
Figure 4-8. Wall failure on older (1980s vintage) multi-family wood-frame building due to lack of load path. Internal pressurization may have also contributed to this failure (Captiva Island).

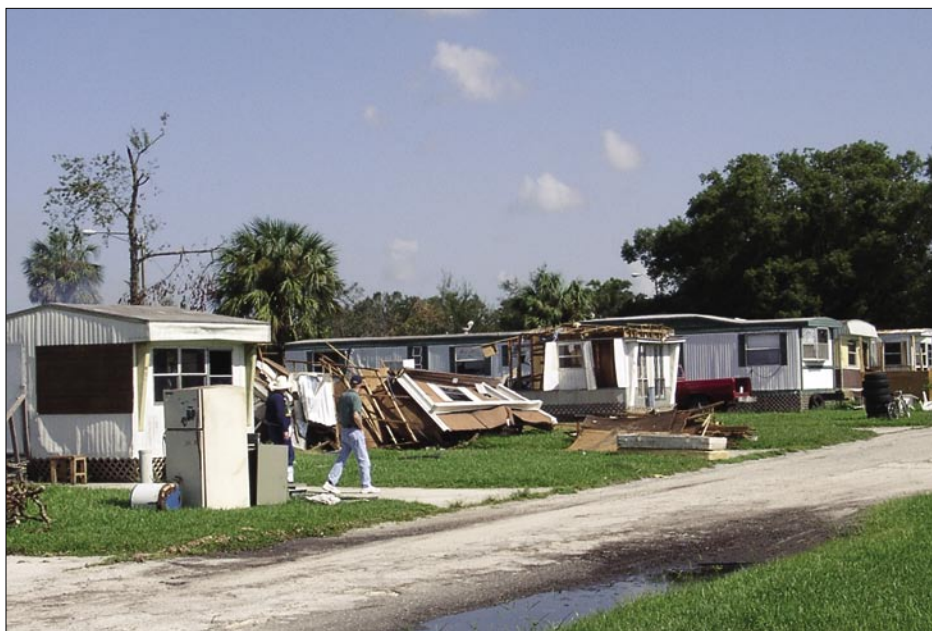
The pre-1976 HUD standard homes, which are now over 25 years old, performed poorly as expected. These homes were built in accordance with minimum requirements, and many of the homes were subjected to the narrow path of Hurricane Charley's highest winds and were damaged beyond repair. Figure 4-9 shows a pre-HUD home that was totally destroyed; however, surrounding pre-HUD homes appeared to have survived with little damage.

Figure 4-9.
Pre-1976 HUD
manufactured home
sustained substantial
damage (Bowling Green)

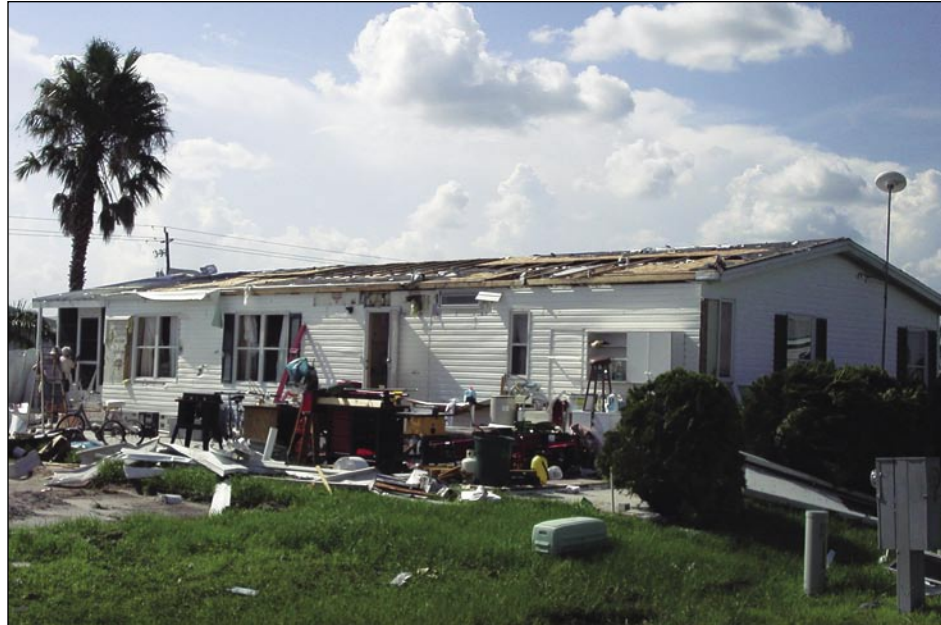
The post-1994 HUD standard home, built after the improved wind-resistant requirements were added to the HUD manufactured housing standards in 1994, performed better than its predecessors. In general, the main wind-force resisting systems in these homes remained intact. In many cases, when an attached accessory structure was torn off a home, it also tore off the metal paneling to which it was attached. Typically, this starts a continuing sequence of peeling of the skin, which could include both walls and the roof (Figure 4-10). The roof structural failures

Figure 4-10.
Post-1994 HUD
manufactured home with
significant roof damage
(peeling of roof panels)
resulting from collapse
of attached accessory
structure (Zolfo Springs).

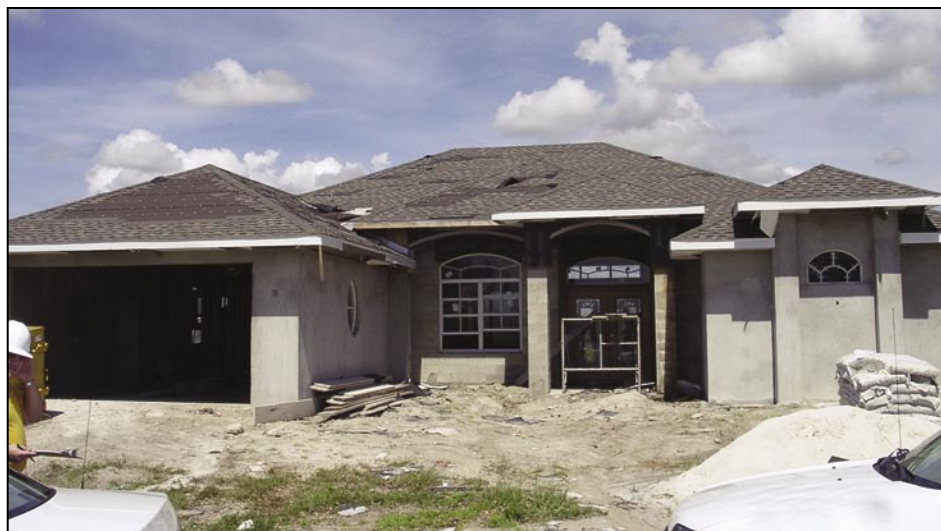
Figure 4-11.
New concrete masonry
residence built to 2001
FBC standards performed
well structurally, although
it did experience some
asphalt shingle damage
(Port Charlotte).

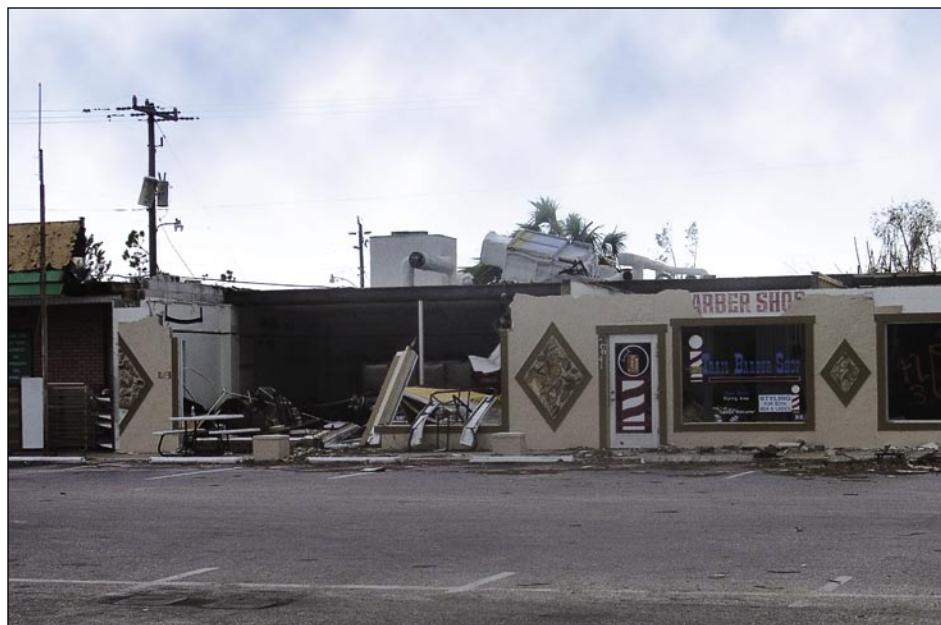
In contrast to reinforced masonry, an unreinforced masonry building is very vulnerable to damage in a high-wind event, as shown in Figures 4-13 and 4-14 (and previously in Figure 3-9). The lack of reinforcing means that uplift is resisted only by the mortar; if the mortar is cracked, the engaging of the dead weight of the walls is reduced in resisting uplift loads. If the roof separates from the walls, the walls become cantilevered and can be blown over.

Figure 4-14.
Partial failure of an unreinforced concrete masonry commercial structure (Port Charlotte)

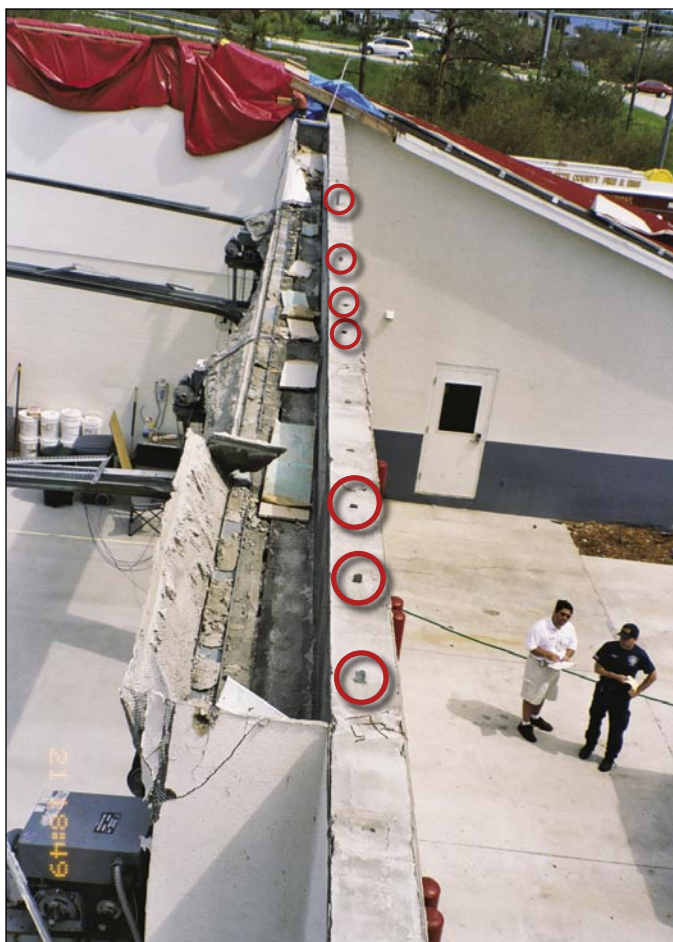
Fire Station No. 12, a fairly new building in Port Charlotte, is a concrete structure with reinforced masonry walls and a concrete slab on grade foundation. The building was being used as a shelter for the fire station employees and their families during the hurricane. The roof framing system consisted of wood trusses supported by a tie-beam on the masonry wall. Wood roof trusses over the apparatus bays spanned approximately 68 feet. The anchorage of roof trusses to the load bearing wall apparently failed and blew away; however, all other structural components of the building stayed intact (Figure 4-15).

Figure 4-15.
Roof truss hurricane anchor straps failed at the tie-beam at Fire Station No. 12 (Port Charlotte)

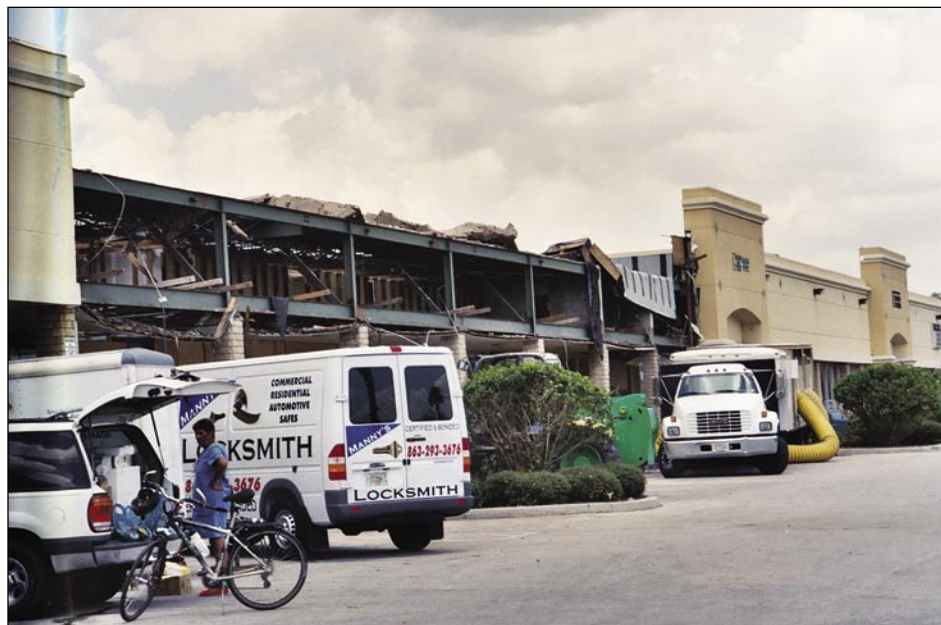
The main structural members of the steel-frame buildings observed by the MAT appeared to have withstood the hurricane force better than the wood and pre-engineered metal structures, but not as well as the reinforced concrete structures. An office building and a shopping center constructed of a structural steel-framing system were observed in Wauchula. The exterior walls and window systems failed, the building envelope was penetrated, and the roof decking blew off the joist; however, no damage was observed to the main structural steel-framing members (Figure 4-16). No heavy steel-frame failures were observed.

Figure 4-16.
Older steel-frame
structure performed well
in spite of major damage
to the roof decking
and the exterior walls
(Wauchula)

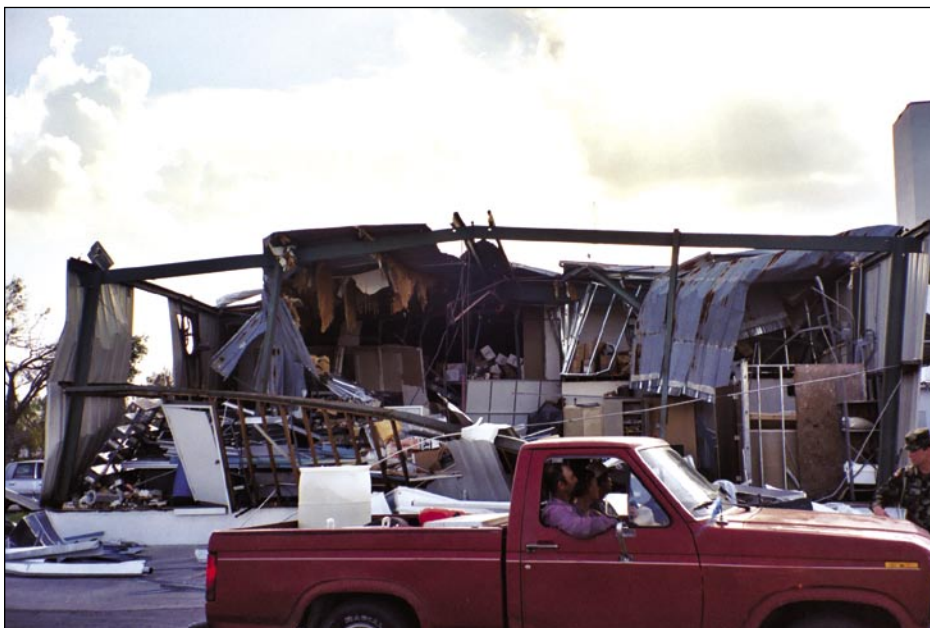
A pre-engineered metal building system is generally the most economical and is normally utilized for commercial purposes such as warehouses, storage facilities, hangars, and other similar uses. These buildings are easily recognized by their sheet metal siding, tapered rigid frames, and long spans with open spaces. Secondary members consisting of girts and purlins are installed to support the metal siding and roofing panels. Figure 4-17 shows the structural collapse of a pre-engineered building well inland in Arcadia; an adjacent reinforced concrete-frame hospital, however, was structurally undamaged.

Figure 4-17.
Completely destroyed
pre-engineered metal
building (Arcadia)

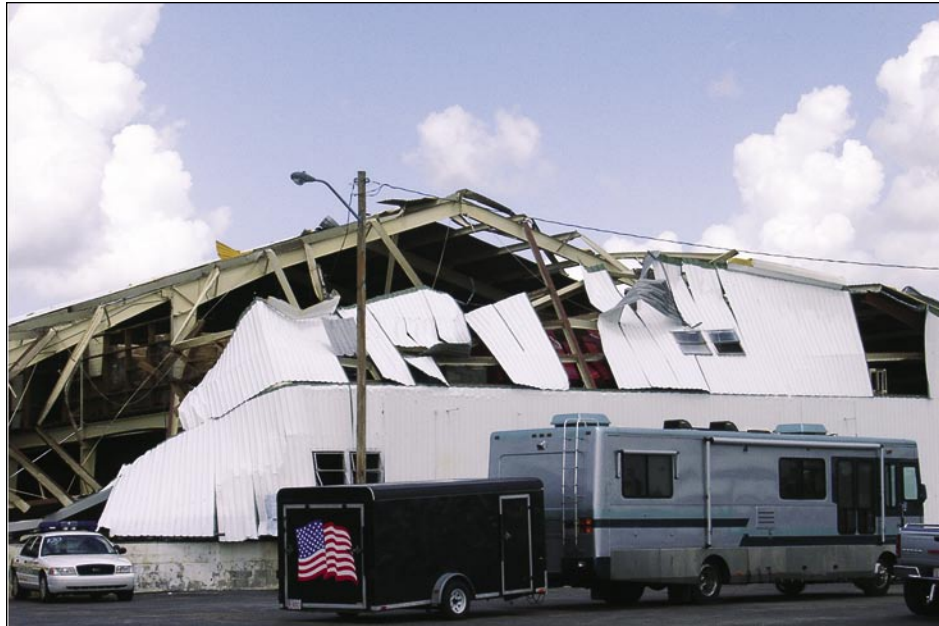
Failure of the main structural members of pre-engineered buildings was observed at numerous locations. Many of the main support members were corroded, which may have led to the failure. In Wauchula, a large pre-engineered building partially collapsed because the main structural steel columns of the rigid frame had lost a significant amount of its cross-sectional area due to corrosion (Figure 4-18). These members did not have the capacity to support the hurricane loads and failed, causing failure of the superstructure. In general, other buildings surrounding this facility were not damaged to the extent of this storage facility.

Figure 4-18.
Collapsed older pre-engineered metal structure (Wauchula)

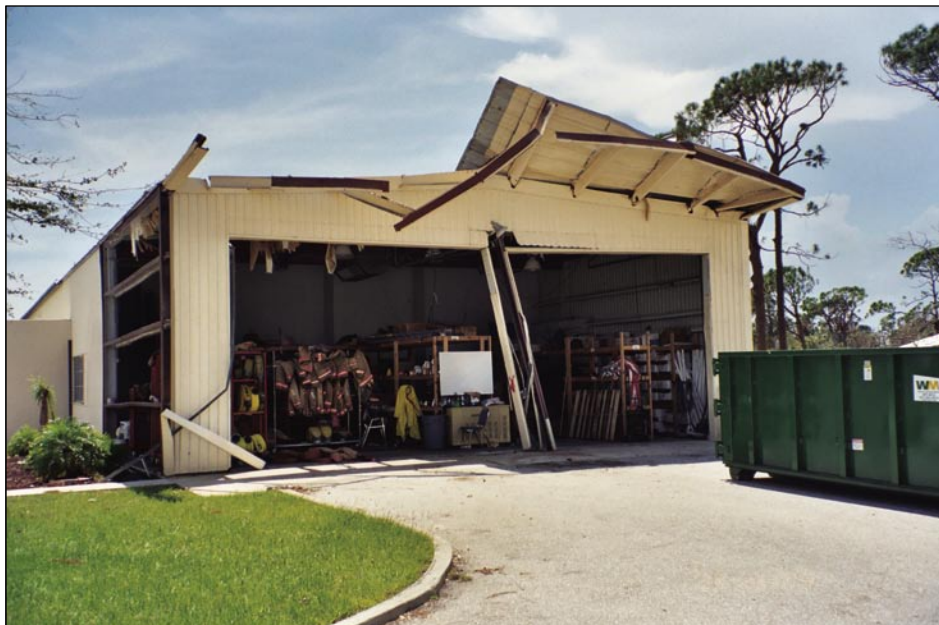
In the Port Charlotte area, some fire stations and other essential facilities were constructed of pre-engineered metal building systems. As previously observed after other storms, in some cases, the pre-engineered metal framed systems performed the worst of all the structural framing systems evaluated. Exterior walls consisting of sheet metal siding failed prematurely due to corrosion, resulting in failure of the main structural framing members and column collapse (Figures 4-19 and 4-20).

Figure 4-19.
Main column at Fire Station No. 8 collapsed due to corrosion and metal siding failed (Port Charlotte)

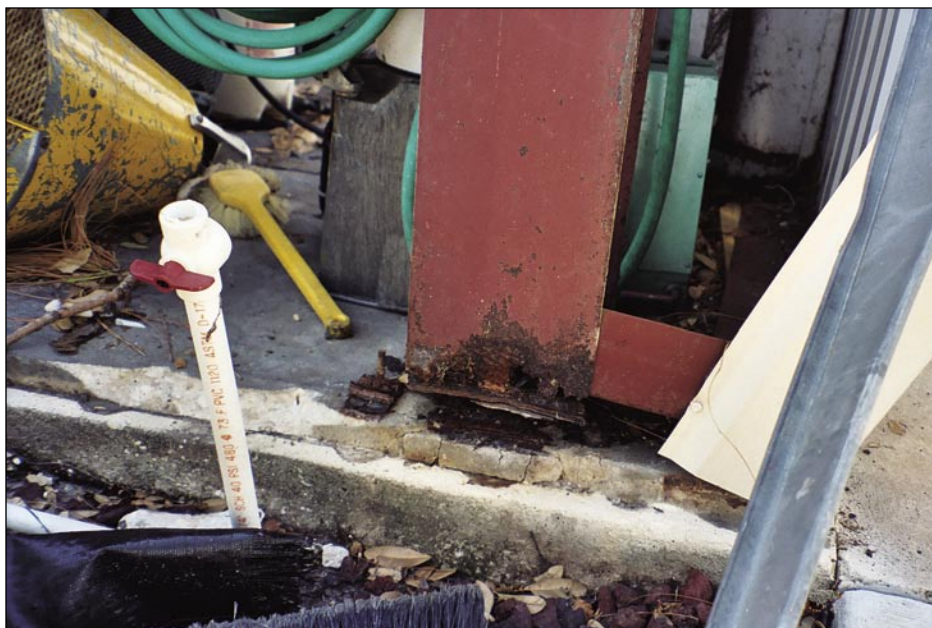
Figure 4-20. Significant amount of corrosion at Fire Station No. 8, which contributed to failure shown in Figure 4-19

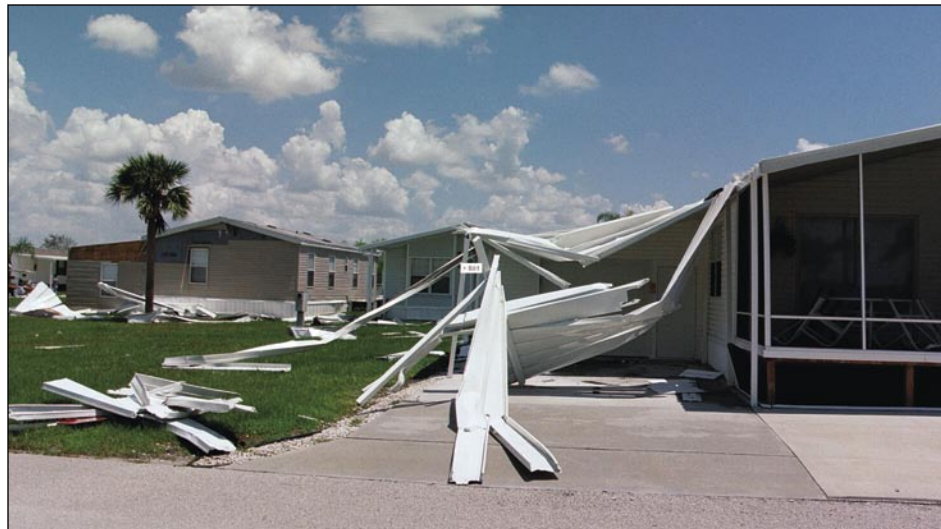
Figure 4-21.
Damaged carport (Zolfo
Springs)

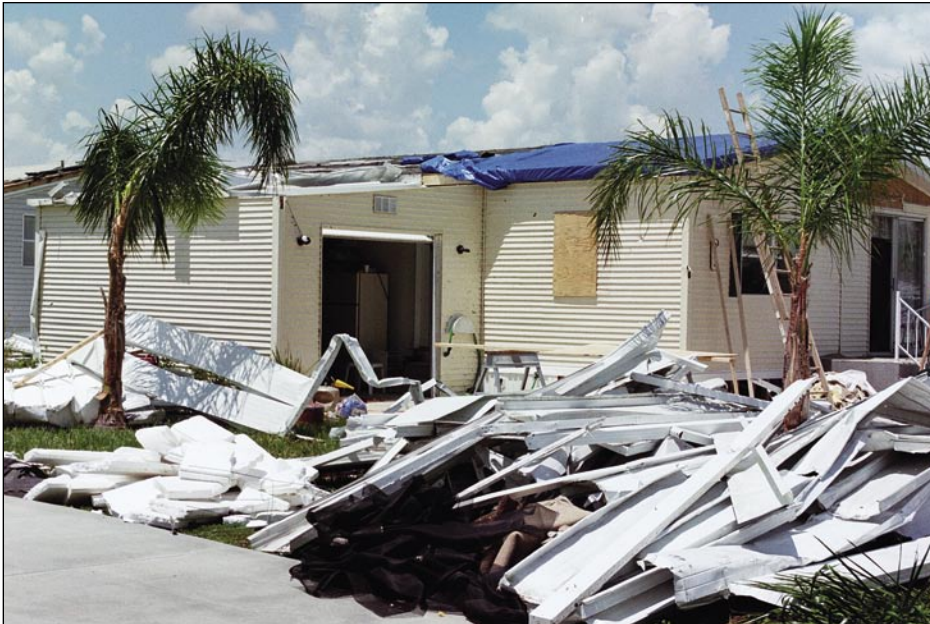
Figure 4-22.
Damaged garage (Zolfo Springs)

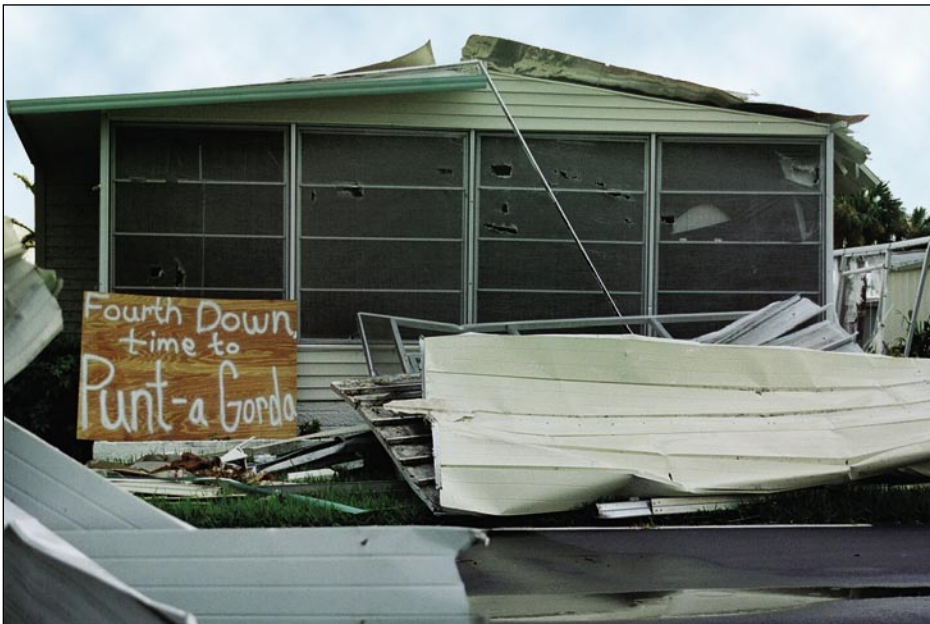
Figure 4-23.
Damaged screened porch
(Punta Gorda)

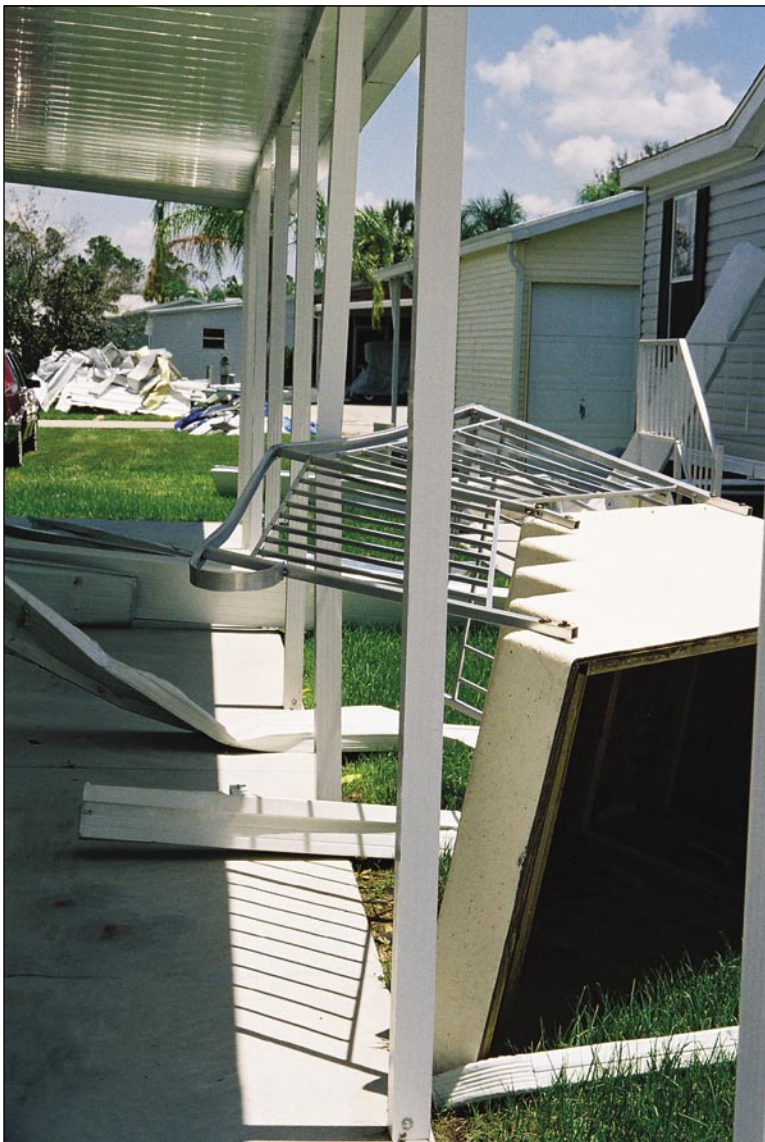
Figure 4-24 shows a freestanding stairway from a manufactured home that was not sufficiently anchored and had blown against the posts of the carport of an adjacent manufactured home, nearly causing the post to be torn from its anchor. If the post had been deflected much more, it is likely that the carport would have been so compromised it would have blown away, resulting in material being torn off the manufactured home and thereby subjecting it to water intrusion. The pile of debris visible in the distance through the carport is typical of damage caused by attachments in this manufactured home park.

Figure 4-24.
Stairway blown into a post of an
aluminum carport accessory structure
(Zolfo Springs)

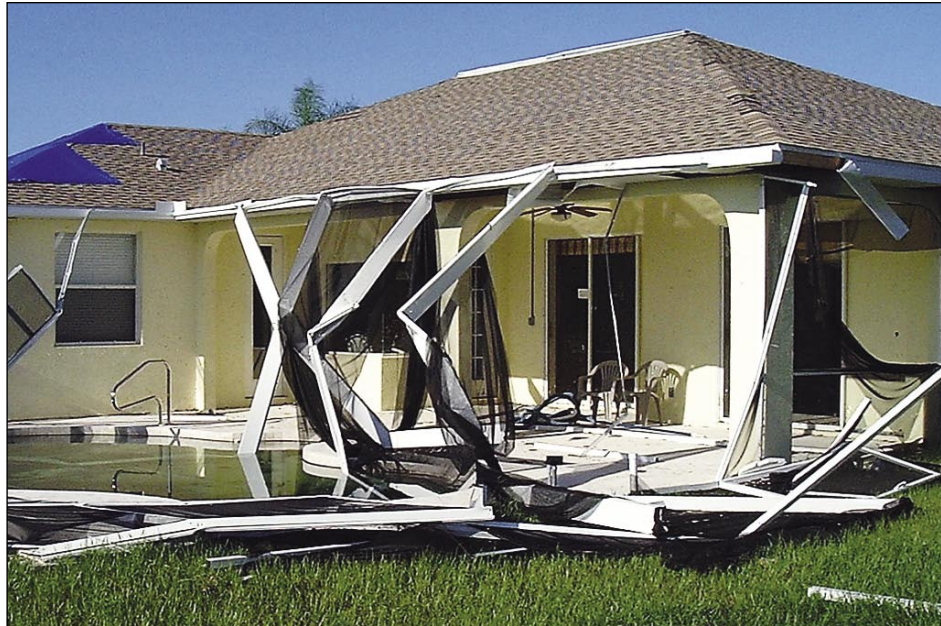
The aluminum screen and pool enclosures that collapsed were observed to be on the windward side of residences of site-built and manufactured homes in areas that experienced wind gusts over 110 mph with open exposures to wind (see Figure 4-25). There were several instances of aluminum debris from the pool enclosures breaking windows of the house to which the enclosures were attached, resulting in interior water damage.

In several cases observed, the apparent cause of the primary failure was that the windward outside corner posts became detached from the slab. Typical construction of these structures included corner posts attached to adjacent 1-inch by 2-inch open back aluminum with only two #10 screws and mid-span posts similarly attached, but with the addition of substantial aluminum angle brackets secured to the slab with substantial anchor bolts. Figures 4-25 through 4-27 show the consequences of inadequately attached corner posts. In Figure 4-26, note

Figure 4-25.
Typical consequence of
corner post failure
(Punta Gorda Isles)

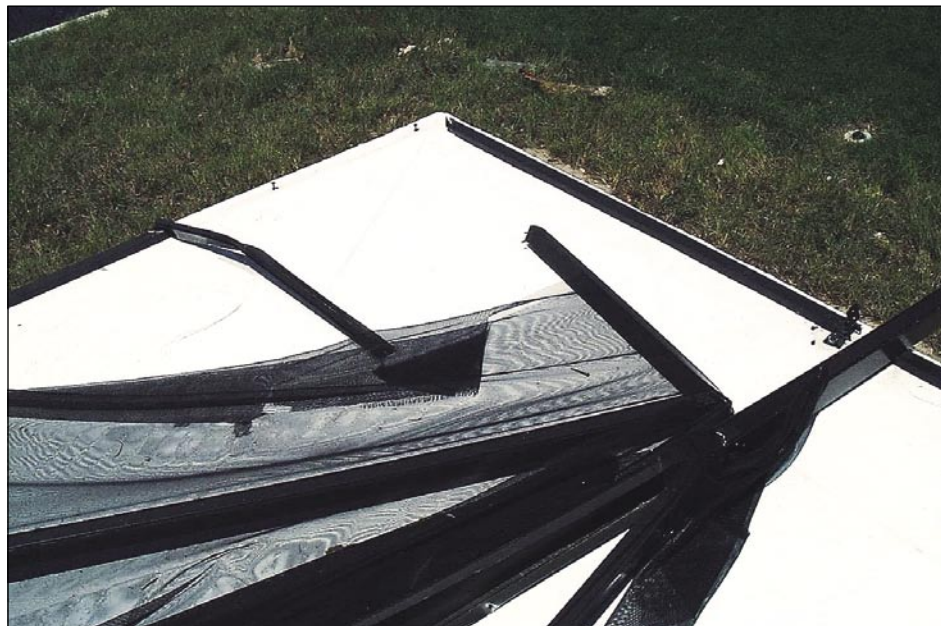
that there was no direct tie-down of the corner post to the slab. The corner post was only tied down with lateral screws into one open back. Although the photographs show mid-span post anchoring failures, the MAT observations were that the mid-span posts failed subsequent to the corner posts. An additional mode of failure is likely to have occurred as a result of insufficient diagonal bracing.

Figure 4-26.
Consequence of corner
post not directly tied
down to the slab (Punta
Gorda Isles)

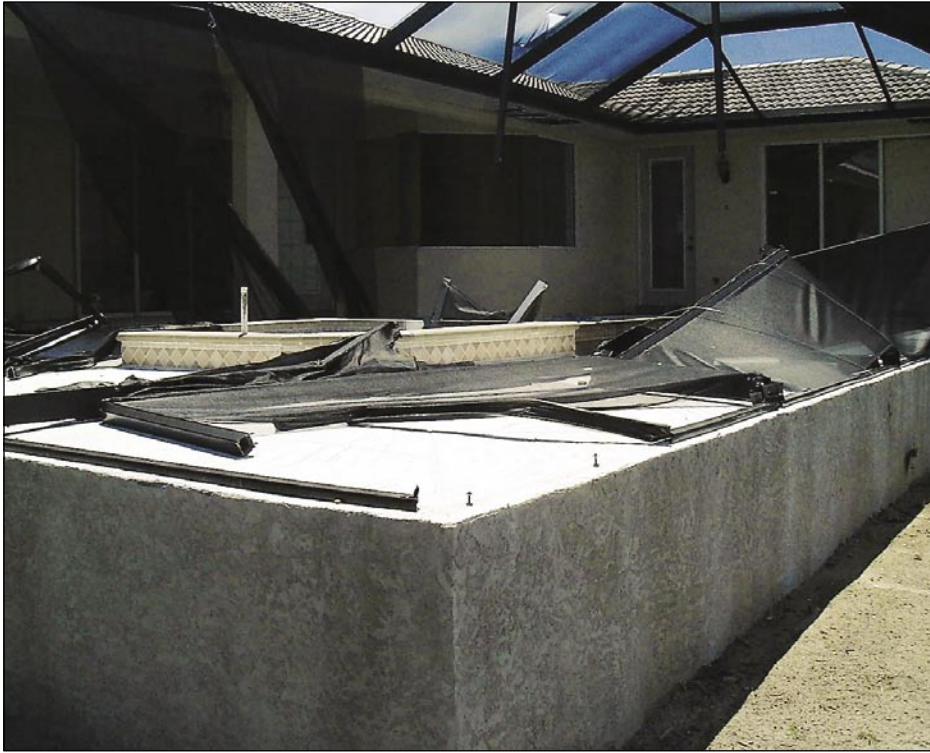
Figure 4-27.
Breakfast nook window
viewed through the pool
cage (Punta Gorda Isles)
