# *Basic Assessment and Characterization of Damage*

*The MAT's observations of the type and extent of damage caused by Hurricane Charley's high winds and flooding are broadly presented in this chapter and discussed in detail in Chapters 4, 5, and 6.*

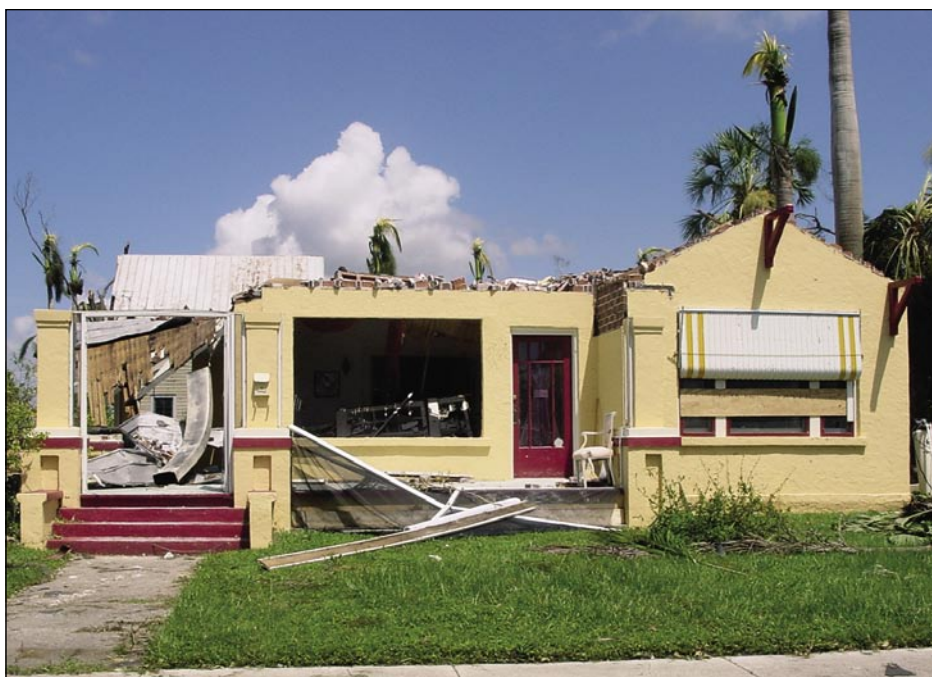
Figure 3-2 shows a masonry home with a wood roof structure. Failure of the window in the front wall of the house likely led to pressurization of the house and contributed to the dramatic failure of the roof structure.

**Figure 3-2.**  
Failure of roof structure from pressurization of a pre-2001 FBC house when the window failed on windward face (Punta Gorda)

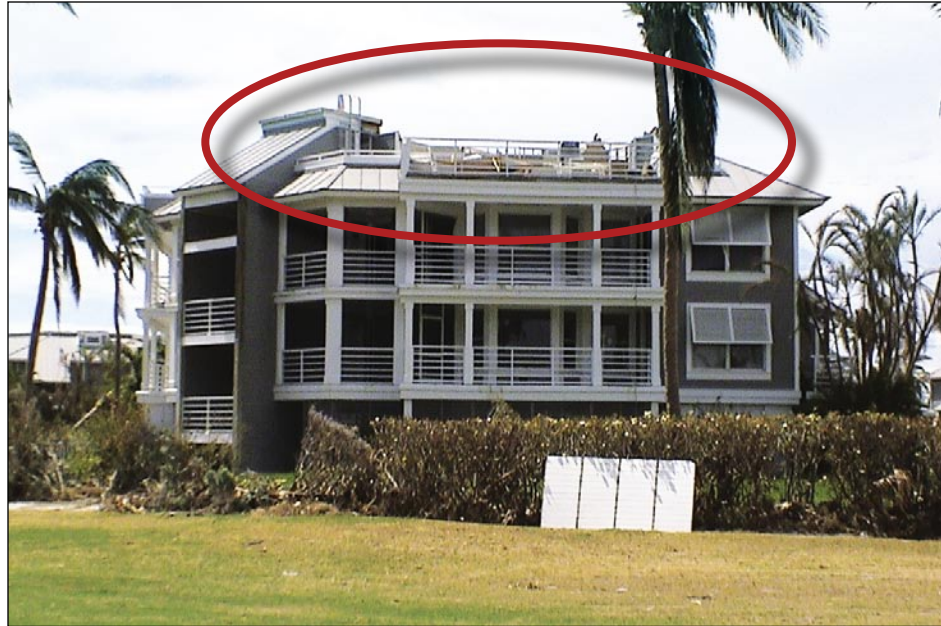
Figure 3-3.  
Loss of roof structure in  
a wood-frame building  
likely due to internal  
pressurization resulting  
from unprotected  
windows and doors  
(Captiva Island)

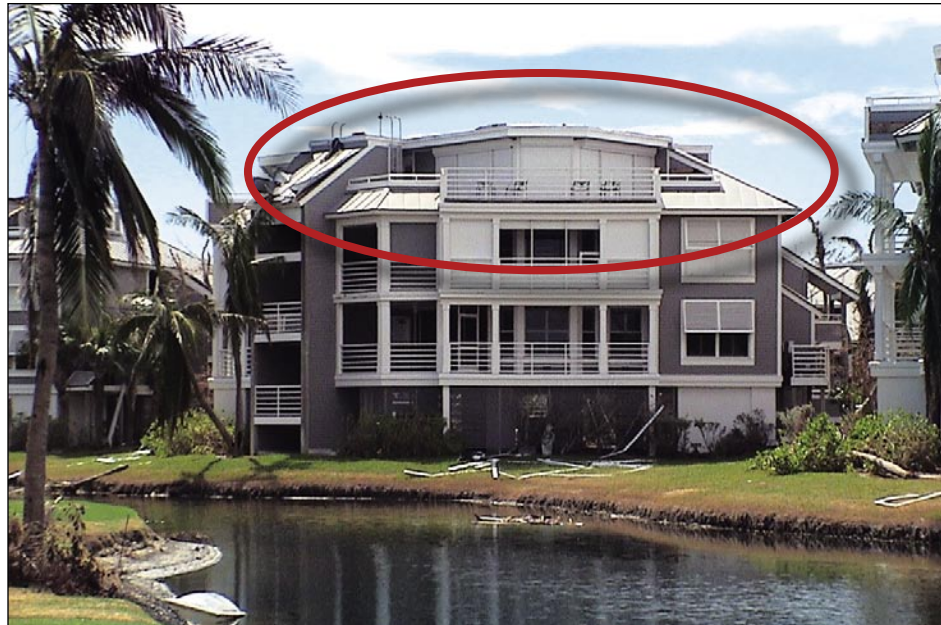
Figure 3-4.  
Nearby undamaged  
wood-frame building  
similar to that shown in  
Figure 3-3 protected with  
shutters (Captiva Island)

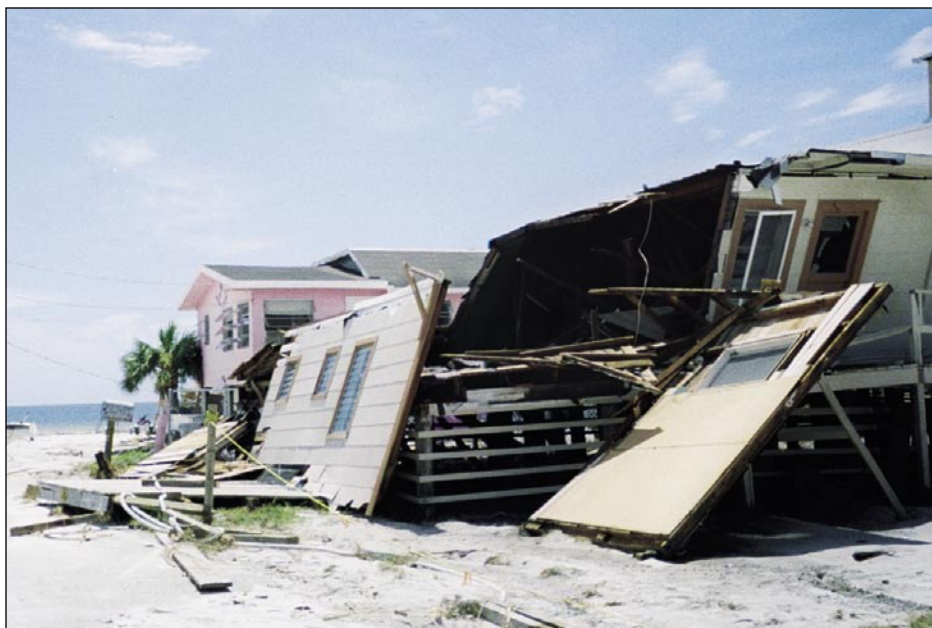
**Figure 3-5.**  
Wall failure on older multi-family wood-frame building due to lack of continuous load path. Internal pressurization may have also contributed to this failure (Fort Myers Beach).

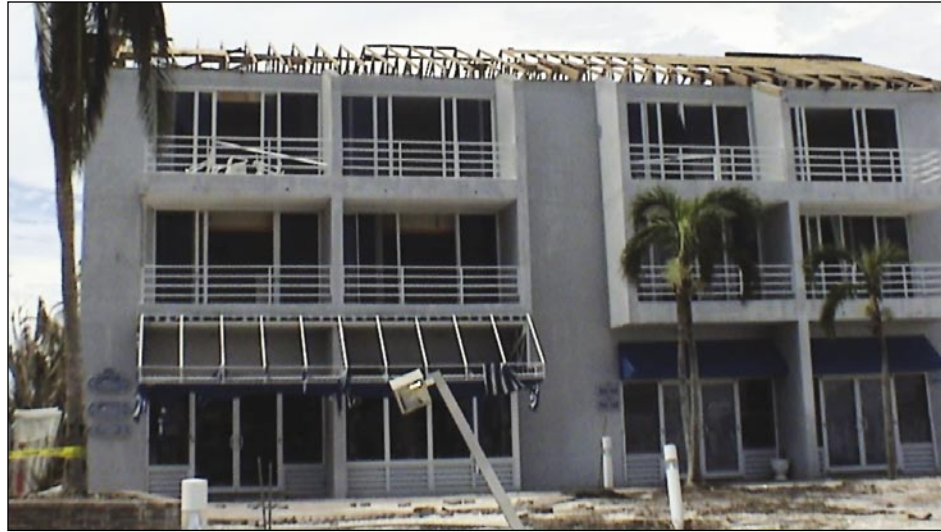
**Figure 3-6.**  
Damage to older multi-family building roof deck with inadequately supported and braced overhang (Captiva Island)

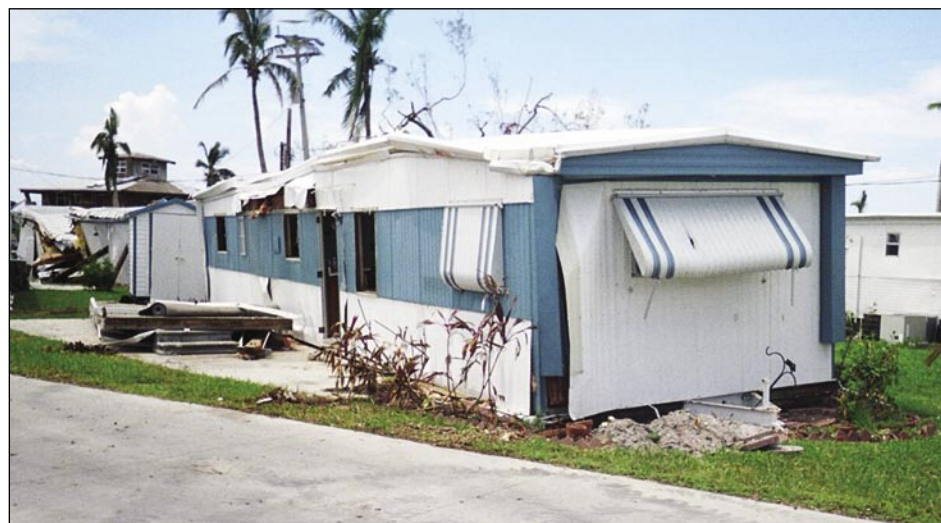
**Figure 3-7.**  
Pre-1976 manufactured home unit displaced from its foundation, damaging the structure itself (Pine Island)

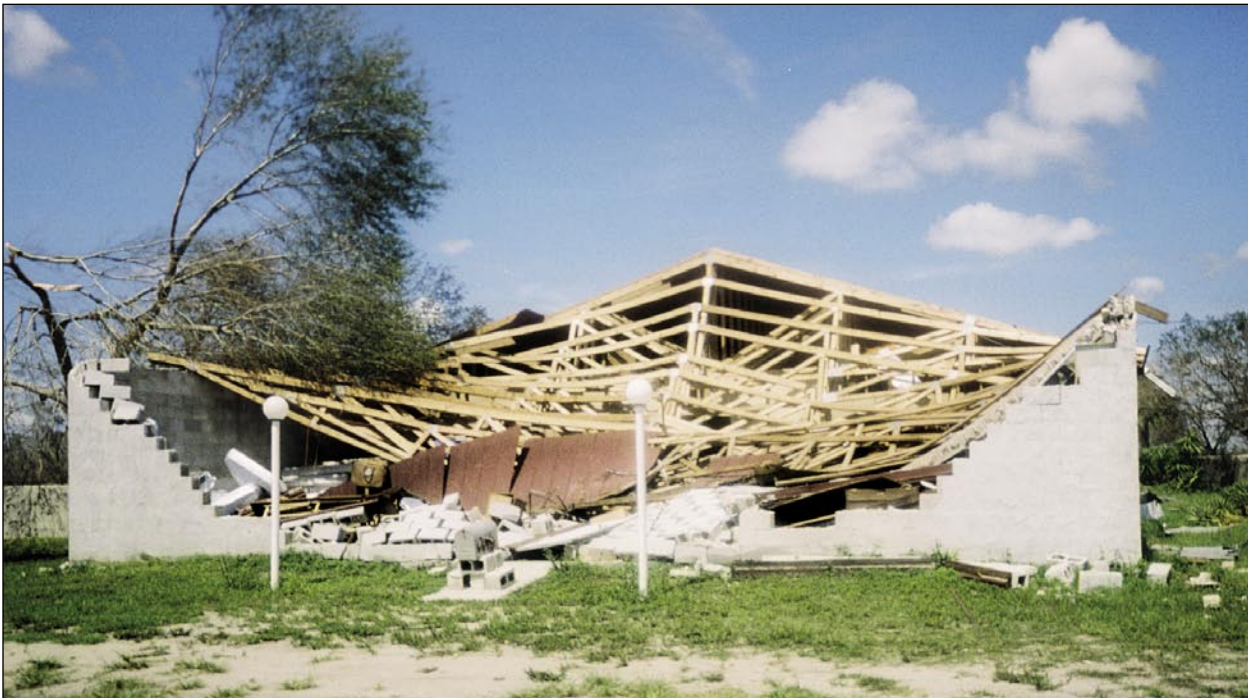
Figure 3-9. Example of wood truss roof failure due to sheathing loss and lack of bracing at gable end on a pre-2001 FBC unreinforced masonry building (north of Arcadia)

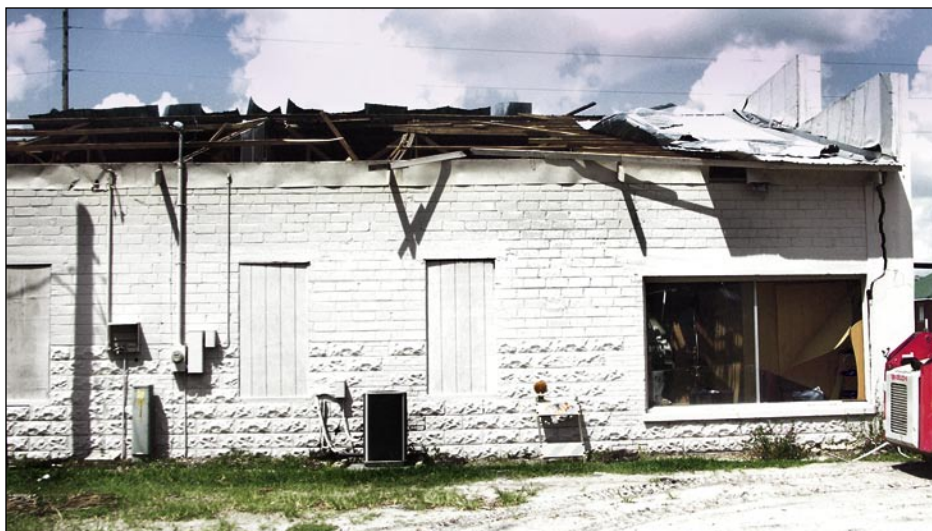
Figure 3-10. Roof sheathing and partial failure of wood roof structure on a masonry building. Note damage to inadequately reinforced masonry parapet at gable end wall (Wauchula).

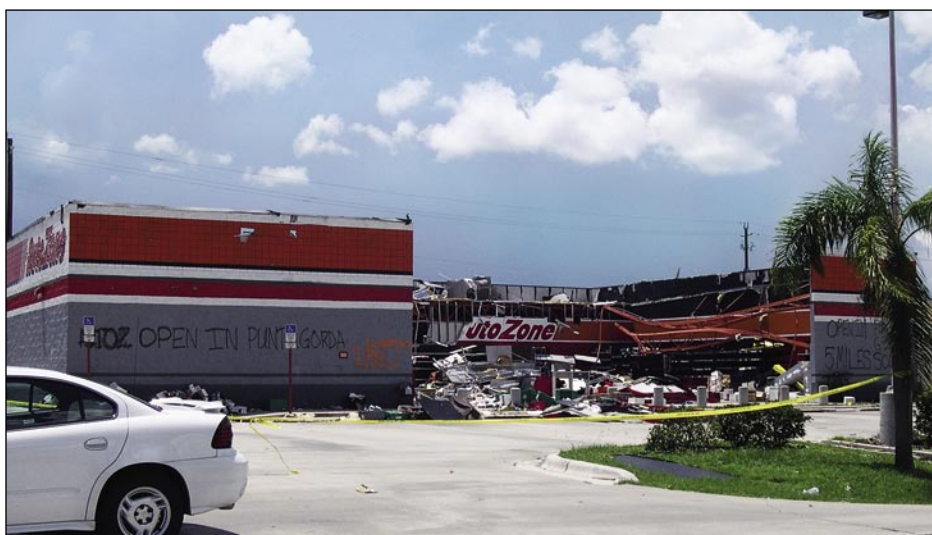
to damage to an inadequately reinforced masonry gable end wall. In Figure 3-11, the metal roof deck supported on steel joists failed. Field observations of the building shown in Figure 3-11 noted failed welds at the plate connectors used to secure the steel joists to the wall systems. The MAT observed that this type of roof damage to masonry buildings often led to partial or total collapse of walls that were left unsupported when roof systems failed. Unreinforced masonry (URM) construction, insufficient steel reinforcement, or improper grouting in the walls, particularly along the tops of walls and at gable ends, may have also contributed to the damages observed. These types of damages were observed primarily around the Port Charlotte and Punta Gorda areas of Charlotte County with isolated incidences observed along the path of the eye into De Soto, Hardee, and Polk Counties.

Figure 3-11. Damage to a pre-2001 FBC masonry building with steel joist roof framing and metal deck (Port Charlotte)

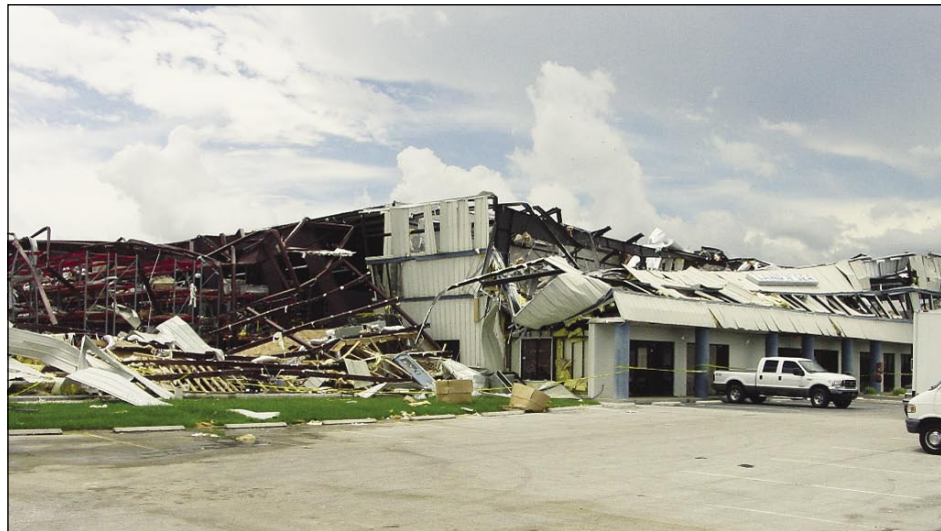
**Figure 3-12.**  
Pre-engineered metal building with progressive failure and severe panel loss (Arcadia)

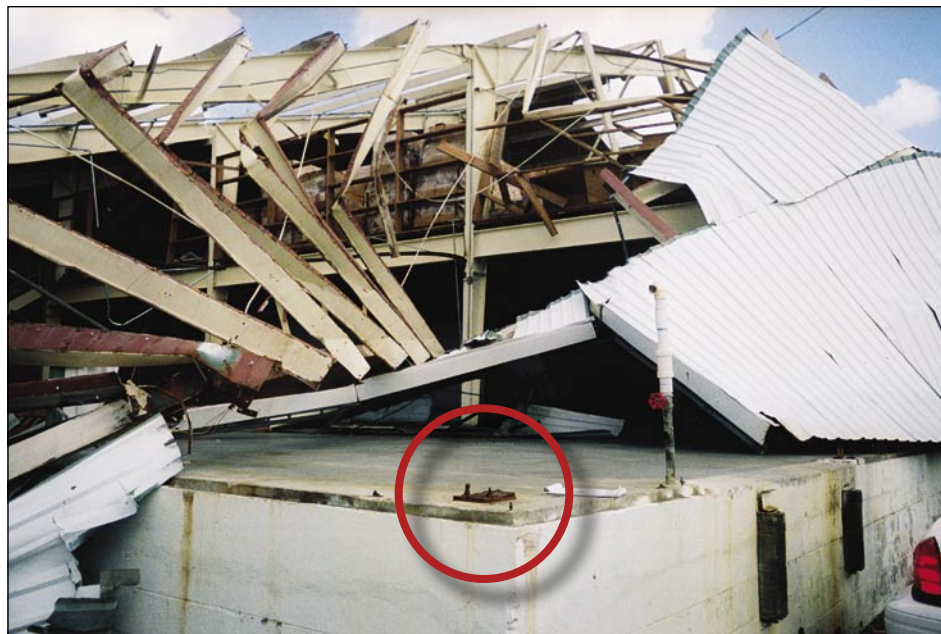
**Figure 3-13.**  
Roof framing failure and gable end wall collapse due to insufficient supports of pre-engineered metal building. Note corroded base plate with failed bolts for gable end wall column (Wauchula).

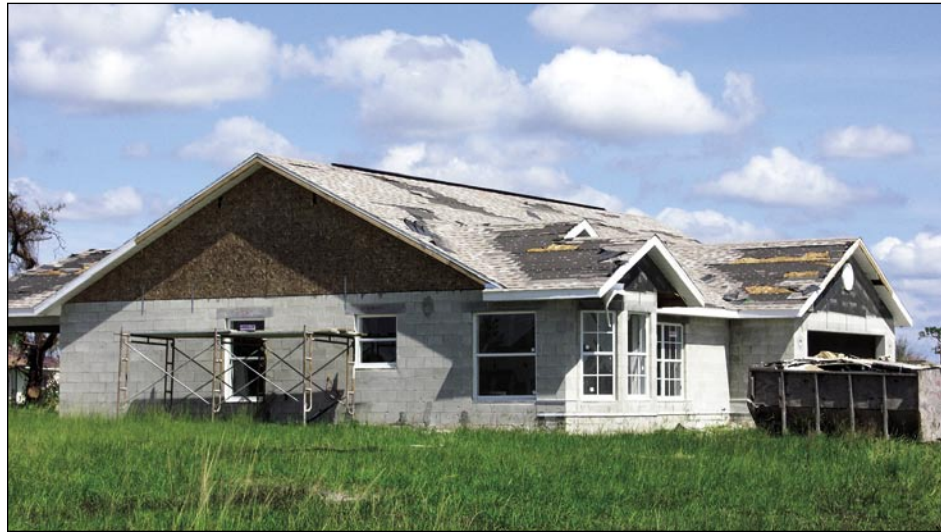
Figure 3-14.  
Asphalt shingle roof covering damage on a new one-story house. In some areas, the underlayment was also blown away (Deep Creek).

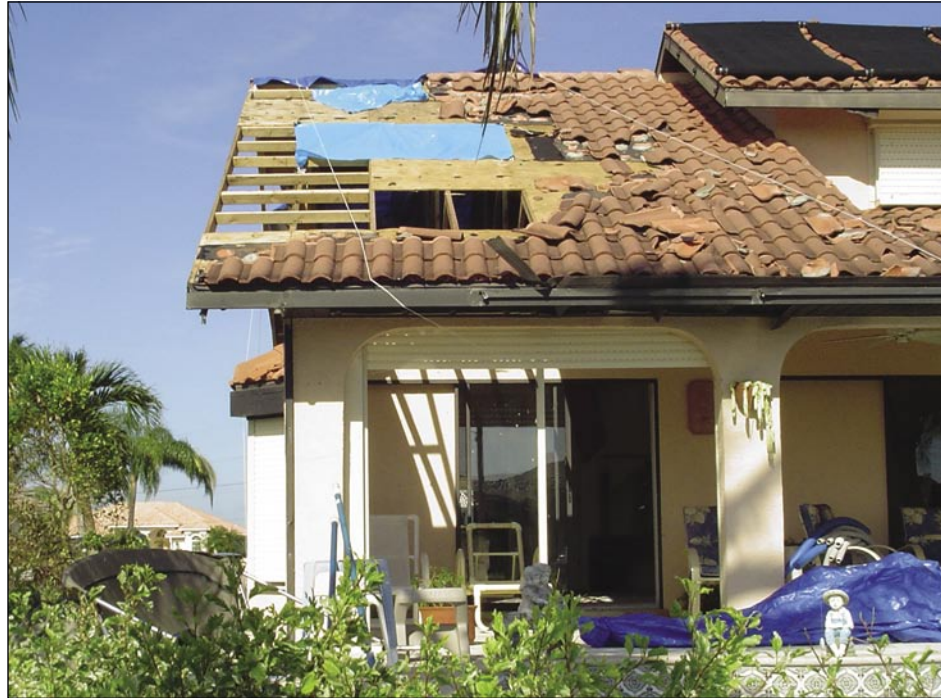
**Figure 3-18.**  
Example of roof decking  
loss on one-story house  
(Punta Gorda)

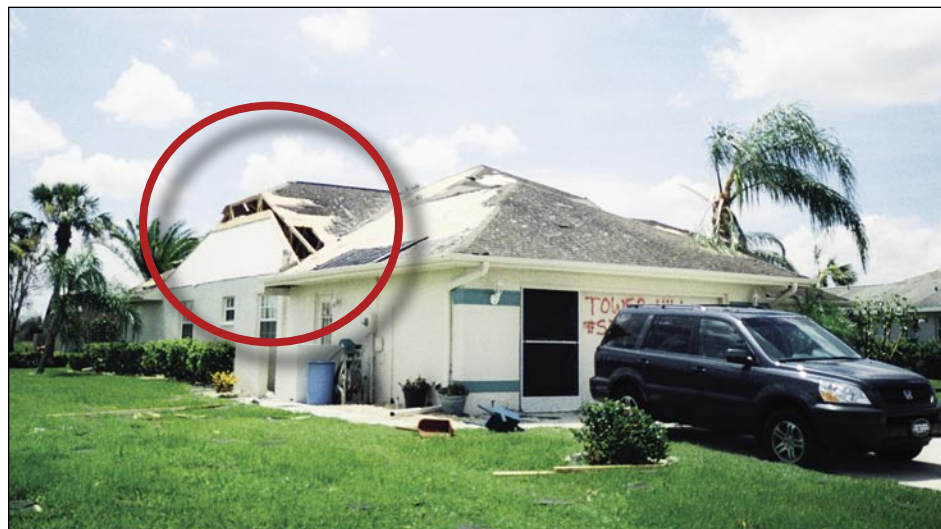
**Figure 3-19**  
Partial gable end wall  
failure with loss of roof  
shingles (Deep Creek)

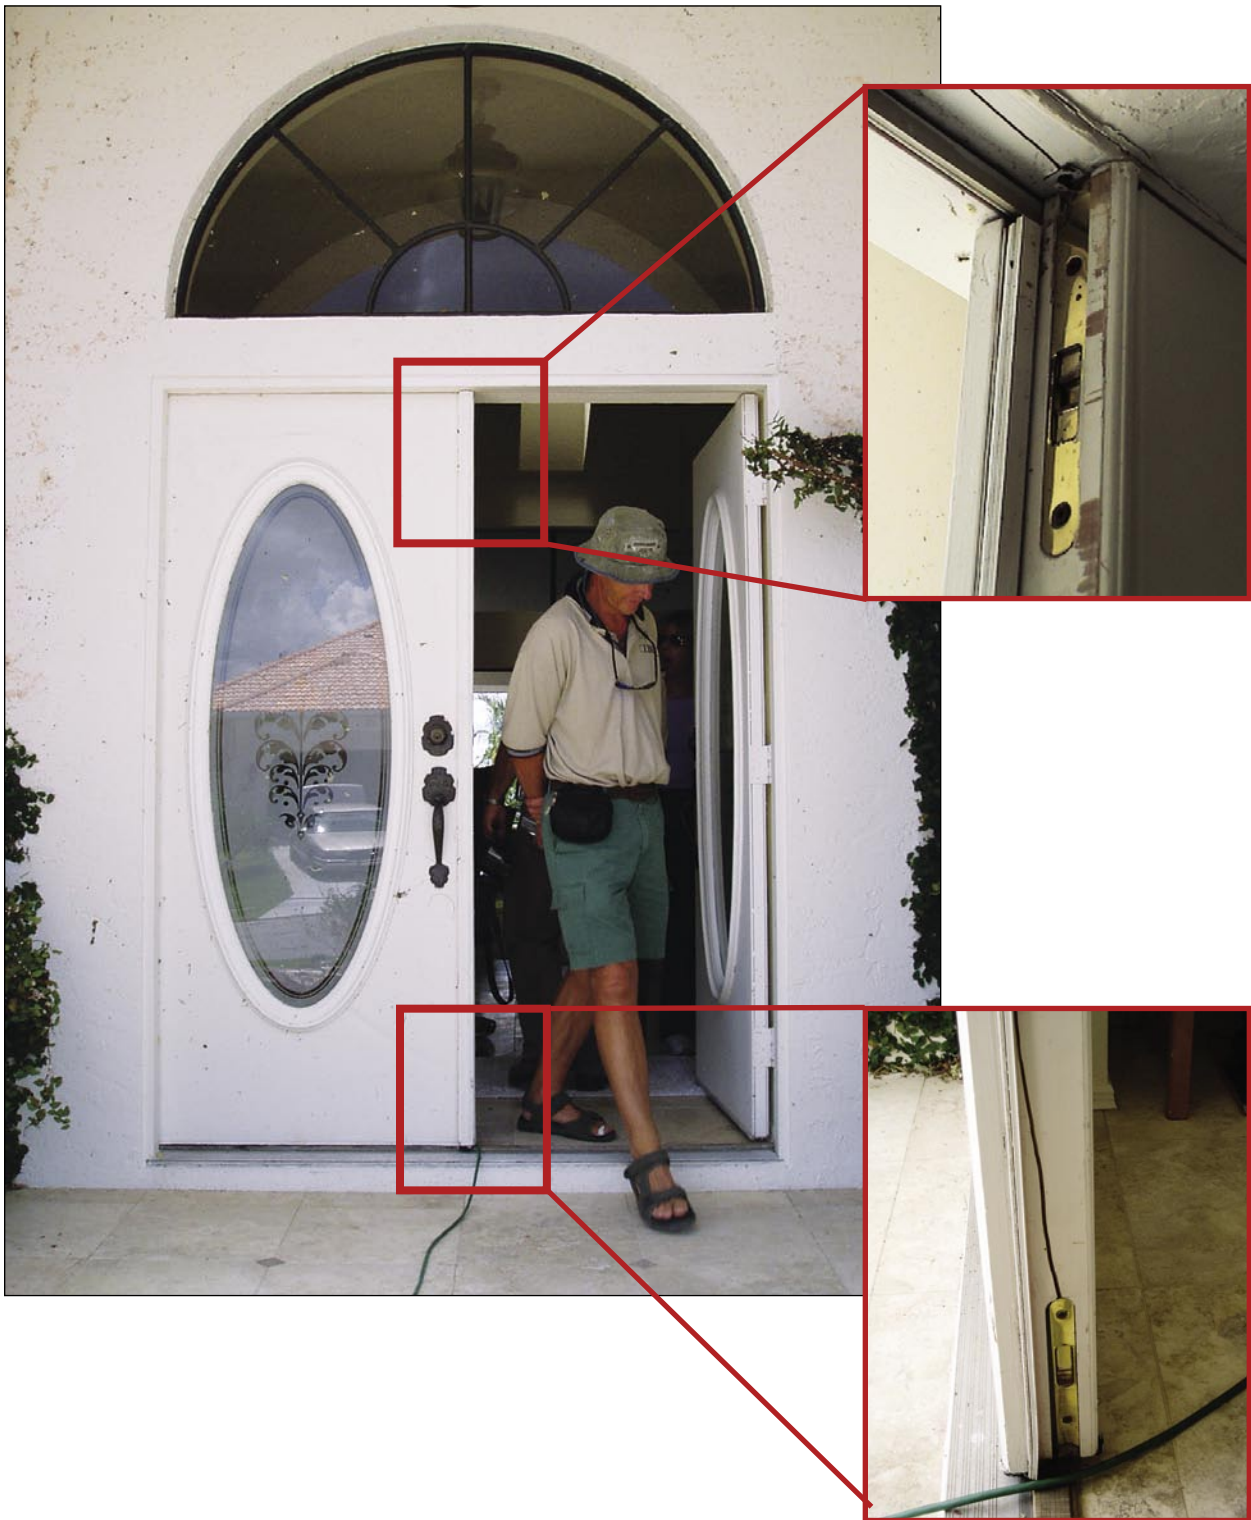
Figure 3-20. Double-entry door that failed under wind pressure. Upper inset shows close-up of crack in door frame at top latch. Lower inset shows crack in door emanating from bottom latch (Punta Gorda).

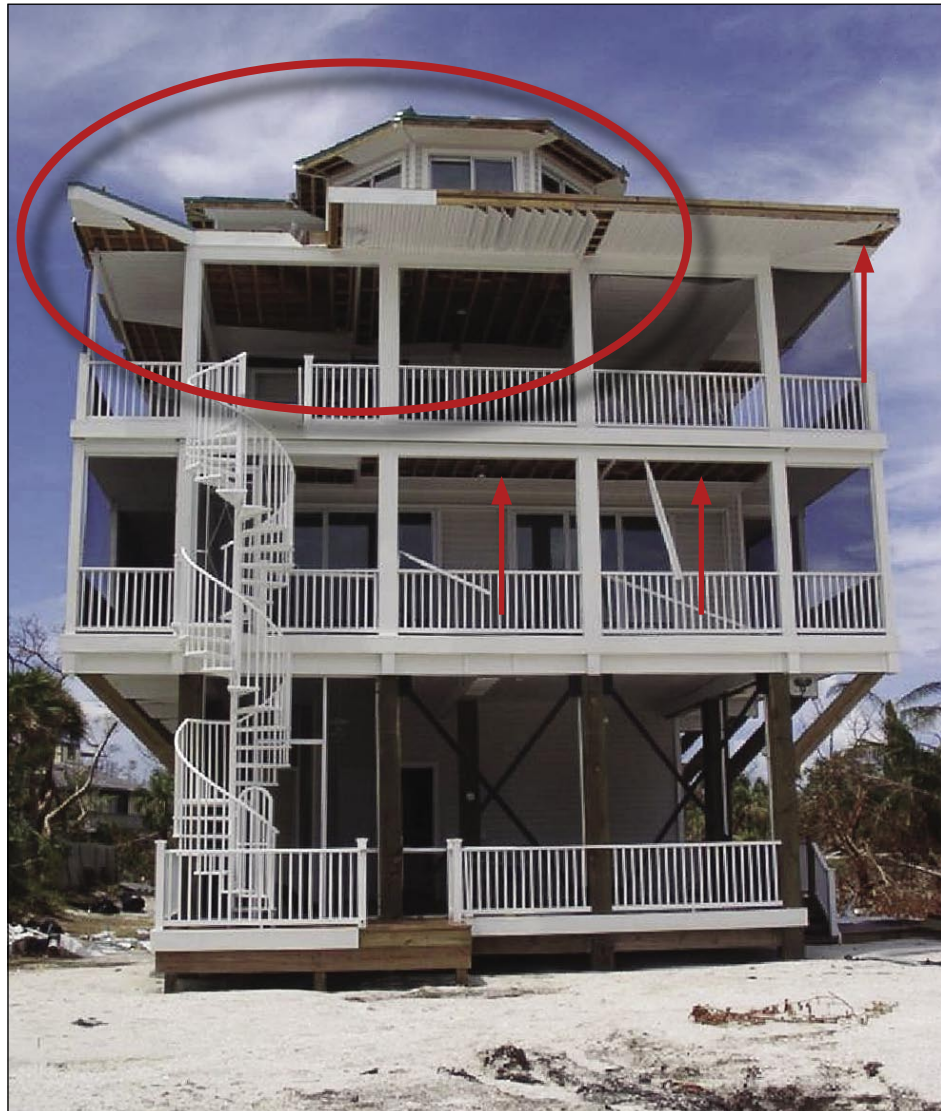
Figure 3-21.  
Typical elevated wood-  
frame house with  
extensive soffit damage  
(North Captiva Island)

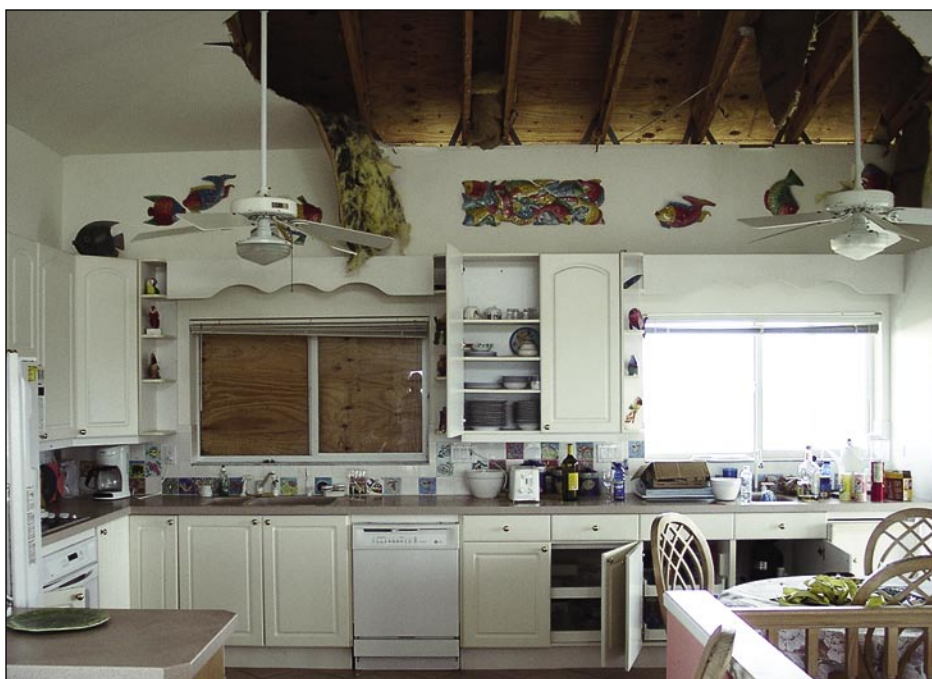
**Figure 3-22.** The drywall ceiling in the home shown in Figure 3-21 collapsed after becoming waterlogged and weakened by wind-driven rain that entered through the exterior soffit space. Plywood covers the opening of a window broken by windborne debris after the plastic shutters blew off (North Captiva Island).

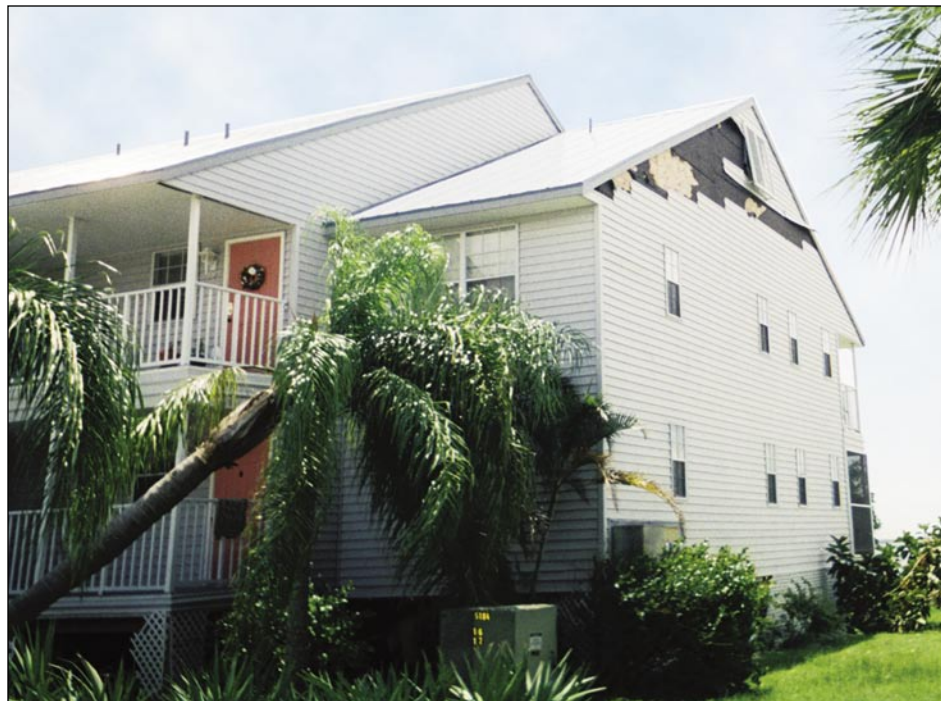
Figure 3-24.  
Vinyl siding wall covering  
on multi-family building  
with damage to gable  
end wall sheathing  
(Port Charlotte)

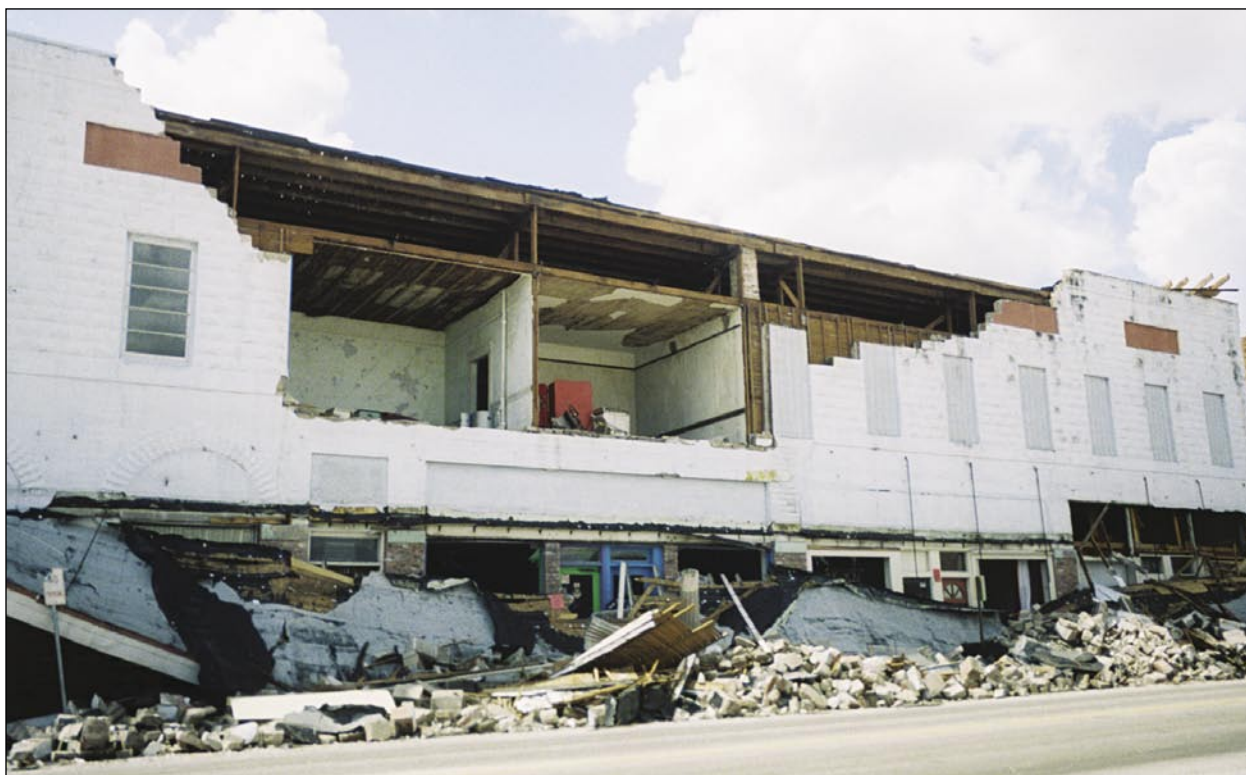
Figure 3-25. Example of unreinforced masonry wall and parapet collapse due to breaching of roof (on opposite side of building) (Wauchula)

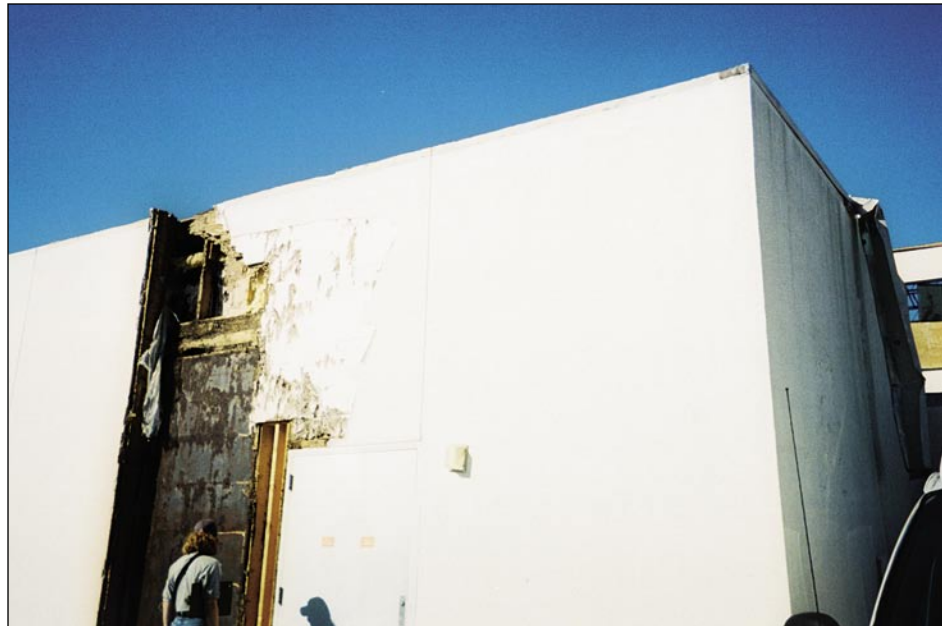
Figure 3-26.  
Example of damage to  
EIFS wall panels (Punta  
Gorda)

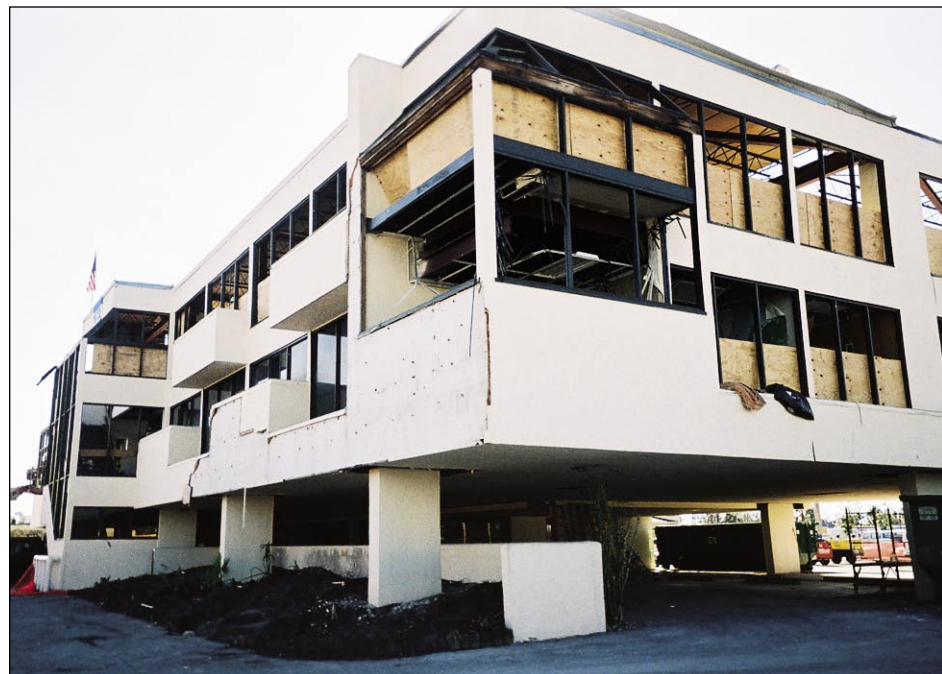
Figure 3-27.  
Structural steel frame  
building showing loss of  
roof decking and damage  
to EIFS wall coverings  
(Punta Gorda)

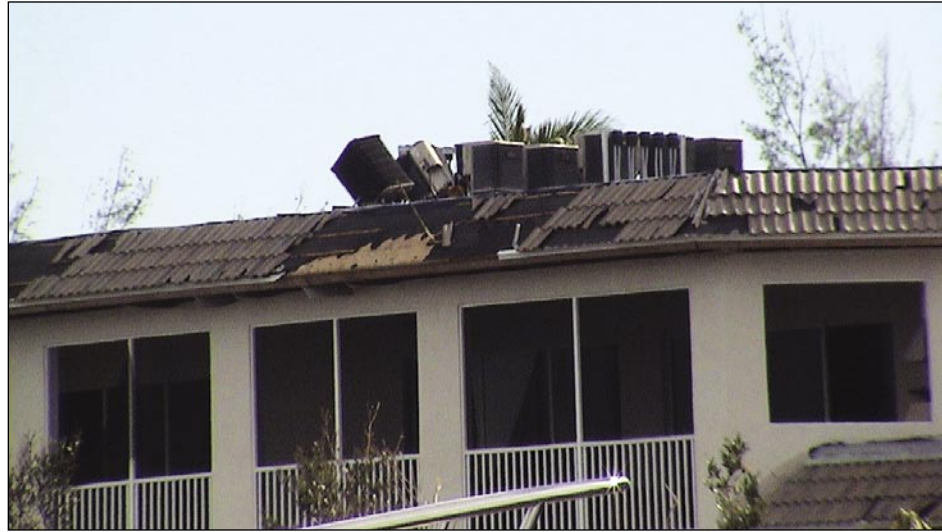
Figure 3-29.  
Dislocation of rooftop  
equipment (Pine Island)

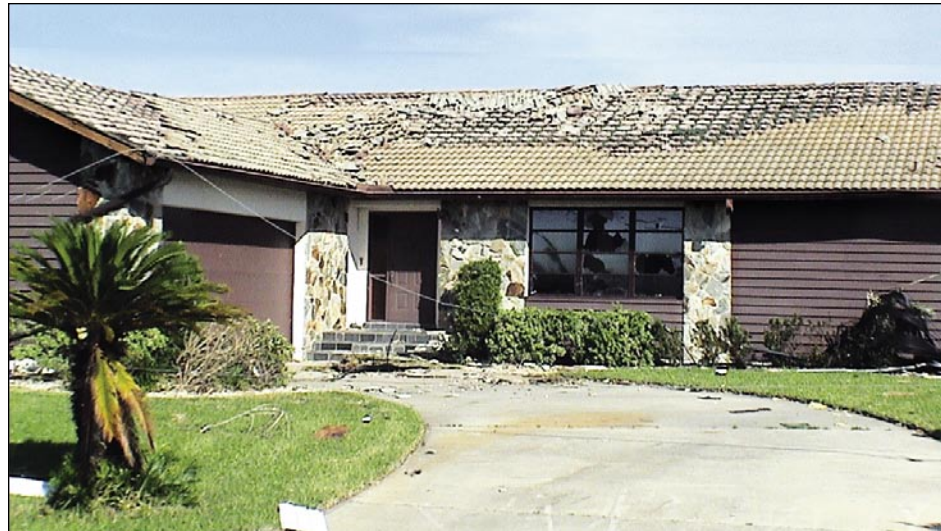
**Figure 3-31.**  
Extensive damage to mortar-set tile roof on this pre-2001 FBC home. Note broken windows to the right of the front door (Punta Gorda).

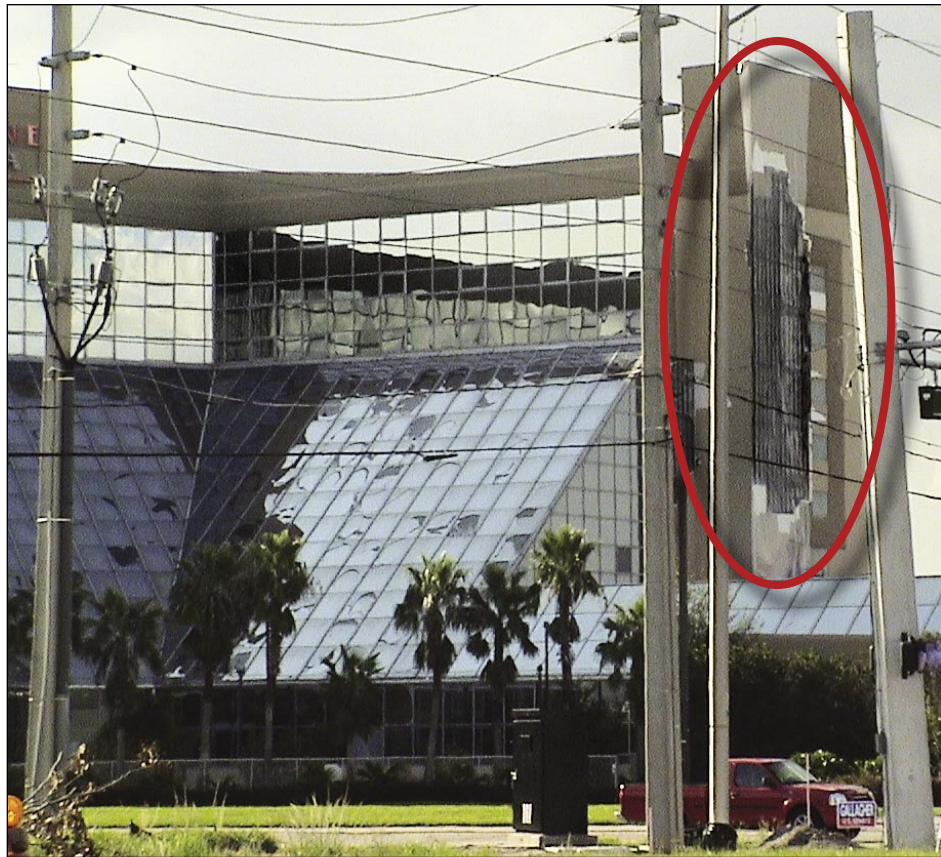
Figure 3-33.  
Damage to glass atrium  
of high-rise hotel. Note  
the loss of EIFS, which  
was the cause of the  
glass breakage (Orlando).

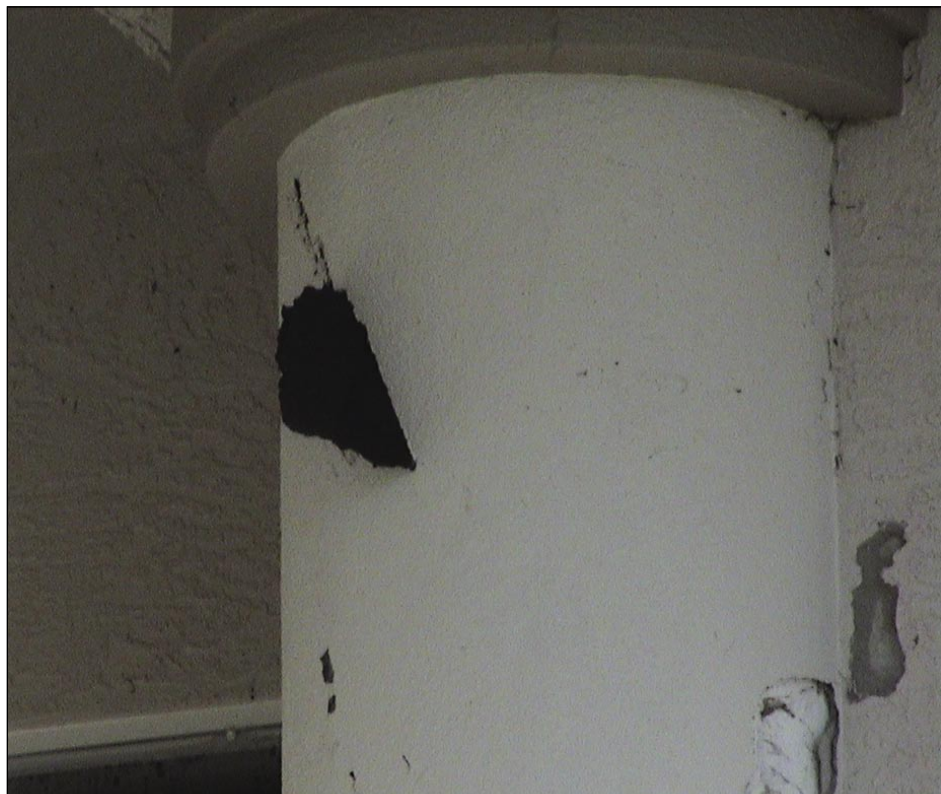
Figure 3-34.  
Edge impact of an  
asphalt shingle on  
decorative column  
(Punta Gorda)

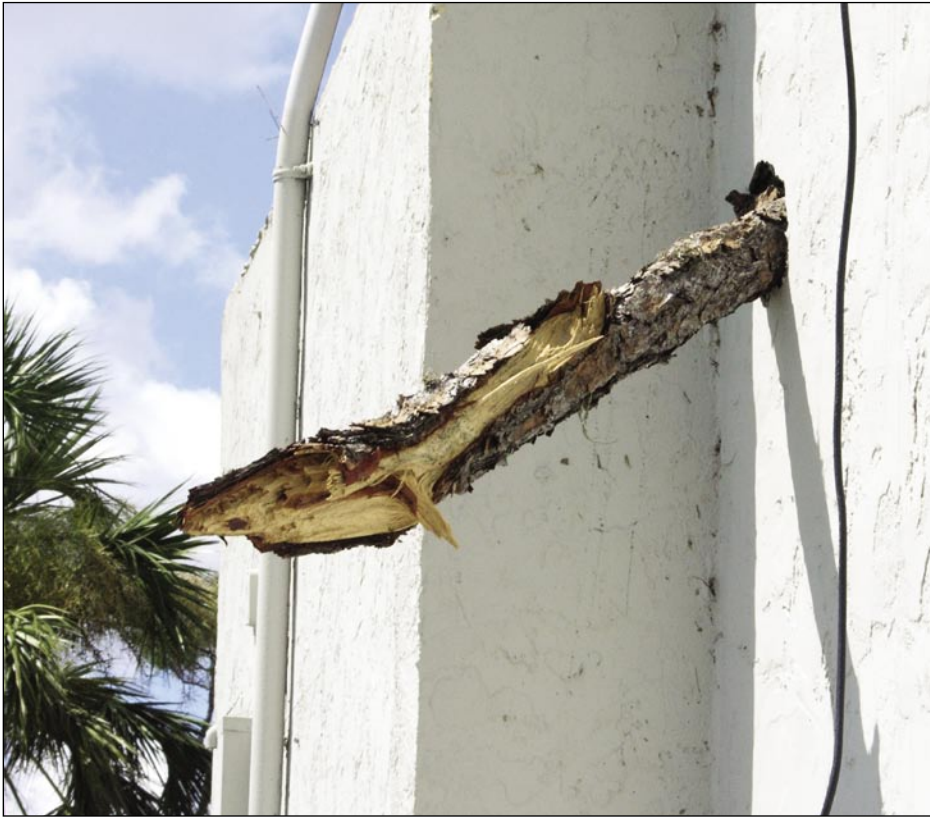
Figure 3-35. Impact of tree branch through the stucco and metal lath wall system of a fire station. The branch was about 5 inches in diameter and protruded about 3 $\frac{1}{2}$  feet out of the wall (Aqui Esta, east of Punta Gorda Isles).

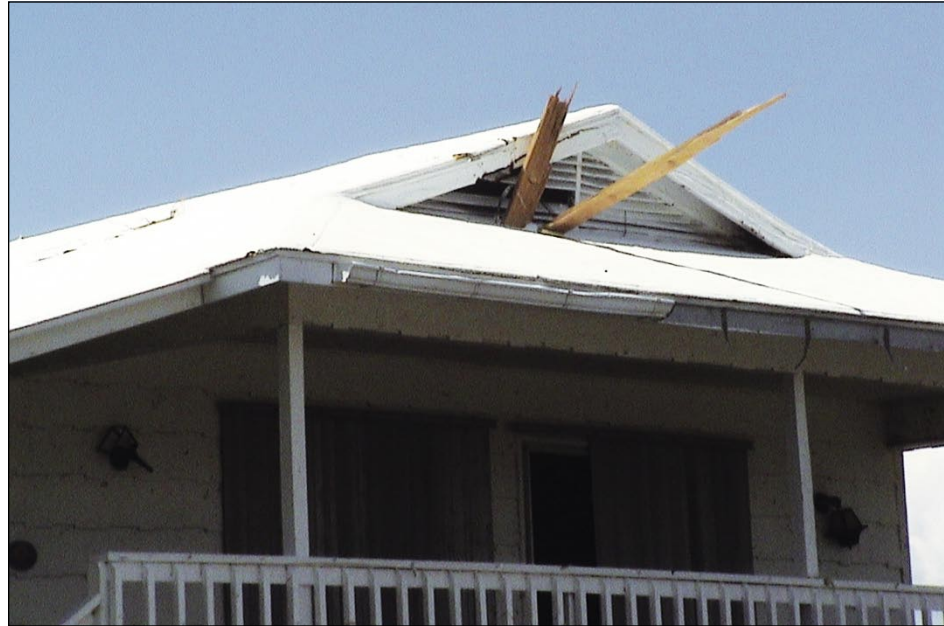
Figure 3-37.  
Impact of structural wood members in the gable end from a neighboring house (Pine Island)

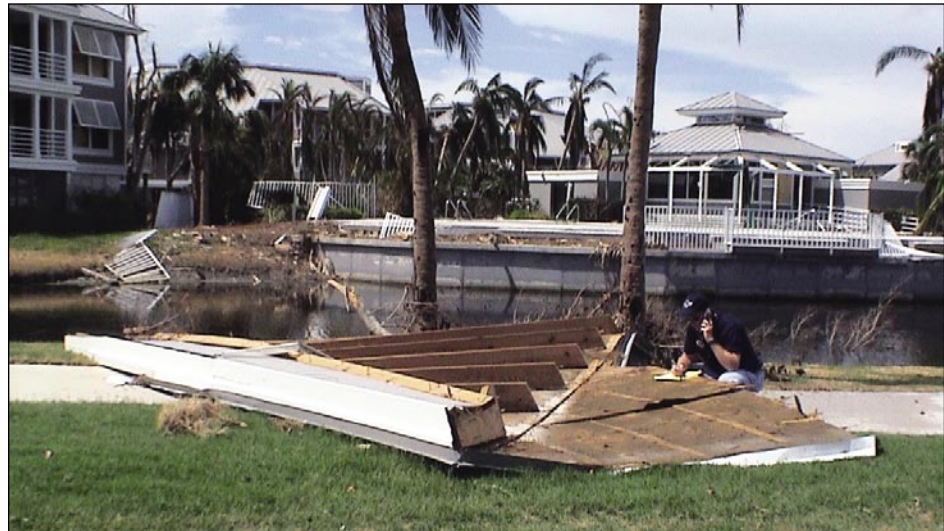
Figure 3-38.  
Large section of roof structure transported over 200 yards from its source (Captiva Island)

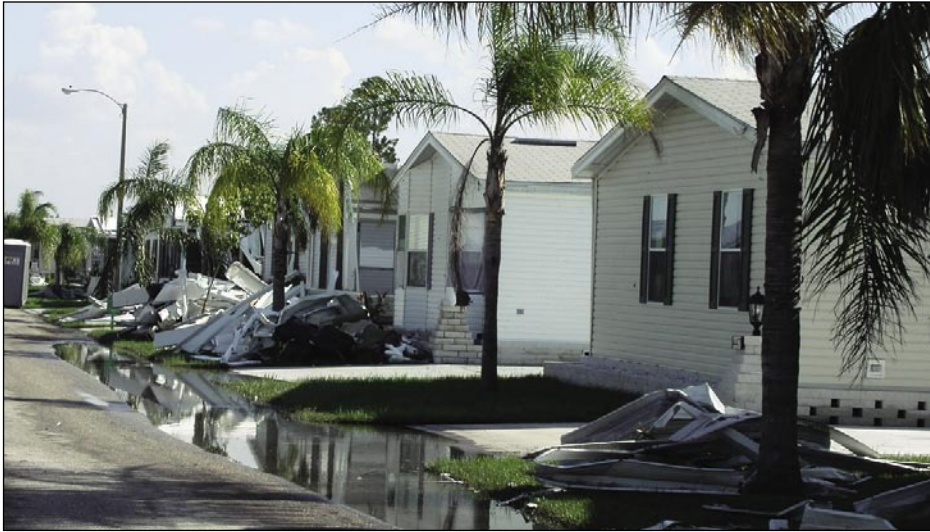
Figure 3-39. Typical metal roof panel and siding debris from failed accessory structures and manufactured homes that were stripped of siding resulting from accessory structures failure (Arcadia)

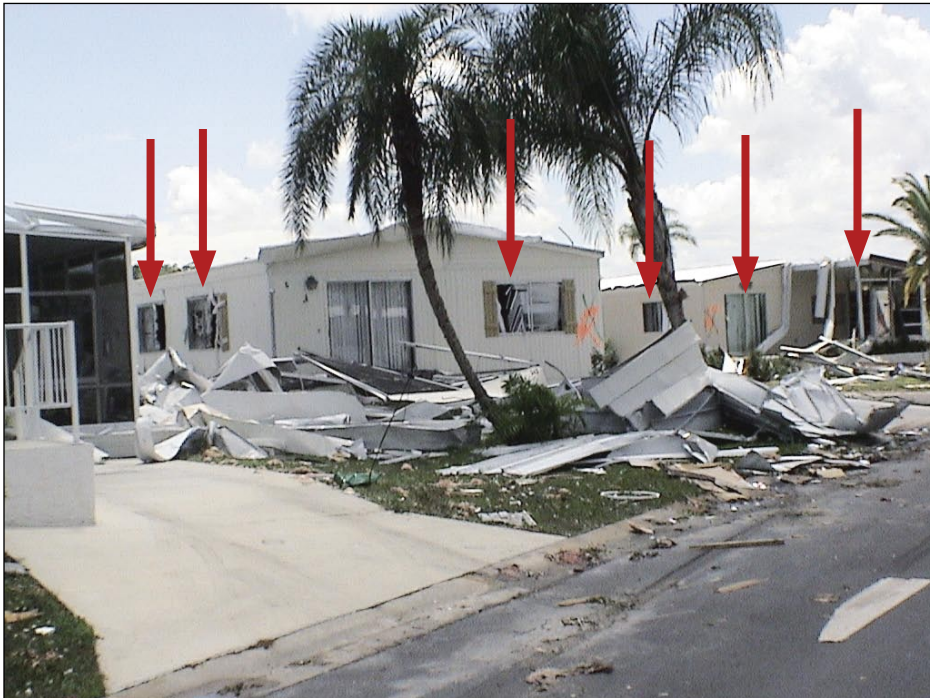
Figure 3-40. Typical metal roof panel and siding debris caused glazing damage to units (Port Charlotte)

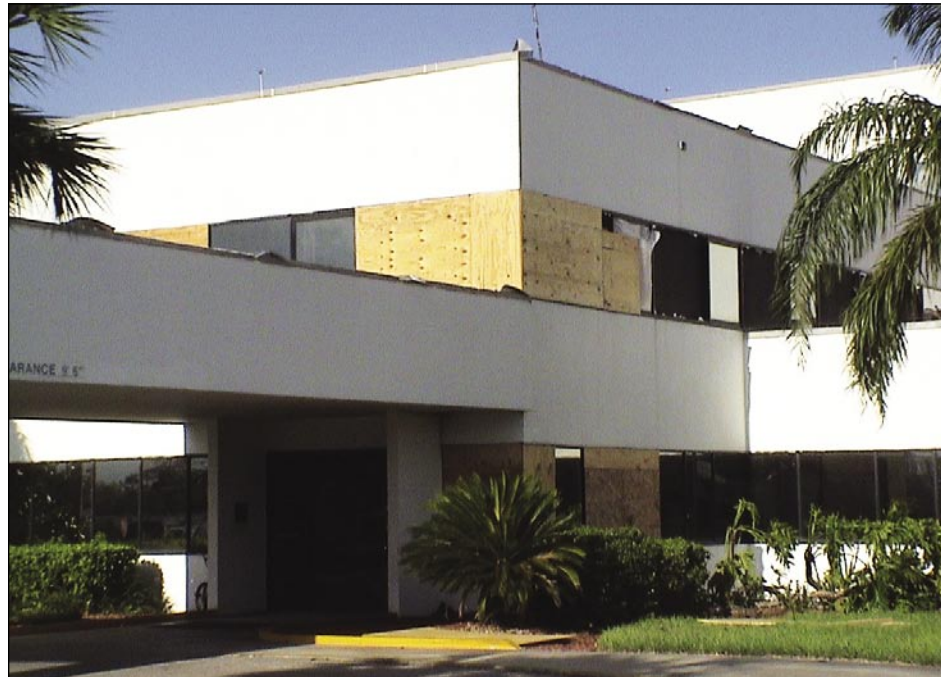
**Figure 3-41.** Aggregate from the built-up roofs broke windows at the intensive care unit of a hospital where 3-second peak gust wind speeds were estimated between 110 and 120 mph (Arcadia).

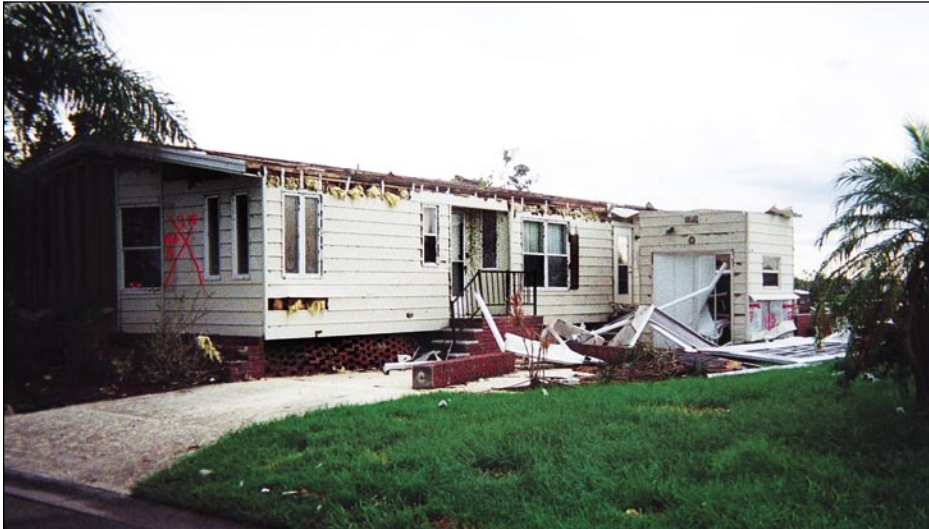
Figure 3-45. Example of typical damage to roof covering, roof sheathing, and exterior siding of a manufactured home as a result of the failure of an attached carport structure (Port Charlotte)
