# *Basic Assessment and Characterization of Damage*

*The MAT's observations of the type and extent of damage caused by Hurricane Charley's high winds and flooding are broadly presented in this chapter and discussed in detail in Chapters 4, 5, and 6.*

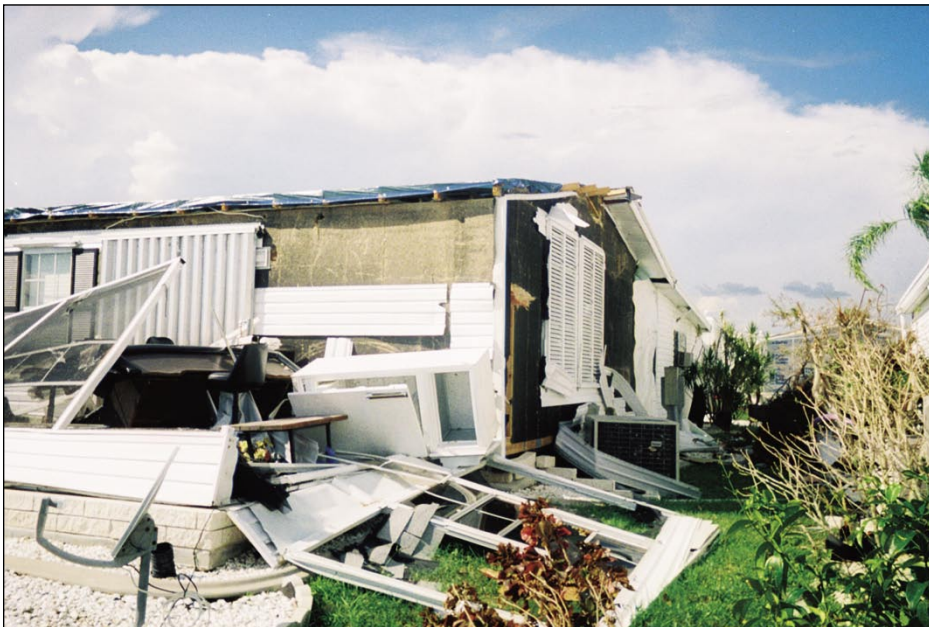
Figure 3-46. Example of damage to manufactured home roof covering, roof deck, and siding due to failure of screen enclosure attached to home (Port Charlotte)

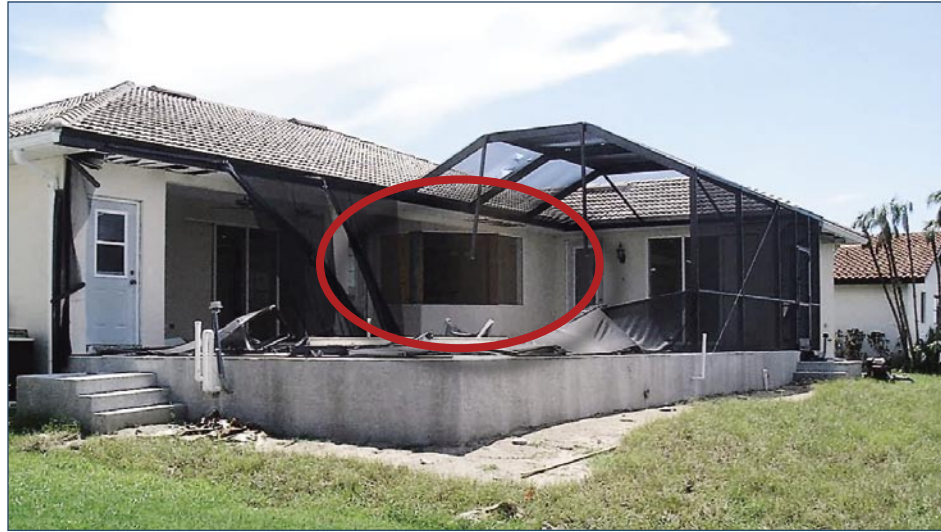
Figure 3-47.  
Example of damage to  
pool screen enclosure.  
Note broken window  
in center of photo from  
debris (Punta Gorda  
Isles).

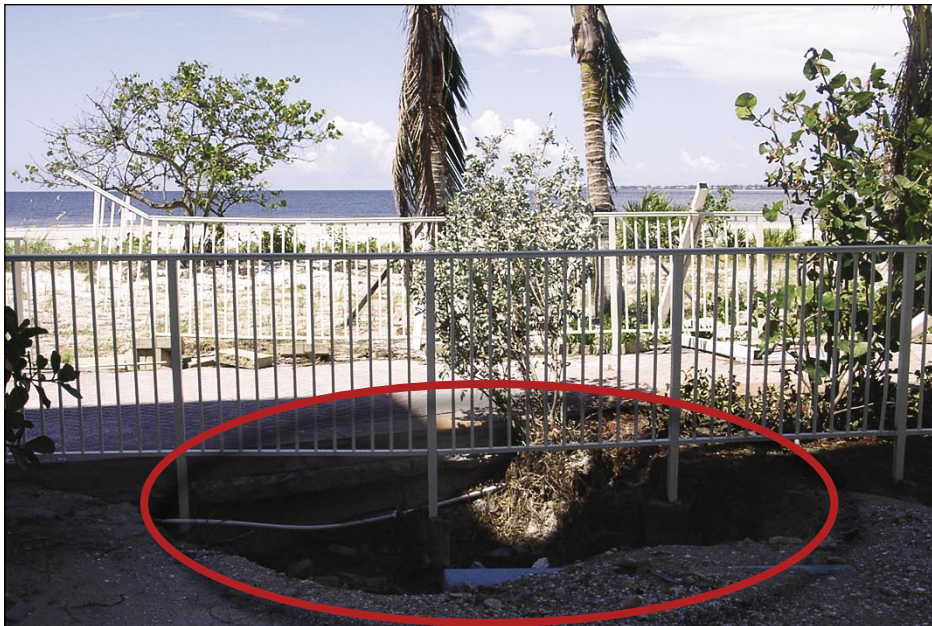
Figure 3-48.  
Minor scour of parking lot  
from overwash of storm  
surge (Fort Myers Beach)

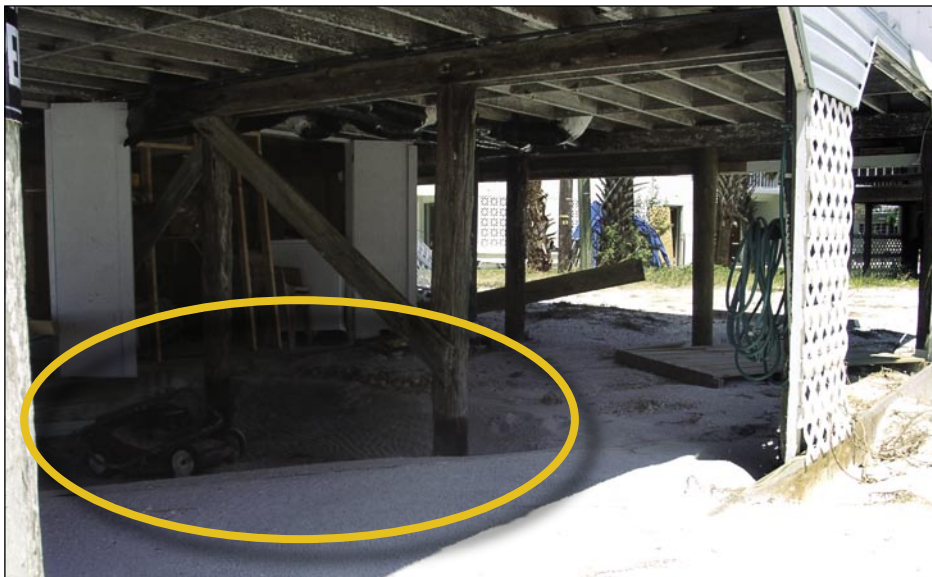
Figure 3-49.  
Minor scour around pile  
(Fort Myers Beach)

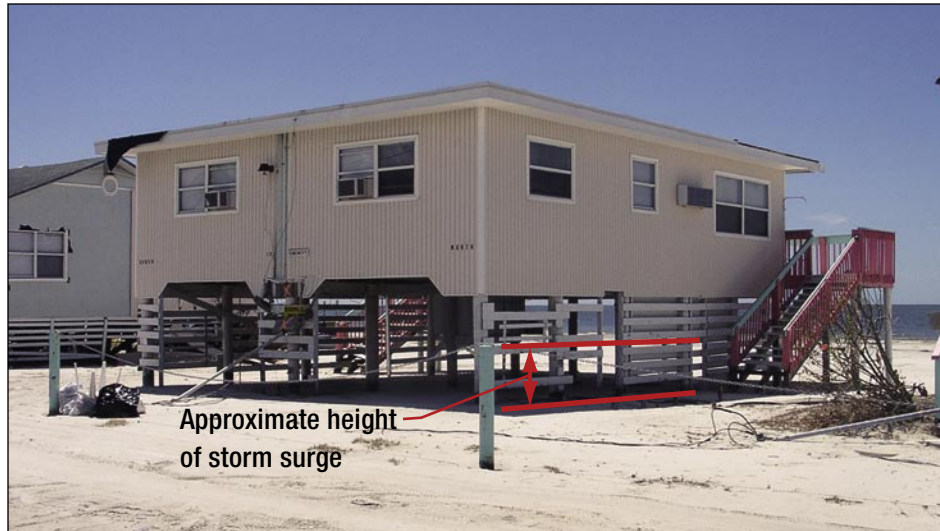
Figure 3-51.  
Storm surge damage of 2  
to 3 feet limited to lower  
floor of two-story house  
(Fort Myers Beach)

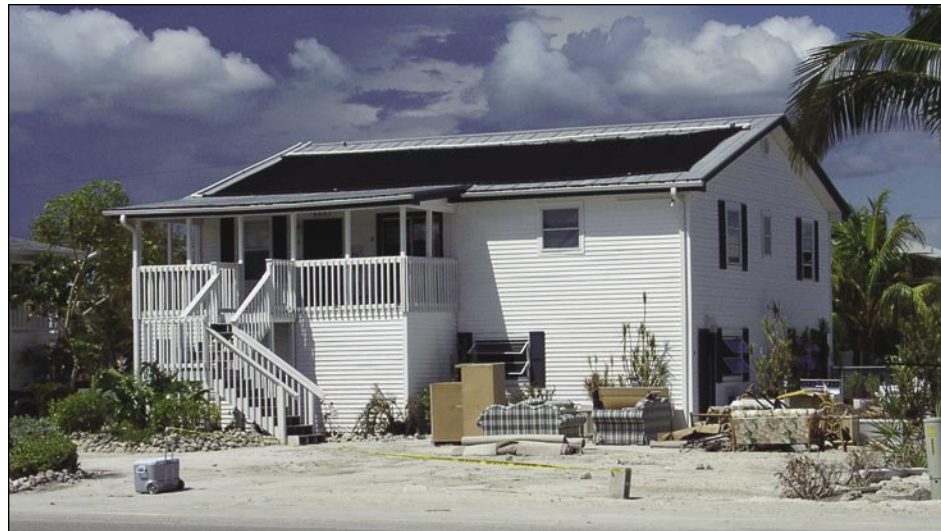
Figure 3-52.  
Typical house with first-  
floor living space at  
grade sustained 2 to  
3 feet of storm surge  
damage (lack of wall  
damage suggests low  
velocity flows)  
(Fort Myers Beach)

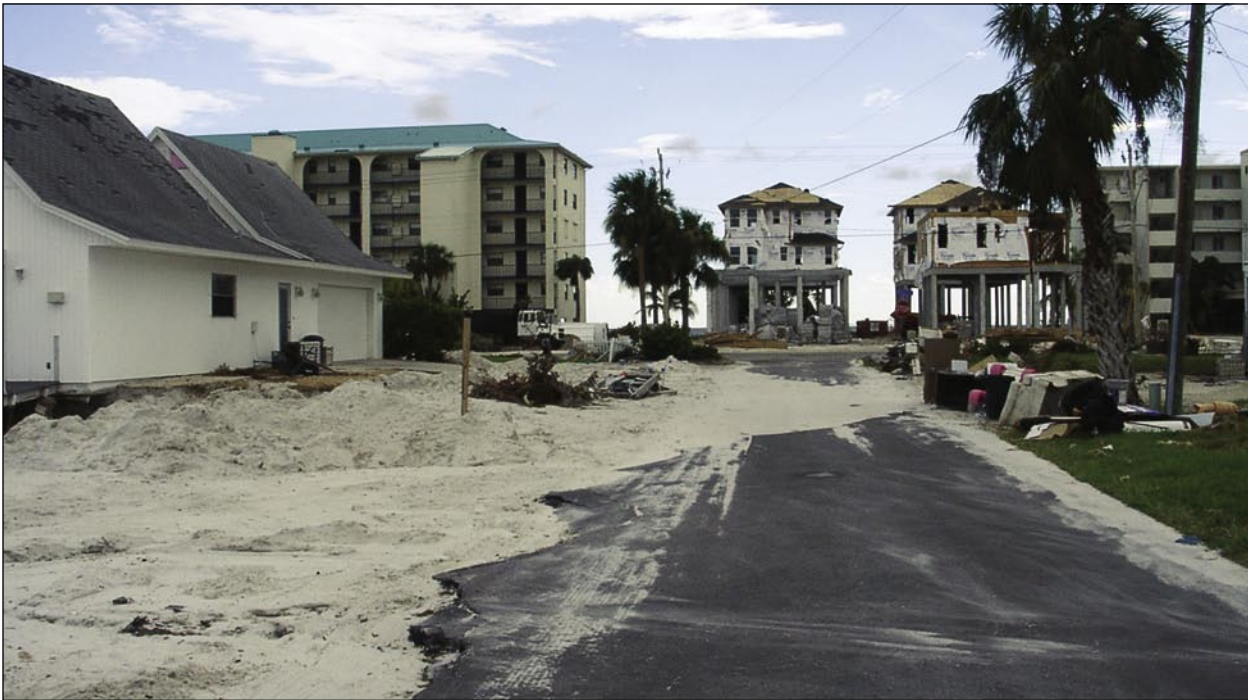
Figure 3-55. Storm surge caused scouring of the road and damage to the infrastructure (i.e., water main) (Fort Myers Beach)

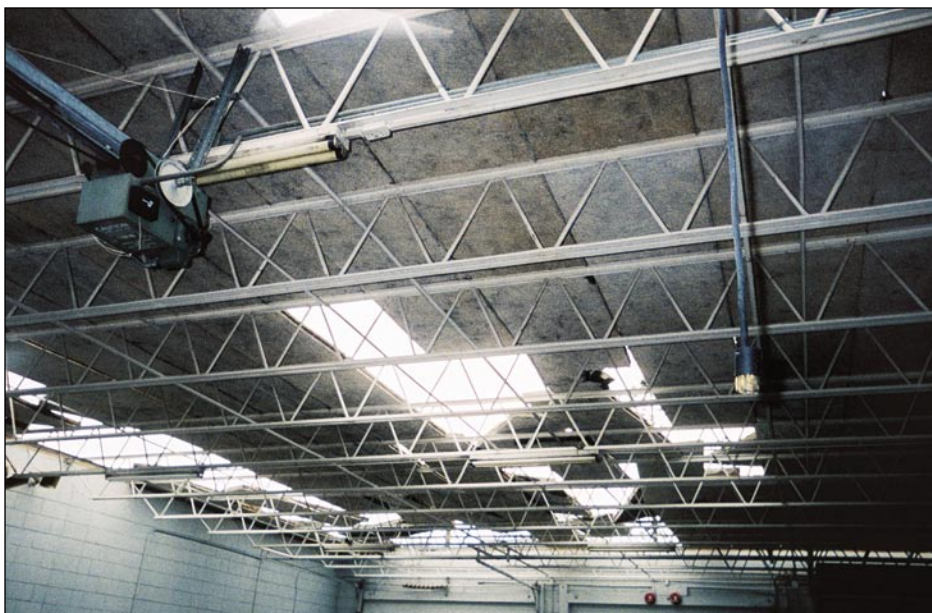
Figure 3-56. Cementitious wood-fiber roof deck panels at this older fire station were not adequately secured to resist uplift (Port Charlotte).

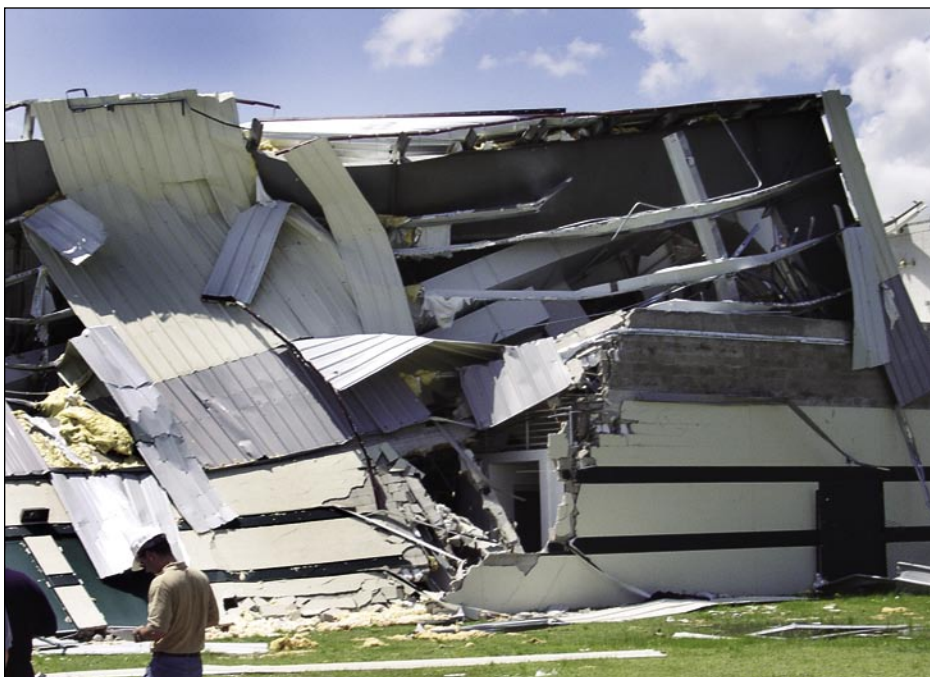
Figure 3-58.  
End wall damage to long span, pre-engineered metal building designed for use as a storm shelter (Turner Agri-Civic Center, Arcadia – see Section 6.5.1.1)
