# *Performance of Critical and Essential Facilities*

## 6.1 Emergency Operations Centers

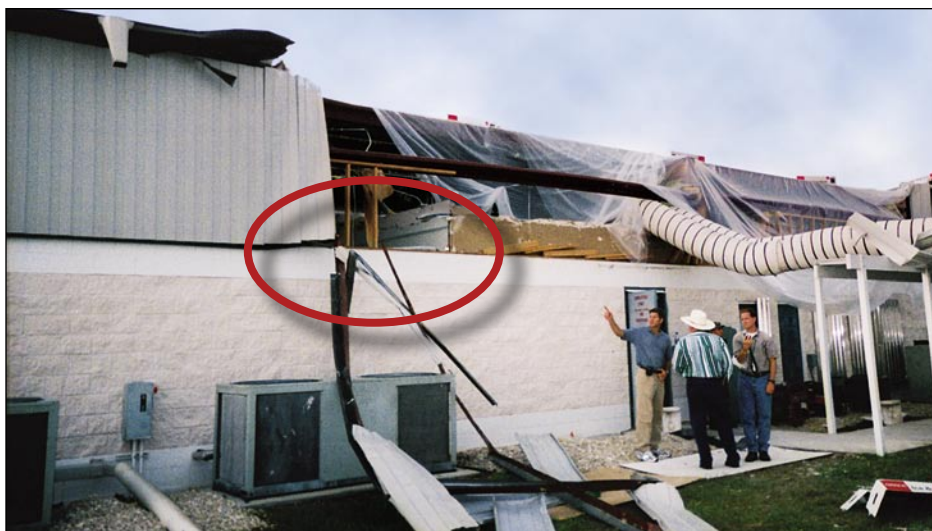
Most of the damage that was observed at the Charlotte County EOC (Figure 6-1) was to the building's envelope (i.e., the roof and wall coverings). Examples of this damage can be seen in Figures 6-1 and 6-2, which illustrate typical roof panel loss and wall panel loss, respectively. Roof damage appeared to center around the failure of the clips that either released from the purlins (Figure 6-2) or from a failure of the clip/panel connection. Additional roof failures were observed at the overhangs located at the rear of the facility at the two large rolling and sectional doors. Figure 6-3 shows the overhang on the southwest building corner.

Figure 6-1.  
Exterior wall and roof  
damage at Charlotte  
County EOC

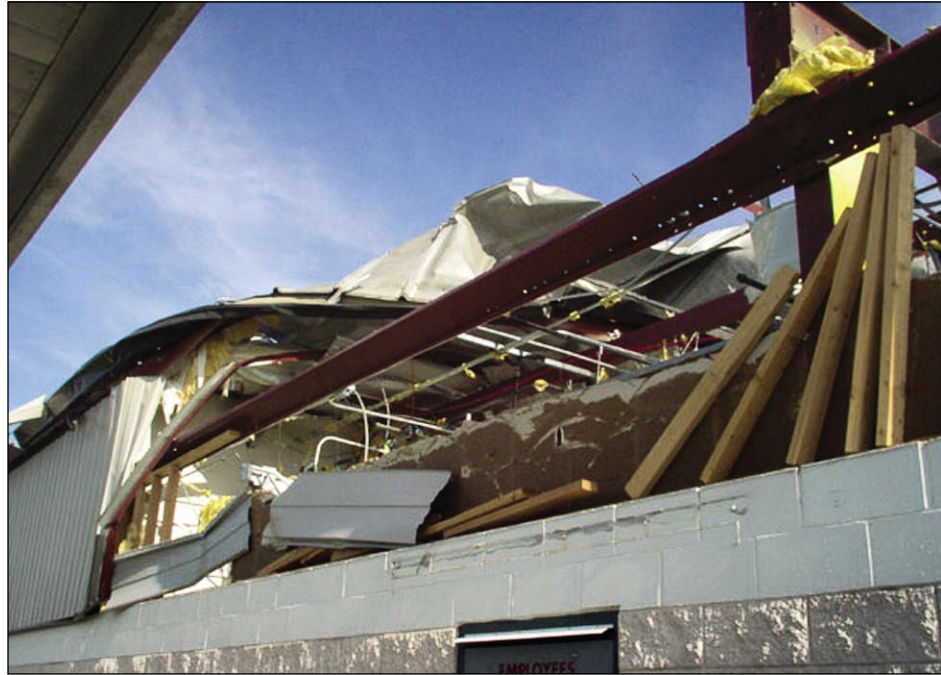
Figure 6-2.  
Failure of wood stud wall  
supporting wall panels  
above masonry wall  
(Charlotte County EOC)

Wind induced wall damage was limited to the upper portions of the exterior walls constructed of metal panels attached to the steel frame and to wood studs acting as purlins between the frame and the top of the masonry walls. Failures observed varied from clip and connection failures, similar to those observed with the roof panels, to complete failures of stud-supported sections (Figure 6-3).

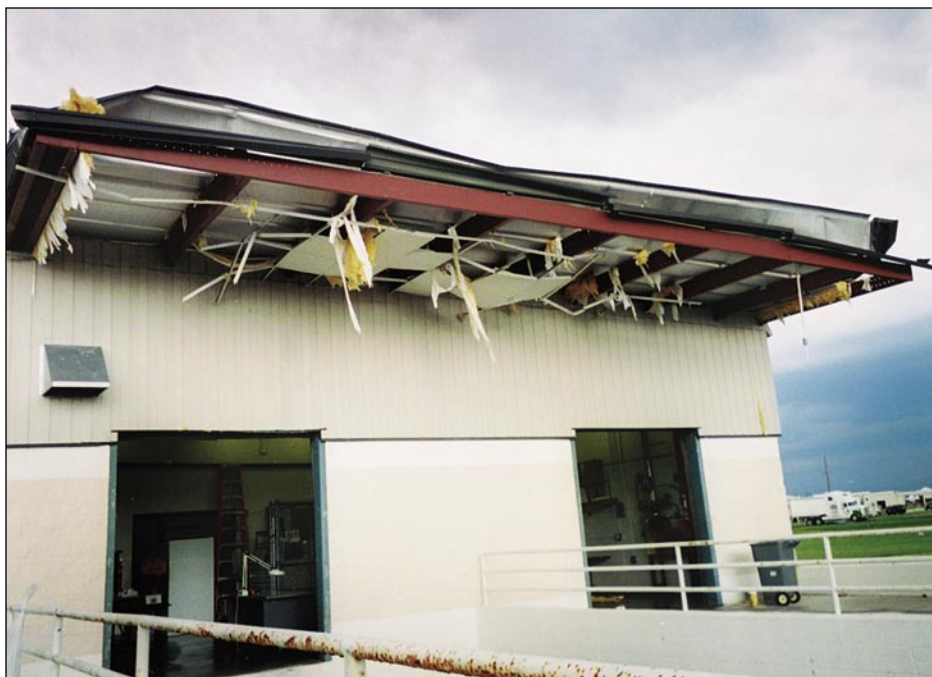
Some isolated structural damage was observed in the roof framing. Damage to the frame was observed in areas where the roof panels were removed from the building by the wind. Damage was typically limited to deformed purlin members, but a few of the primary structural members were also damaged.

Figure 6-3.  
Failure of roof and soffit  
panels at rear awning  
(Charlotte County EOC)

The damage to building components described above is avoidable and these systems can be designed and constructed to resist wind loads and windborne debris. The failure of the building envelope at the EOC should not have occurred. The damage around the site is consistent with a wind speed in the range of 120 to 140 mph 3-second peak gust. This wind speed is close to the design wind speed for this portion of the county for which at the time the building was designed in accordance with the 1991 SBC (110 mph fastest mile wind speed = 130 mph 3-second peak gust).

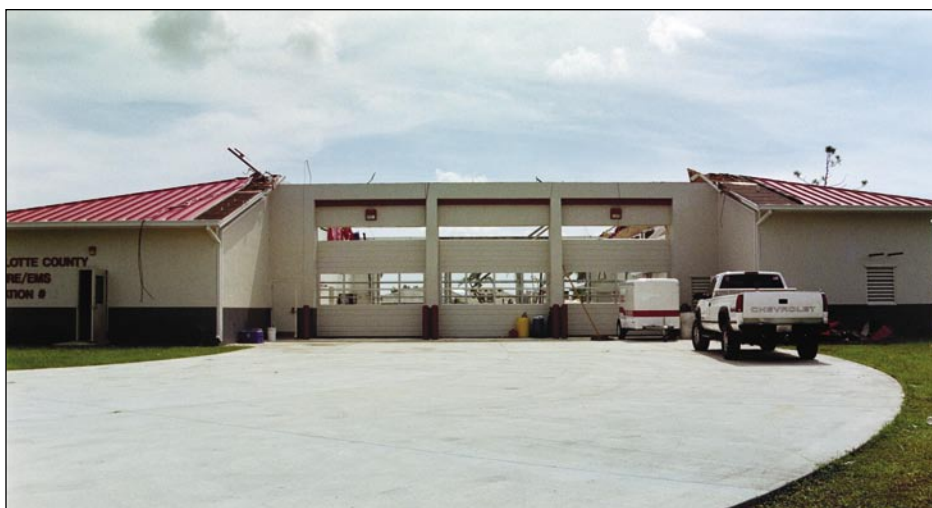
Figure 6-4.  
Overview of west side of  
Port Charlotte Fire Station  
No. 12

Fire/Police Station Year of Construction	Roof Covering Damage	Roof Deck Damage	Other Envelope Damage
Port Charlotte: Charlotte County Fire/ EMS No. 12  Early 1998	Metal panel roof covering loss in areas where structure did not fail. Primary damage was observed at hip flashing; additional damage at clip fasteners to deck. Clips were not installed at even spacing.	Loss of wood trusses and wood panel roof deck over apparatus bays (likely cause was pressurization of bay due to loss of rolling and sectional doors). See Figure 6-4 (note that clips/straps were used to secure trusses to walls).	Loss of all three bay doors on east side of station during period of positive pressure acting on doors. Two of the three doors' tracks remained in place. Broken windows around building exterior.
Port Charlotte: Fire Station No. 1  1980	BUR covering (mineral surface) was damaged due to uplift failure of deck system below. Base sheet of covering was attached to deck with tube-nails.	Numerous cement-fiber deck panels (secured with clips) failed from uplift forces. Openings and unstable sections of roof deck were located over apparatus bay and functional areas.	Two of three sectional doors (fully glazed) had broken glazing and were blown into apparatus bays. Windows and doors were broken or damaged. See Figure 6-5.

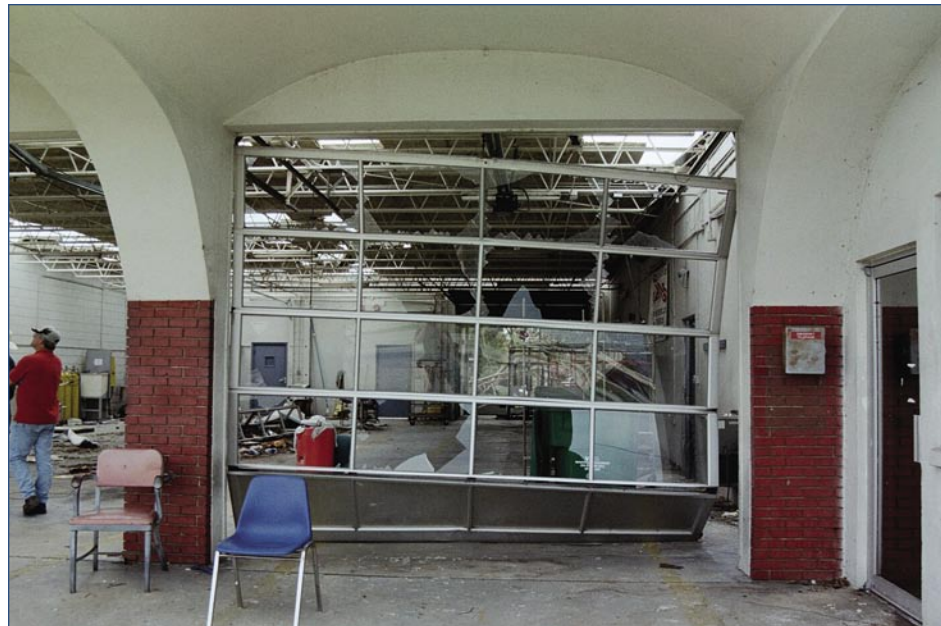
Figure 6-5.  
View of damaged garage door and interior of Port Charlotte Fire Station No. 1; note missing roof deck panels over apparatus bay.

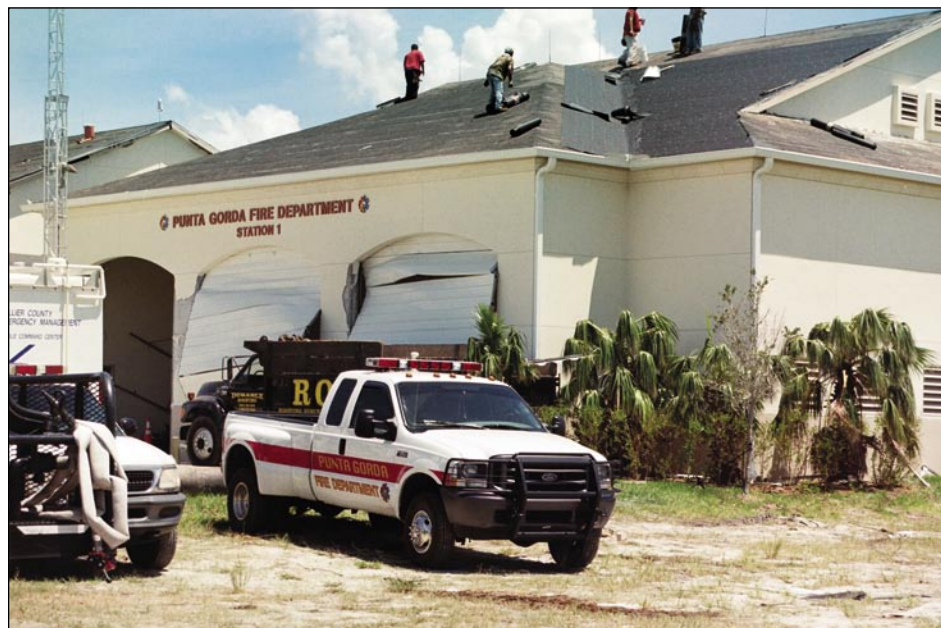
Fort Meade Fire Station	Tile roof covering loss and damage		
Punta Gorda: Fire Station No. 1 and Public Safety Complex  2002	Tile roof covering loss and damage. See Figure 6-6.		Soffit damage and failures. See Figure 6-7. Damage to rolling and sectional doors at several bays.
Punta Gorda: Aquí Esta Fire Station  2000	Minor damage to V-crimp metal roof panel system. Observed damage was noted at a hip lap.		Minor damage to V-crimp metal roof panel system. Observed damage was noted at a hip lap.
Port Charlotte: Charlotte County Fire and EMS Station No. 7  1976	Asphalt roof shingles failed across roof. Some covering loss was initiated due to gable end wall failure; however, other shingle loss was due to poor installation of shingles with staples, some observed to be at 45 degree angle to shingles.	Damage at gable included loss of wood panel roof decking	The two bay doors were in-place, but damaged. The rear bay door was blown into the apparatus bay and one personnel door was suctioned off the building. Window breakage and damage to perforated soffit was observed.

Figure 6-6.  
Overview of Punta Gorda Fire Station No. 1. The tile roof had been removed and a new roof was being installed. Note the damaged doors.

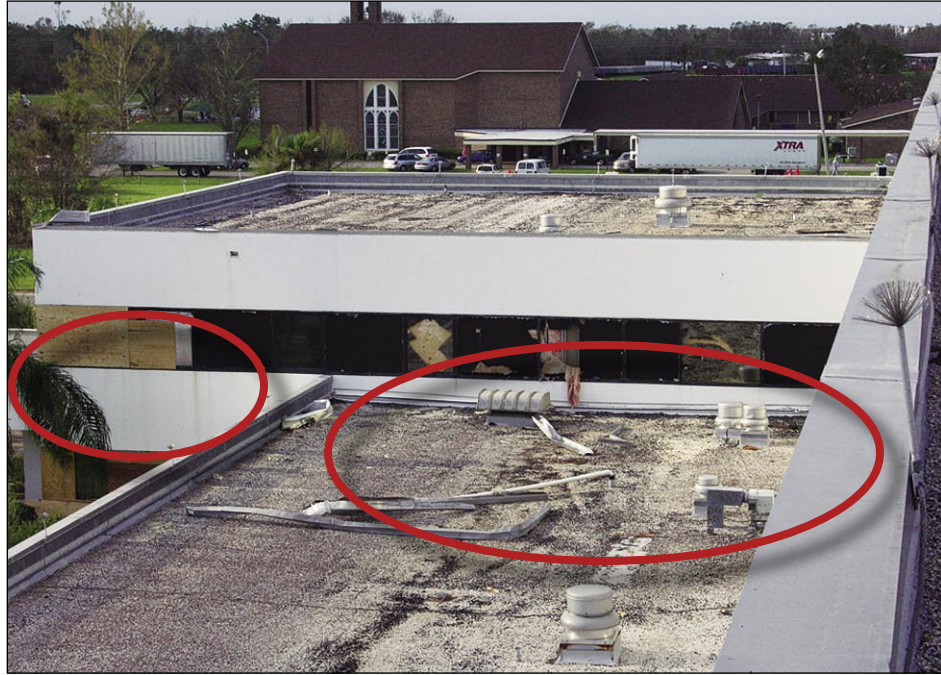
**Figure 6-8.**  
Aggregate damaged the windows to ICU rooms at a hospital (Arcadia)

The gutters lying on the lower roof in Figure 6-8 came from the right side of the upper roof and may have caused some of the glass breakage. However, the majority of the damage was broken by flying aggregate from the hospital's BURs.

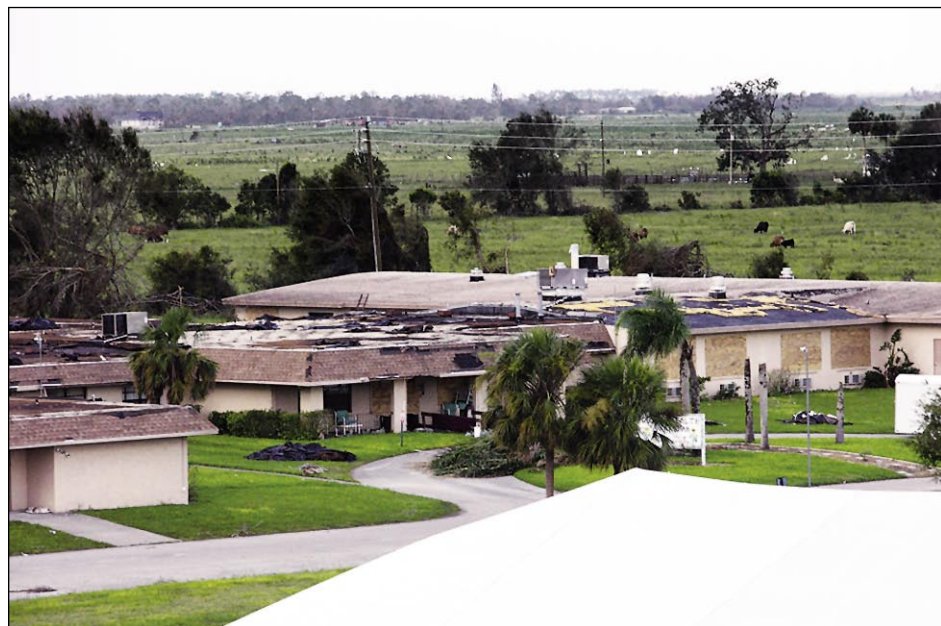
**Figure 6-9.**  
Roof covering damage resulting in water intrusion, which required evacuation of a skilled nursing facility (Arcadia)

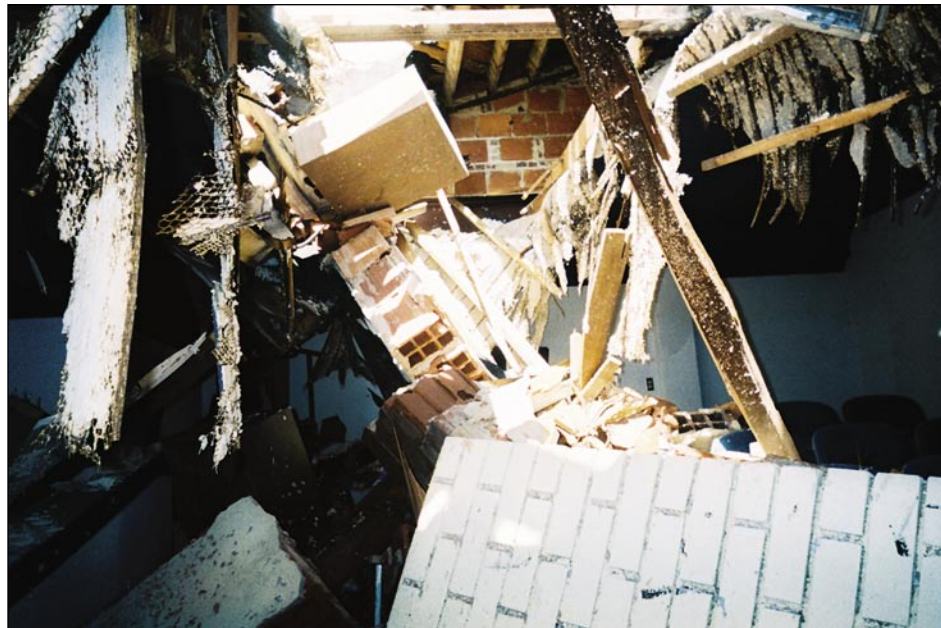
Damages to structural walls of schools evaluated by the MAT were limited to a few older buildings with walls or parapets constructed of URM or hollow clay tile. At one high school, the collapse of hollow clay tile walls and URM parapets caused extensive damage (Figures 6-10 and 6-11). Most exterior wall surfaces observed at school buildings did not suffer significant damage.

Figure 6-10.  
Hollow clay tile wall/  
parapet damage to  
roof of a high school  
auditorium (Punta Gorda)

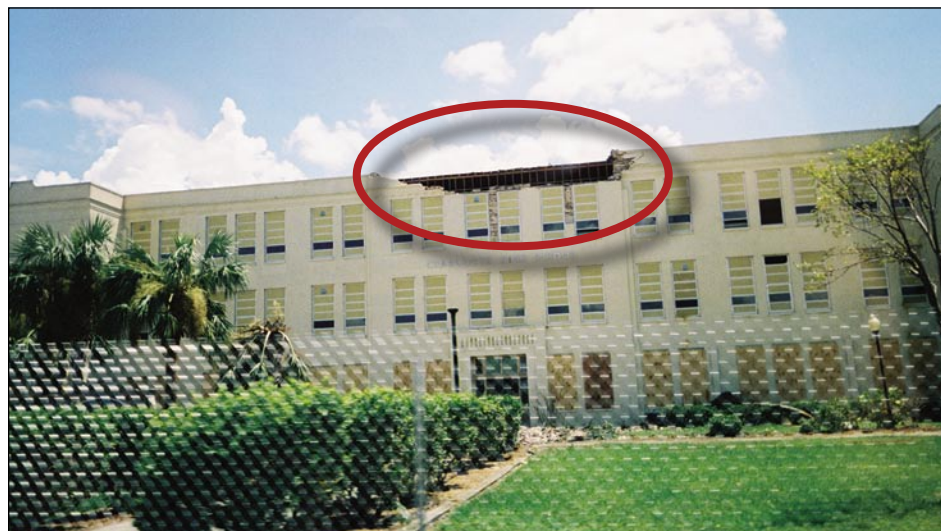
Figure 6-11.  
URM parapet damage  
to front façade of a high  
school (Punta Gorda)

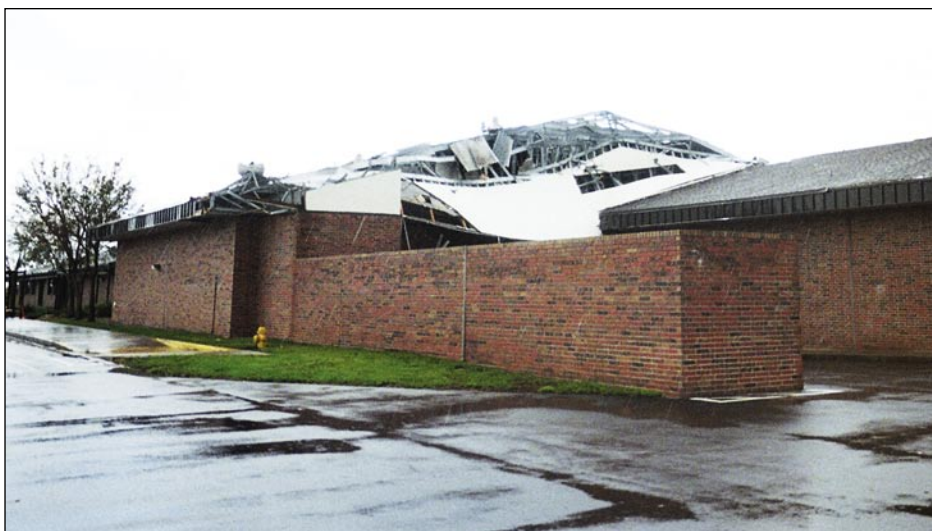
Damages to roof framing systems at schools occurred at large, gable end roofs with light-metal trusses where the gable end was pushed into the building due to inadequate lateral bracing and collapsed (Figure 6-12). A few plywood and OSB roof sheathing damages were also encountered along the edges and at the corners of older school buildings. Roof coverings and soffits were the most commonly damaged elements of school buildings evaluated by the MAT. Typical roof covering damages included loss of roof membrane systems due to inadequate connection to the roof deck, loss of edge flashing or coping,

Figure 6-12.  
Collapsed gable end wall  
at an elementary school  
(Deep Creek)

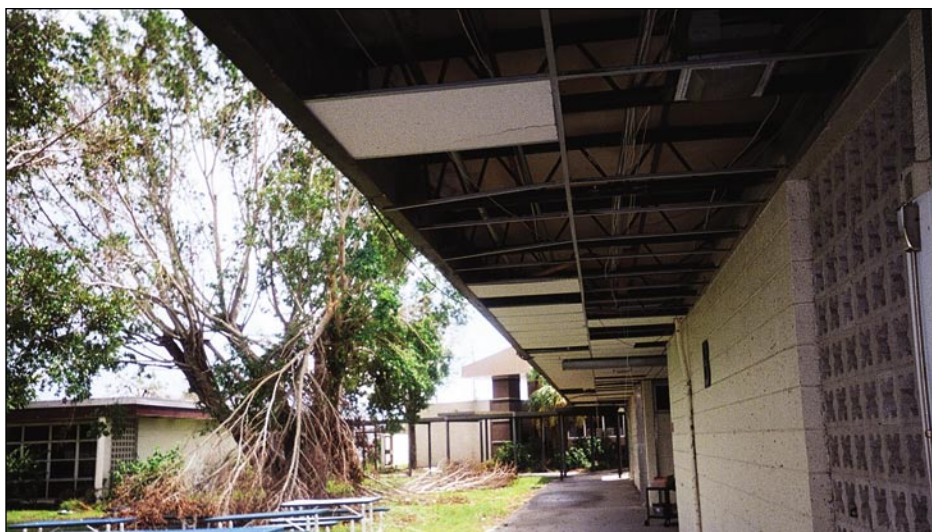
or tearing of the membrane from debris impact. Metal roof coverings were lost or damaged due to inadequate connections or a loss of the edge flashing. Thin metal panel soffits and lightweight composite panel overhangs (which functioned as soffits) were often lost due to inadequate connections or excessive deflections caused by wind pressures along the edges and corners of the building (Figure 6-13).

Figure 6-13.  
Loss of lightweight  
composite panel  
overhang at an  
elementary school  
(Charlotte Harbor)

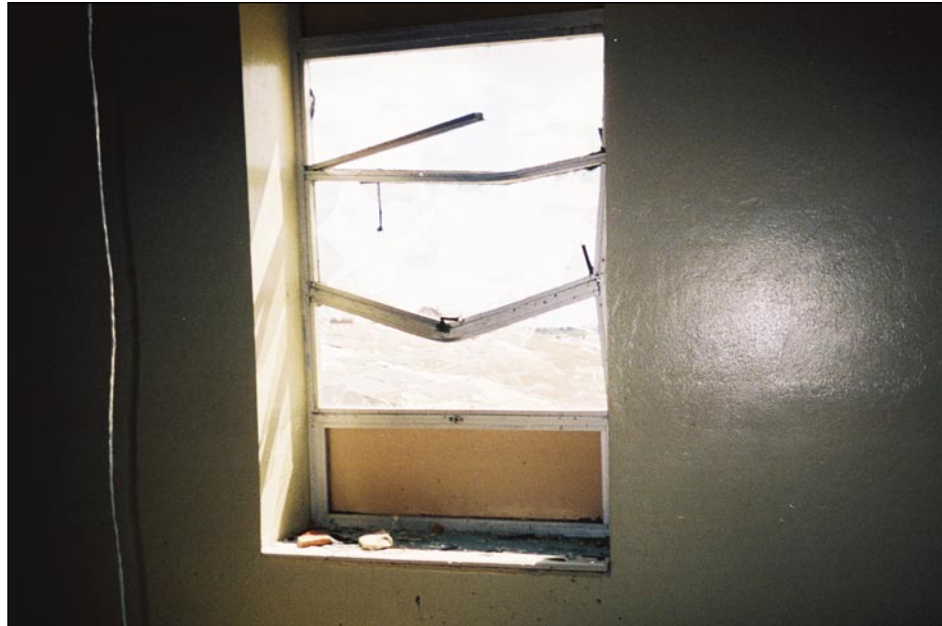
A few single and double metal entry doors in school buildings evaluated by the MAT were damaged due to inadequate locks or door frames that were not properly connected to the walls, which caused the doors to blow open or out during the storm. Some metal-framed windows constructed with annealed glass panes were broken due to debris impact and/or bending of the frames that supported the panels (Figure 6-14).

**Figure 6-14.**  
Broken window damage  
at a high school (Punta  
Gorda)

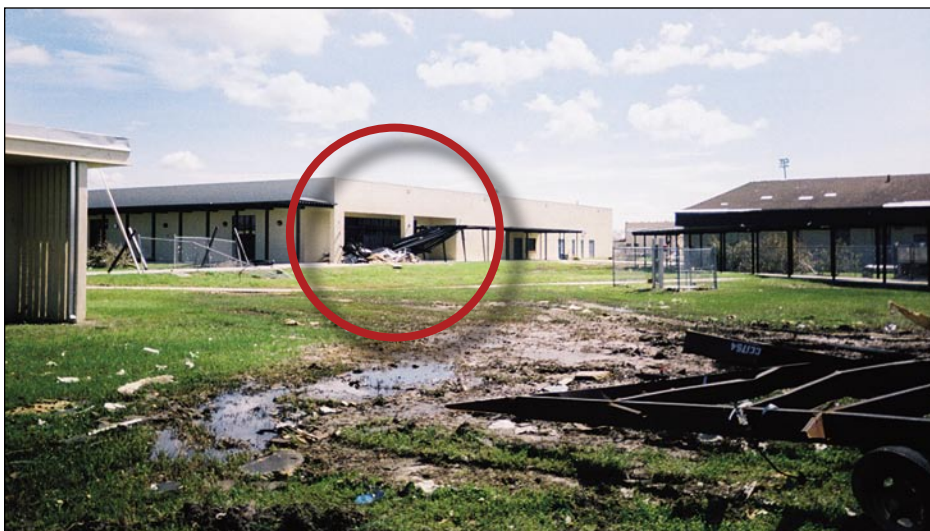
Many school buildings evaluated by the MAT suffered damage or collapse of metal awnings and walkway canopies, typically due to inadequate anchorage of the roof sheathing or the posts that supported the awnings and canopies (Figure 6-15). Several portable classrooms were damaged by debris impact or destroyed, presumably due to inadequate foundation anchorage (Figure 6-16). Some sections of chain-link fencing collapsed due to wind-blown debris that accumulated. A few pre-stressed concrete light poles at school athletic facilities were cracked or snapped due to inadequate steel shear ties.

Figure 6-15.  
Collapsed metal walkway  
canopy at a high school  
(Punta Gorda)

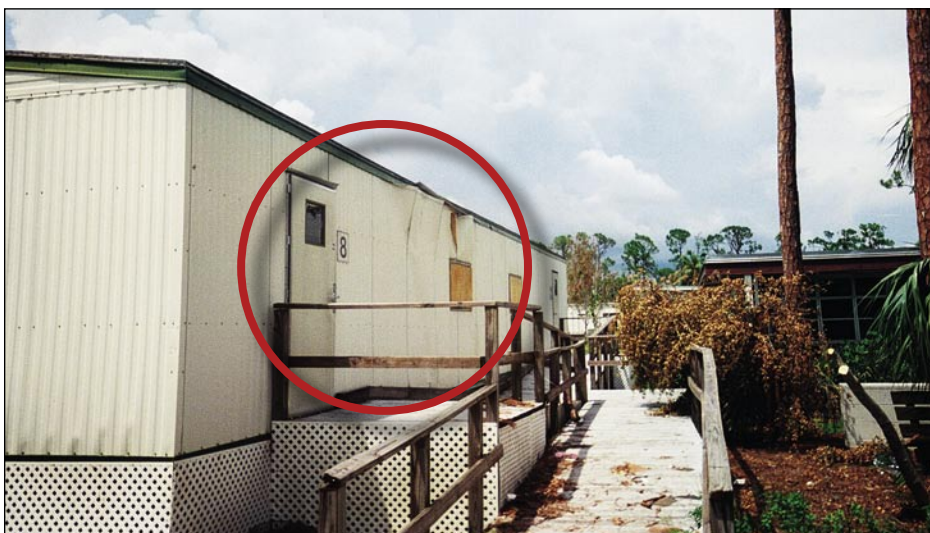
Figure 6-16.  
Damaged portable  
classroom unit at an  
elementary school  
(Charlotte Harbor)

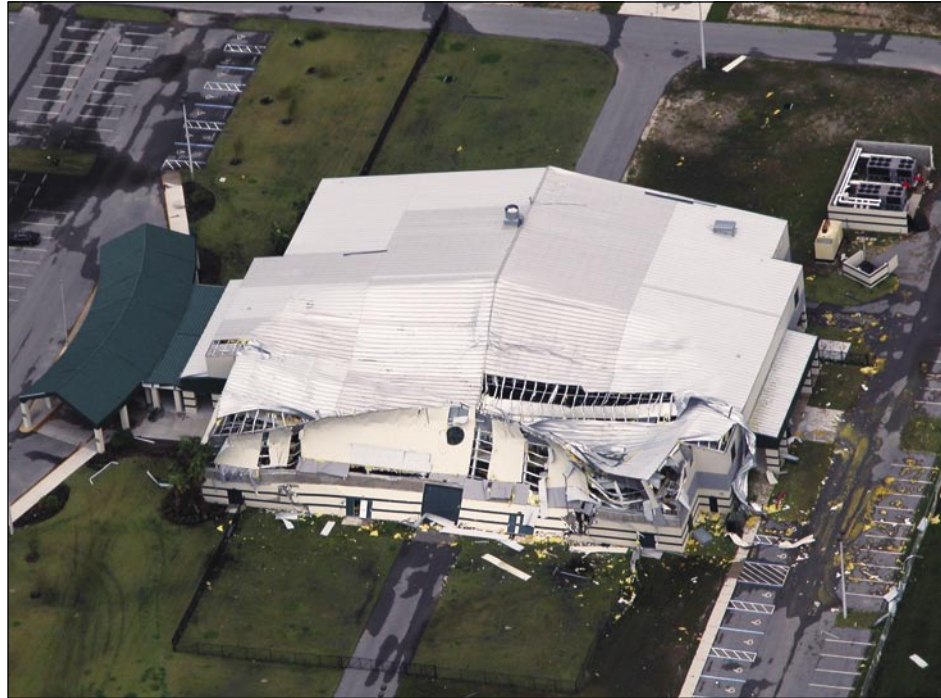
**Figure 6-17.**  
Aerial view of Turner  
Agri-Civic Center damage  
caused by Hurricane  
Charley (Arcadia)

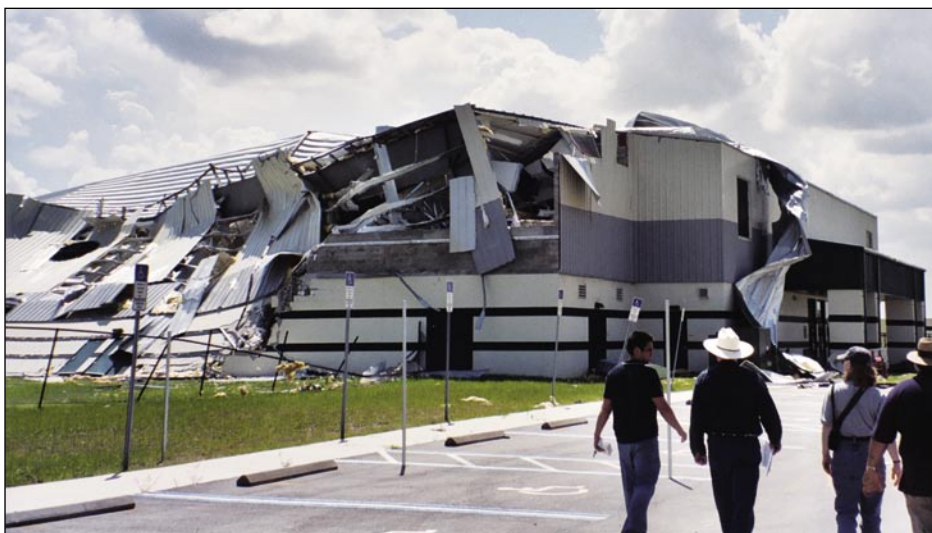
This building experienced damage to the cladding systems (evident at numerous places where panels were missing) and in the structural frame, which partially collapsed at one end of the facility. The MAT's inspection of the damage noted that, for the roof, the failure of the plane of the roof system was typically a separation of the two-piece clip that connected the panels to the purlins. A few clips were observed that were still intact, with clip screws pulled from the purlins. In addition, metal panels were observed to be missing from the soffit at

the entry canopy. The on-site representative meeting with the MAT reported that the roof panels were lifting off the frame prior to the collapse of the end wall.

Figure 6-18.  
End wall failure at  
Turner Agri-Civic Center  
(Arcadia)

Structurally, purlin spacing was observed to be the same at the perimeter, corners, and field of the roof. The roof structure was braced with rod x-braces. No roof bracing was observed at gable end walls or in the direction of the long, steel frames. Reinforced masonry walls at one end wall failed. The MAT observed reinforcing in the masonry end wall that failed, but insufficient information was available to determine if the construction was compliant with the applicable building code.

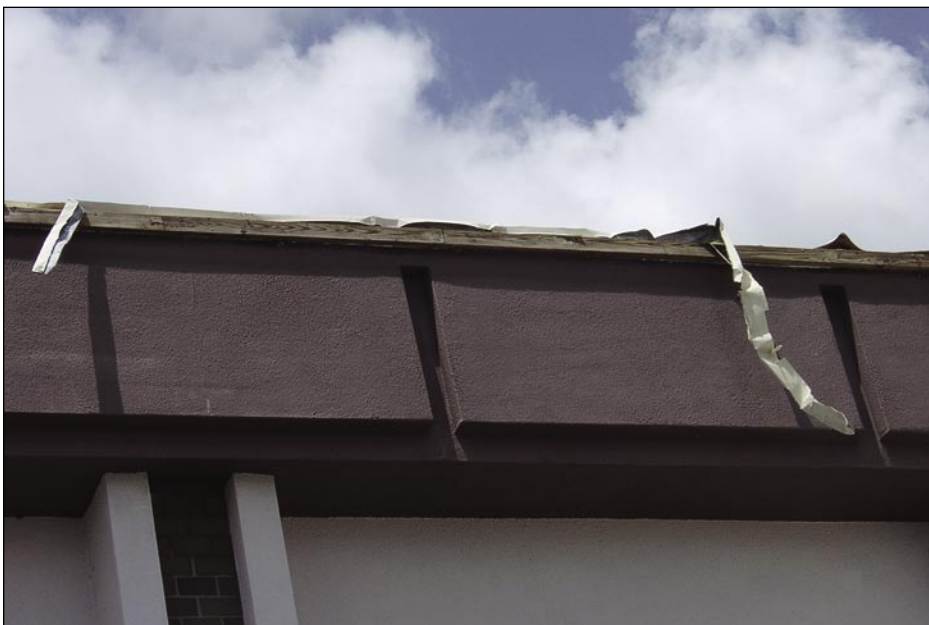
During the MAT assessment, no structural damage was observed and minimal damage was observed on the designated shelter areas of the facility. However, roof covering and exterior wall, trim, and coping damage was observed at the school (Figure 6-22). Damage to mechanically attached single-ply membrane roof coverings occurred on the gymnasium roof and one of two lower roof areas adjacent to the gymnasium (see Section 5.3 for further discussion). It is important to note that the gymnasium was not identified as usable shelter space and was not being used for shelter during the height of the storm.

Figure 6-22.  
Edge flashing failure at  
Port Charlotte Middle  
School

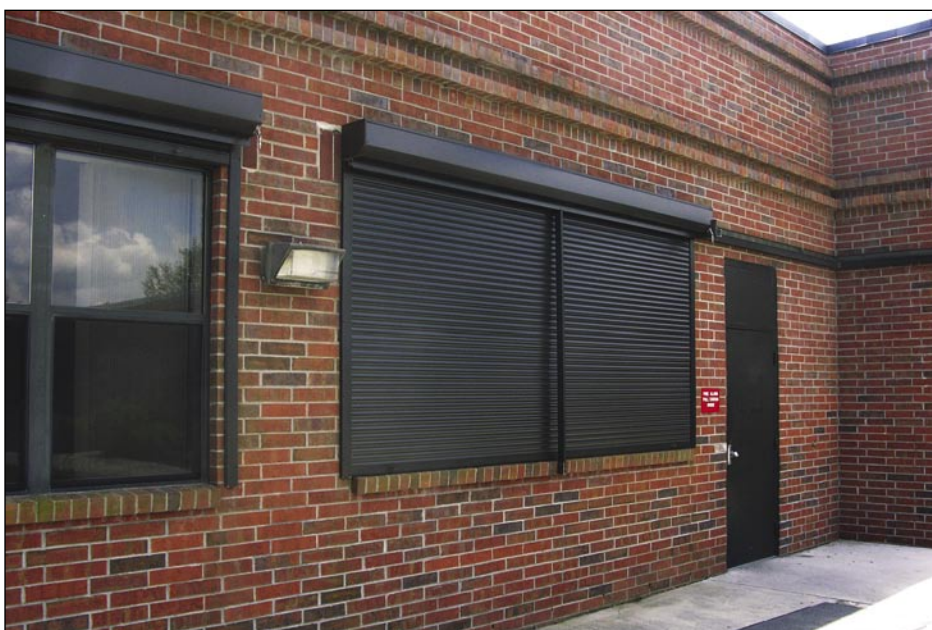
Some areas of the school have been retrofitted with shutters to protect windows from windborne debris. The shutters are roll-down, permanently installed systems that protect the windows during hurricanes. Although these shutters were not in place throughout the facility, they were placed on areas of the school that were identified for use as shelters. Figure 6-24 shows an example of a shutter system at the shelter area.

**Figure 6-24.**  
Shutters installed at openings at Liberty Elementary School shelter area (Port Charlotte)
