# Mitigation Assessment Team Report on **Hurricane Ike**

## Mitigation Assessment Team Report **Hurricane Ike in Texas and Louisiana**

Building Performance Observations, Recommendations,  
and Technical Guidance

FEMA P-757 / April 2009 / NHC 2009 Release

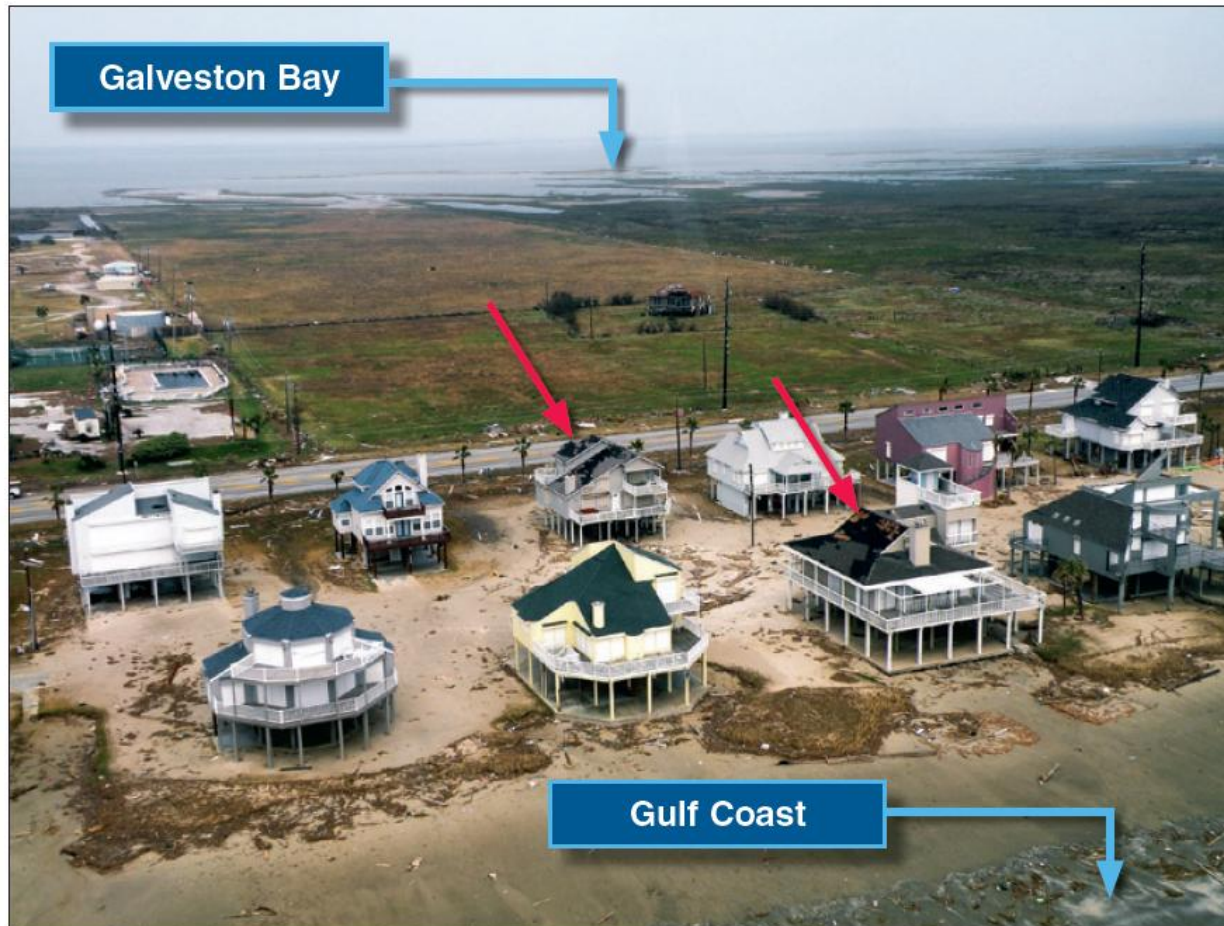
- Chambers County experiences highest wind speeds
- Hurricane force winds continue to hammer the north and east sides of the Galveston West Bay
- Backside winds produced West Bay home damage

# Damage produce by Backside Winds

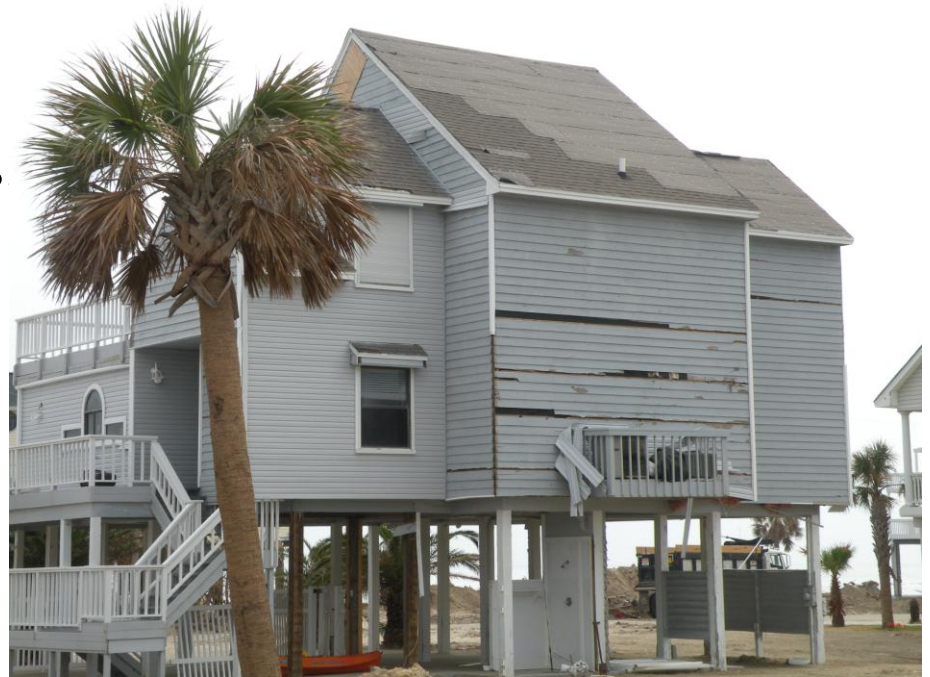
- Shingle loss varied from a few shingles to whole roofs
- TDI currently allows Class F shingles (ASTM D 3161 rated at 110 mph) for all wind zones – 110, 120, & 130 mph.

- TDI should only allow ASTM D 7158 rated shingles:
  - Class D – 90 mph rating
  - Class G – 120 mph rating
  - Class H – 150 mph rating
- Manufacturers should provide Class labeling on the backside of shingles

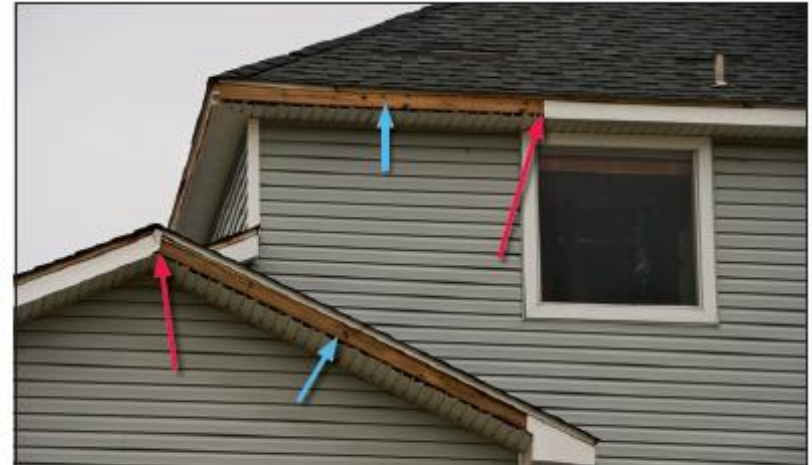
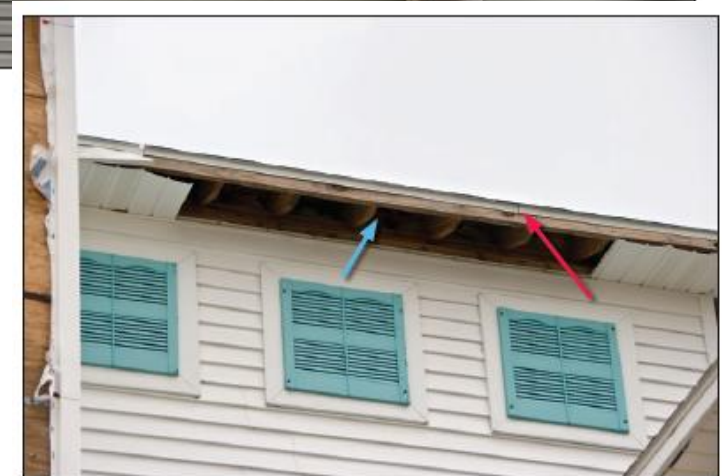
- Failures of aluminum fascia covers and vinyl and fiber cement soffits were frequently observed.
- TDI and Inspectors should ensure that high wind zone products and installation methods are used.

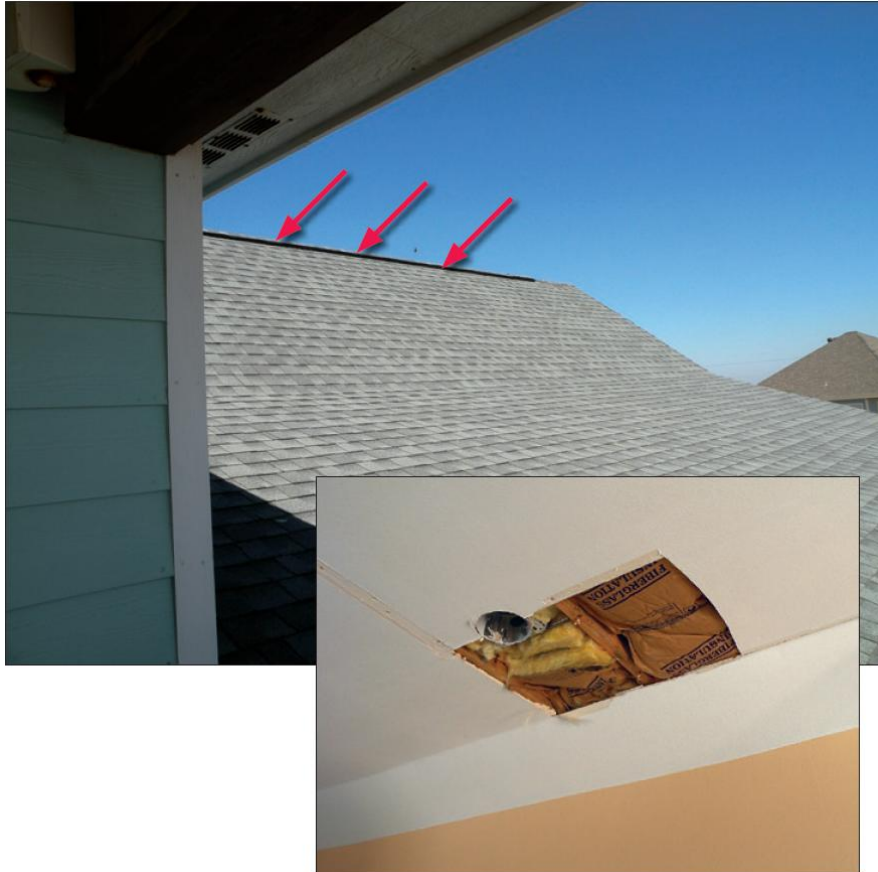
- Observed failures included:
  - Continuous roof ridge vents.
  - Gable end vents.

- Recommendations:
  - Continuous roof ridge vents frequently allows the infiltration of water into the attic and should not be allowed by TDI
  - Gable end vents should be properly connected to the structure and shuttered.

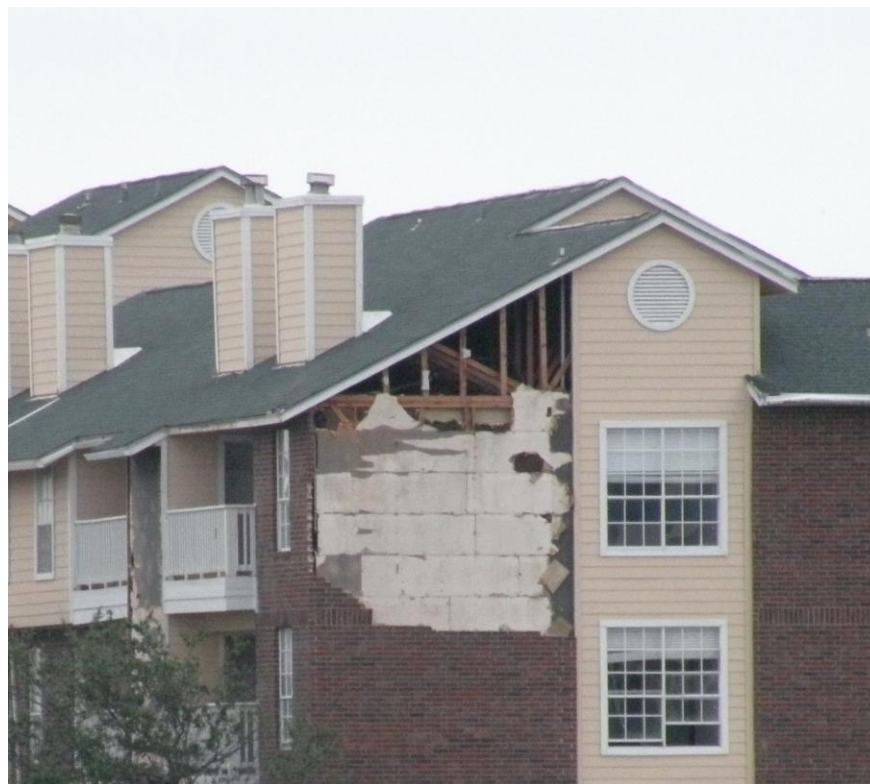
- Sheathing failures are routinely the result of :
  - Internal and external pressures
  - Installations not consistent for high wind zones
  - Poor connection to the building structure

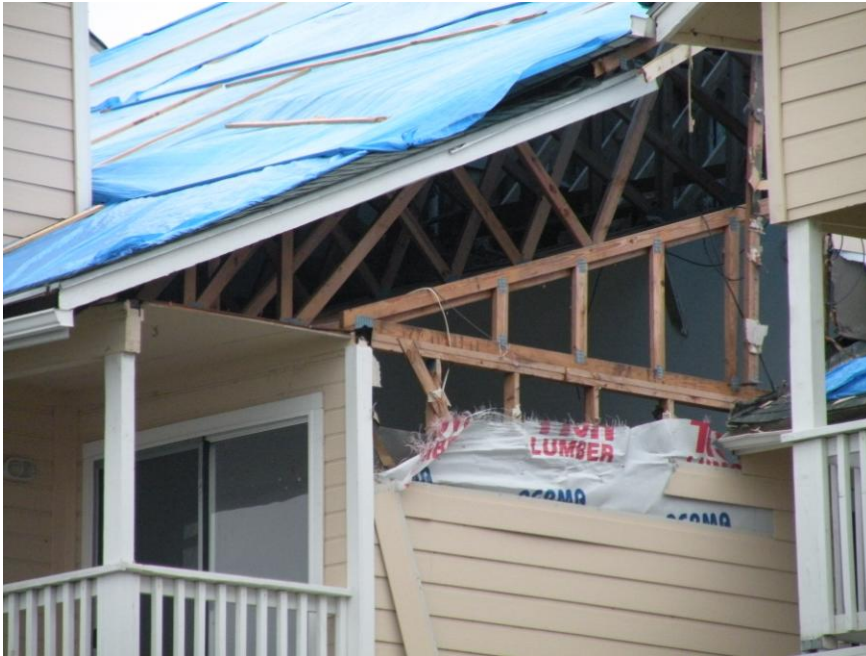
# Building Sheathing Failures

- It is recommended that TDI require that exterior wall substrates be fully sheathed with plywood or OSB sheathing.

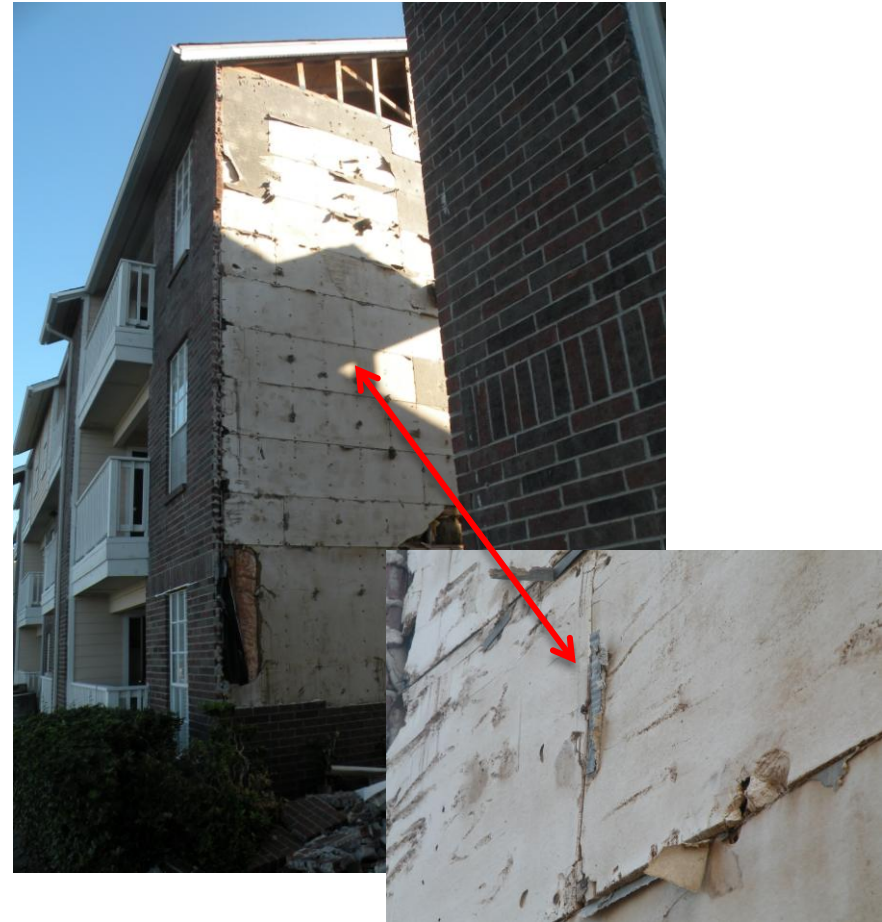
- Brick veneer failures were the result of:
  - Corroded brick ties.
  - Improper or no tie embedments.
  - Tie spacing non-compliant for high wind zone installations.

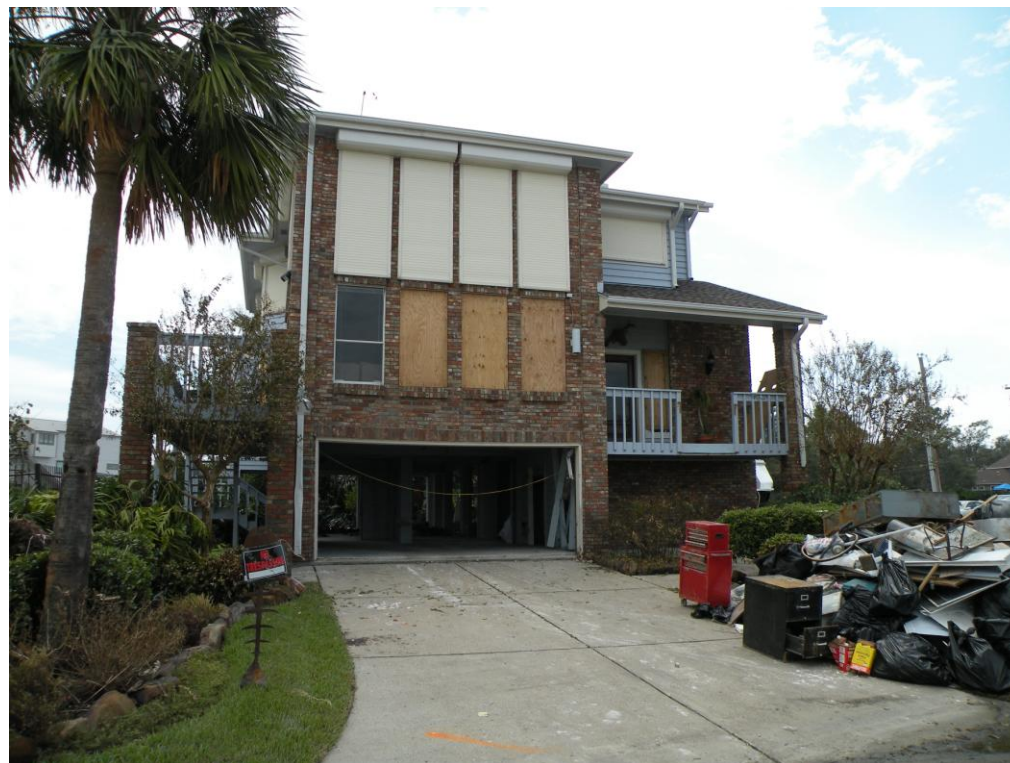
- Shutter performance varied from:
  - Excellent
  - Only installed on the windward face
  - Not attached to the building structure
  - Non-existent

- ASCE 7-05/2003 IRC require opening protection within 1 mile of the coastal mean high water line where wind speeds are 110 mph or greater.
- TDI requires opening protection only in the Seaward (130 mph) and Inland I (120 mph) zones.
- It is recommended that TDI include the 1 mile portion of the Inland II wind zone (110 mph) in its windborne debris protection requirement.

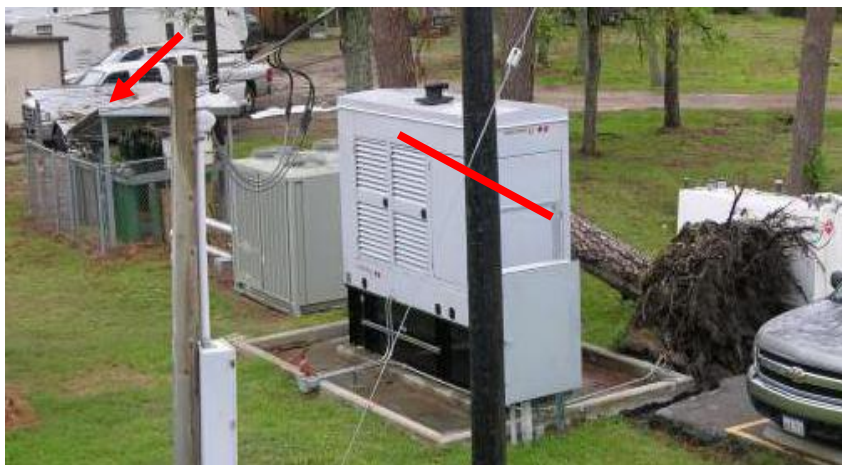
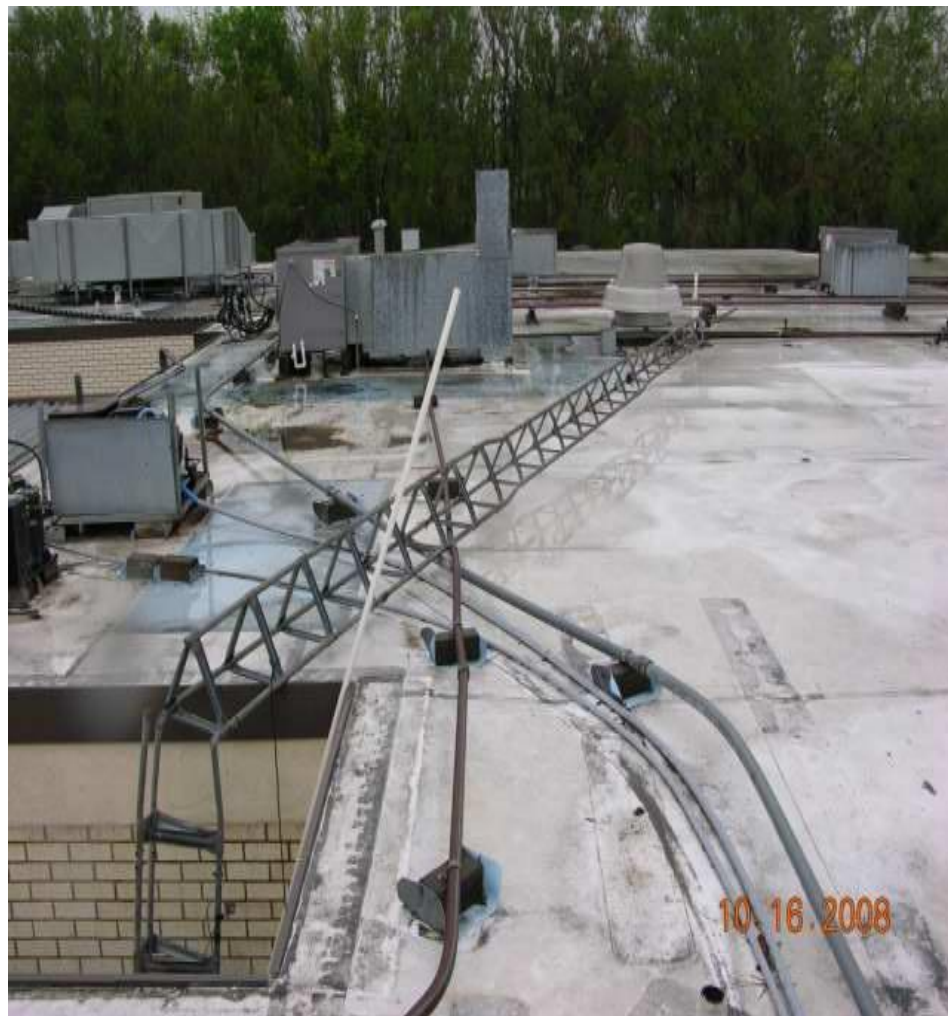
- Observation: Most critical facilities had wind vulnerabilities -- some were significant

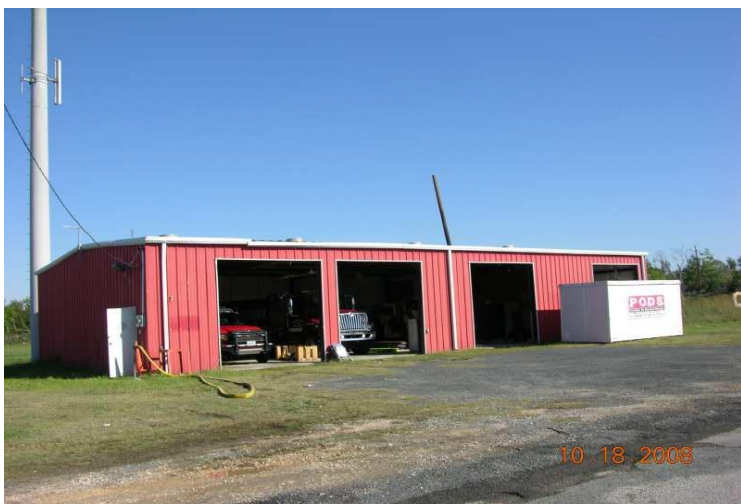
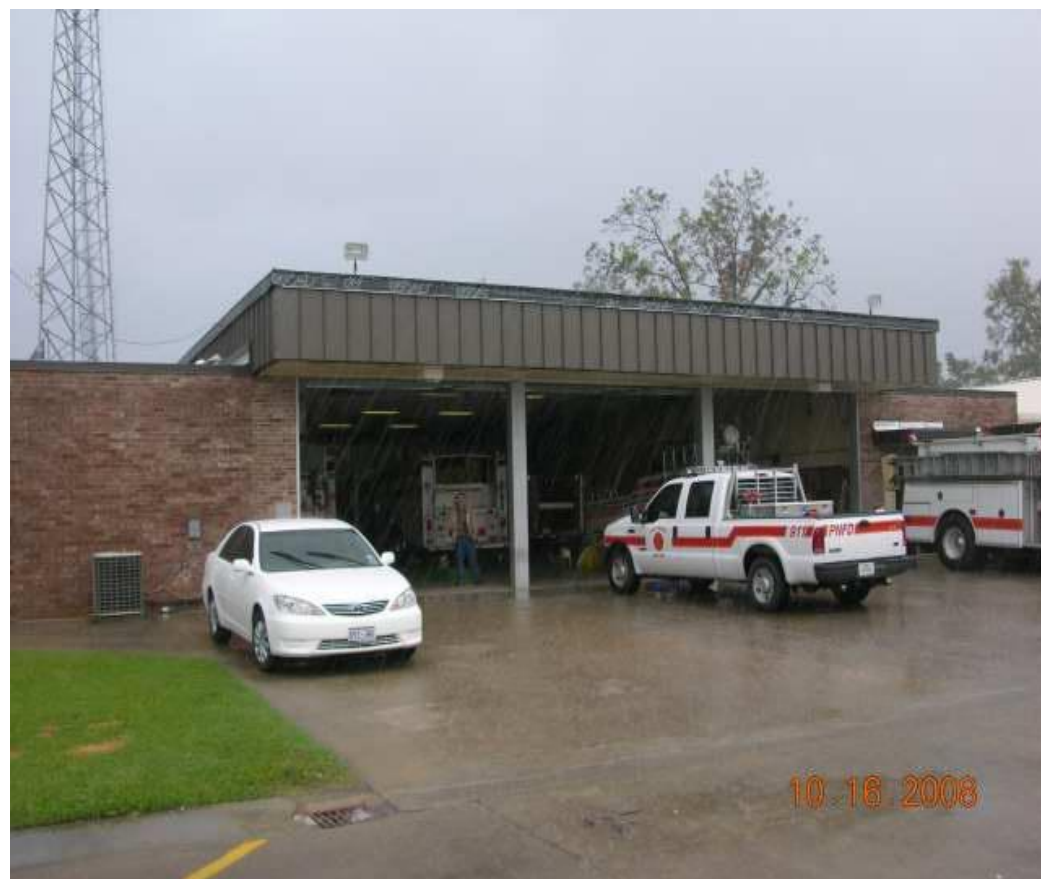
- Observation: Mitigated projects not sufficiently robust and/or not sufficiently comprehensive
