**Investigation of  
October 20-27, 1983 Blowout,  
Eugene Island Block 10,  
Lease OCS-G 289.2 Gulf of Mexico**

**Maurice Stewart  
Jack Hendricks  
Robert Whitaker  
Robert Meurer  
Ronald Prehoda**

1985

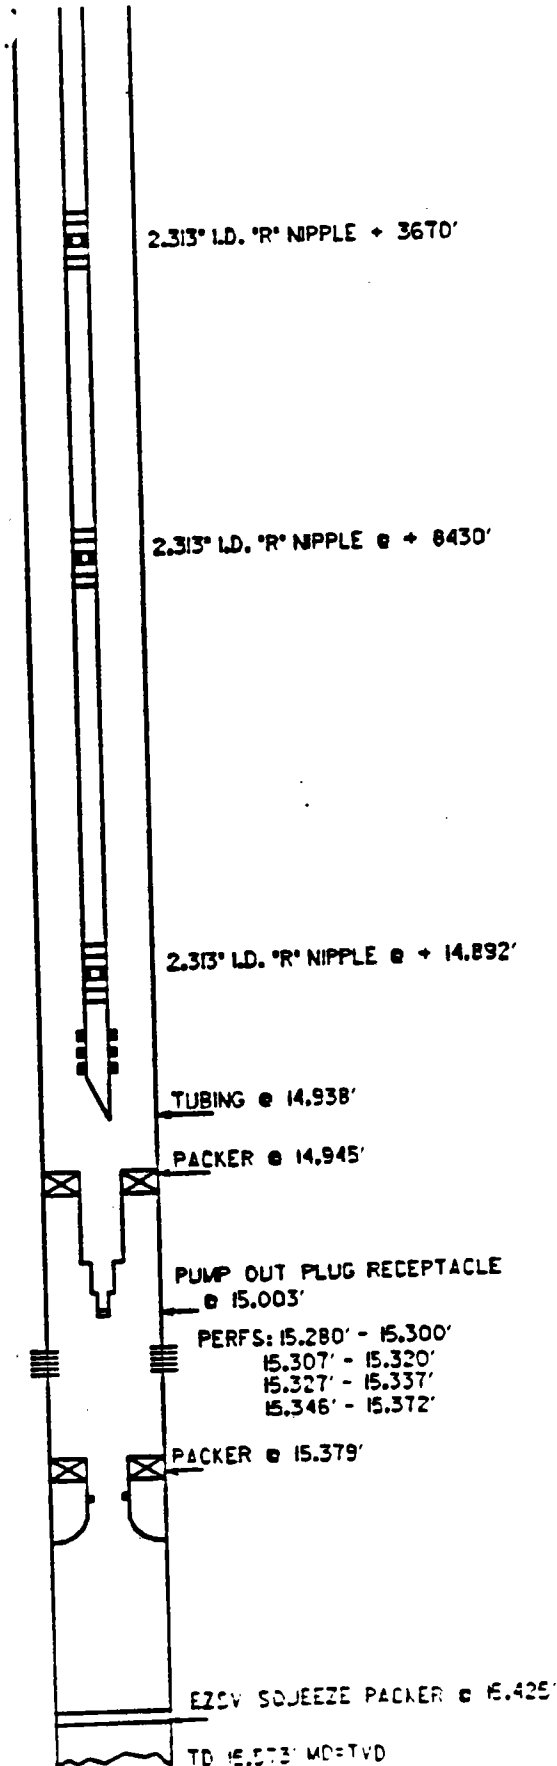
DOWNHOLE EQUIPMENT ARRANGEMENT  
AT TIME OF LOSS OF CONTROL

The tubing string was picked up to approximately 7 feet above the packer, to the depth of 14,938 feet (See Attachment No. 3). Displacement of the

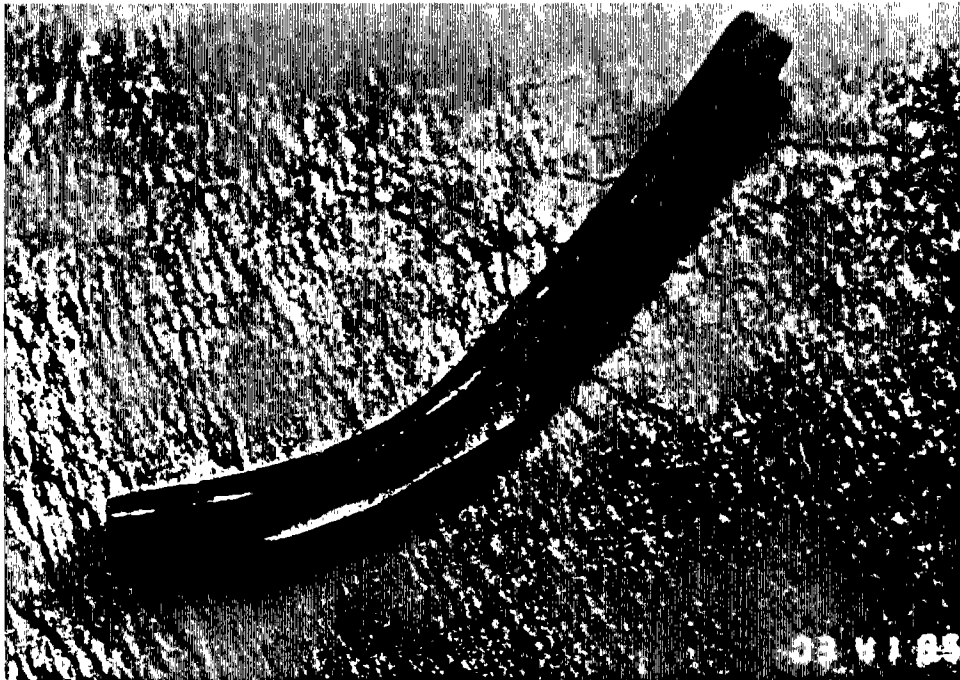
2. Part of a teflon CB ring apparently wedged between the ball and the seal of the TIW safety valve, jamming the valve and preventing it from closing. The wedged CB ring fragment also caused a misalignment of the TIW valve actuator stem, which allowed gas to escape past the O-ring of the stem, thus flow-cutting the valve and resulting in uncontrolled flow from the well (See Attachment No. 7).

CB ring fragment found in the valve (2.5X).

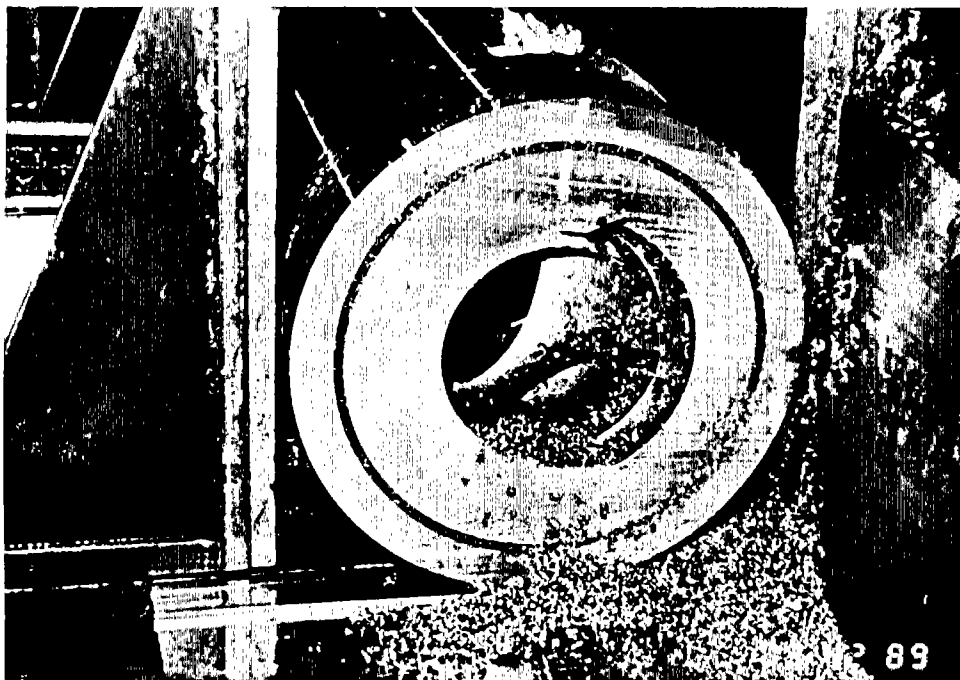
Valve immediately after sectioning.

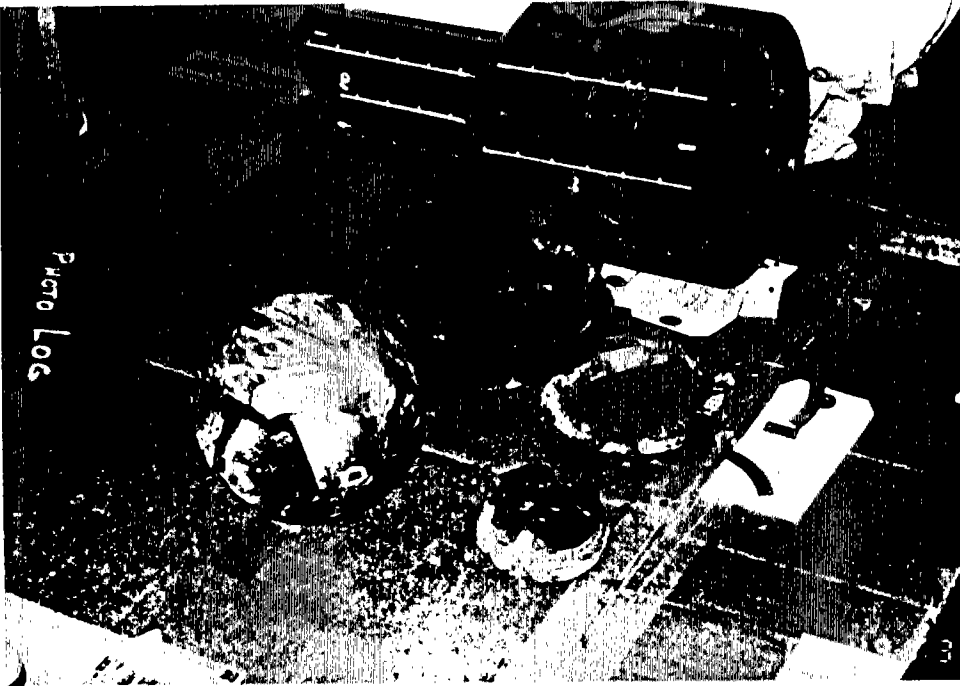
Valve components after sectioning.
