Investigation of November 10, 1986 Blowout and Fire OCS Lease 0244 West Cameron Block 71

Gulf of Mexico
off the Louisiana Coast

J. L. Guidry
P. McDonald
S. J. Patkowski
C. J. Schoennagel
B. R. Stewart

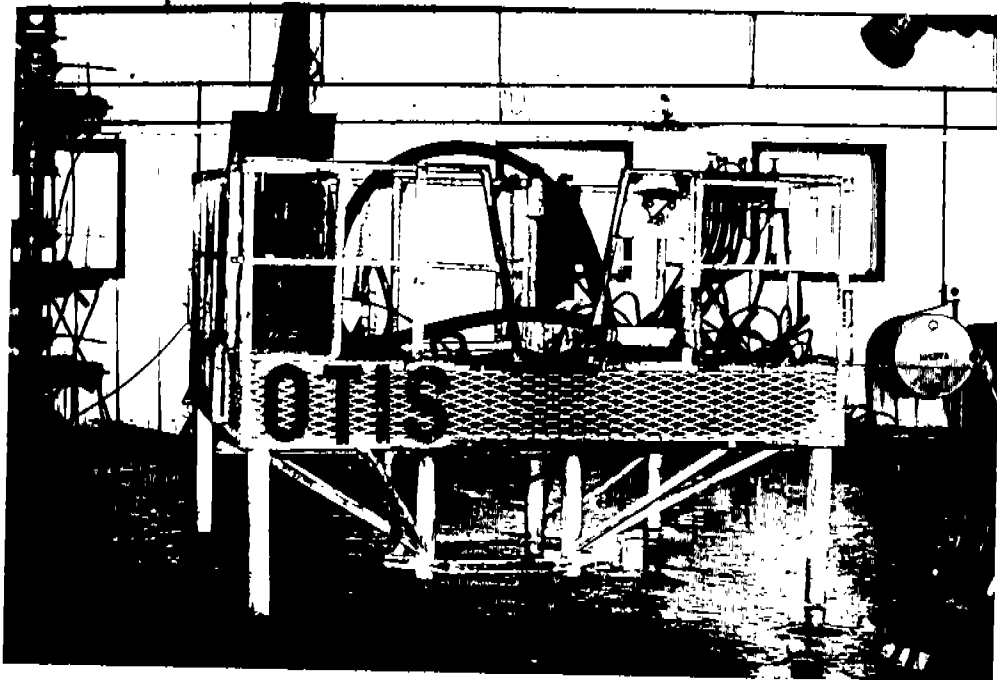
The personnel in the workbasket were blown out by the force of the blowout and fire. If they had not been blown out, escape from the workbasket would have been difficult because the ladder leading from the workbasket passed the window where the fire was located.

Workbasket

2. Lessees and contractors should review possible alternative means of escape from the workbasket in the event of a fire that renders the normal exit impassable.
