OCS REPORT
MMS 86-0006

**Investigation of January 6, 1984, Flash Fire
Ship Shoal Block 269
Gulf of Mexico,
Off The Louisiana Coast**

February 1986

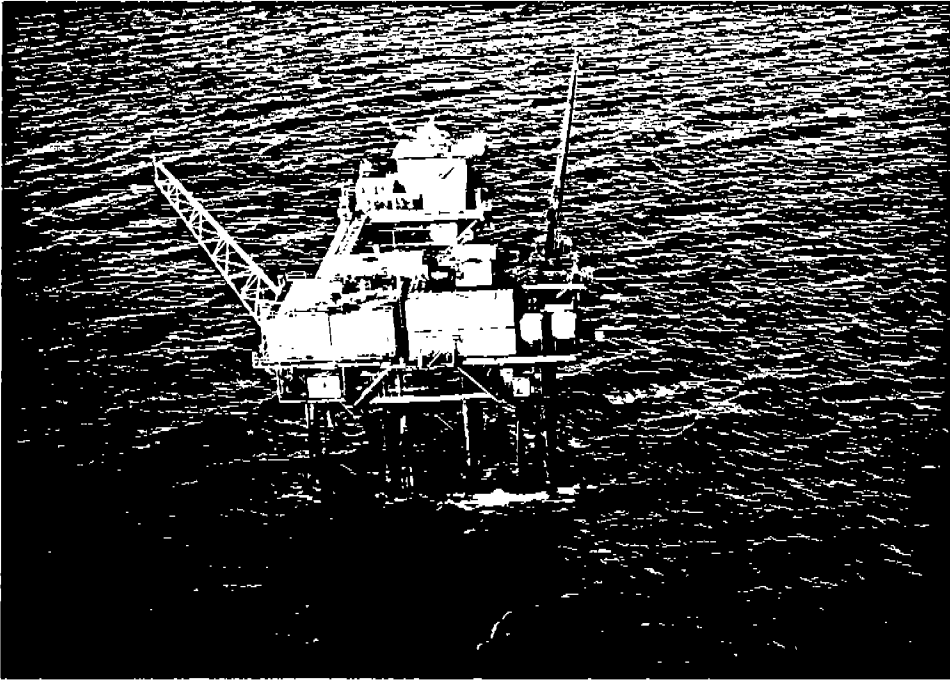
Photograph No. 1

The photographs of the facilities are included in Attachment 4. Photographs 1 and 2 show the position of Platforms A and A-Auxiliary, and the connecting walkway in relation to each other. In photographs 1 and 4, one can see the general area where the fire occurred. Photograph 3 shows the stair landing to the living quarters, where the welder was working at the time of the fire.

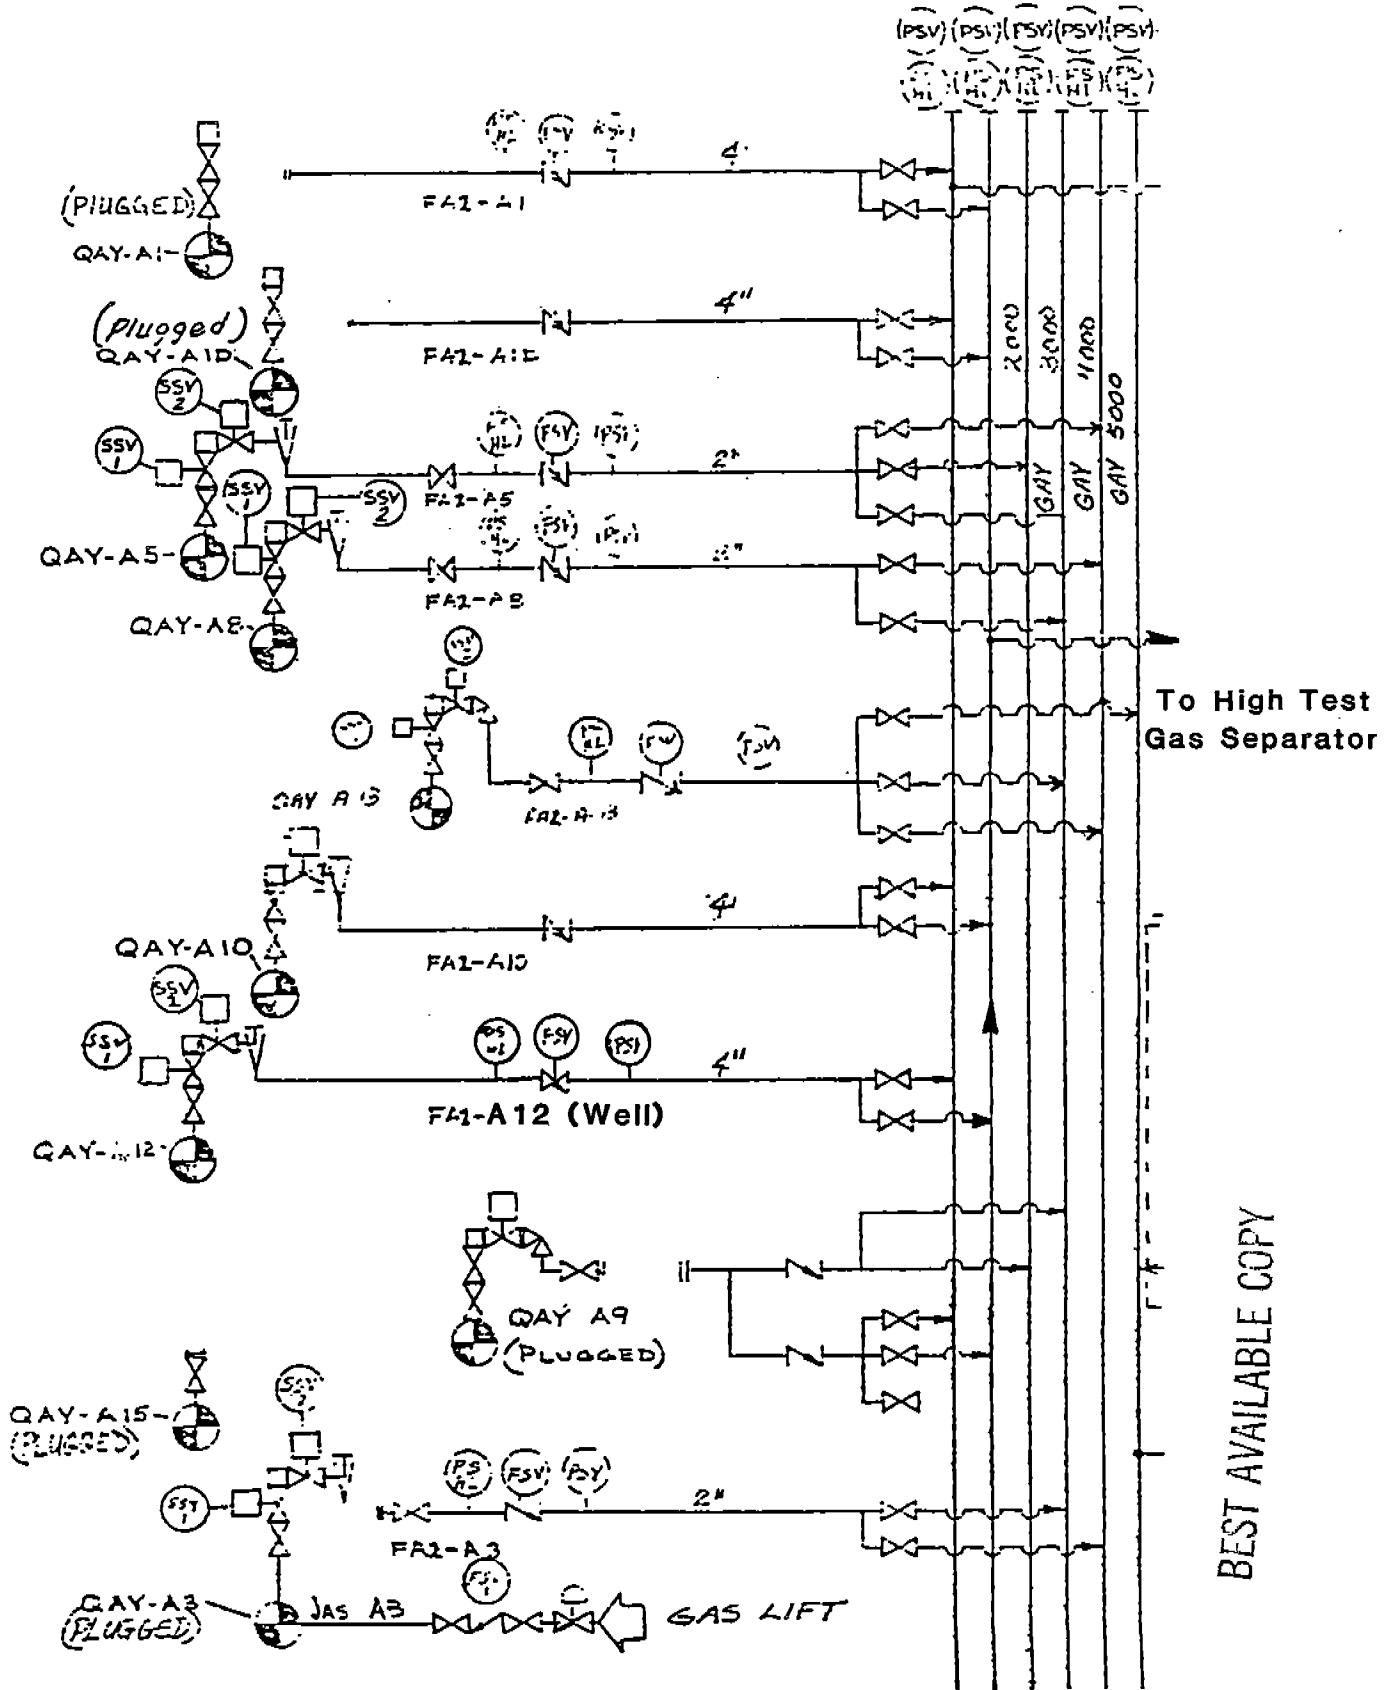
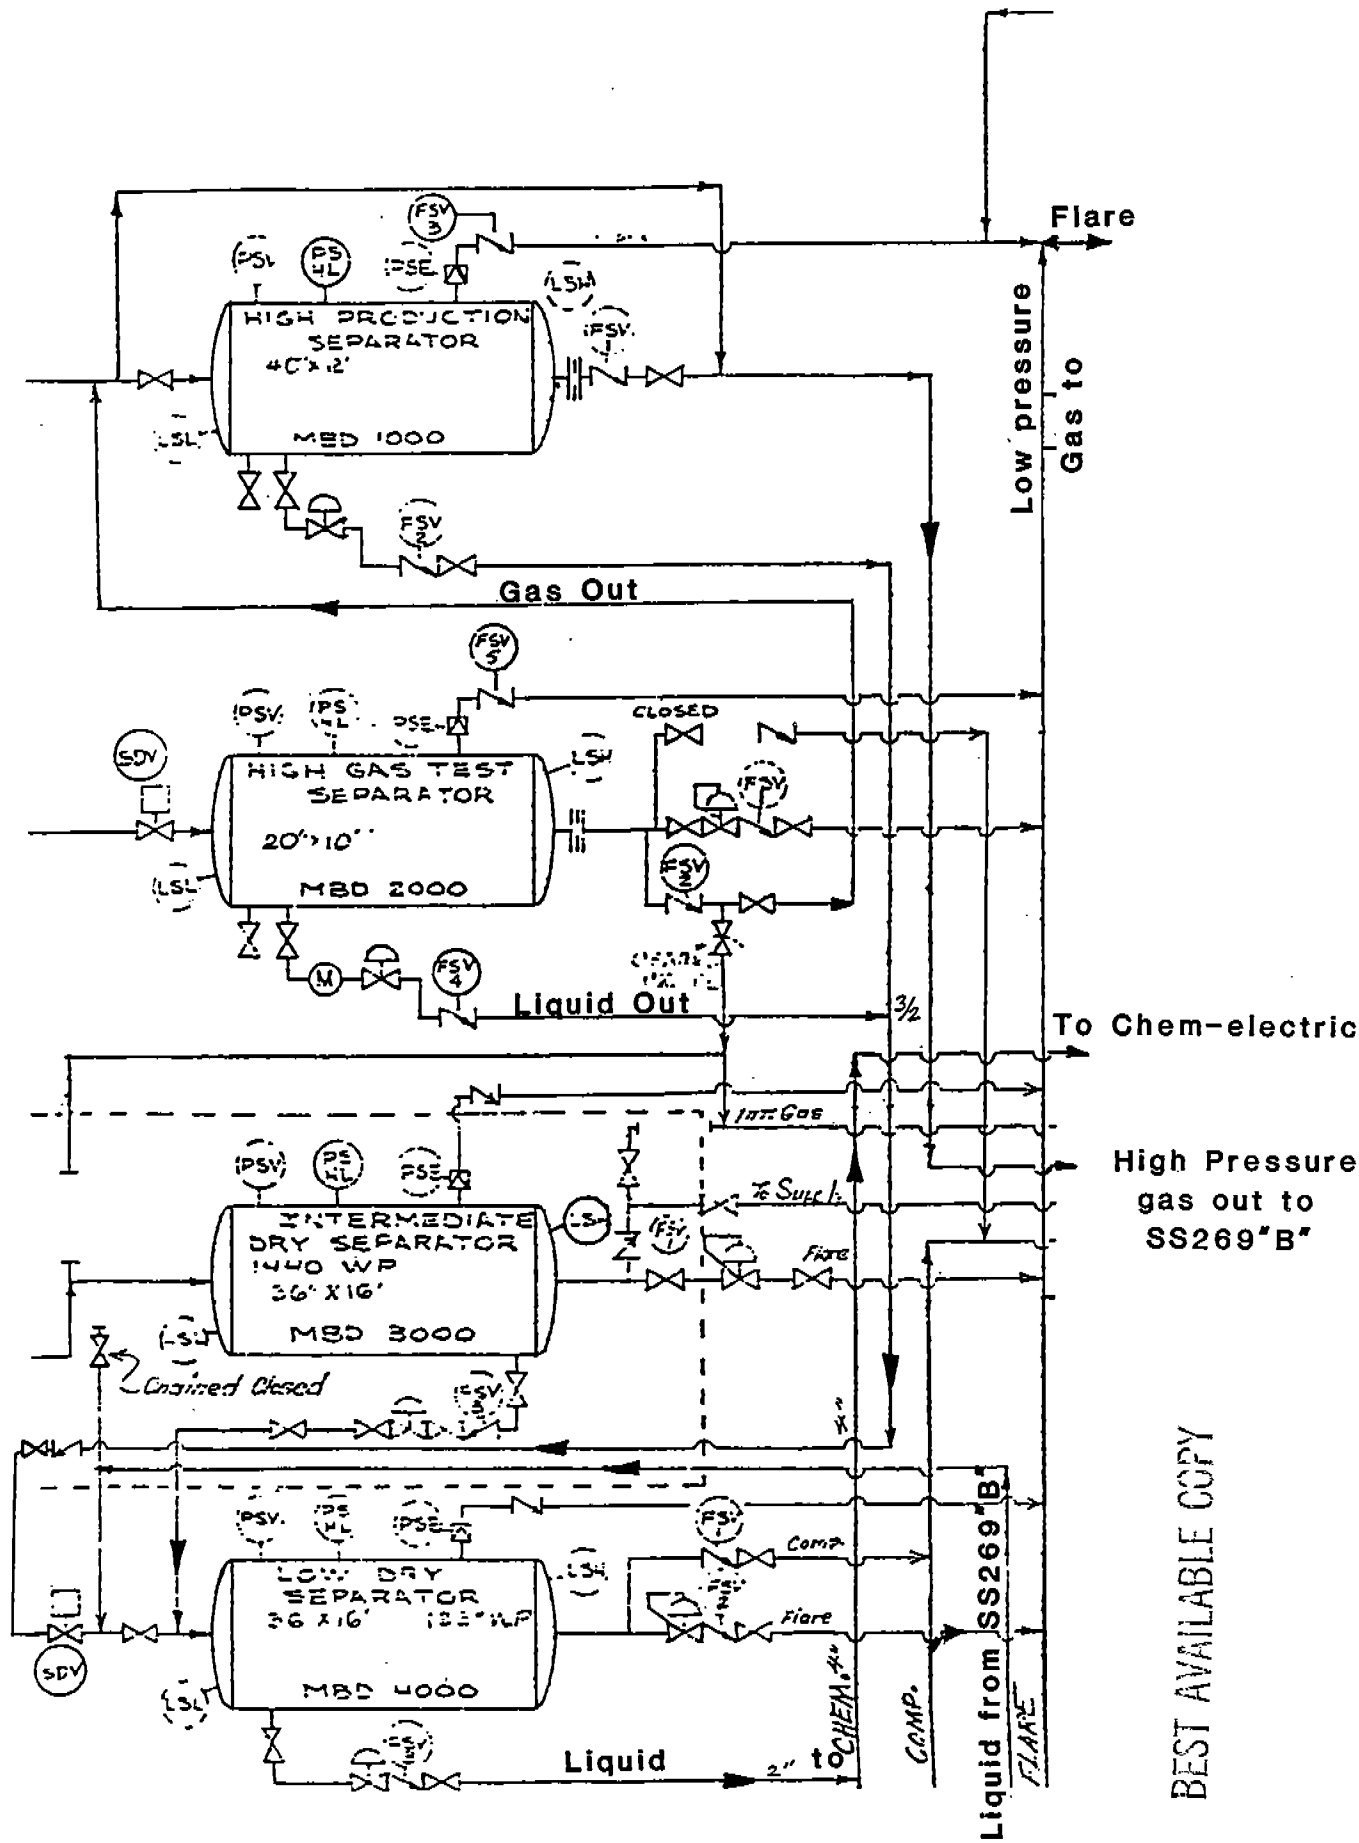
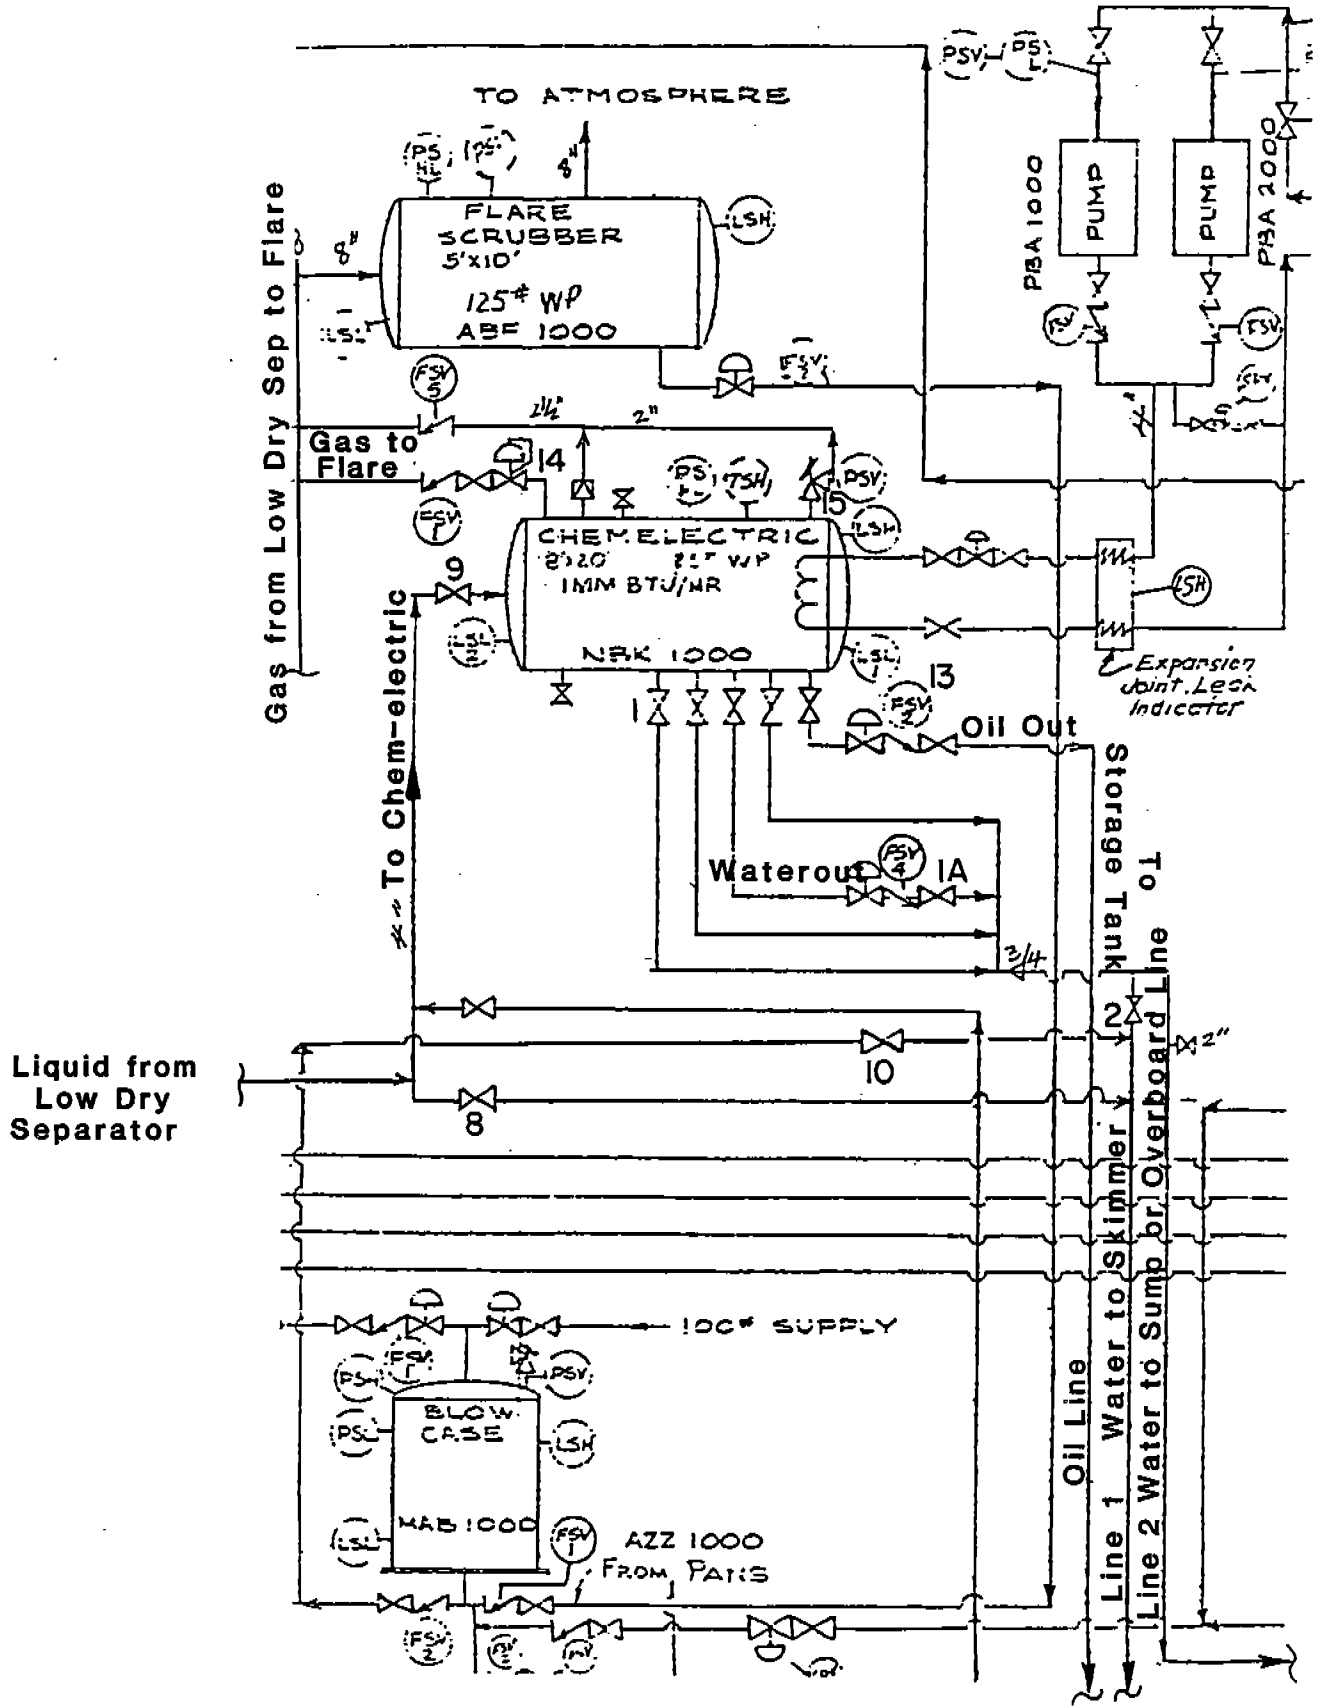
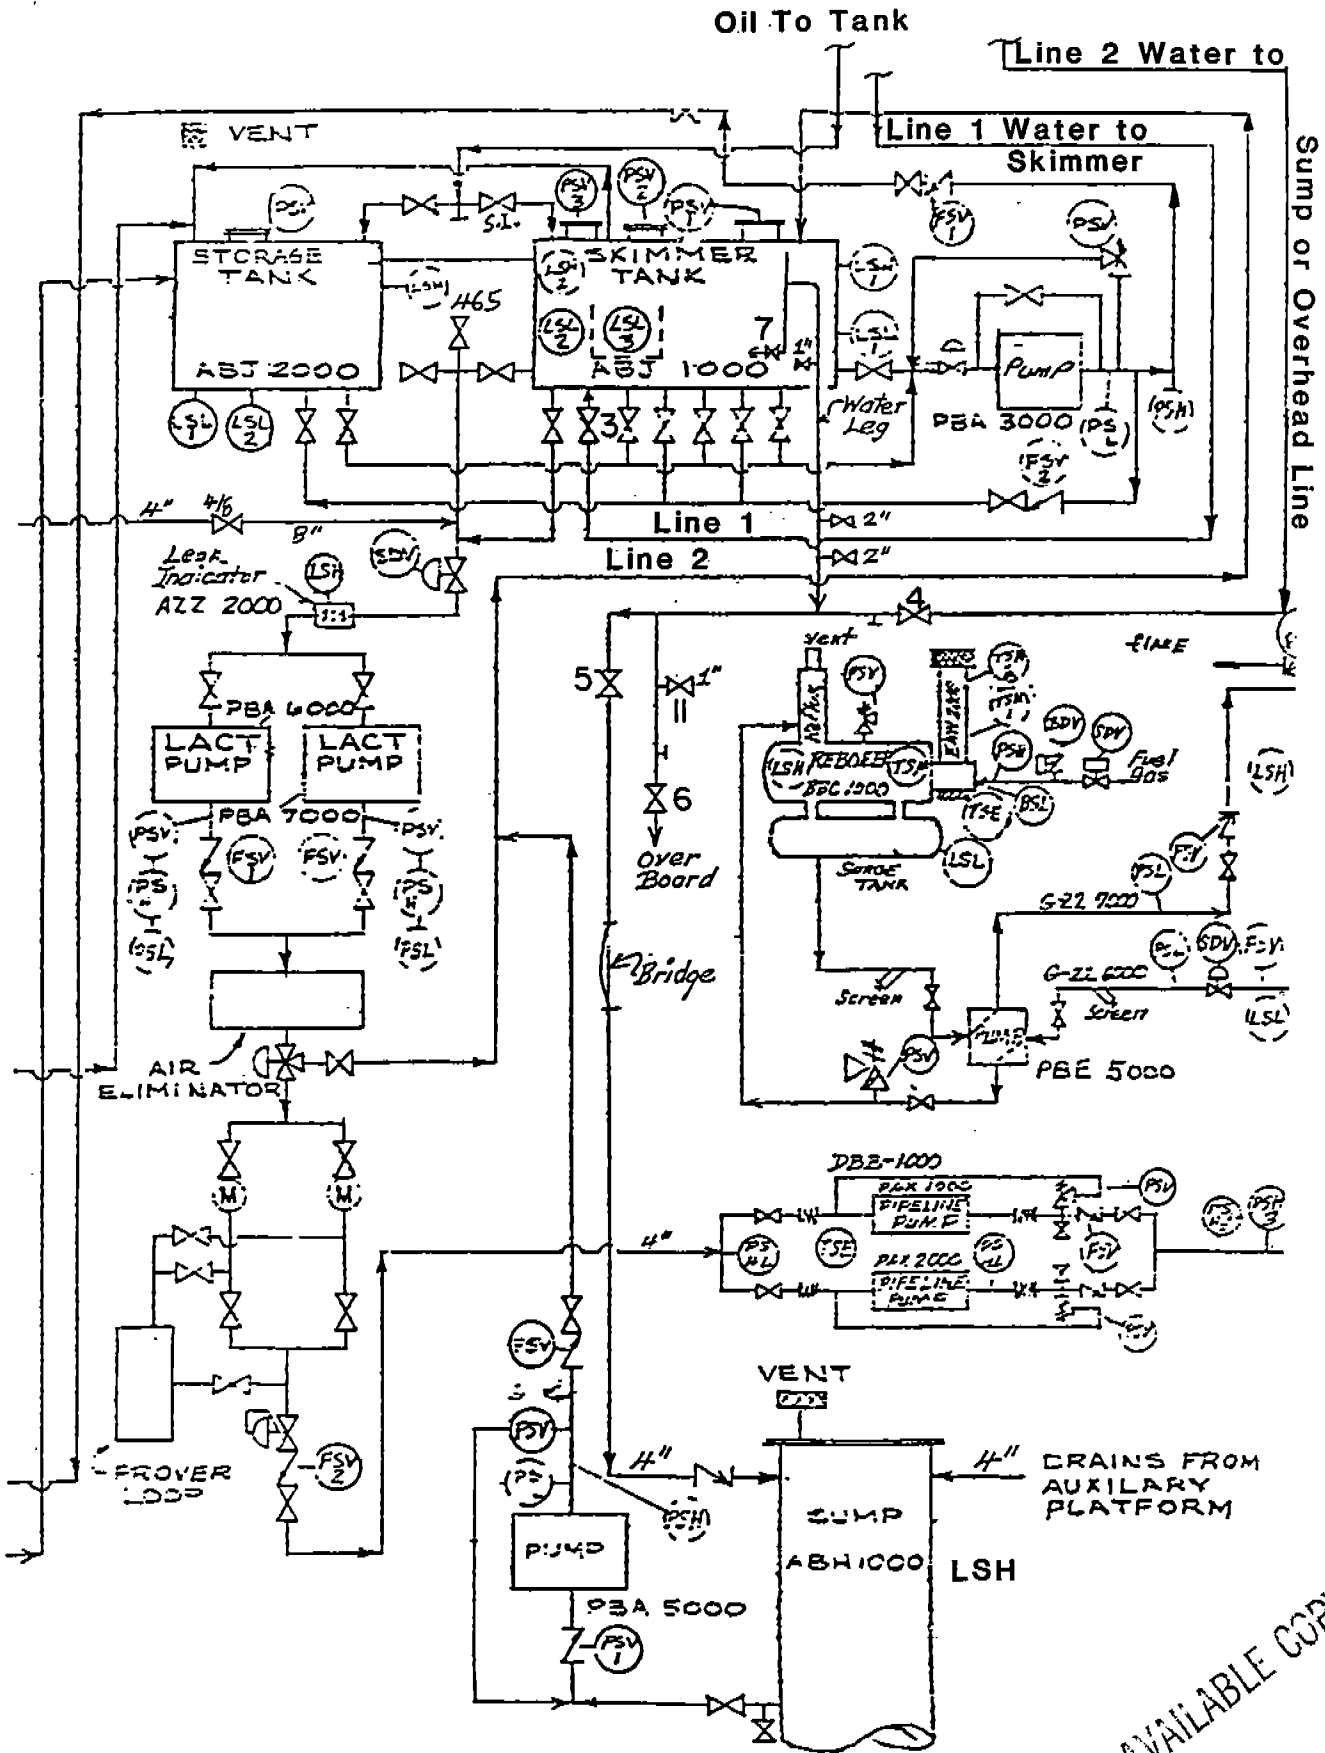
FLOW SCHEMATICS ATTACHMENT 5

The flow schematic for Platform A indicates that water from the chem-electric can be routed to either the skimmer tank, the sump on the auxiliary platform, or the 6-inch overboard line on Platform A (Attachment 5, pages 17-20). The water

from the chem-electric could also be routed to all three locations at the same time by opening the valves 2, 4, 5, and 6 on the water outlet. Assuming that the water from the chem-electric was routed to all three locations, then it is conceivable that the fluid from the skimmer tank could gravity feed to the sump on the auxiliary platform and through the overboard line to the Gulf. Installation of a check valve in the skimmer tank inlet line during the design stage would have eliminated a hydrostatic liquid flow to a lower level discharge point.

The skimmer tank is located on the top deck of Platform A. The chem-electric, high gas test separator, high production separator, and low dry separator are located on the middle deck of Platform A. On Friday morning, January 6, 1984, the skimmer tank, according to the tank gauge, contained 15 feet 4 inches of fluid. Of that amount, 7 feet 1 inch were water and 8 feet 3 inches were oil. On Saturday morning, January 7, 1984, the total amount of fluid in the skimmer tank was 9 feet 7 inches. Of that amount, 4 inches were water and 9 feet 3 inches were oil. The design capacity of the skimmer tank is 2,100 barrels. The water leg spill-over height on the skimmer tank was approximately 12 feet 4 inches at the time of the accident. Therefore, it is not conceivable that the fluid level in the skimmer could have been less than the total height of the water leg, unless the fluid was drained by some other method. On Friday, January 6, 1984, the chem-electric caused a platform shut in at approximately 4:55 p.m. because of the leaking burst plate. Contrary to the testimony of Mr. Hebert, Well A-12 was restored to production at approximately 6 p.m. by bypassing the chem-electric. This is supported by Transcontinental Gas Pipe Line Corporation's gas sales chart. At that time, bypass valve 8 was opened, allowing oil production to go from the low dry separator to the skimmer tank. Based upon analysis of the platform flow schematic, if valves 2, 4, and 5 were opened to allow liquid production from the low dry separator to go to the sump, the fluid from the skimmer tank (located on the top deck) could gravity feed to the sump located on the middle deck of the auxiliary platform. This old platform has had many revisions to the process system. Therefore, bypassing the chem-electric to keep Well A-12 flowing was, in our opinion, primarily the resultant cause of the pollution, based on an analysis of the platform flow schematic. Because of the complexity of the old system, it is possible that no one realized the skimmer tank could ultimately gravity feed to the sump if valves 2, 4, and 5 were opened and valve 6 were closed. Valve 3 is normally an open valve.

1. Liquid hydrocarbons hydrostatically discharged from the skimmer tank to the sump and drip pans on the auxiliary platform presumably were the material cause/fuel for the fire.
2. Ignition was caused by a piece of extremely hot metal, being trimmed by the welder on the handrails of the living quarters on the top deck, dropping in the water where hydrocarbons were present.

1. Failure to recognize at the time of equipment design the need for and the installation of a check valve in the skimmer tank inlet line to prevent hydrostatic liquid flow to lower levels was a contributing cause.
2. Lack of planning, coordinating, and flagging of valves by operating personnel during bypass operations of a major vessel was another contributing cause.
3. Weather conditions at the time of the accident were such that the seas and currents ran directly into Platform A from the auxiliary platform.
4. Since the accident occurred at night, darkness was a contributing factor because most personnel could not see hydrocarbons on the water.

- A. Check valves should be installed on skimmer inlets (vessel inlets) that are capable of hydrostatically discharging or backflowing to a sump or any overboard discharge system.

- F. Safety Alert -- In future designs, skimmer tanks should have the inlet line tie in the top section of the tank instead of the bottom.
- G. The panel recommends that this case be closed with the submission of this report.
