**OCS Report
BSEE 2014-02**

**Investigation of October 27, 2013, Fatality
Vermilion Area Block 200 Platform “A”
Lease No. OCS-G 09500, Complex ID No. 24098-01**

**Gulf of Mexico
Off the Louisiana Coast**

**U.S. Department of the Interior
Bureau of Safety and Environmental Enforcement**

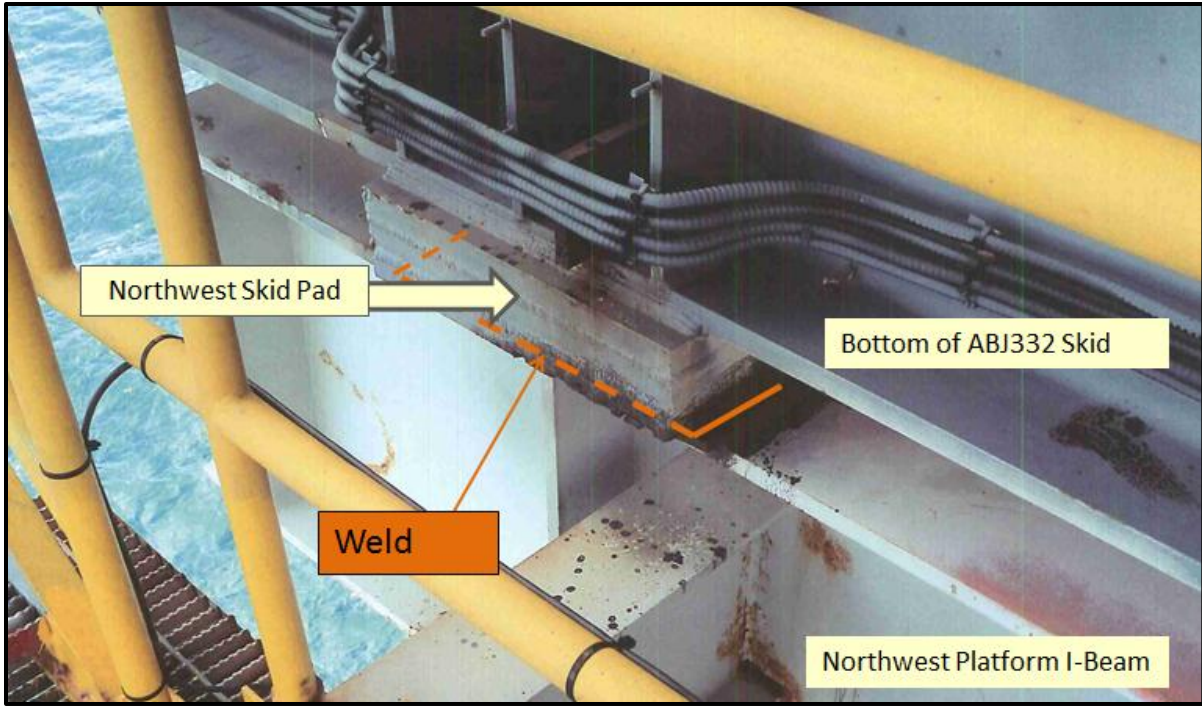
The dry oil storage tank ABJ332 skid assembly consisted of one (1) 16 foot diameter x 85 foot long horizontal cylindrical tank (designated ABJ332), two (2) 83 feet long flare booms mounted to and extending away from the skid at a 17-degree angle, and miscellaneous process piping and catwalks. The skid assembly was anchored on each end to the platform’s steel I-beams extending out from the north side of the superstructure. The main connection points that held the skid assembly in place were 4 rectangular steel pads. The pads consisted of three 2 inches thick plates stacked and welded together. Each plate measured 24 inches long by 20 inches wide. The pads were welded to the I-beams and the skid sat on top of the pads attached by additional welds. Process piping and catwalks that were welded to the tank and platform also provided some additional anchorage of the skid to the platform (see Figure 3 for a pre-incident photograph of one of the steel pads). The horizontal cylindrical tank had been emptied, cleaned, and opened to atmosphere by decommissioning work that occurred prior to the mobilization of the DB *William Kallop*.

Figure 3: Pre-Incident Photo of One of the Rectangular Steel Pads Supporting the Dry Oil Storage Tank ABJ332 Skid Assembly at Vermilion Block 200 Platform “A” (Photo provided by Talos/ERT)

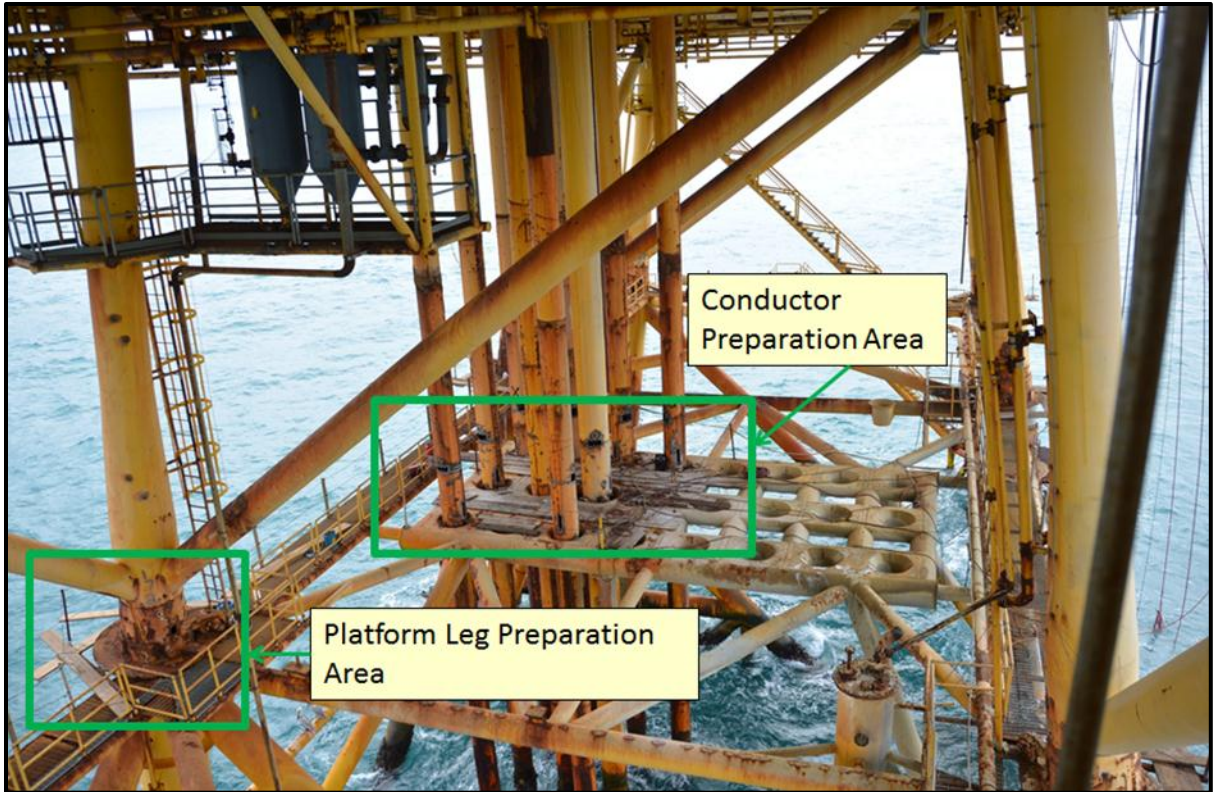
After the safety meeting, the DB crew for the 12p/12a shift broke into 2 main welding teams; one team was to work around the ABJ332 skid assembly, the second welding team reported for work at the top of platform jacket area for cutting of the well conductors (Figure 4).

Figure 4: Platform Jacket Work Area (Post-Incident Photo taken by Panel Site Visit on November 14, 2013)

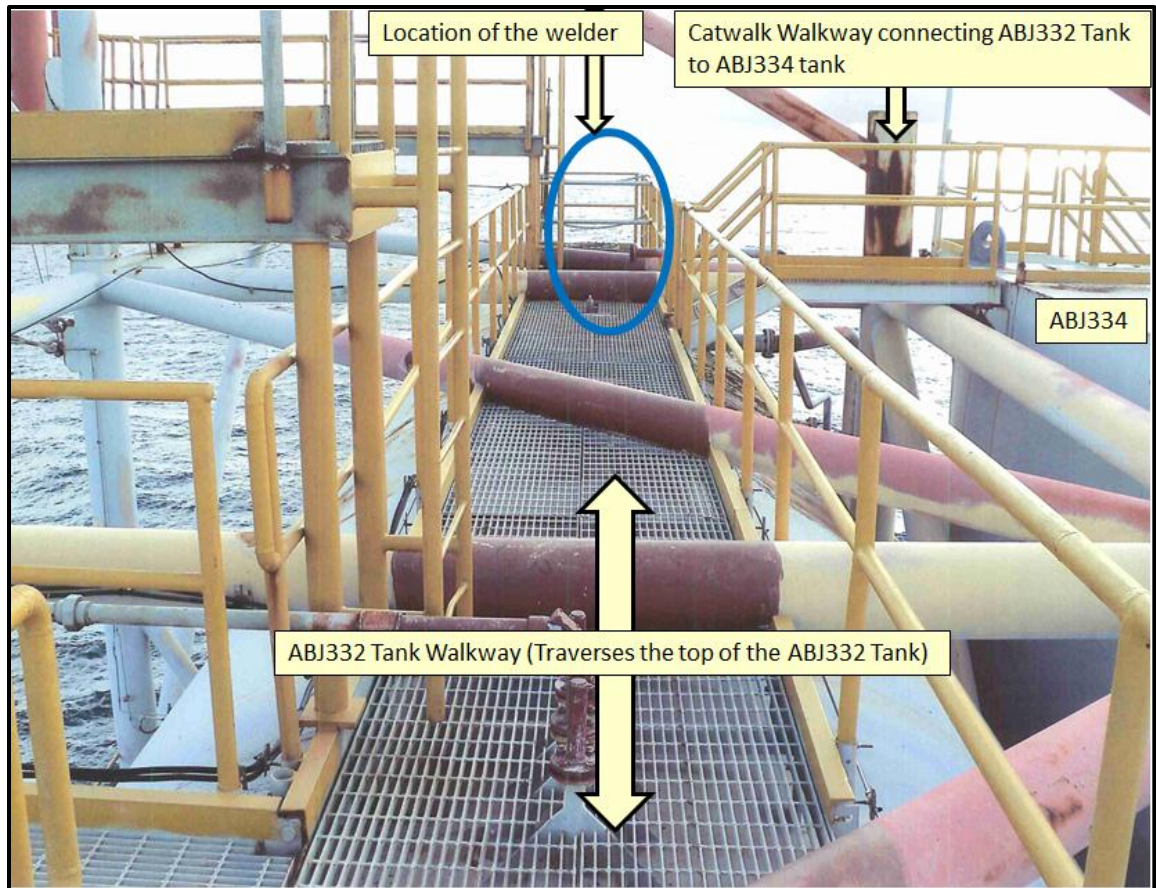
Figure 5: Pre-Incident Photo of the walkway on top of the ABJ332 Tank skid at Vermilion Block 200 Platform “A” (Photo provided by Talos/ERT)

At approximately 7:05 p.m., the welder was standing on the walkway of the ABJ332 tank (outboard side of the catwalk) and began cutting the base of the catwalk’s handrail where it attached to the tank (Figure 5). The welder cut one side of the catwalk’s handrail completely. As he made the final cut to the remaining contact point, the catwalk and the dry oil storage tank ABJ332 skid assembly began to vibrate. The entire skid package, including the flare booms rotated outward away from the platform and fell 115 feet into the water below. (see Figure 6 for an aerial Before & After of the platform structure). The welder was last seen by the deck foreman still standing on the tank as it rotated away from him.

This incident was caused by the failure to recognize that the dry oil storage tank ABJ332 skid assembly, with the two vent booms still attached, represented an unstable configuration if not secured by multiple welded connection points. The removal of the welded connection points directly led to the skid assembly rotating on the two outboard pads and falling 115 feet into the Gulf of Mexico when the last connection point, the base of the catwalk handrail, was severed. The welder, who was standing on the catwalk that traverses the top of the ABJ332 tank, was carried overboard with the skid assembly. Although the welder was wearing a fall protection harness, he was not required to anchor to a secure point as he was working within the handrails of the catwalk. The Panel concluded that the use of fall protection equipment would not have prevented the individual being carried overboard as the entire tank skid assembly, including the tank walkway toppled overboard (refer to Figure 5 for the location of the welder).

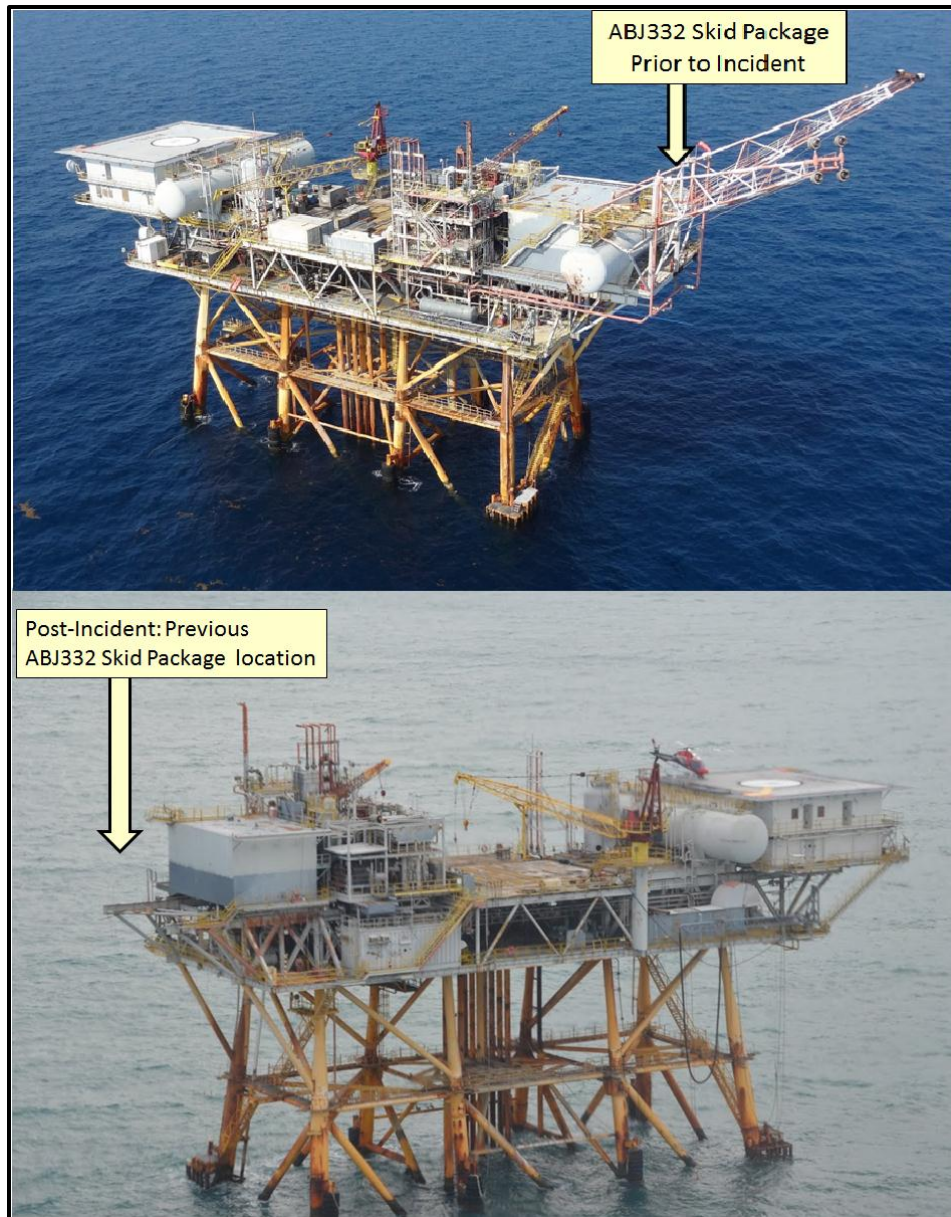
The man overboard emergency plan was initiated and all crewmembers were mustered for a head count. The welder was identified as being only person missing. The tank package was observed floating for a brief time after hitting the water before sinking. The welder however, was not observed at or around the tank. Service vessels in the area began a search, and were ultimately joined by assets from the USCG. Despite these efforts, the welder was not located. After two days of surface and underwater searching, the divers recovered the body of the welder from amidst the tank wreckage on the seafloor.

Figure 6: Aerial Before & After Photos of Vermilion Block 200 Platform “A” (Top Photo from Talos/ERT-OFS June 28, 2012 Site Visit; Bottom Photo from Panel Site Visit, November 14, 2013)

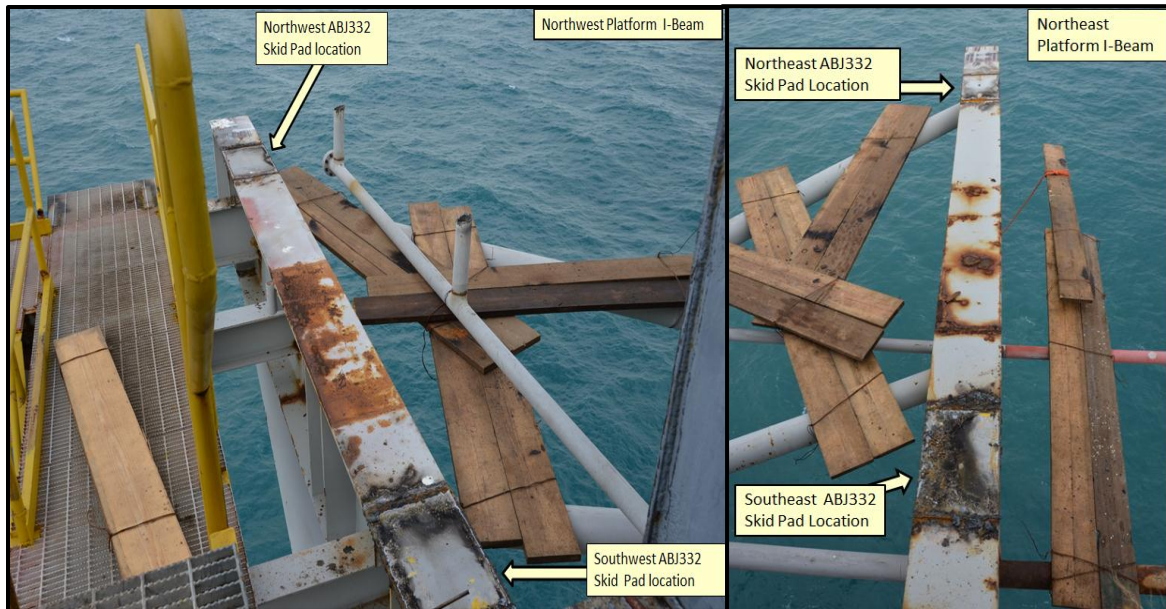
Figure 7: Post-Incident Photos of the Wood Scaffolding. Northwest Platform I-Beam (Left) and Northeast Platform I-Beam (Right) that Supported the Dry Oil Storage Tank ABJ332 Skid Assembly at Vermilion Block 200 Platform “A” (Photo from Panel Site Visit, November 14, 2013)

- The condition of the scaffolding was recognized as being less than what Talos/ERT would publically claim as their standard in an internal Talos/ERT email (November 9, 2013) discussing the upcoming visit by BSEE to the incident site. When discussing the visit, the Talos/ERT employee states “ the platform is not in the shape we would have it to prepare for a BSEE Inspection as far as housekeeping and the way boards are set up for access to platform piles for workers” (i.e., temporary scaffolding). The standard of scaffolding installed at the platform (Figure 7) was not consistent with the standards for safety (e.g., OSHA) promoted by both Talos/ERT and OSF throughout their SEMS policy documents.

- The Panel concluded that the condition of the scaffolding/temporary work platforms was an indicator of the safety culture at the work site.

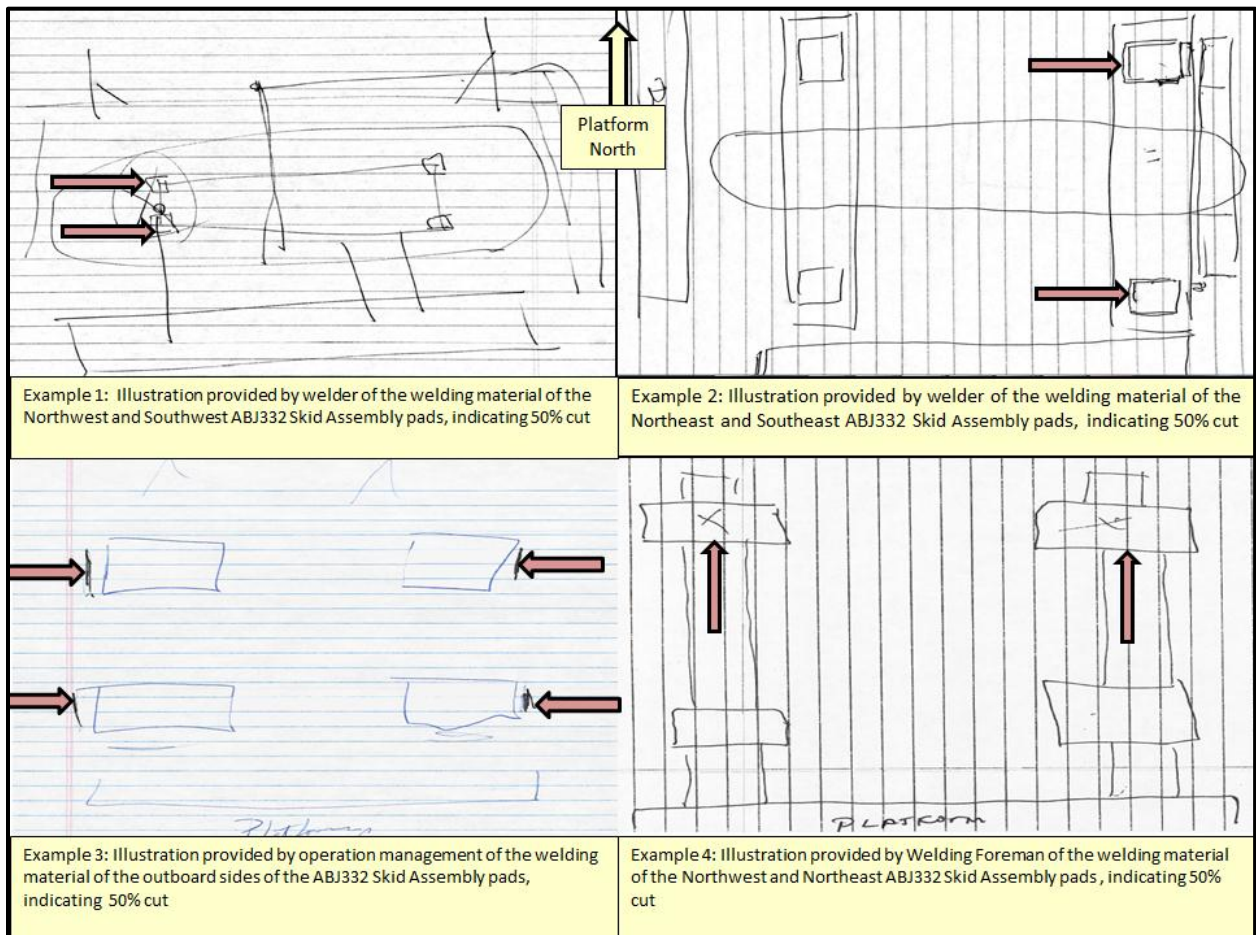
- The standing verbal work instruction for the “prepping” activities conducted on October 27, 2013 was to “cut 50%”. This work instruction was verbally communicated to both shifts. During the Panel Interviews with both OSF and Talos/ERT personnel, this work instruction was consistently referred to as a “standard procedure”, “standard policy” or “routine practice”. However, no one could produce a written procedure or work instruction that describes what “cut 50%” translates to in terms of actions. The JSAs do not contain any reference to this work instruction.

- During the Panel interviews, the interviewees were asked to draw a picture of what “cut 50%” would look like when cutting the pads supporting the dry oil storage tank ABJ332 skid assembly (see Figure 8 for a sampling of these drawings). Based on the inconsistencies in the drawings and supporting explanations provided by supervisors, foremen, workers and management, there did not appear to be a consistent understanding of this work instruction in place at the time of the incident. Some described “50%” as fully cutting two of the four pads, either two outboard (the platform) or two inboard. Others described that “50%” meant cut away half the weld on each of the four pads.

Figure 8: Sampling of Post-Incident Sketches Drawn by OSF and Talos/ERT Personnel to “Describe the Process of Cut 50%” (from Panel Interviews). Panel found inconsistent depiction of not only “50%” but of inboard vs. outboard weld

The advantages of employing a crew familiar with working with each other, however, were minimized when it was found that there were multiple interpretations of work instructions, specifically in the instruction to “cut 50%.” The use of this term was characterized as being a standard practice and commonly understood. However, the panel found significant variations in what this term meant in actual practice. This lack of a consistent understanding of the work instruction extended across both companies, and was identified at multiple levels within the OSF and Talos/ERT organizations.
