**Investigation of Fire and Fatality  
East Cameron Block 60  
April 9, 1999**

**Gulf of Mexico  
Off the Louisiana Coast**

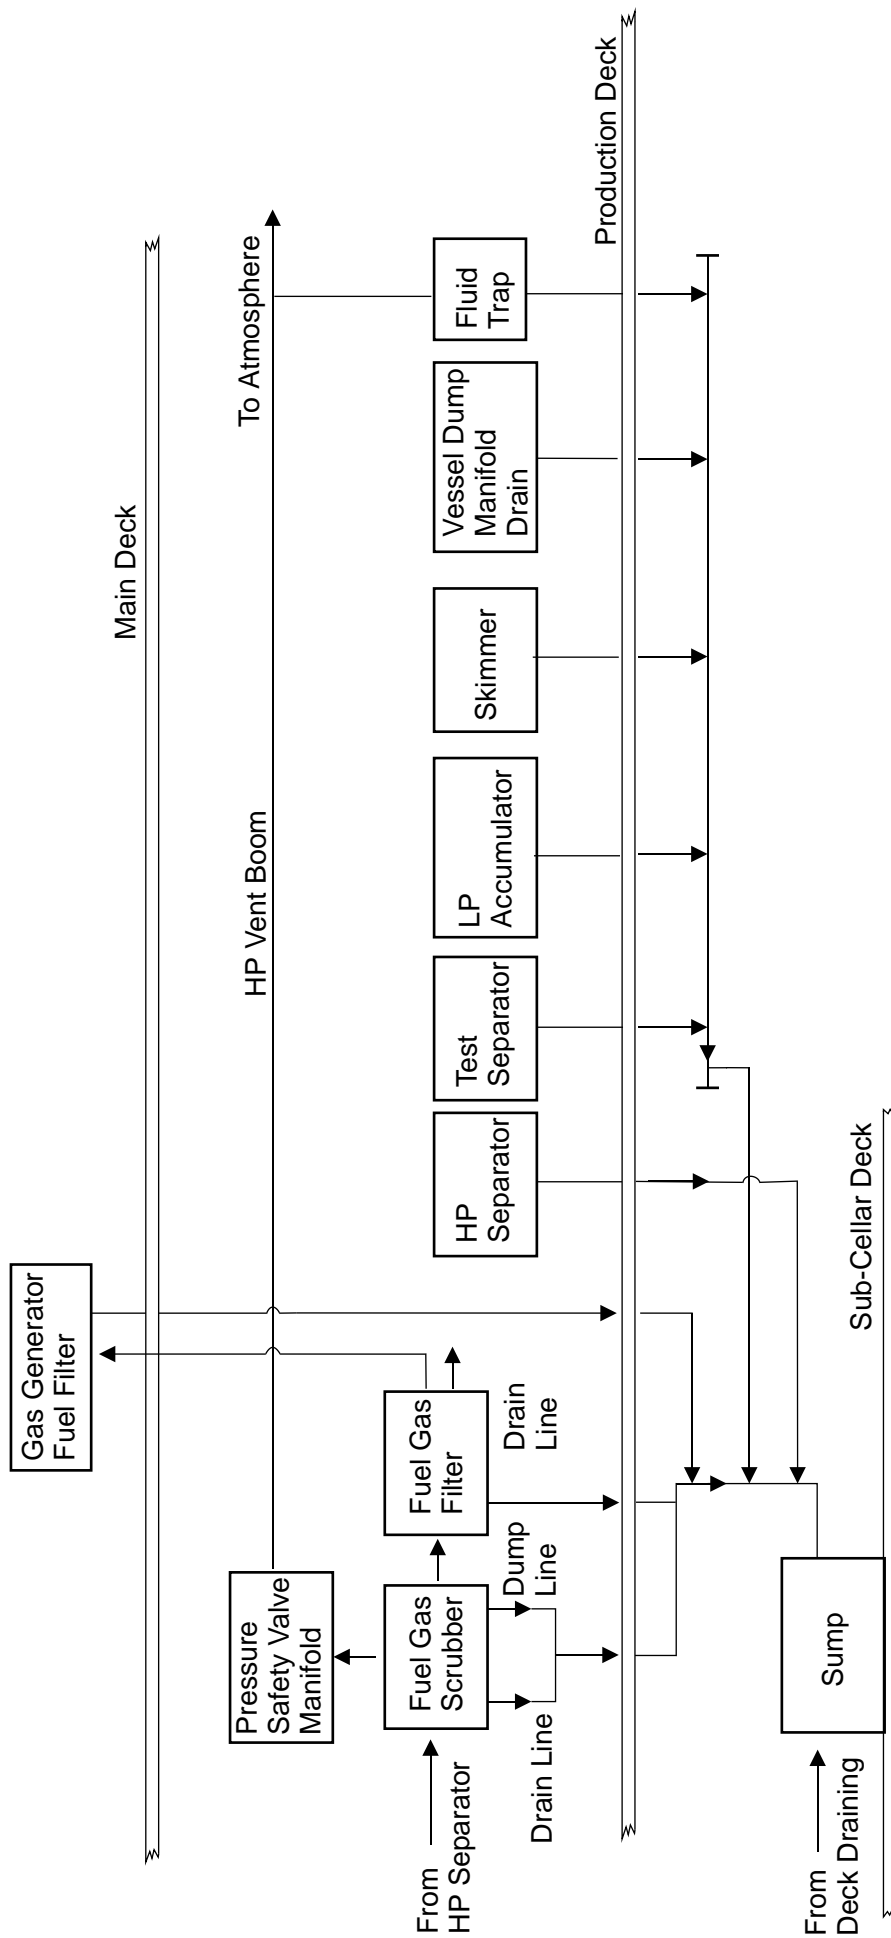
Simplified Partial Flow Schematic of Platform

For the following discussion of the platform's sump system, refer to Attachment 2. The dump lines of the HP Separator, Test Separator, Low Pressure Accumulator (LP Accumulator), and Skimmer tie into a line, henceforth referred to as the Manifold Drain. The drain lines of the above vessels, together with the Manifold Drain, tie into the sump system as shown in Attachment 2.

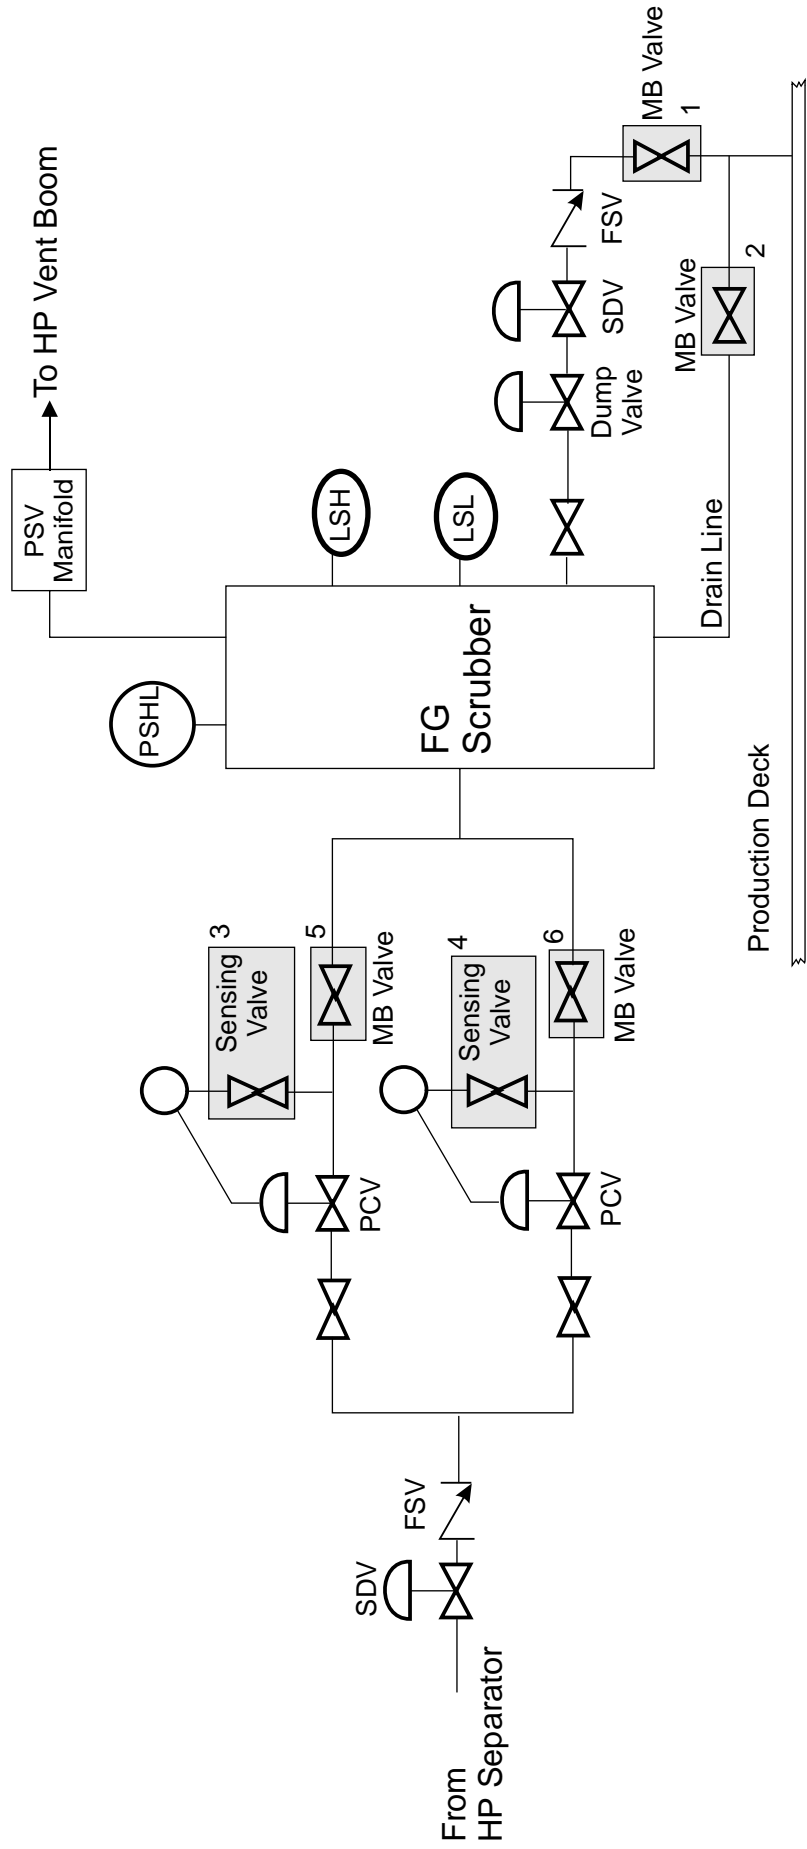
Simplified Flow Schematic of Fuel Gas Scrubber

To isolate the FG Scrubber from downstream components, D-2 stated that he closed the MB Valves on both the FG Scrubber dump and drain lines (shaded areas 1 and 2 on Attachment 3). He stated that the MB Valve on the FG Scrubber drain line was already closed. The closing of both valves would effectively achieve downstream isolation. D-2 stated that he red-flagged both lines. To achieve upstream isolation, D-2 stated that he then closed the needle sensing valves for the upstream PCV's (shaded areas 3 and 4 on Attachment 3), believing them to be the incoming block valves (shaded areas 5 and 6). This resulted in both the incoming MB Valves and PCV's remaining open, thereby allowing communication between the FG Scrubber and the HP Separator during the blowdown operations.

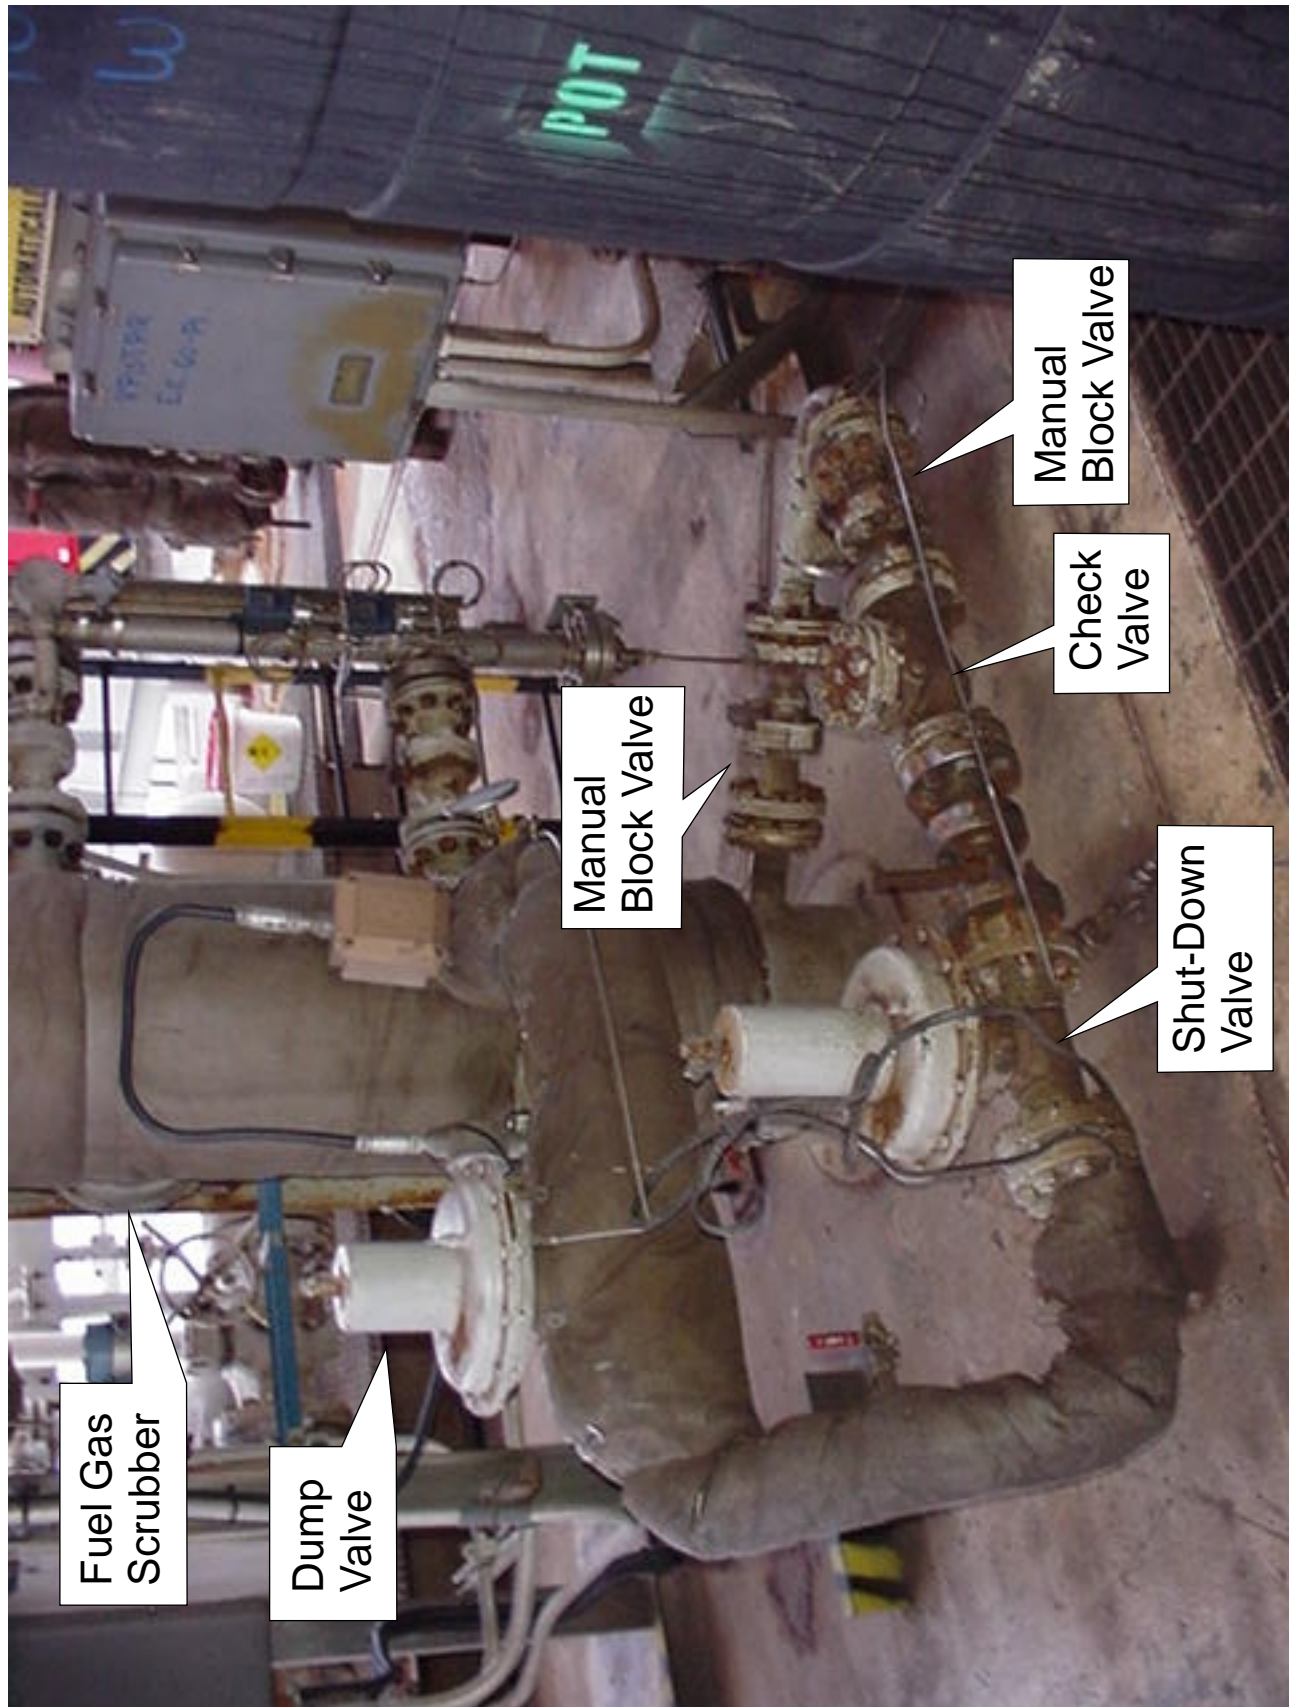
Photograph of Fuel Gas Scrubber

FG Scrubber dump line and the SDV located upstream of the FG Scrubber. The FG Scrubber also is equipped with a pressure safety valve manifold (PSV Manifold), which allows FG Scrubber blowdown to a High-Pressure Vent Boom (HP Vent Boom). *For a simplified flow schematic of the FG Scrubber, see Attachment 3. For a photograph of the FG Scrubber, see Attachment 4.*

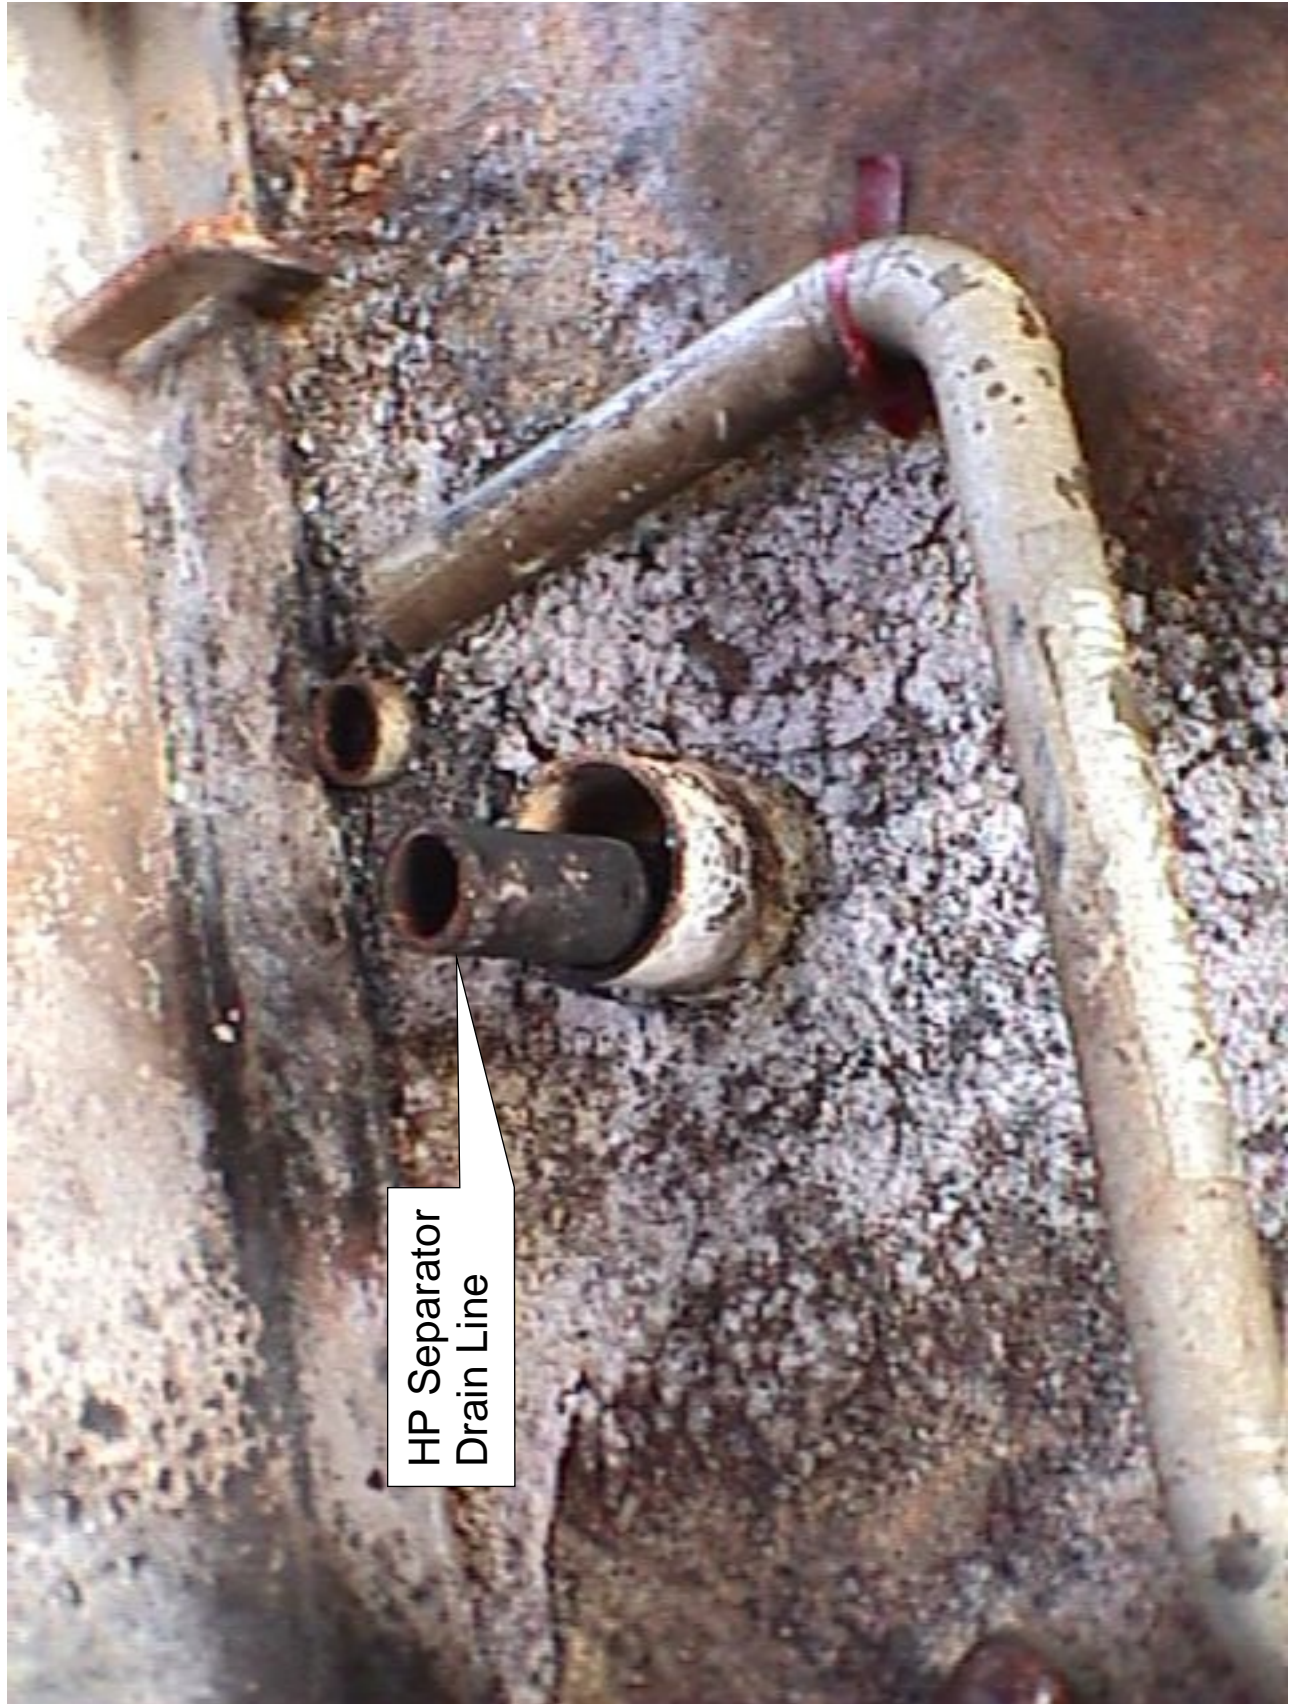
Photograph of Severed HP Separator Drain Line on Production Deck

After leaving the production deck and returning with U-2 and U-3, U-1 saw that the cut on the HP Separator was made too close to the deck and, resultantly, could not be threaded. *For a photograph of the severed HP Separator drain line, see Attachment 6.* The decision was made by U-1 to cut the pipe below the production deck at a location on the subcellar deck. From this point forward, the exact correlation of the movements of U-2 and U-3 with respect to those of U-1 cannot be determined with a great degree of accuracy. U-1 stated that he brought U-2 and U-3 to the subcellar deck and gave them instructions to cut the pipe with an electric bandsaw. U-1 stated that he felt that the previously mentioned assumed permit applied to this pipe as well, since the pipe to be cut at

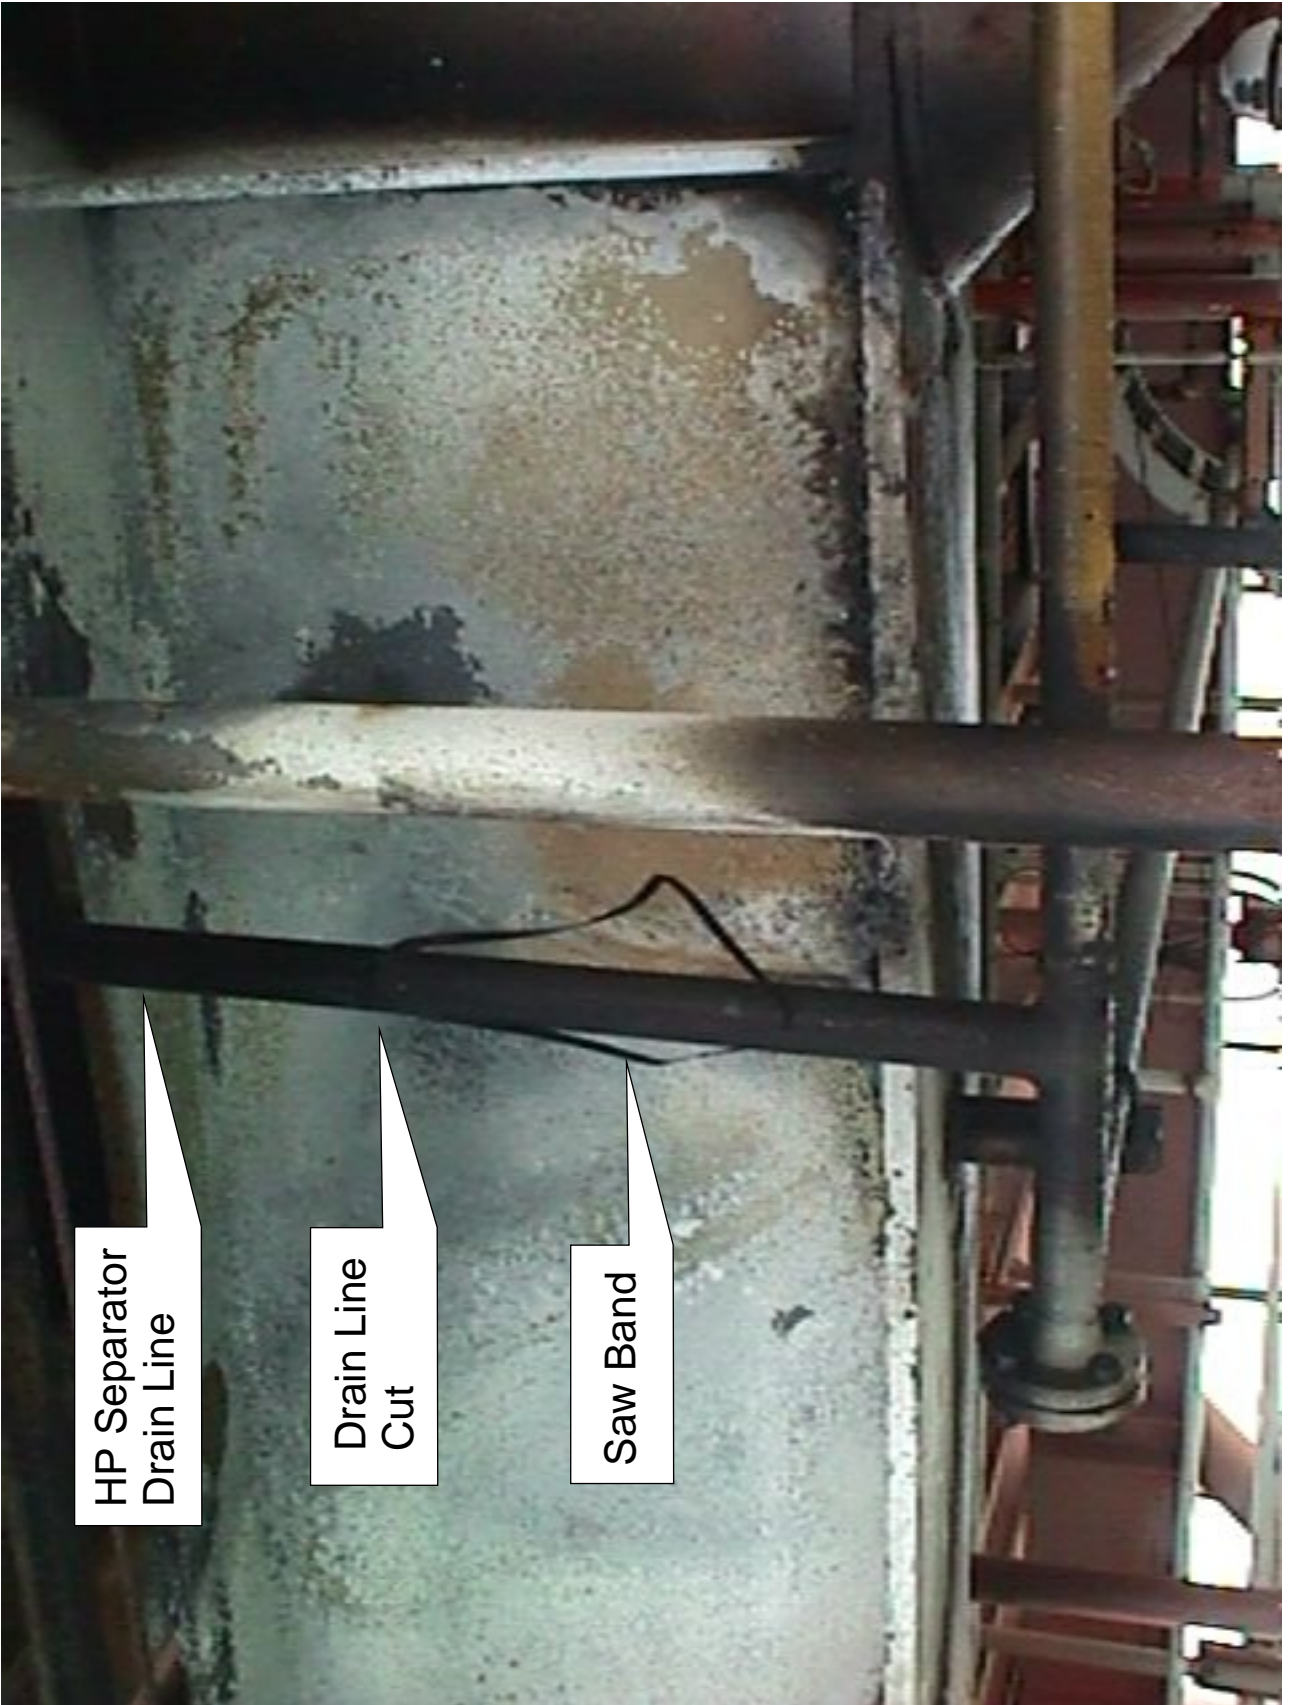
HP Separator  
Drain Line

*For a photograph of the HP Separator's drain line with the saw's band*

*attached to the cut, see Attachment 7.*

Based upon the preceding findings, the conclusion of this panel is that at approximately 1336 hours, while U-3 was cutting a section of the HP Separator drain line with an electrically powered bandsaw, condensate was probably released from the FG Scrubber through either the FG Scrubber drain line or dump line into the platform's sump system. The release caused condensate to surge upward through the HP Separator drain line, spray from the cut being made by the bandsaw unto U-3, and flow from the top portion of that drain line onto the production deck. On the production deck, the condensate sprayed onto various vessels and into the deck drains. The electrical component of the band-saw ignited the condensate, resulting in the fire which occurred on both the sub-cellar and production decks and which also caused the injuries to U-2 and U-3.

Drain Line  
Cut
