**Investigation of Drillship Draw Works Failure
Atwater Valley Block 116
OCS-G-13206
October 22, 1999**

**Gulf of Mexico
Off the Louisiana Coast**

**David Dykes
David Trocquet
Randall Josey**

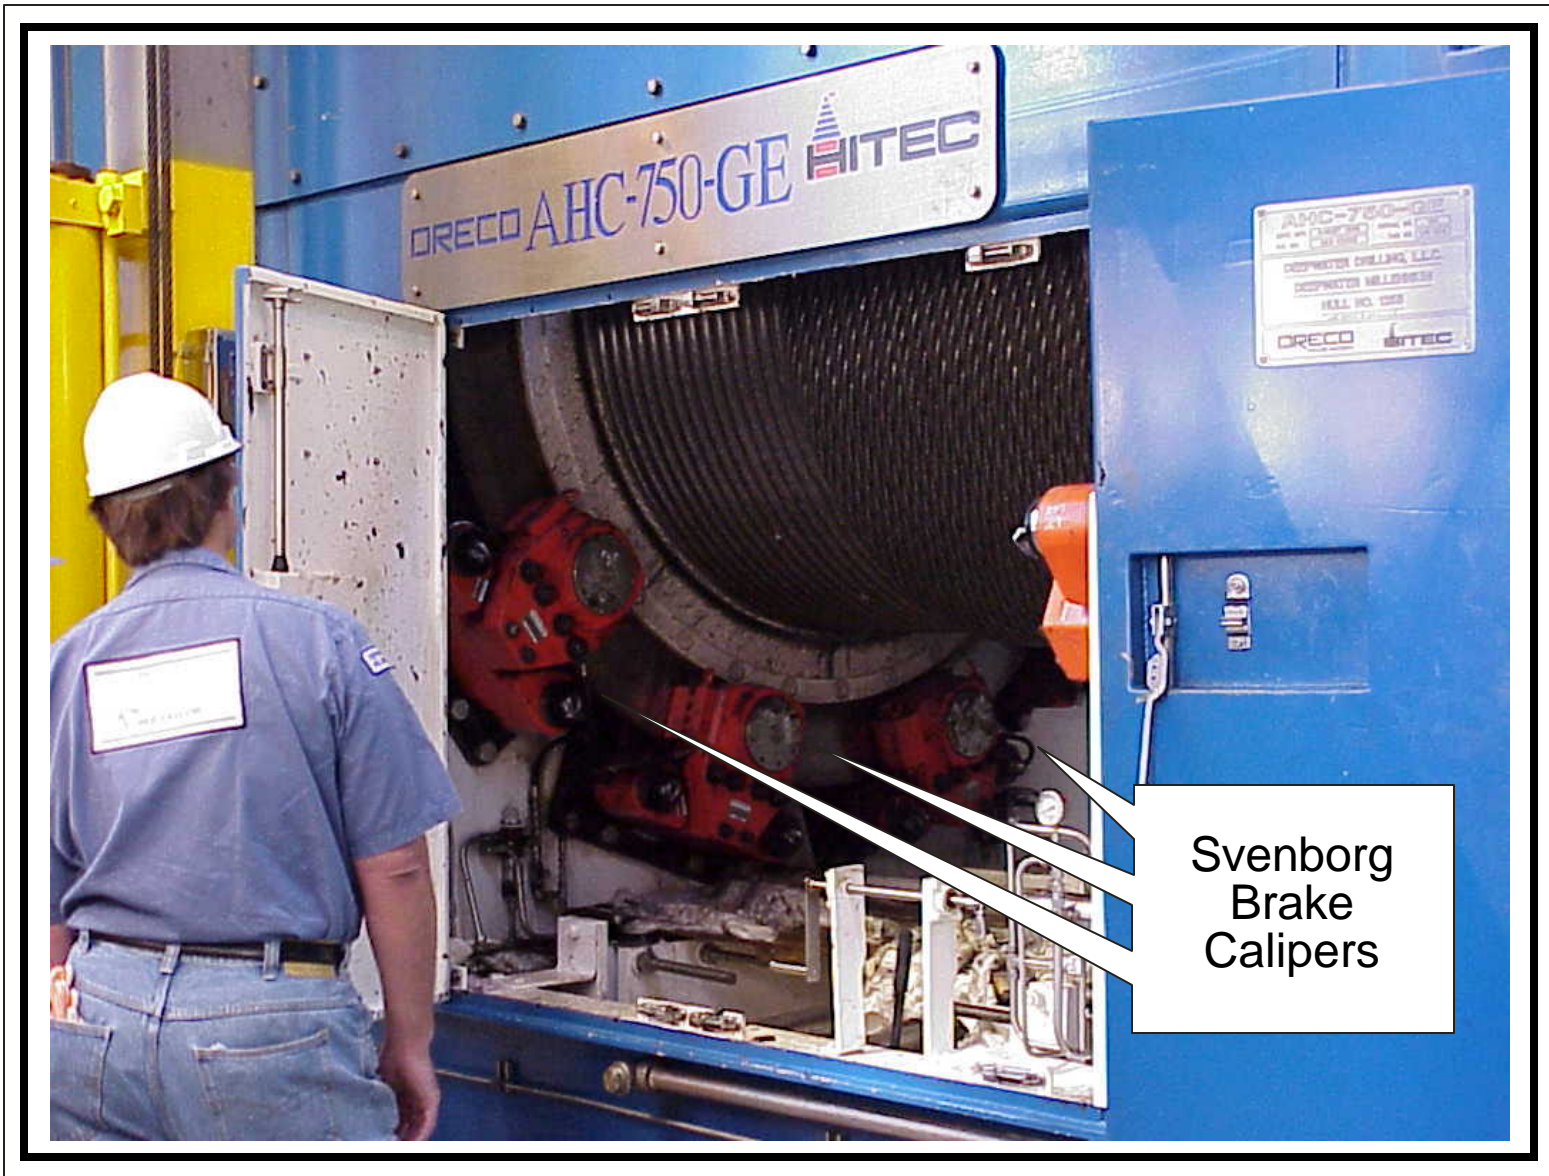
- Air gaps ranged from high 2.44 millimeters to low 1.14 millimeters.
- Air gap average was 1.97 millimeters. The Svenborg recommended air gap is 1 millimeter. Brake holding capacity is reduced approximately 6 percent per millimeter. This air gap of 1.97 millimeters resulted in a 5.8 percent loss of brake holding capacity.

- Brake pad coefficient of friction was 0.267, which indicates a 33.3 percent loss of brake holding capacity when compared with the Svenborg-recommended coefficient of friction of 0.4.

Dreco AHC 750 GE Draw Works with Svenborg Brake Calipers (*Deepwater Millennium*)

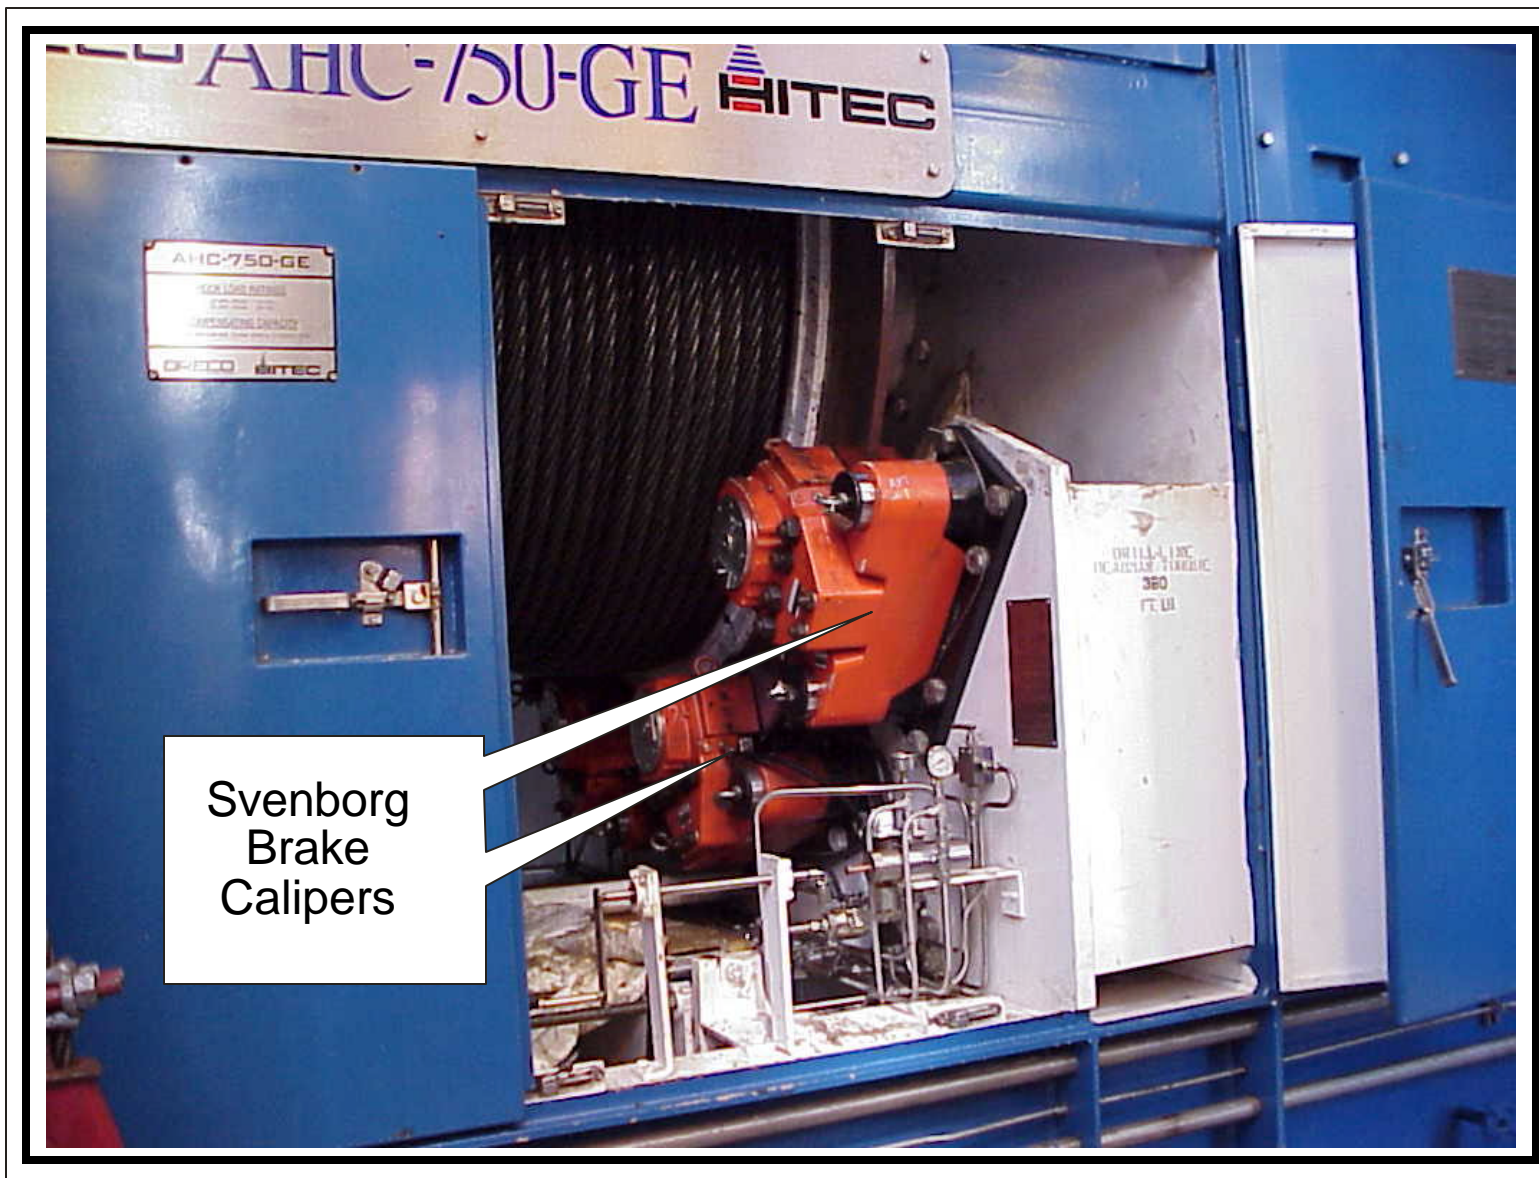
Drecto AHC 750 GE Draw Works with Svenborg Brake Calipers (*Deepwater Millennium*)

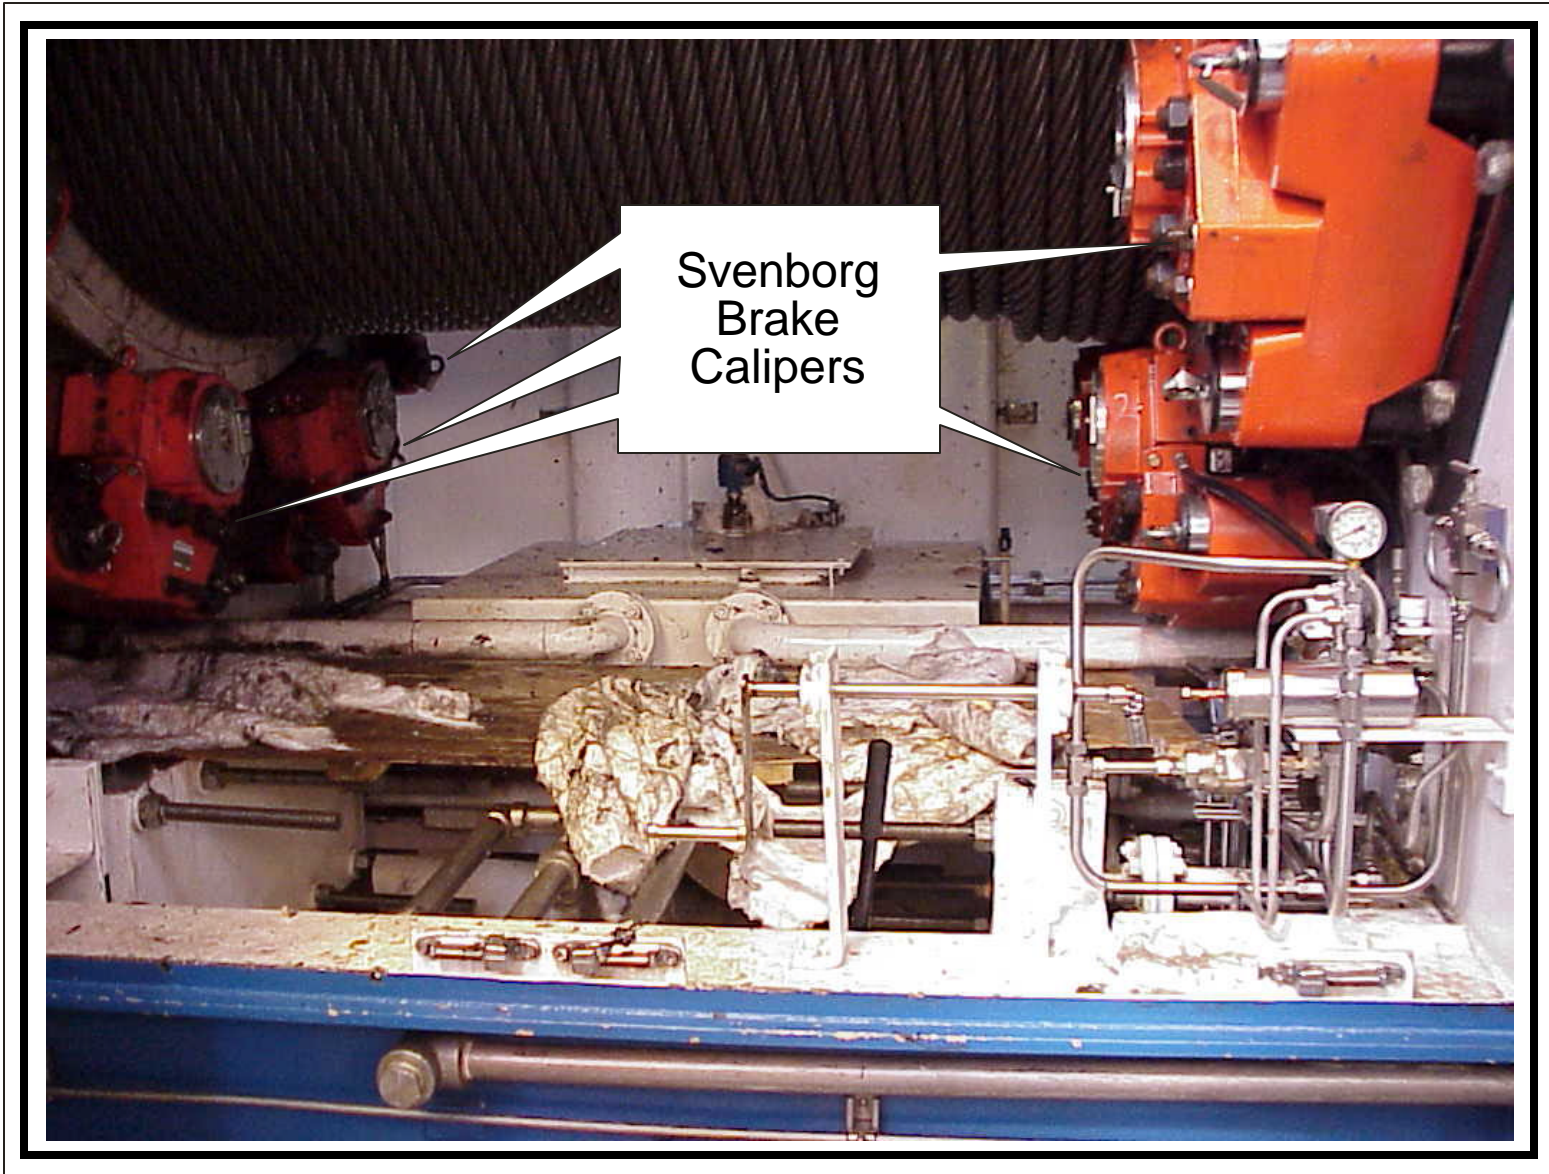
Dreco AHC 750 GE Draw Works with Svenborg Brake Calipers (*Deepwater Millennium*)

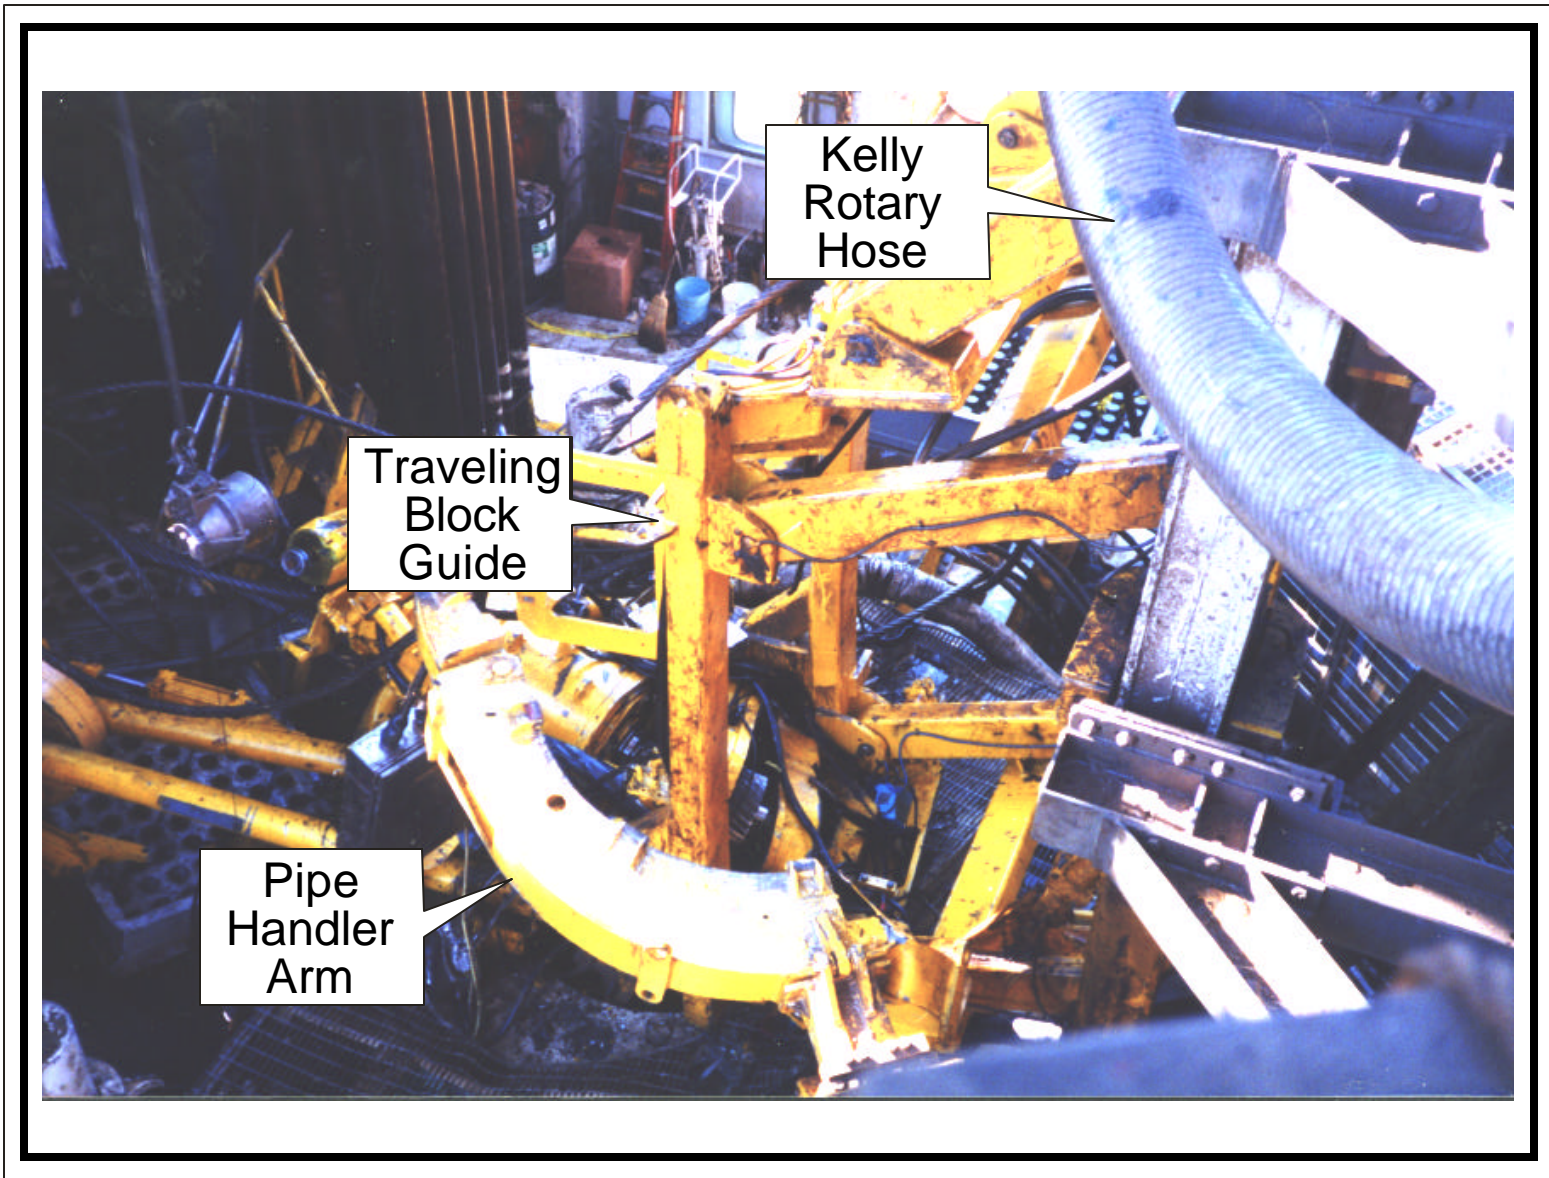
As a result of this accident, the draw works assembly and top drive assembly were damaged beyond repair. The main bearing of the rotary table was also damaged beyond repair. The riser spider and gimbal

sustained damage but not beyond repair. The bails, elevators, 20 joints of riser pipe, and the BOP/LMRP assembly were completely lost. The derrick, along with mux lines support equipment, sustained minor damage. Total estimate of damage and repair or replacement costs is approximately \$20 million. *For pictures of damages, see Attachments 7-9.*

Damages - *Deepwater Pathfinder* Drill Floor

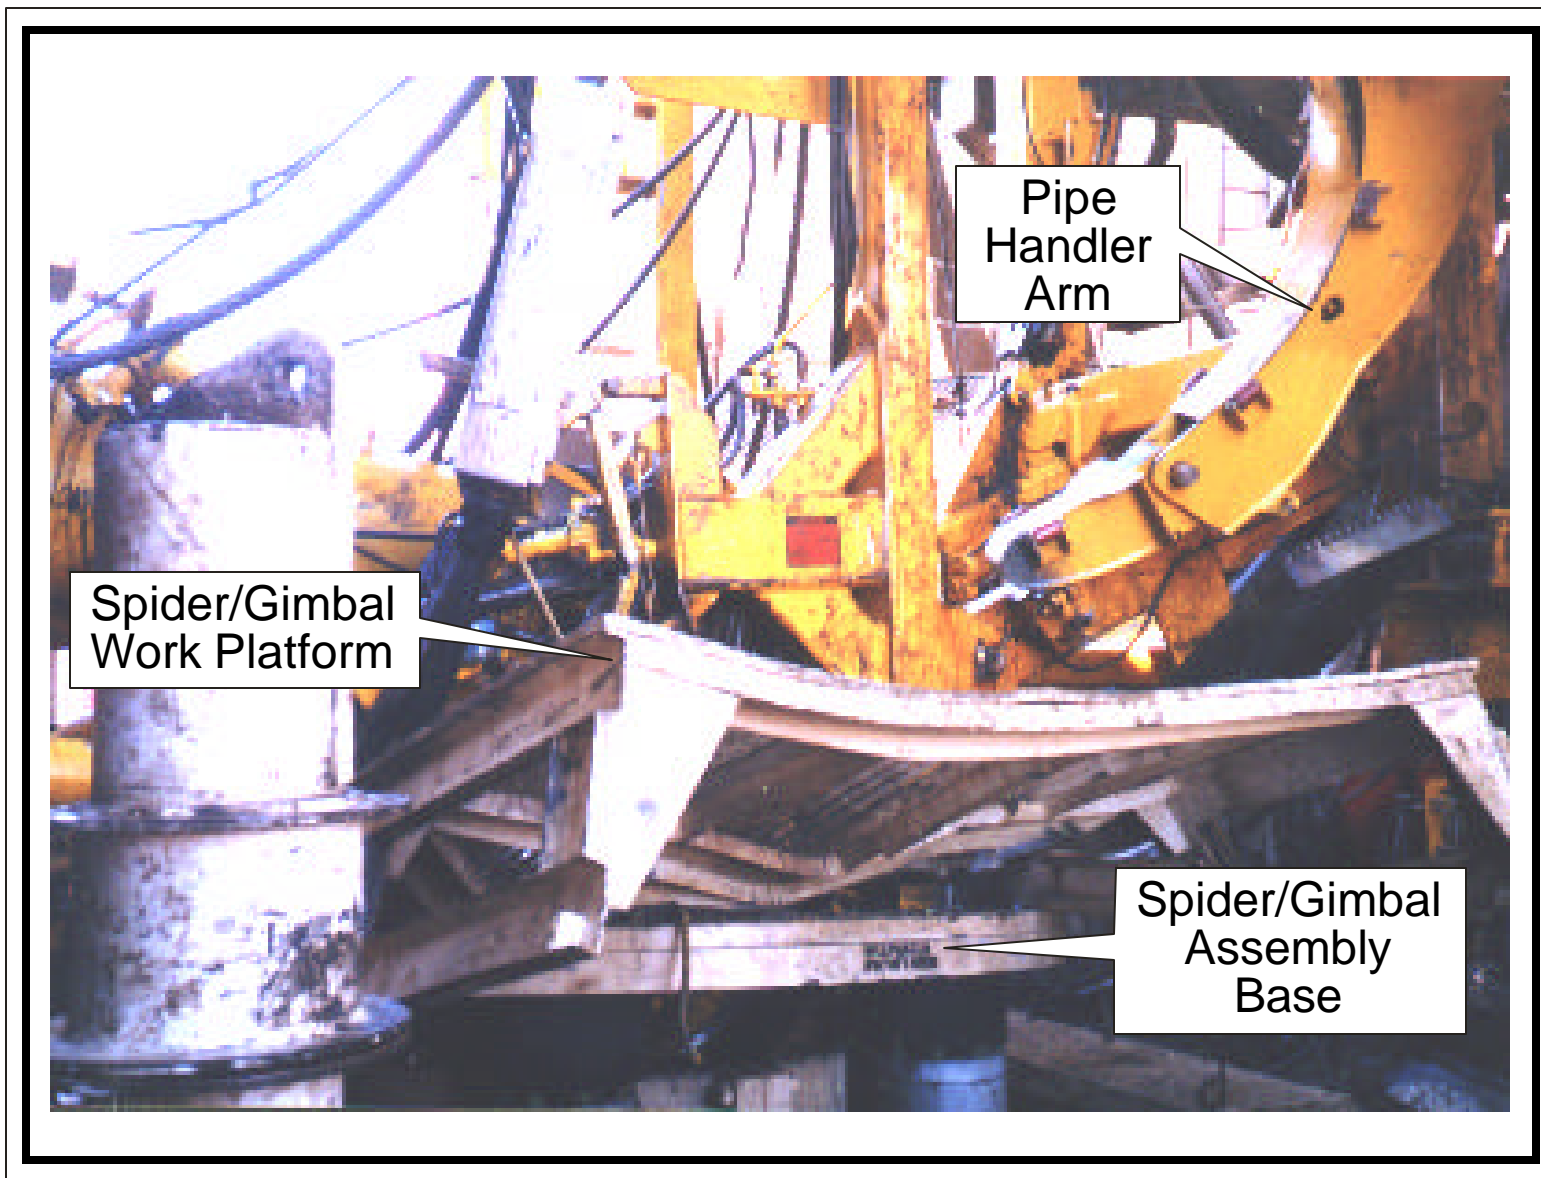
Damages - *Deepwater Pathfinder* Drill Floor

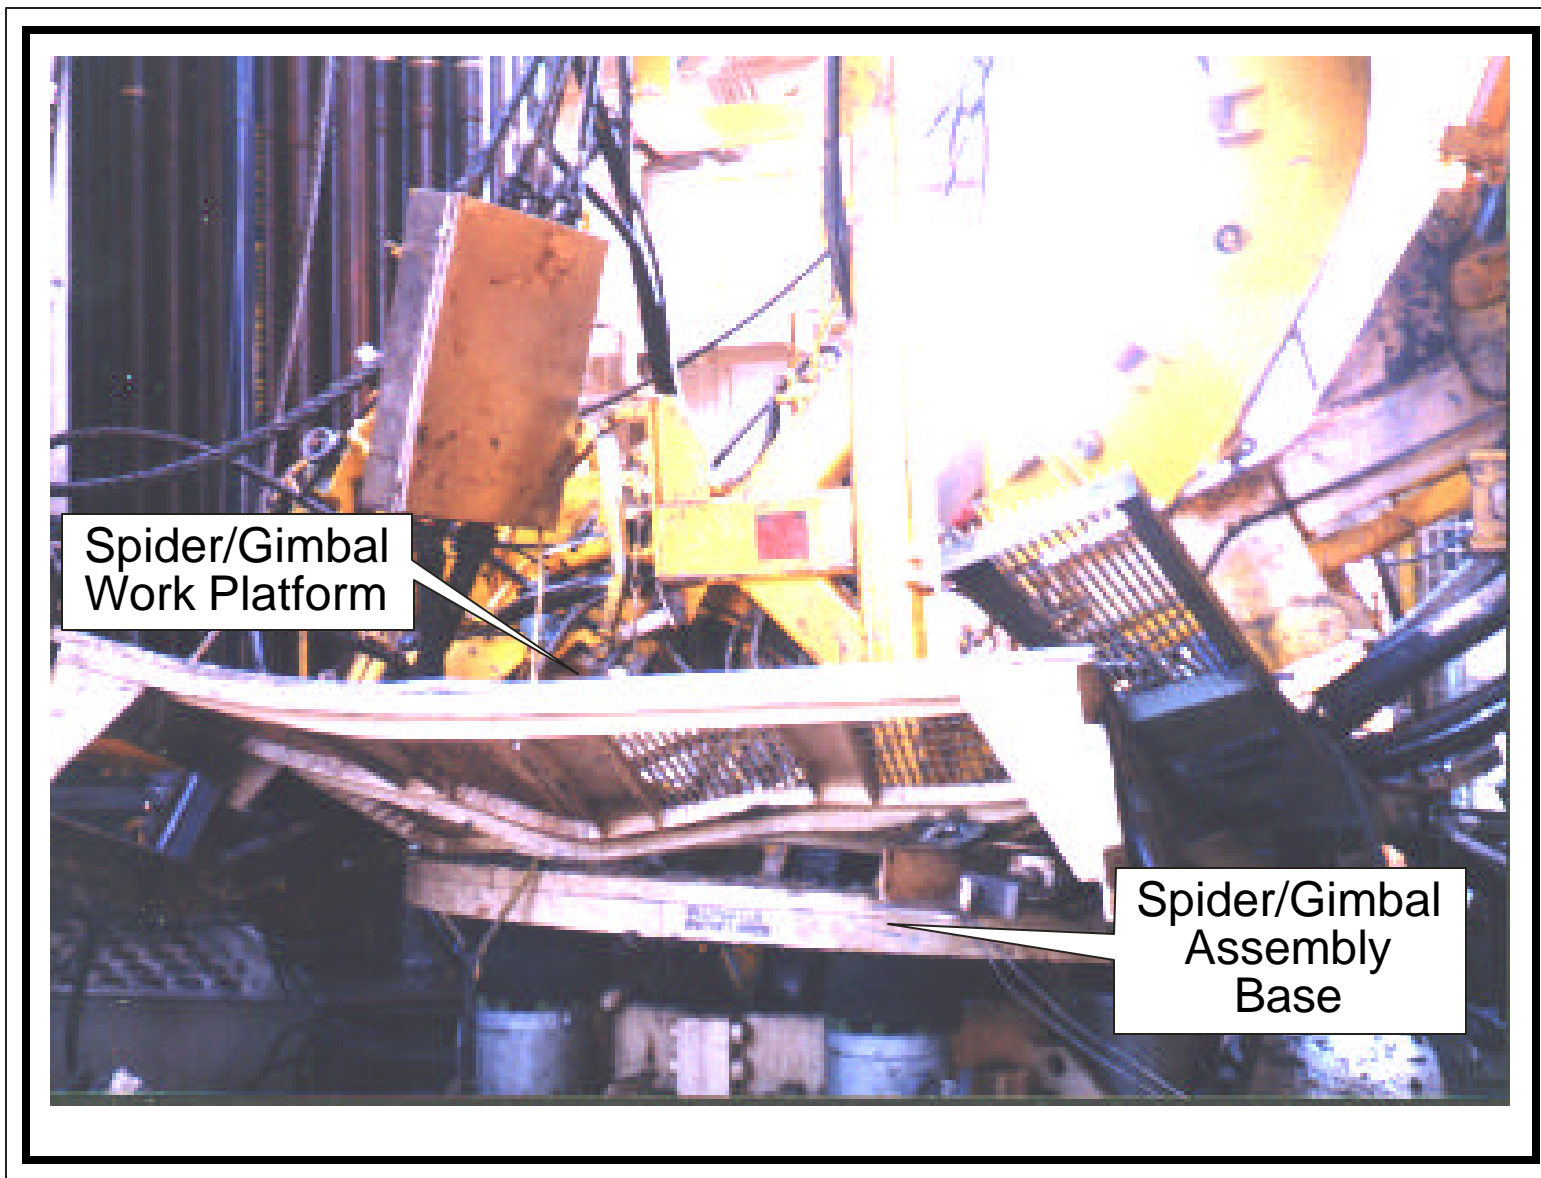
Damages - *Deepwater Pathfinder* Drill Floor
