**Investigation of Blowout and Fire
Ship Shoal Block 354
OCS-G 15312 Well A-2
September 9, 1999**

**Gulf of Mexico
Off the Louisiana Coast**

**U.S. Department of the Interior
Minerals Management Service
Gulf of Mexico OCS Regional Office**

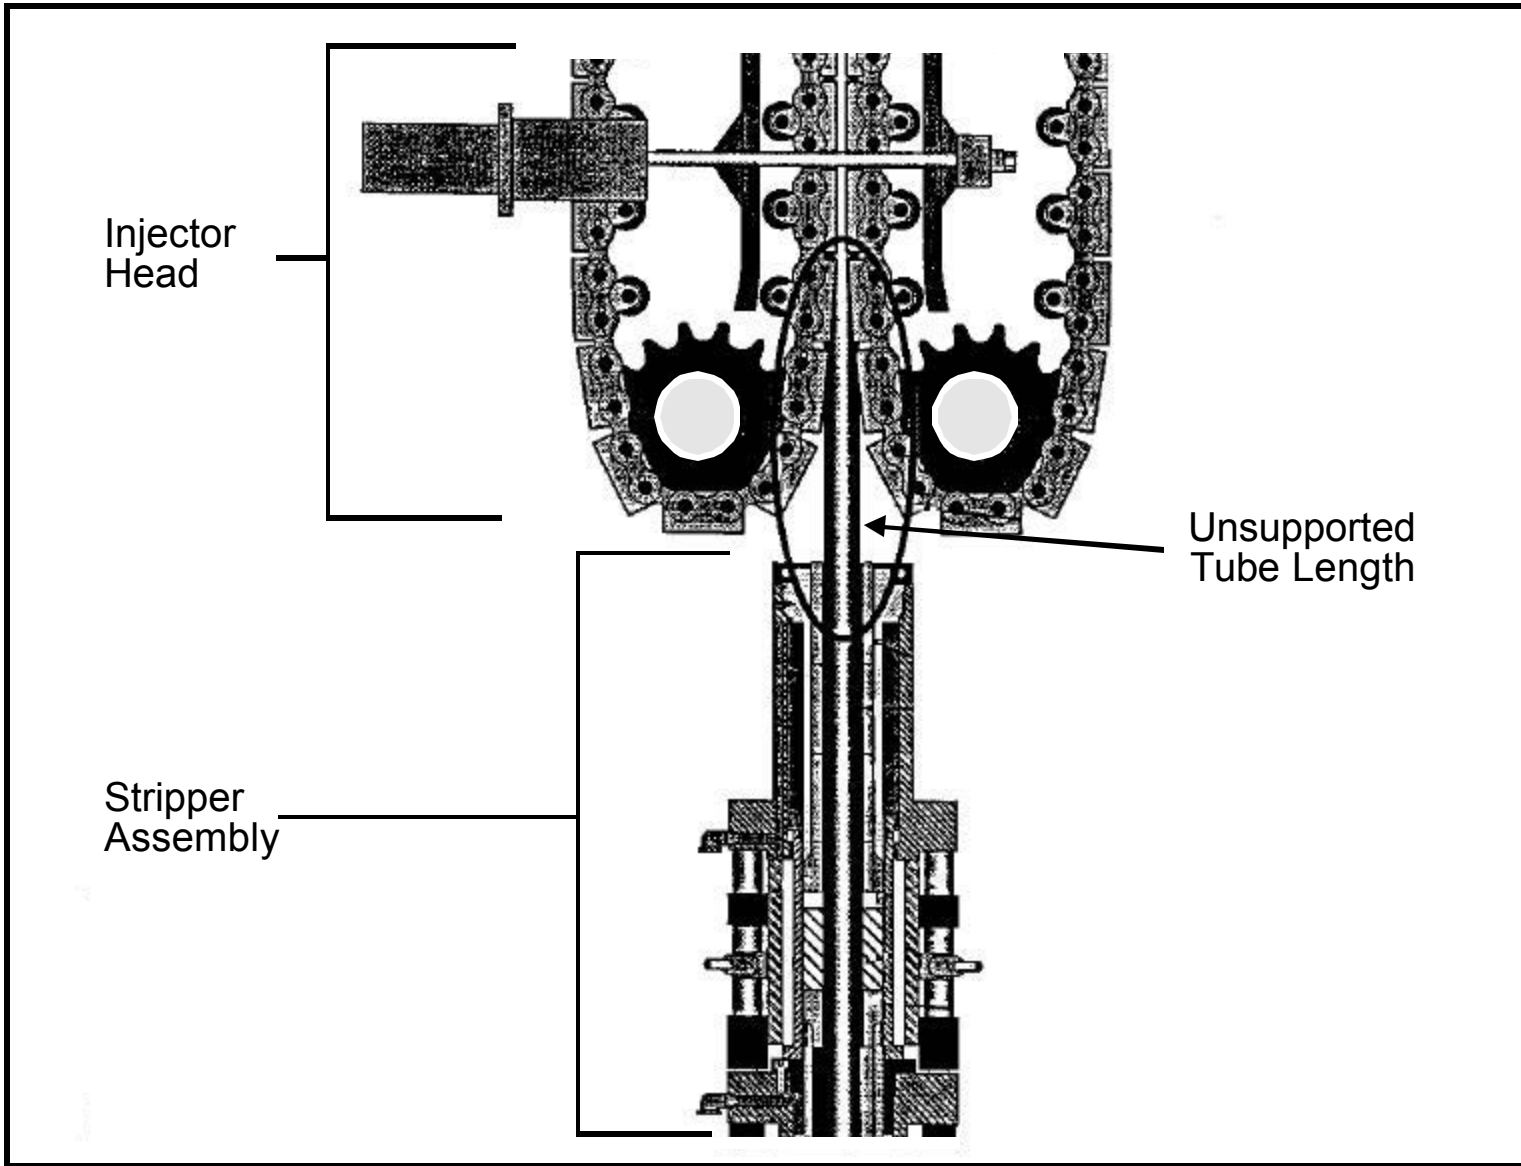
Schematic of Coil Tubing Unsupported Length Between Stripper Assembly and Injector Head

NFX's final report indicates that the 1.25-inch OD, 0.134-inch wall thickness, 100 grade coiled tubing that was being used has a calculated maximum recommended thrust load of 15,423 lbs. The calculation uses the Secant formula and an unsupported length of approximately 13 inches, while assuming a safety factor of 1.25. (*For schematics of unsupported coiled tubing length, see Attachments 3 & 4.*) The report also indicates that for the HR-440B injector in high gear, the calculated maximum pressure setting for the injector hydraulic control pilot valve was 2,150 psi, based on a maximum injector thrust force of 15,423 lbs. The maximum pressure setting for the injector hydraulic control pilot

report also was unable to determine the cause of the sudden stop of the coiled tubing as it was run into the wellbore. Upon coming to an abrupt stop, the coiled tubing experienced an excessive compressive load, which resulted in the buckling and parting of the tubing. The force required to buckle the coiled tubing is a function of several factors, including the coiled tubing geometry and material specifications, the unsupported length of tubing between the stripper and injector, as well as the alignment of the injector chains and stripper. The compressive load or forces were applied to the coiled tubing by the injector chains, which gripped the coiled tubing and thrust the tubing through the stripper and into the wellbore. The magnitude of the forces applied to the coiled tubing by the injector chains is regulated by the injector hydraulic control pilot valve settings. On the basis of the available information, this panel concluded that the pressure settings for the injector pilot valves exceeded the maximum allowable limits for 1.25-inch coiled tubing.

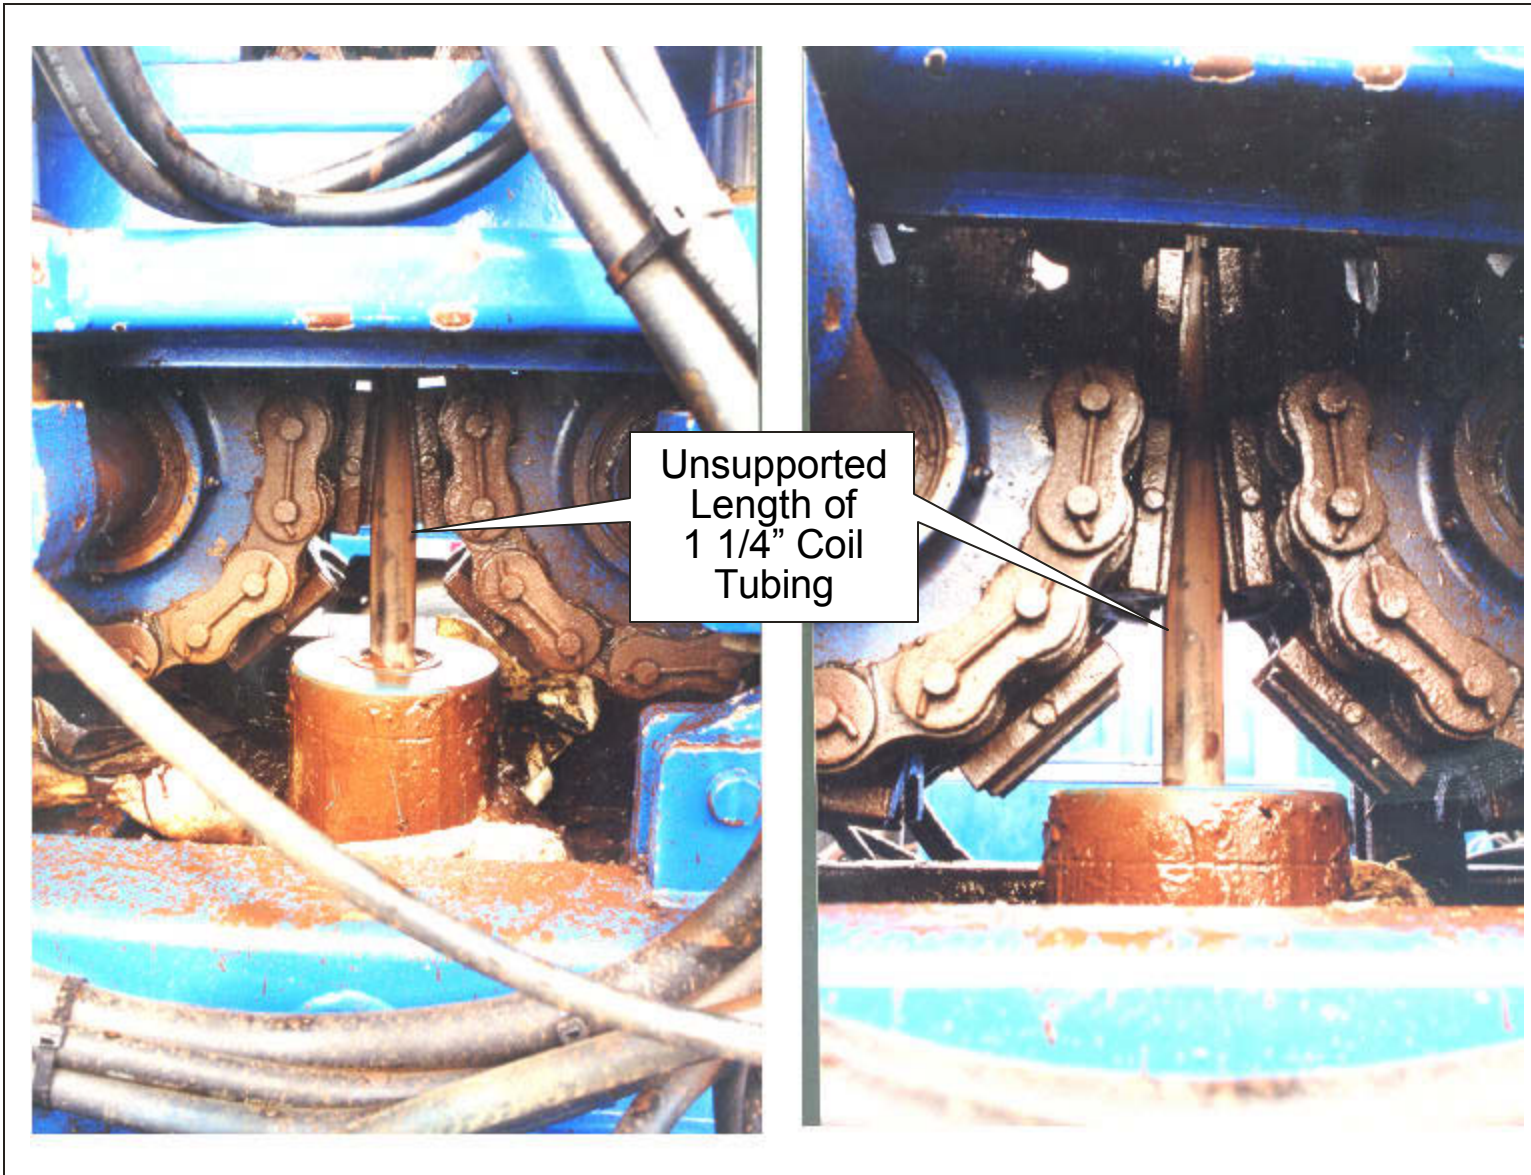
Photographs of Coil Tubing Unsupported Length Between Stripper Assembly and Injector Head

Cause The immediate **cause** of the accident, which led to the uncontrolled flow, was the parting of the coiled tubing above the stripper assembly and the subsequent inability to contain the wellbore fluids.
