**Investigation of Fall and Fatality
Main Pass Block 140
May 19, 2000**

**Gulf of Mexico
Off the Louisiana Coast**

**U.S. Department of the Interior
Minerals Management Service
Gulf of Mexico OCS Regional Office**

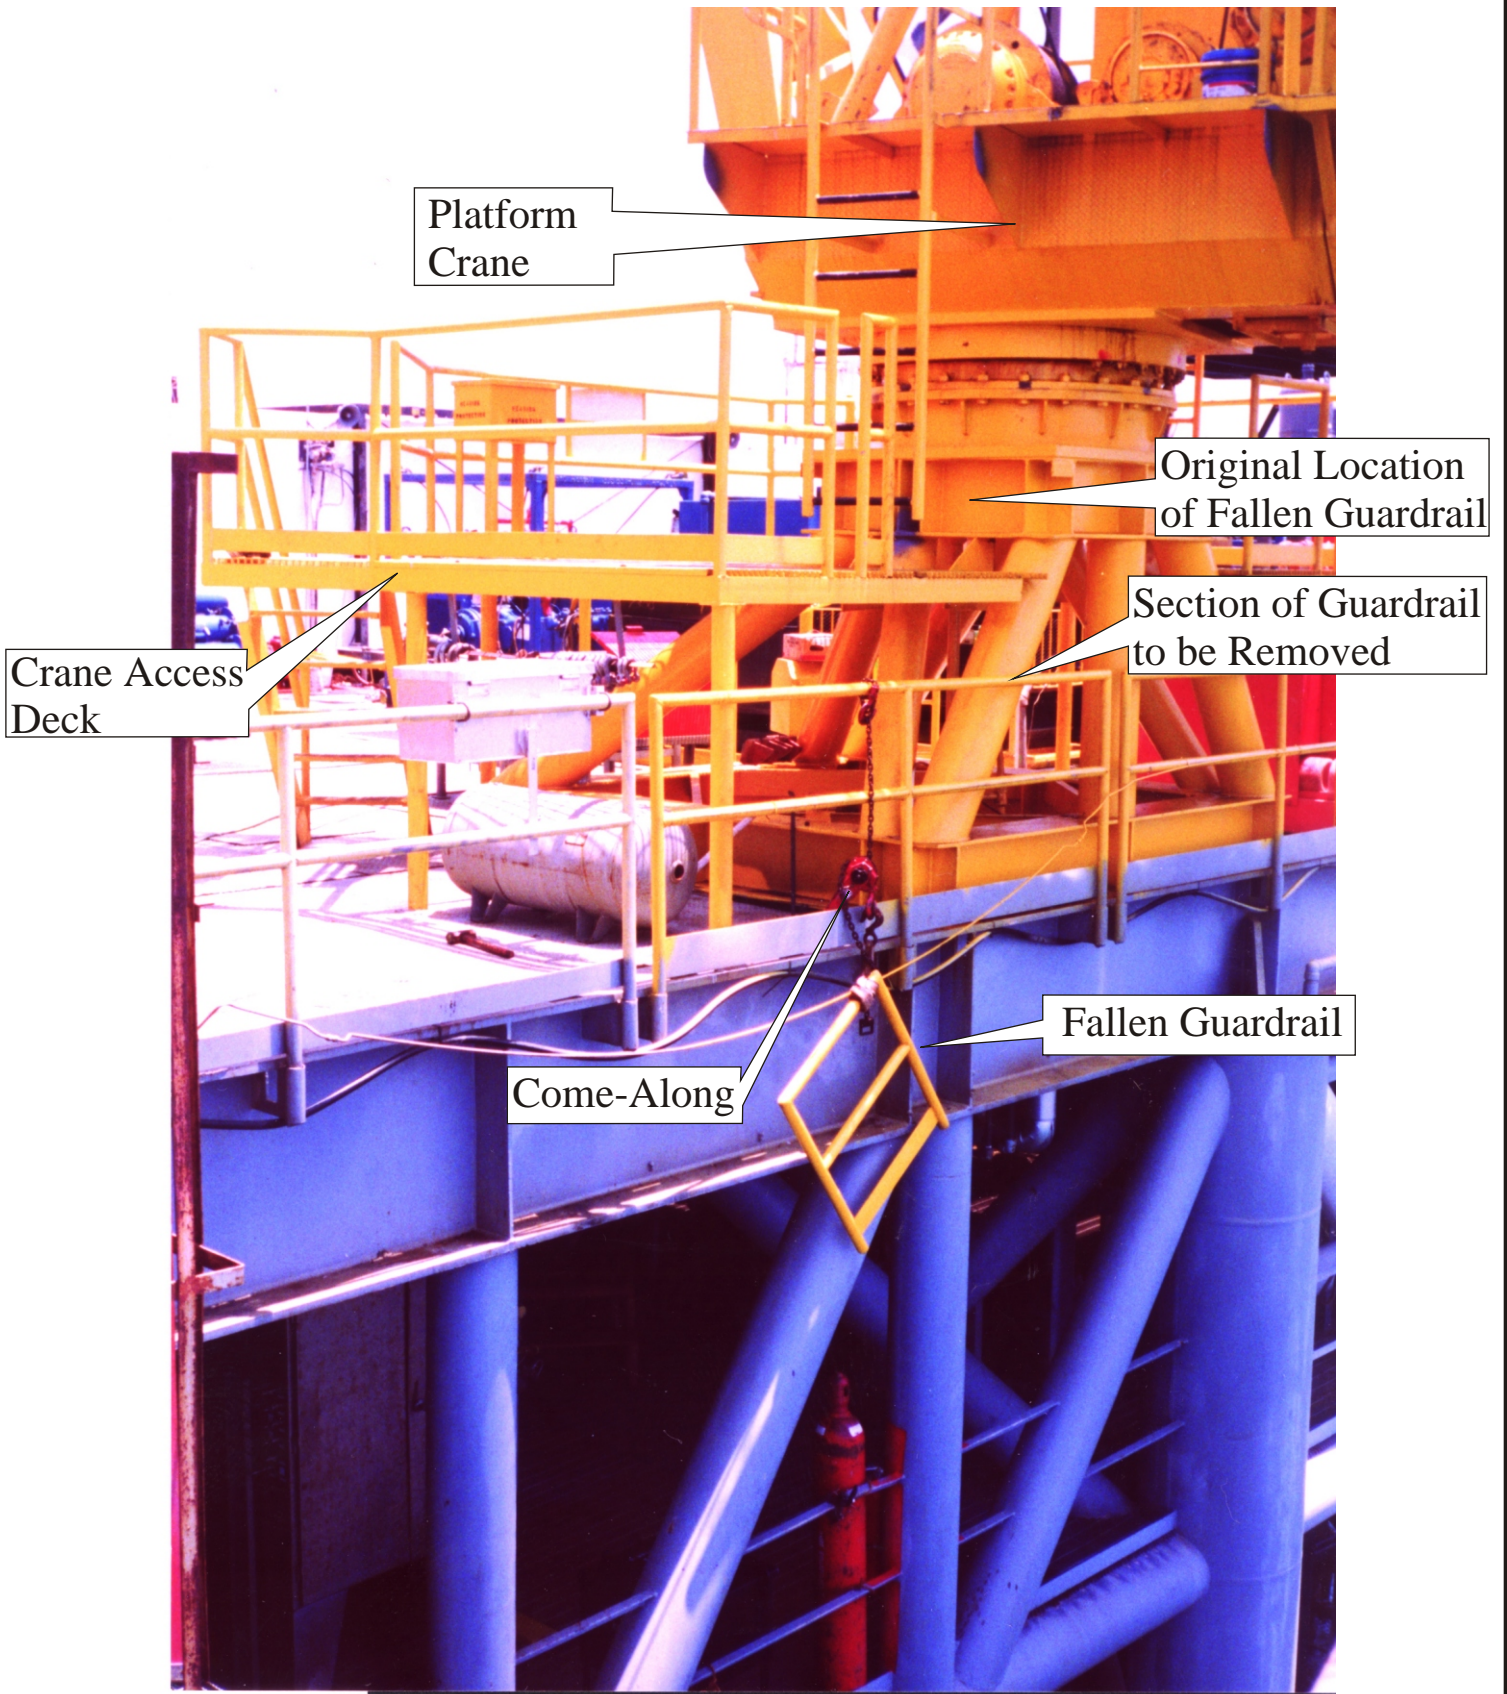
Photograph of Post-Accident Scene

the access deck and saw that the guardrail on that deck had fallen from the deck. M-4 was then witnessed to have fallen from the access deck. After having rushed to the edge of the platform, crewmembers saw that M-4 had fallen to the Plus 10 deck, approximately 60 feet below the main deck. They also saw M-4 roll off the deck into the water.

Material Analysis A visual examination by a metallurgist of the base posts of the guardrail that failed revealed both incomplete and poor welding of the posts to the

platform's crane access deck. Paint and corrosion on the post surfaces indicated that portions of the posts were not welded, while flat weld metal surfaces indicated that some welded portions did not thoroughly fuse with the deck. Furthermore, where fusion did occur, the weld was very thin. It is the conclusion of the metallurgist that the failure was the result of all of the above.

It is the conclusion of the panel that the tensioning of the come-along caused an excessive force to be exerted on the guardrail which, in conjunction with poor and incomplete welding, caused the existing welds between the guardrail posts and the access deck to fail. The Mar-Con employee who was using the come-along fell with the guardrail as a result of either leaning against the guardrail or holding onto the guardrail as he tensioned the come-along. The employee was fatally injured as a result of the fall.

1. A summarization of the first Safety Alert for reference purposes.
2. A recommendation that designated operators and their contractors perform a second JSA for any activity for which an initial JSA was performed and whose steps have been changed since the initial JSA was performed.
3. A recommendation that operators instruct both their representatives and contractors to communicate regarding any change in the steps of an activity that is to be performed, especially when a JSA has been performed prior to the change.

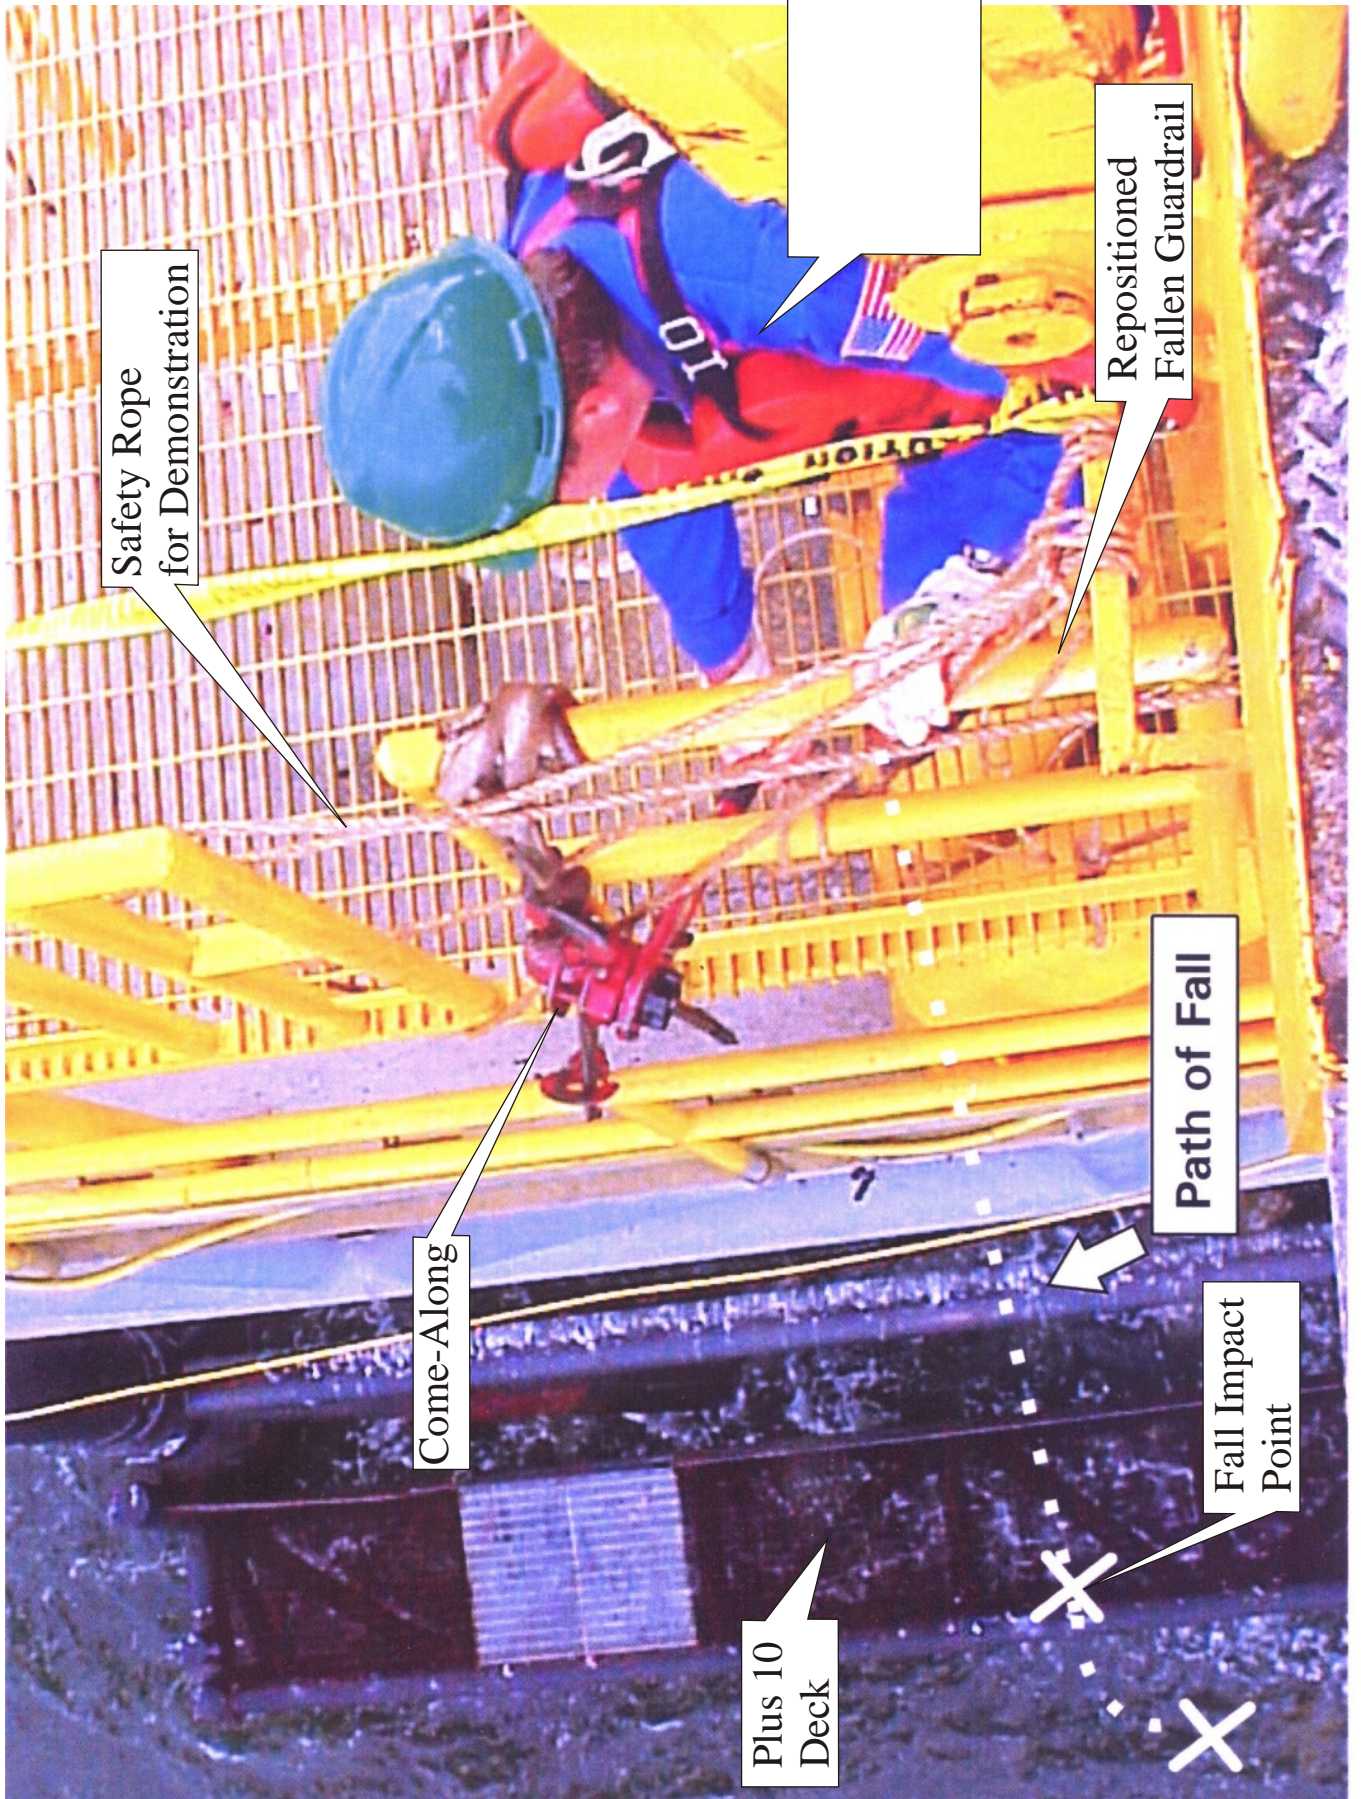
Photograph Demonstrating Fall

M-2 suggested to M-1 that, instead of removing the guardrail by cutting and then later welding it back into place, the guardrail could be lifted out of the sockets into which its vertical posts were inserted. M-1 accepted the suggestion and ordered the crew to use a come-along to lift the guardrail. One end of the 1½ -ton come-along was attached by a chain to the top portion of the guardrail to be removed on the main deck and the other end by a strap to the top portion of the guardrail on the platform's crane access deck. The crane's access deck is approximately five feet above the main deck. While M-1 and M-2 were hammering on one end of the guardrail to be removed and another Mar-Con employee, M-3, was attempting to loosen the other end by using a pry bar, a fourth Mar-Con employee, M-4, was tensioning the come-along. After experiencing difficulty in loosening the guardrail, M-1 instructed M-4 to put further tension on the come-along. At that point, approximately 0815 hours, various employees heard a sound from
