**Investigation of Electrocution on Drilling Rig  
Ship Shoal Block 170, Well No. 1  
OCS-G 33644  
26 January 2013**

**Gulf of Mexico  
Off the State of Louisiana**

**U.S. Department of the Interior  
Bureau of Safety and Environmental Enforcement**

**September, 2014**

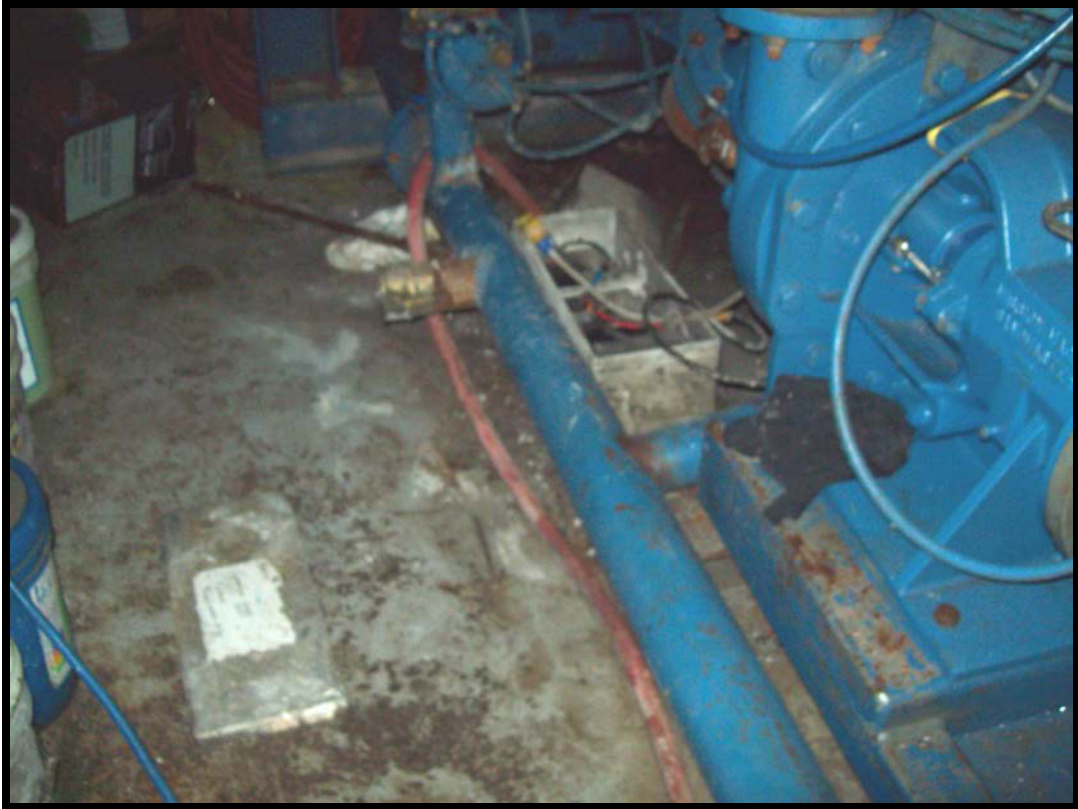
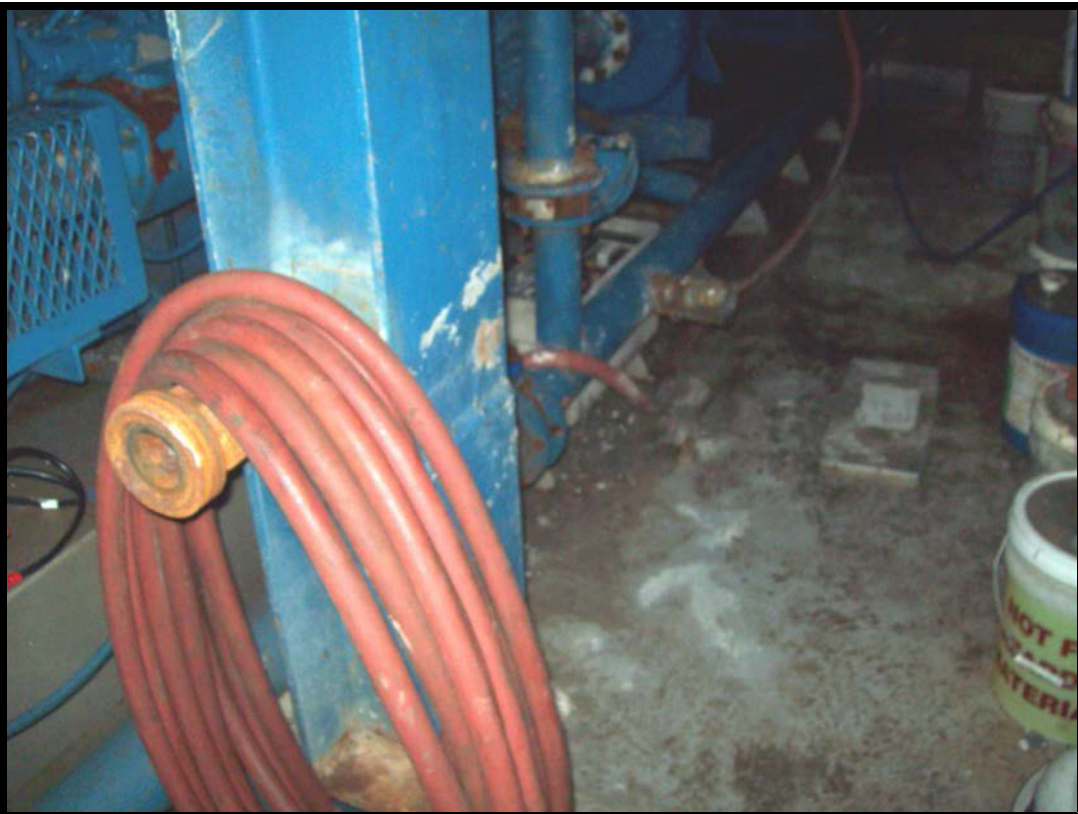
*Figure 10: Deck condition immediately after Incident*

The work area where the Cementer was found is shown in *figures 8 and 9*. The photographs were taken the day after the Incident. The Rig deck in the proximity of the Incident location was described in statements as being "damp." Examinations of other photographs taken immediately after the Incident indicates possible residual salt water or other liquid residue on the deck in the proximity of the Battery Box area (*see figure 10, p. 25*).

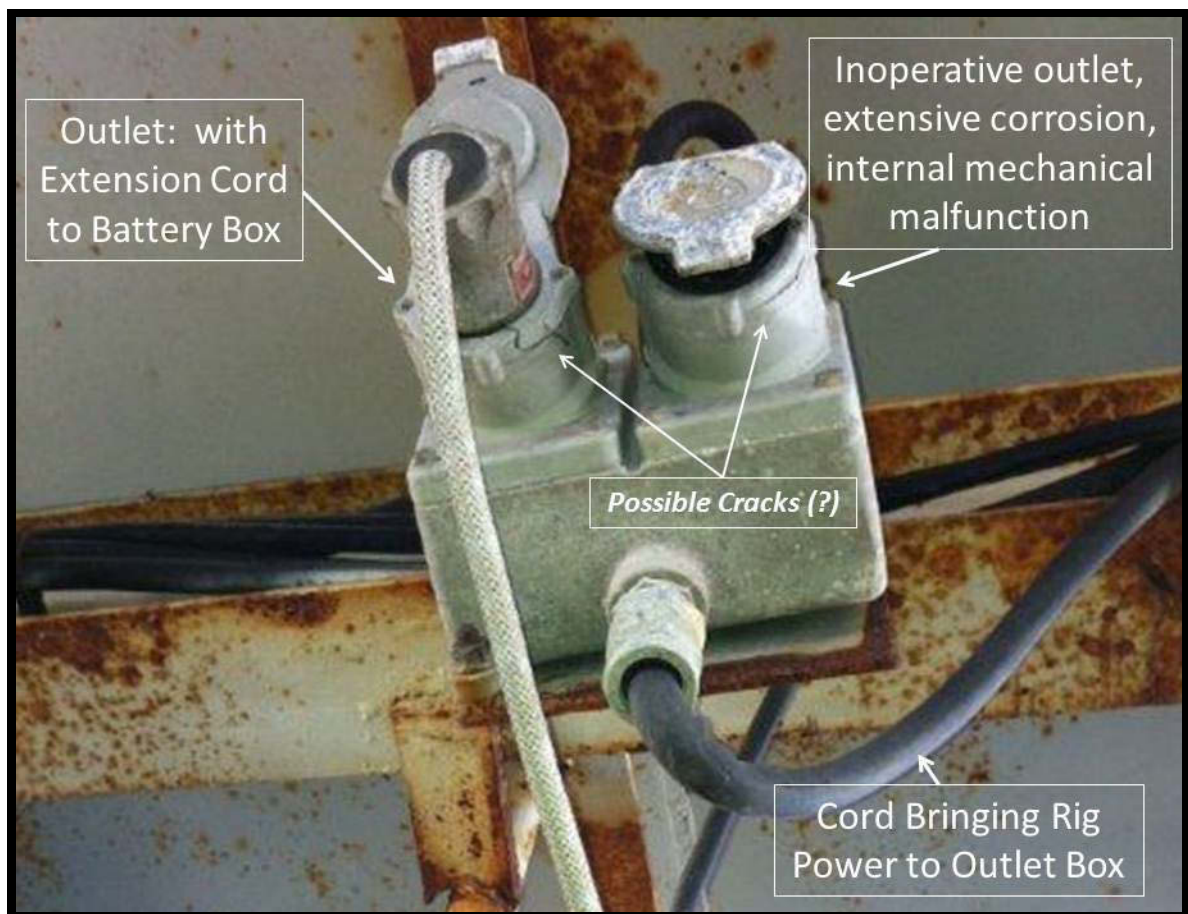
**Figure 16: Appleton dual Outlet Box on Cementing Unit Skid**

At the time of the Incident, the Outlet Box was defective in that only one of the dual outlets actually worked properly. The casing of the Outlet Box itself exhibited signs of corrosion and appeared to have stress or wear cracks in the connection seals of both plug receptacles.

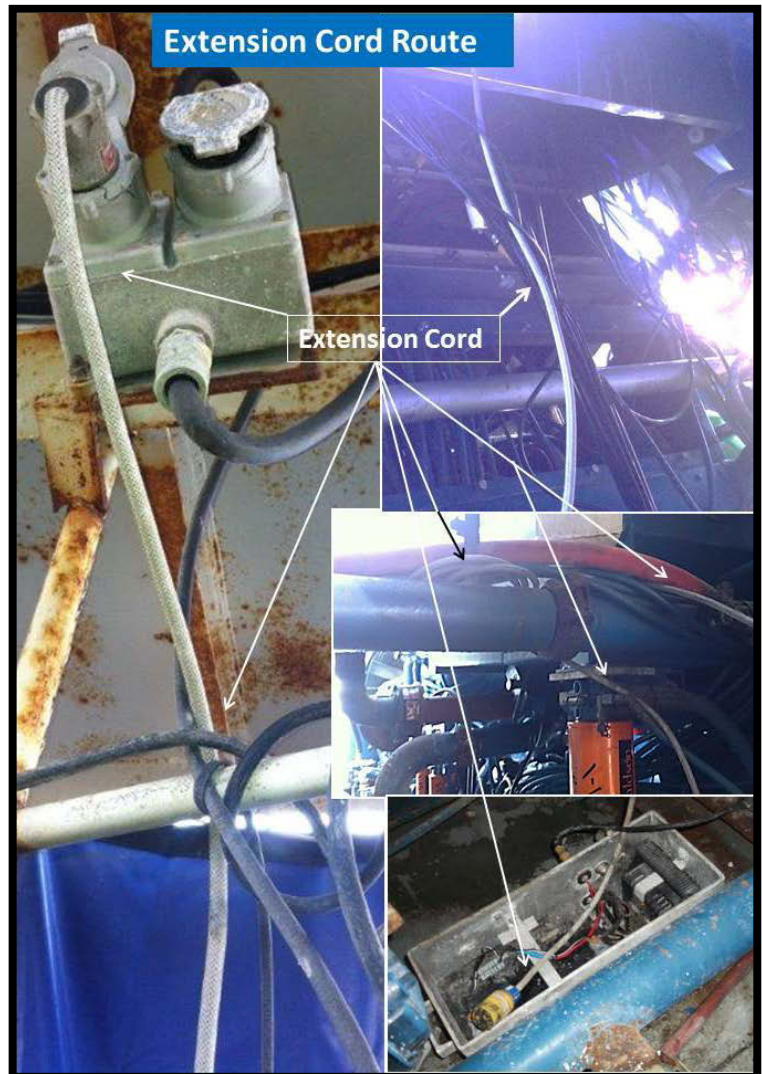
**Figure 19: Extension Cord, from Outlet to Battery Box**

The on-site built Extension Cord was approximately 20-ft long and utilized aluminum armor on the outside and three conductors, white, black, and red. Examination of the Extension Cord after the Incident found it to be of indeterminate age, but estimated to be at least three years old. The armor coating was in poor condition with numerous holes, frayed webbing, and loose armor strands.

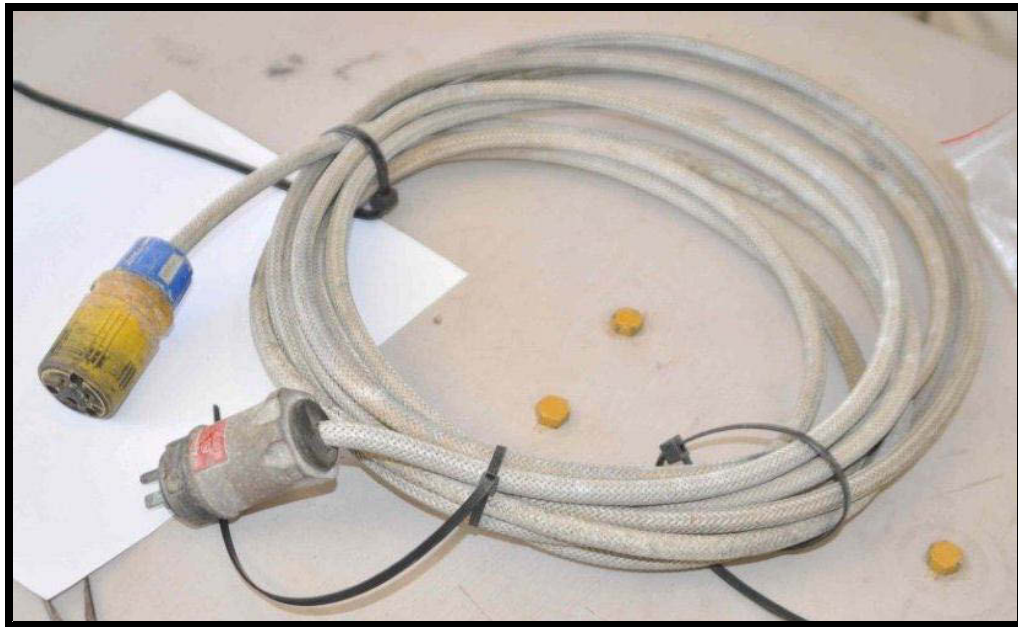
**Figure 20: Extension Cord**

The male plug end attached to the Extension Cord was an ‘Appleton’ explosion proof type. The female plug end was of an unknown manufacture with a NEMA rating 5-15 (*NEMA type 5 [dust-tight only, not water-tight] – 15 amp*). The male plug end exhibited obvious signs of corrosion. Additionally, it was damaged and missing one screw attaching the face plate. The female end was not designed or rated for use in a high moisture area. The female end had extensive burn residue extending from the plug end throughout the portion covered by the inlet insertion bracket of the Battery Box, which also had extensive burn residue (*see figures 20, 21*).

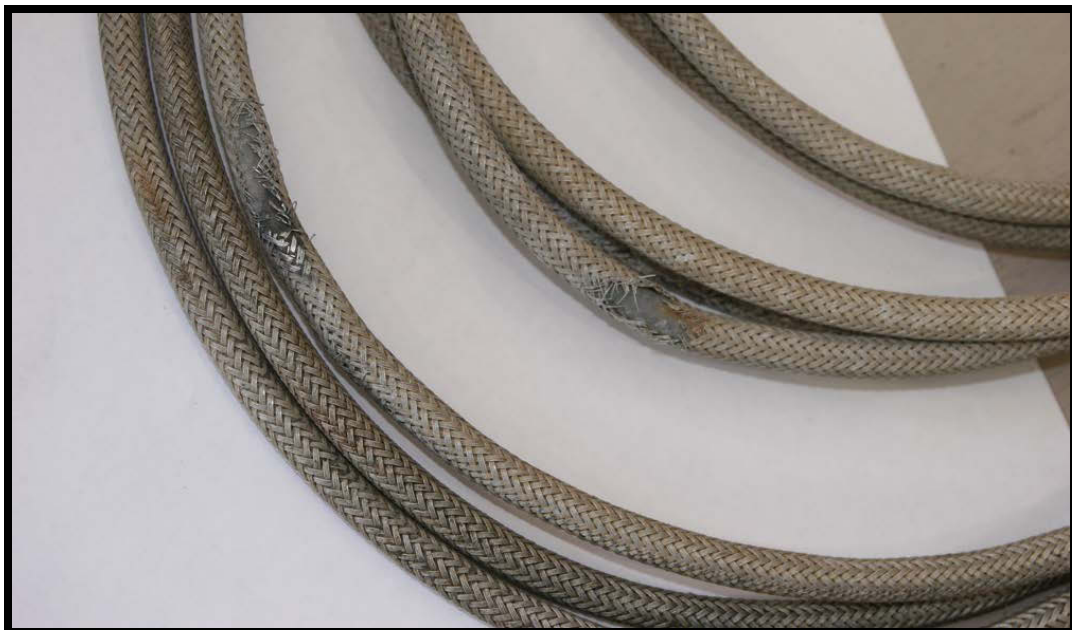
***Figure 22: Armor Condition of Extension Cord***

Statements indicate that the materials used to build this Extension Cord were substandard, and though it may have met standard electric code or best practices from a size/length/conduction ratio (*it appeared to be AWG-14 size when AWG-16 is adequate*) the qualities were not tagged on the cord. The Extension Cord was defective from a material standpoint because of the armor.

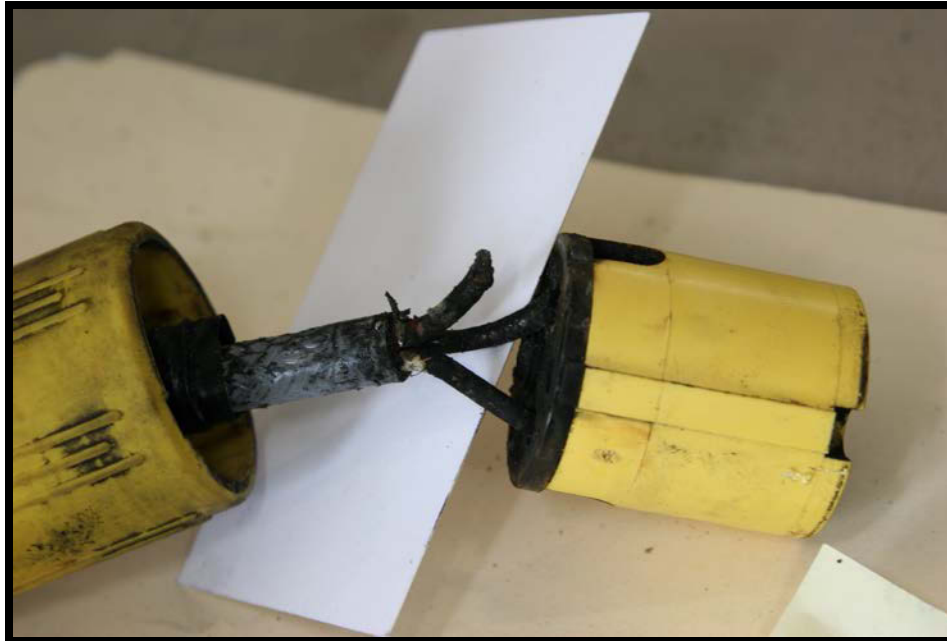
*Figure 23: Internal female end of Extension Cord after Incident*

According to statements by the SMEs, at some time prior to this Incident, moisture entered the female plug end and shorted the hot leg to the ground leg of the female socket. This short burned the ground wire inside the female socket. This carbonized black coating, evident inside the female socket, became the new current path inside the female socket to the grounding lug of the socket and to the wheeled Battery Charger's metal case (*see figure 23*).

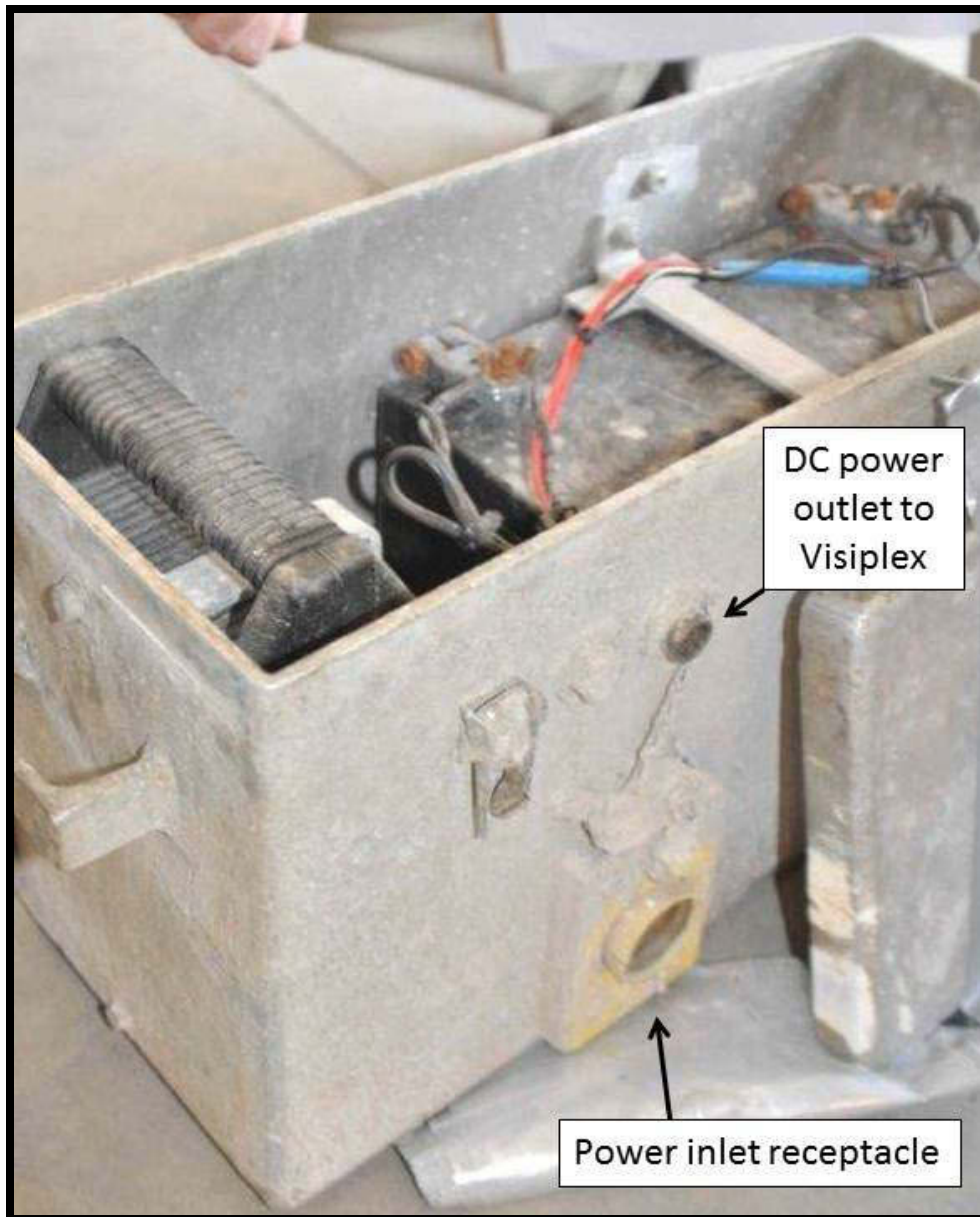
*Figure 24: Battery Box opened for SME inspection*

The location of the Battery Box on the deck of the Rig inside the bottom rail of the Skid was in proximity to the pumps, connections to tanks, and open to the weather. This location allowed the Battery Box to be frequently in contact with various liquids including salt water used to wash the deck, and cement. Photos taken immediately after the Incident indicates the deck in proximity to the Battery Box could have been wet. When examined later, the removable top and all of the sides of the Battery Box were found to be covered with dried cement (*see figure 24*).

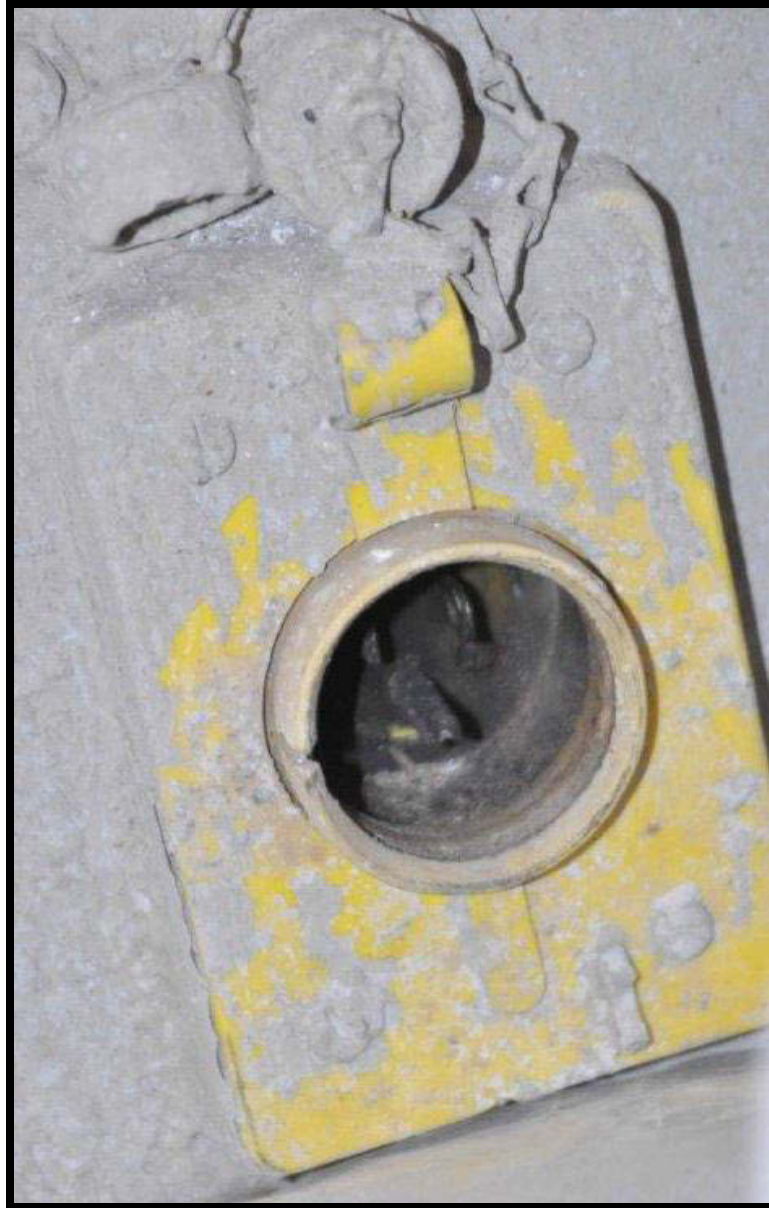
***Figure 25: Battery Box Extension Cord inlet receptacle***

Power to the Battery Box delivered by the Extension Cord was transmitted by plugging the female end of the Extension Cord into a power inlet receptacle containing a male plug, located on the side of the Battery Box. The inlet receptacle had a partial metal guide to insure proper mating. Neither the female plug end nor the inlet receptacle would have met NEMA 4 water-tight standards. The side of the battery box containing the inlet receptacle for the Extension Cord was covered in dried cement as was the receptacle itself (*see figure 24 and 25*).

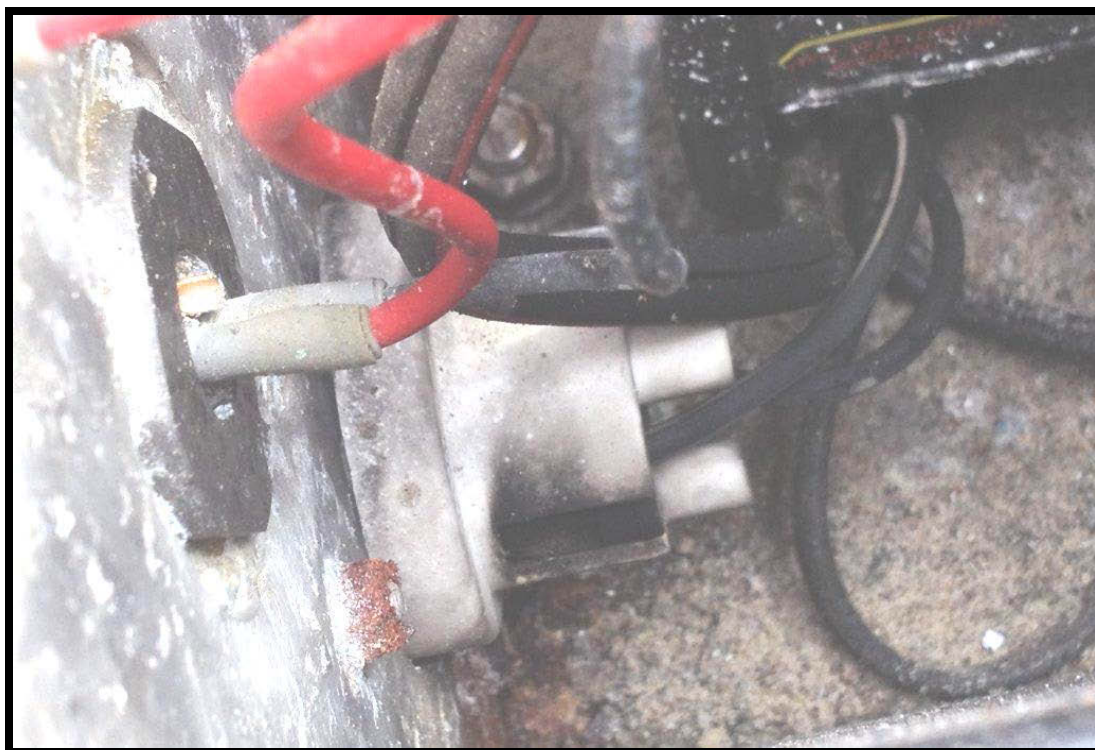
*Figure 29: Insulator, power entry, Battery Box at time of the Incident*

When inspected, the insulator for the male plug receiving power into the Battery Box was found to have a heavy burn residue (*see figures 29, 30*). The power receptacle inlet and guide also had a notable charred appearance and a burned smell that was evident two months after the Incident. The heaviest burn residue on the insulator appeared to be in the approximate location of the ground wire on the replacement battery box male plug.

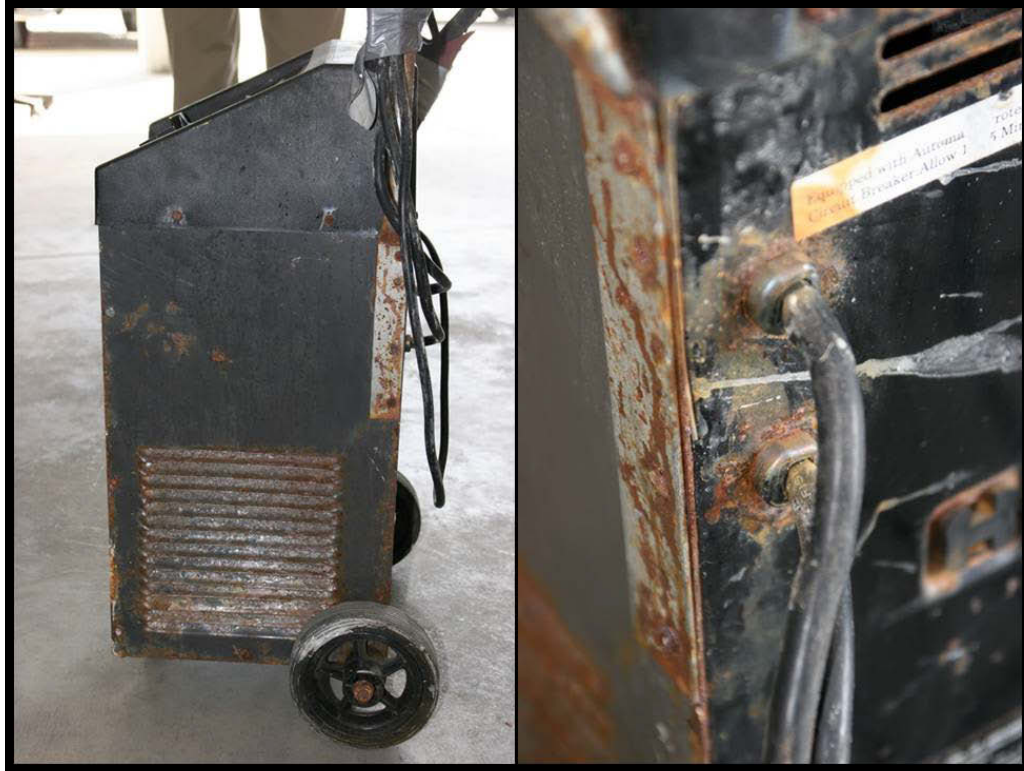
Figure 33: Rig Battery Charger weathering, side and back

The Battery Charger showed evidence of corrosion and weathering from exposure to the elements despite the warning labels to avoid contact with water (see figure 33). However, examination of the external and internal components of the Battery Charger by the SME Group did not discover any obvious malfunctions that would have contributed to the Incident (see figure 34 for wiring schematic of Battery Charger).

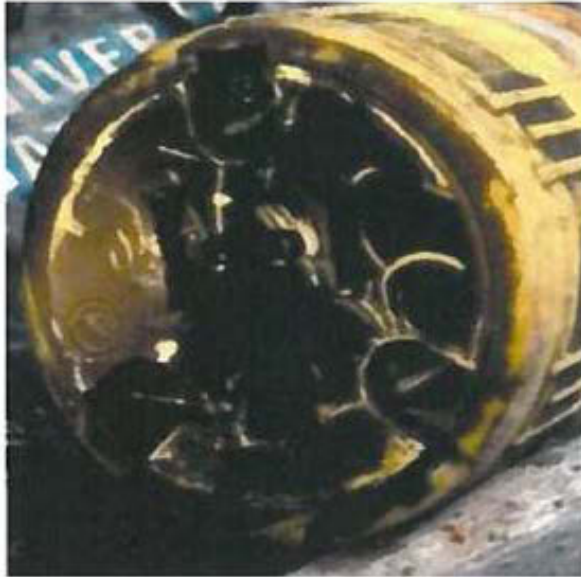
Female end of the extension cord. Note the signs of electrical burning.

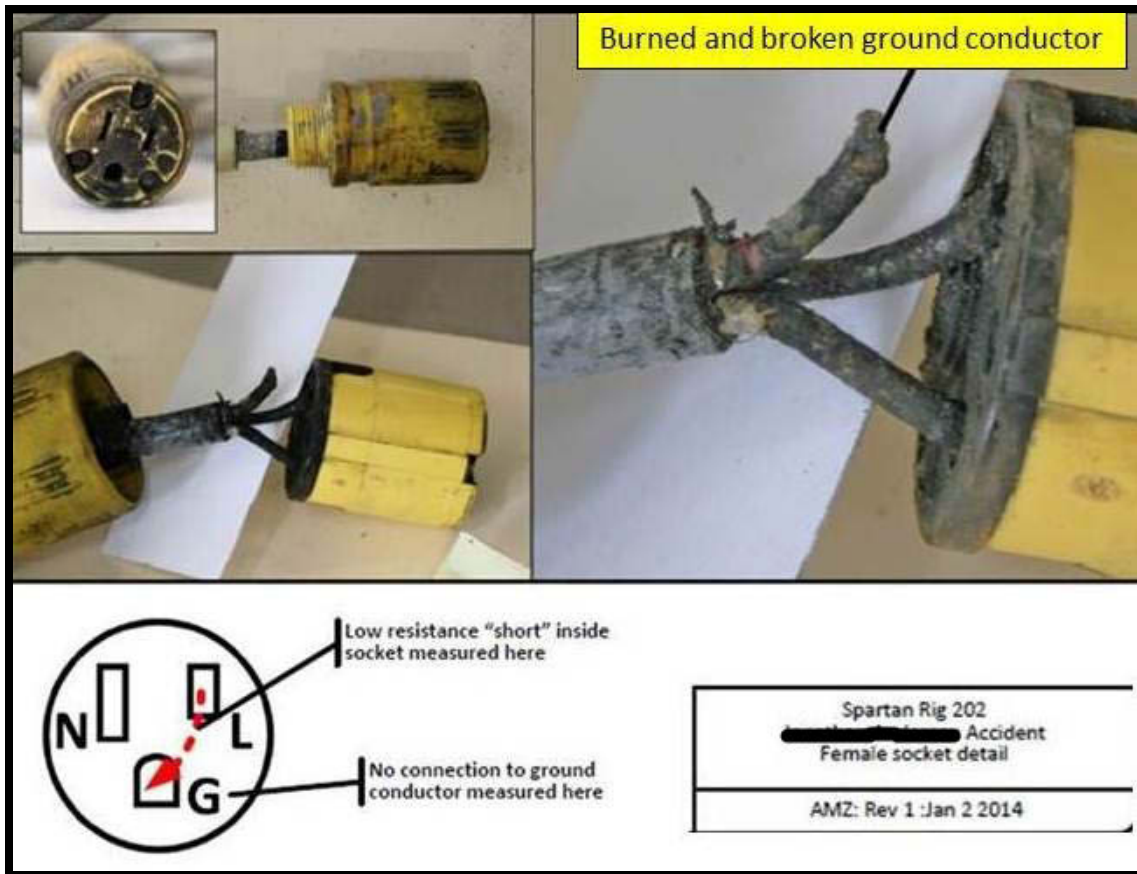
**Figure 41: SME Group Report, Attachment 1**

*“The 120V “hot” terminal within the female socket was shorted to the socket’s ground terminal. This defect was noted by electrical resistance measurements between the line and ground terminals of the female socket.*

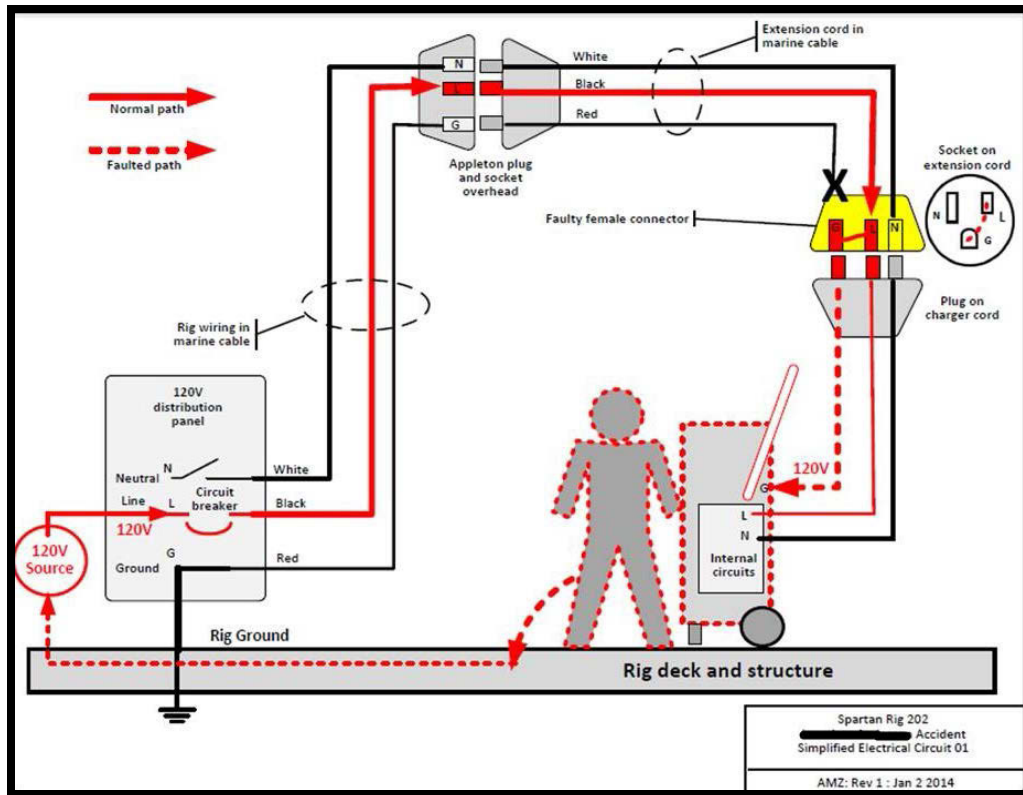
Figure 42: SME Group Report, Attachment 2

"The attached diagrams illustrate simplified schematics showing both the normal current path and the fault current path. The normal 120 V current flowed through the circuit breaker, then through rig wiring and the extension cord, to energize the "line" side of the charger's internal circuitry.
