**Investigation of Loss of Well Control
South Timbalier Block 188, Well CA-3
OCS-G 1899
22 April 2003**

**Gulf of Mexico
Off the Louisiana Coast**

**U.S. Department of the Interior
Minerals Management Service
Gulf of Mexico OCS Regional Office**

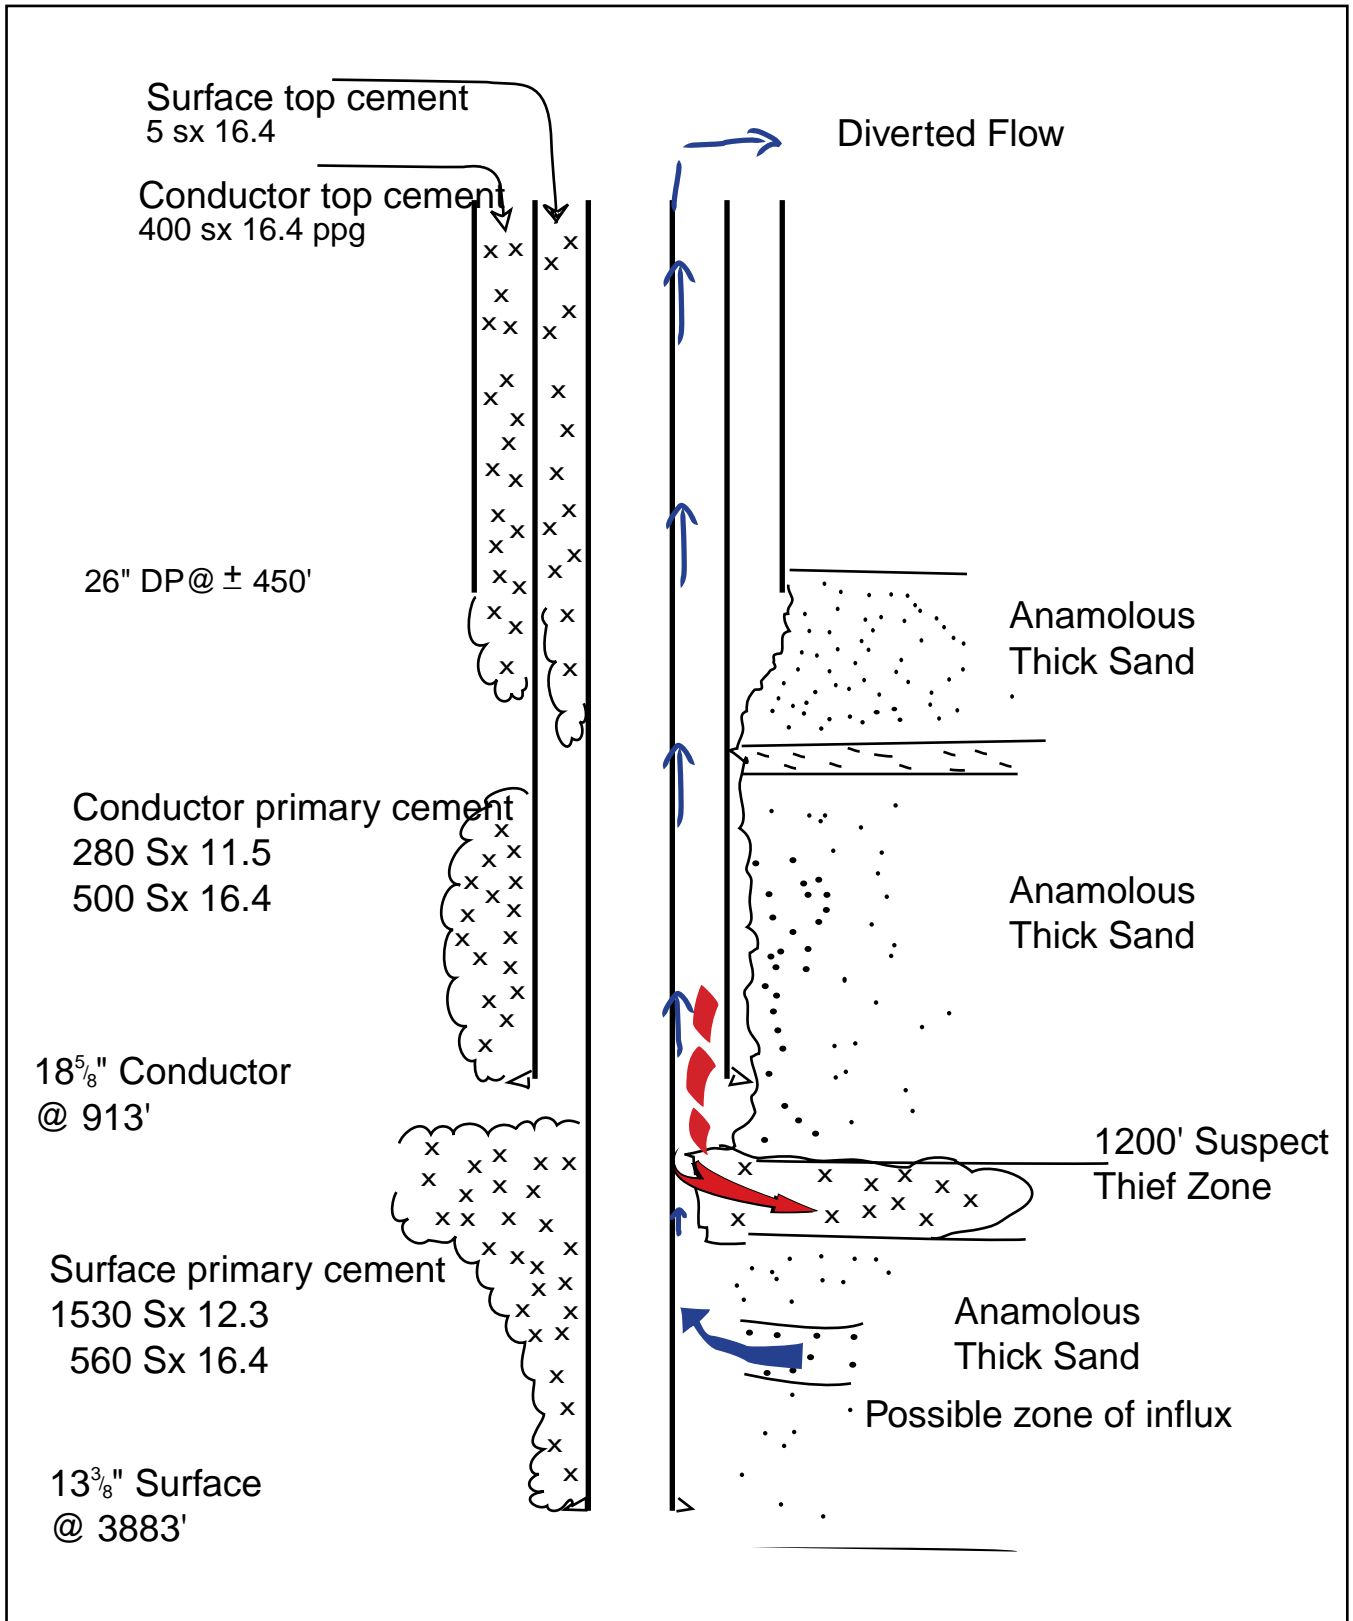
South Timbalier Block 188 CA-3: to surface casing installation

However, once the CA-3 drive pipe was drilled out, an anomalous, thick sand deposit was immediately encountered that initially caused large seepage losses and finally complete loss of drilling fluid returns. The drilling plan was subsequently modified and a string of conductor casing was run to 913 ft and cemented. Because no cement returns were received at the surface, a top cement job was performed. When the conductor casing was subsequently drilled out, the anomalous sand deposit continued to be encountered to a depth of 4,800 ft where surface casing was to be set, with significant seepage losses continuing (*see Attachment 2 for casing and cement schematic of Well CA-3*).

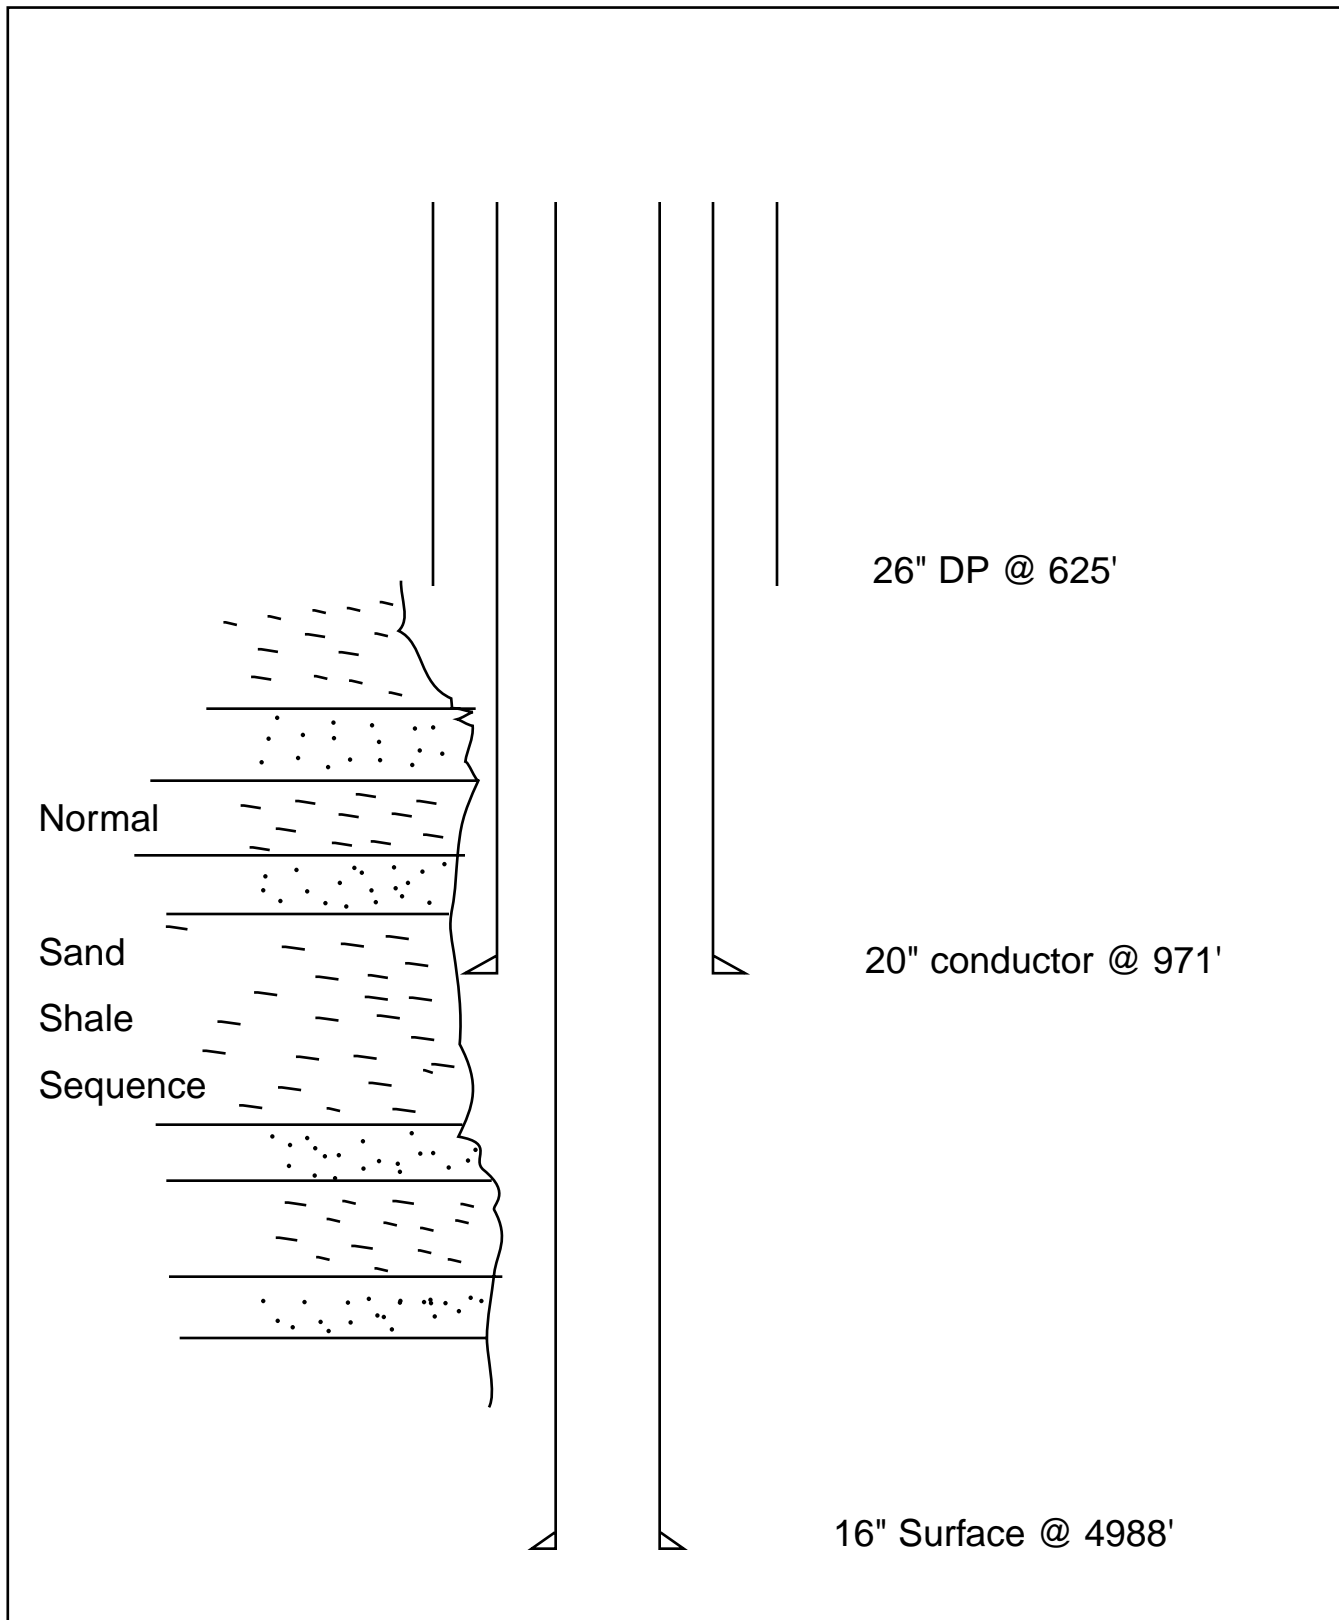
South Timbalier Block 189 CA-7: to surface casing installation

The 2002 well program scheduled the C-7 well first. This well was permitted to be drilled from the Platform to a bottomhole location (BHL) within adjacent Lease OCS-G 1572. The CA-7 was spudded on 3 November 2002 and completed as planned with no abnormal drilling incidents. The casing program for the CA-7 utilized new drive-pipe (the CA-7 was drilled from a pre-existing slot with no previously installed drive-pipe) driven to 626 ft, conductor casing set at about 971 ft, and surface casing set at 4,988 ft (*see attachment 3 for casing plan of CA-7*).

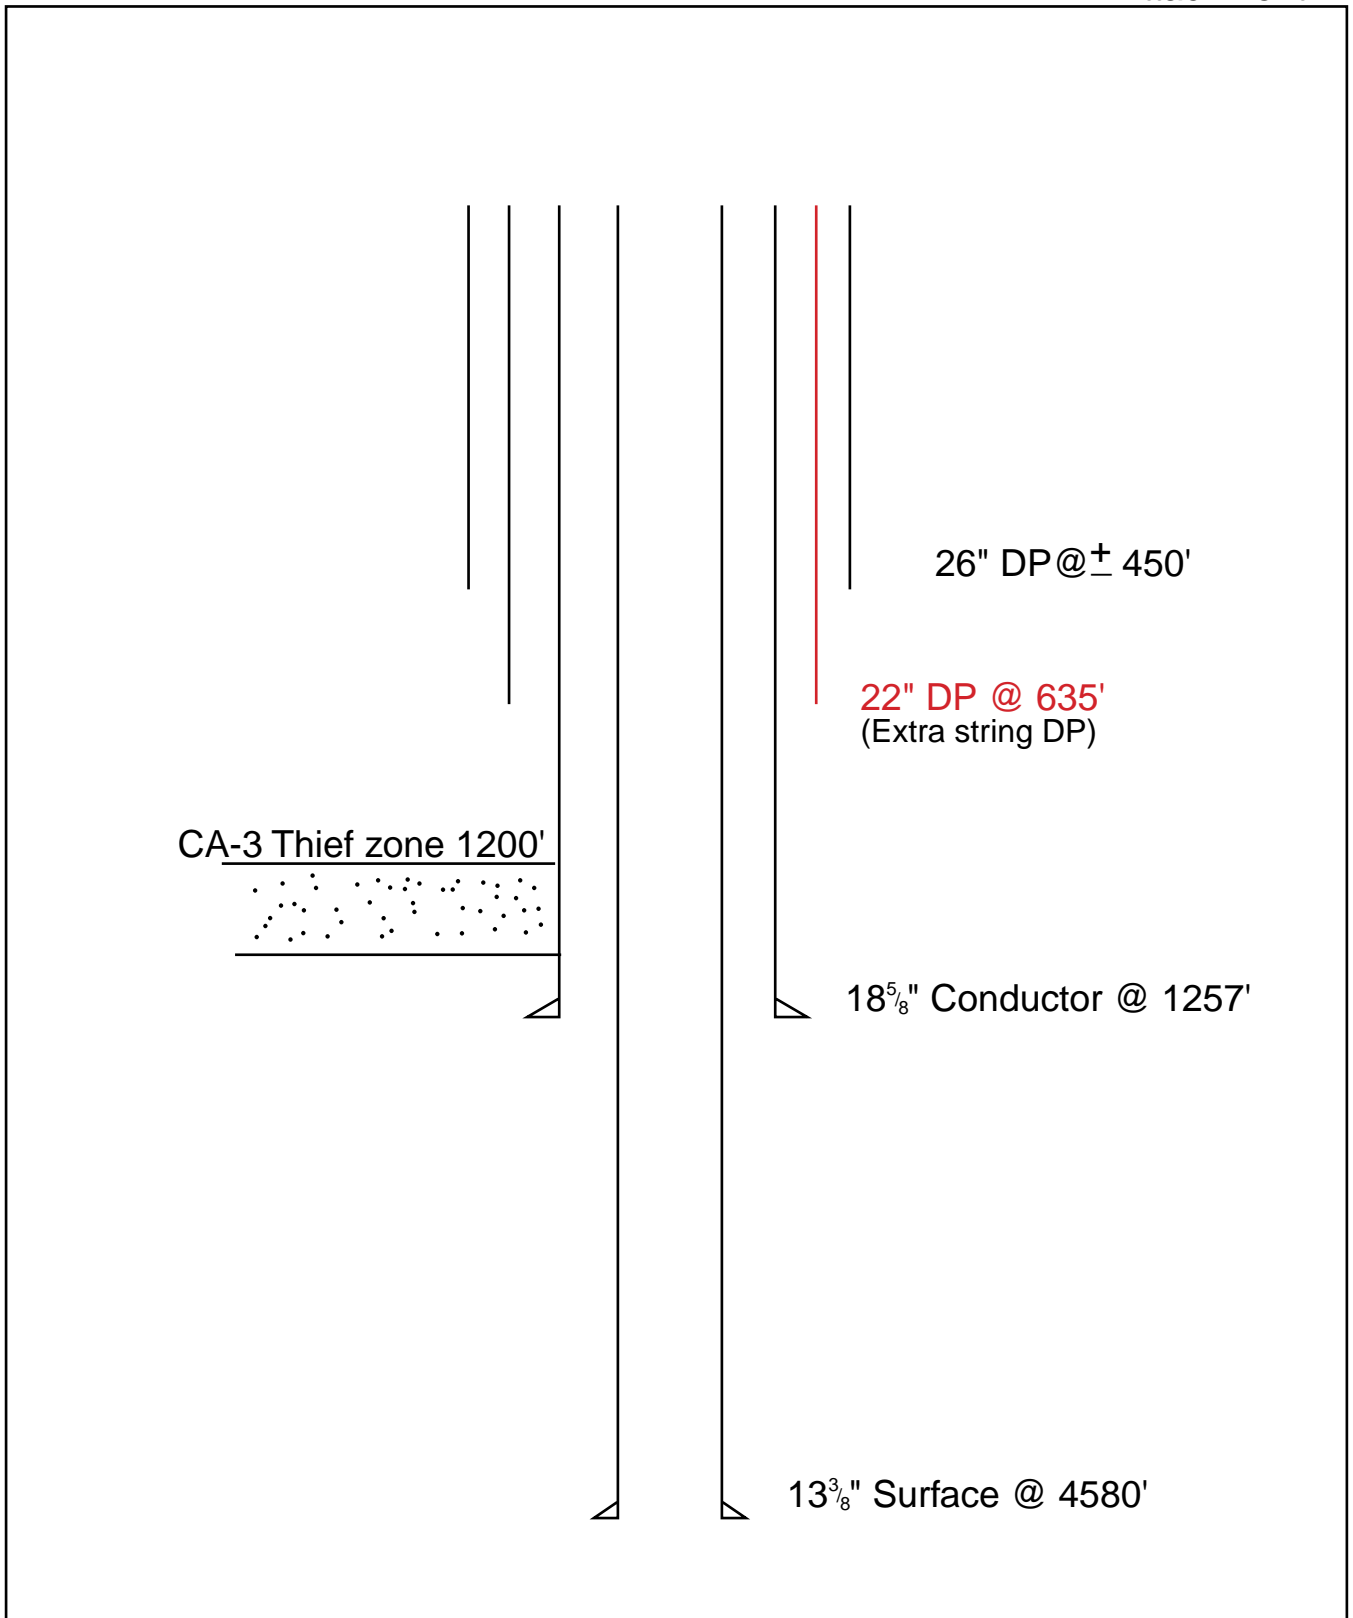
South Timbalier Block 189 CA-4: to surface casing installation

The chronology of events during the drilling of the CA-4, after the completion of the CA-3, indicates that the well did not experience the drilling problems to the extent encountered in the CA-3, though the CA-4 did encounter lost circulation and no returns during cementing of the conductor pipe. However, the design of the CA-4 was significantly different than that of the CA-3. In the CA-4, the Operator drove new drive-pipe 188 ft deeper than that which had been installed for the CA-3. According to testimony, the deeper drive-pipe enabled the Operator to set the conductor casing at 1,331 ft rather than the 931 ft in the CA-3. In the CA-4, after the setting of the conductor casing at 1,331 ft, presumably isolating the primary thief zone encountered at approximately 1,200 ft in the CA-3, the surface hole for the CA-4 was drilled with normal fluid loss and the surface casing was cemented with full returns.
