**Investigation of Loss of Well Control
Eugene Island Block 107, Well B-1 Workover
OCS-G 15241
8 March 2003**

**Gulf of Mexico
Off the Louisiana Coast**

**U.S. Department of the Interior
Minerals Management Service
Gulf of Mexico OCS Regional Office**

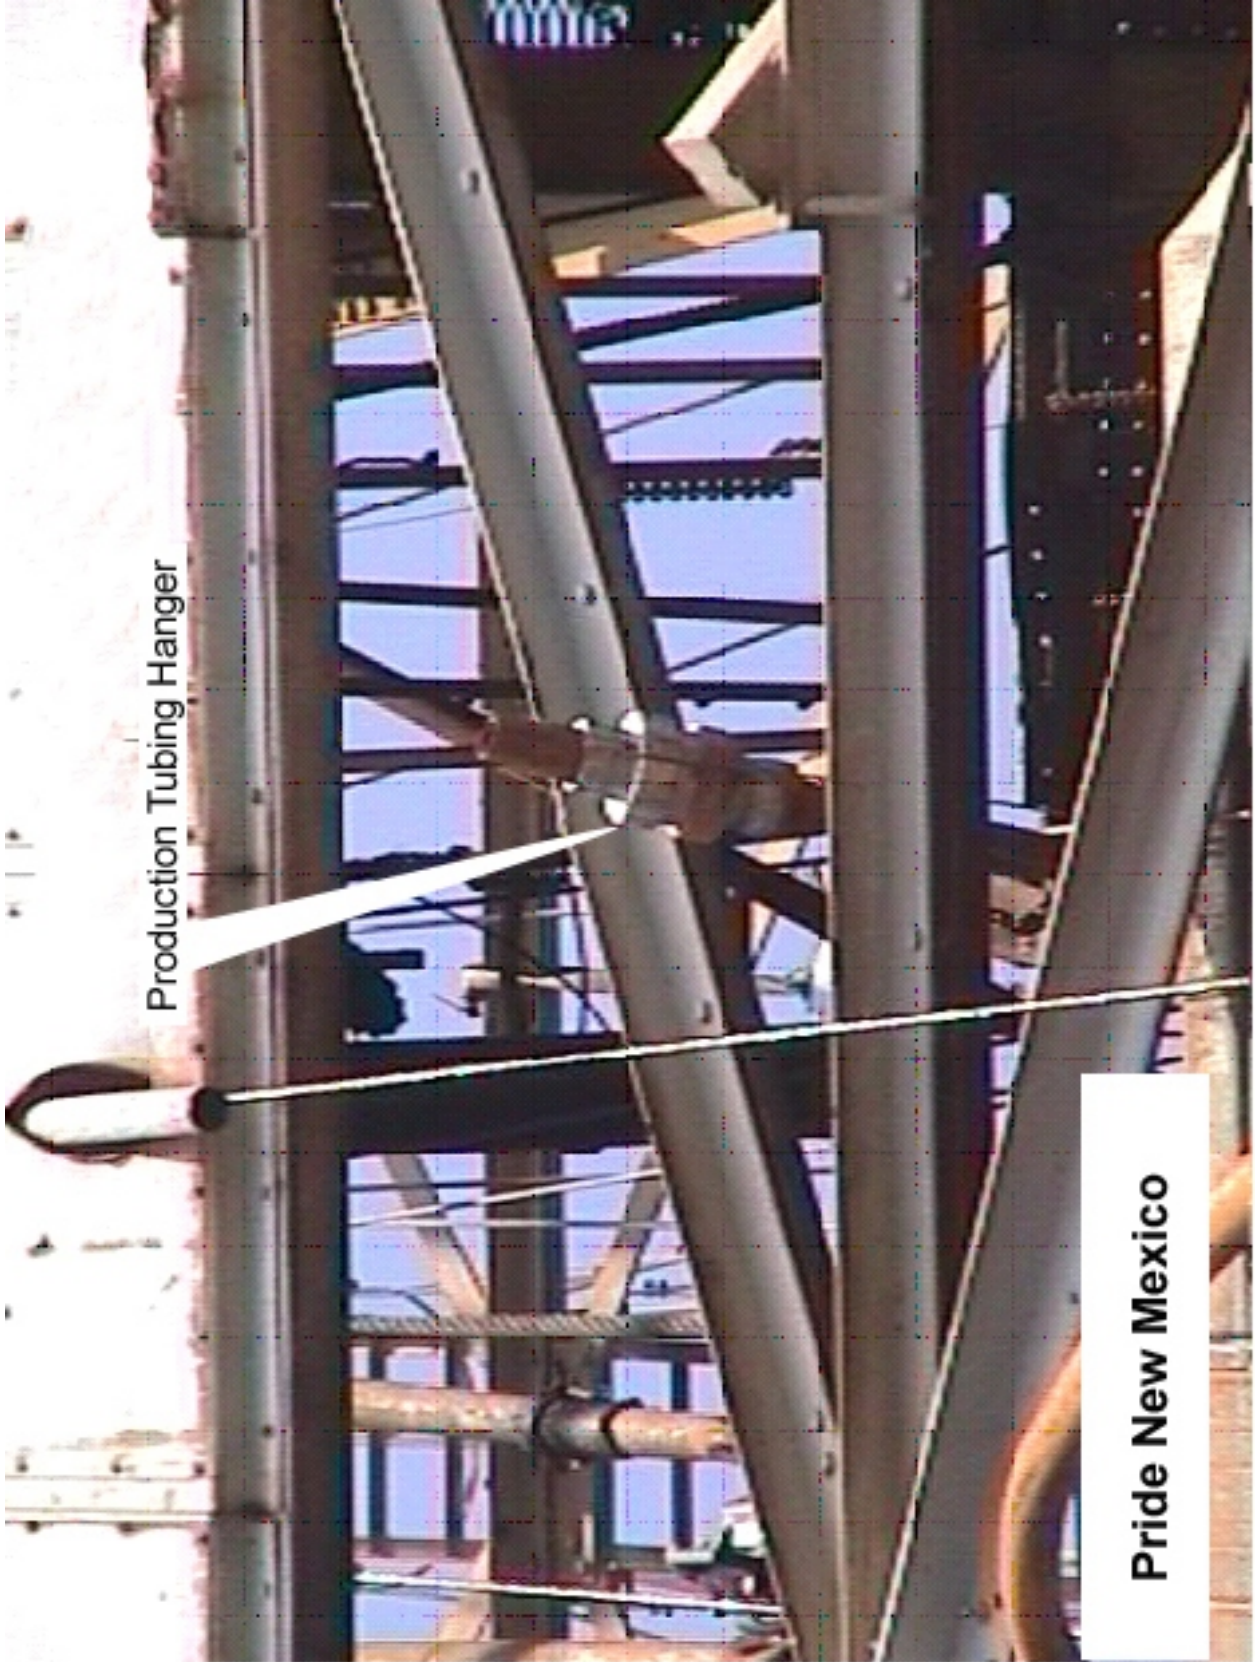
Eugene Island Block 107, Well B-1, Hanger Ejected from Well into Derrick

2245 hrs - Pressure on the hanger rose above 6,000 psi. During attempts to control pressure by bleeding, and during preparations to swap valves to lubricate annulus, the hanger and tubing attached to it were suddenly ejected from the wellhead. The ejection was followed by an uncontrolled flow of gas, water, condensate, blowing as high as the crown block, according to testimony. The hanger was later found lodged near the crown block within the derrick (*see Attachment 3*). Approximately 600 ft of 2 7/8-inch production tubing and the surface controlled subsurface safety valve (SCSSV) were found to be wrapped around and through the derrick (*see Attachments 4-6*).

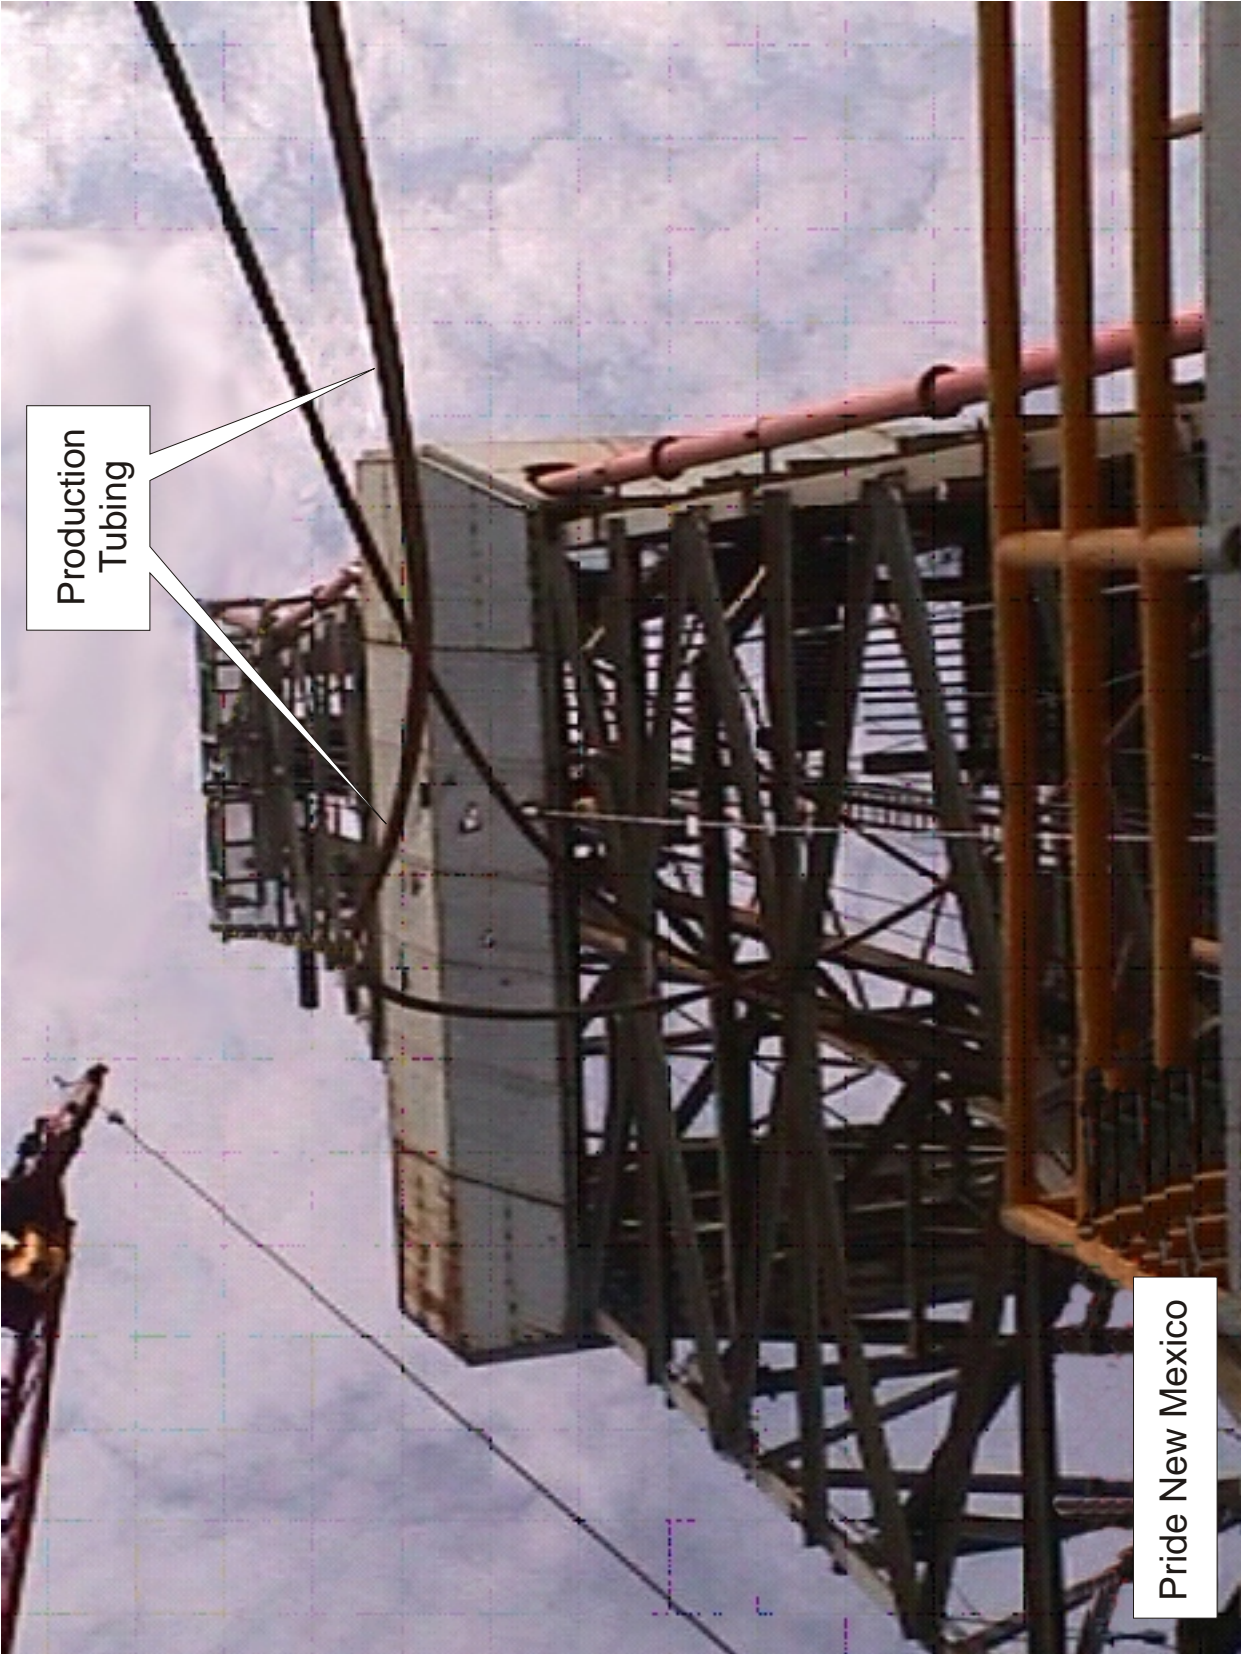
Eugene Island Block 107, Well B-1, Tubing Ejected from Well
Outside of Derrick

The manufacturer's representative had replaced the 12 pins, 3 at a time, six hours prior to the advent of pressure, to manufacturer's specifications according to testimony. However, the pins obviously failed to hold the hanger in place under the well conditions encountered and were found to have their noses sheared off. The pins removed prior to the failure were not sheared. Furthermore, the tubing hanger showed evidence of scraping against the sheared lock screws as it was ejected (*see Attachments 6, 7, and 8*).

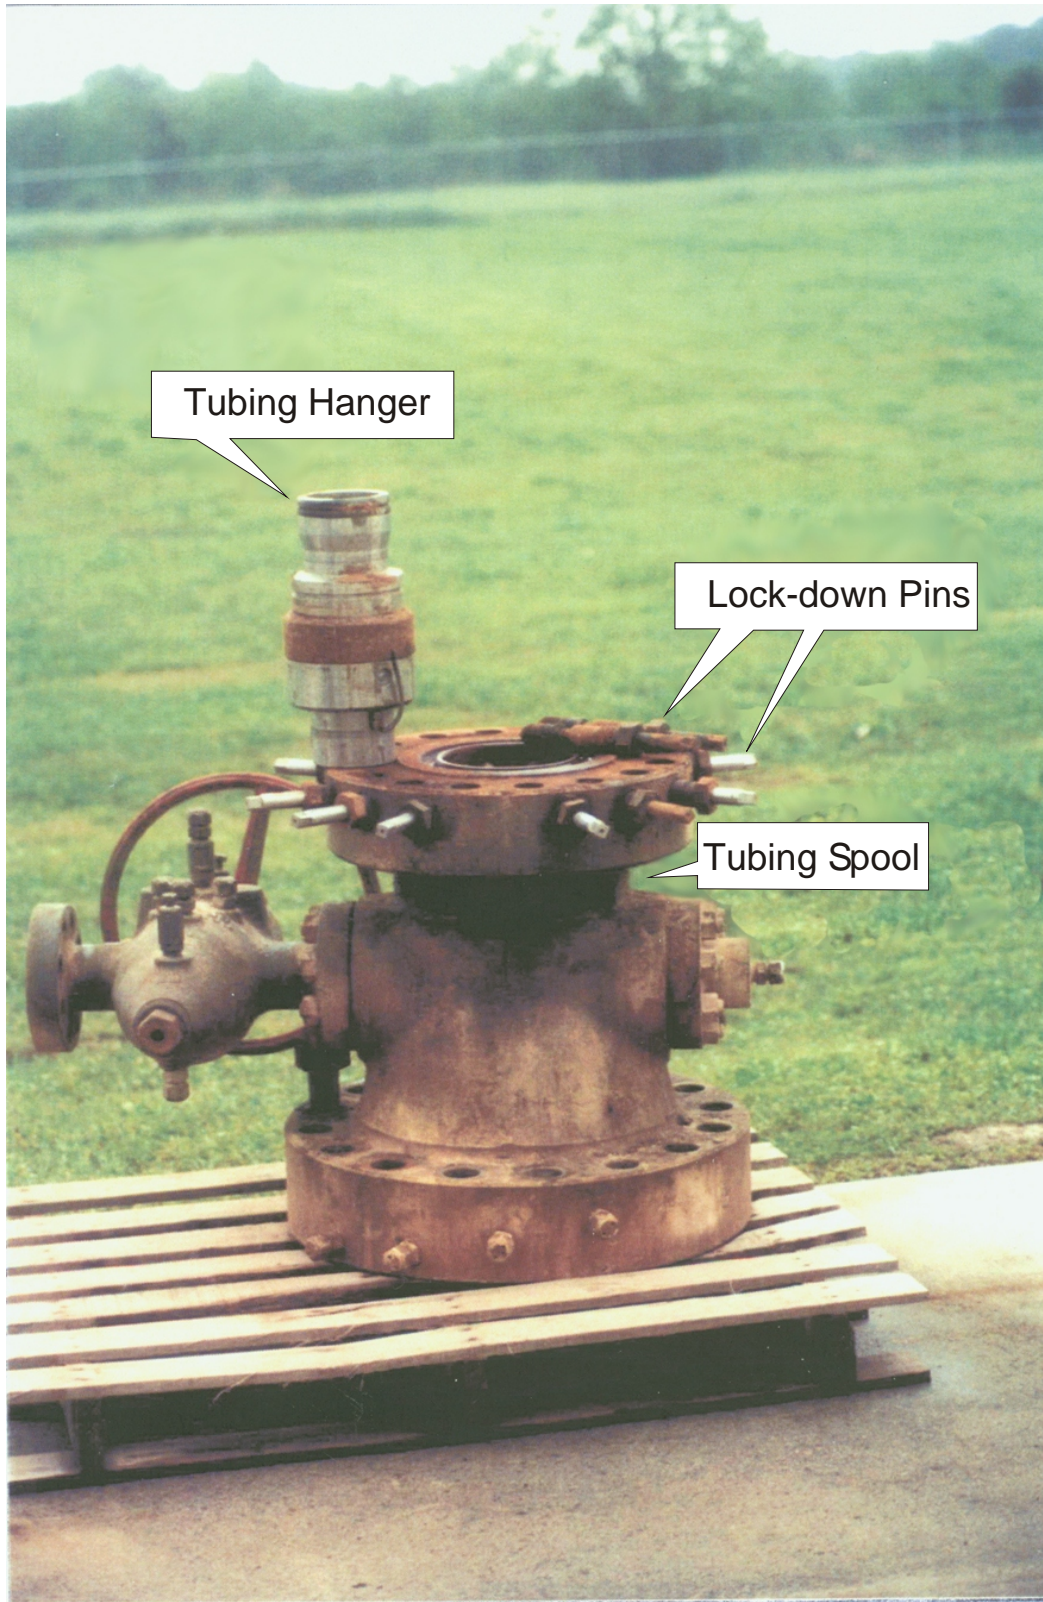
Tubing Hanger, Spool, and Lock-down pins from EI Block 107, Well B-1

The cause of the ejection of the hanger and tubing was the subject of an internal Operator investigation in conjunction with an investigation by the Manufacturer of the hanger. These reviews determined through inspection of the tubing hanger spool and tubing hanger lockdown lock screws (or hold-down pins) that the hold-down pins holding the tubing hanger in place failed when the pressure reached approximately 6,100 psi (*see pictures, Attachments 7, 8 and 9, diagrams, Attachment 10 and 11*).

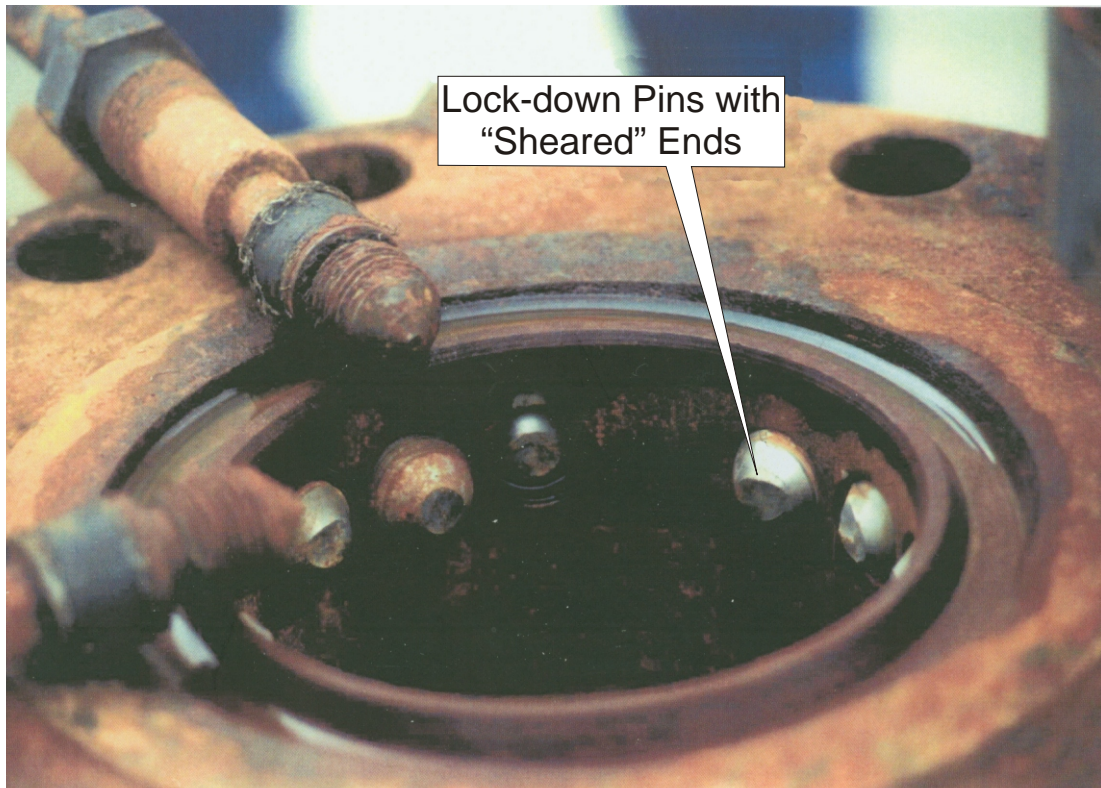
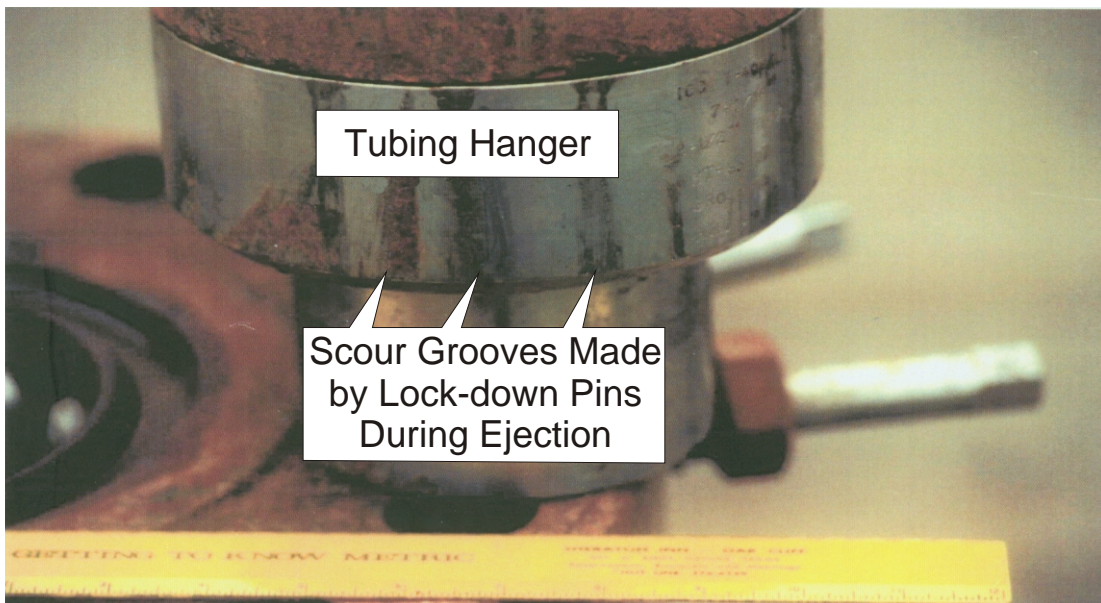
Sheared Lock-down Pins, Ejected Tubing Hanger, EI Block 107, Well B-1

However, in the B-1 well, shortly after the annulus pressure in the wellbore rose above 6,000 psi, the nose of the hold-down pins retaining the hanger in place sheared off (*see pictures, attachment 8 and 9*). The failure allowed the ejection of the hanger followed by loss of well control. According to well service reports, shortly prior to the failure, the hold-down pins of the hanger had been replaced by a representative of the hanger manufacturer, torqued and the settings were re-checked. The hold-down pins hold the tubing hanger in place and energize the sealing elements of the hanger as shown in *Attachment 11 and 12*.

The engineering firms reported back to Operator that the lock-down (hold-down) pins holding the hanger in place failed by shear forces placed on the hanger by the annulus pressure greater than 6,000 psi. Further, the engineering analysis found that the pins as installed would have been expected to fail at about a pressure of 6,100 psi, even though the hanger was rated to contain up to 15,000 psi. A conclusion of the metallurgic and failure studies also found that the reason the pins failed "*was the result of only partial engagement between the [hold-down pins] and energizing ring of the tubing hanger. At the time of failure, the [hold-down pins] were at 39 percent of full engagement. [The engineering report] conclude[d] the partial engagement of the [hold-down pins] was the major contributory factor to the failure.*"

The report also indicates the reason for the failure of the hold-down pins to engage the energizing ring fully. It says, "*the calculated engaged length of the [hold-down pins] (0.173 inches) at failure conditions agrees well with the difference between the nominal drawing dimension for overall length and the measured length of [hold-down pins] (.015-.017 inches) which were sheared in the failure. ... Full engagement of the [hold-down pins] (0.438 inches) is necessary to satisfy the [manufacturer] design criterion for shear (0.53 of yield strength) at the rated working pressure of 15,000 psi with a blind hanger.*"

The conclusion of the technical reports, after full analysis of hardness, tensile properties, diameters, and lengths of the hold-down pins that failed, and additional data, was that the hold-down pins were of proper length and design but were installed so that only a portion of the nose of the pins engaged the tubing hanger. The Manufacturer's representative on the Rig recorded that he had torqued the pins to the proper

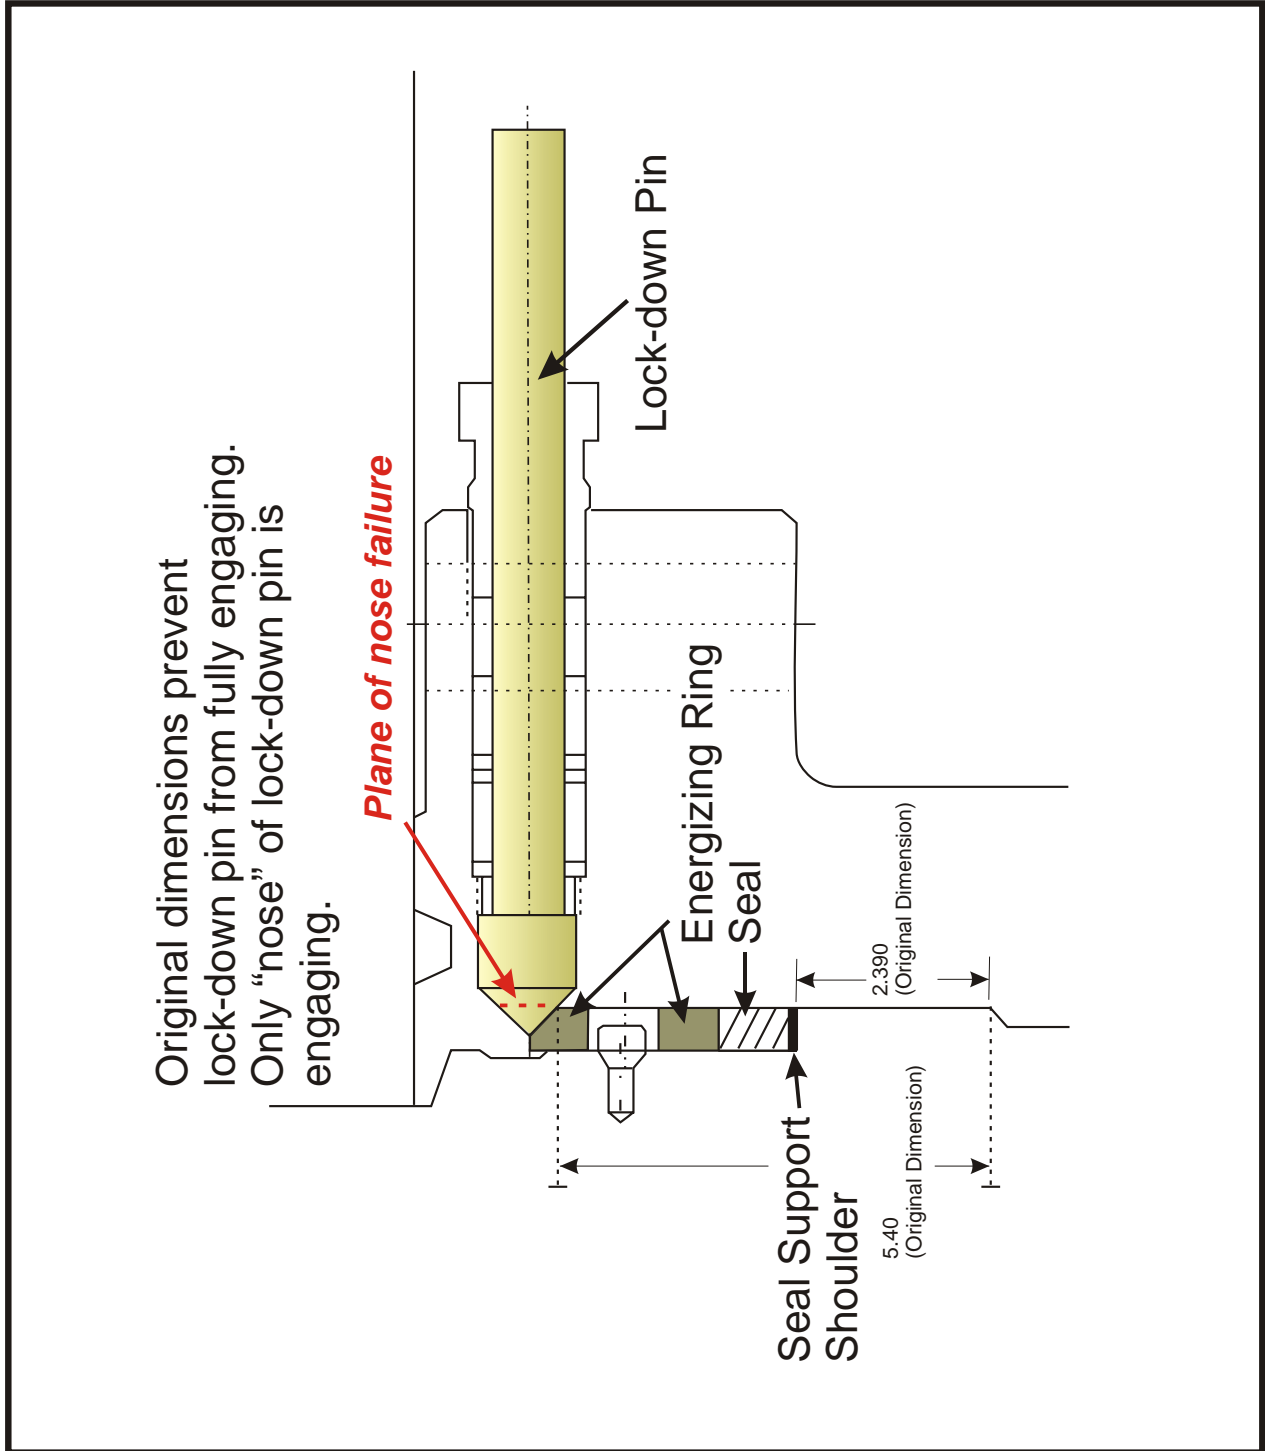
Schematic and Original Dimensions of Engagement of Hanger and Lock-down Pin.

According to testimony, the reason the pins failed to engage the ring to the designed depth, enabling the hanger to contain the designed pressure, lay in a flaw in the design of the hanger as it mated with the hanger spool and energizing ring. The metal-to-metal mate between the hanger and the spool, and between the energizing ring and the hanger, were designed at a 45-degree angle. However, the actual mating of the hanger and spool caused the hanger energizing ring to sit too high in the spool to allow the hold-down pins to be fully run-in.

Under a certain series of circumstances as in this loss of control event, the design would cause the hanger to fail to hold the pressure because the engagement of the nose of the hold-down pins was insufficiently complete. The Manufacturer noted that the absence of the hold-down force of the weight of a tension-set string of tubing, the removal of the well-head (which also acts to hold the hanger in place), combined with high pressures on the annulus, are the events that all must be present for the design flaw to cause the hanger to fail.
