**Investigation of Fatal Accident  
South Pelto Block 15, Well No. 4  
OCS-G 09652  
26 January 2005**

**Gulf of Mexico  
Off the Louisiana Coast**

**U.S. Department of the Interior  
Minerals Management Service  
Gulf of Mexico OCS Regional Office**

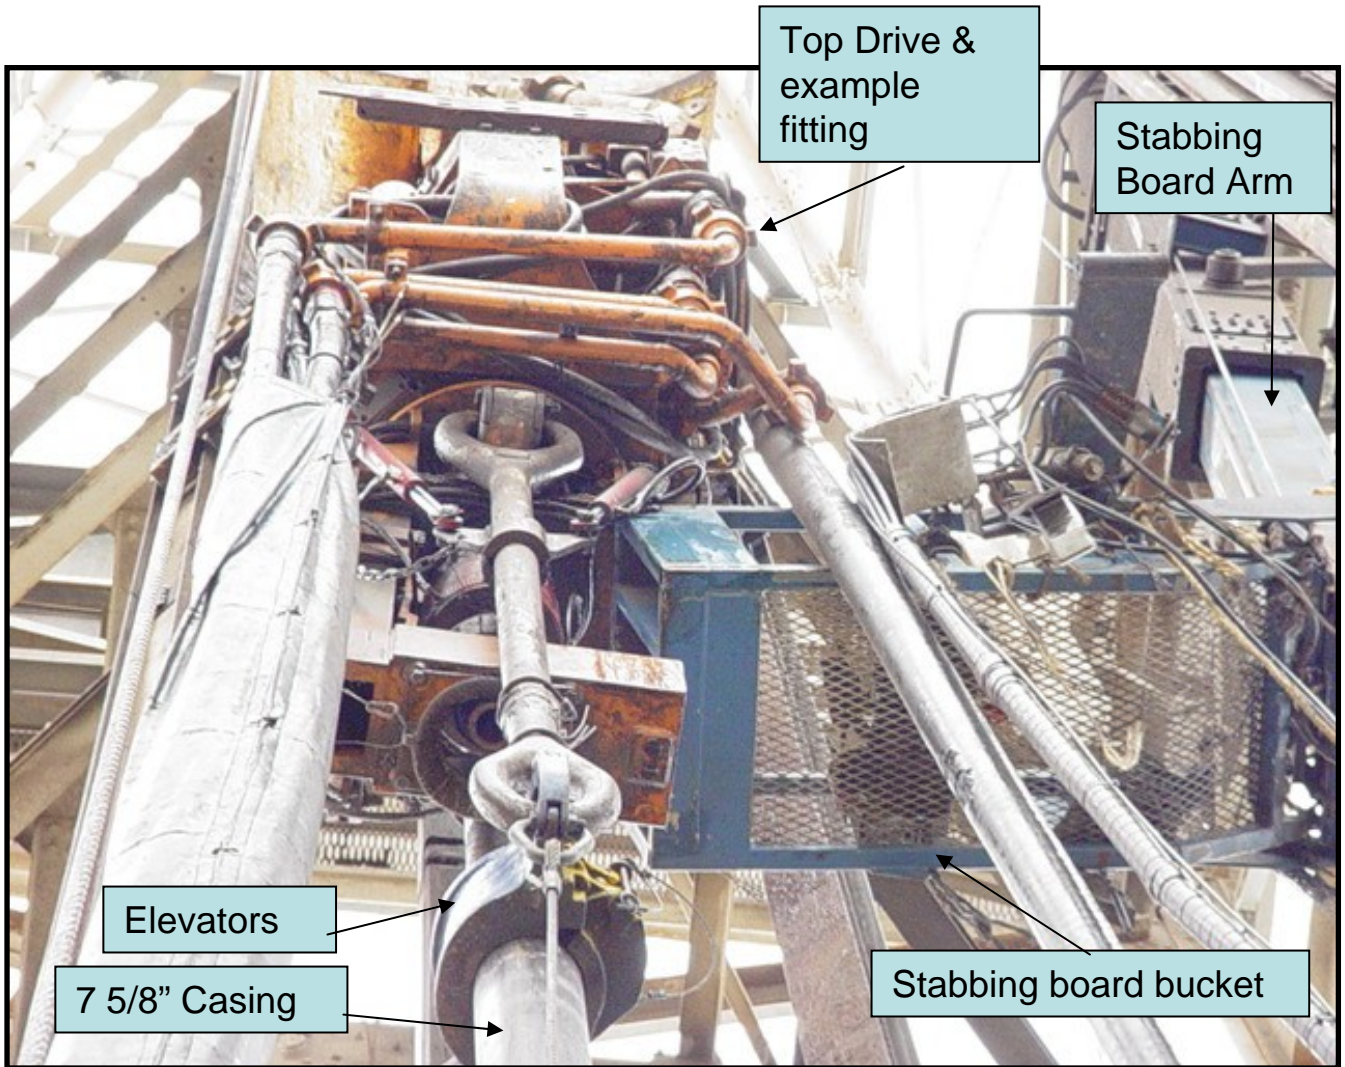
It was then discovered that the personnel bucket of the HSB was caught on the top drive unit and was suspended horizontally (*see Attachment 2*). The Stabber, who had been in the bucket, was observed to be partially suspended from his safety harness, not responding to communication from the drill floor.

**Hydraulic Stabbing Board Bucket Hung on Top Drive**

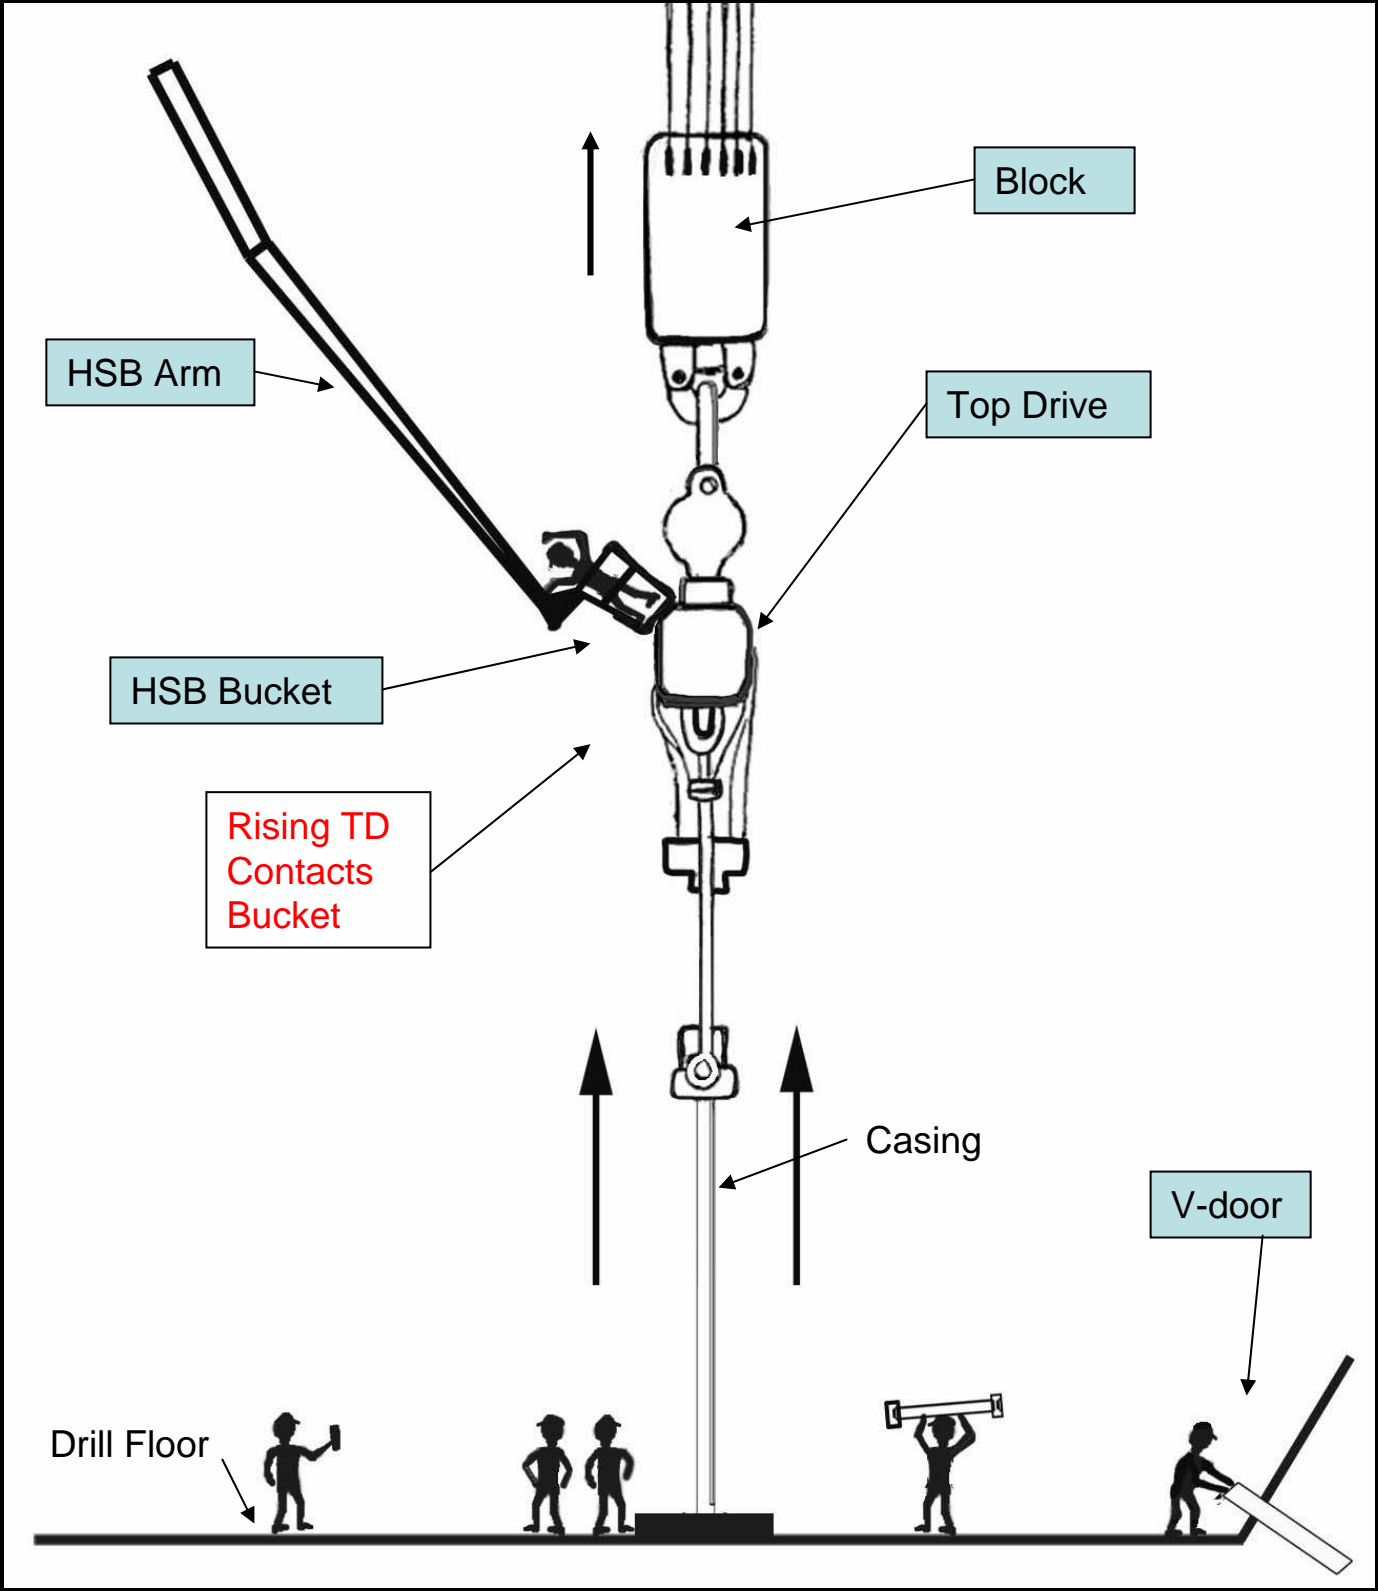
**Pictorial Representation of Casing Operation Accident**

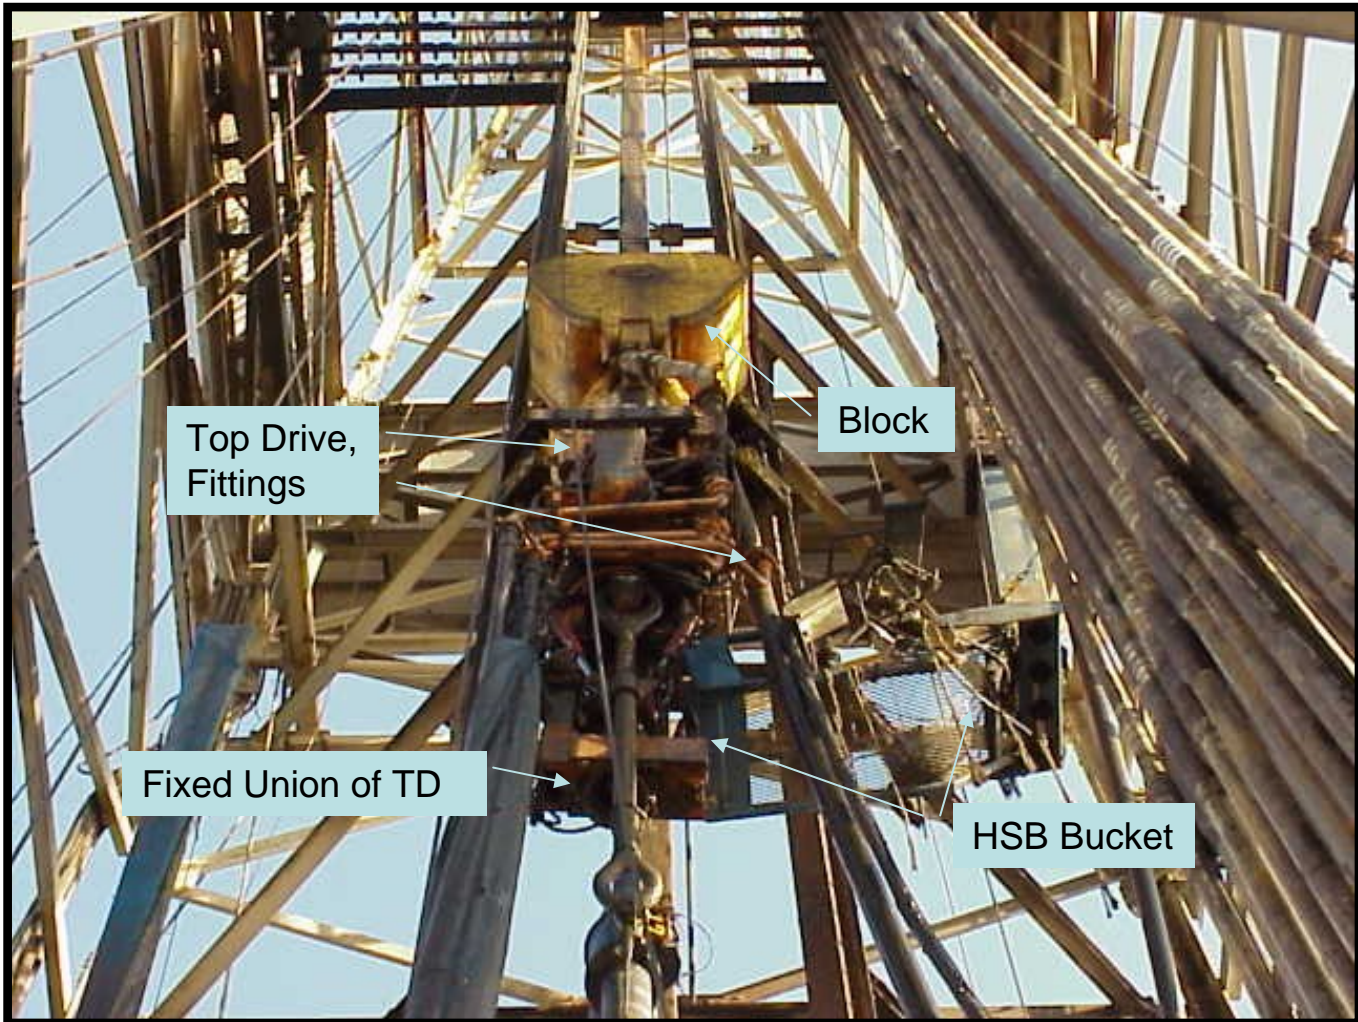
At 0800 hrs, the HSB personnel bucket was struck and hung up on the top drive unit as the block was ascending. The driller immediately halted the ascension of the block after hearing verbal warnings from the Casing Crew floor men, who had been preparing to set the slips. The ascent of the block, estimated at about 4 ft per second (from testimony), was completely halted within approximately 2-3 seconds (calculated) of the impact of bucket and top drive. Afterwards, the personnel bucket was found hung at 90 degrees from vertical on the top drive fixed union, some 10 ft below the top of the top drive unit (*see Attachments 10 & 11*).

**Block, Top Drive, Hung Stabbing Board**

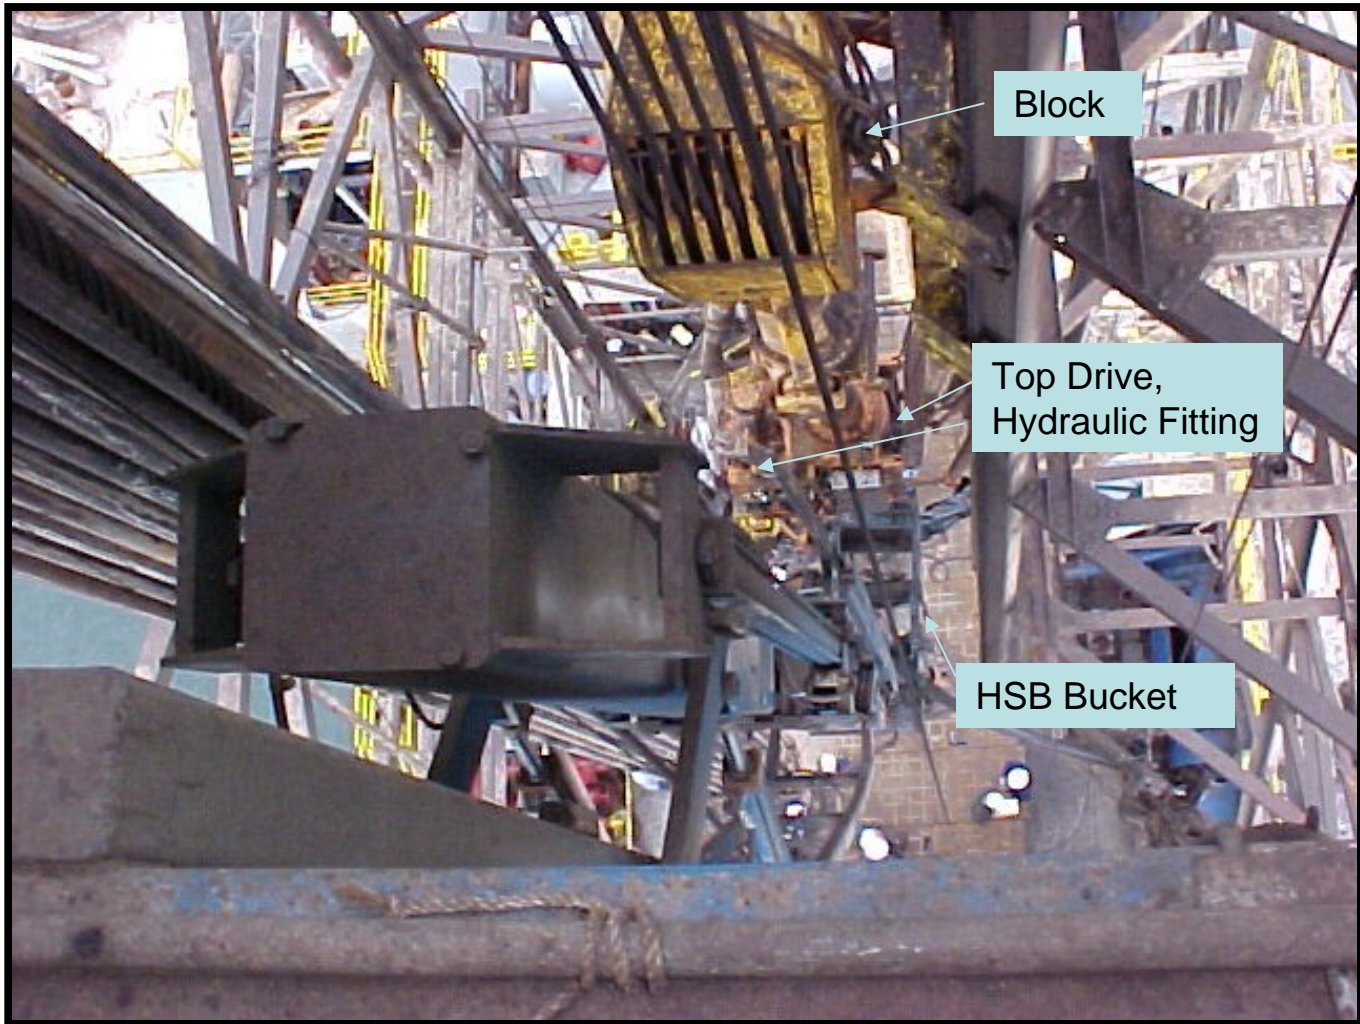
**View From Above:**

**Block, TD, Hydraulic Fitting, Hung HSB Bucket**

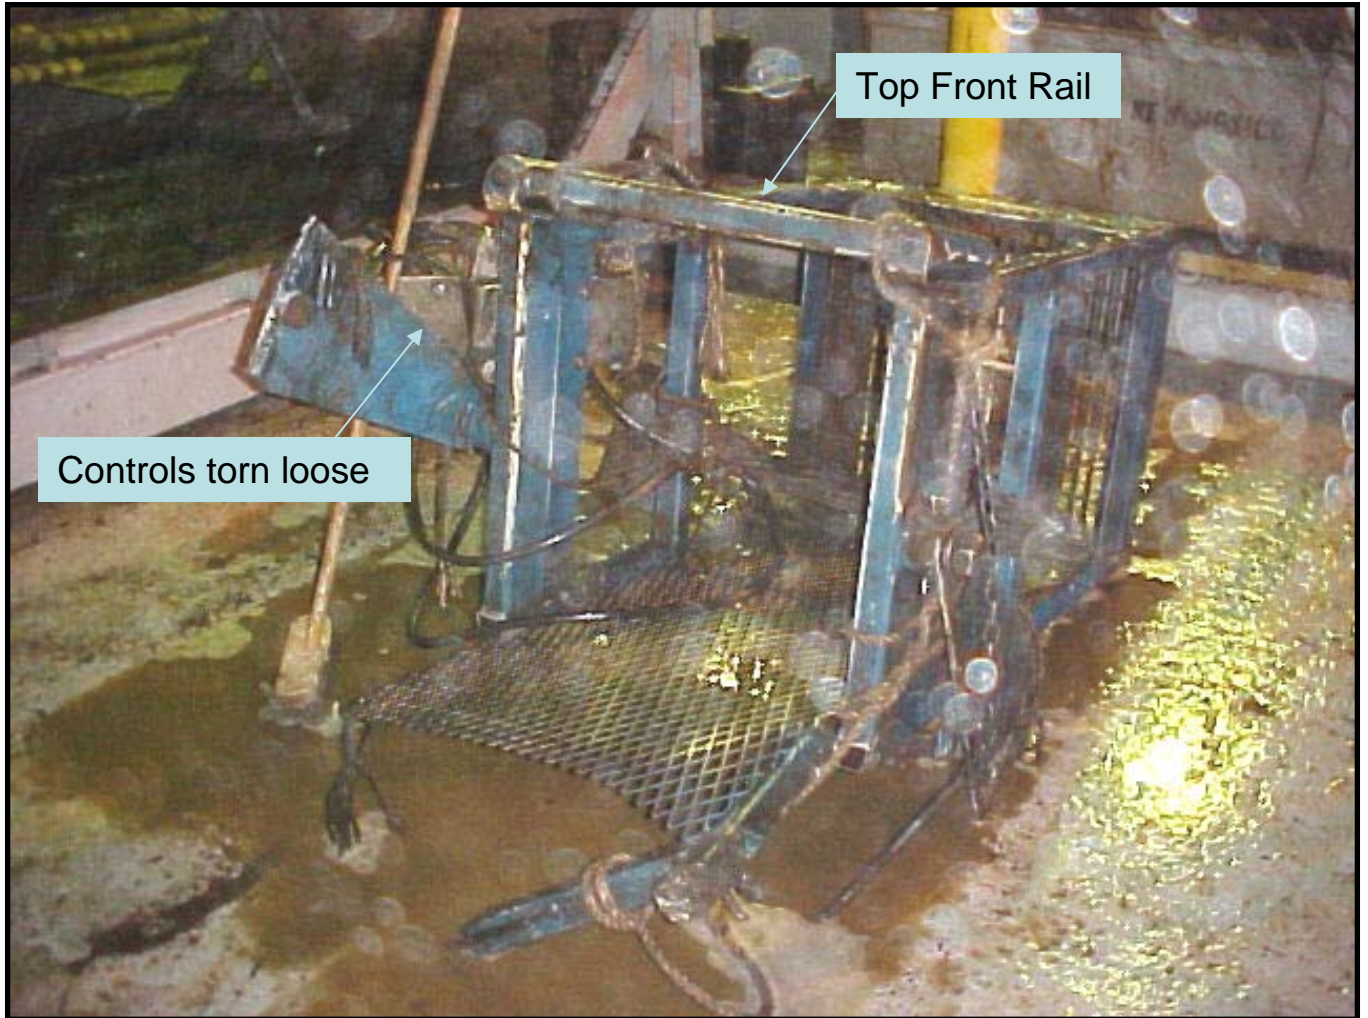
Marks on the bottom of the HSB personnel bucket matched the profile of a hydraulic fitting on the top of the top drive (*see Attachments 12 & 13*) and some residual scratch marks and personnel basket paint was on the top drive. A drawing was constructed approximating the path that the personnel basket would follow if it were initially lifted by the hydraulic fitting and then broke loose, ending in the observed position (*see Attachment 14*). The drawing shows that the personnel bucket could have been lifted to an angle of approximately 135 degrees before breaking loose from the hydraulic fitting, sliding along the top drive, falling, and lodging on the fixed union.

**HSB Personnel Bucket, After Accident**

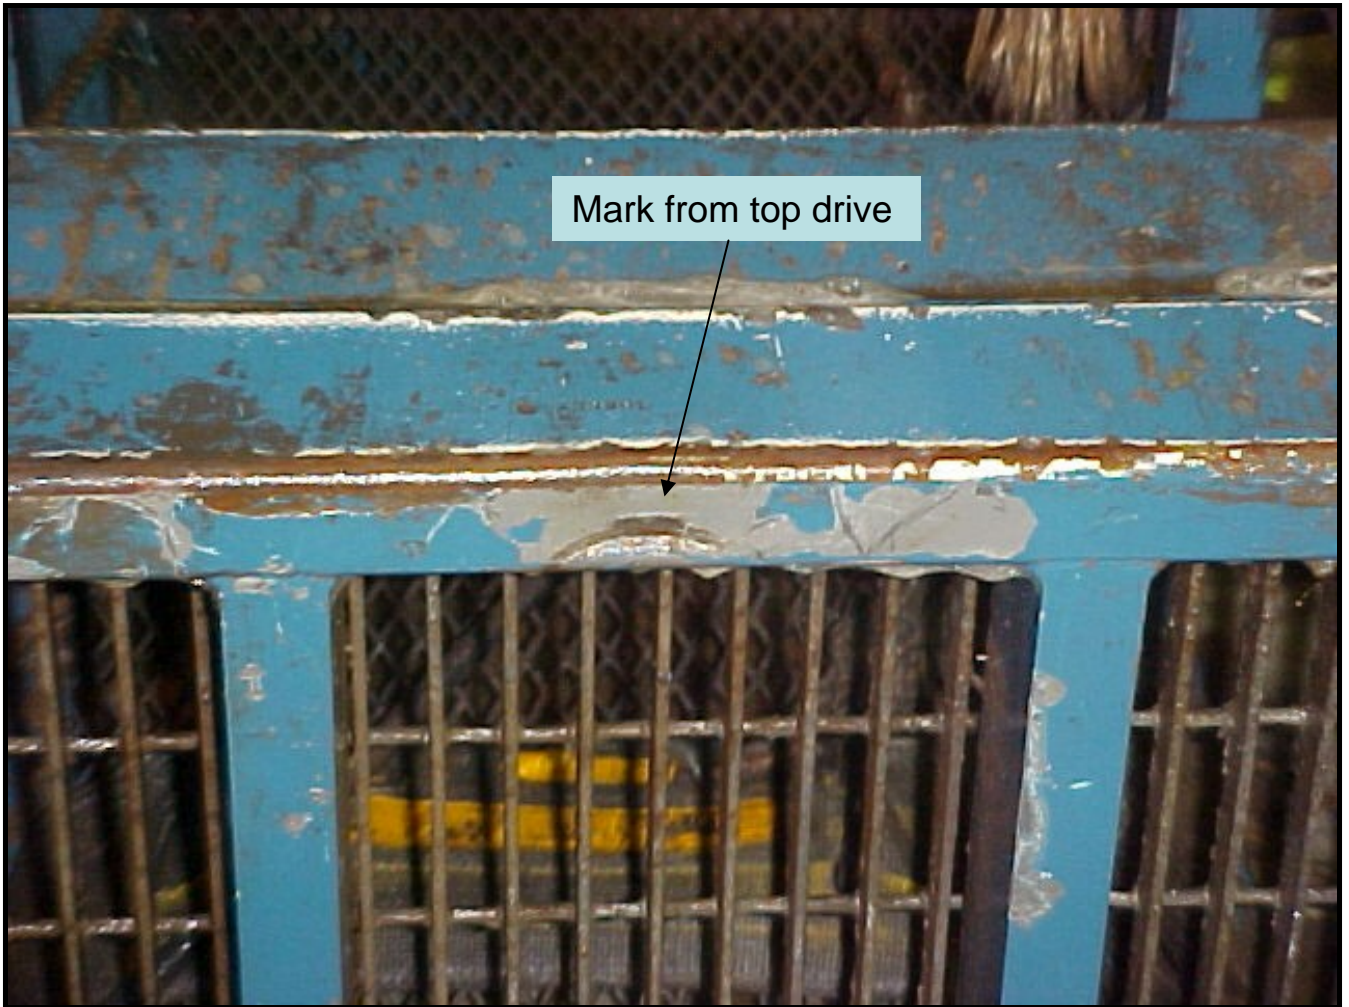
**Fitting Union Mark on Bottom of Personnel Bucket**

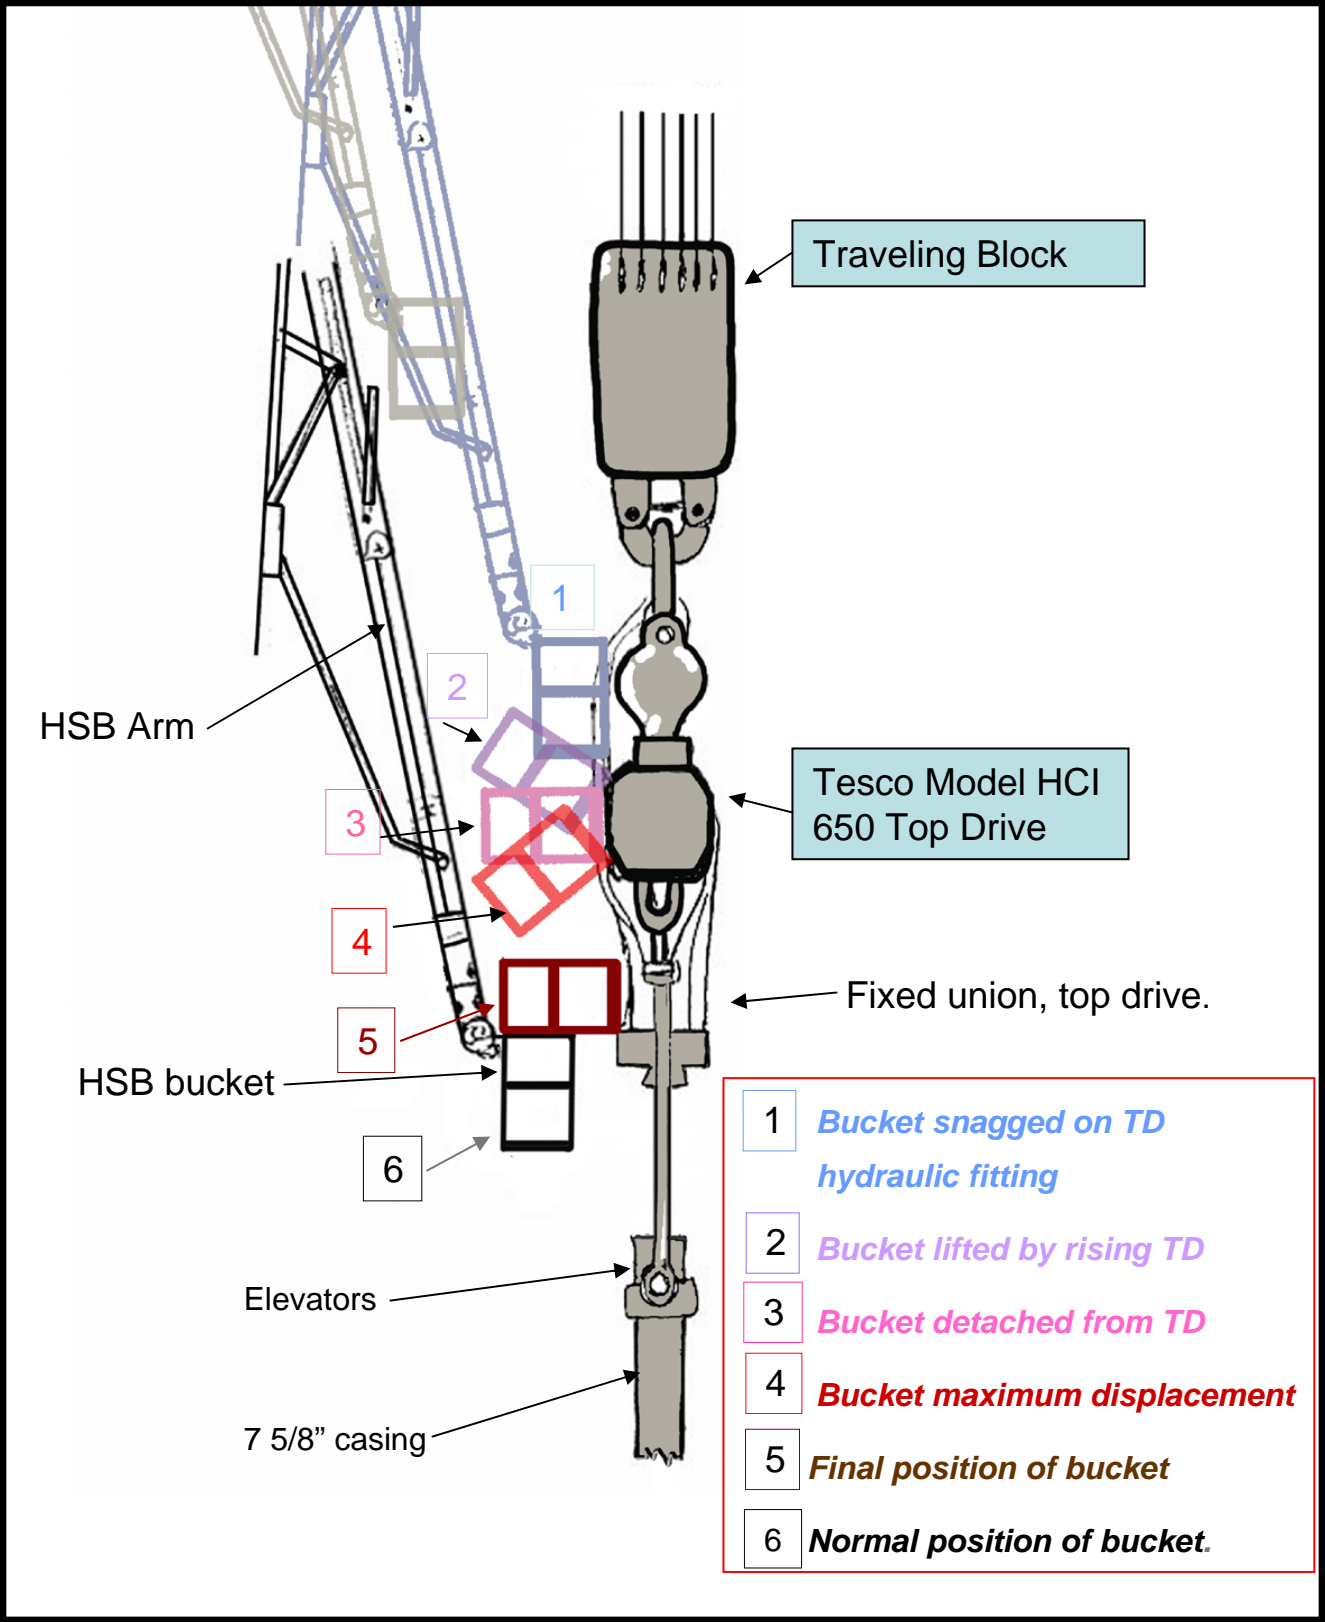
- 1. The HSB personnel bucket was caught on the top drive unit as it was ascending, and upended. This upending caused the front top rail of the HSB personnel bucket to crush the stabber against the boom arm of the HSB. The injuries from this contact caused the death of the stabber.*
- 2. It is concluded that the stabber activated the controls for the HSB before the passage of the top drive unit and that, as a result, the HSB bucket was accidentally maneuvered by the Stabber into the path of the rising top drive unit.*
- 3. It is concluded that the HSB controls had a prolonged response hesitation or Delay. The Delay of the response to the controls played a contributory role in the fatality.*

Drawing of Movement of HSB Bucket When Hit by Top Drive
