**Investigation of Loss of Well Control  
South Timbalier Block 135, Well No. 6  
OCS 0462  
1 December 2005**

Gulf of Mexico  
Off the Louisiana Coast

U.S. Department of the Interior  
Minerals Management Service  
Gulf of Mexico OCS Regional Office

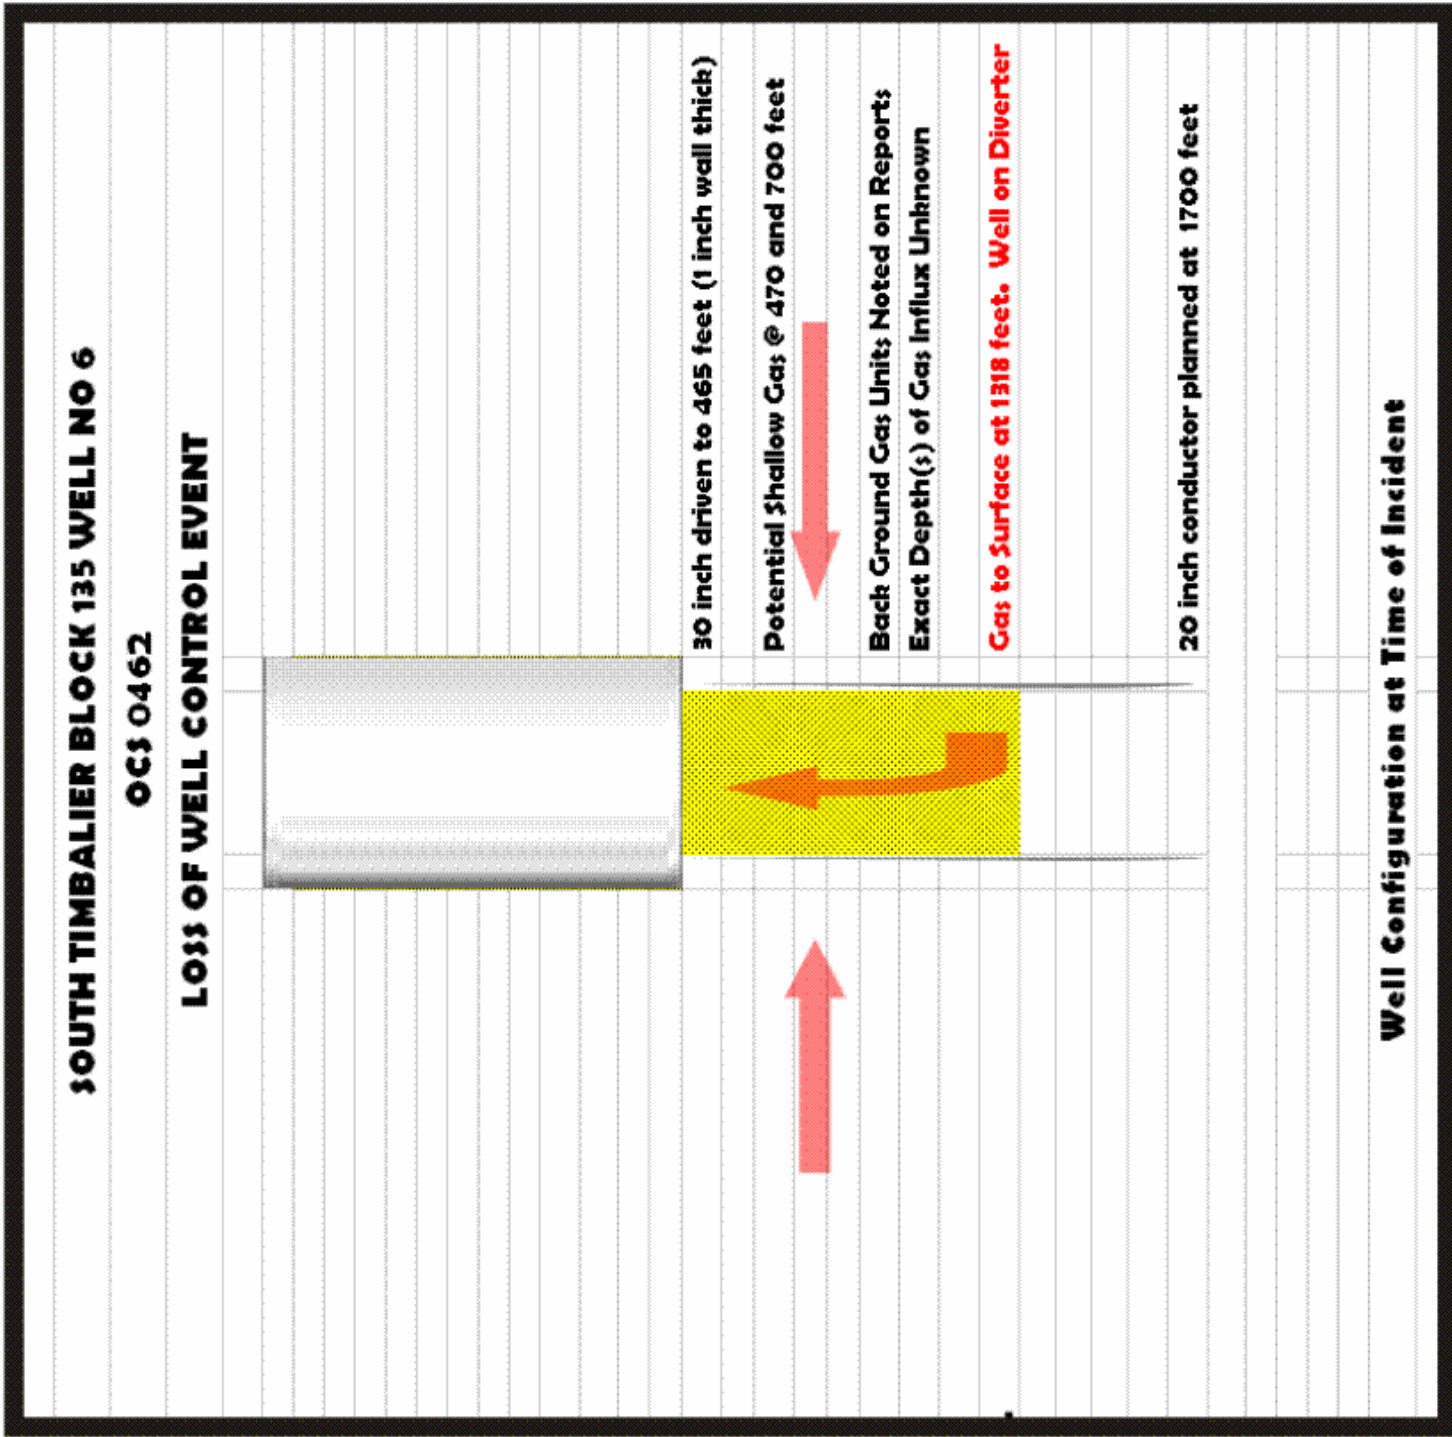
South Timbalier Block 135 Well No. 6 Well Bore Configuration at Time of Incident

The loss of well control of the subject well was caused by drilling into a sand lens below 1,000 feet without sufficient mud weight to offset the higher pore pressure encountered. During the permitting stages for this well, the Operator had anticipated the maximum mud weight at the 20-inch conductor shoe to be about 8.9 pounds per gallon. The well was eventually controlled through persistent circulation of kill weight mud exceeding 11 pounds per gallon.

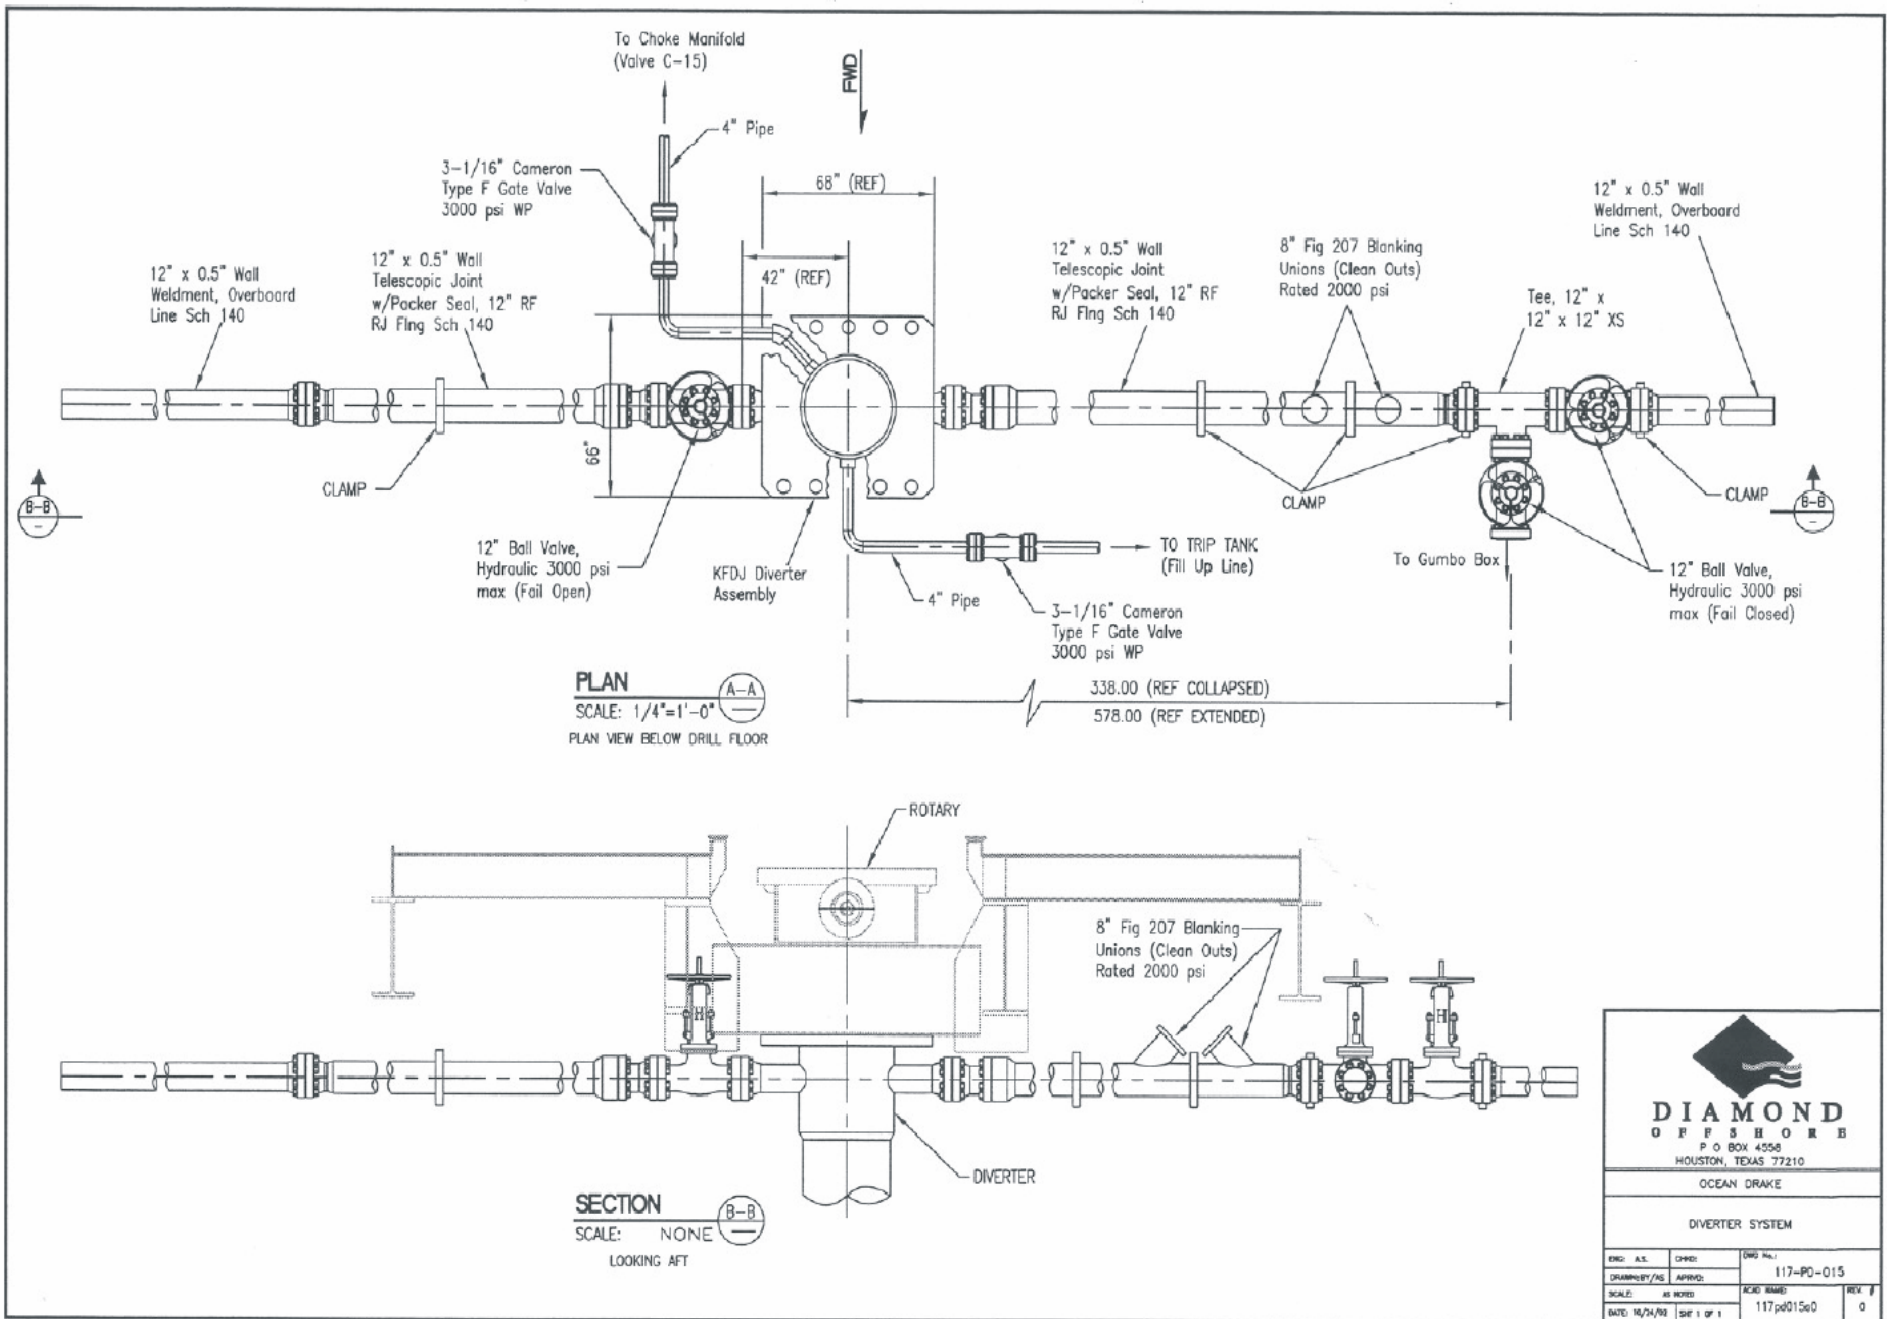
Diverter System Schematic on Ocean Drake

personnel noted gas emanating from the drive pipe by drill pipe annulus. The well was shut in at 1600 hours on 01 December 2005 and placed on the diverter system (See *Diverter System Schematic, Attachment 4*) at that point. Contractor personnel on the Rig continued to pump kill weight mud while monitoring the well. As a precaution, at 1645 hours, all non-essential personnel were evacuated to the *M/V Randall McCall*. Within two hours, the non-essential personnel were allowed to return to the rig. The well continued to “burp” gas over the next day, but remained under control while on diverter. Operations continued over the next five days, circulating heavy weighted mud approaching 11 pounds per gallon, while washing to bottom and back-reaming to prevent stuck pipe. With approval from MMS, on 07 December 2005, the Operator washed to total depth of 1,318 feet and mixed and spotted a barite plug. After tripping to bottom to circulate and clean up the hole, approval was obtained from MMS by the Operator to set the 20-inch conductor casing at 1,274 feet, significantly higher than had originally been programmed in view of the hole conditions. The original plan had been to drill down to 1,700 feet prior to setting the conductor pipe. The Operator received verbal approval from MMS at 1700 hours on 12 December 2005, to obtain a Formation Integrity Test (FIT) below 20-inch conductor casing in the 26-inch "rat-hole" after washing barite plug without drilling 10 feet of new formation. It was also agreed to drill ahead with a 12.8 pound-per-gallon FIT and reduce the safe drilling margin to 0.3 pound per gallon.

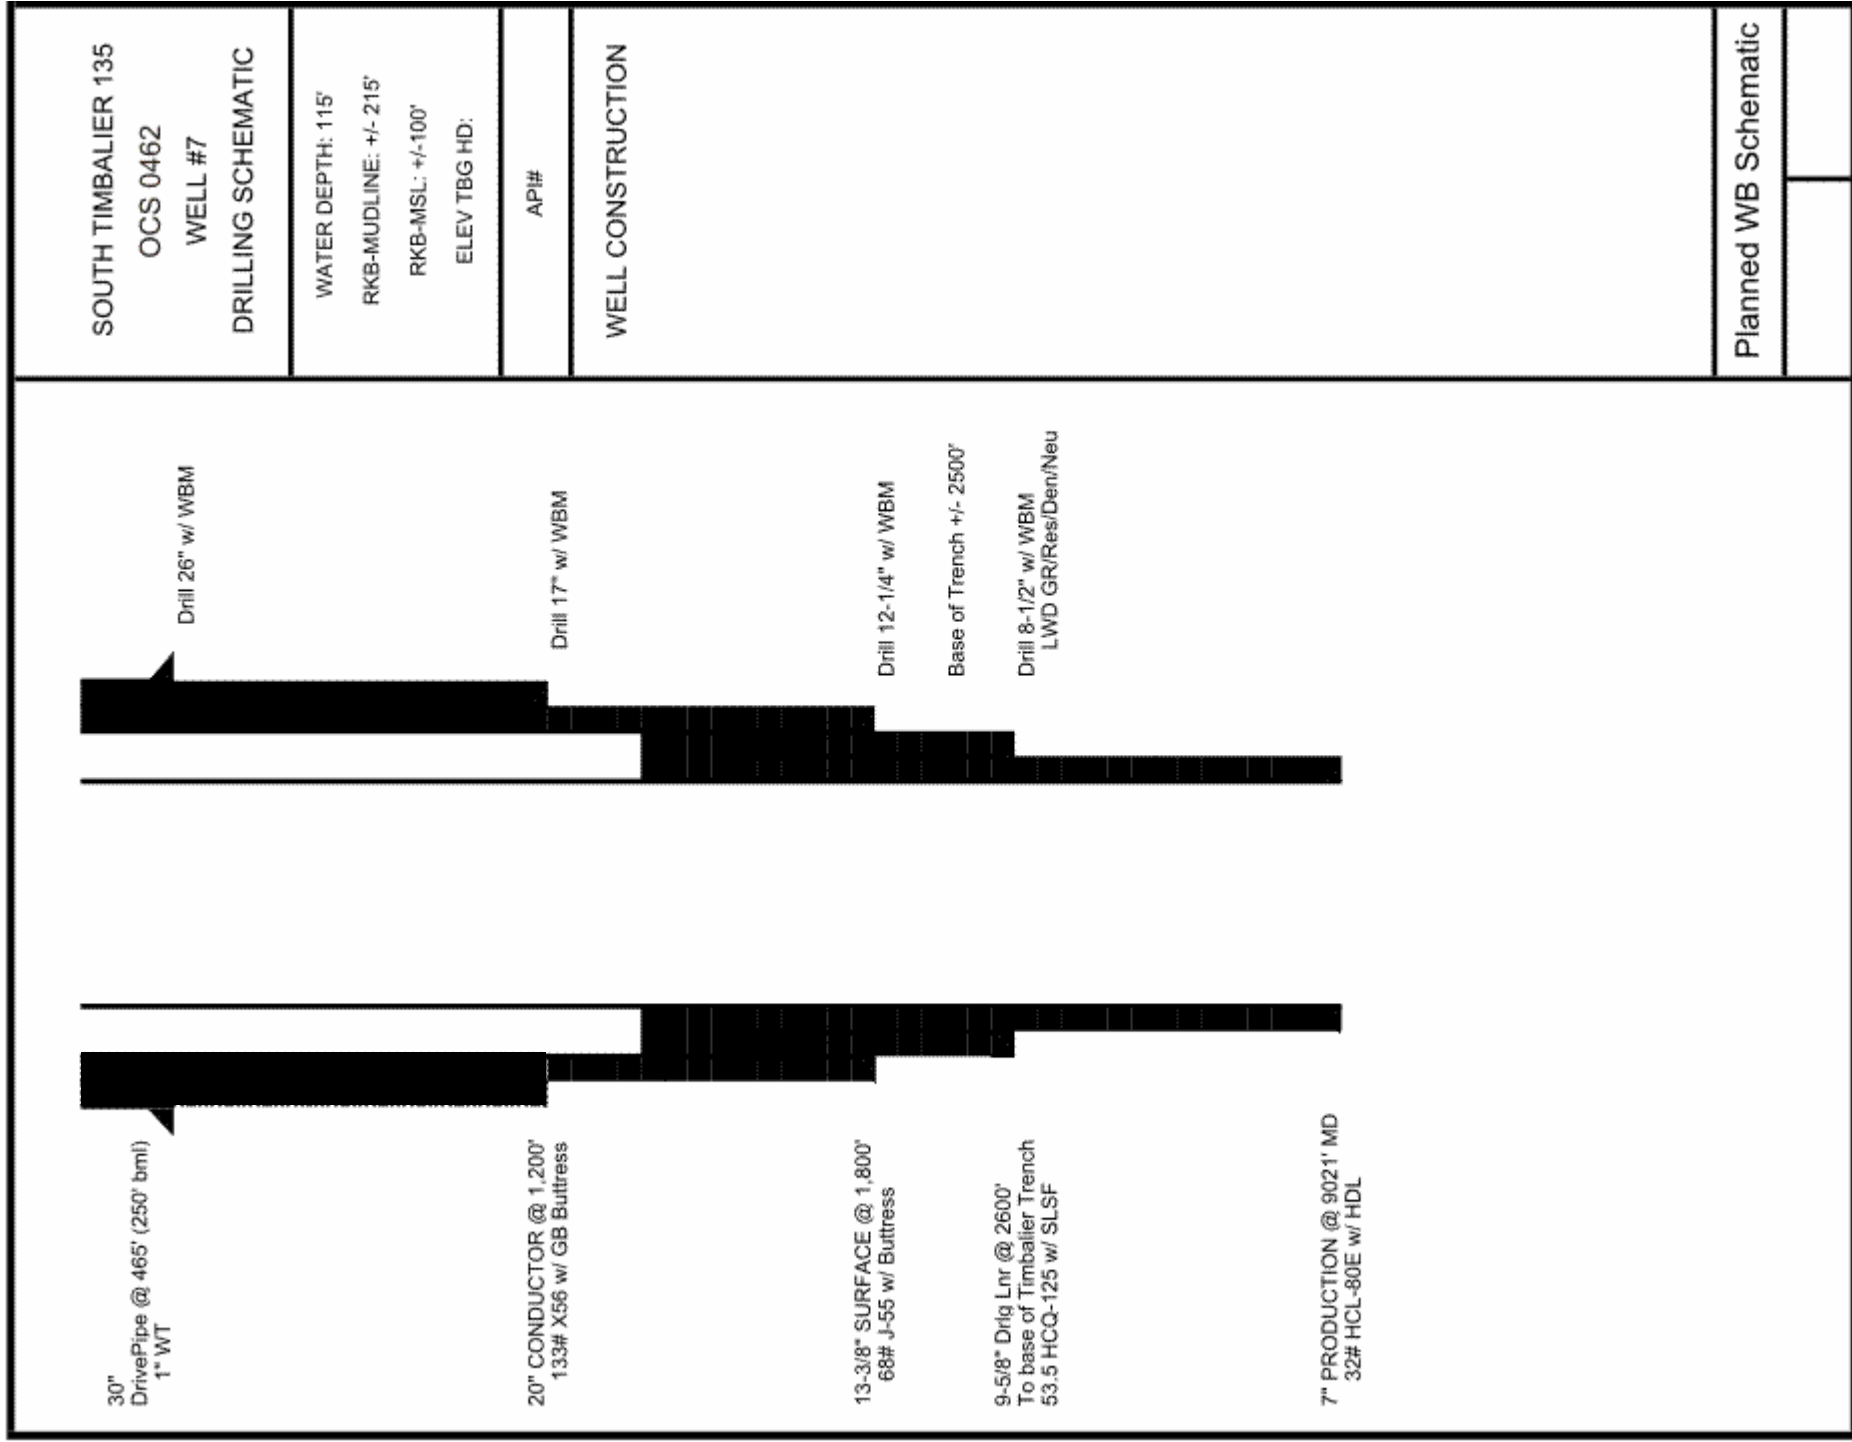
The Operator successfully drilled and set conductor pipe on Well No. 7, an immediate offset well to the subject diverter incident (*See Attachment 6*). Several recommendations resulting from the Operator's initial investigation of the diverter incident on the No. 6 well had been incorporated in the well plans for subsequent development wells, including (1) setting conductor pipe above the depth where the shallow gas interval had been encountered in the No. 6 well, thus minimizing drilling into known shallow hazards with only drive pipe set; (2) modifying the mud weight schedule over the conductor hole section by utilizing the mud weights required to control gas flow in the No. 6 well; (3) driving the drive pipe to the point of refusal, thereby minimizing surface blowouts in the event of having to shut in while on the diverter system; and (4) inspecting and testing all diverter and outlet valves prior to drilling, ensuring that equipment is sound and working.
