**Investigation of Fatality  
Grand Isle Block 37 Platform Z  
OCS 00392  
February 28, 2006**

**Gulf of Mexico  
Off the Louisiana Coast**

**U.S. Department of the Interior  
Minerals Management Service  
Gulf of Mexico OCS Regional Office**

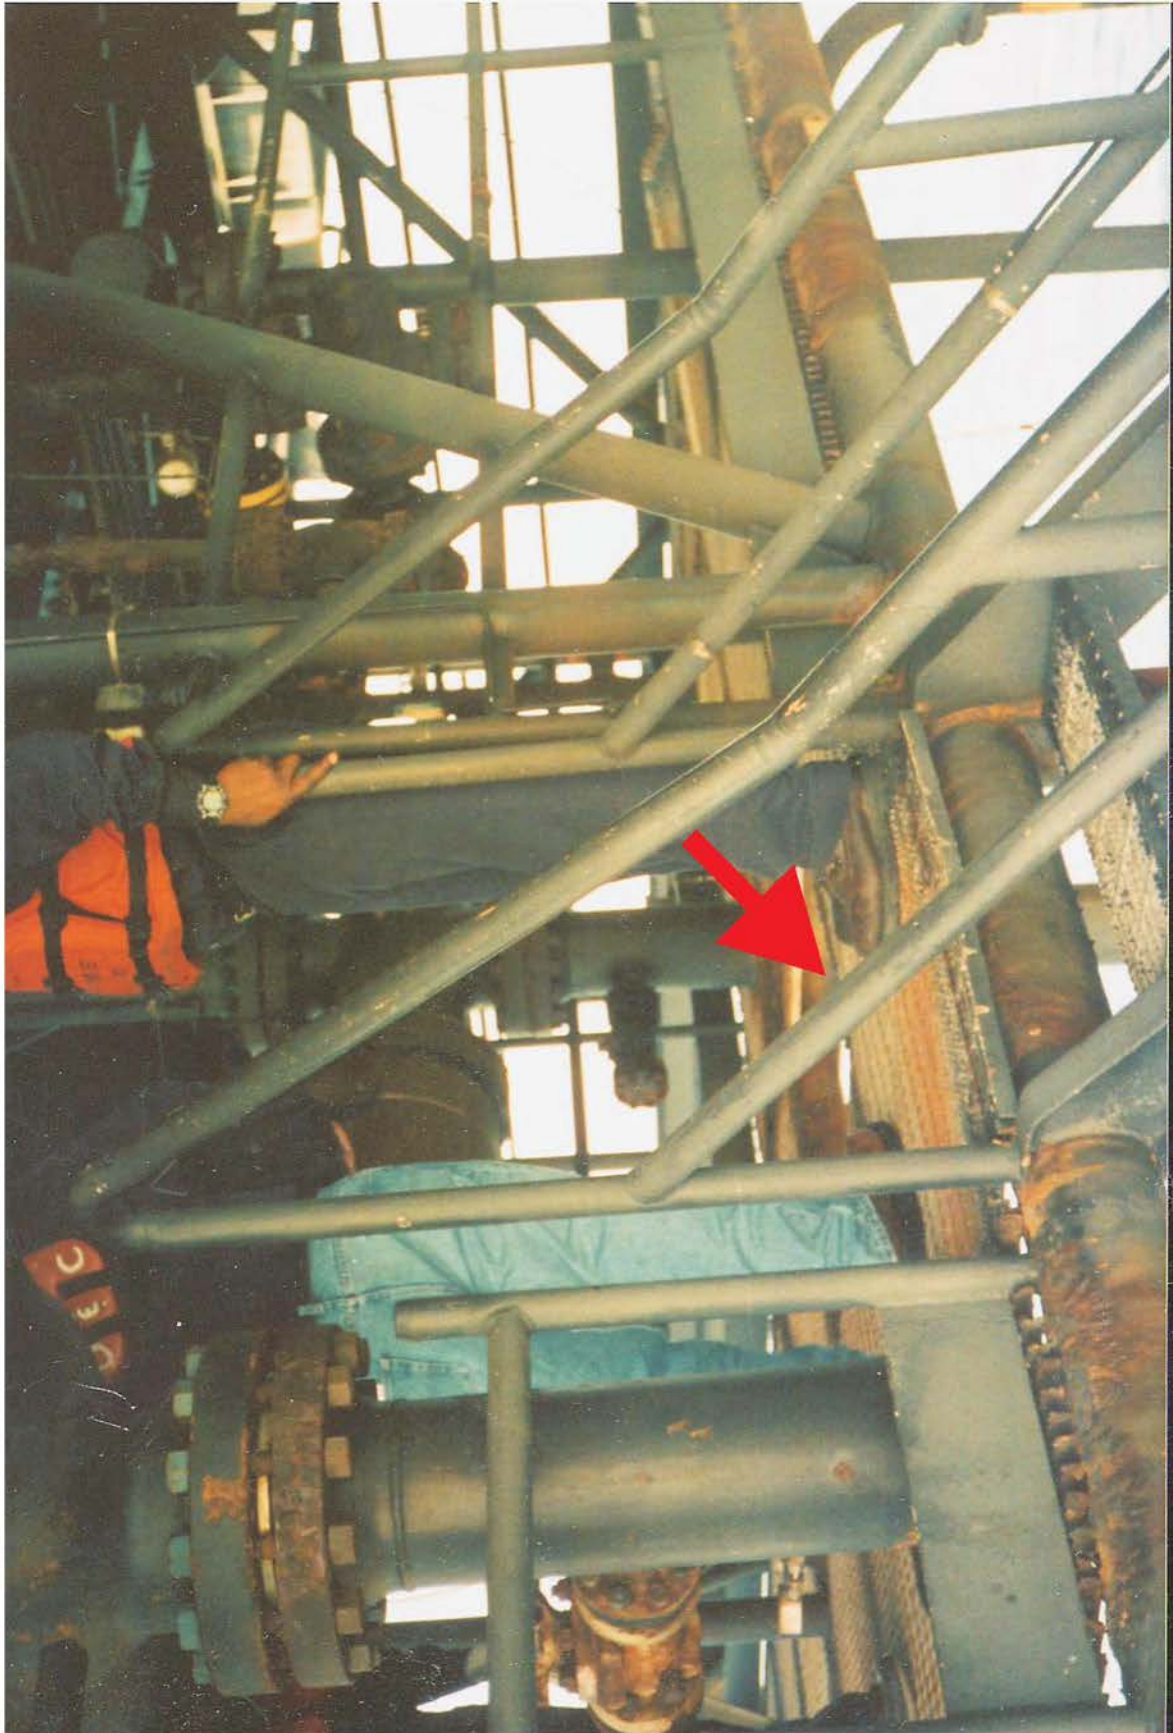
Attachment 2 – Missing Grating; Employee Fell Through Consequent Hole.

The CD rep. went up to the cellar deck (see attachment 2) and, after about ten minutes, fell approximately 20 feet to the plus-10 deck (see attachment 3), striking the grating, and subsequently falling into the water. After recovery from the water, he was given emergency treatment, flown to Our Lady of the Sea Hospital in Galliano, Louisiana, but was pronounced deceased early that afternoon.

The CD rep. deviated from the original plan of action, which was to go by boat to the GI 37 W platform. Once he reached the GI 37 Z platform, he boarded the platform and walked around for approximately ten minutes before falling to his death. Judging from the point of impact, and the missing grating directly above the impact, the panel concluded that the CD rep. fell through the open hole created by the missing grating.

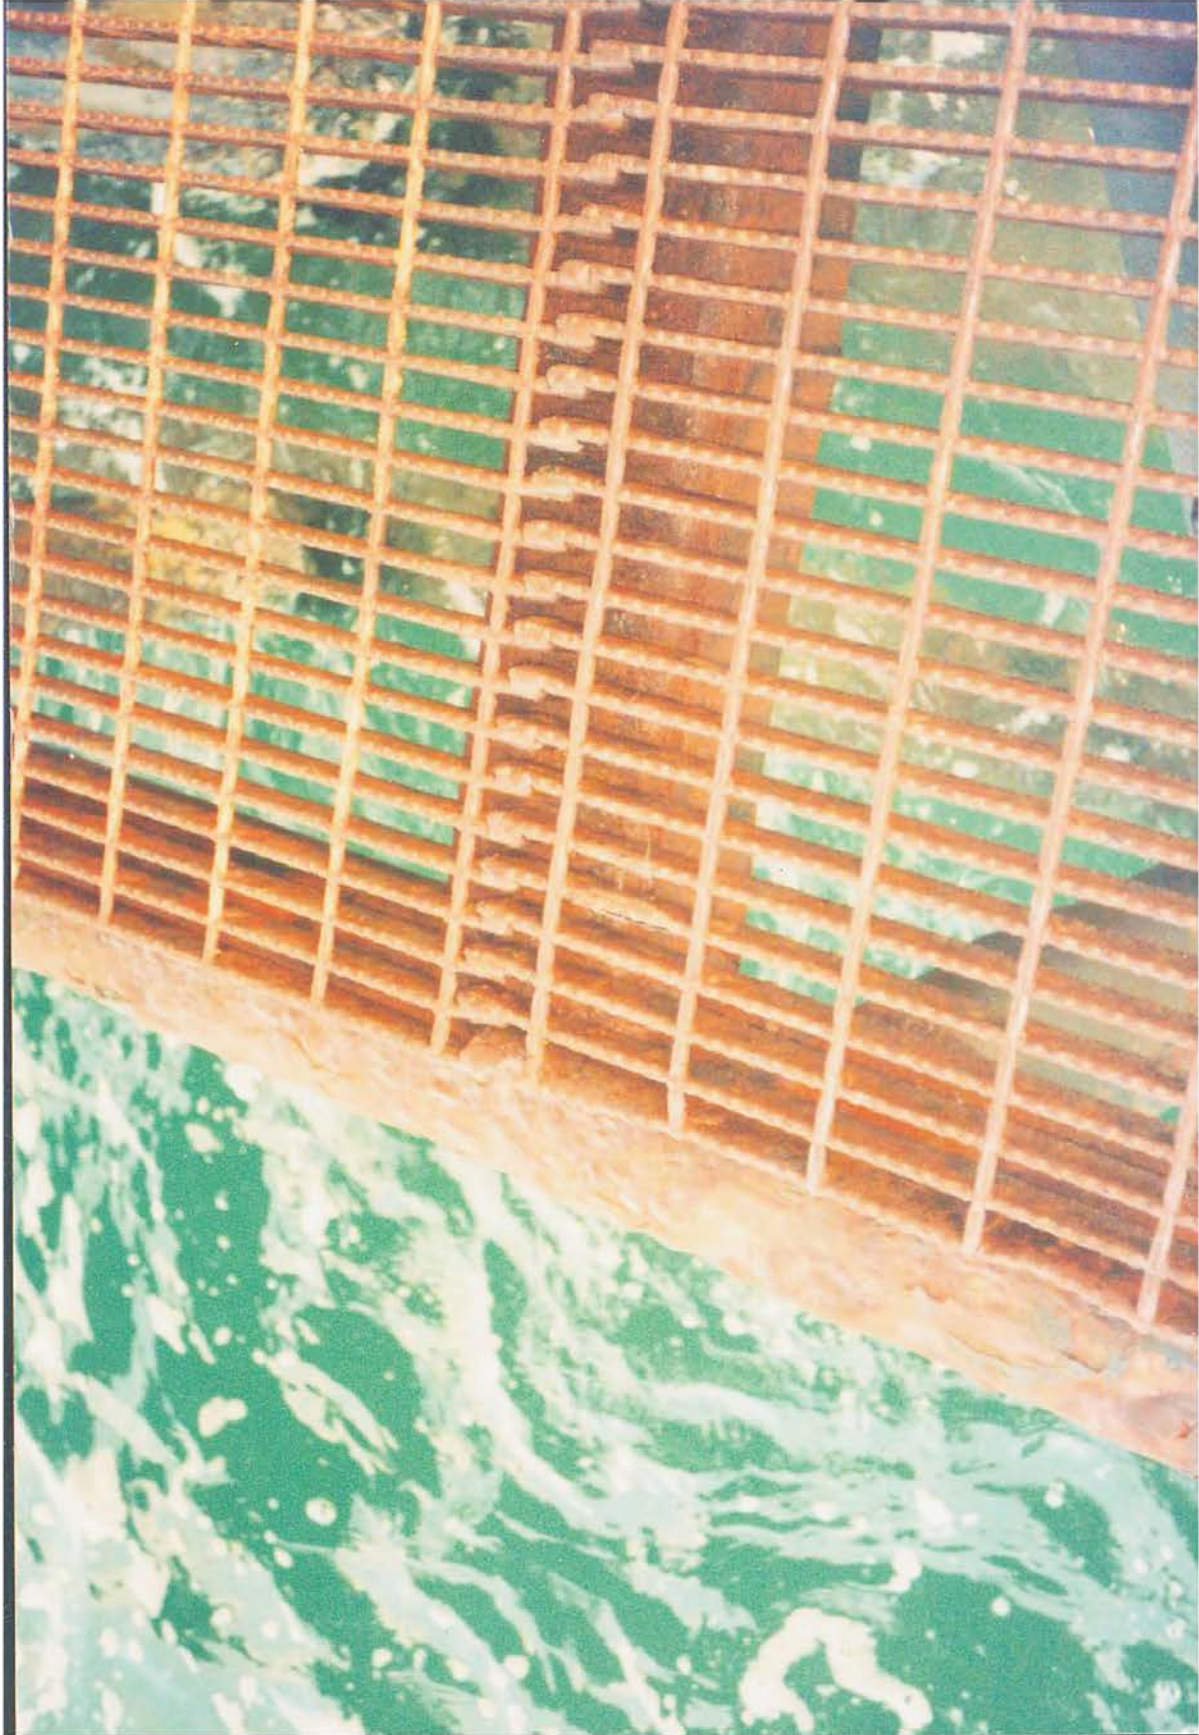
The boat captain was alone and remained on the boat. In interviews, the boat captain stated that he saw the CD rep. on the cellar deck. After looking away briefly, the captain looked back and saw the CD rep. falling approximately 20 feet from the cellar deck, striking his head on the plus-10 deck, and entering the water. The boat captain was unable to determine if the victim was deceased or unconscious. Being unable to retrieve the victim by himself, the boat captain traveled to a neighboring structure for help. The CD rep. was retrieved from the water and brought to the Bay Marchand shore base, from where the CD rep. was flown to Our Lady of the Sea Hospital in Galliano, Louisiana, where he was pronounced deceased early that afternoon. The CD rep. was wearing a personal flotation device (PFD) and was seen by the captain only in a face-up position while in the water.

Walkway Employee Struck Prior to Entering Water.

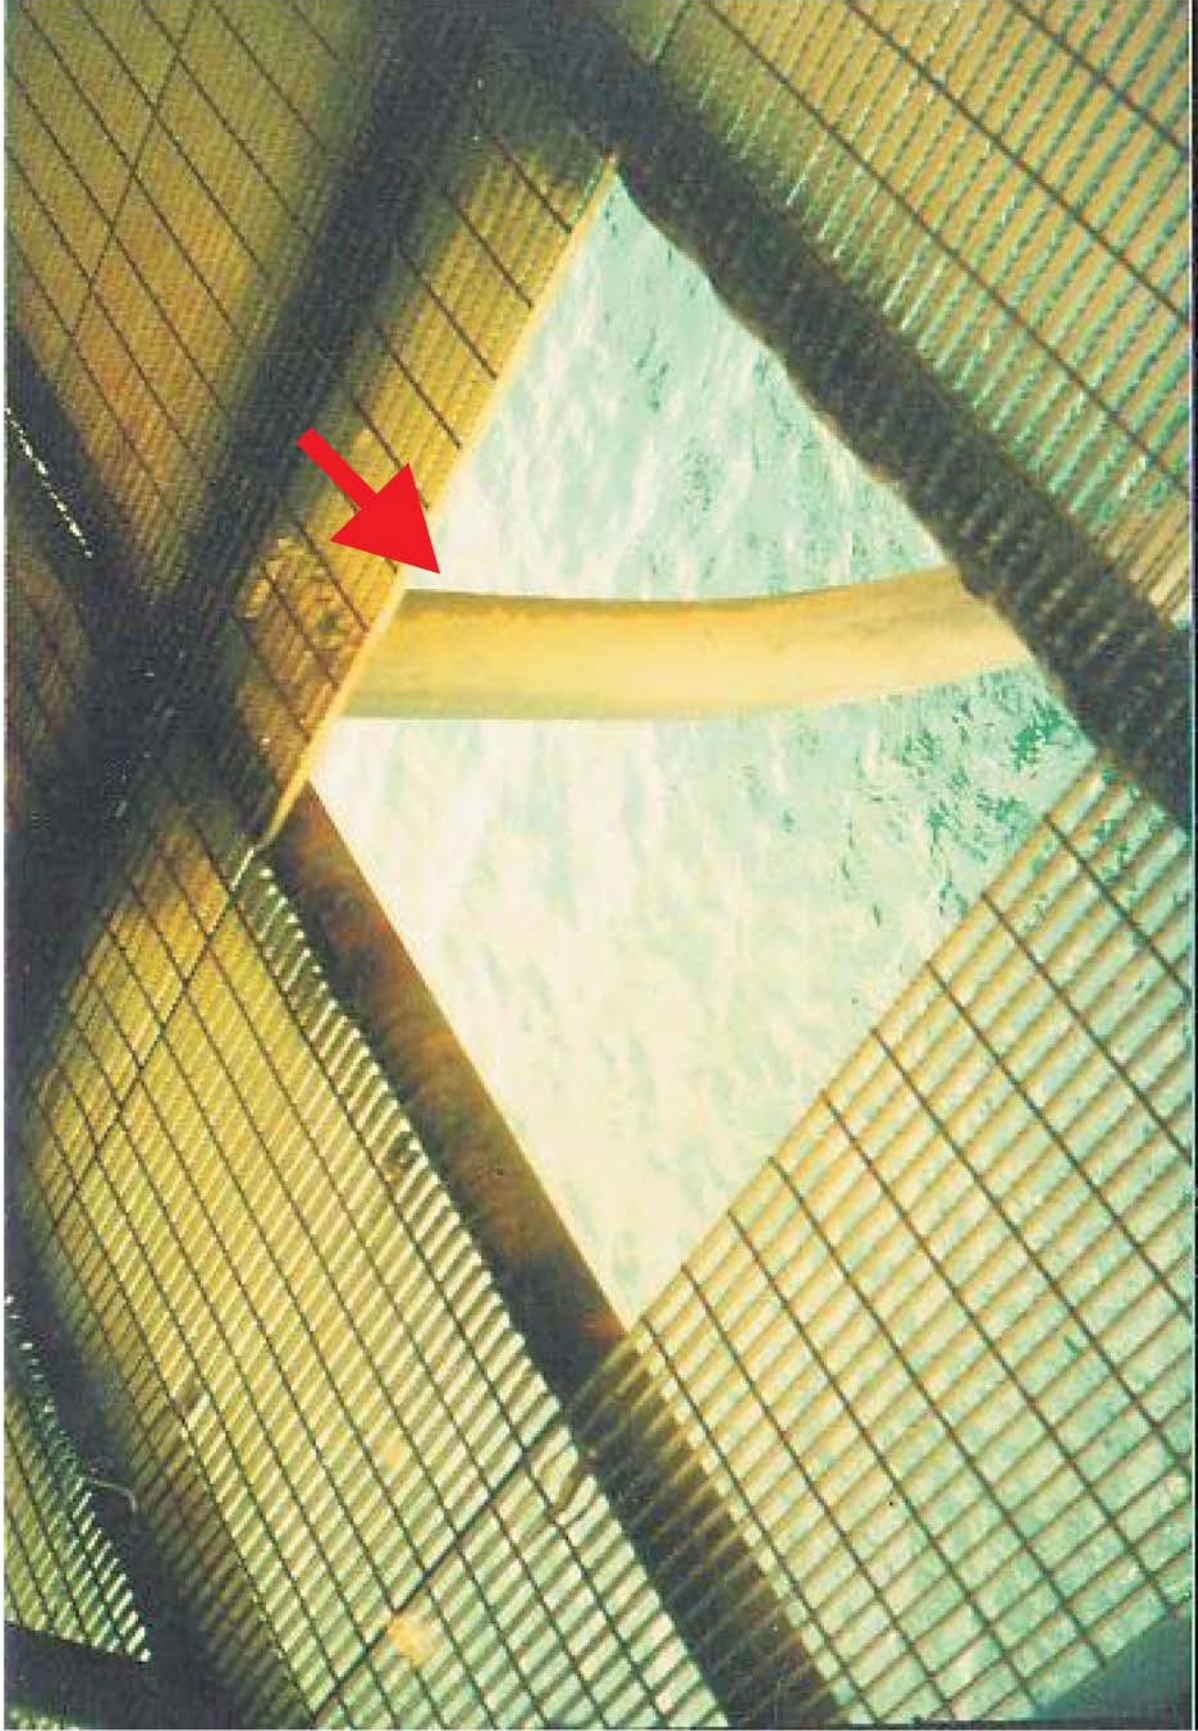
Platform Z, located in GI 37, was damaged by the storm surge and winds associated with Hurricane Katrina in August of 2005, with some of the gratings torn away, leaving holes of various sizes in the deck (see attachments 4, 5, and 6). The platform repair needs had been previously identified, with that work pending a commencement schedule.

Additional Hole #1 Missing Grating

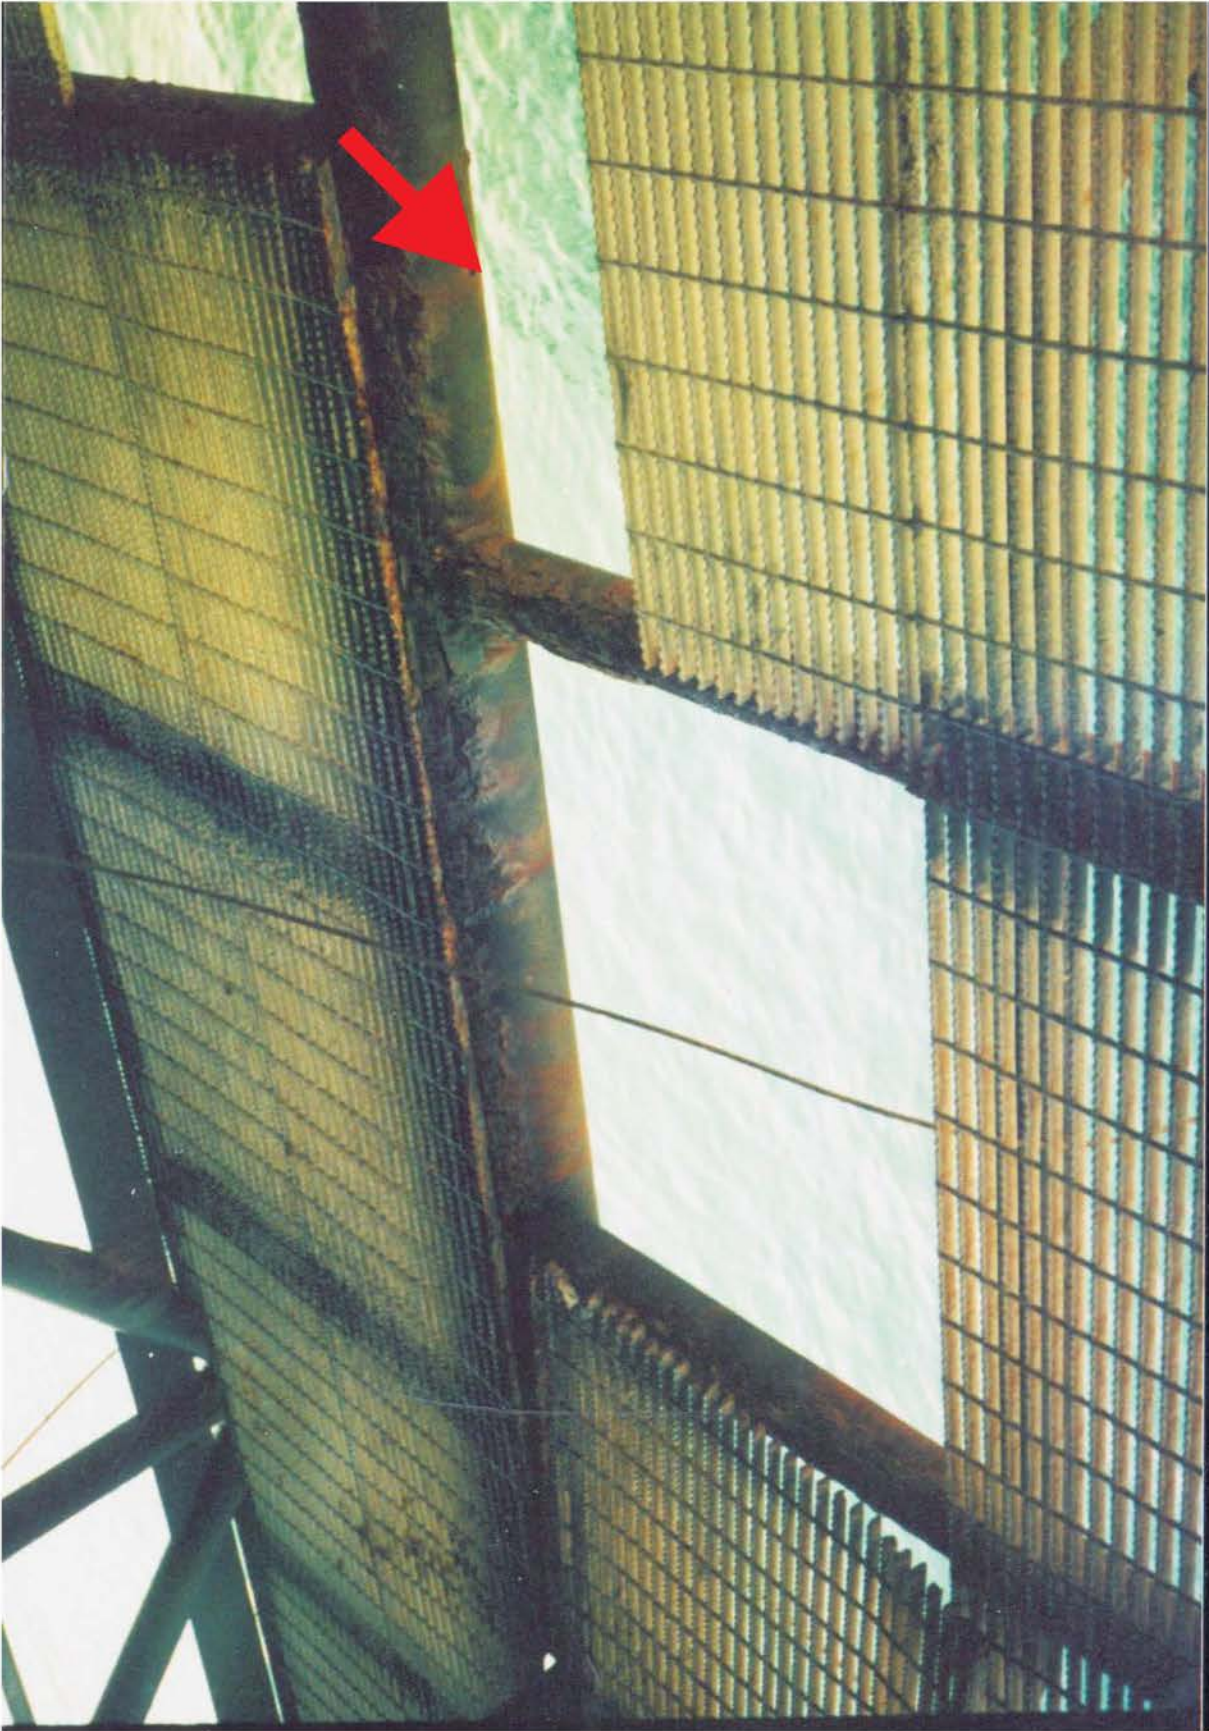
Additional Hole #2 Missing Grating

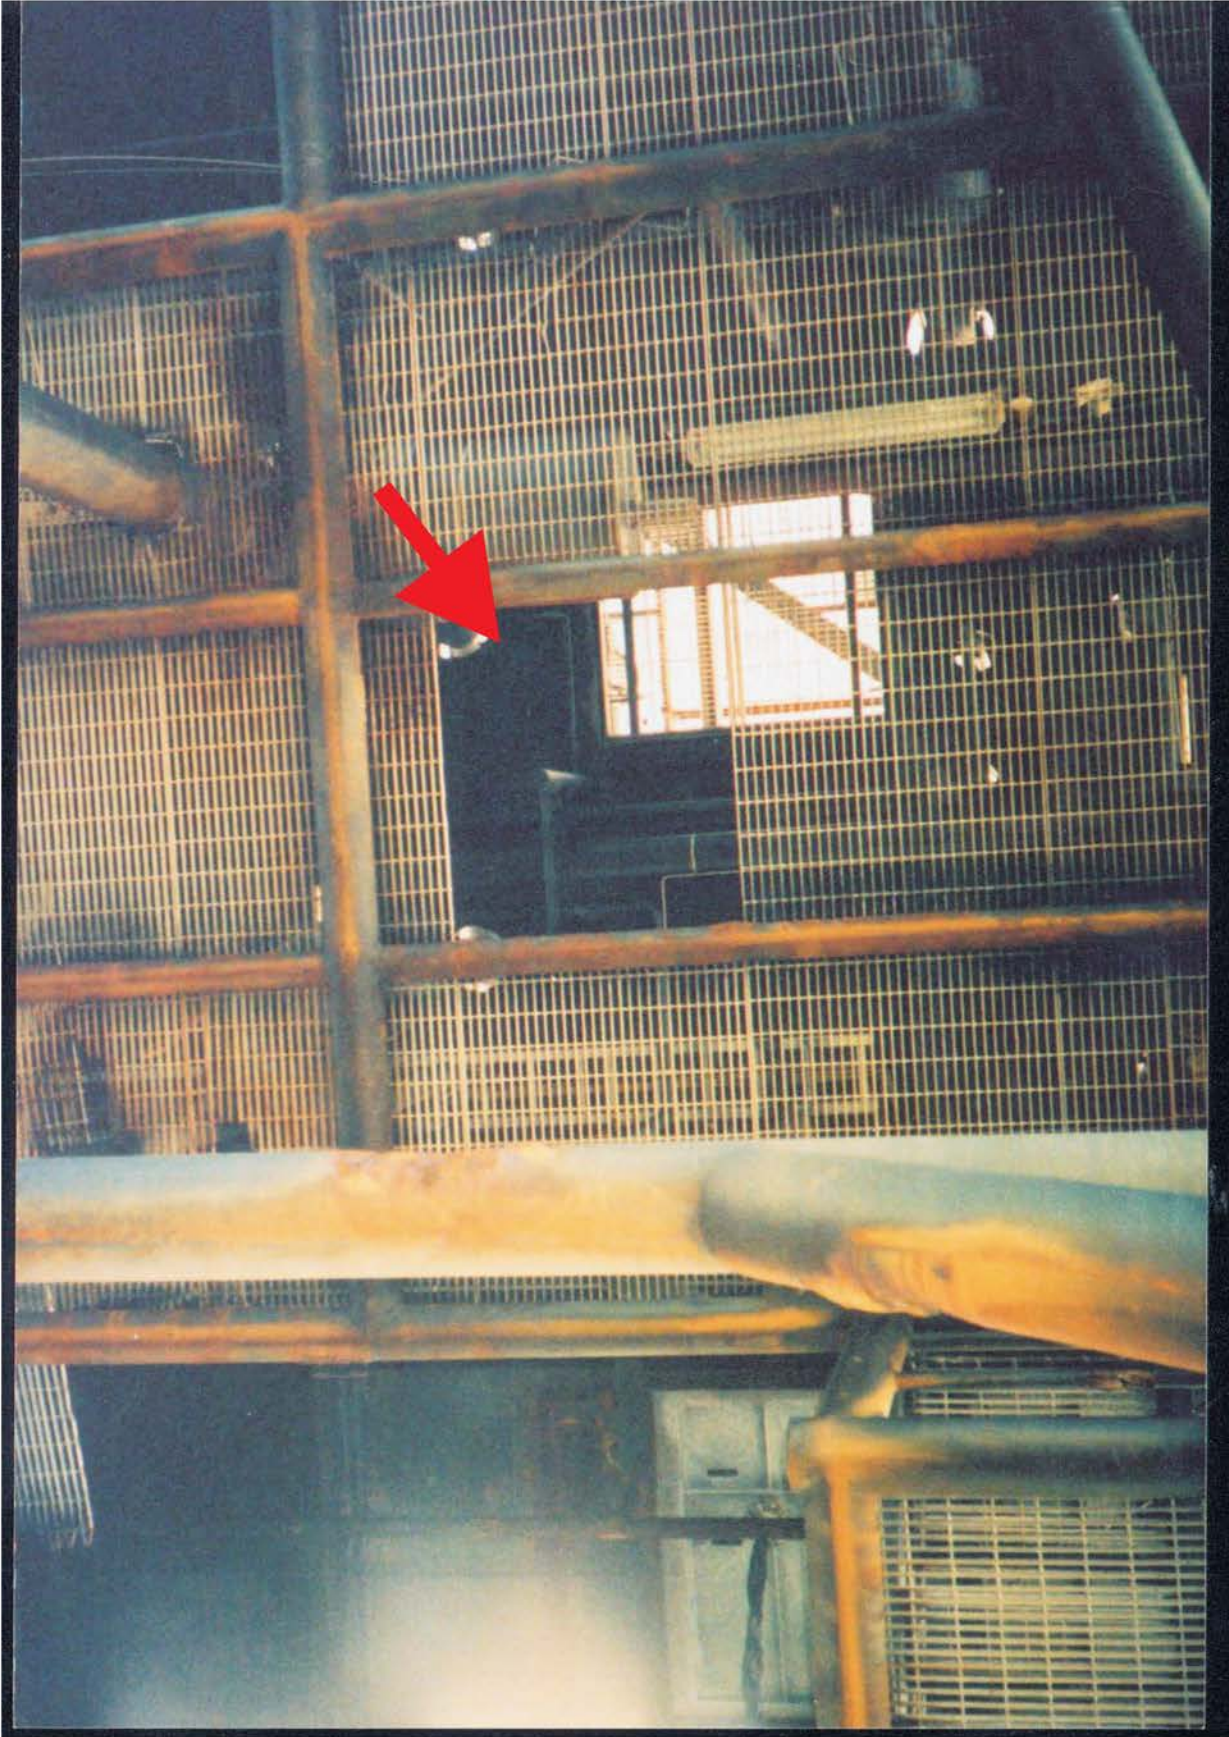
Additional Hole #3 Missing Grating
