**Investigation of Fatality and Loss of Well Control  
High Island Block A466, Well No. B-11  
OCS G-03242  
20 February 2006**

Gulf of Mexico  
Off the Texas Coast

J. David Dykes – Chair  
Richard Clingan  
Jim Hail  
Frank Patton

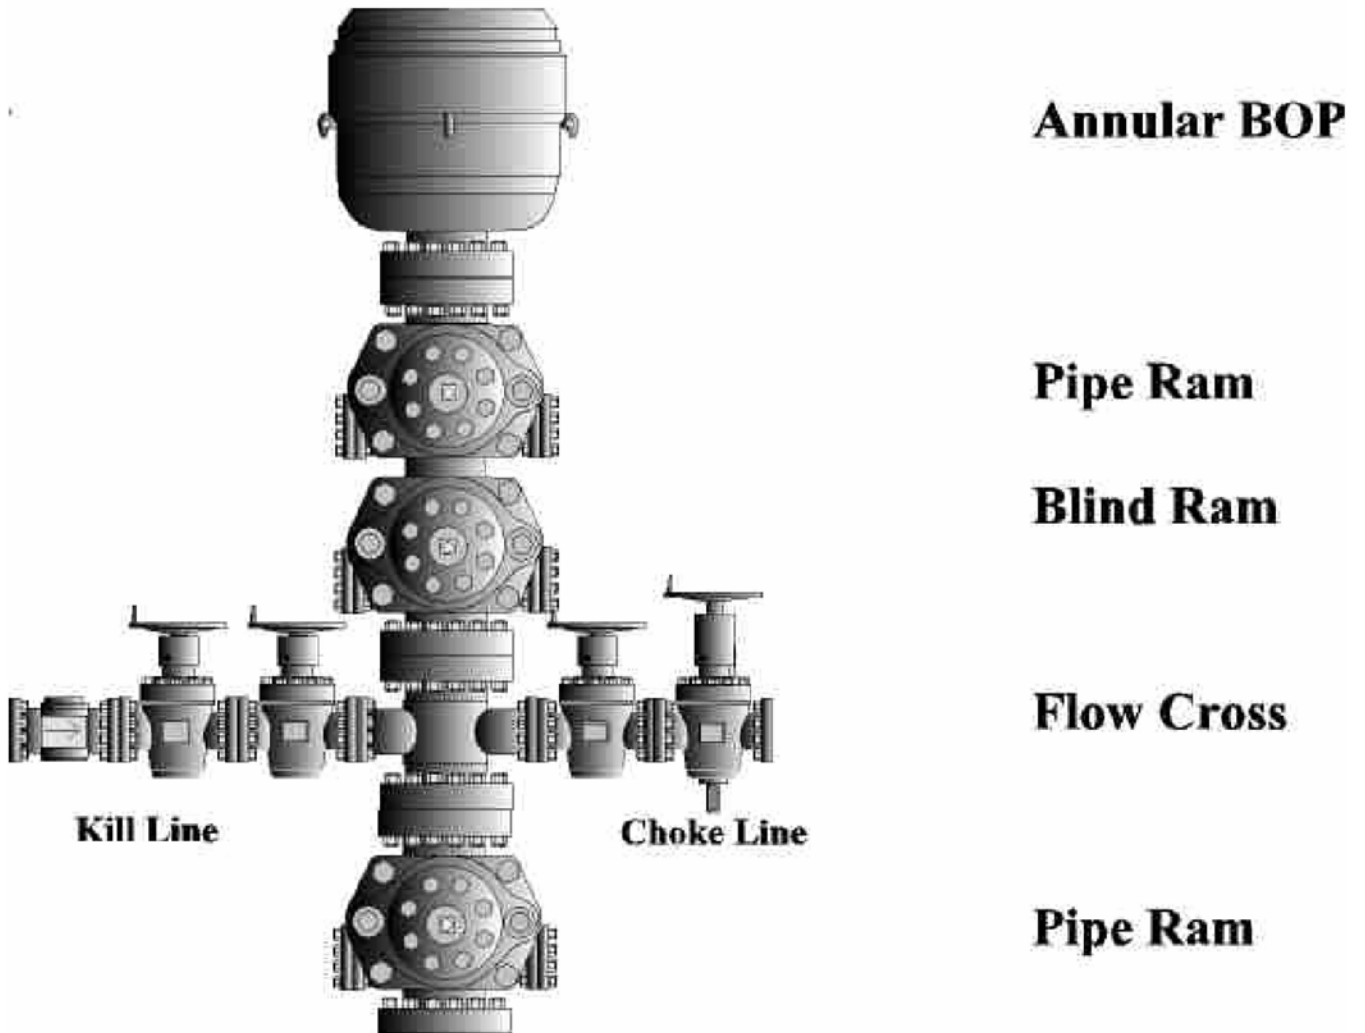
Diagram of Approved BOP Configuration

The approved permit displayed a drawing of the blowout preventer (BOP) stack to be used. The diagram shows a 7 1/16 inch, 5000-pound BOP with 1 annular, 2 pipe rams, 1 blind ram, and a spool with a proper choke kill valve configuration. *(See Attachment 3 for diagram of approved BOP configuration.)*

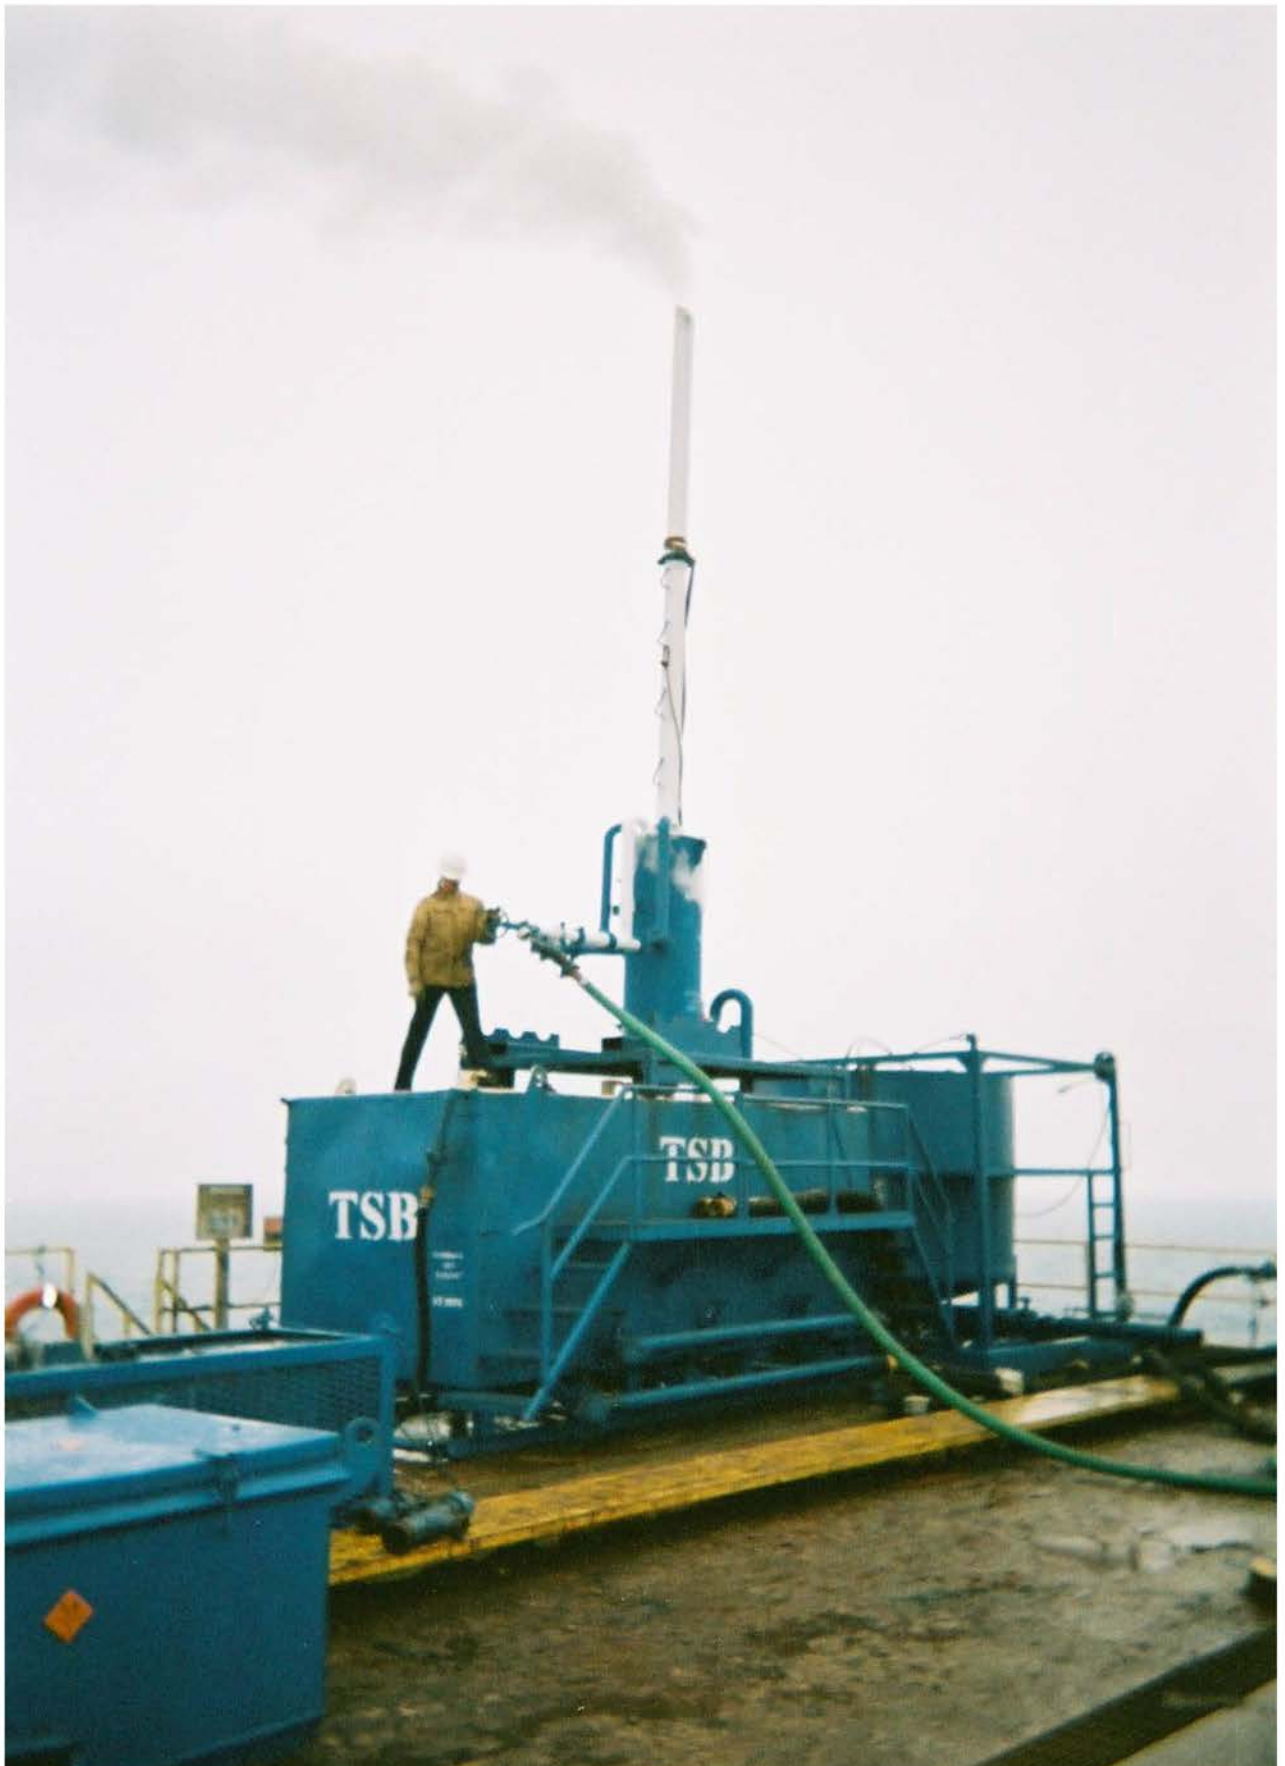
Photograph of TSB Crewmember Working Without Fall Protection

During a review of pictures taken by a TSB crewmember, another TSB crewmember was observed operating the choke on the gas buster. The choke is located on top of the trip tank at an elevation greater than six feet off the deck and near the outside edge of the platform (*See Attachment 5 of photograph of TSB crewmember working without fall protection*). TSB’s *Supervisor’s Health/Safety/Environmental Manual and Training Guide* (Safety Manual) states in the section titled “Personal Protective Equipment Programs,” subsection “Fall Protection,” the following:

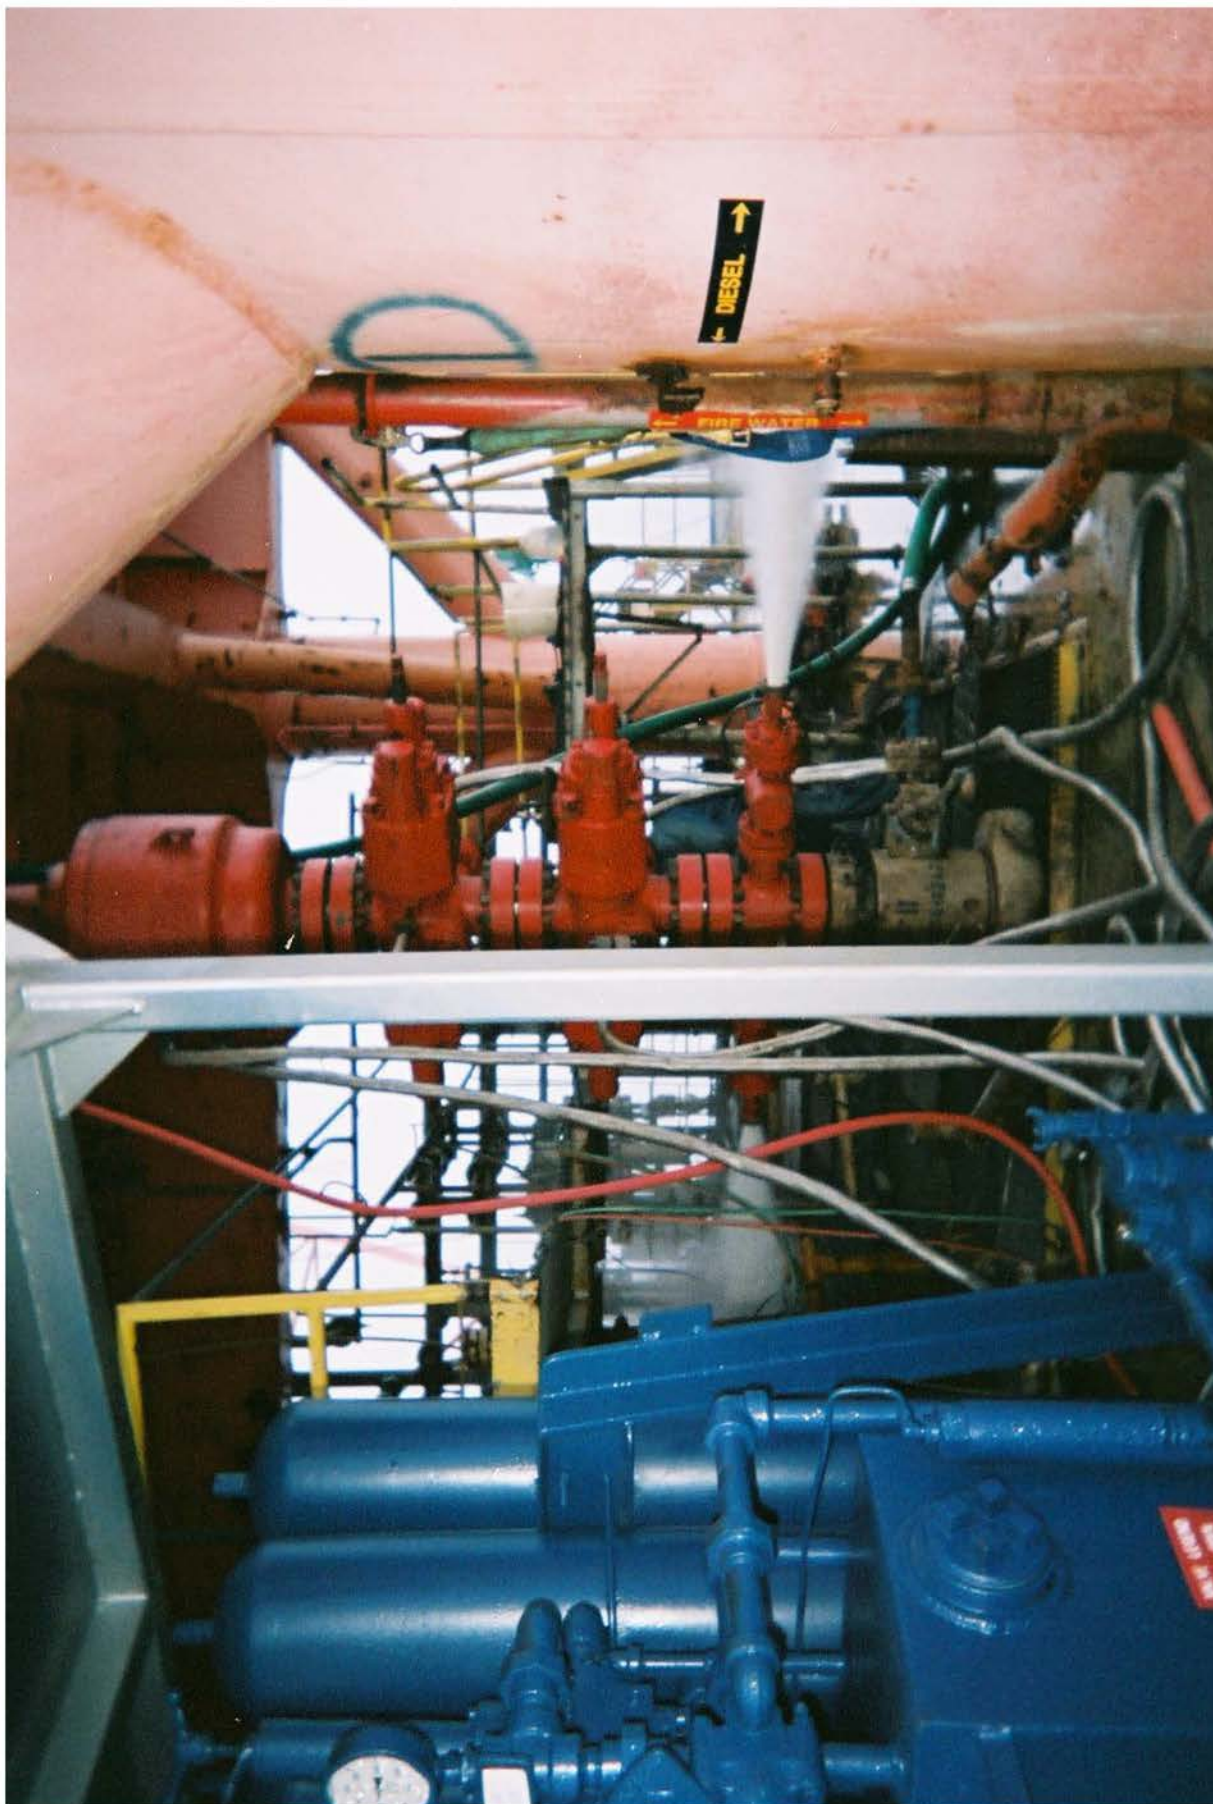
Photograph of Bleeding Gas at BOP Stack

Another crewmember stated that he observed the TSB day crew supervisor bleeding the gas off the casing at the wellhead instead of bleeding it off through the gas buster (*see Attachment 6 for photograph of bleeding gas at BOP stack*). The result of the action led to pollution of the Gulf waters (*see Attachment 7 for photograph of pollution*).
