**Investigation of Fatality
West Cameron Block 240
OCS-G 27008
December 1, 2006**

**Gulf of Mexico
Off the Louisiana Coast**

**U.S. Department of the Interior
Minerals Management Service
Gulf of Mexico OCS Regional Office**

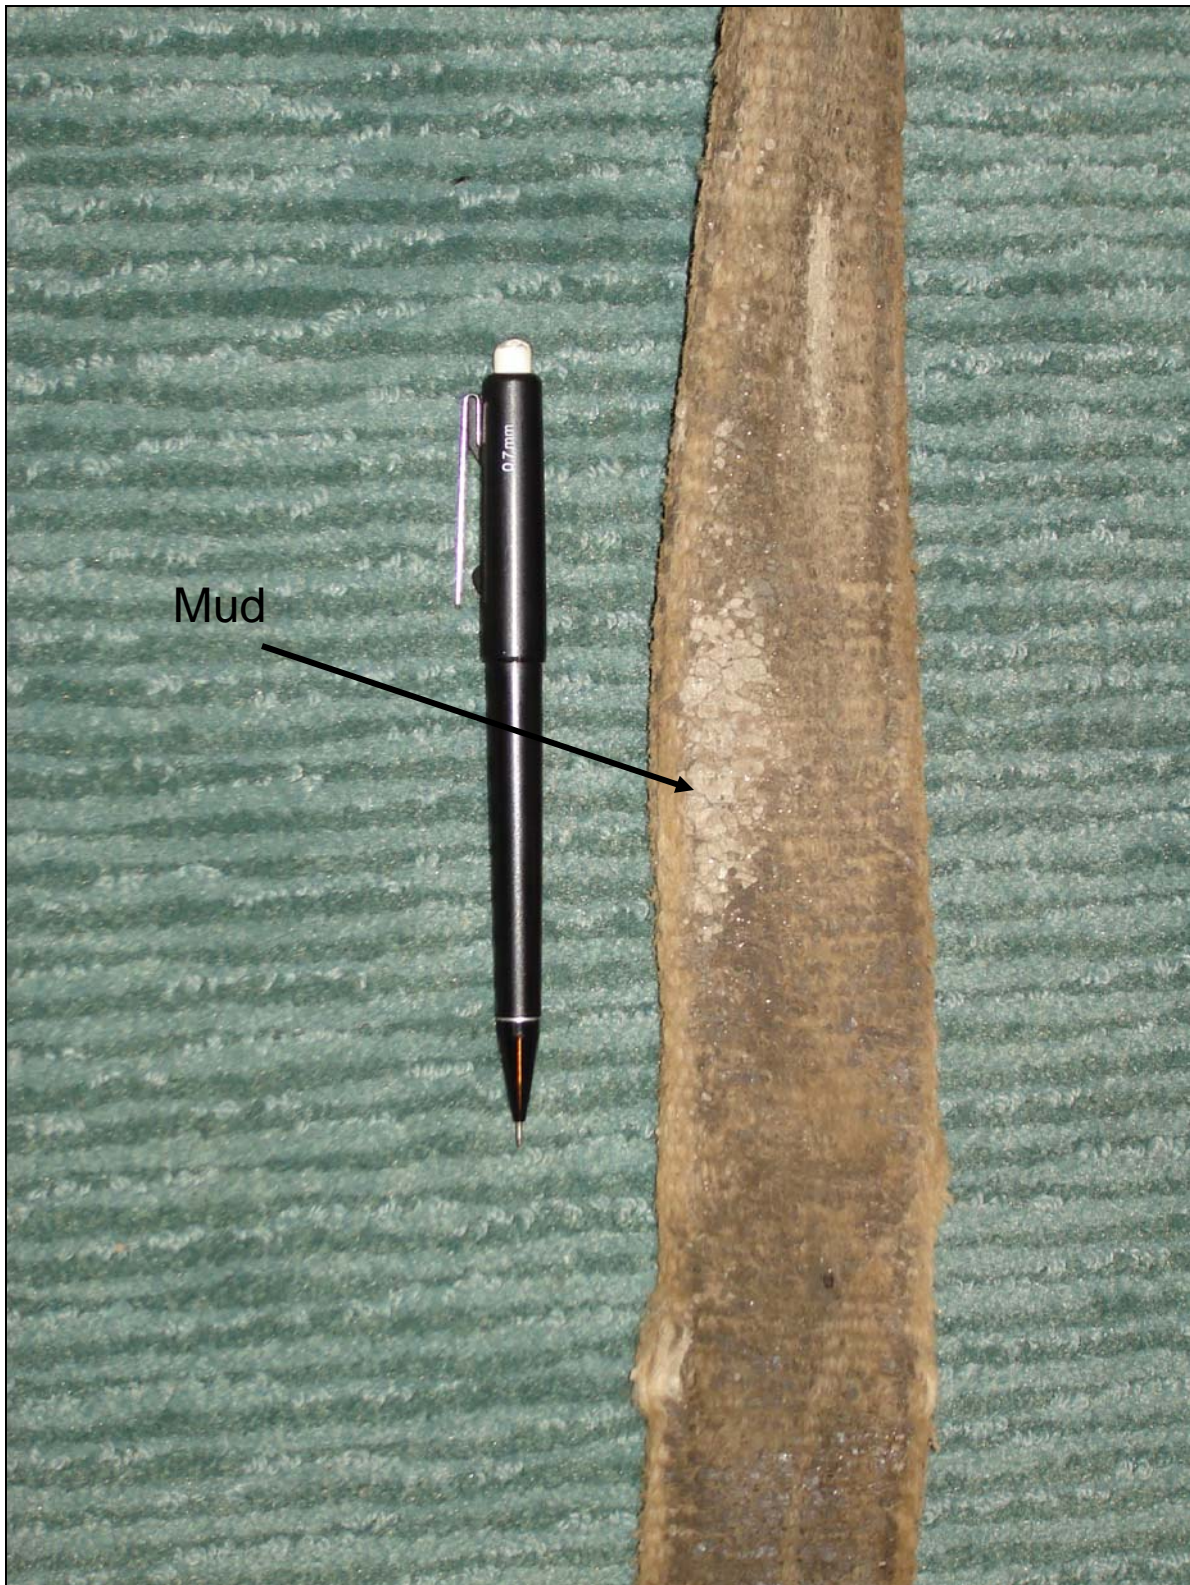
While T-R3 was on the rig floor, he was solely responsible for attaching the nylon strap below the tool joint to allow T-D/HO to make the lift, and then walk the drill pipe to the V-door once it was lifted by T-D/HO. TR-3 acknowledged there was evident pipe dope on all of the drill pipe joints being lifted, with some having more pipe dope than others. *For an indication of the condition of the nylon strap, see Attachments 2-6.*

1. It is the conclusion of the panel that, as the last joint of pipe was being pushed to the V-door, the necessary slackening of the hoist cable and an improperly cinched strap caused the eye of the cinched strap to ride up onto the pipe's tool joint and slip off the drill pipe.

Photo of Mid-Section of Nylon Strap used during the WC 240 Fatality

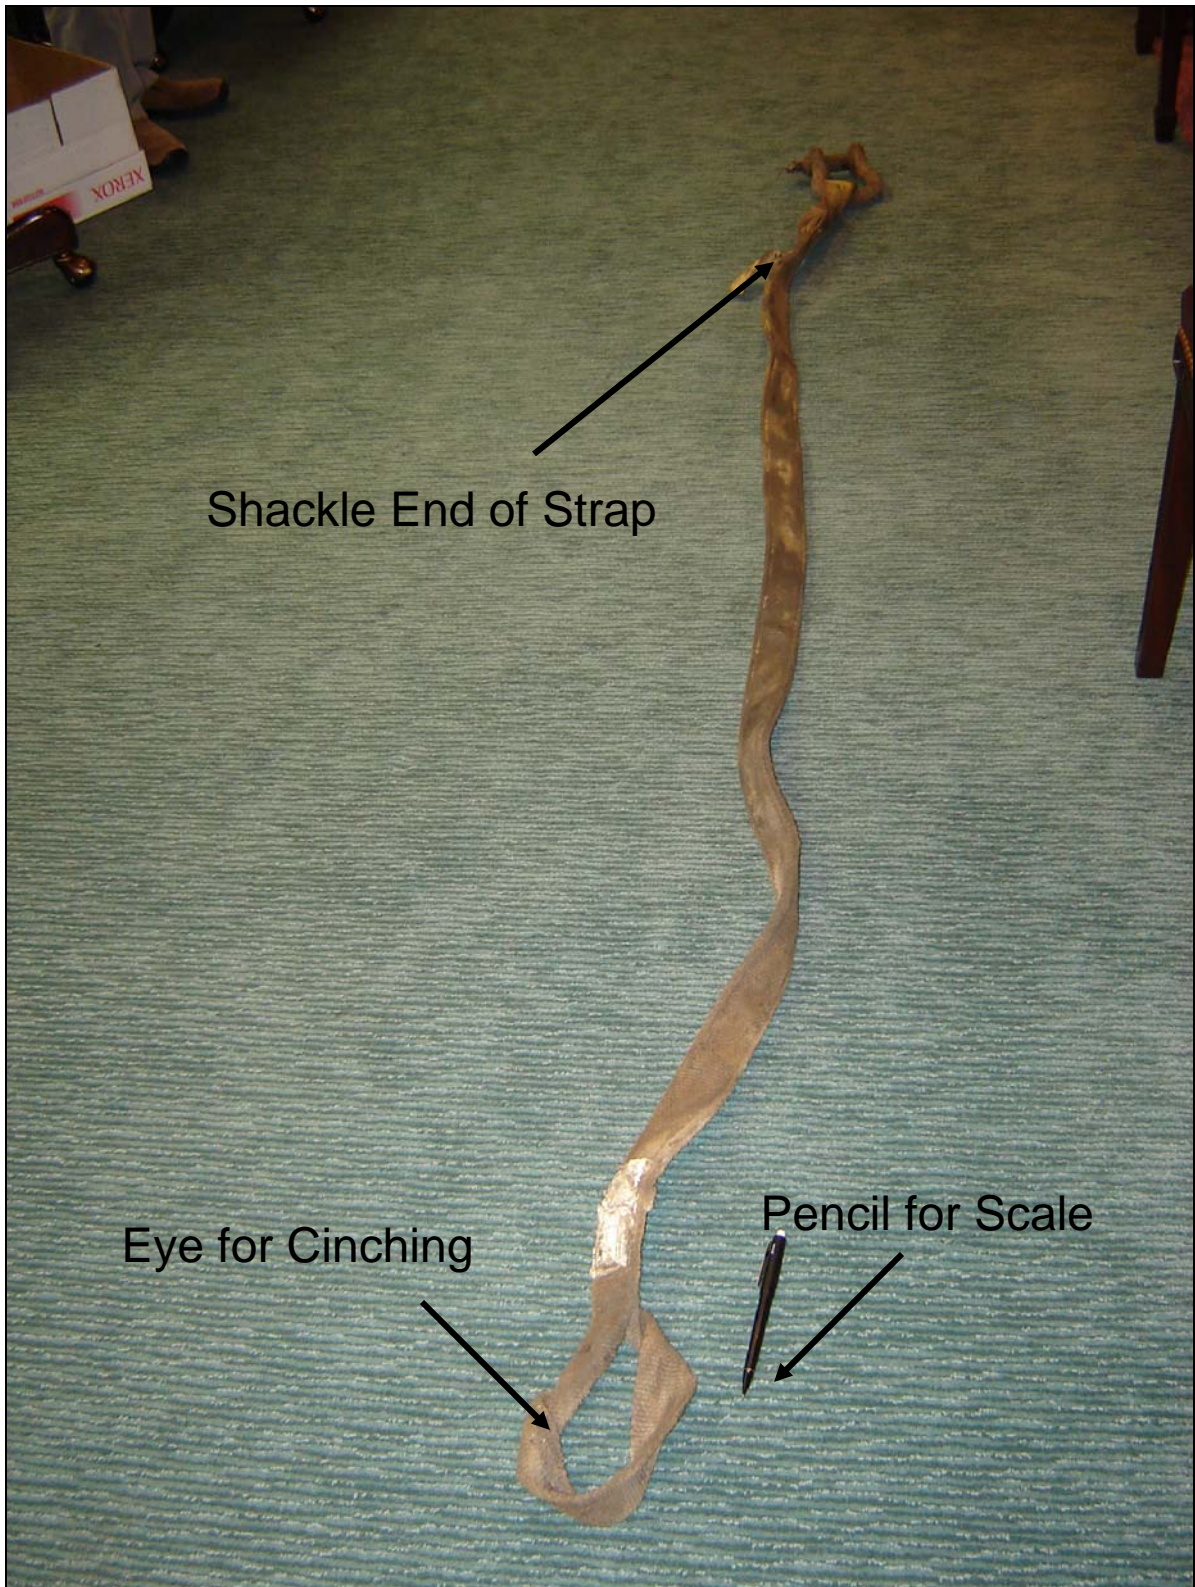
Photo of Nylon Strap used during the WC 240 Fatality

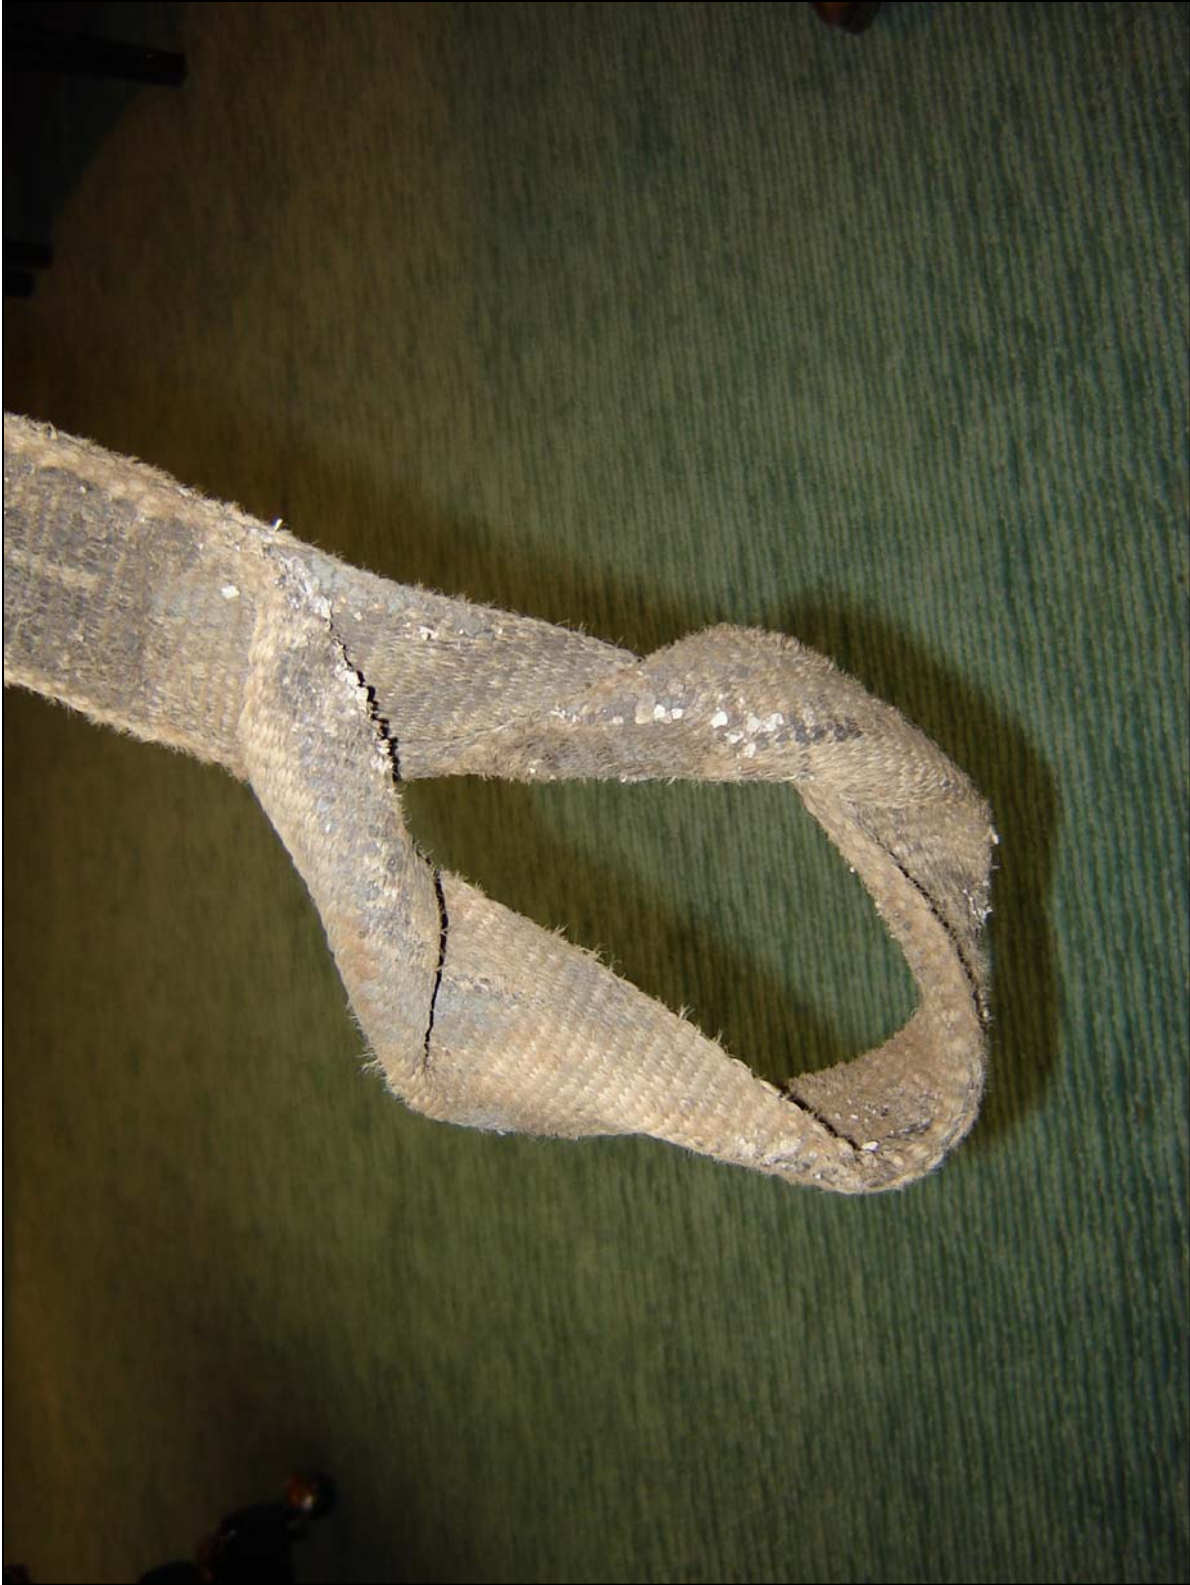
Photo of Nylon Strap Eye

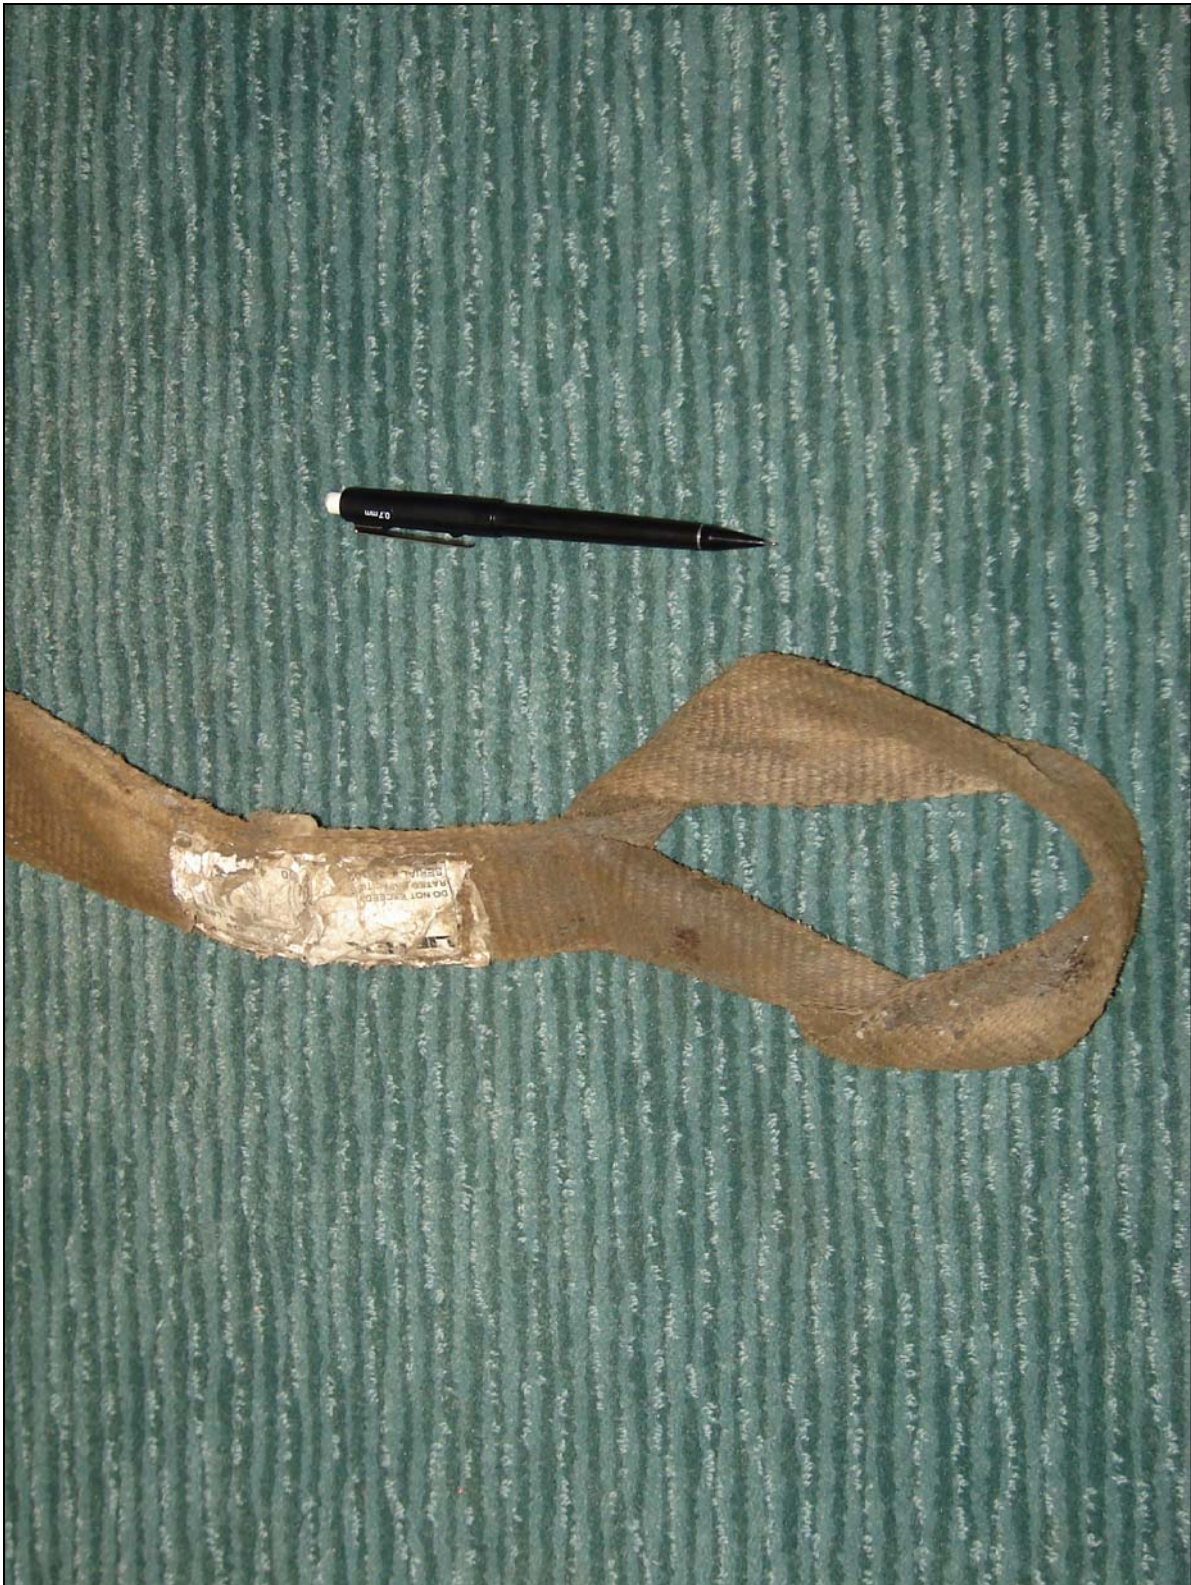
Photo of Nylon Strap with Eye

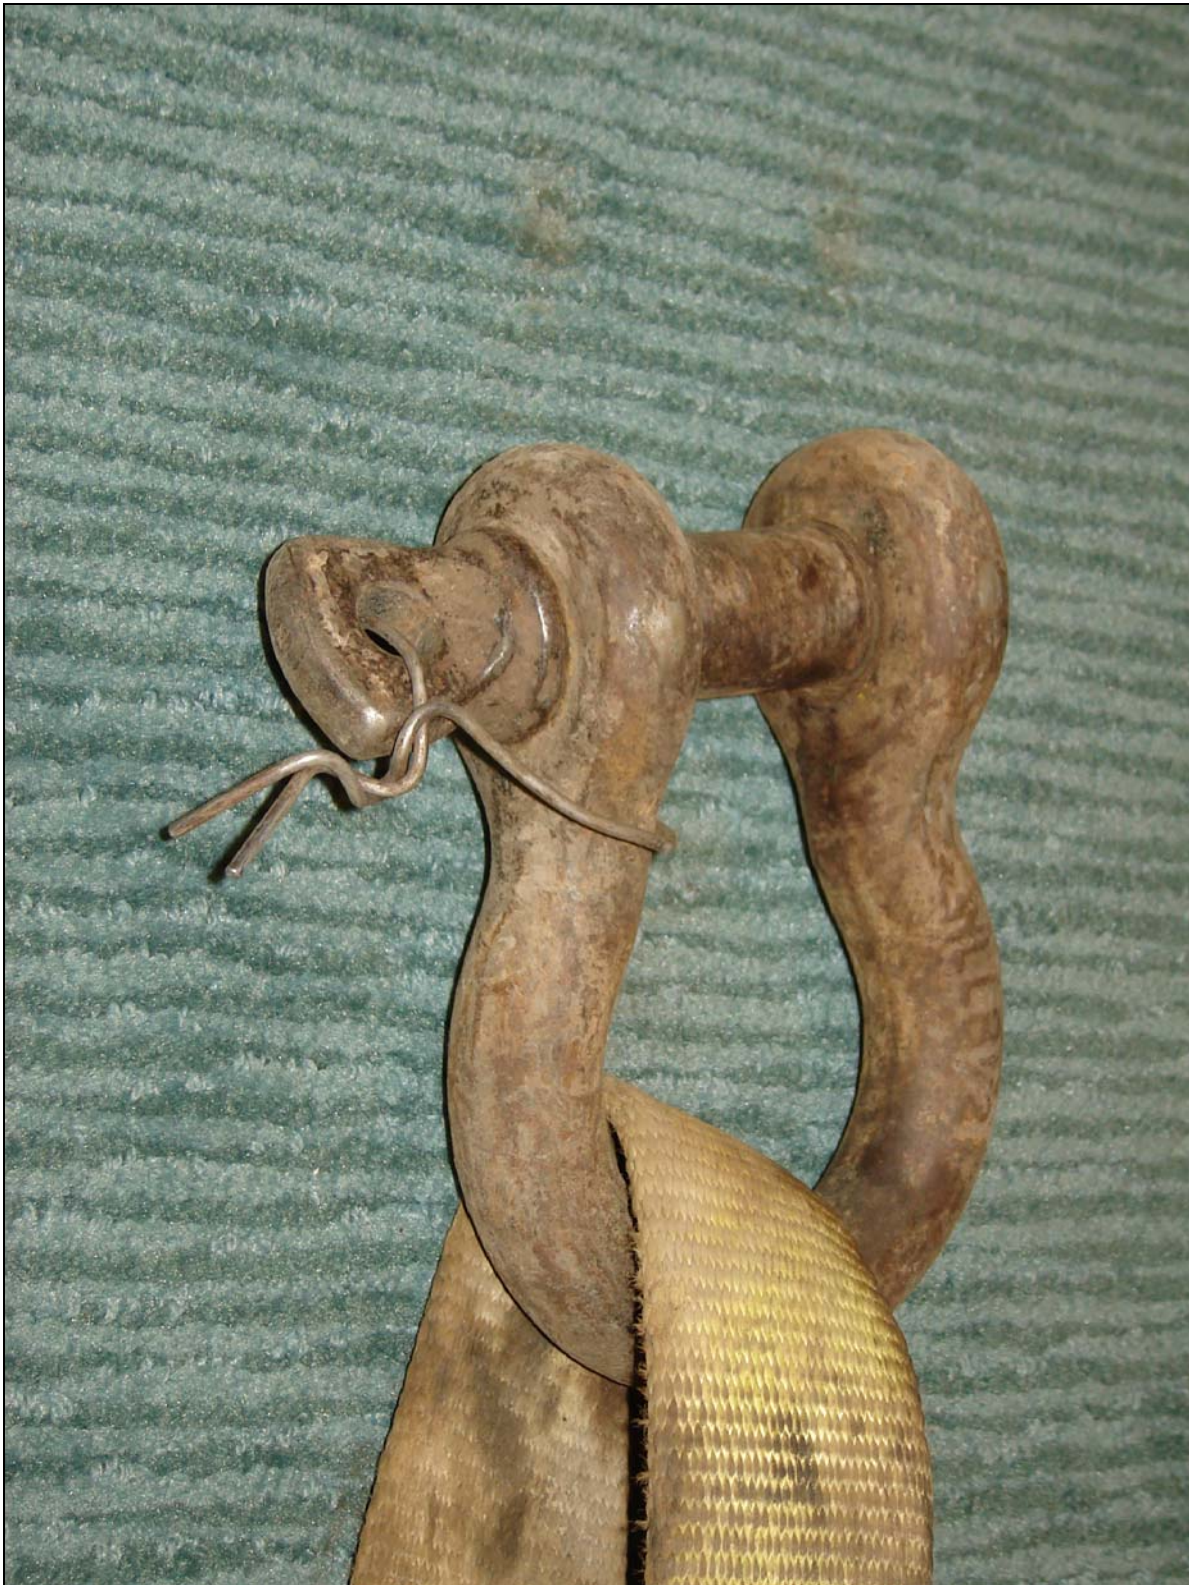
Photo of Shackle at End of Nylon Strap

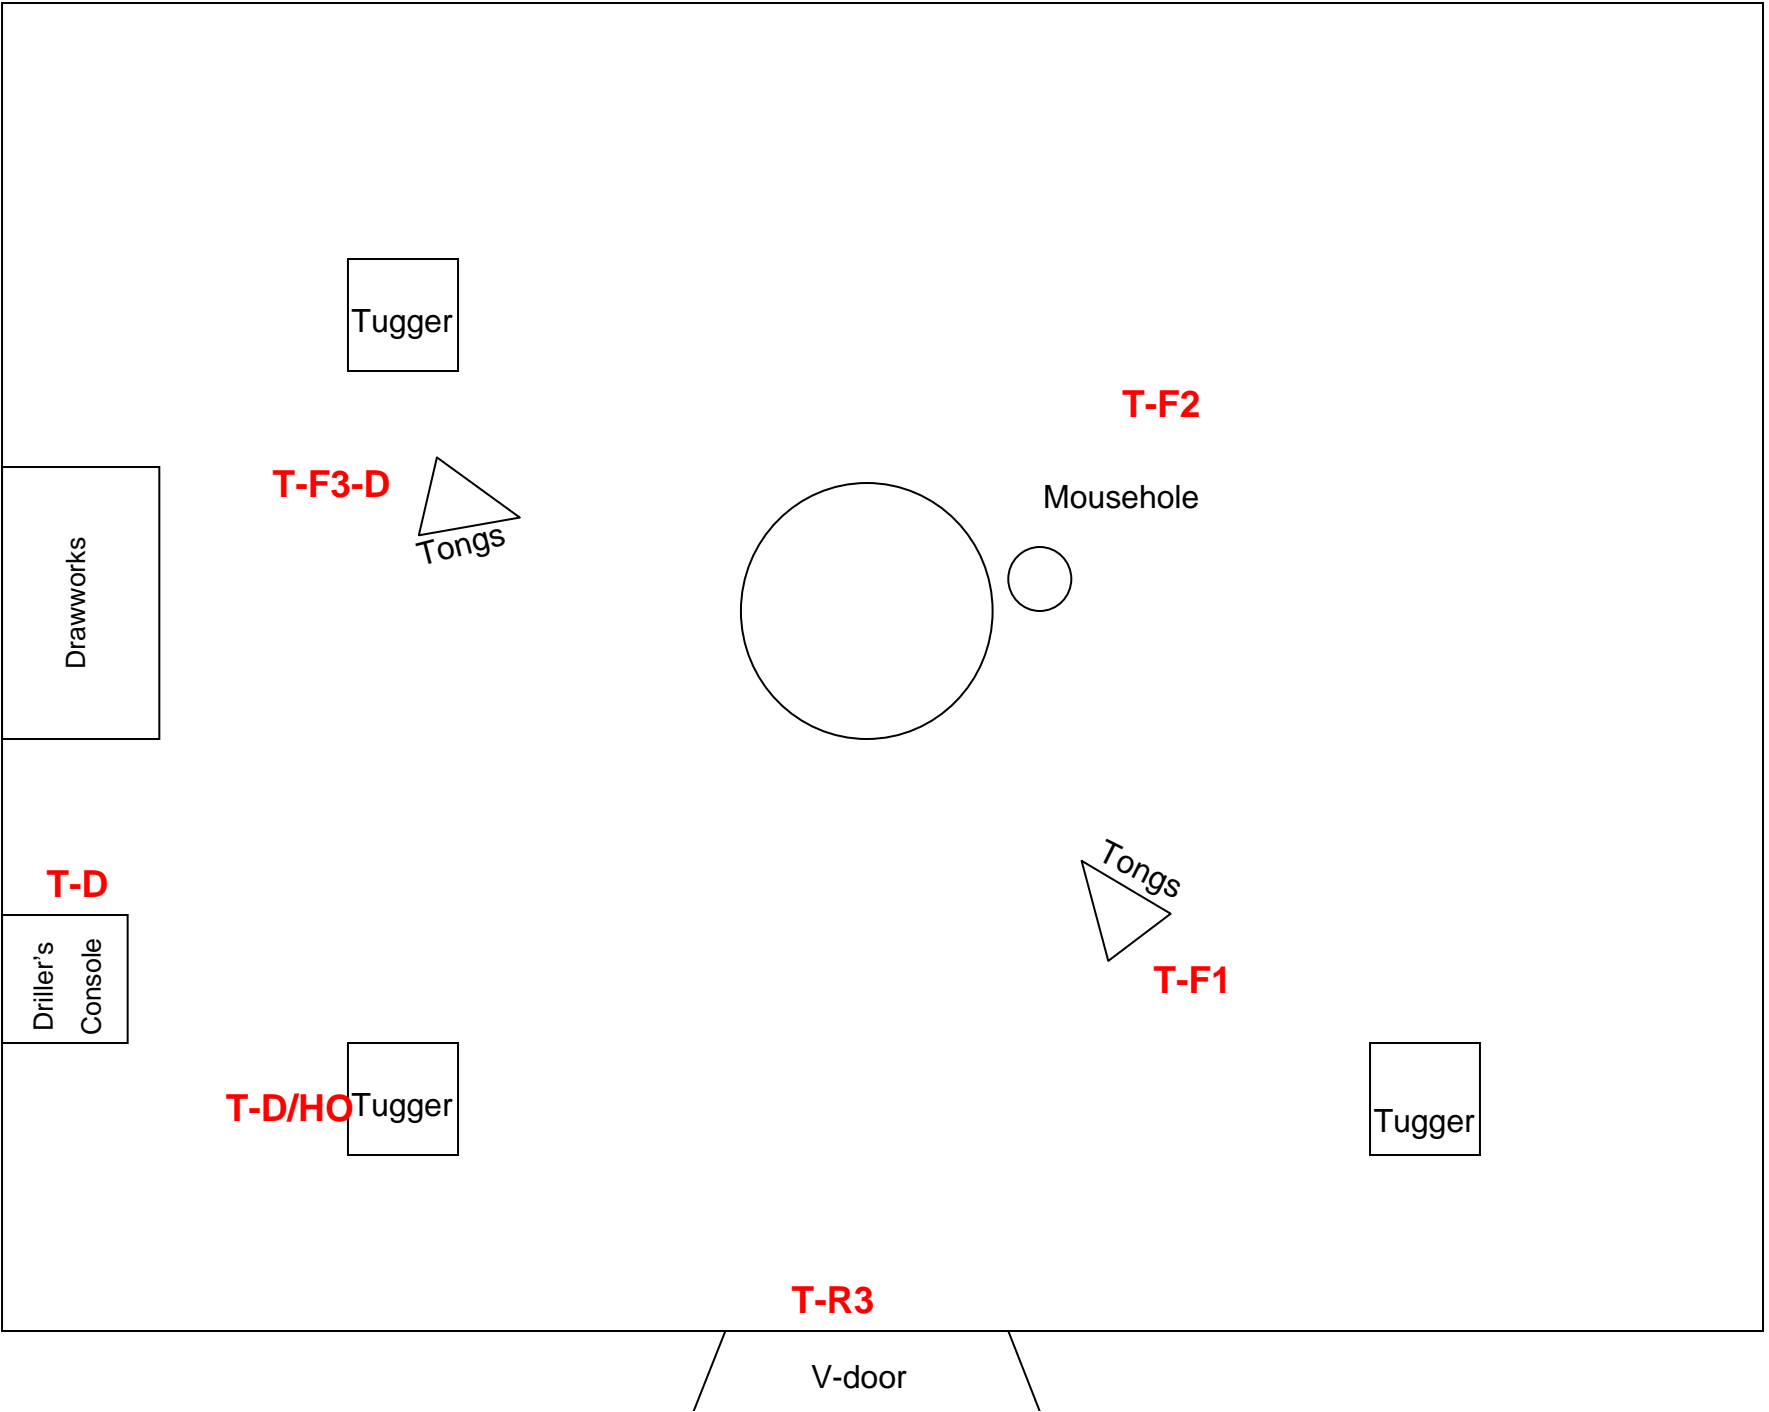
Layout of the TODCO 207 Rig at Time of Fatality

Prior to T-R3 making any connections to the drill pipe, T-F1 showed him the proper way to make the cinch three to four times according to T-F1. T-F1 said that he watched T-R3 make a few connections and then resume pulling the drill pipe. According to T-F1, T-F1 corrected T-R3 for attaching the nylon strap too high on the drill pipe tool joint. T-F1 said that he “had to set the joint down and explain to T-R3, because if it [the nylon strap] got on the tool joint the pipe would slip out.” T-F2 said that on one occasion the drill pipe was set higher than previous tool joints in the mousehole, which required T-F1 to cinch the strap below the tool, because T-R3 was having difficulties because of the tool joint’s height. Besides monitoring T-R3 make every strap connection, T-F1 was also responsible for operating the tongs, breaking drill pipe connections, and signaling to T-D/HO to lift the drill pipe. *For a depiction of the location of pertinent personnel at the time of the accident, see Attachment 7.*

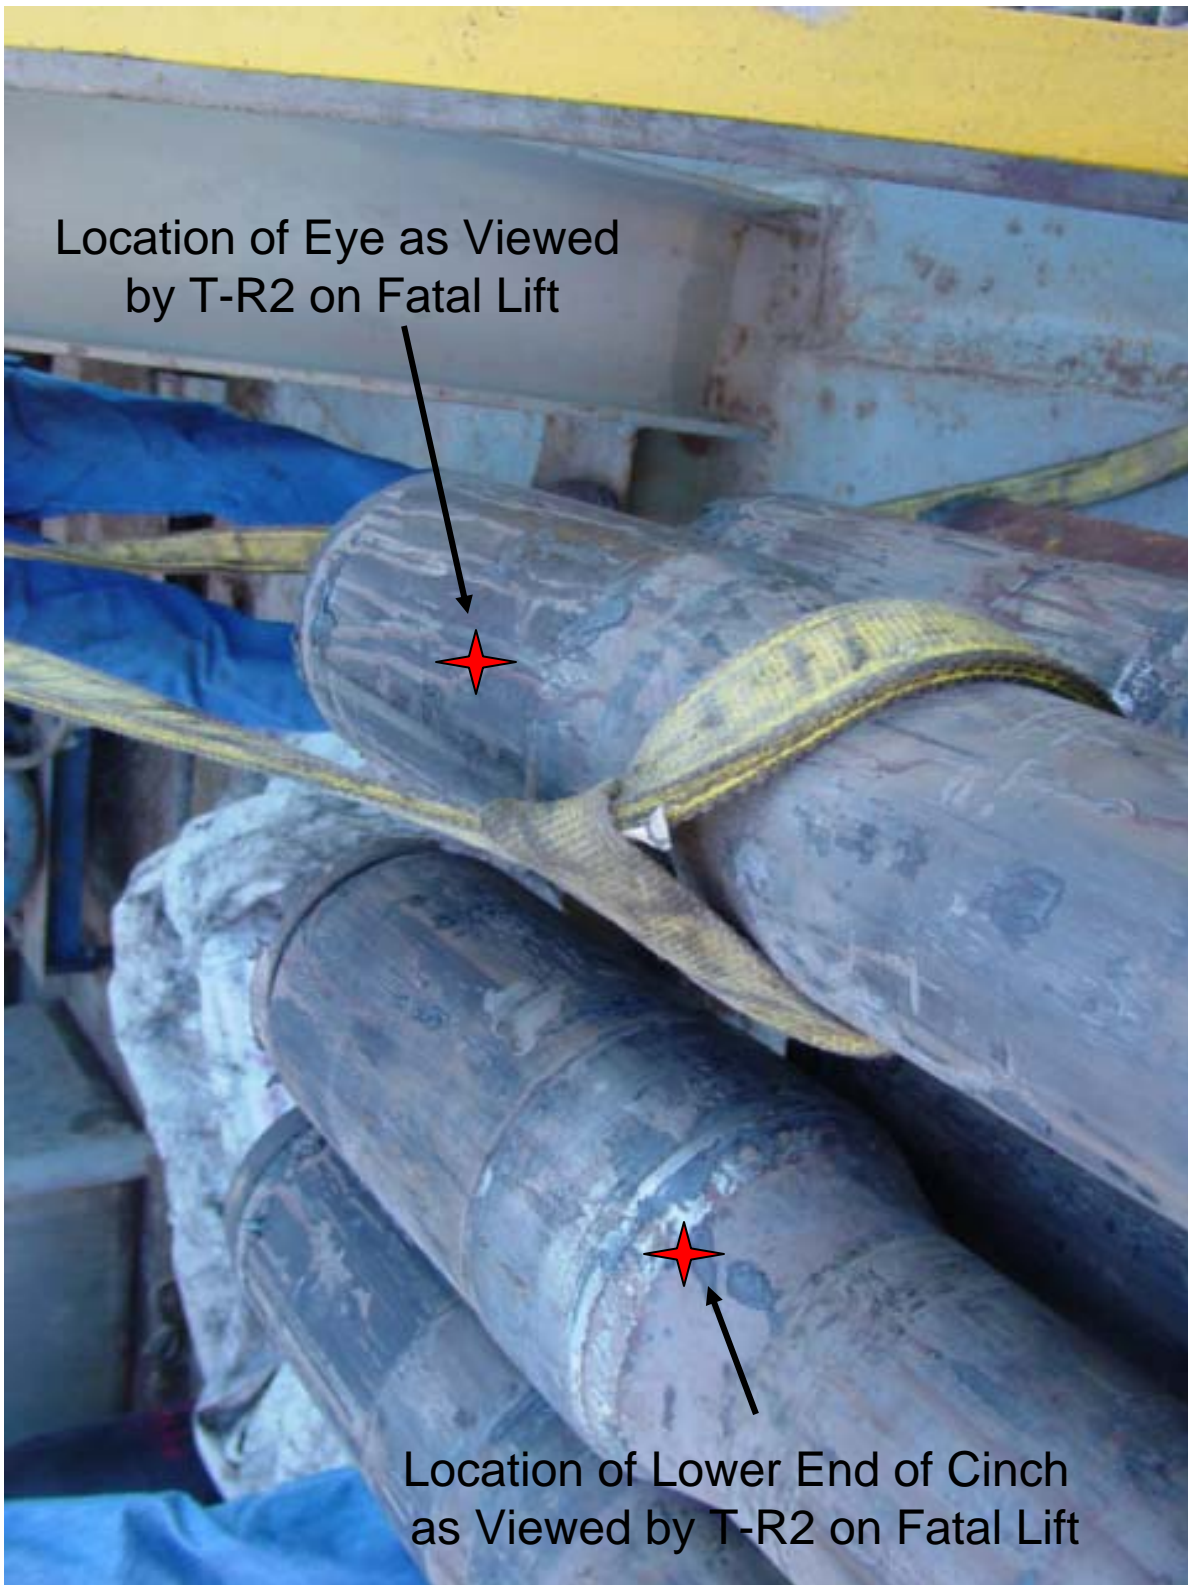
Prior to the drill pipe striking T-F3(D), T-R2 witnessed a loose strap connection on the drill pipe while it was suspended above the rig floor, prior to its falling, and he thought the strap might come off. After T-R2 saw this, he hollered at T-R1 to get off of the catwalk, because “it looked like it wasn’t on there real good.” *For a depiction of the single choker hitch used during the laying down operation and the location of the strap on the pipe as viewed by T-R2 on the fatal lift, see Attachment 8.*

The exact manner in which the strap was improperly cinched is not known. It is concluded that the strap was placed either 1) too high on the joint with the eye of the strap either on the bevel of the tool joint or on the joint itself or 2) too low on the joint, thereby allowing the momentum of the strap, as the pipe was being lifted, eventually to slip over the bevel and eventually off the drill pipe's tool joint. **Therefore, the improper cinching of the strap onto the pipe is concluded to be a cause of the incident.**

Photo of Depiction of Single Choker Hitch

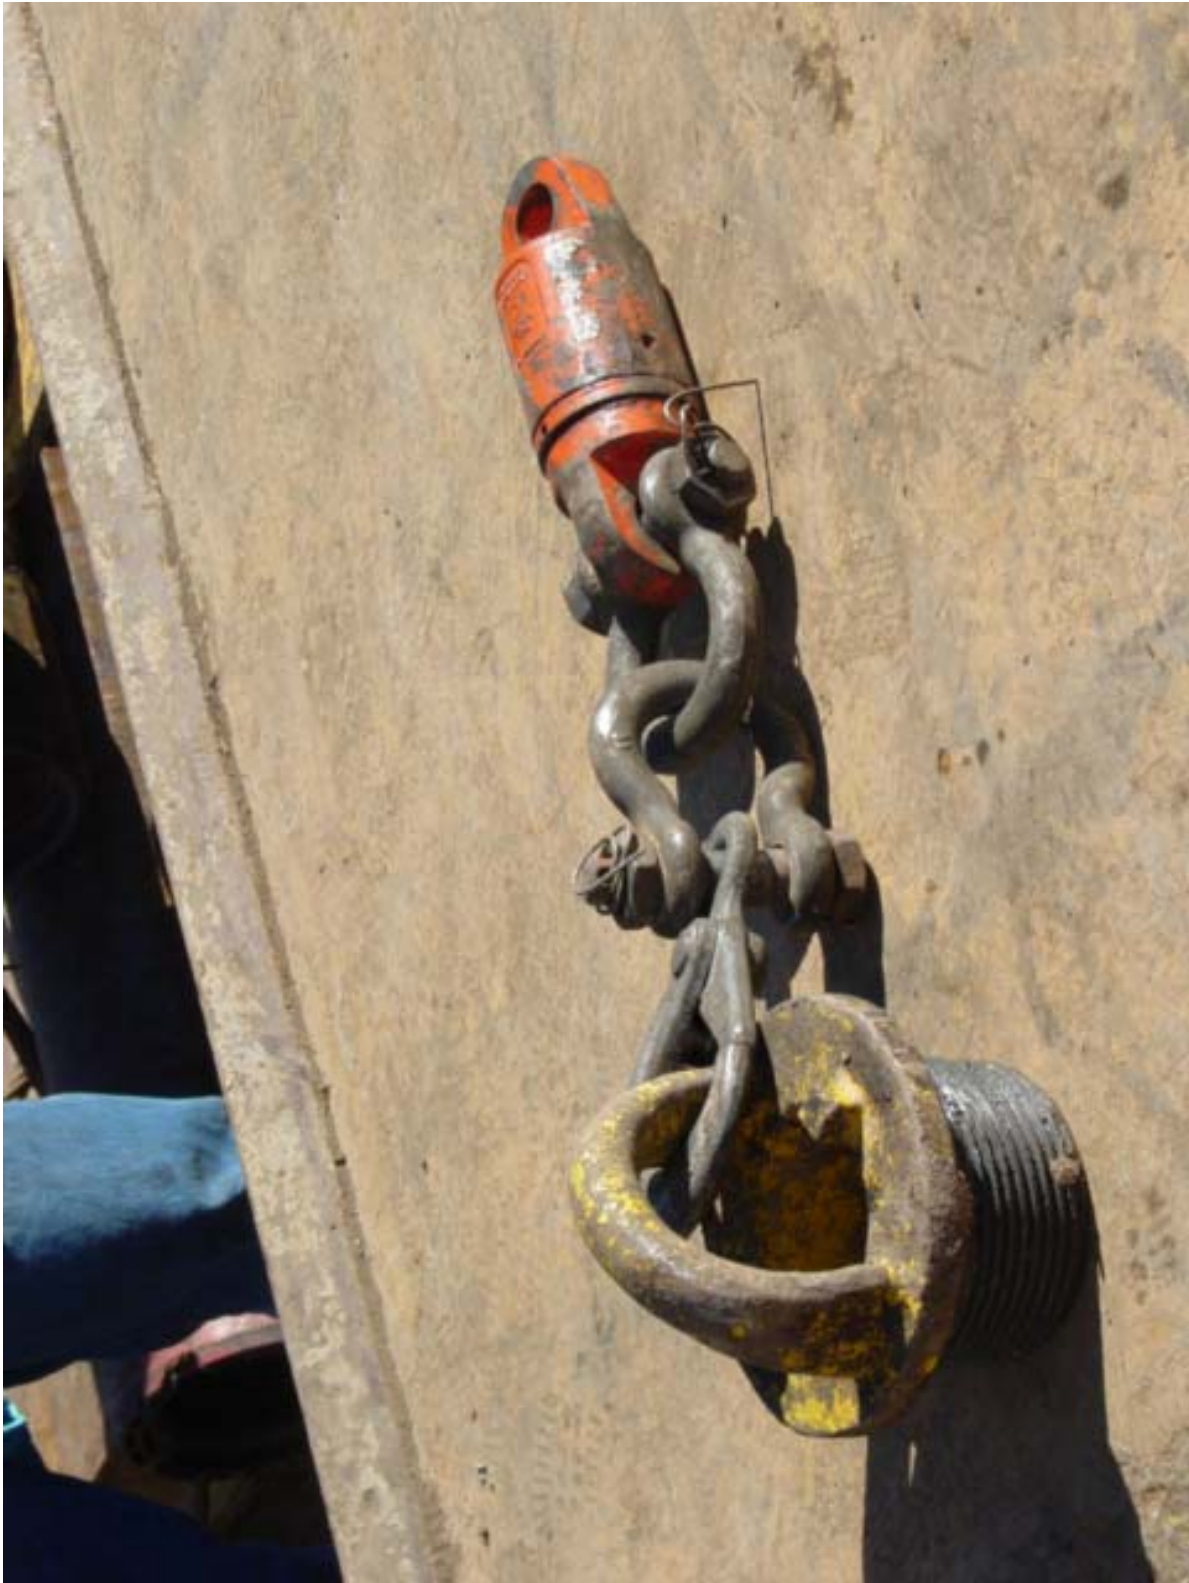
Photo of Lifting Sub that Replaced the Nylon Strap

After the incident, TODCO replaced the nylon straps for similar operations by requiring the pulling of drill pipe on every TODCO rig worldwide to be performed with a threaded lifting sub. T-VPHSE said that the decision to replace the strap “wasn’t recognizing that use of the nylon strap was in anyway unsafe.” He stated that the decision represents a desire to take action immediately to prevent the likelihood of reoccurrence. *For photo of the lifting sub, see Attachment 9.*
