**Investigation of Loss of Well Control and Fire  
South Timbalier Area Block 220, Well No. A-3  
OCS-G 24980  
23 July 2013**

**Gulf of Mexico  
Off the Louisiana Coast**

David Trocquet – Chair  
Jack Williams  
Marty Rinaudo  
James Richard  
Charles Arnold  
Michael Idziorek  
Michael Pittman  
Matthew Capon - USCG

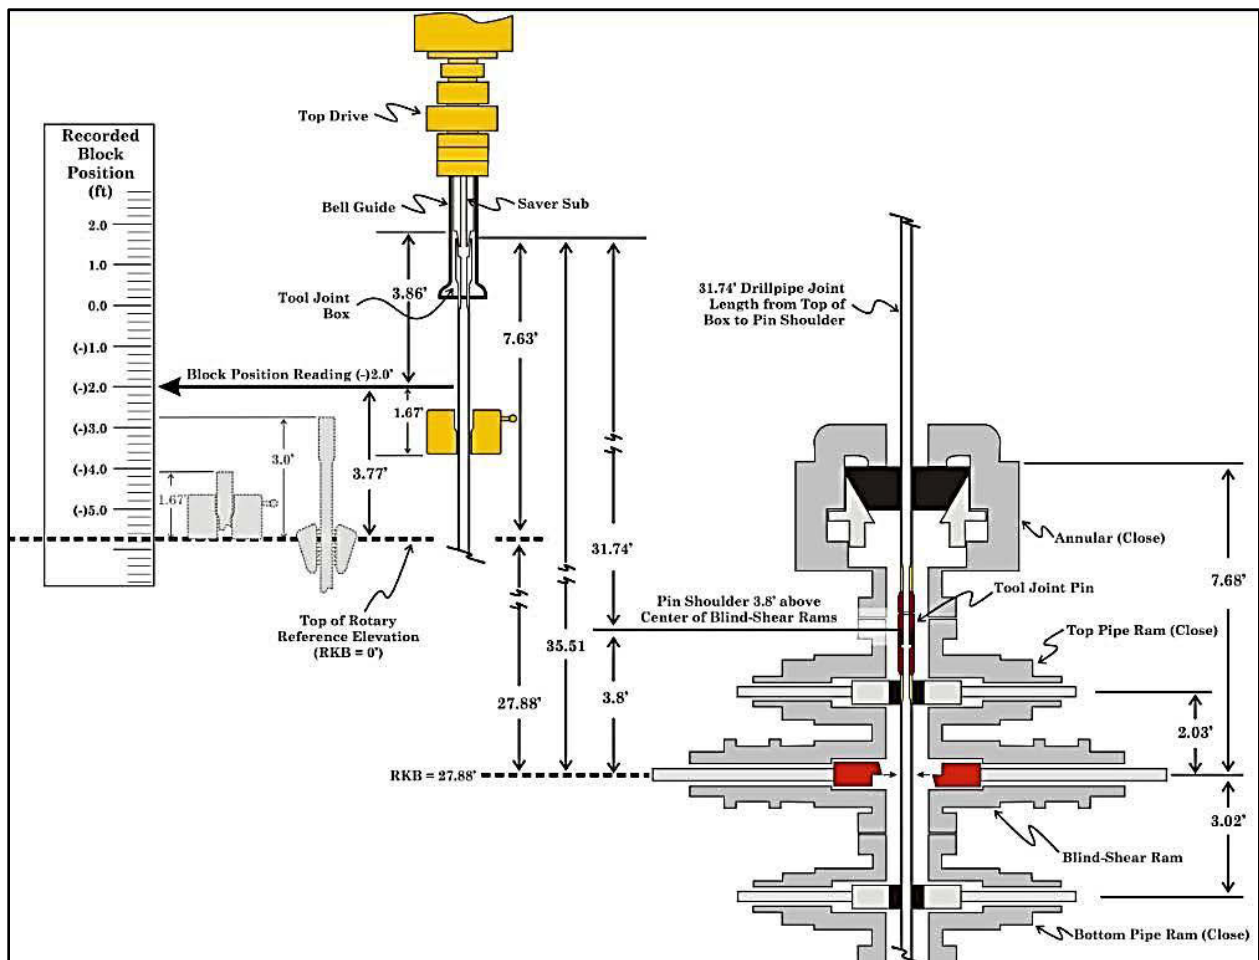
**Figure 21:** Estimated position of tool joint and top drive bell guide preventing installation of safety valve (from SME Committee Report)

Statements from the Driller and Derrickhand indicated that they first attempted to direct the Floorhands to install the safety valve into the drill string as per the Hercules procedure. Statements indicated that the force of the ejecting fluid was pushing the pipe out of the hole and the weight of the drill pipe string remaining in the hole was apparently insufficient to pull the string down to a position where the valve could be installed. It was noted that this proved impossible because the connection of the drill string was about 8-ft above the rig-floor, pushed up inside of the top drive bell guide (see figure 21). In that position, the Floorhands could not access the box end to position the safety valve.

pressure of the Well, operating on the end of the drillpipe and packer, was already forcing the pipe out of the hole up into the top drive bell guide making it impossible to position the pipe so that the safety valve could be stabbed. So he then closed the annular. It remains unknown if closing the annular early contributed to the inability to stab the safety valve.

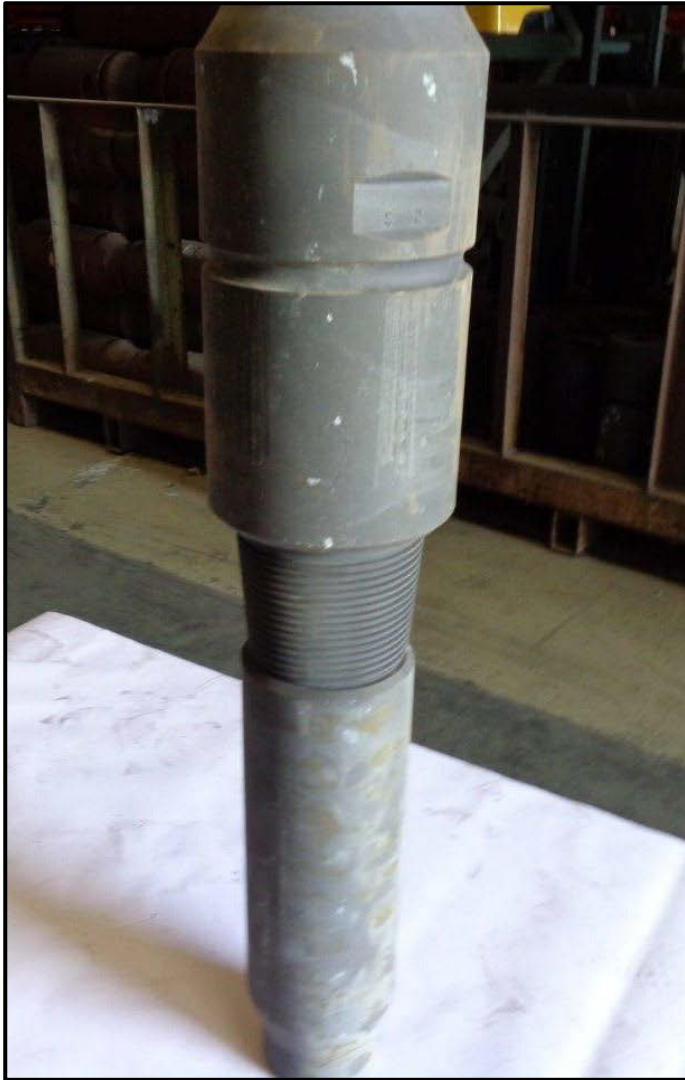
**Figure 22:** Top drive 5-in pin above 3 ½-in box

Statements were also received that the top drive pin connection had not been changed from 5-in to 3 ½-in

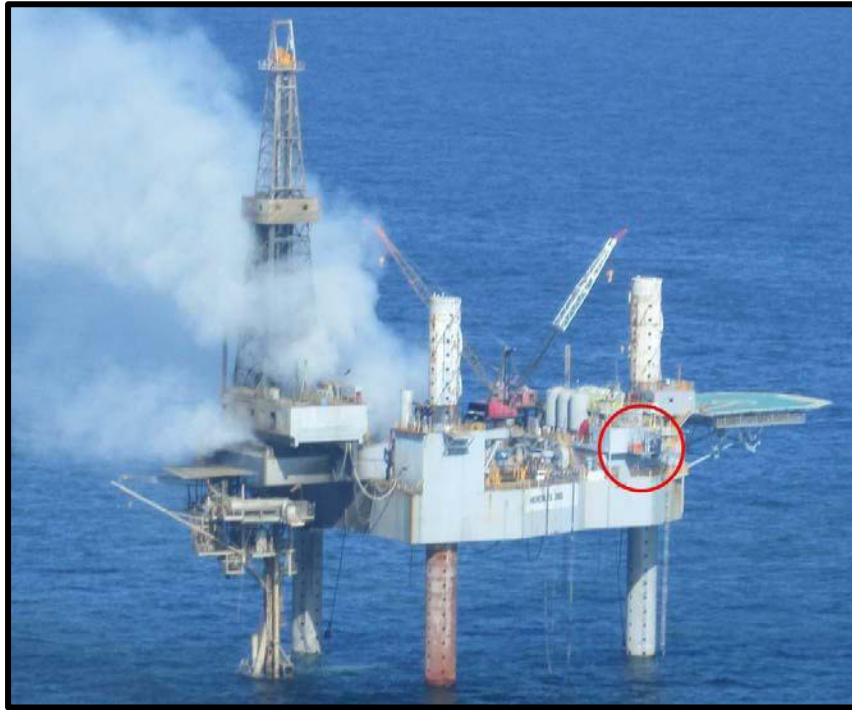
**Figure 28:** Hercules 265 capsule No. 2 location – after deployment

When the #2 life-capsule (*see location, figure 28*) reached the waterline it briefly became caught on the starboard escape ladder. The motormen used the vessel's engine and rudder controls in combination with the sea swells to free the life-capsule. Once free the life -capsule moved safely away.

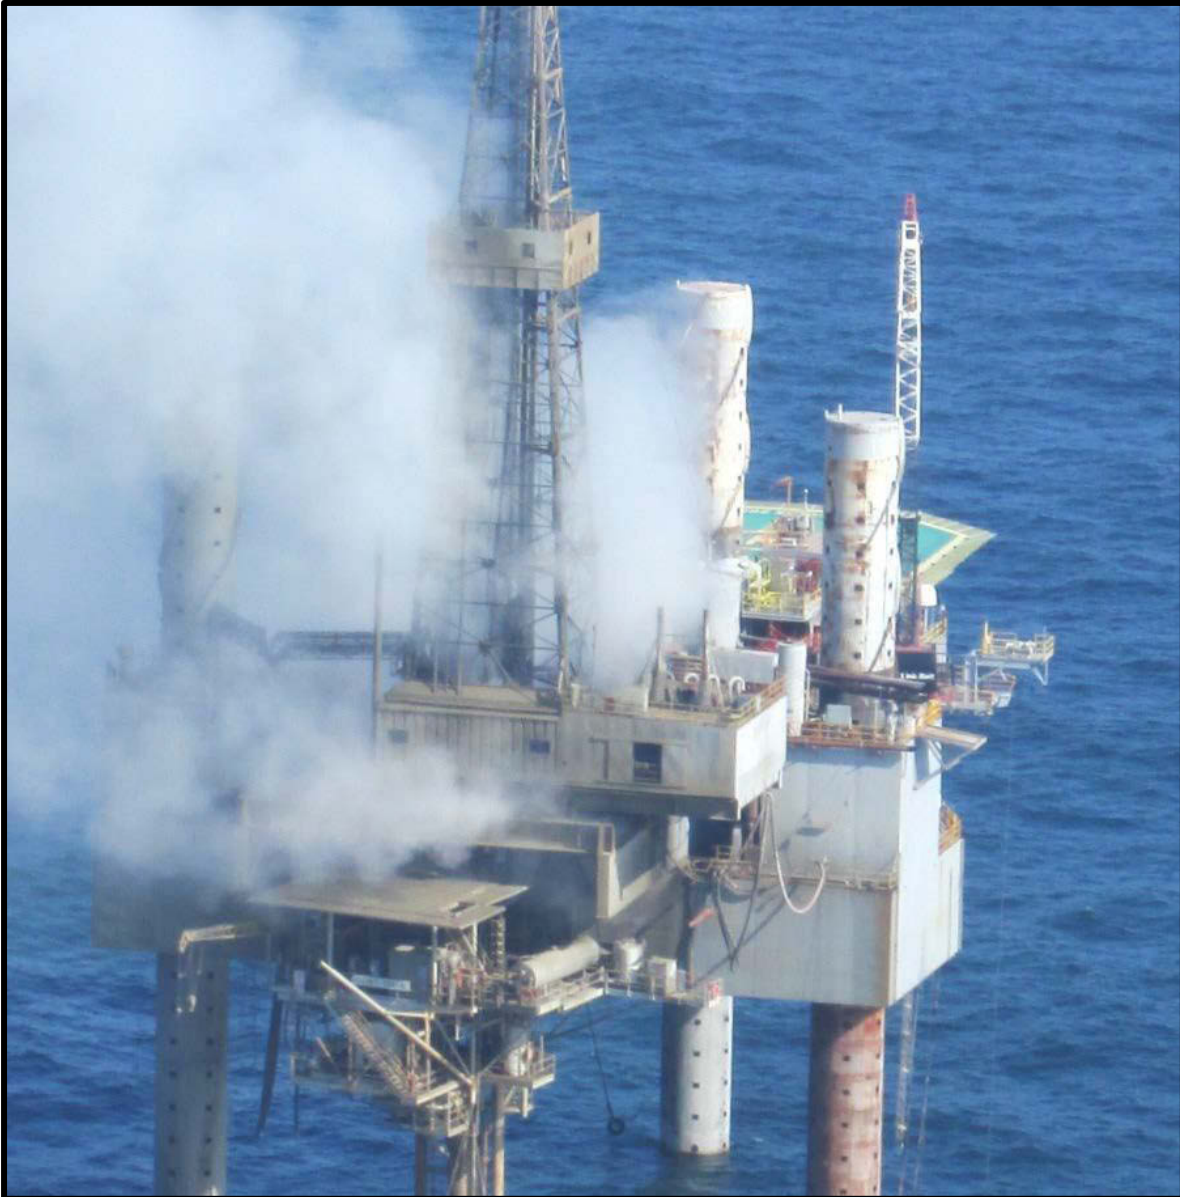
**Figure 29:** *Rig and Platform after abandonment and loss of control*

After the Rig was abandoned, the uncontrolled flow from the Well continued to strengthen. The SME Committee Report stated their opinion that leakage through all BOP stack components became obvious by approximately 0900 hrs “as high velocity sand began eroding the blind shear ram seals...”

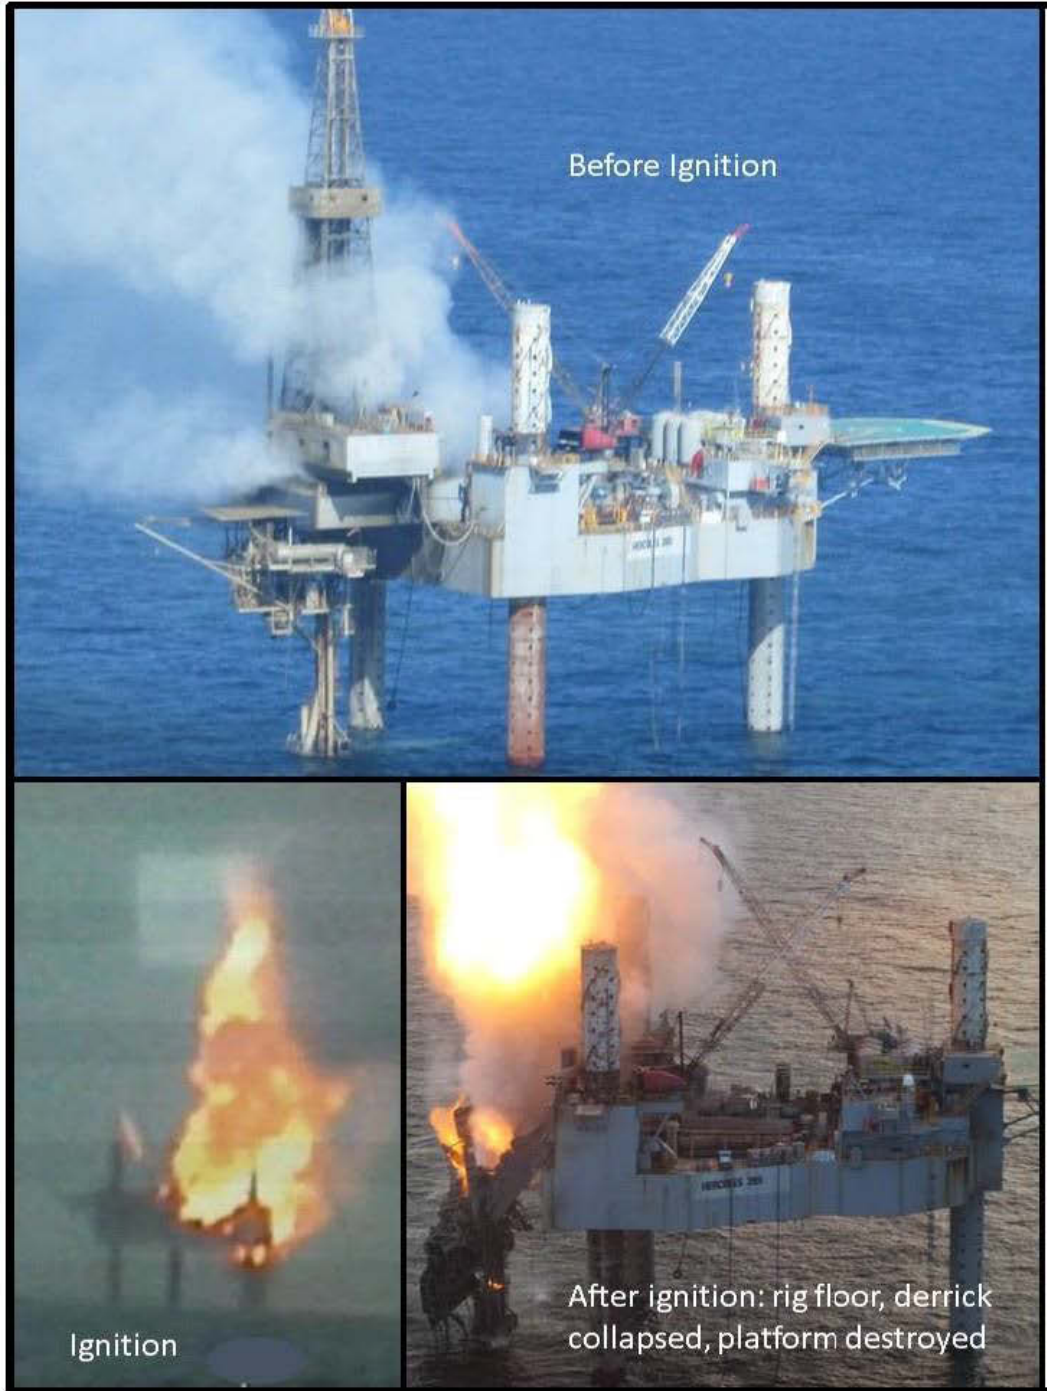
*Figure 30: Rig, Platform, and Well prior to and after ignition*

of production of some formation water suddenly caused the Well to bridge naturally at 2145 hrs, 26 July 2013. The bridging extinguished the fire except for an occasional small residual flame and some continued burning of combustibles on the remains of the Platform and Rig.

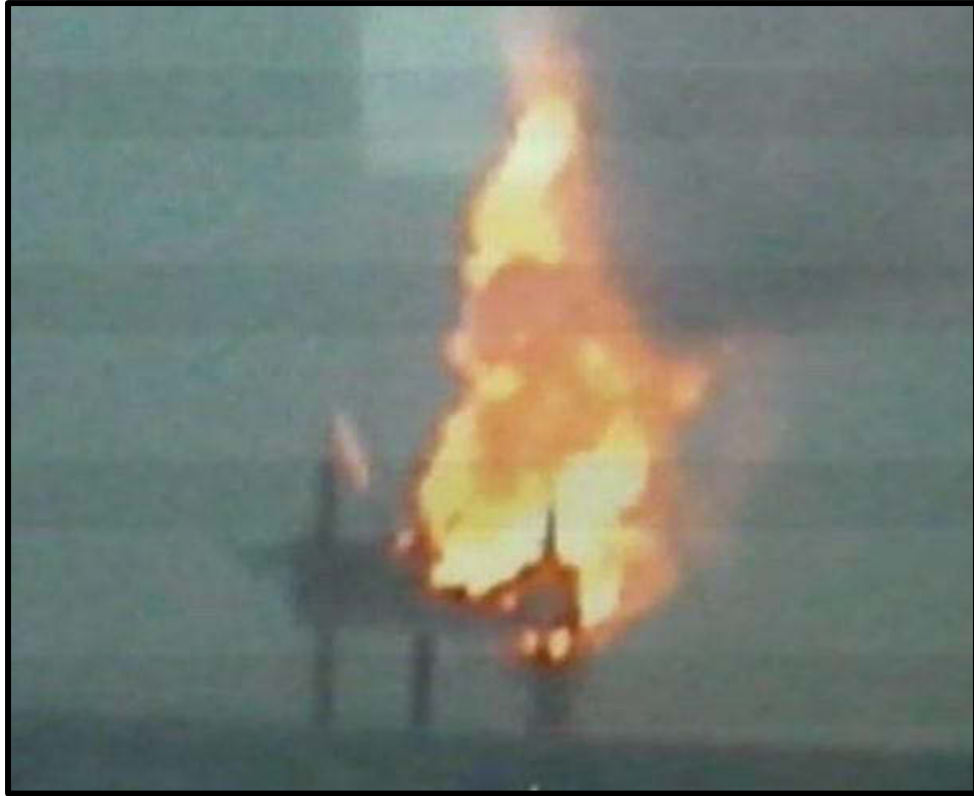
*Figure 31: Hercules 265 on fire.*

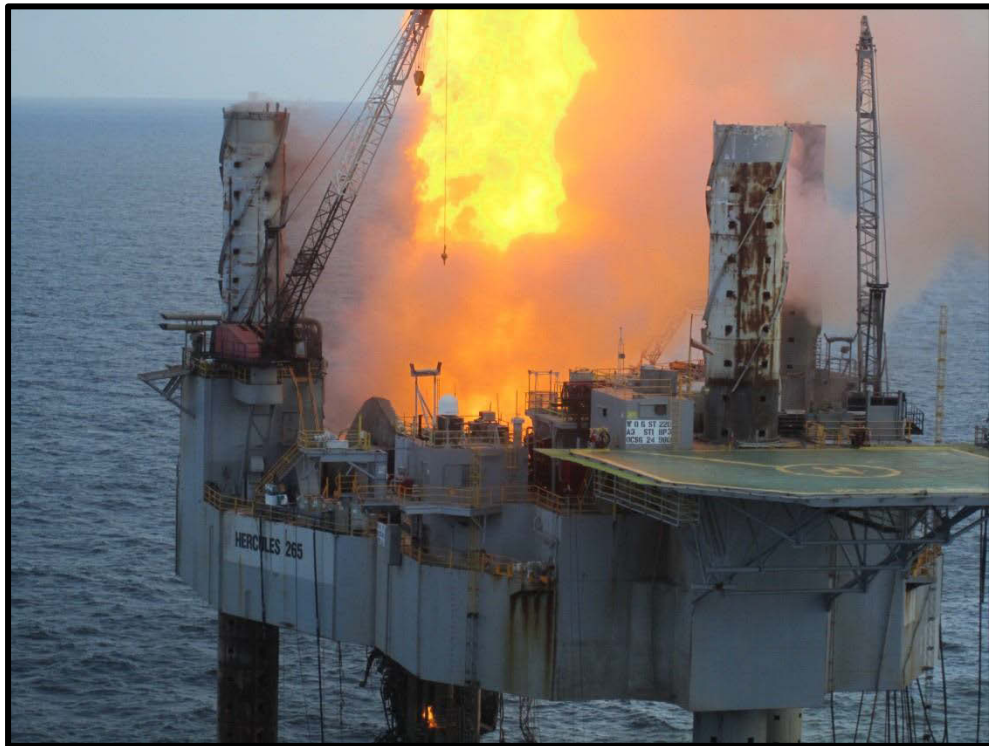
*Figure 32: Blowout and fire in progress*

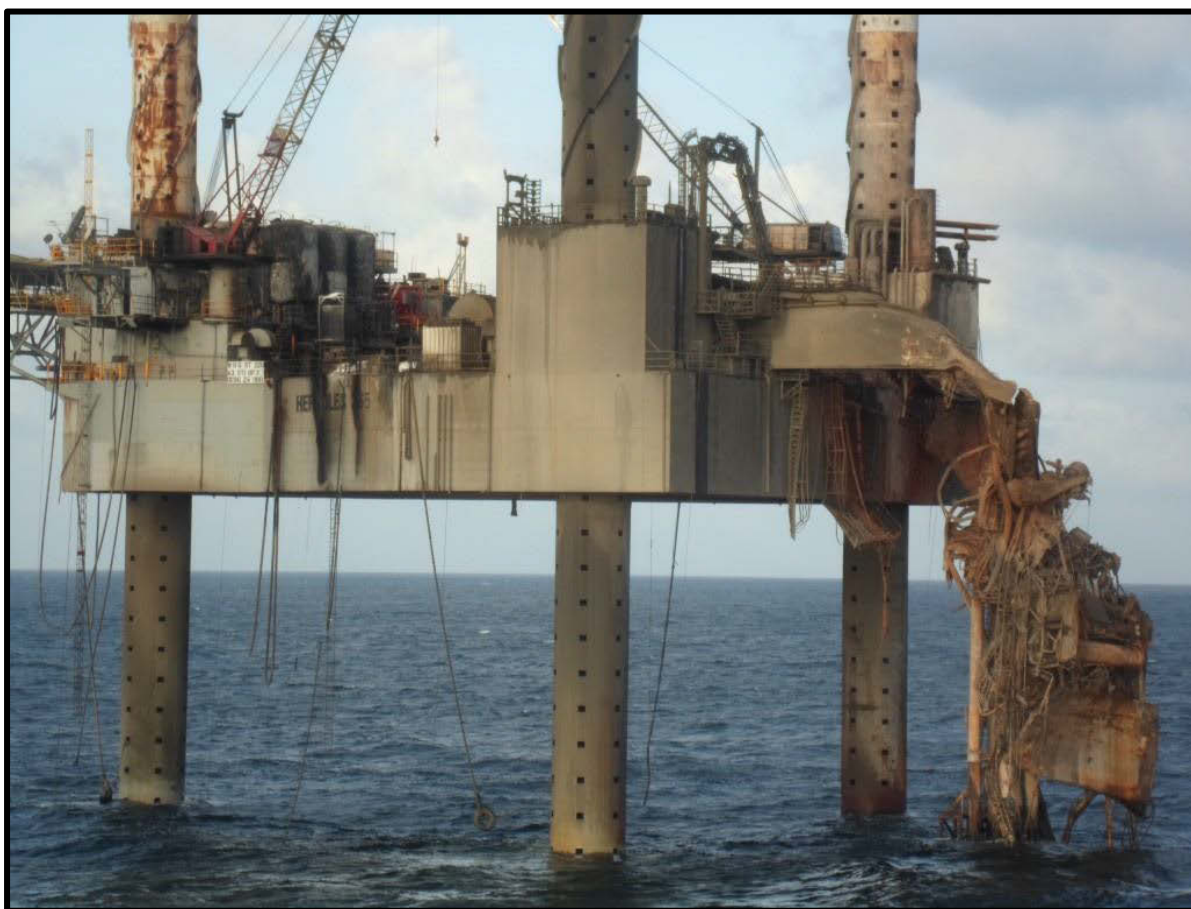
**Figure 33:** *MODU and Platform, after Well bridged*

**26 July 2013:** The Well bridged over and remained in that status for the duration of the response (*see figures 33-36*).

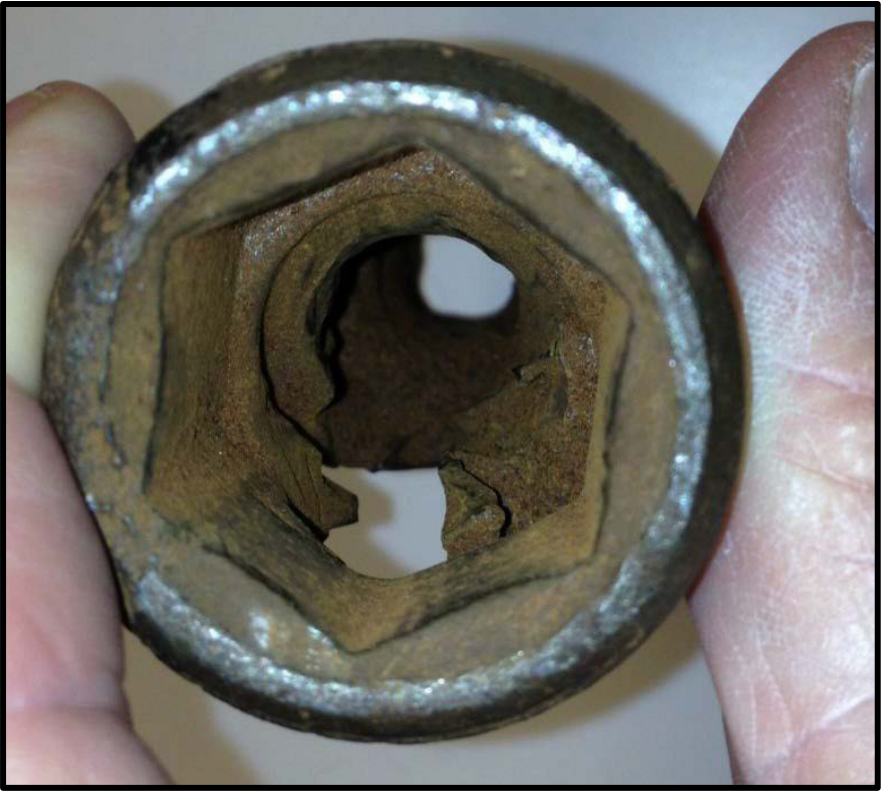
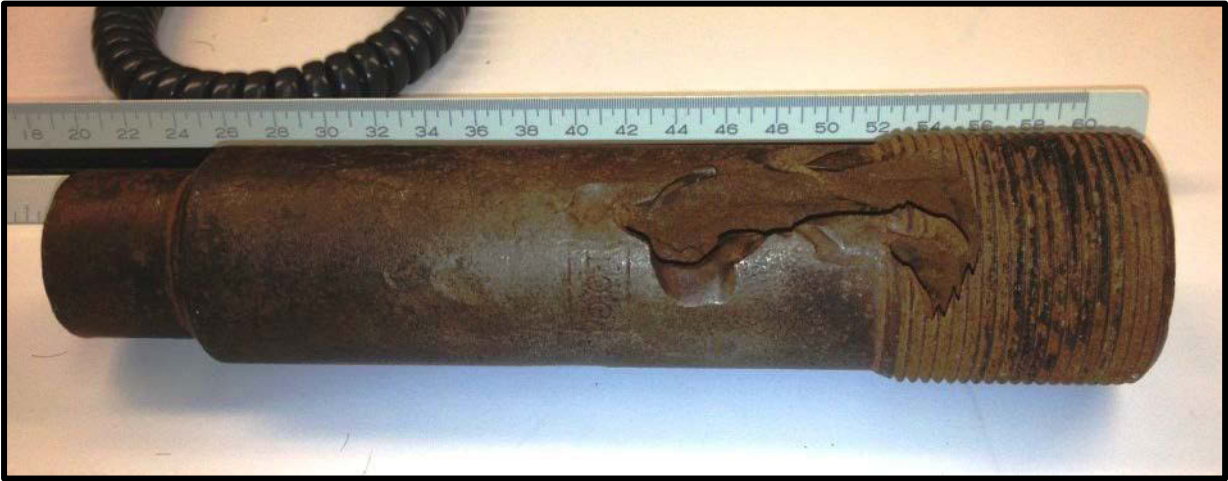
The King Engineering review presented pictures of erosional damage that can occur from micro-fines in the stream and other damage that can result from a high delta P ratio. Those pictures include eroded choke bodies and flanges, and a schematic of the turbulent flow path that helps cause such erosion. *Figures 44 and 45* are examples (not from the King Engineering presentation) of a choke body eroded by cavitation and/or fines in the well stream, and a delta P ratio over 0.6.

**Figure 44:** Choke body eroded from high delta P and micro-fines

**Figure 45:** Choke body eroded from high delta P and micro-fines (2)

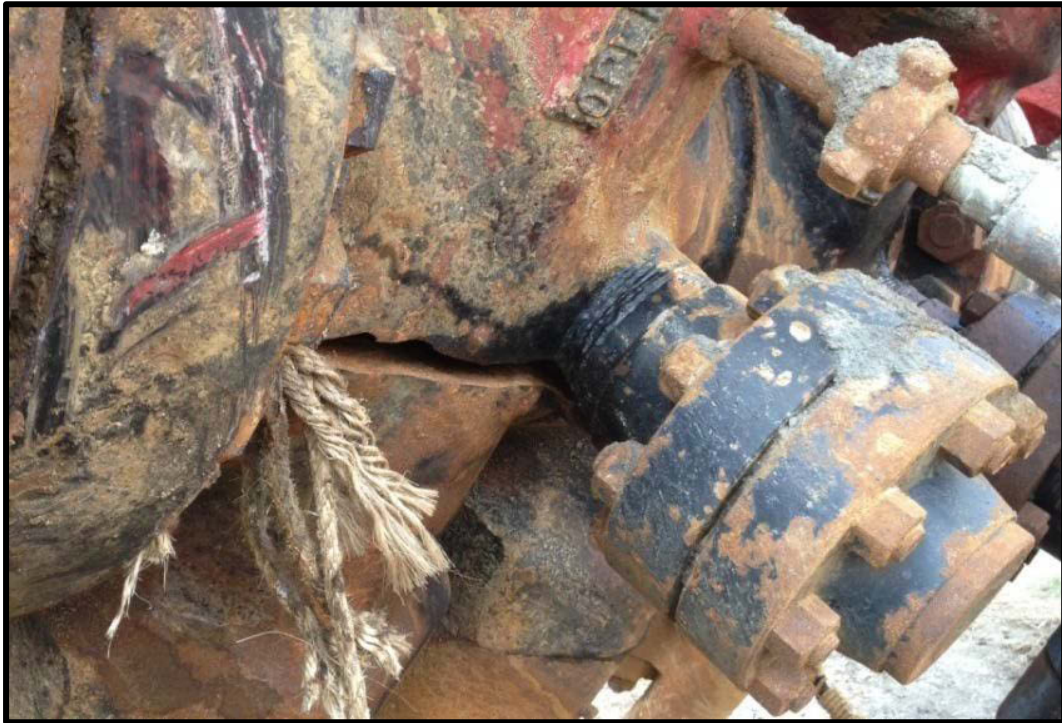
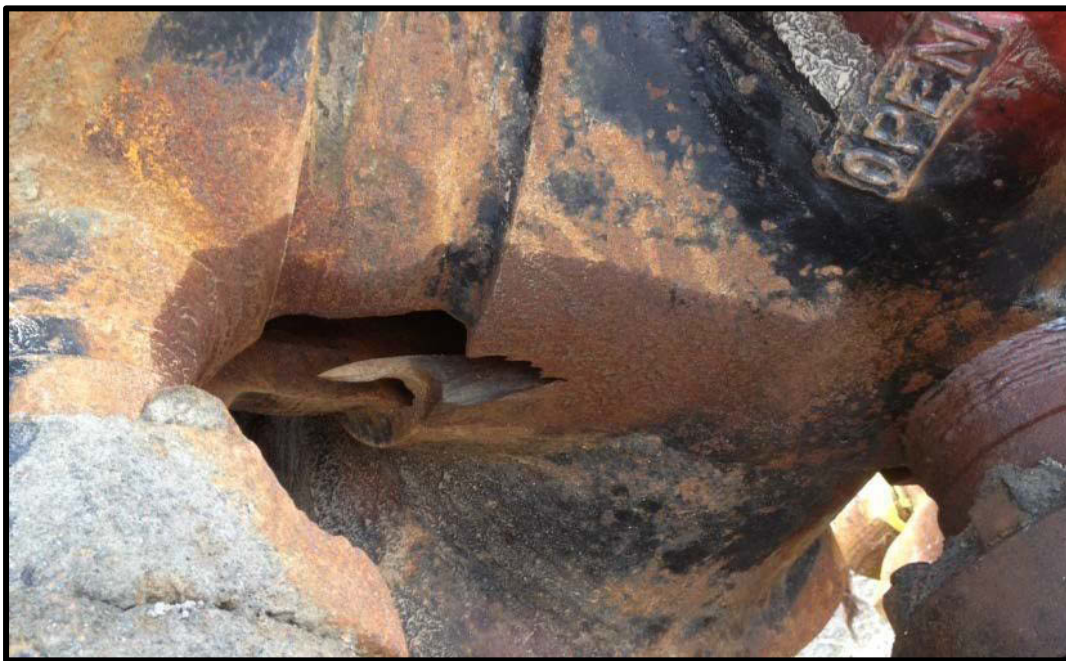
The Panel found the actions to close the rams came too late; by the time the attempt to close was made, the well was already flowing at a pressure exceeding the BOP's capabilities. The flow of gas up through the well also carried sand from within the formation. This mixture of gas and sand travelling at high velocity quickly eroded the surfaces within the BOP, which would have prevented any chance of maintaining a proper seal. When the BOP stack was recovered from the rig, The Panel was able to document evidence of this sand cutting on the BOP.

The damage to the choke body shown in *figures 44 and 45* bears passing similarity to the damage observed to be sustained by the BOP on the Well during the Incident (*figures 46, 47*).

*Figure 46: BOP erosion*

*Figure 47: BOP erosion (2)*

*“...Further, it is believed that this high pressure in the well and a loss of hydraulic closing pressure would have allowed the blind shear rams to begin to leak continuously at a high pressure if they had successfully sealed. Gas moving through a small opening at sonic velocity and carrying sand is known to cause very high erosion rates that can cut through steel in a short period of time...” (emphasis added).*
