**Investigation of Loss of Well Control
South Pelto Block 10, Well No. 10
OCS-G 02925
14 February 2008**

**Gulf of Mexico
Off the Louisiana Coast**

**U.S. Department of the Interior
Minerals Management Service
Gulf of Mexico OCS Regional Office**

**New Orleans
November 2008**

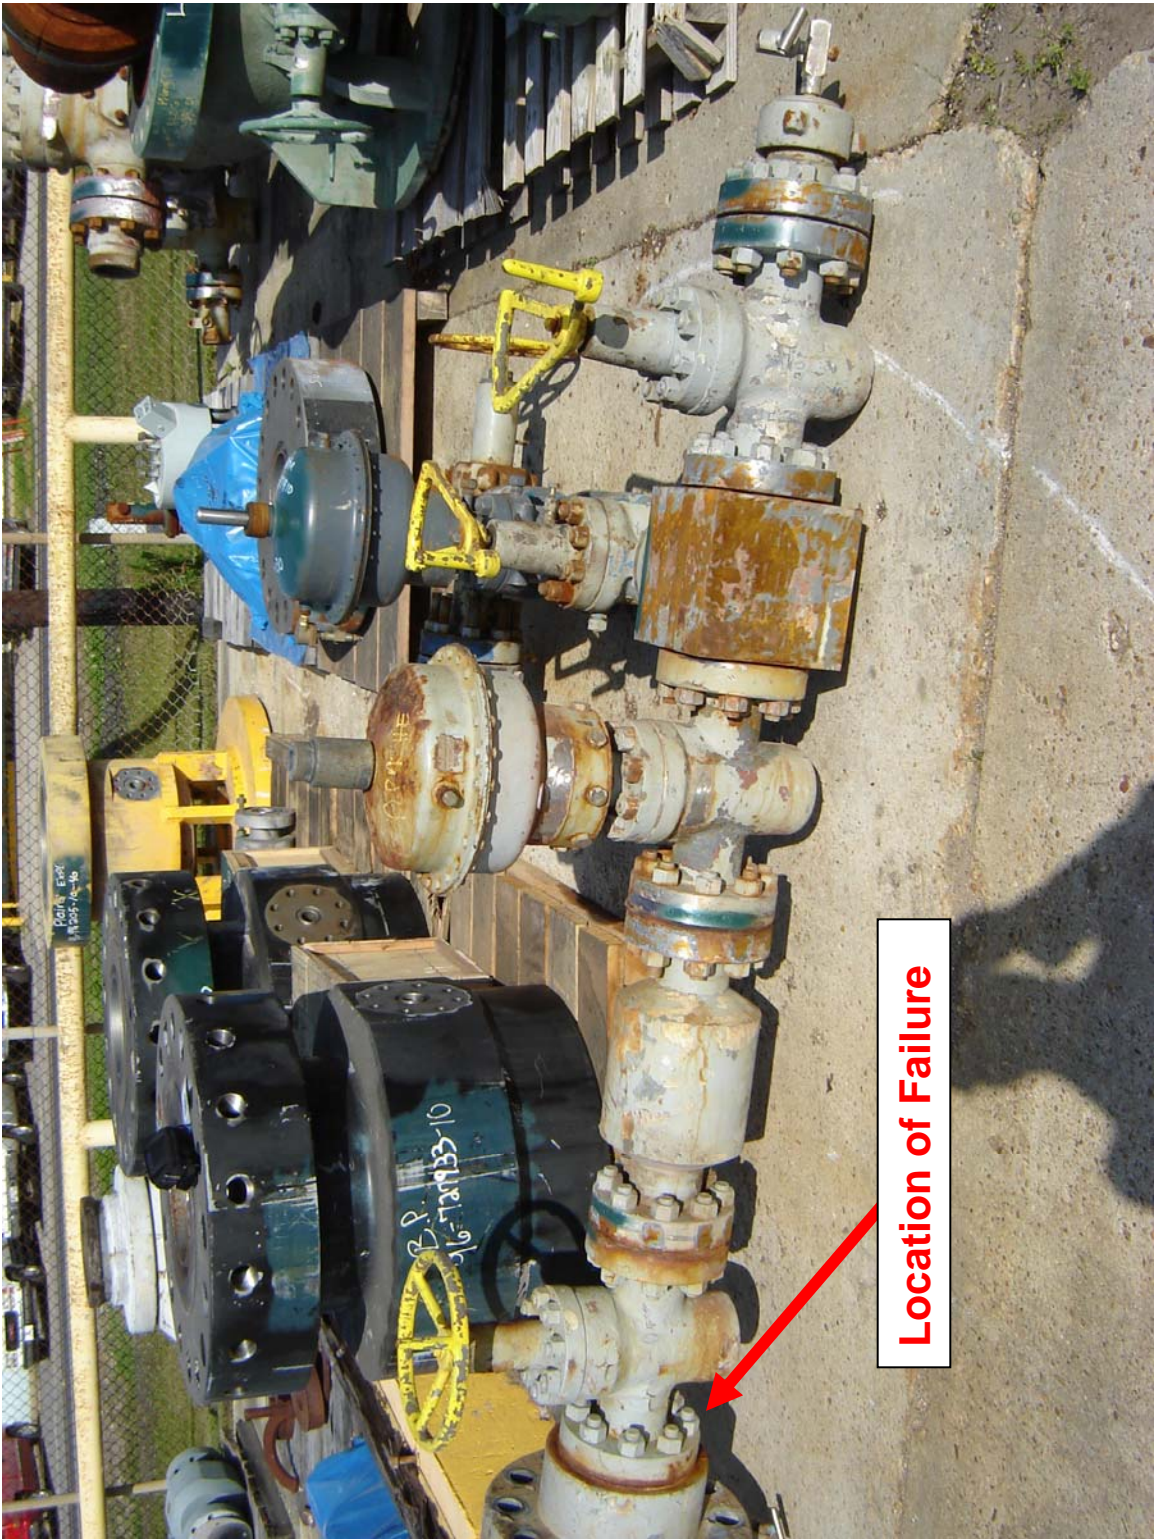
Attachment 7

Photo of Tree in the Cameron Yard Post-Mortem

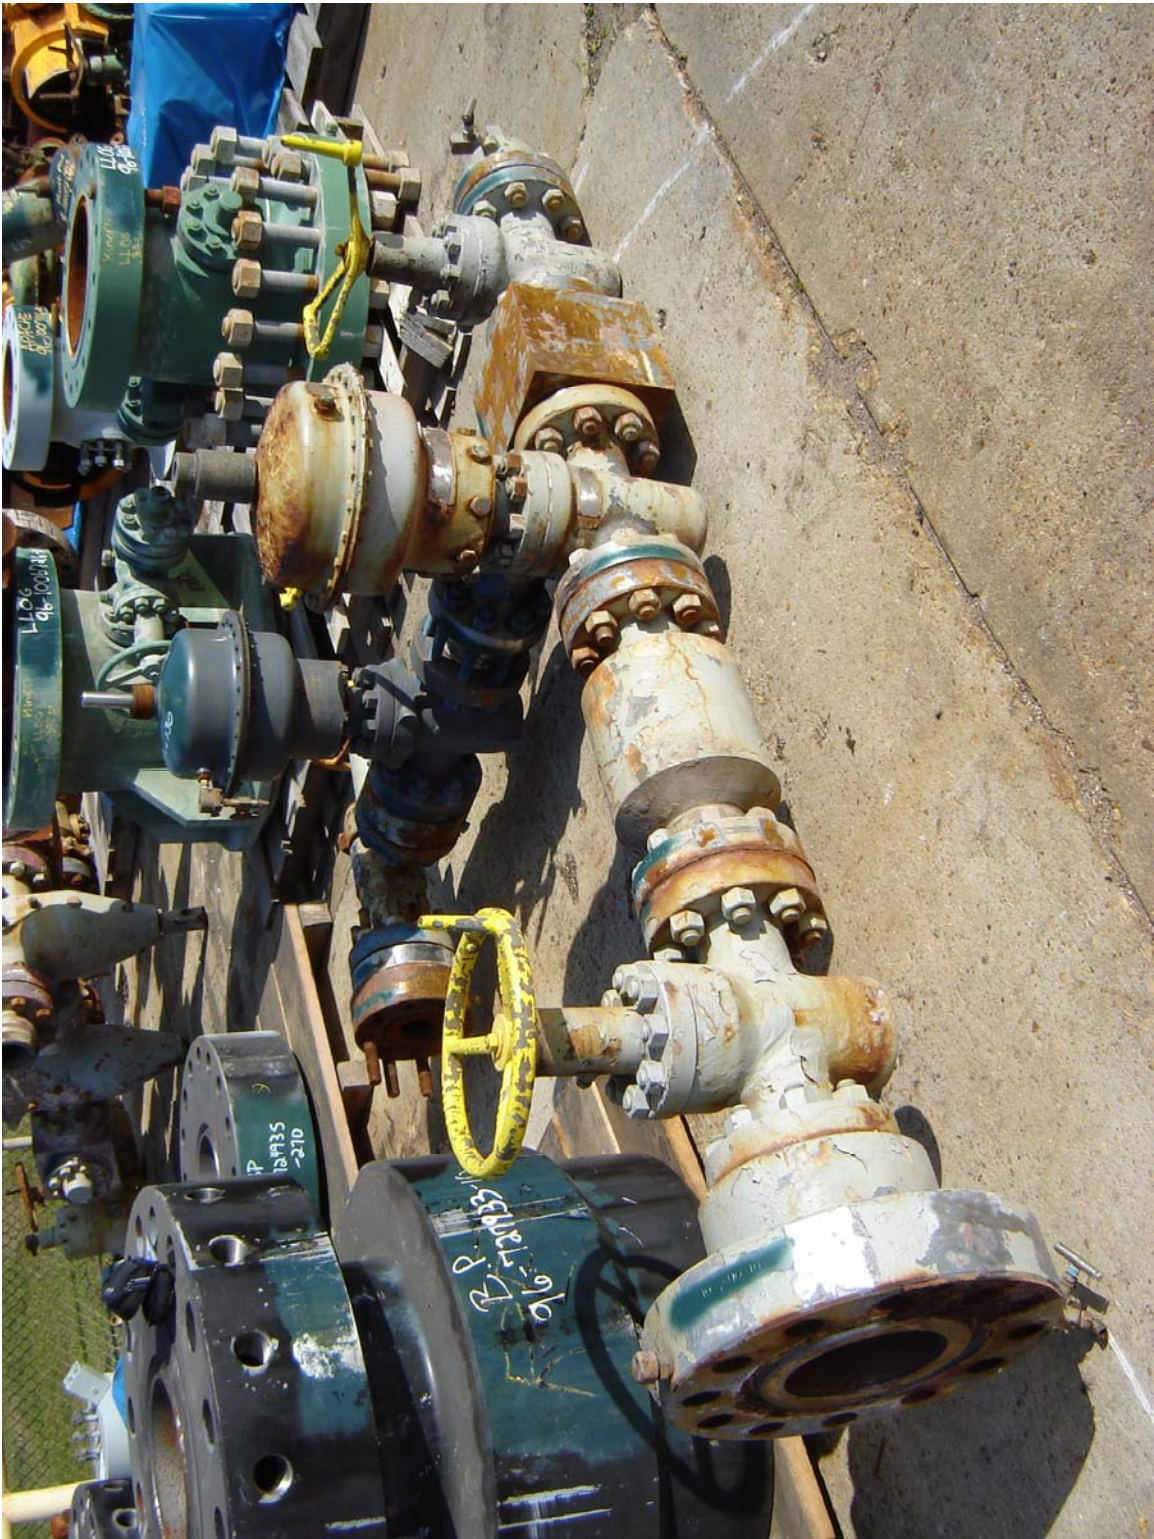
Attachment 8

Photo of Tree in the Cameron Yard Post-Mortem
