**Investigation of Blowout
Main Pass Block 91 Platform A
OCS-G 14576
August 23, 2007**

Gulf of Mexico
Off the Louisiana Coast

U.S. Department of the Interior
Minerals Management Service
Gulf of Mexico OCS Regional Office

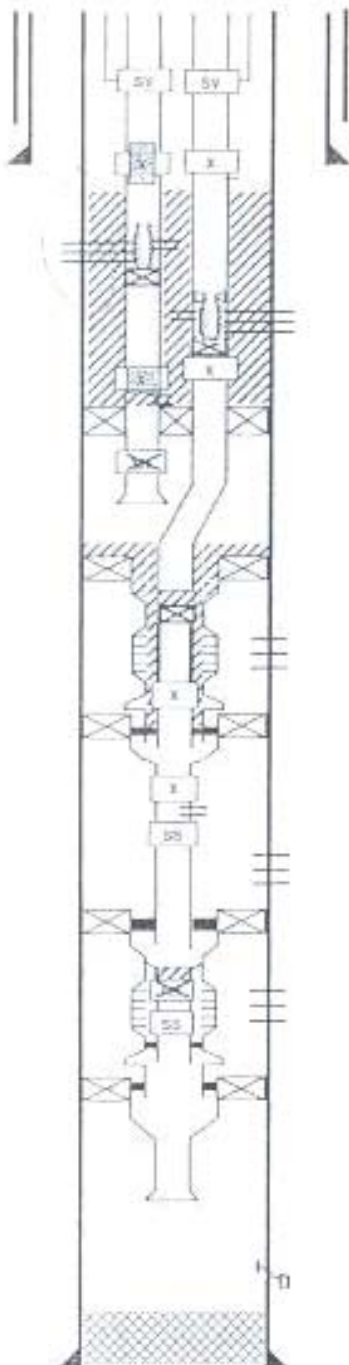
Schematic of well A-1/A-1D

DESCRIPTION OF EQUIPMENT	ID	OD	DEPTH (RKB)				
			SS	LS			
Carnoo TRDP-4E scssvs with FCs SSSV IS NOT HOLDING 703	1.875	4.125	519	589			
SS - DX plug set in X nipple, 8/18/03 (annual plug check)							
X nipples with FCs	1.875	2.625	1995	1964			
Cement Packer from 4925' to 6595' MD (tested to 1000 psi)							
SS- TTWLG assembly w/ 30/50 sand (Pulled pack-off and A-stop)			5401				
SS- Tubing Punch @ 5428' (2" x 4 spf) (to test cement packer)			5428				
FE Sand perfs : 5428' - 5432' (4' x 18 spf)	4		5428	5432			
SS- 1.71" Alpha Bridge Plug (gravel pack base)			5440				
LS- TTWLG assembly with 30/50 sand (Packoff with A-stop on top)			6442				
LS- Tubing punch @ 6470' MD (2" x 4 spf) (to test cement packer)			6470				
GD Sand perfs: 6470' - 6475' (5' @ 18 spf)	5		6470	6476			
LS- 1.71" Alpha Bridge Plug (gravel pack base)			6481				
X-nipple with FC's	1.875	2.625		6554			
SS- X nipple with cml retainer on X-lock	1.875	2.625	6584

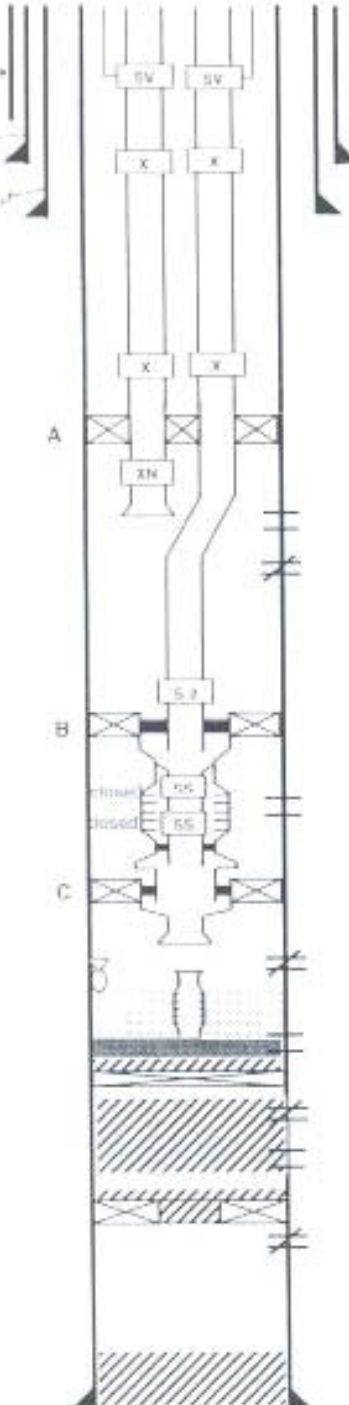
Schematic of well A-2/A-2D

DESCRIPTION OF EQUIPMENT	ID	OD	DEPTH (RKB)					
			SS	LS				
CAMCO TRDP 4E SC55V6 WITH FCS	1.875	4.125	614	644				
X-ripples with FCS	1.875	2.7	3021	1051				
X-ripples (DX plug installed in both ripples 9/707)	1.875	2.7	4567	4590				
EA SAND @ 4440'								
A Comp Set "D" Dual Packer	1.99	6.469	4651	4651				
XN ripple	1.791	2.7	4662					
WL entry guide	1.995	2.700	4668					
EC-1 SAND PERFS : 4850' - 4854' (4' - 12 SPF)								
squeeze perfs. 4877' - 4878'	4		4850	4854				
FB-U SAND @ 5582'								
FD SAND @ 5864'								
GD SAND @ 6970'								
S-2 ripple	1.875	2.700	716					
B Comp-Set gravel pack packer	3.250	6.547	719					
2-3/8" 4 7/8 isolation tubing								
ISO "O" sliding sleeve (closed)	1.875	2.700	727					
ISO "O" selective sliding sleeve (closed)	1.875	2.700	729					
GF SAND PERFS. 7294' - 7300' (6' - 12 SPF)								
C Comp-Perm It Sump packer	4.000	6.500	730					
WL entry guide	1.995	2.700	731

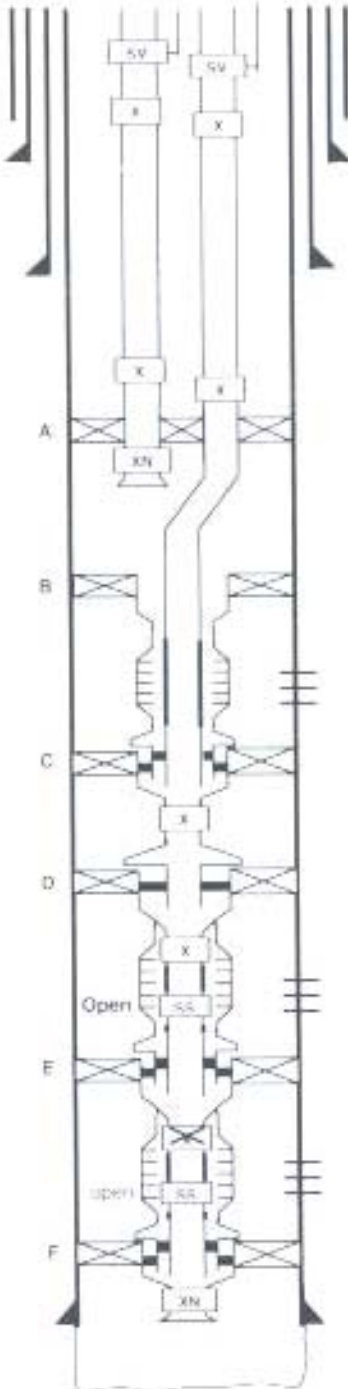
Schematic of well A-3/A-3D

DESCRIPTION OF EQUIPMENT	OD	ID	DEPTH (RKB)				
			SS	LS			
Cameron (Type DCP-FBB) 2.436' ACME Box x 2-3/8" CS Box							
Cameron THHP 4E SCSSV w/ 12 pups	4.125	1.875	502	594			
X-nipple w/ 15' pups (DX plug installed in LS nipple 9/7/07)	2.700	1.875	993	1085			
X-nipple w/ 15' pups (DX plug installed in SS nipple 9/7/07)	2.700	1.875	6056	6086			
A 7-5/8" 33.7-39# OSCA Dual packer	6.489	1.995		6143			
XN nipple w/ 4' pups	2.700	1.791	8154				
WLRG (EOT)	2.700	1.940	8159				
B 7-5/8" 29.7-39# OSCA Comp-Set II "HP" packer	6.437	4.000		6396			
4" NU Bnd P-110 11.6# Blank (56)	4.000	3.476		6474			
4" NU Bnd 8-GA WESCO 316-L Excel SL/HD Screen (36)	4.545	3.550		6471			
Inner- 2-3/8" BTS-8 Blast joint (50')	2.700	1.937	6456				
"GA" sand perfs from 6492 - 6500	8		6492	6500			
Inner- 2.687" x 4' production seals	2.687	1.937	6506				
C 7-5/8" 29.7-33.7# OSCA Comp-Set II "HP" packer	6.547	4.000		6508			
X nipple	2.700	1.875		7439
