**Investigation of July 20, 1983,
Blowout Matagorda Island Block 657,
Lease OCS-G-4139 Gulf of Mexico**

OCS-G 4139 WELL #1
MATAGORDA ISLAND BLOCK 657

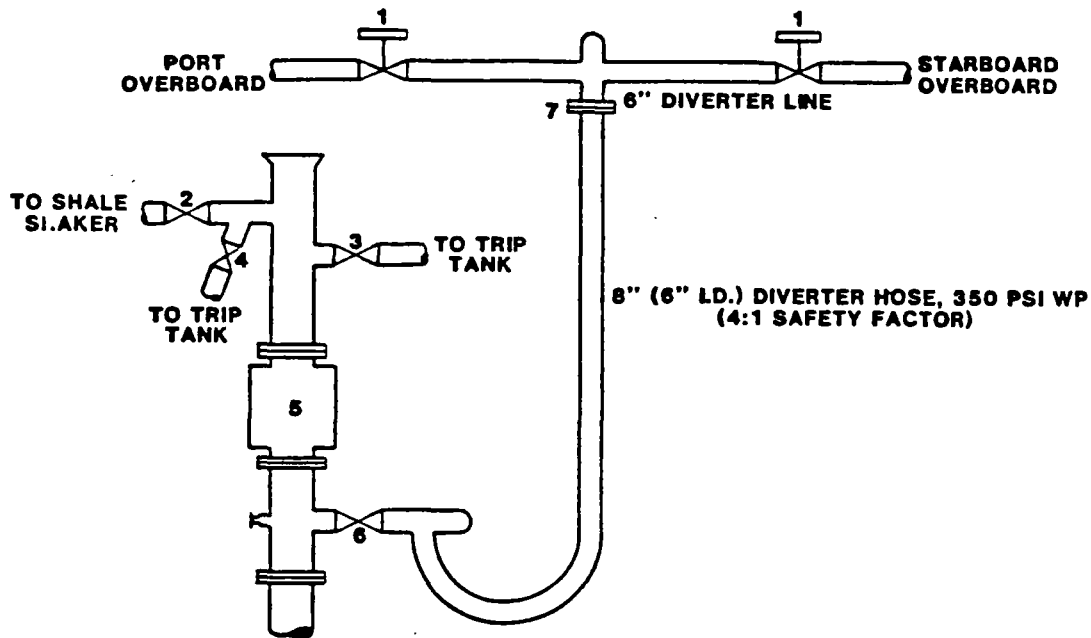
**OCS - G 4139 WELL #1
MATAGORDA ISLAND BLOCK 657
DIVERTER SYSTEM - PENROD 52 JACKUP RIG**

1. The panel was unable to determine the cause of the diverter equipment failure. The diverter line apparently plugged but we do not know why. The Corps of Engineers allowed the drilling rig to remain on the bottom of the Gulf of Mexico.
2. The 6" diverter piping is probably too small but meets the current MMS regulatory requirements.
3. The diverter system was flow through tested as recommended by MMS and diversion through the system was successful for 25 minutes.

- C. The panel recommends, and the MMS is funding, research to develop technology for improving diverter systems. The problem of diverter plugging will be studied.

- E. The panel recommends that larger diverter lines be required. This requirement has been proposed in the Regulatory Reform Document. Louisiana State University is conducting studies on the diverters for MMS.

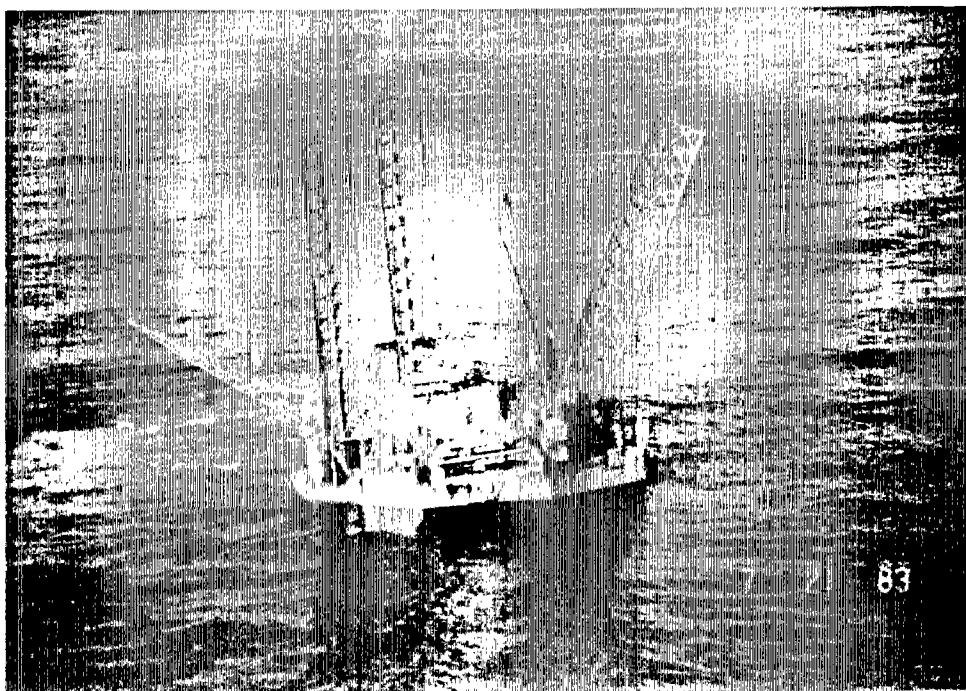
During the night of the 20th, the well apparently bridged and broached, resulting in a flow around the outside of the conductor casing. During the surveillance flights on the morning of the 21st, the well was observed to be flowing, causing a 15' to 20' boil in the water, and the rig was slowly sinking. By the morning of the 22nd the well flow ceased and the rig sank with only parts of two legs exposed. The photographs attached show this clearly.

Rig began to sink, July 21, 1983

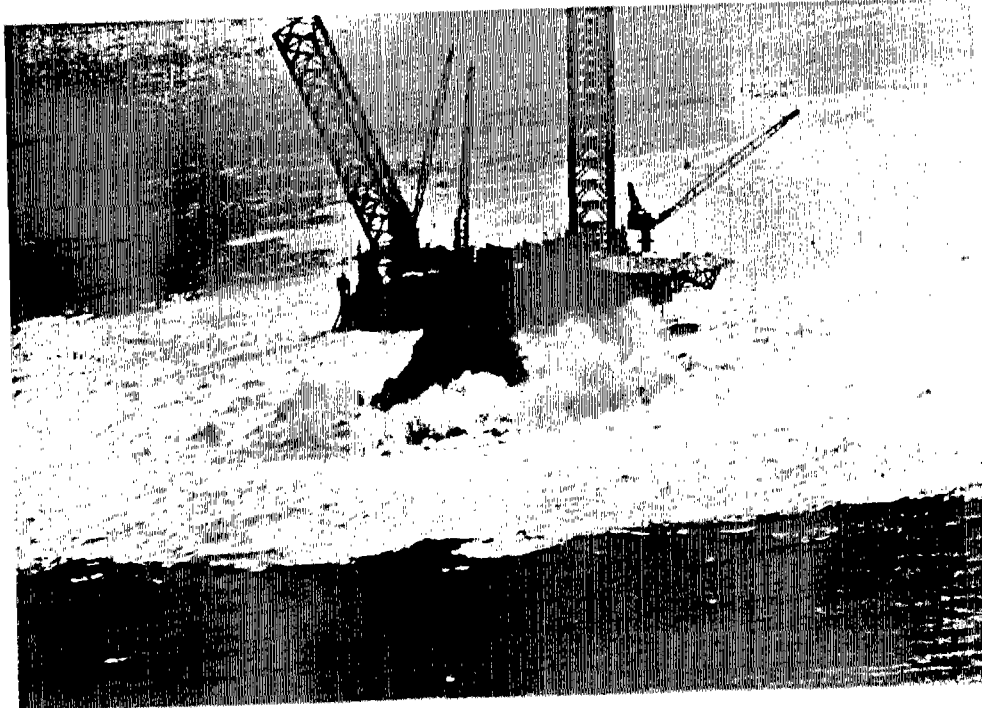
Boil in water caused by well flow, July 21, 1983

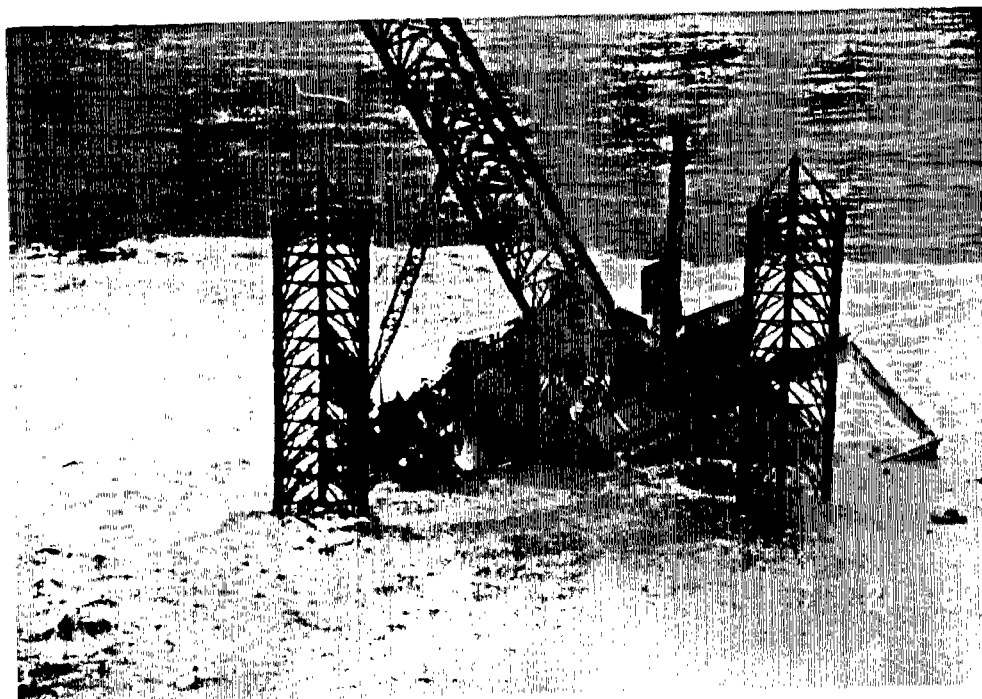
Rig tipped to side with view of boil caused by well flow, July 21, 1983

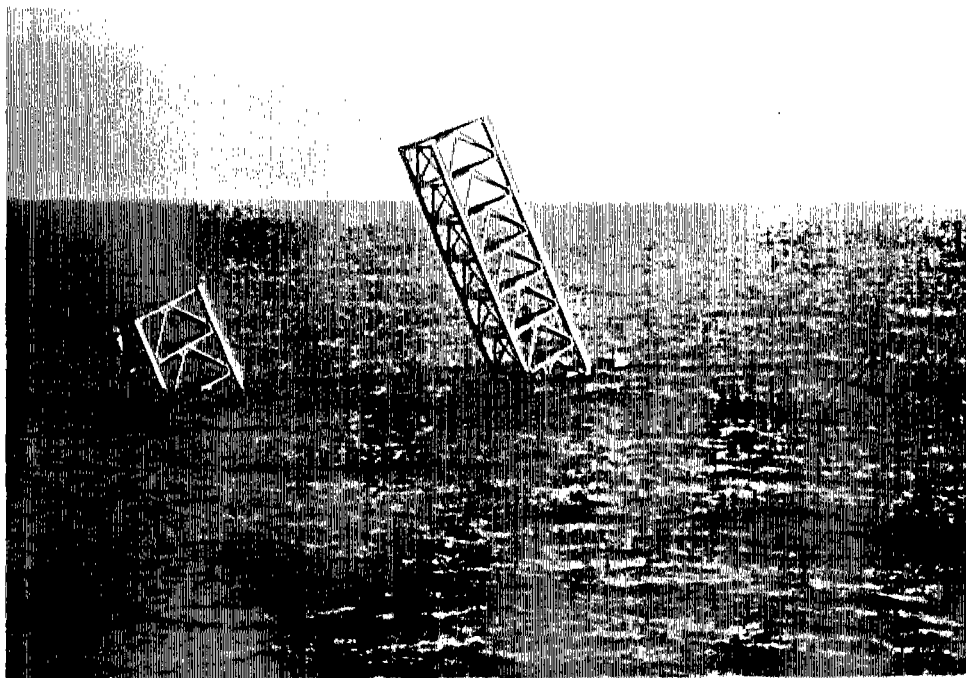
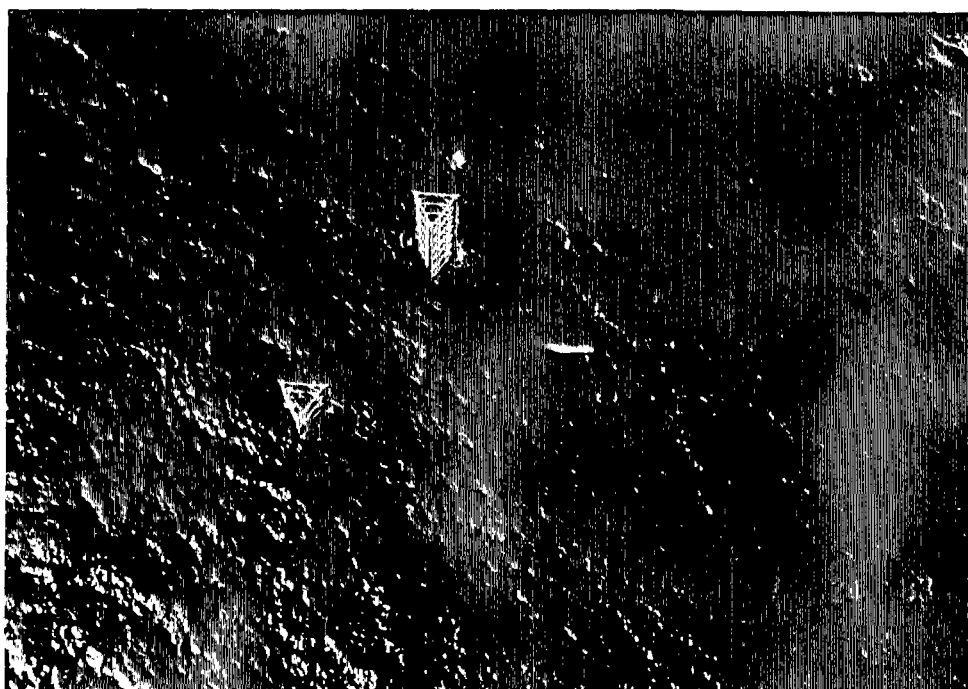
A seismic survey of the rig site was conducted on July 24-25, 1983. The top portion of two legs and a crane boom were the only parts of the rig visible above the sea surface during the time of the survey. The third leg was twisted and bent; the top of it appeared to be 40' below the sea surface.

Parts of two legs exposed, July 24, 1983

Penrod requested permission from the Corps of Engineers, the Coast Guard, and MMS to remove all obstructions that were above the original surrounding sea floor (at a 68' depth) and to leave the rest of the rig in the crater. The Corps of Engineers, with the final authority, granted Exxon (Penrod) permission. Penrod plans to blow off the legs and cranes and to let them fall on or beside the sunken rig.
