Investigation into June 22, 2012, Oil Spill Pacific Operators Offshore, LLC Platform Houchin

Lease OCS-P 0166, Area 6B, Block 5163

Pacific OCS Region

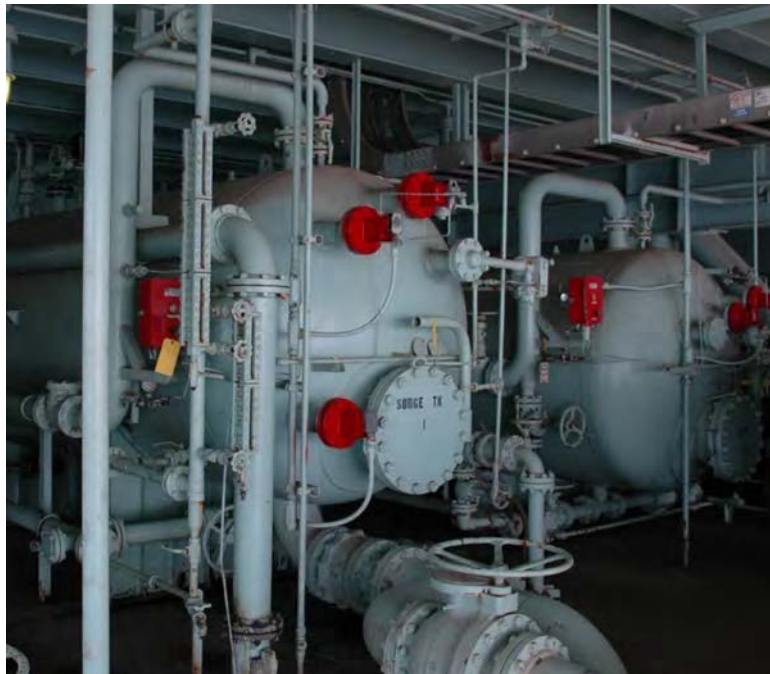
Figure 2 – Surge and CTS (right) Tanks on board Platform Houchin. (BSEE photo)

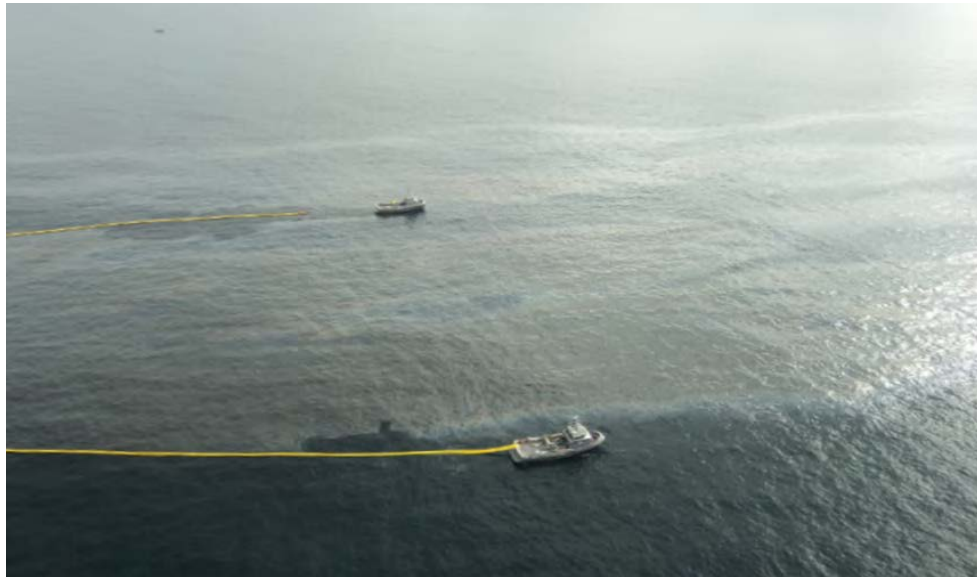
Fig. 4 – Oil Containment Following Response by Clean Seas, LLC. (BSEE Photo)

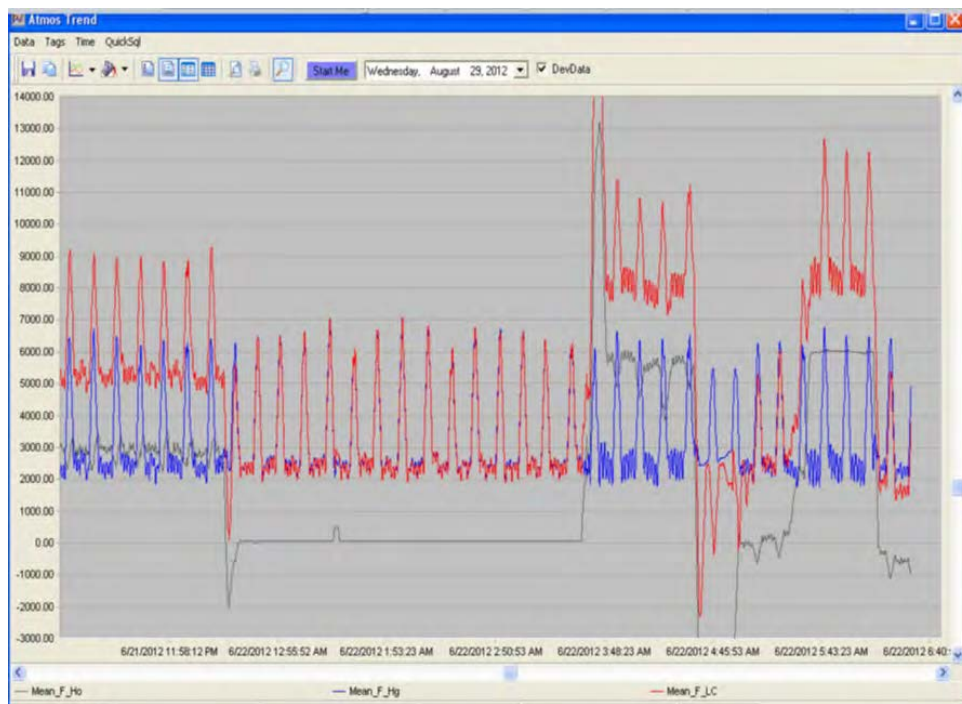
The operator also reported that he had left the production office at 0110 hours and had observed nothing unusual. The operator did not report becoming aware of the shut-in until 0300 hours when he left the production office and found that the deluge system was on. However, in later review of documents provided by POOLLC following a request by BSEE, production oil measurement readings from La Conchita had shown that it had stopped recording flow from Platform Houchin at 0030 hours.

Fig. 5 – Flow from Houchin Platform (Black Line) as recorded at the La Conchita Processing Facility. (POOLLC Document Production)

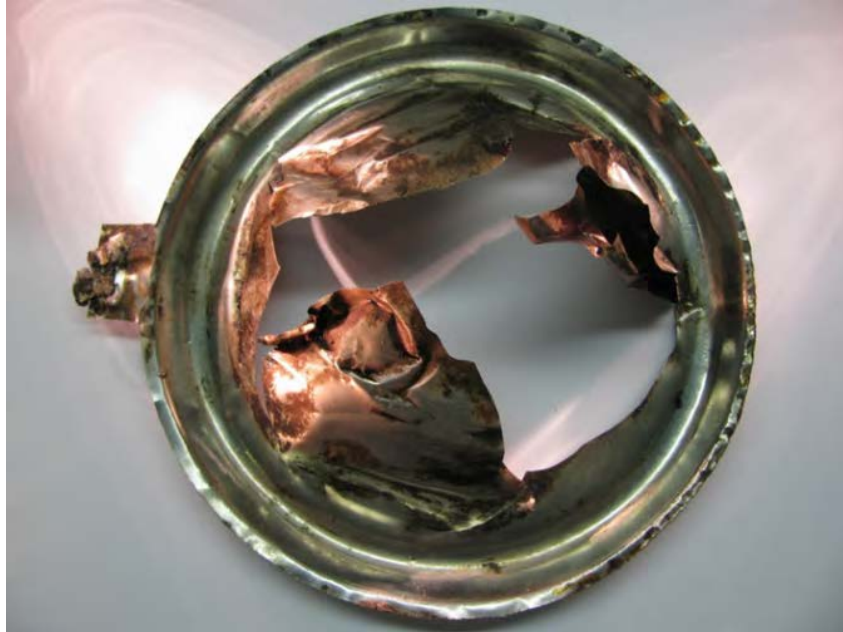
Normally, rupture discs of the type used on the surge vessel have an attached metal tag that is visible outside of the pipe when installed. This tag would have information such as burst pressure rating and manufacturer. The tag on the PSE recovered from surge vessel number one was missing, and appeared to have corroded away.

The ANL analysis included the use of a Scanning Electron Microscope, and Energy Dispersive X-ray Spectroscopy. Since the rupture disc was missing its identification tag, ANL performed a series of tests that concluded that the PSE had been made of Type 321 Stainless Steel and, based on the thickness of the material, would have had an estimated burst pressure of 210 psig. Analysis also revealed that corrosion pits were located on the high-pressure side of the disc, along with cracking that was present before the burst occurred. These microscopic cracks and surface corrosion compromised the disc's integrity and led to rupture below its nominal burst pressure.

Fig. 6 – Rupture Disc (PSE) Recovered from Houchin Surge Tank One (BSEE Photo)

The Investigation Team concluded that the failure of the PSE on surge tank number one initiated the release of hydrocarbons into the flare header that resulted in oil being inadvertently released into the ocean via the disposal tube and the flare stack.

A conclusion was also made that the failure of the audible alarm to sound and alert the operator only prevented a quicker response to the upset condition. The failure of the rupture disk in combination of operating without an adequate flare scrubber resulted in the release of hydrocarbons reaching the Pacific Ocean much more rapidly than if the operator would have been able to respond to an audible alarm. Based on its condition as determined by testing, the PSE rupturing below its set or nominal pressure was inevitable.

- Issue a Safety Alert warning of potential Pollution from Production Operations Due to Rupture Disk Failure. (A draft has been circulated through the POCSR and to Headquarters.)
- Issue additional INC's for operating without an adequate flare scrubber and failing to submit an application to modify the production facility. (Two additional INC's were issued on March 6, 2013.)
- Determine the presence of Pressure Safety Elements on Platform Houchin and other facilities, evaluate their usage and verify identification tags are present and legible. (The PSE's on Platforms Houchin and Hogan were removed and replaced with blind flanges. PSE's were found to be in use on other POCSR platforms. BSEE inspectors verified that the identification tags were in place and legible as

required. The BSEE production engineer verified that the usage of the PSE's was in compliance with applicable regulations and standards.)
