# Investigation of H<sub>2</sub>S Gas Release Platform Hidalgo, OCS-P 0450 Pacific OCS Region

## Contents

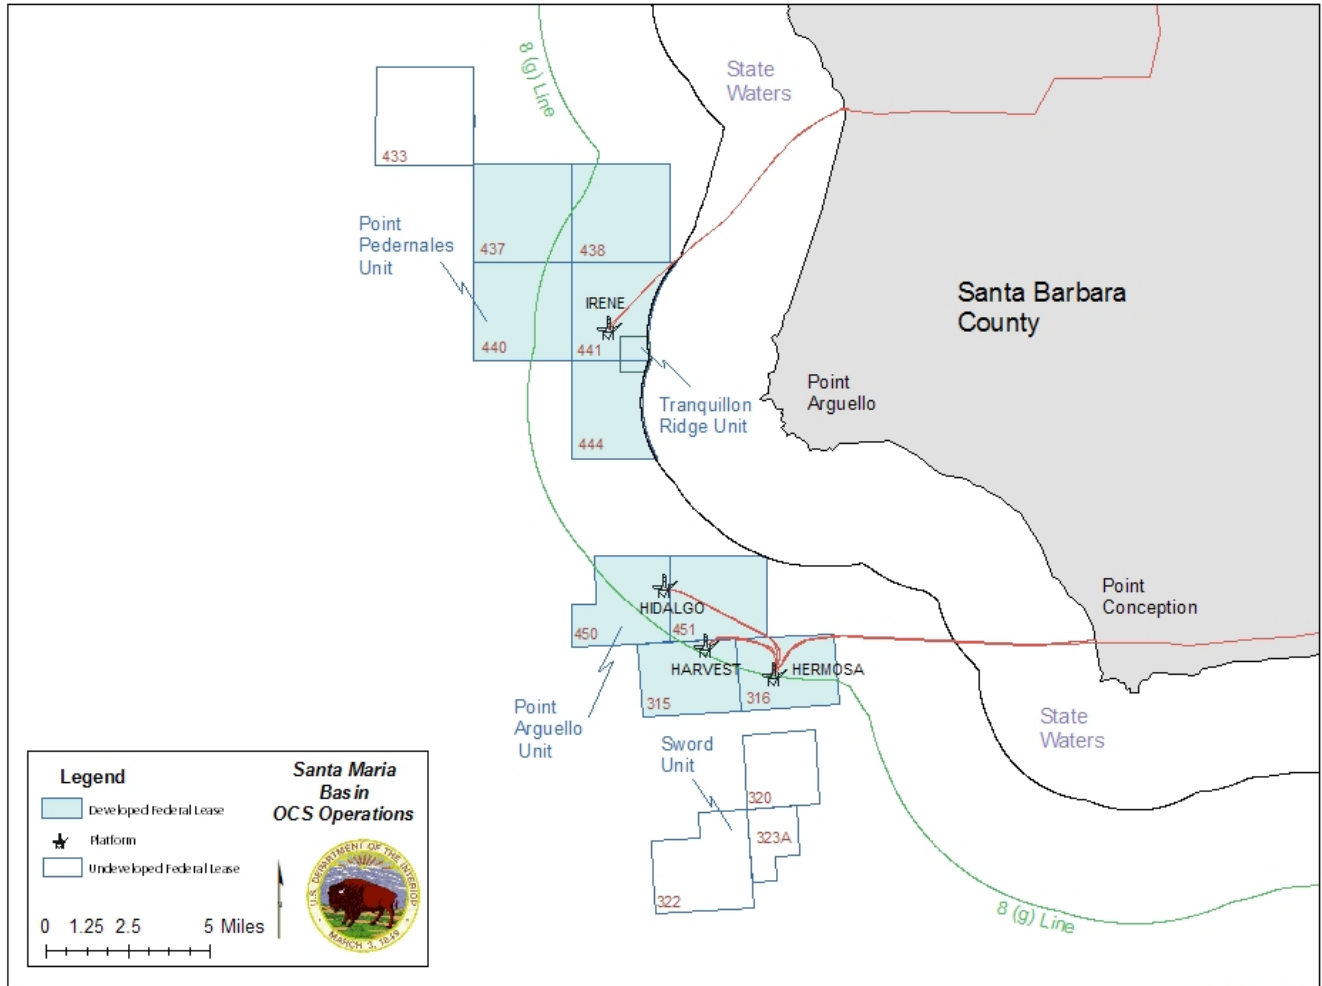
# Attachment 1 – Location of Lease OCS-P 0450, Area 6B, Block 6524

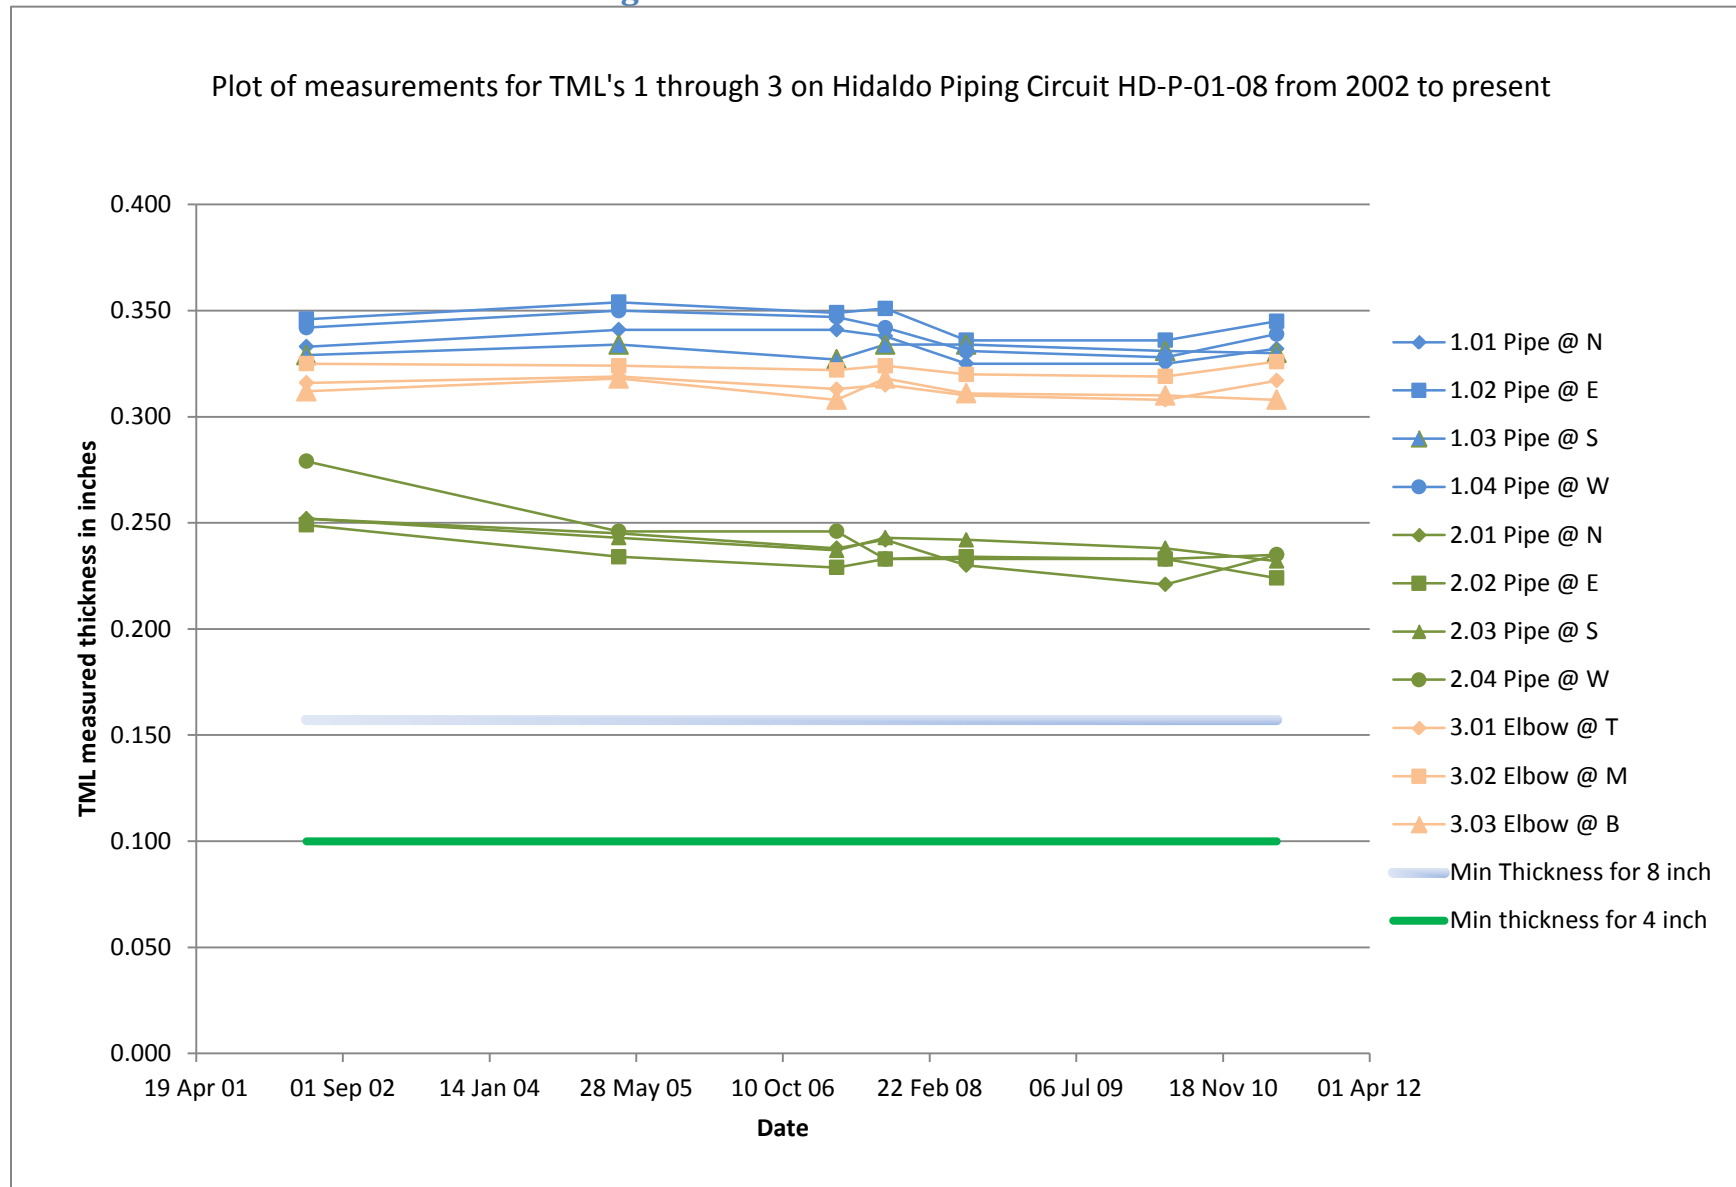
ACCURATE NDE & INSPECTION LLC  
 MECHANICAL INTEGRITY DEPARTMENT  
 PLAINS EXPLORATION AND PRODUCTION COMPANY

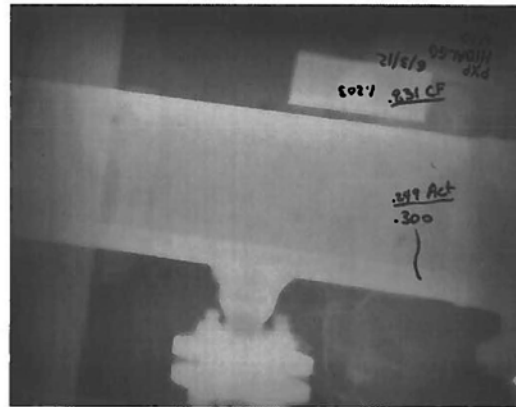
**Figure 1:** Above at right, processed profile radiographic image which shows a minimum (actual) wall thickness of 0.249" and no significant indications of erosion / corrosion.

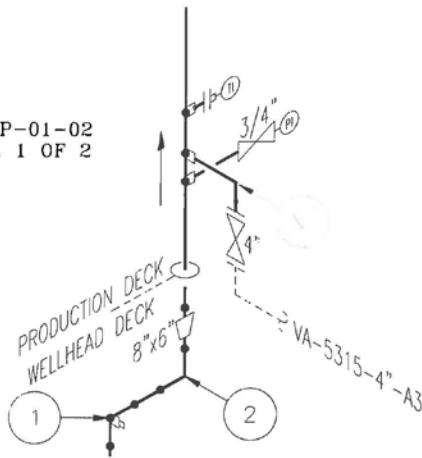
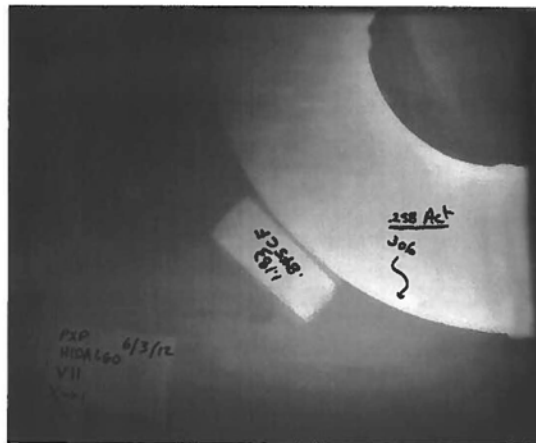
Figure 3: Above at right, processed profile radiographic image which shows a minimum (actual) wall thickness of 0.258" and no significant indications of erosion / corrosion.

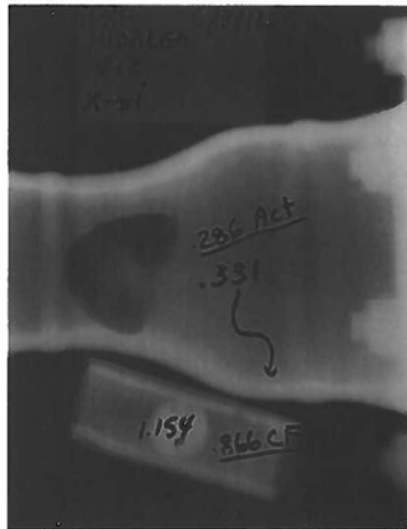
**Figure 5:** Above at right, processed profile radiographic image which shows a minimum (actual) wall thickness of 0.286" and no significant indications of erosion / corrosion.

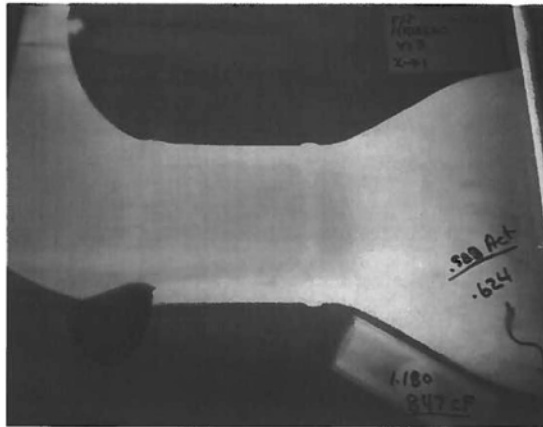
**Figure 7:** Above at right, processed profile radiographic image which shows a minimum (actual) wall thickness of 0.528" and no significant indications of erosion / corrosion.

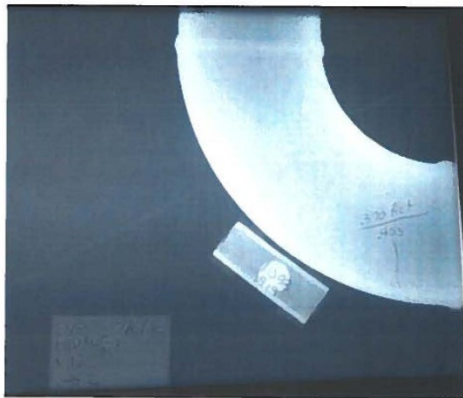
Figure 3: Processed radiographic image at HD-P-01-08, 4" elbow (TML 46), which shows a minimum (actual) wall thickness of 0.370" and no significant indications of erosion or corrosion.

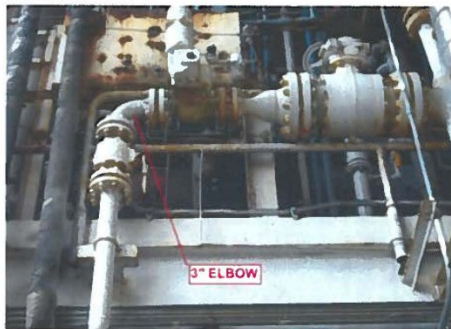
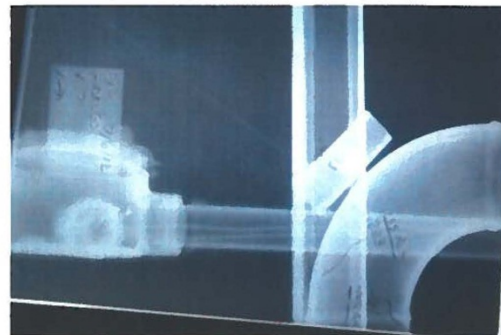
Figure 4: Processed radiographic image at HD-P-01-15, 3" elbow, which shows a minimum (actual) wall thickness of 0.255" at the outside radius and 0.148" near the weld on the inside radius. Indications of internal corrosion have been observed at this inside radius area (X1.2).

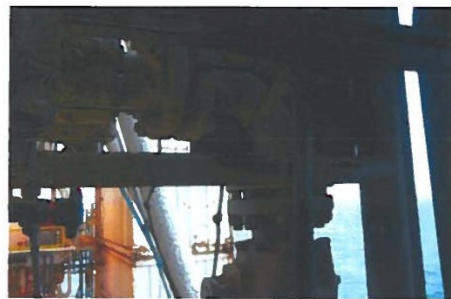
Figure 5: Location of 3" elbow upstream of BDV-V17 (top), and set-up for radiography (bottom) for HD-P-01-15, 3" elbow (TML 11 to be assigned to circuit).

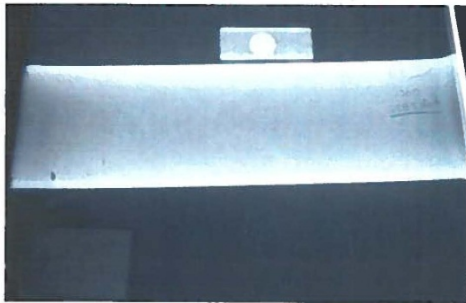
Figure 9: Processed radiographic image at HD-P-01-33, 4" pipe (TML 4), which shows a minimum (actual) wall thickness of 0.283" and no significant indications of erosion or corrosion.

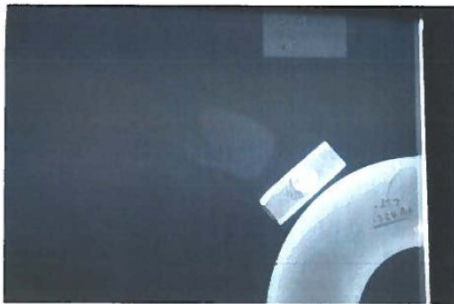
Figure 12: Processed radiographic image at HD-P-01-33, 4" pipe (TML 11 to be assigned to circuit), which shows a minimum (actual) wall thickness of 0.283" and no significant indications of erosion or corrosion.

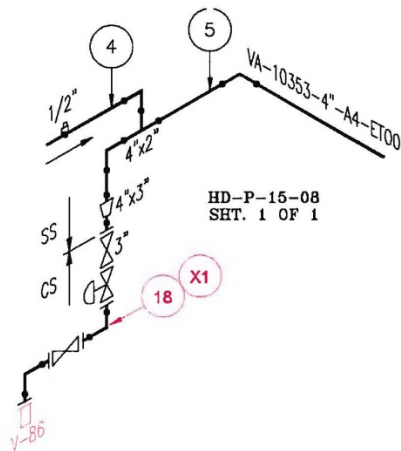
Figure 11: A partial view of isometric drawing HD-P-15-08, sheet 1 of 1. The tie-in to V-86 and location of profile radiography (X1) are shown in red.

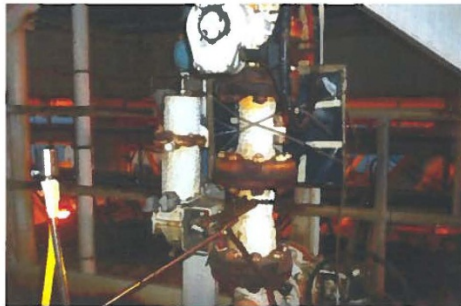
Figure 13: Set-up for radiography of 4" pipe near BDV-V20 (item is not part of annual inspection cycle).

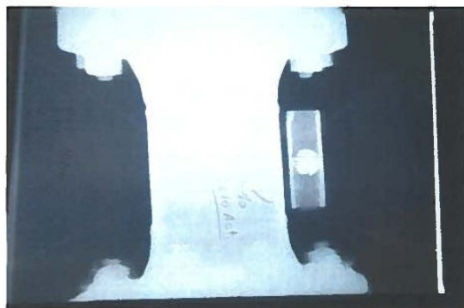
Figure 15: Processed radiographic image for 4" pipe, which shows a minimum (actual) wall thickness of 0.240" and no significant indications of erosion or corrosion.

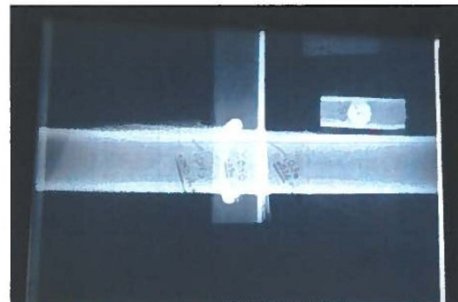
Figure 16: Processed radiographic image for 2" pipe, which shows a minimum (actual) wall thickness of 0.036". Severe external corrosion has been observed.

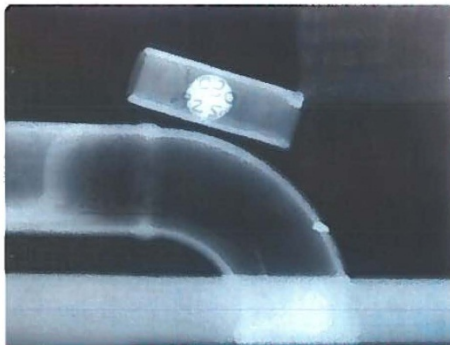
Figure 3: Processed radiographic image at HM-P-01-02, 2" elbow (TML 5), which shows a minimum (actual) wall thickness of 0.221". A thickness of 0.229" (X1.1) has also been observed at the adjoined 2" pipe. No significant indications of erosion or corrosion have been found.

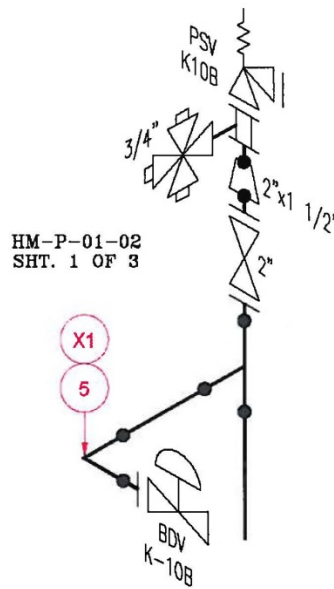
Figure 2: A partial view of isometric drawing HM-P-01-02, sheet 1 of 3. The location of profile radiography (X1) is shown in red.

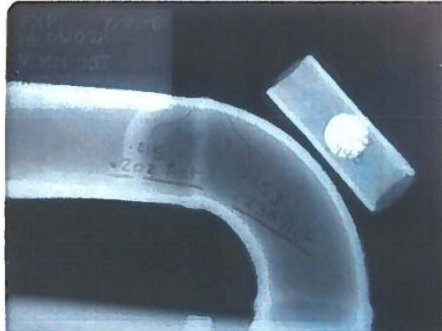
Figure 6: Processed radiographic image at HM-P-01-02, 2" elbow (TML 10), which shows a minimum (actual) wall thickness of 0.238". A thickness of 0.203" (X1.1) has also been observed at the adjoined 2" pipe. No significant indications of erosion or corrosion have been found.

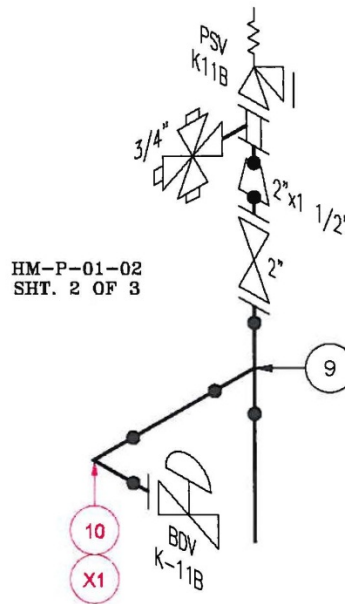
Figure 5: A partial view of isometric drawing HM-P-01-02, sheet 2 of 3. The location of profile radiography (X1) is shown in red.

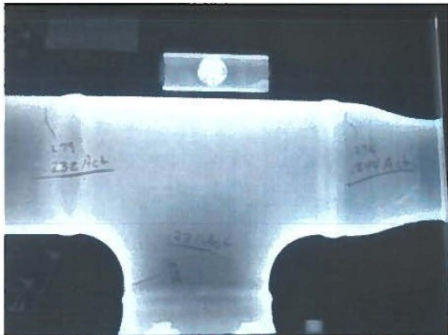
Figure 9: Processed radiographic image at HD-P-01-05, 4" tee (TML 27 to be assigned), which shows a minimum (actual) wall thickness of 0.231" and no significant indications of erosion or corrosion. Thicknesses of 0.232" (X1.1) and 0.244" (X1.3, TML 28 to be assigned) have also been noted on the adjoining pipe and reducer, respectively.

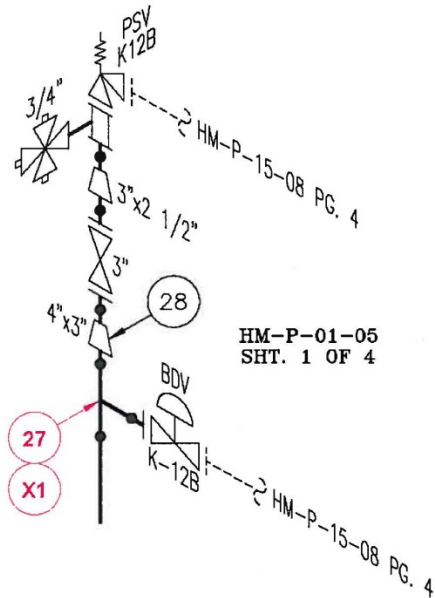
Figure 8: A partial view of isometric drawing HD-P-01-05, sheet 1 of 4. The location of profile radiography (X1) is shown in red.

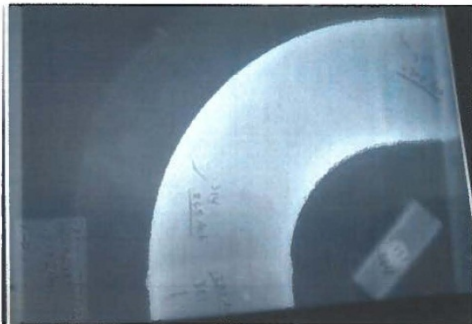
Figure 12: Processed radiographic image at HD-P-01-05, 3" elbow (UT not performed due to insulation), which shows a minimum (actual) wall thickness of 0.265" and no significant indications of erosion or corrosion. Thicknesses of 0.304 (X1.1) and 0.283" (X1.3) have also been observed at the adjoining 3" pipe.

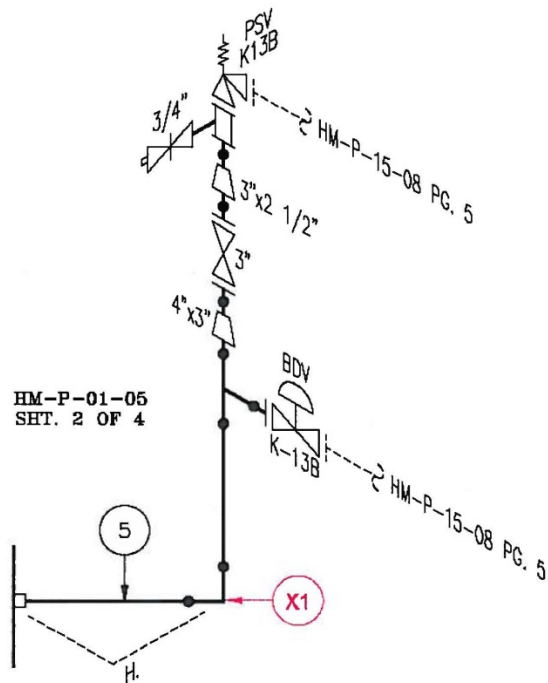
Figure 11: A partial view of isometric drawing HD-P-01-05, sheet 2 of 4. The location of profile radiography (X1) is shown in red.

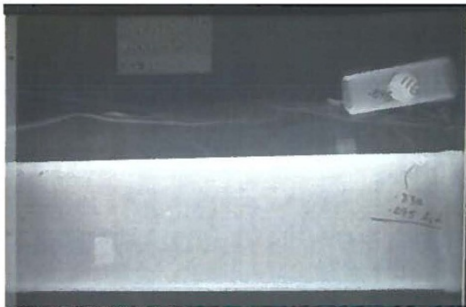
Figure 15: Processed radiographic image at HD-P-01-05, 3" pipe (UT not performed due to insulation), which shows a minimum (actual) wall thickness of 0.295" and no significant indications of erosion or corrosion.

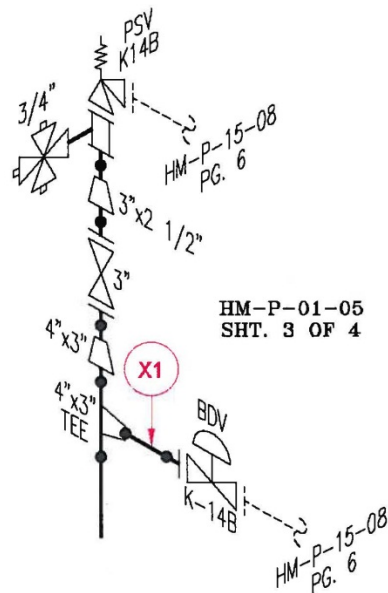
Figure 14: A partial view of isometric drawing HD-P-01-05, sheet 3 of 4. The location of profile radiography (X1) is shown in red.

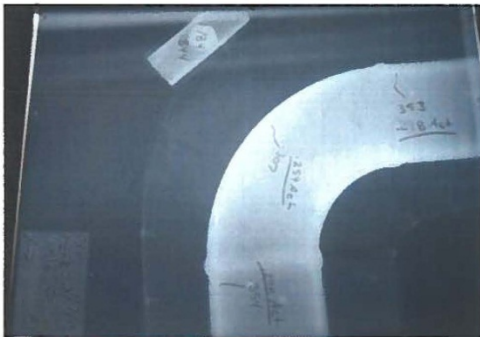
Figure 18: Processed radiographic image at HD-P-01-08, 3" elbow (UT not performed due to insulation), which shows a minimum (actual) wall thickness of 0.259" and no significant indications of erosion or corrosion. Thicknesses of 0.298" (X1.1) and 0.298" (X1.3) have also been observed at the adjoining 3" pipe.

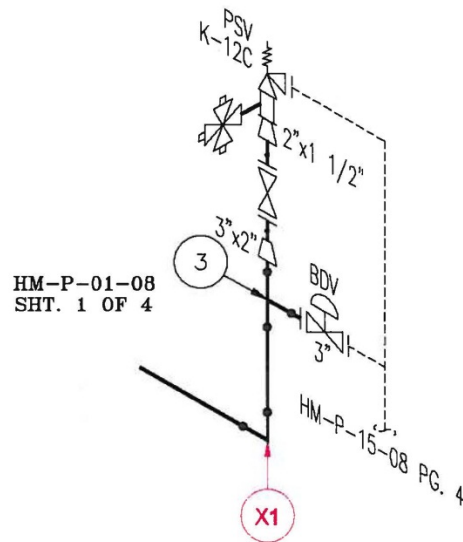
Figure 17: A partial view of isometric drawing HD-P-01-08, sheet 1 of 4. The location of profile radiography (X1) is shown in red.

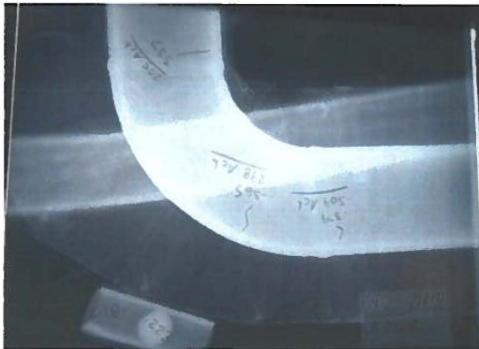
Figure 21: Processed radiographic image at HD-P-01-08, 3" elbow (UT not performed due to insulation), which shows a minimum (actual) wall thickness of 0.365". Thicknesses of 0.275" (X1.1) and 0.379" (X1.3) have also been observed at the adjoining 3" pipe. Light active external corrosion has been noted at the 3" pipe (X1.1).

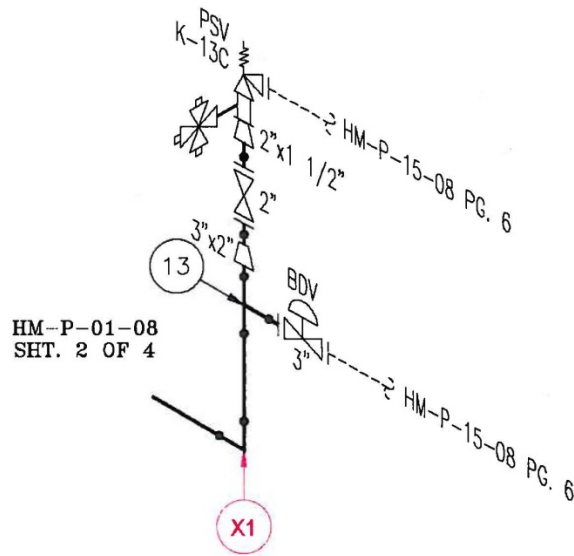
Figure 20: A partial view of isometric drawing HD-P-01-08, sheet 2 of 4. The location of profile radiography (X1) is shown in red.

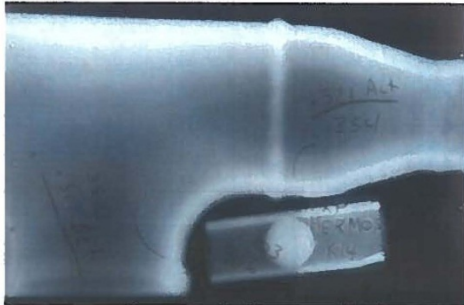
Figure 24: Processed radiographic image at HD-P-01-08, 3" tee (TML 31 to be assigned), which shows a minimum (actual) wall thickness of 0.319". A thickness of 0.321" has also been observed at the 3"x2" reducer (TML 32 to be assigned). No significant indications of erosion or corrosion were noted.

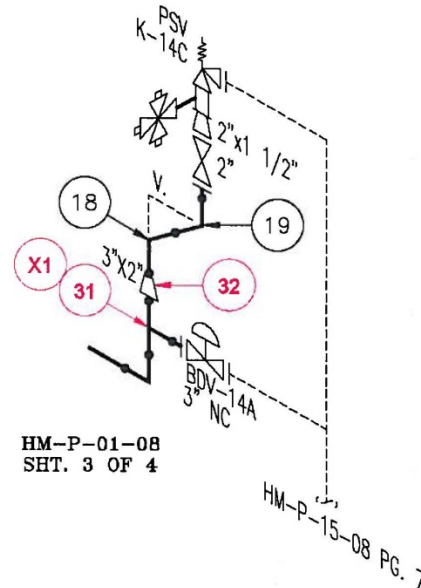
Figure 23: A partial view of isometric drawing HD-P-01-08, sheet 3 of 4. The location of profile radiography (X1) as well as new TML's 31 and 32 are shown in red.

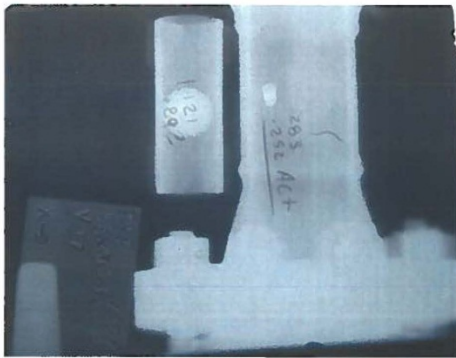
Figure 27: Processed radiographic image at HM-P-01-12, 2" pipe (TML 1), which shows a minimum (actual) wall thickness of 0.252" and no significant indications of erosion or corrosion have been found.

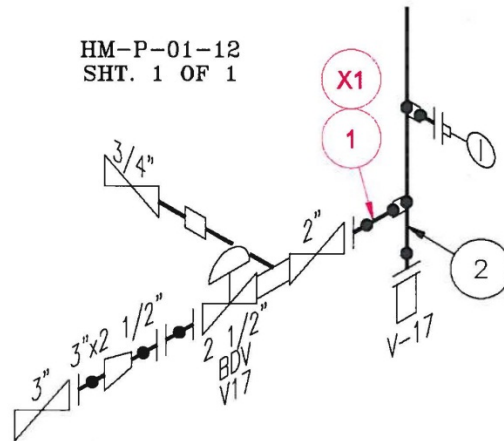
Figure 26: A partial view of isometric drawing HM-P-01-12, sheet 1 of 1. The location of profile radiography (X1) is shown in red.

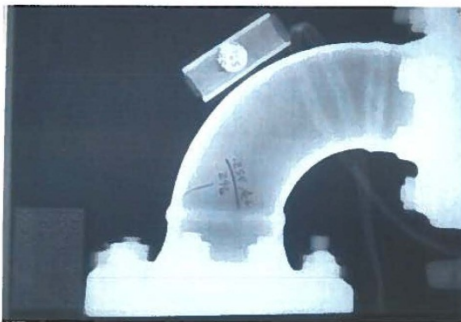
Figure 30: Processed radiographic image at HM-P-01-15, 3" elbow (TML 14 to be assigned), which shows a minimum (actual) wall thickness of 0.254" and no significant indications of erosion or corrosion have been found.

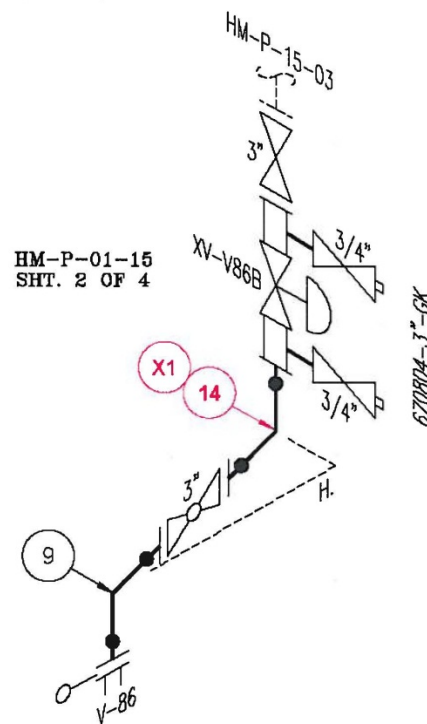
Figure 29: A partial view of isometric drawing HM-P-01-15, sheet 2 of 4. The location of profile radiography (X1) is shown in red.

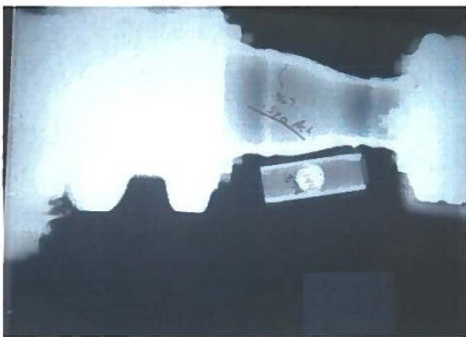
Figure 33: Processed radiographic image at HM-P-01-21, 3"x2" reducer (TML 81 to be assigned), which shows a minimum (actual) wall thickness of 0.320" and no significant indications of erosion or corrosion have been found.

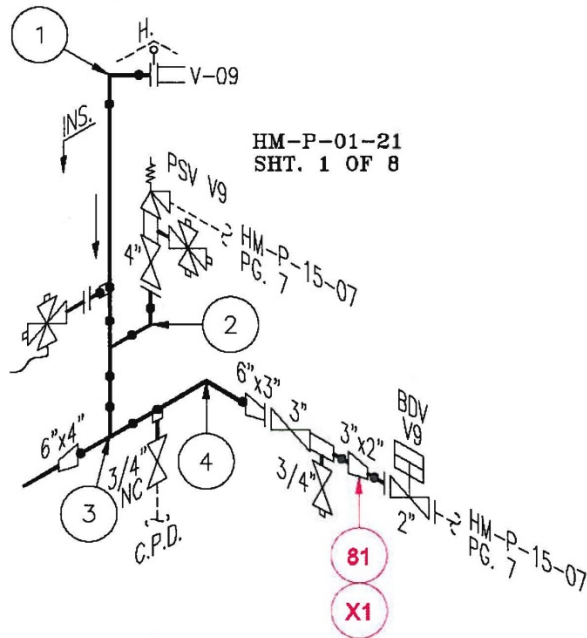
Figure 32: A partial view of isometric drawing HM-P-01-21, sheet 1 of 8. The location of profile radiography (X1) is shown in red.

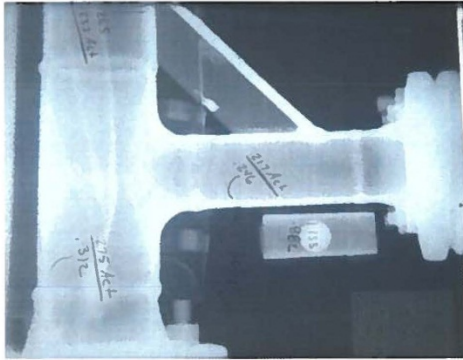
Figure 36: Processed radiographic image at HM-P-01-21, 2" pipe (TML 48), which shows a minimum (actual) wall thickness of 0.217" (X1.1). Thicknesses of 0.275" (X1.2) and 0.233" (X1.3) have also been observed at the 2" tee and pipe, respectively. Light active external corrosion has been noted at the 2" pipe (X1.1).

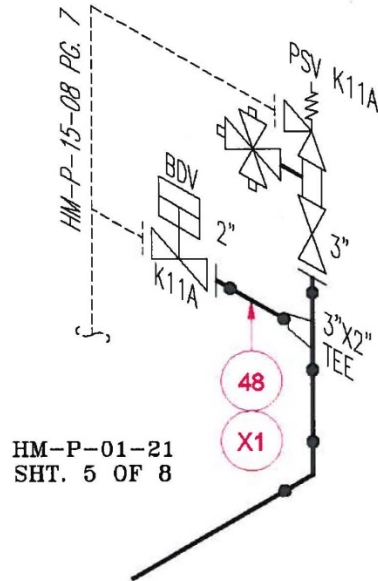
Figure 35: A partial view of isometric drawing HM-P-01-21, sheet 5 of 8. The location of profile radiography (X1) is shown in red.

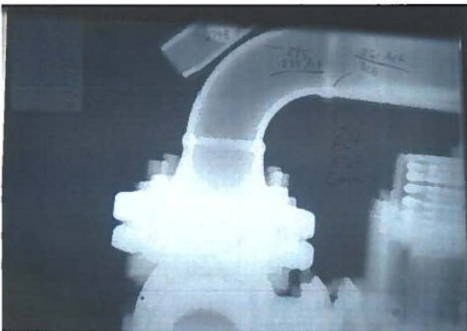
Figure 39: Processed radiographic image at HM-P-01-21, 2" elbow (TML 51), which shows a minimum (actual) wall thickness of 0.235". A thickness of 0.261" (X1.1) has also been observed at the adjoining 2" pipe. Active external corrosion has been noted near the elbow to pipe weld.

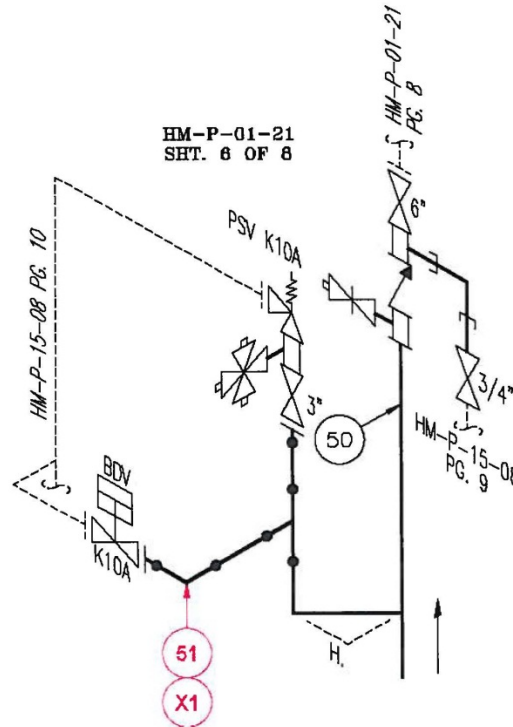
Figure 38: A partial view of isometric drawing HM-P-01-21, sheet 6 of 8. The location of profile radiography (X1) is shown in red.

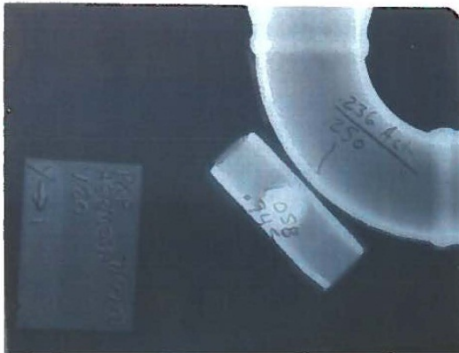
Figure 42: Processed radiographic image at HM-P-20-03, 2" elbow (TML 34), which shows a minimum (actual) wall thickness of 0.236" and no significant indications of erosion or corrosion have been found.

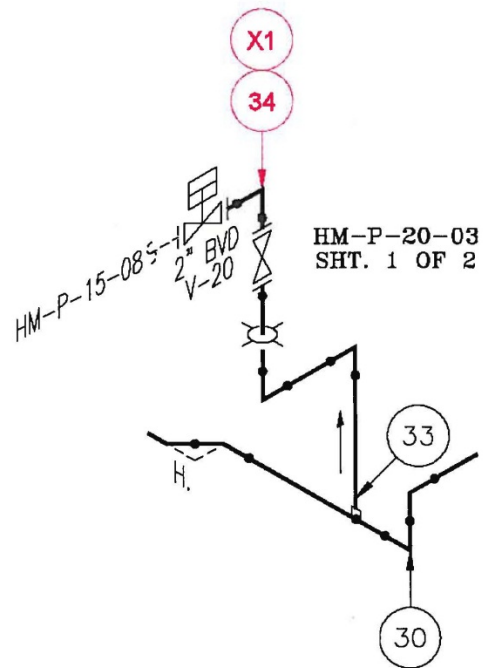
Figure 41: A partial view of isometric drawing HM-P-20-03, sheet 1 of 2. The location of profile radiography (X1) is shown in red.
