**Investigation of Fatal Accident
North Padre Island Block 969, Platform JA
OCS-G 5953
19 January 2008**

**Gulf of Mexico
Off the Texas Coast**

**U.S. Department of the Interior
Minerals Management Service
Gulf of Mexico OCS Regional Office**

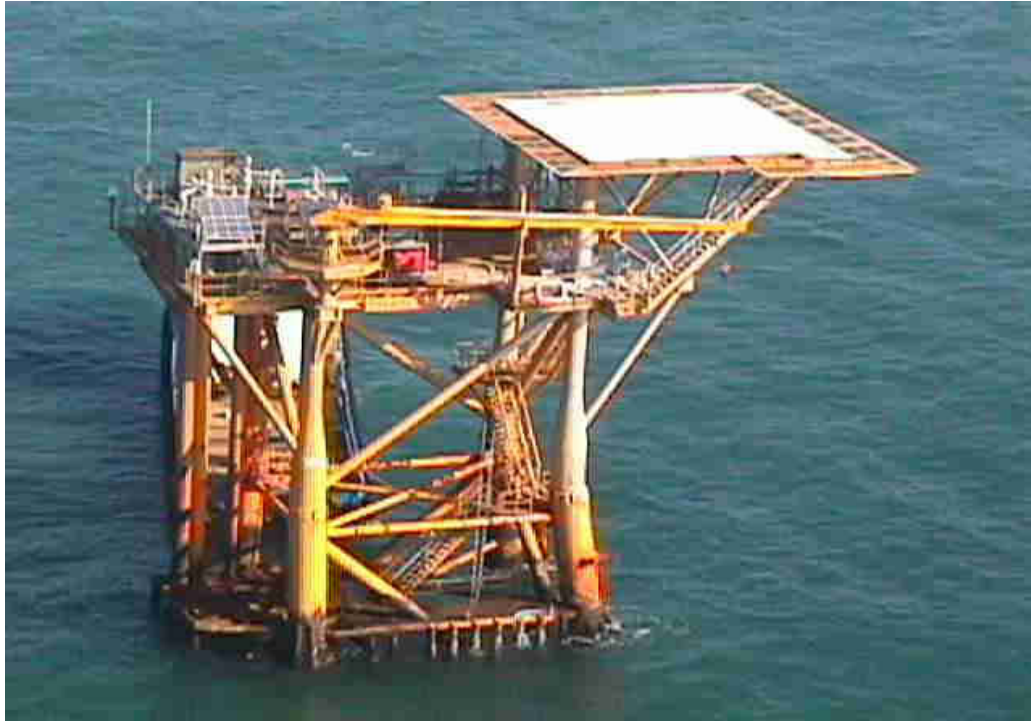
Figure 1: Photo of PN 969, Platform JA.

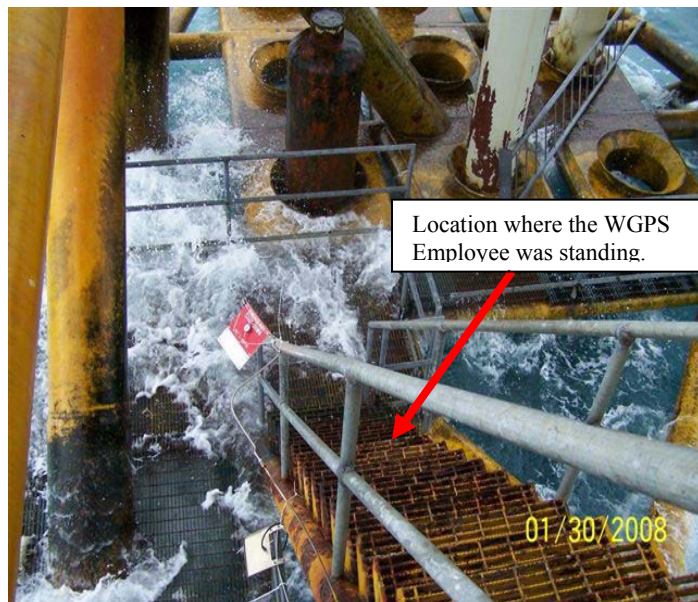
The OSW was tasked to perform regularly scheduled navigation aid inspections or "Quarterly Inspections". The WGPS Employee volunteered to go to PN 969 on the morning of January 19, 2008 with the task of assessing the reason for shut in and to bring the platform back online. It was assumed that the ESD was the likely cause of the shut in. If the ESD was determined to be the cause of shut in, the plan was to affect permanent repair if feasible (temporary if needed) in order to bring the platform back online. The WGPS Employee (presumably) determined that the permanent fix was feasible and descended the stairways to an elevation of approximately +10 to +12 feet above the boat landing.

Figure 3: Photo of the WGPS Employee's location on stairs leading to boat landing.

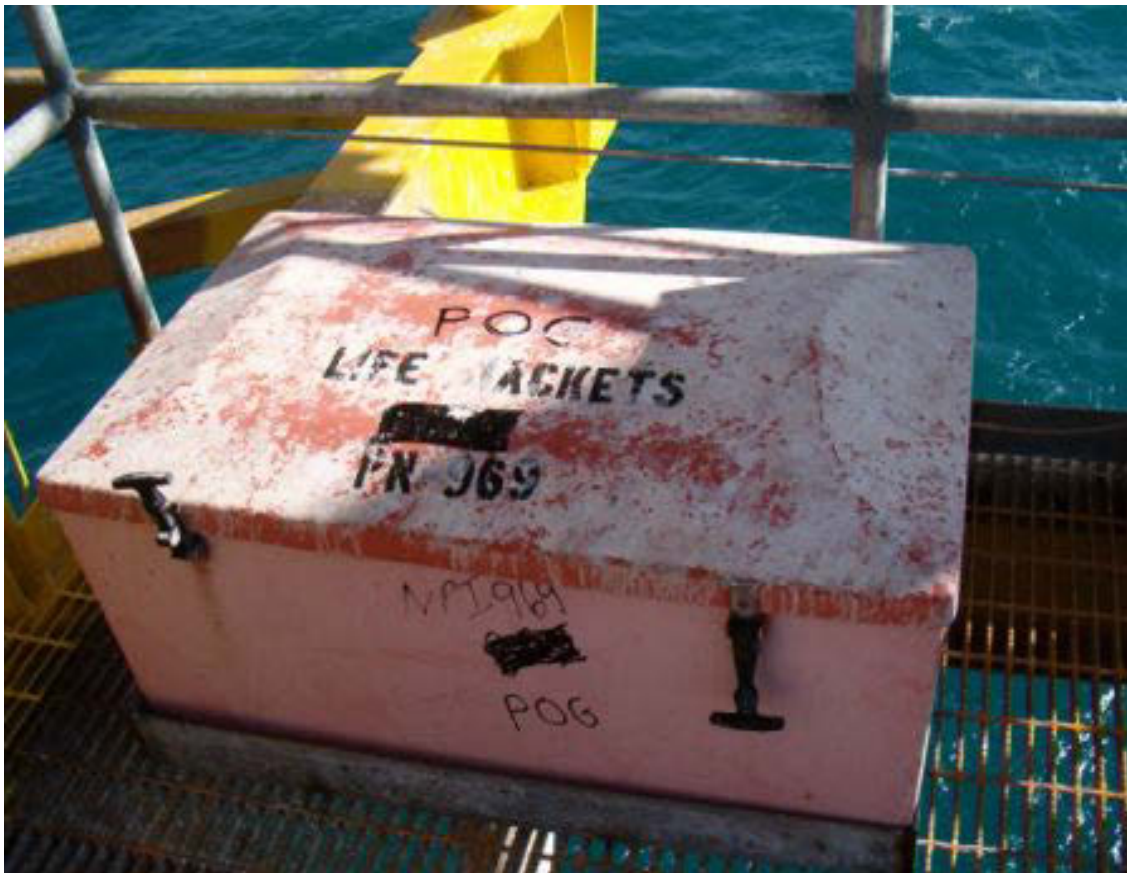
Despite his reputation as an experienced, safe, and conscientious worker, the WGPS Employee was not wearing a life jacket at the time of the incident. There were three to four Type 1 life jackets, in serviceable condition, available at the top of the stairs leading to the incident site (see Figure 4). There was a policy in place, including signage, at the top of stairs explicitly stating “PFD’s Required Beyond This Point” (see Figure 5). The Lead Operator indicated that the WGPS Employee had been made aware of the life jacket policy. There were no other safeguards regarding life vests and descent to the boat landing area known to this investigative panel.

Figure 4: Photo of life jacket box at the top of the stairs.

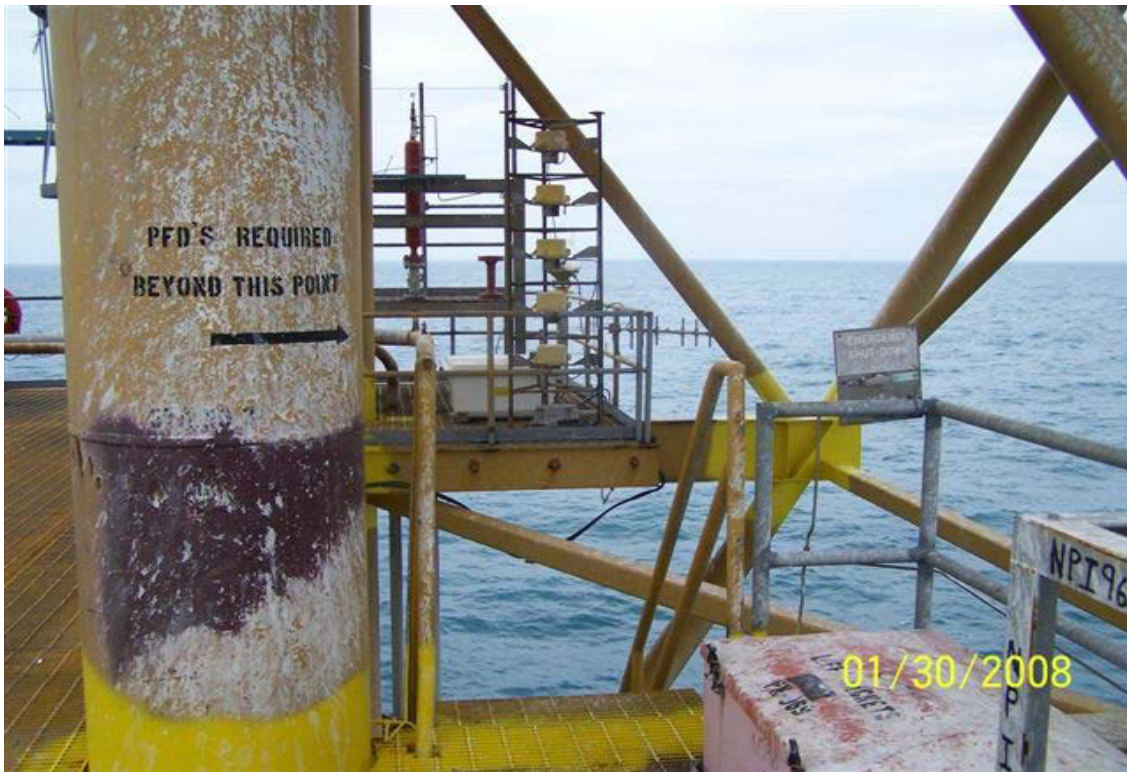
Figure 5: Photo of sign stating “PFD’S REQUIRED BEYOND THIS POINT”.
