**Investigation of Pipeline Leak
Pipeline Segment No. 4582
Main Pass Area Block 288
23 June 2007**

Gulf of Mexico
Off the Louisiana Coast

OCS Report
MMS 2008-056

**U.S. Department of the Interior
Minerals Management Service
Gulf of Mexico OCS Regional Office**

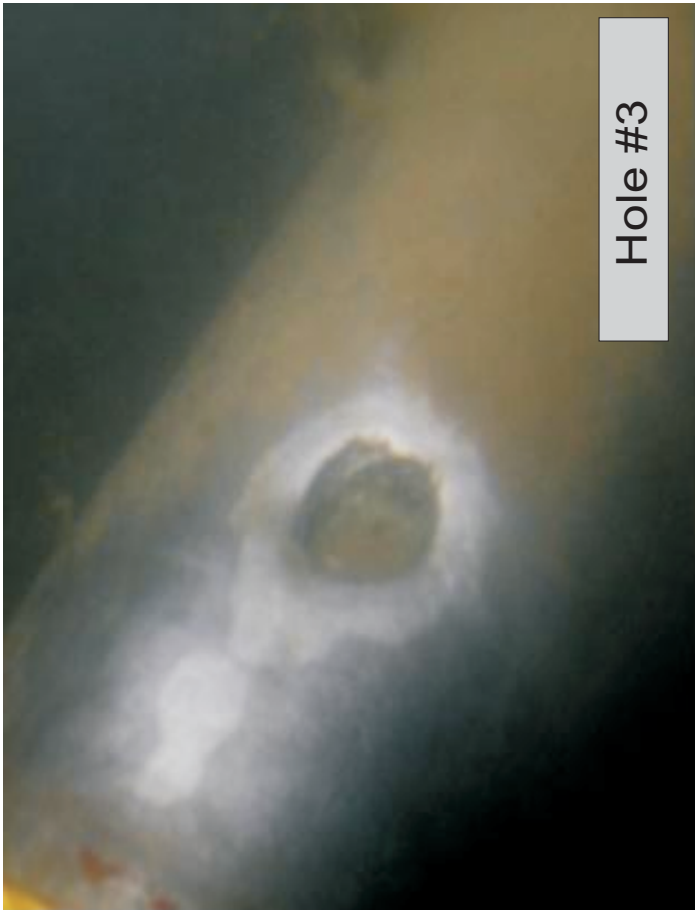
Hole #3

Divers then cleaned around all four holes and covered them with duct tape after inspecting the pipe for external damage and finding none of critical significance. Hole No. 4 was found to be $\frac{1}{8}$ -inches x $\frac{7}{8}$ -inches; Holes Nos. 3 and 2 were both approximately $\frac{1}{4}$ -inch diameter (*see Attachment No. 4*). The divers found some damage to coatings and pipe in several places. They also reported that almost all the anodes they checked on both PSN's 4582 and 4581 were fully depleted.

1. The 4.5-inch oil pipeline PSN 4582 was found to have four holes within a 100-foot long section, which allowed the release of the crude oil. The holes were caused by corrosion.
2. The CP prior to the Spill had deteriorated below the minimum level required to protect the pipeline and had remained in that state for at least six months. The failure of the CP was responsible for the corrosion of the pipeline. In April 2007, the level of CP was found to be below minimum acceptable levels for PSN 4582. The Operator failed to take timely action to remedy the deficiency. This allowed the ongoing corrosion to form the holes in PSN 4582.

The Operator's spill response team initiated operations to abate the source by sealing the known leaks using clamps. The Operator contracted a Fast Response Unit (FRU) comprised of a skimming unit, a 100-barrel tank, and four personnel. Overflights were conducted five times daily within a 5-mile radius of the Platform to monitor for any additional sheens. These overflights detected two sheens 2.5 miles southeast of the Platform, one covering an area 5 miles x 50 feet, and the other 300 feet x 300 feet.
