Bureau of
Safety and
Environmental
Enforcement

QC-FIT EVALUATION OF SHEAVE FAILURES

QC-FIT Report # 2016-05
November, 2016

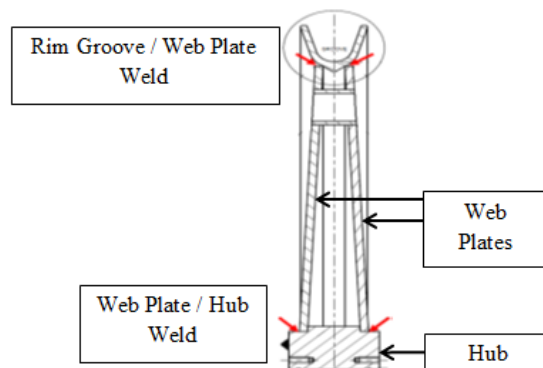
FIGURE 4: DUAL WEB DESIGN SHEAVE ASSEMBLY - WELD LOCATIONS IN RED (OEM PIB#87819987)

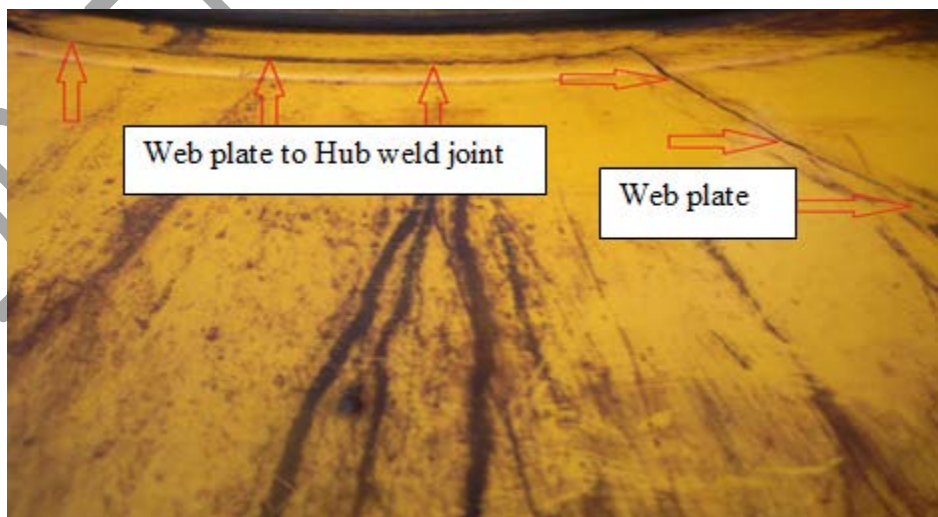
The dual web design sheaves can be interchanged with the single web design sheave. The RCA conducted by the OEM stated that the dual web design sheave prevented weld filler metal from penetrating deep enough to fill the gap on the inside of the hub-web weld joint. Thus, a crack initiated at the gap of the root of the weld and propagated through the weld seam into the web plate (Figures 5 & 6).

FIGURE 5: RED ARROW INDICATES CRACKS IN THE WELD JOINT AND WEB PLATES (OEM PIB#87819987)

- The OEM verified that the sheave failure was due to the dual web design, which prevented welding of the inside of the hub-web weld joint and resulted in a gap. This design allowed for higher stress concentration, resulting in crack initiation at the gap of the root of the weld and propagated through the weld into the web plates (Figures 5 & 6).

- BSEE agrees with the OEM's recommendation that all CMC dual web design sheaves should be replaced with single web design sheaves. The single web design sheave results in a more robust hub-web weld joint and is not as susceptible to cracking as the dual web design sheave.

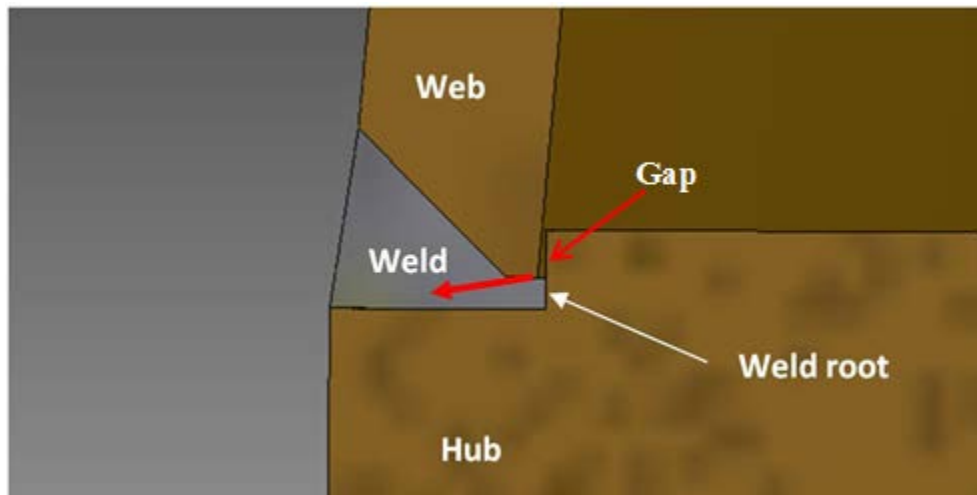
FIGURE 6: DETAILED CROSS-SECTION OF WEB PLATES TO HUB WELD SECTION CRACK INITIATION AT THE GAP AND PROPOGATION PATH SHOWN BY THE RED ARROW (RCA REPORT)

- The OEM specified a hand weld root pass procedure, followed by an automated SAW technique welding procedure. This procedure did not allow for a full penetration depth of the weld filler metal on the inside of the hub-web weld joint, creating a stress concentration.

- The Metallurgical RCA investigation attributed the sheaves' failure to the dual web design of the sheave. The dual web design prevented welding on the inside of the web plates to the hub. The OEM specified a manually welded root pass, followed by an automated SAW technique welding procedure. This procedure did not allow for a full penetration depth of the weld filler metal, which resulted in a gap between the inside of the web plate to the hub weld joint. This gap between the inside of the web plate to the hub weld joint allowed for stress concentration and crack initiation at the gap of the root of the weld (Figure 6).

In the case of this evaluation, the OEM’s welding parameters should have specified that sufficient heat be applied to achieve a wider, deeper penetration along the backing surface gap of the root of the weld. This would have enabled the weld to be more resistant to crack initiation.

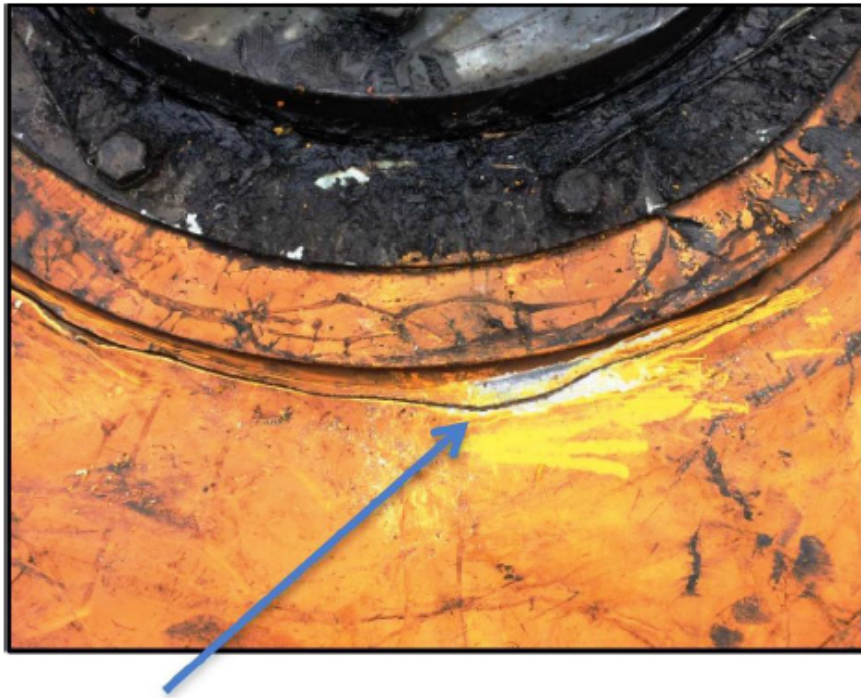
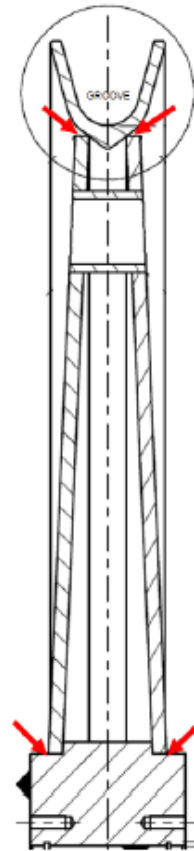
- Issue:** Hub weld cracking incidents have been reported for the CMC's 78" fastline jockey sheave (the middle of the three sheaves in the fastline linkage arm assembly). These cracks propagate from weld defects near the root of the weld between the web plates and the hub.

Illustrations: Above: Example of crack at hub of old fastline sheave. Right: Cross-section of typical sheave. The red arrows are pointing at the welds that supplier defines as "critical".

- Solution:** NOV recommends that the present fastline jockey sheave be replaced with a single-web sheave. Until replacement is performed, the critical welds of the sheaves in the fastline linkage arm assembly should be visually inspected for cracks on a weekly basis. The Critical Welds are shown in the Maintenance Instructions and in the figure below. Additionally, users should ensure that appropriate fastline stabilizers are installed, as these significantly lower the dynamic high-frequency side loading on the sheaves.

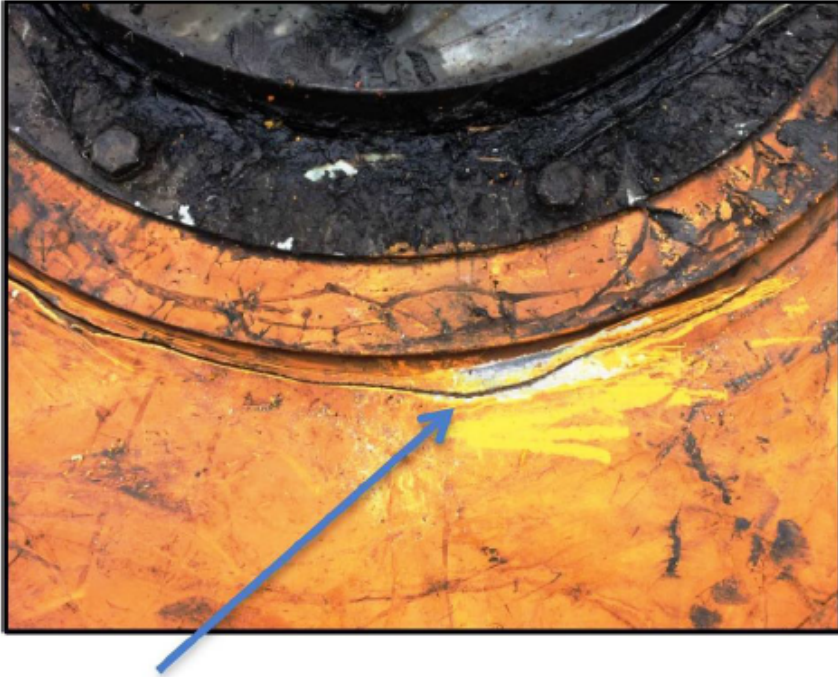
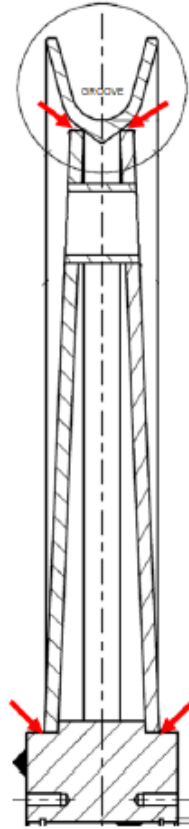
Subject:	Incidents Reported for CMC Wire Sheaves
Product Models:	Crown Mounted Compensator (CMC), CMC-1000-25 / 2500, using 78" wire sheaves with NOV item no. 207785 and 207786.
Affected Assemblies:	Crown block sheave block D1104-A2700, with seven regular sheaves. Fastline and deadline linkage arm assemblies D1104-A4000/A4001/A4002; - each assembly with one regular sheave and two light-weight sheaves.
Objective:	To inform the user about the reported CMC 78" sheave incidents, to stress the importance of frequent sheave inspections according to the Maintenance Instructions, and to recommend replacement of the sheaves. Compared to the previous revision of this bulletin, this revision extends the coverage to include the cluster sheaves in addition to the originally covered jockey sheave position.
Issue:	Hub weld cracking incidents have been reported for the fastline jockey sheave (the middle of the three sheaves in the fastline linkage arm assembly) and among the crown block sheaves. The cracks propagate from weld defects near the root of the weld between the web plates and the hub.

*Illustrations: Above: Example of crack at hub of old fastline sheave.
Right: Cross-section of typical sheave. The red arrows are pointing at the welds that supplier defines as "critical".*

Solution:	NOV recommends that all 78" CMC wire sheaves with item no. 207785 and 207786 be replaced with single-web sheaves. Until replacement is performed, the critical welds of the sheaves should be visually inspected for cracks on a weekly basis. The Critical Welds are shown in the Maintenance Instructions and in the figure below. Additionally, users should ensure that appropriate fastline stabilizers are installed, as these significantly lower the dynamic high-frequency side loading on the sheaves.
