Appendices

What Was EPA Doing When the Blowout Began?

Claims of Digging High

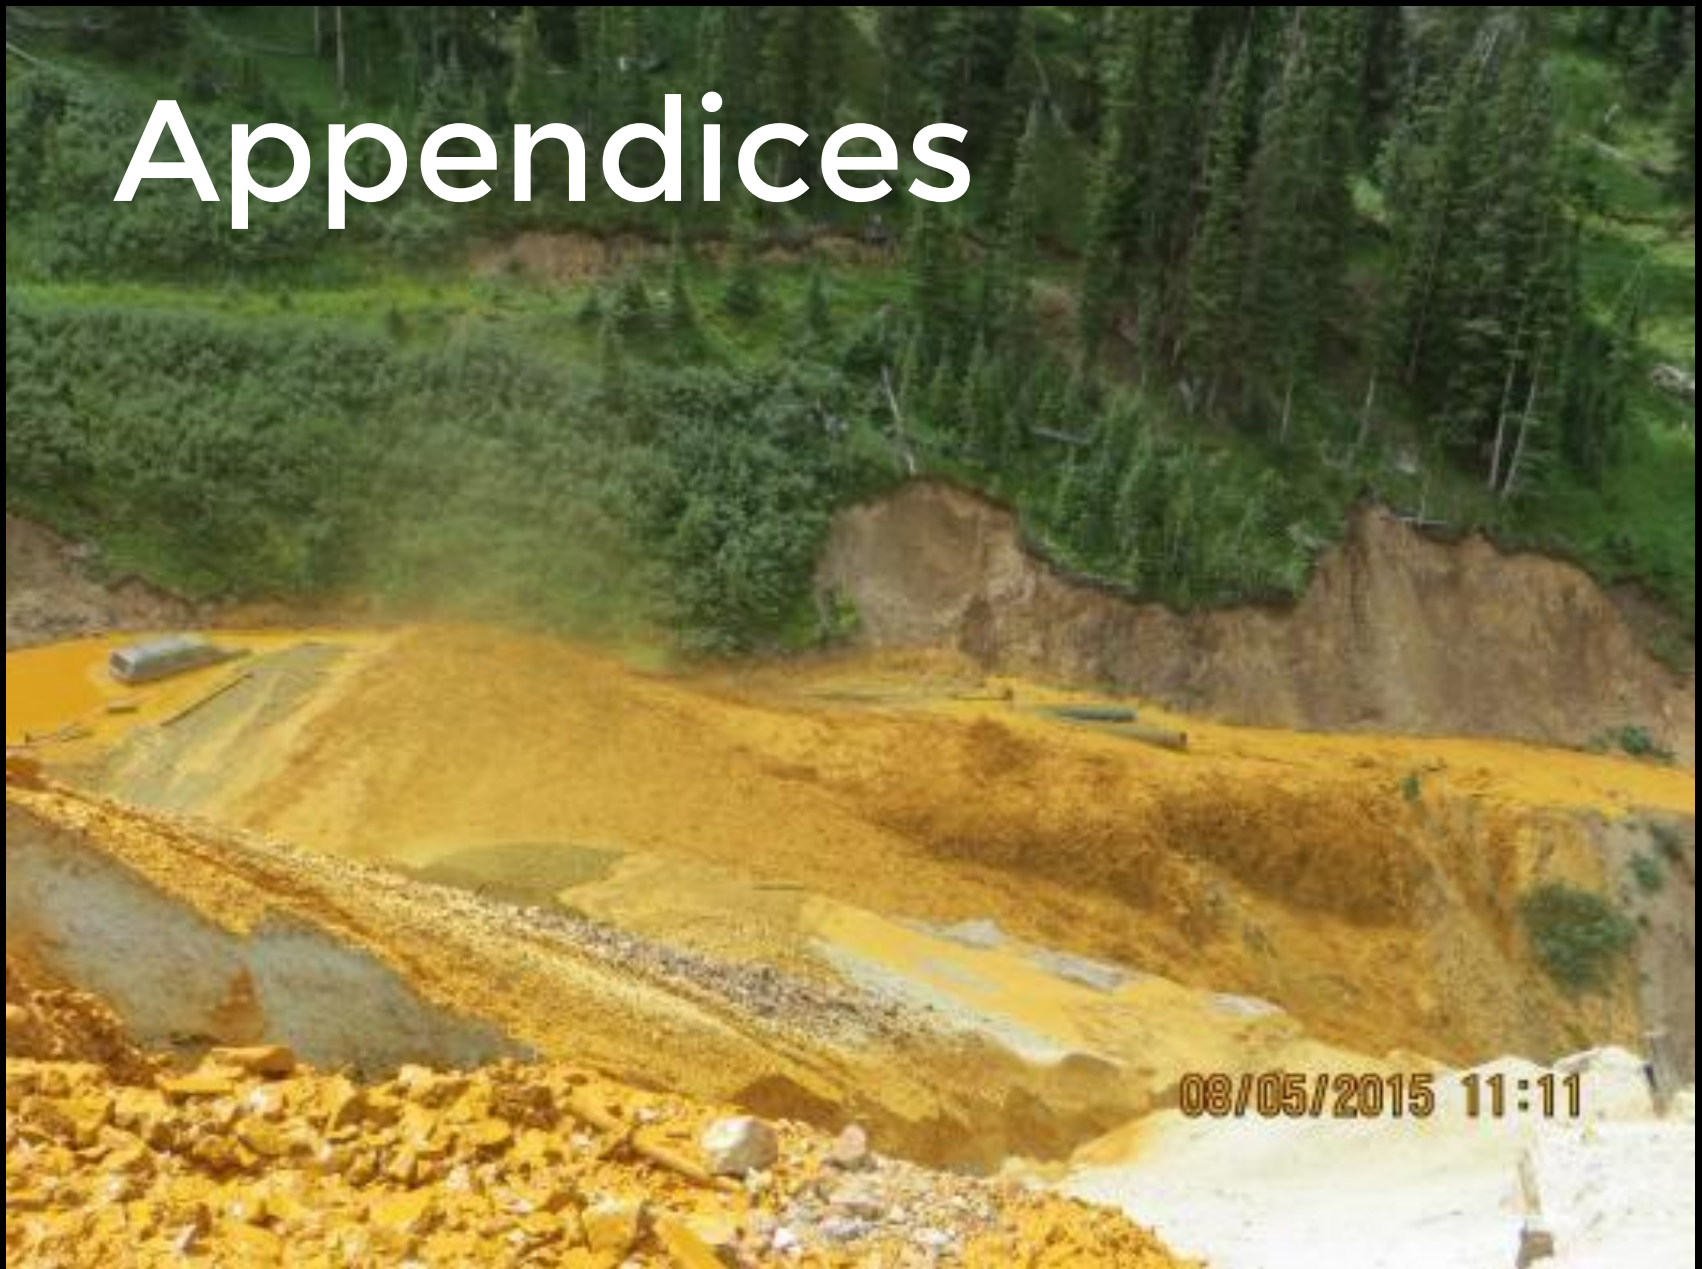
August 5, 2015: Contaminated water rushed into Cement Creek. Photo taken about twenty minutes after the plug was breached at the Gold King Mine.¹

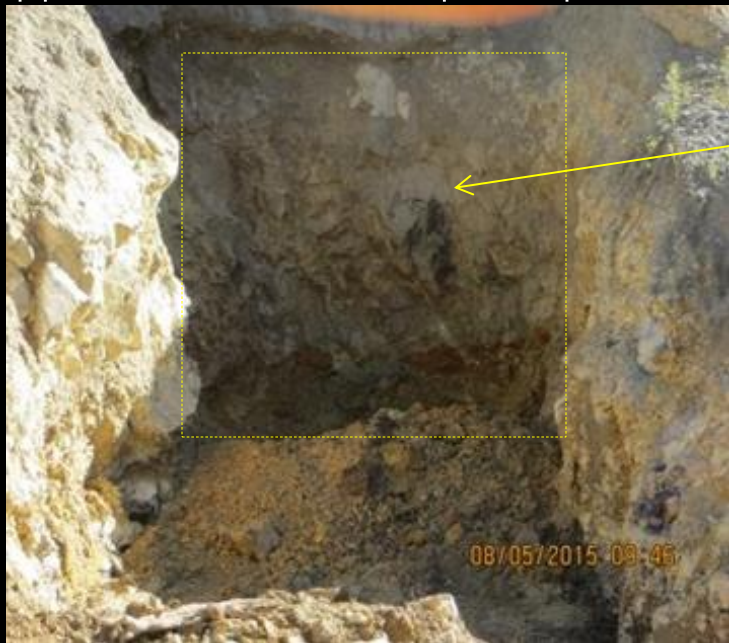
Above:
8/5/15 9:46 AM.²

Rock face – area of bedrock above the adit entrance appears devoid of dirt and unconsolidated material.

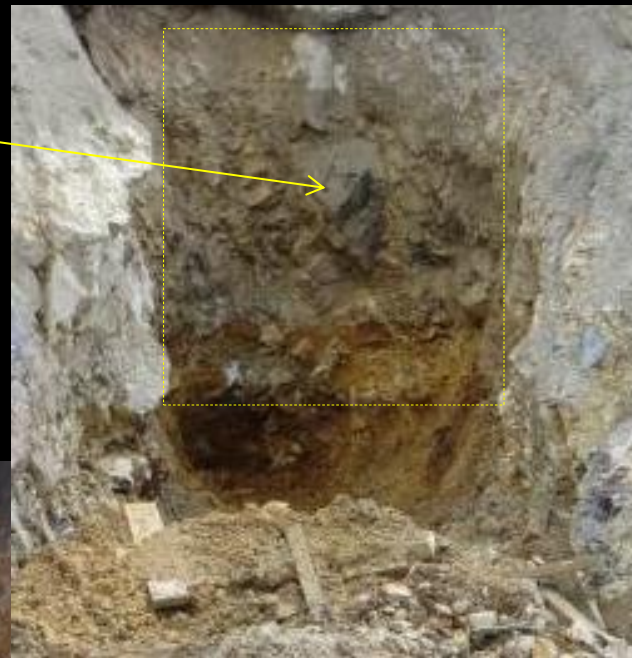
Above:
8/5/15 10:51 AM.⁴

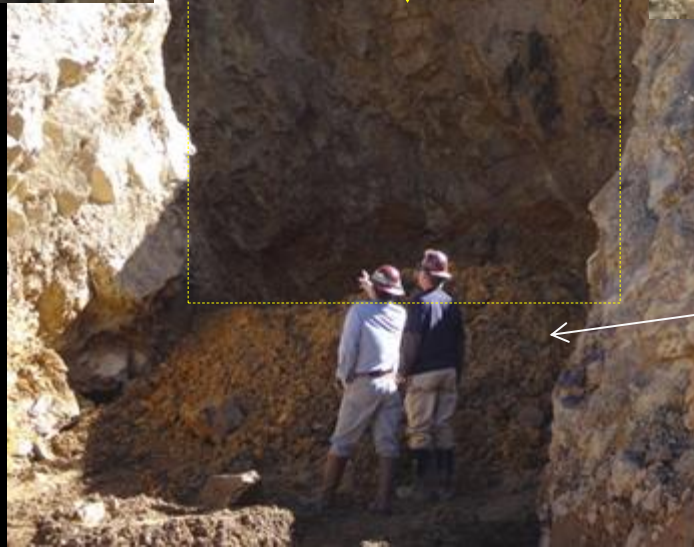
Right:
8/5/15 after 9:46 AM
(Although not time-stamped, cast shadows show the sun was higher than in prior photo.)³

The dirt pile in the photo above is a berm. It is further from the rock face than the dirt pile in the other photos.

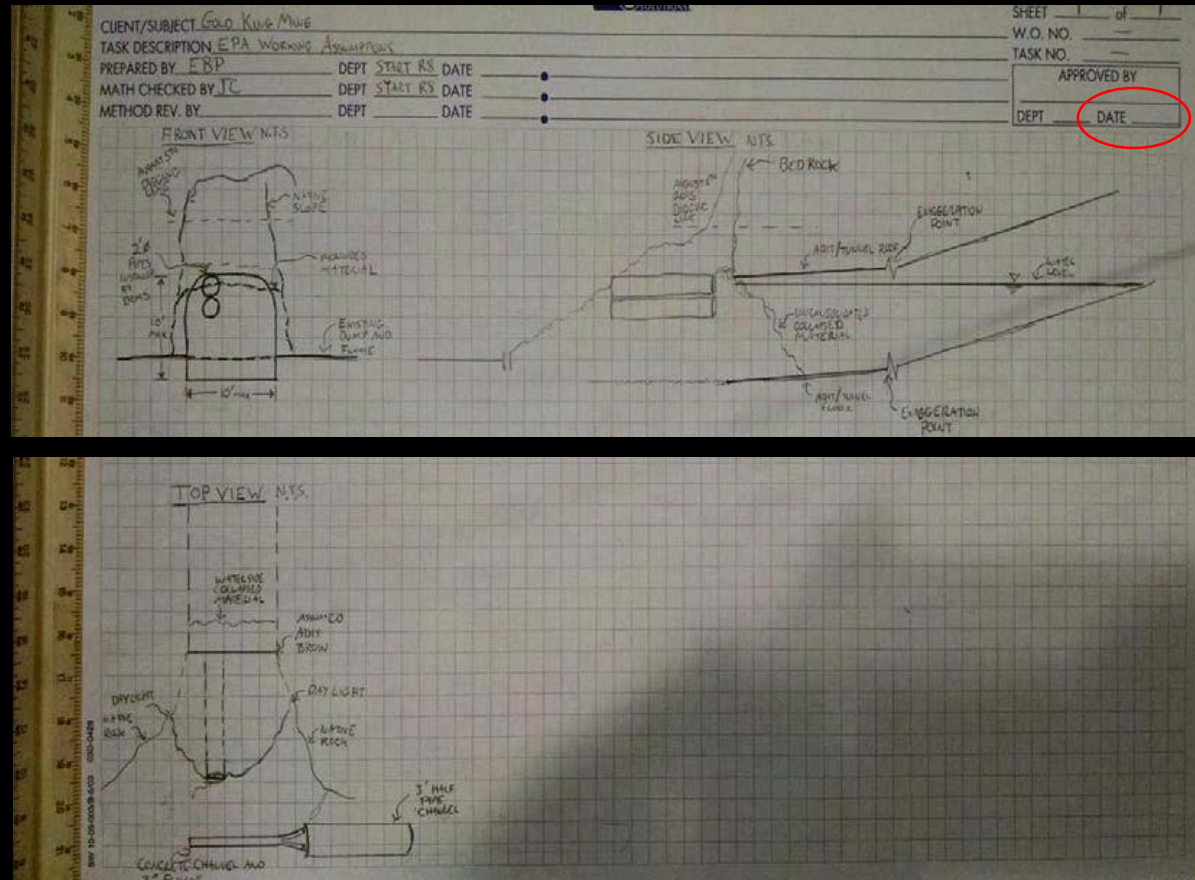
In discussing the EPA drawing, "Attachment D," the *Technical Evaluation* states: "the cross-section view from figure 39 was used as the basis for illustrating the steps that EPA was going to take to open the adit (figures 40 through 45). . . ."¹

Both DOI's *Technical Evaluation* and EPA's *Internal Review* allow the reader to assume that the drawing was used at the site. The Committee was advised that the undated figure was produced on August 11th.²

EPA's Attachment D indicates that EPA knowingly excavated close to the plug, and, in doing so, was at an elevation below the water level that they reportedly assumed in the drawing.¹ The pipes (and dashed red lines) were actually lower relative to the floor as shown in figures A 17, 18, and 19. This means that EPA actually was digging even lower than their assumed water level.

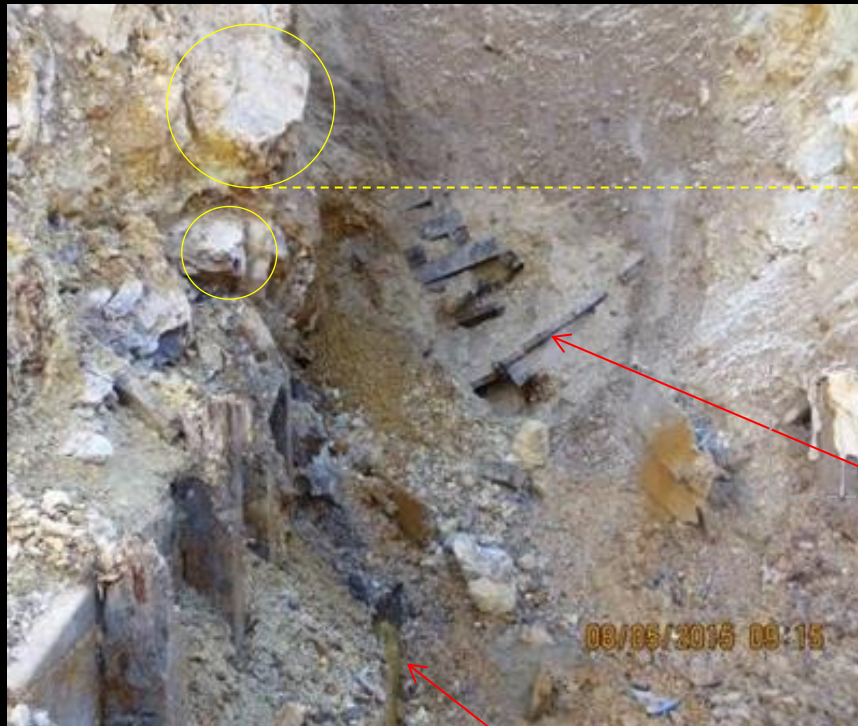
Below: 9:15 AM, August 5. After excavation fully removed the pipes and exposed the plug.¹

Likely remnant of stinger

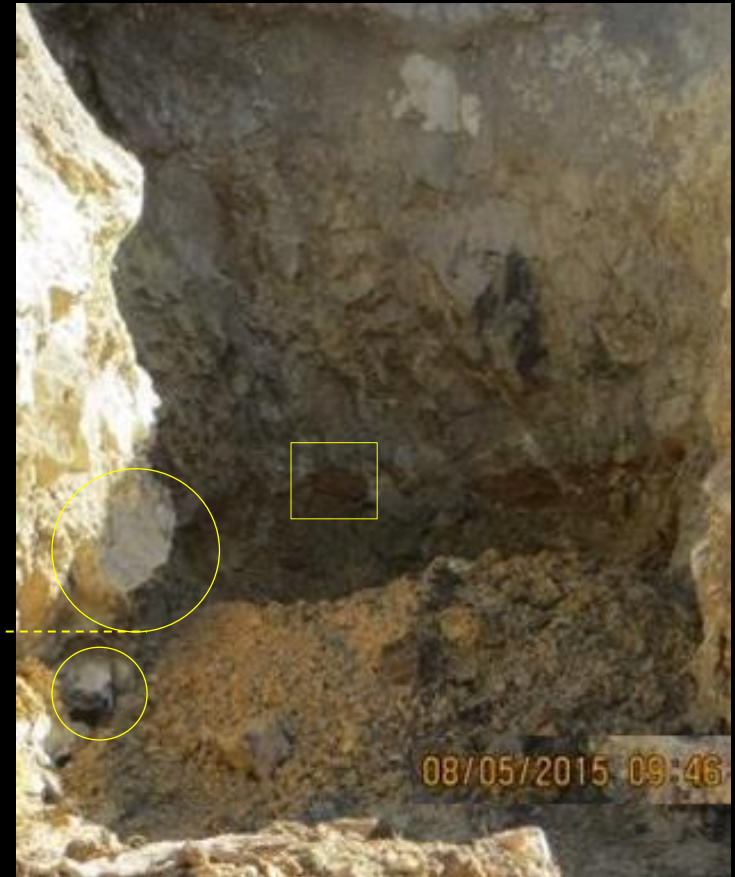
Right: 9:46 AM, August 5. After the excavation toward the adit was partially backfilled and the rock face above the adit entrance was exposed.²

Wooden debris
embedded in plug

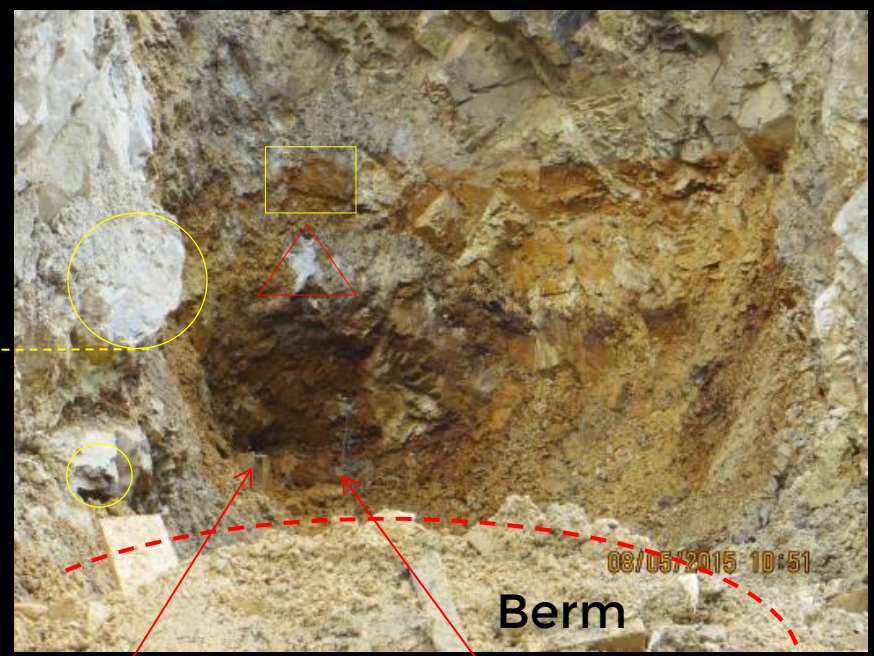
Below: 10:51 AM, August 5. The mound from the previous photo was removed. The top of a berm is visible at the bottom of the photograph. A timber top also is visible. The EPA crew has dug into the plug. The blowout's initial spurt is discernable. There is a white mark on the rock face, possibly from the tooth of the track hoe bucket.²

Timber

Initial spurt

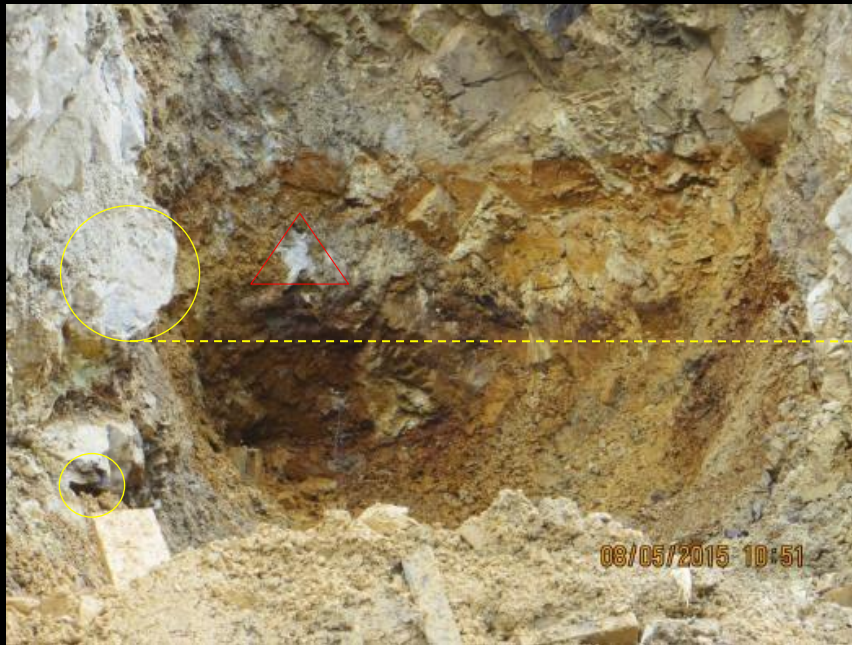
Below: 10:54 AM, August 5. The spurt turned into a wave of orange water. In the lower right, planks are set to direct water toward a channel.²

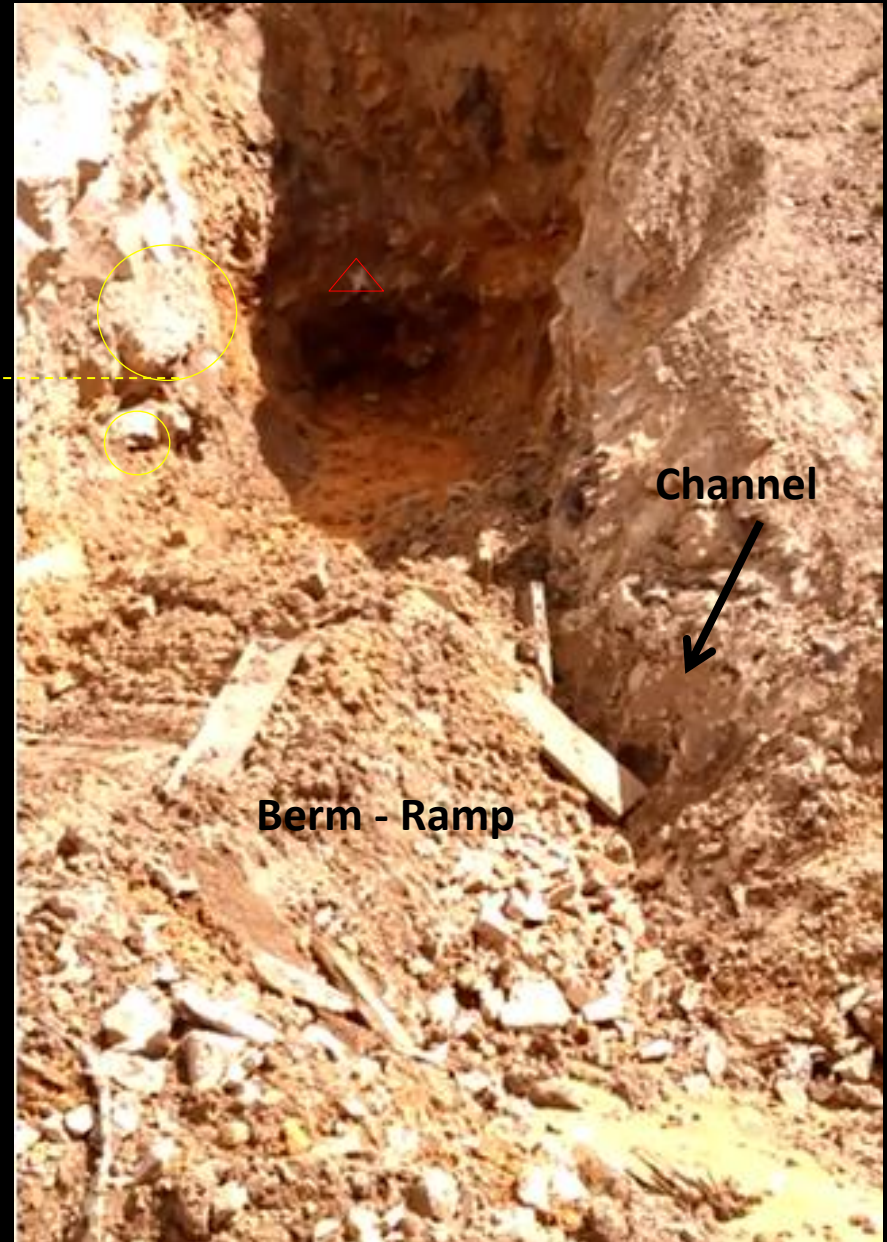
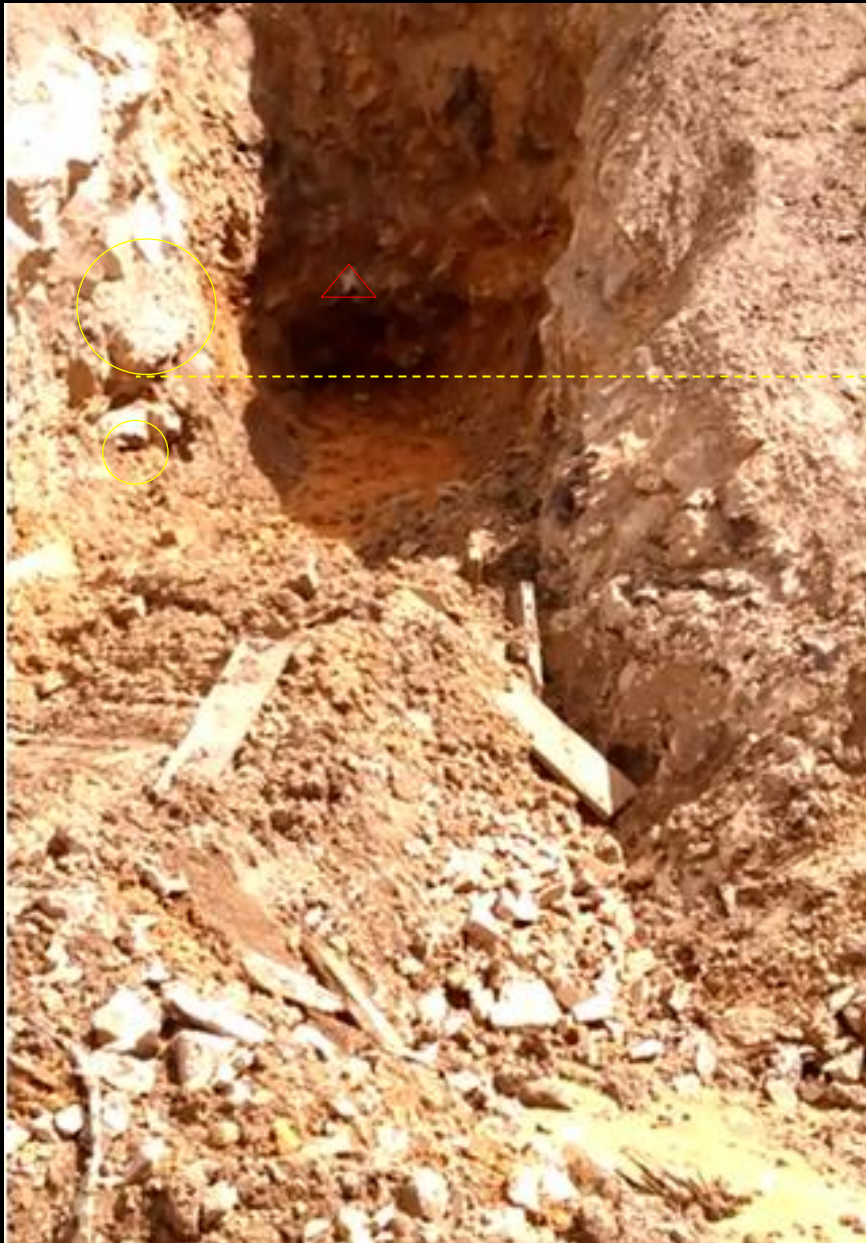
Channel

Berm - Ramp

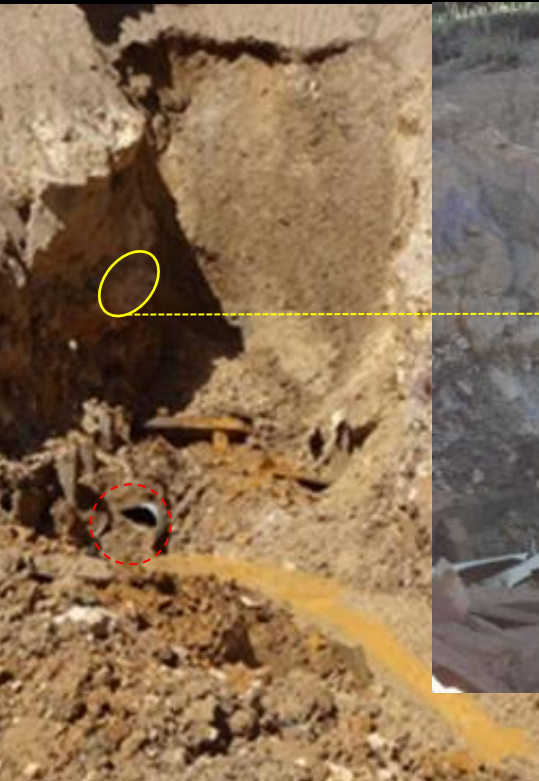
August 4, image believed to be taken around 2 PM

These images run chronologically from left to right. The first image reveals the elevation of the drainage pipe, close to the adit floor. The second image shows the plug above where the drainage and observation pipes had been, and a remnant of the stinger close to the adit floor. The third image shows the extensive amount of backfilling of the excavation before EPA began digging into the plug. The channel prepared on the right side appears to be designed to direct water to the half pipe channel (not pictured). EPA likely dug into the plug below the white mark on the rock face. In the fourth image, the berm in the third image has clearly been washed away and a new berm (at very bottom of photo) has been constructed to divert the later stages of the blowout to the half pipe channel.¹

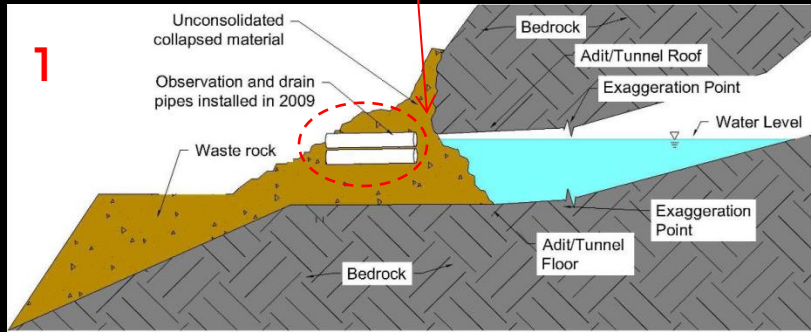
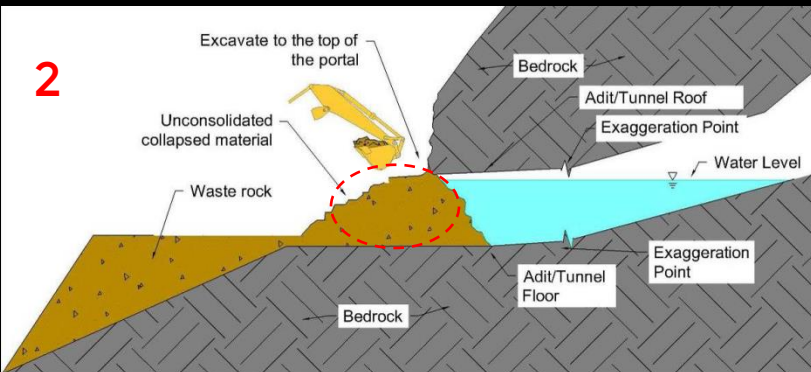
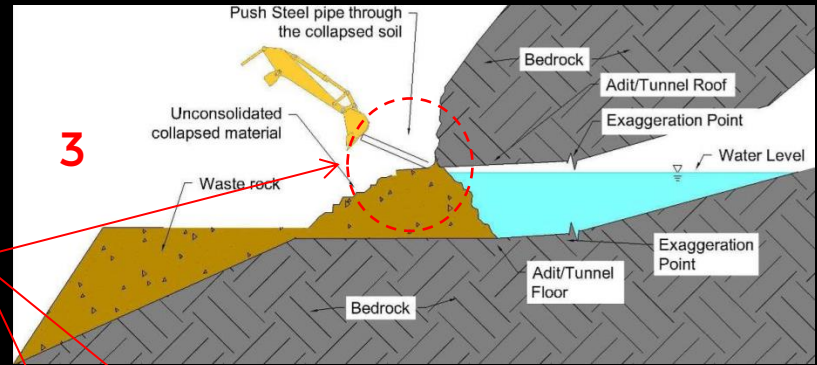
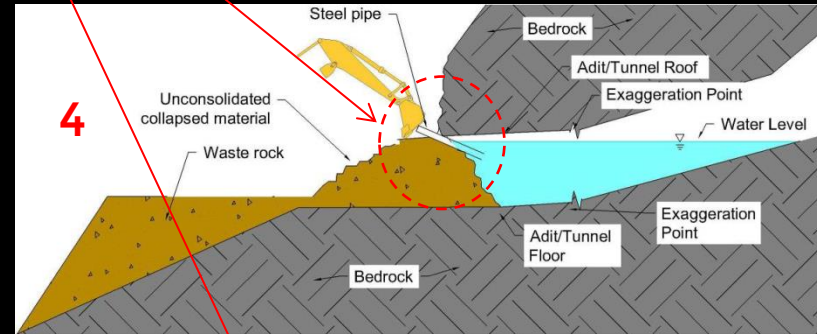
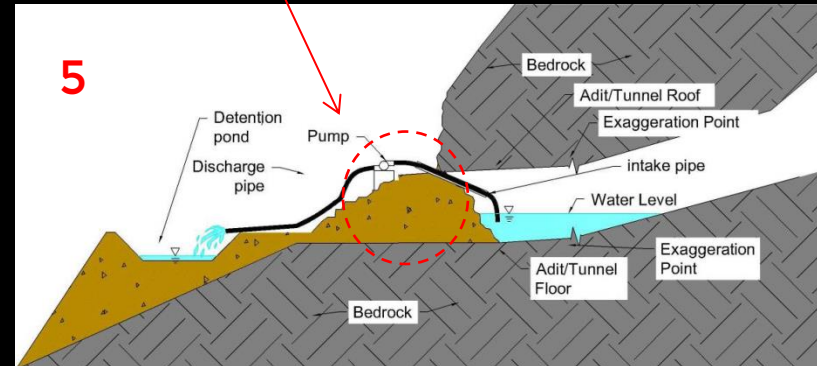
Depiction of "EPA's Plan" in DOI's Technical Evaluation

Although not shown in DOI's sequential figures, these pipes were removed by EPA.¹

Despite DOI's account, the Committee was advised by individuals present at the Gold King Mine on August 5th, 2015 that there was neither a stinger nor a pump on-site at the time of the blowout.²

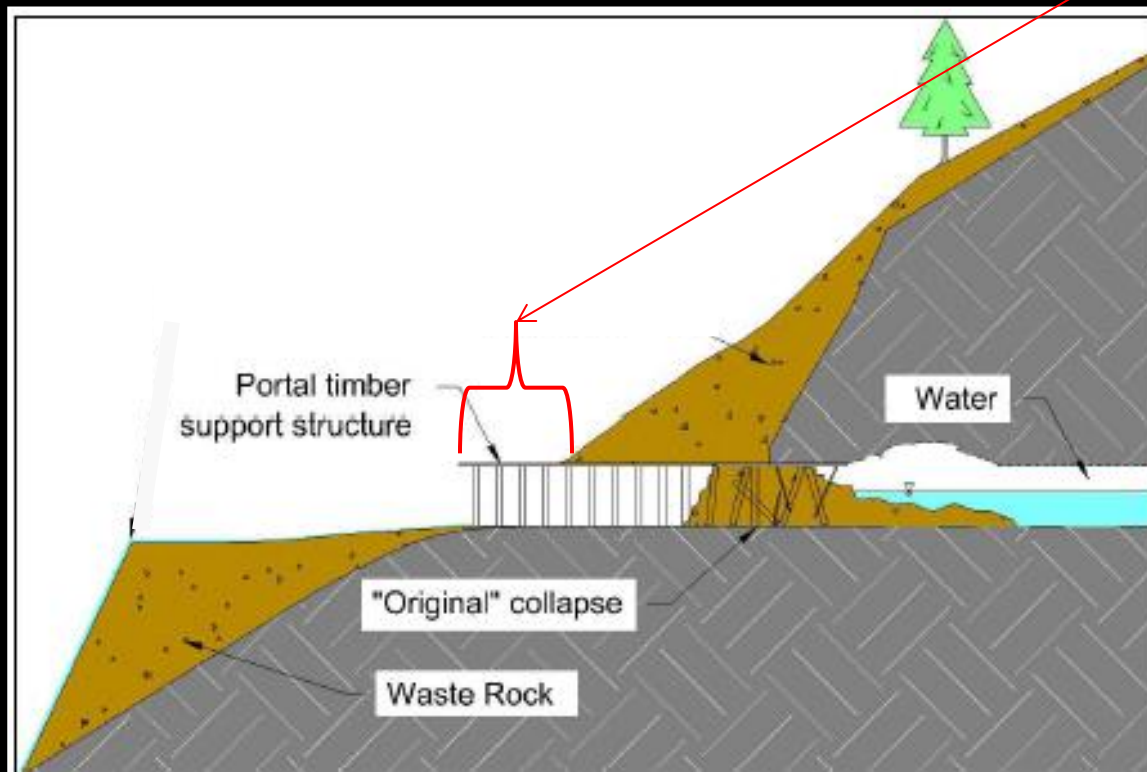
DOI's *Technical Evaluation* depicts the opening of the portal structure (below left) as extending four timber sets (two vertical timbers supporting a horizontal cap timber) beyond the slope of the mountainside. This is inaccurate, as evidenced by a 2004 DRMS photo (right) and a construction photo from 1984 (below right).¹

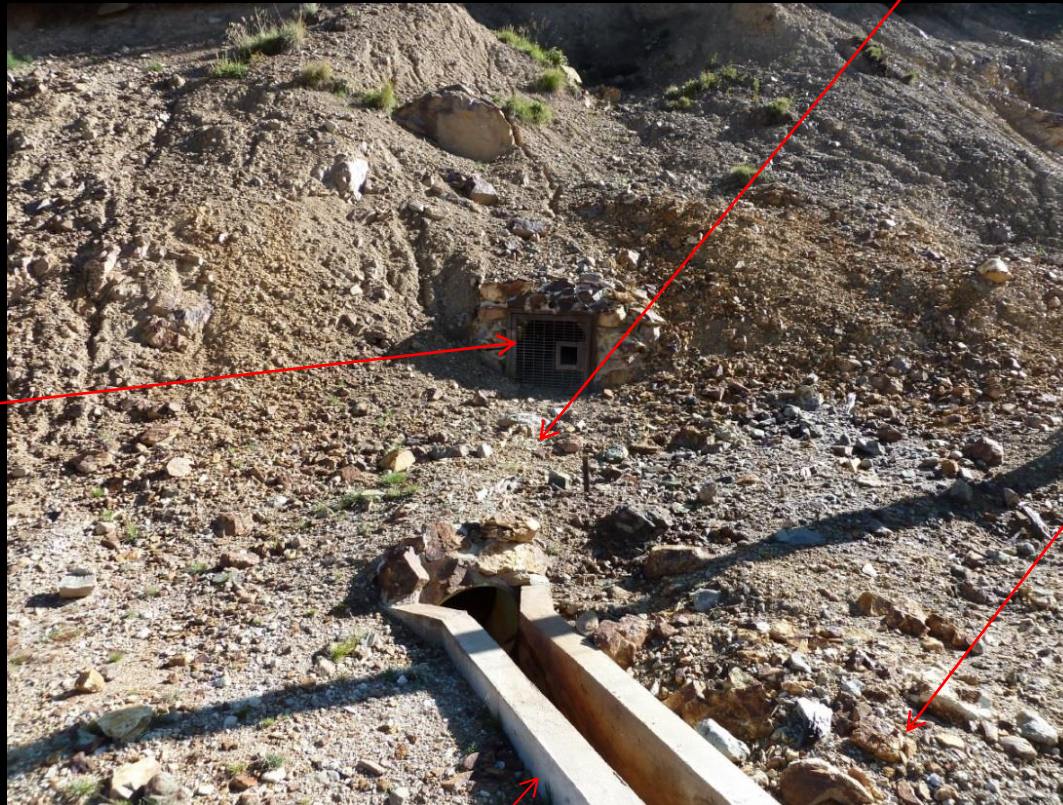
The end of the drainage pipe was buried below the observation pipe. It connected to the pipe that is visible in the top of the concrete channel.

Observation pipe end is covered by a gate.

Concrete channel directed water off of the waste rock dump. The channel turned to the right. (See photos at right).

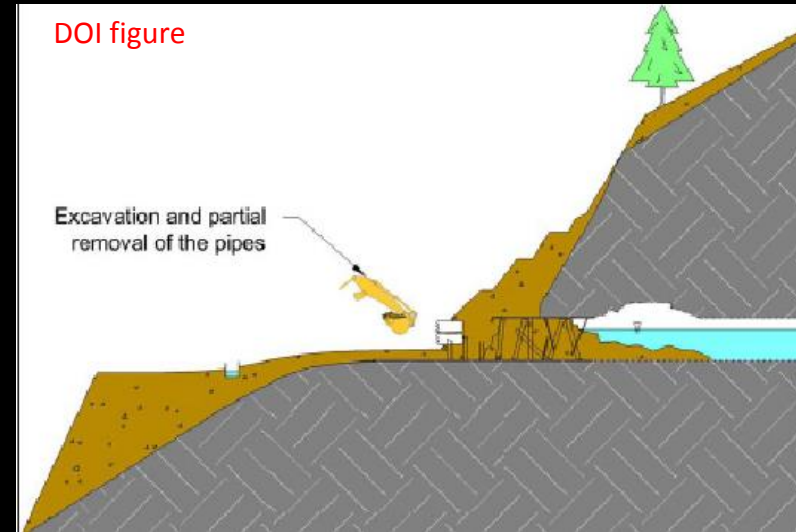
DOI's *Technical Evaluation* states and depicts that "most" of the drainage and observation pipes were removed by EPA in 2014.¹ Photos of work done in 2014 show that little, if any, of the pipes were removed.²

The pipes installed in the lower right photo appear to be 12" in diameter although the DOI *Technical Evaluation* states that they were 24".³

Same rock
Same damage to pipe

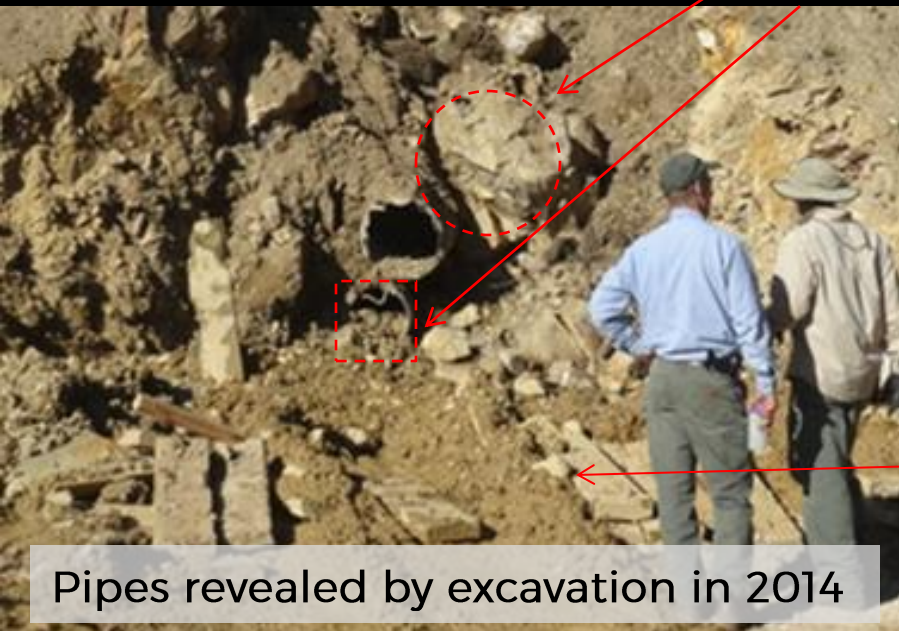
Pipes revealed by excavation in 2014

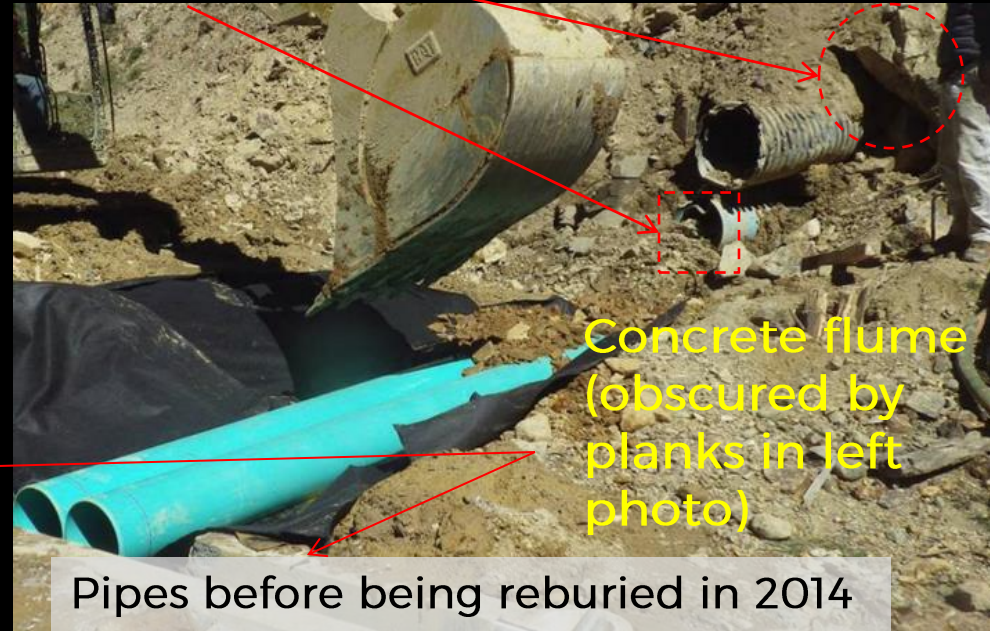
Pipes before being reburied in 2014

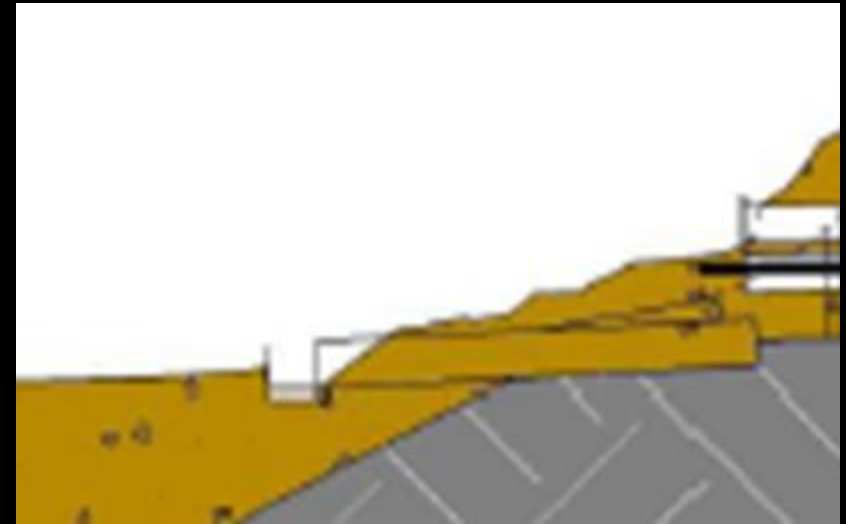
The enlarged portion of the figure in the *Technical Evaluation* (right) reveals that DOI was accurate in noting that the figure is “not to scale.”¹ It is not possible for a two foot diameter drainage pipe to rest at about the same elevation as the waste rock dump/adit floor (photo below)² and abut another two foot diameter pipe that is flush with a eight (or 10) foot roof.³ DOI’s not-to-scale figure makes the physically impossible scenario less obvious, and it obscures EPA’s error.

Above : Enlargement of below DOI figure showing distortion of distance between drainage pipe and waste rock dump.

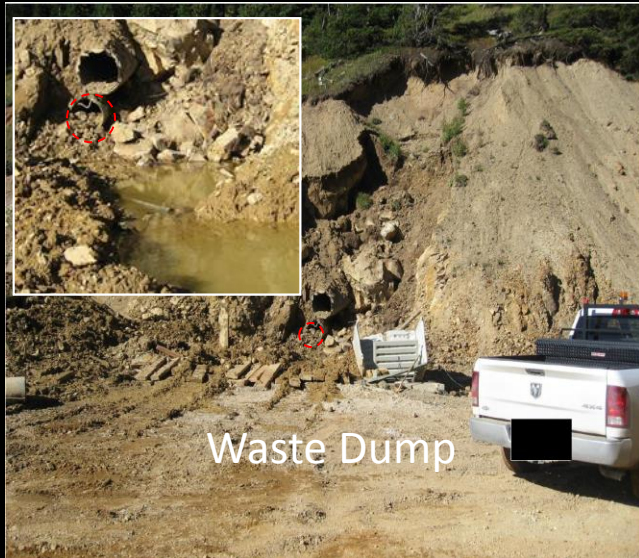
Drainage pipe (red) about level with waste rock dump in 2014. Inset: Pooling water.

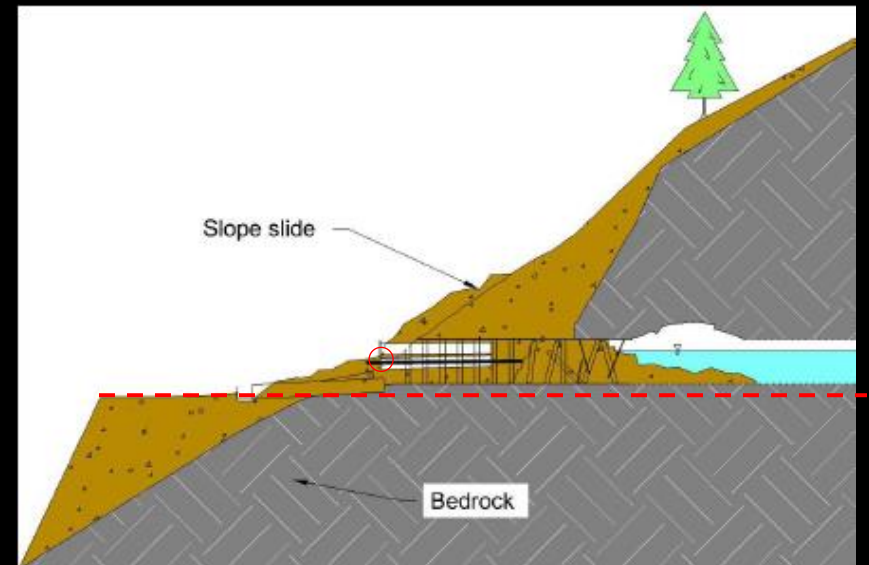
Adit floor and waste rock dump at similar elevation as depicted in DOI’s *Technical Evaluation*.

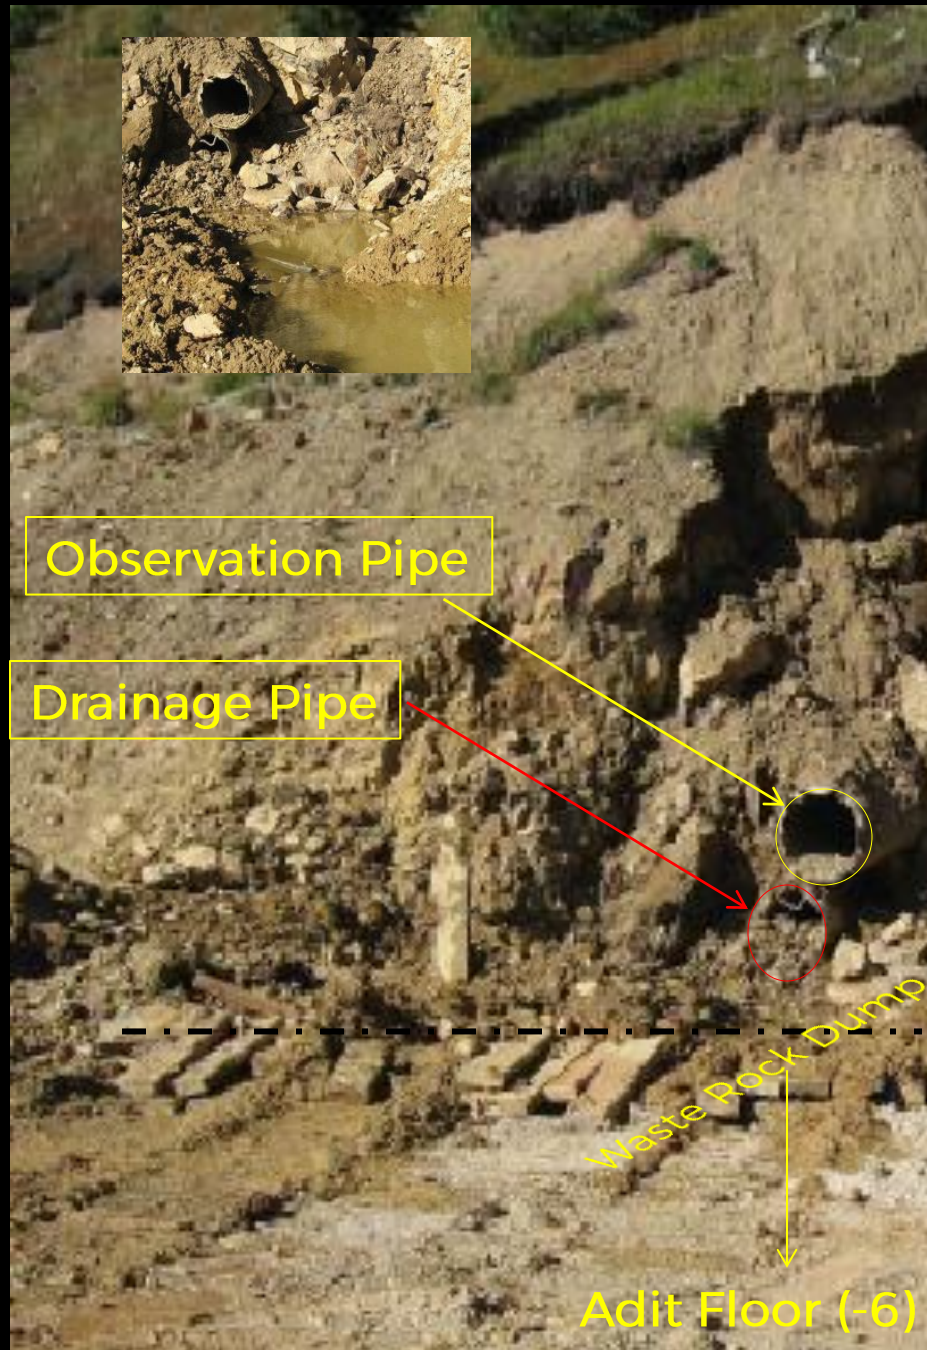
The EPA asserted in its *Internal Review* and in its 2014 Report that the adit floor was 6 feet lower than the waste dump and that EPA's assumed 6 foot water level within the mine was based on observations of pooling water beneath the drainage pipe. EPA asserted that it stopped its work in 2014 when it concluded that the elevation of the adit floor was 6 feet below the waste rock dump.¹

2014 excavation photos show the observation and drainage pipes, and the beginning of the waste rock dump in front of the adit.² The pool is more easily identified in the inset.³ Despite EPA's assertion in 2014 and in its *Internal Review* that the adit floor was six feet lower than the mine, it was not.

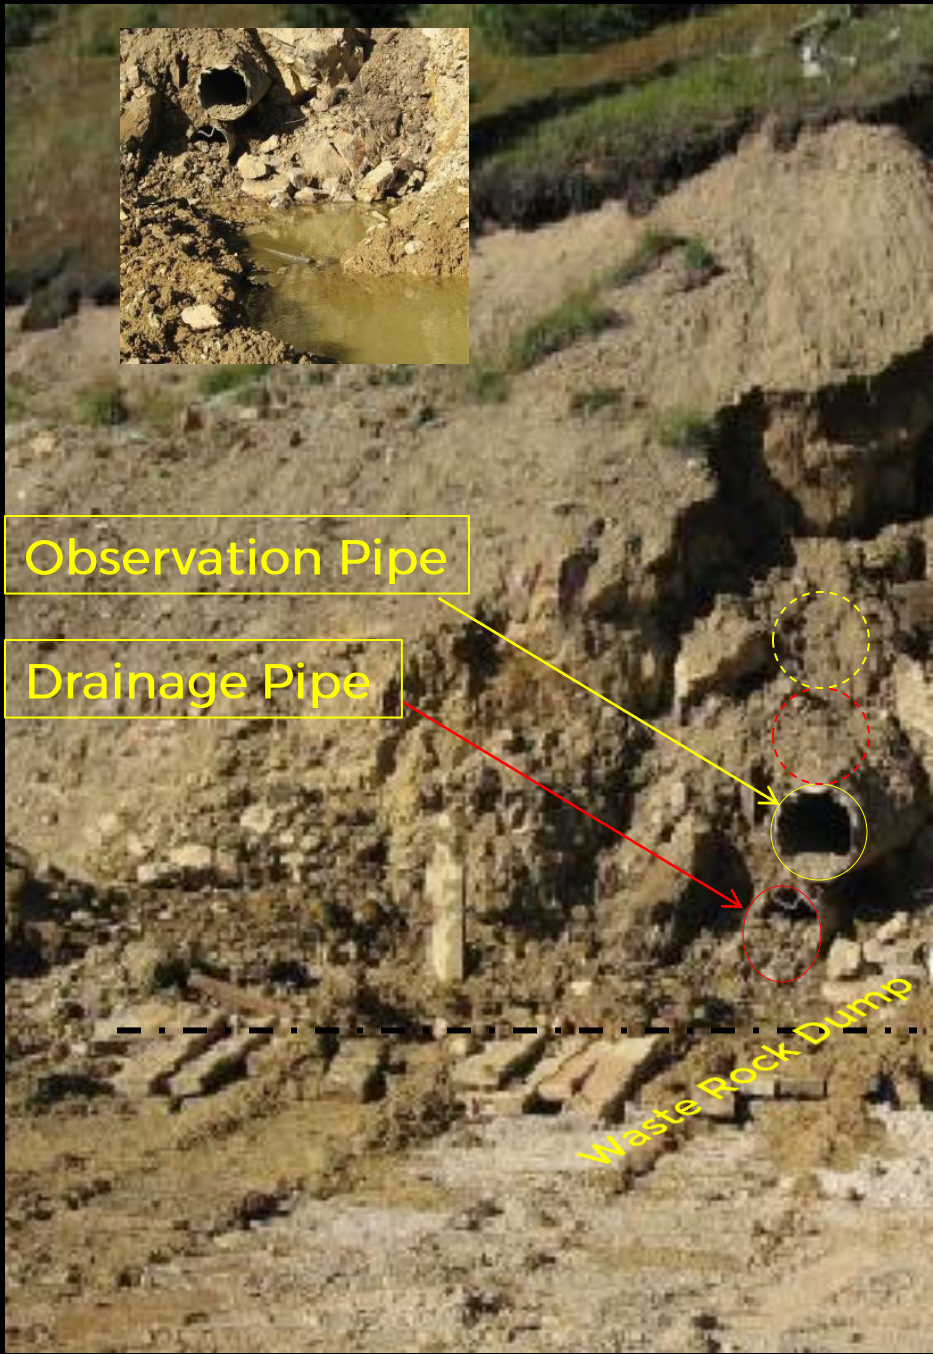
The DOI *Technical Review* is nonsensical. It avoided EPA’s assertion that the adit floor was lower than the waste rock dump. Instead, DOI repeatedly produced figures that showed the adit floor and waste rock dump at a similar elevation (see figures on A12 and A13 for example).

However, DOI also incorporated EPA’s assertion that the observation pipe abutted the roof of the portal structure, and that the drainage pipe was immediately beneath it.¹ For both of these assertions to be true, the drainage pipe would have to be elevated noticeably above the waste rock dump. This is not the case (see left). The dashed circles show the approximated locations of the 24” pipes, abutting an eight foot portal structure roof with a floor approximately level with the waste rock dump.² DOI explained that the water from the drainage pipe pooled because the excavation had a lip (inset).³ However, to make that scenario plausible water draining from the pipe would have required a huge “lip” that was almost level with the bottom of depicted drainage pipe elevation.

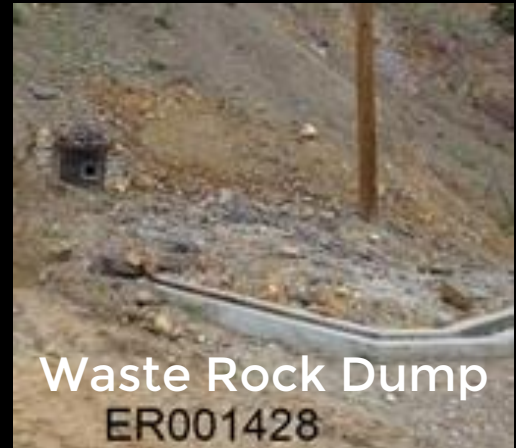
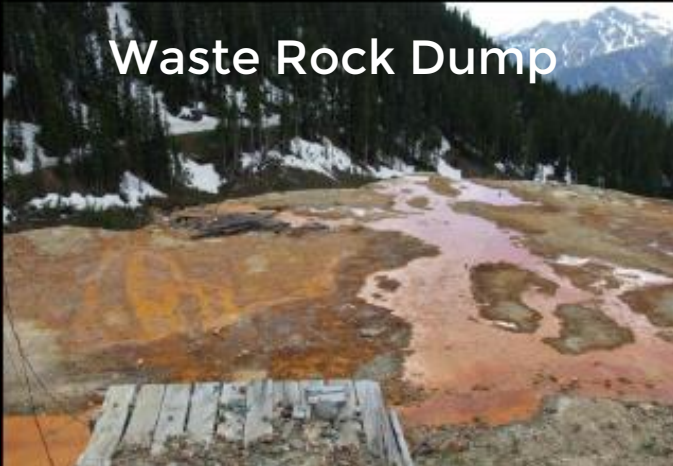
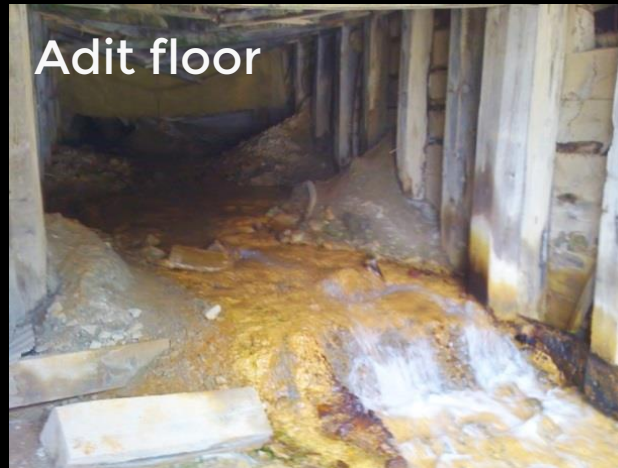
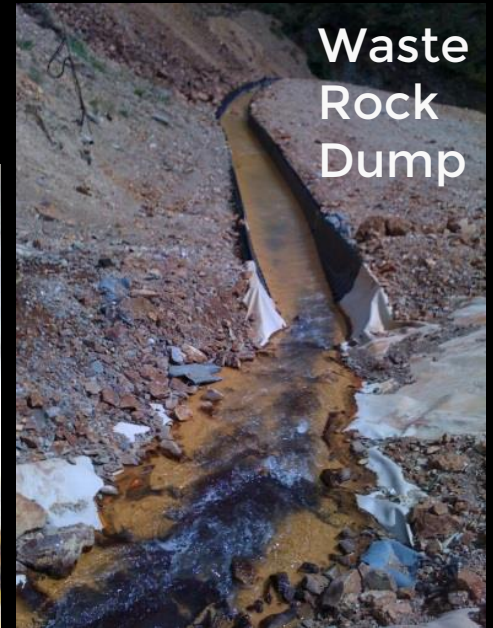
EPA incorrectly asserted that the adit floor was 6 feet lower than the waste rock dump in its *Internal Review* and its 2014 Report, which would be contrary to the drainage purpose of the adit. Discharges from the adit are seen seeping over the waste dump in 2009 (below left).¹ If the adit floor had been six feet lower in elevation at the time, the adit already would have contained six feet of impounded water.

According to a photo provided by the mine owner, mine water (below center) was flowing from the adit in September 2009.² The same month, DRMS installed drainage and observation pipes and a concrete channel. Another photo reportedly taken at the same time, shows water routed into a channel to keep it from flowing from the adit onto the waste rock dump.³ When EPA arrived to conduct work in 2014 it found the concrete channel (right).⁴ The channel was not buried six feet beneath the surface of the waste dump.

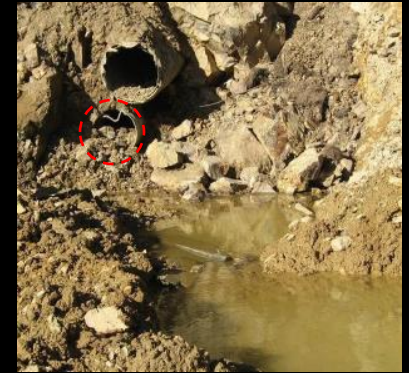
While EPA dropped the claim that the adit floor was six feet beneath the waste rock dump in its *Addendum*, its 2014 report and its *Internal Review* asserted that work stopped at the mine in 2014 based on the pooling water observed by EPA(right).¹

The *Internal Review* also asserted that “The hill above the adit was inspected . . . it was reported that there were no seeps. . .” This assertion also was included in DOI’s *Technical Evaluation*.² The only seepage mentioned as being observed during the 2014 work in either of EPA’s 2014 report or its *Internal Review* is the pool at left.

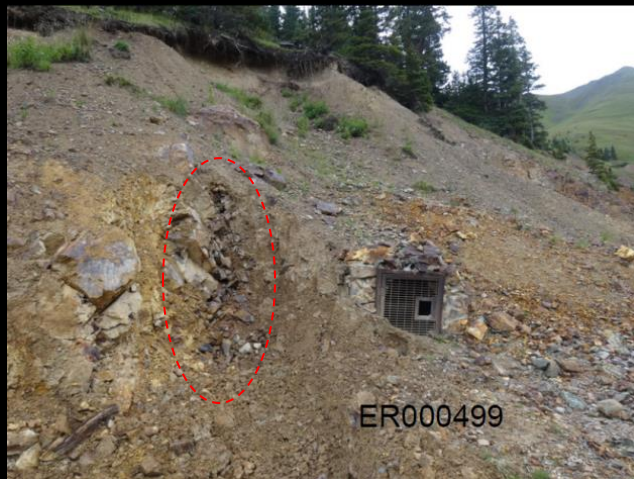
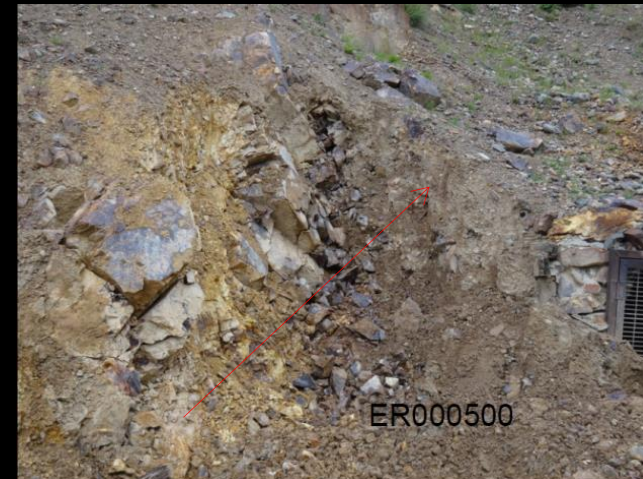
Photos of EPA work in 2014 may show that EPA unearthed seepage higher than the observation pipe (below left covered by grate).³ Striations from digging are visible (below right).³ Visible seepage at this level would not support the assertion in EPA’s 2014 Report and in its *Internal Review* that the water level was believed to be below the level the drainage pipe (photo at right shows drainage pipe below observation pipe.)⁴

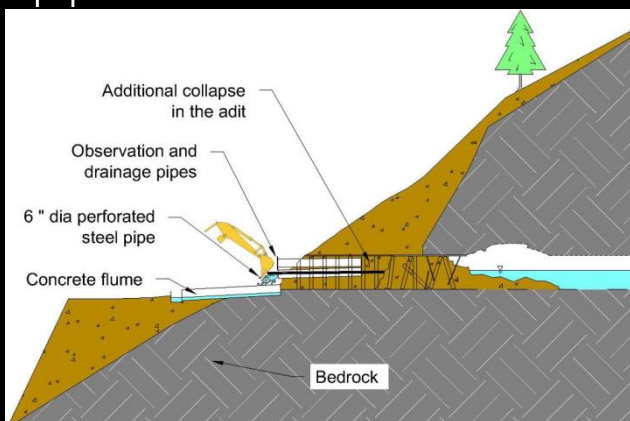
In the below left image, DOI shows the bottom drainage pipe discharging directly to the concrete flume.³ This also is incorrect. There was a pipe between the concrete flume and the discharge pipe.

DOI *Technical Evaluation* depicts stinger installation.

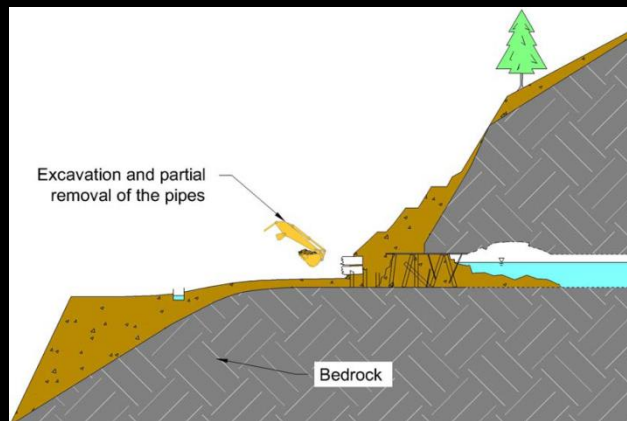
The stinger is gone in the next image, but the *Technical Evaluation* does not mention its removal.
