Appendices

What Was EPA Doing When the Blowout Began?

Claims of Digging High

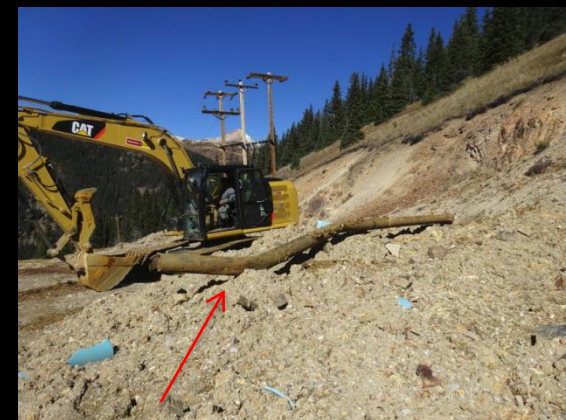
A stinger is a perforated pipe with an enclosed end that can be inserted through solid material to drain liquid. DRMS reportedly installed a stinger in 2009, and stated: “[t]he installed 6 inch perforated steel pipe penetrated approximately 12 feet of collapsed material thought to exist between the original collapse and the end of the drainage pipe. The well point was unable to penetrate through any of the original existing collapse in the tunnel. . . .”¹ The *Technical Review* includes DRMS’s Report on its 2009 work at the mine including installation of the stinger. However, it never mentions the stinger’s partial removal.² EPA’s own *Internal Review* and its 2014 Report also do not mention the partial removal or prior insertion of the stinger. Given DOI’s misrepresentation of the proximity of end of the drainage pipe to the adit opening, DOI also misrepresented the stinger’s position. Having extended at least 12 feet beyond the drainage pipe (or more), the stinger was closer to and may have even penetrated the adit entrance.

Part of stinger removed by EPA in 2014.

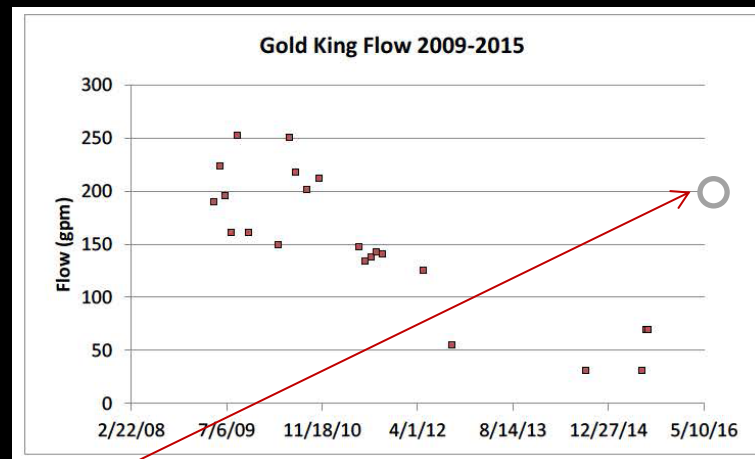
EPA’s *Internal Review* charted a steady decline in discharge from the mine. The added point approximately represents the EPA’s OSC’s description of the discharge prior to the blowout on the 5th.²

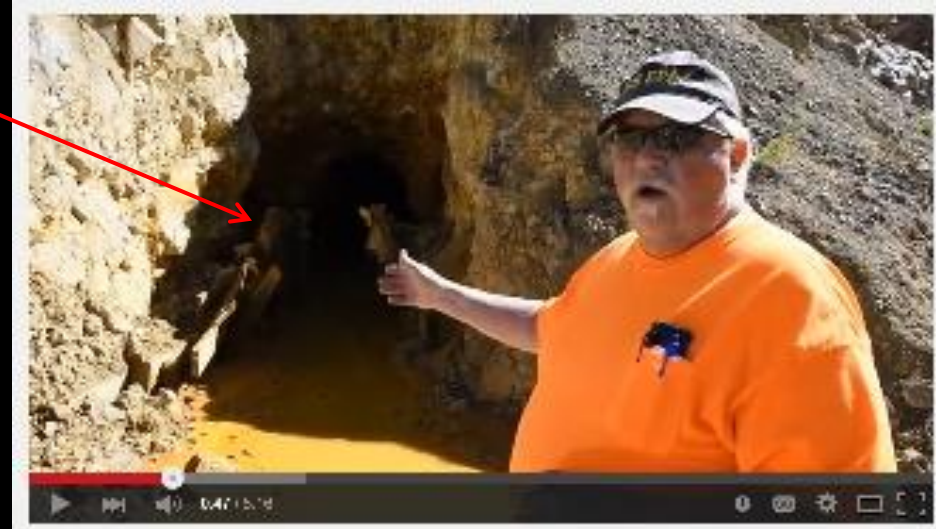
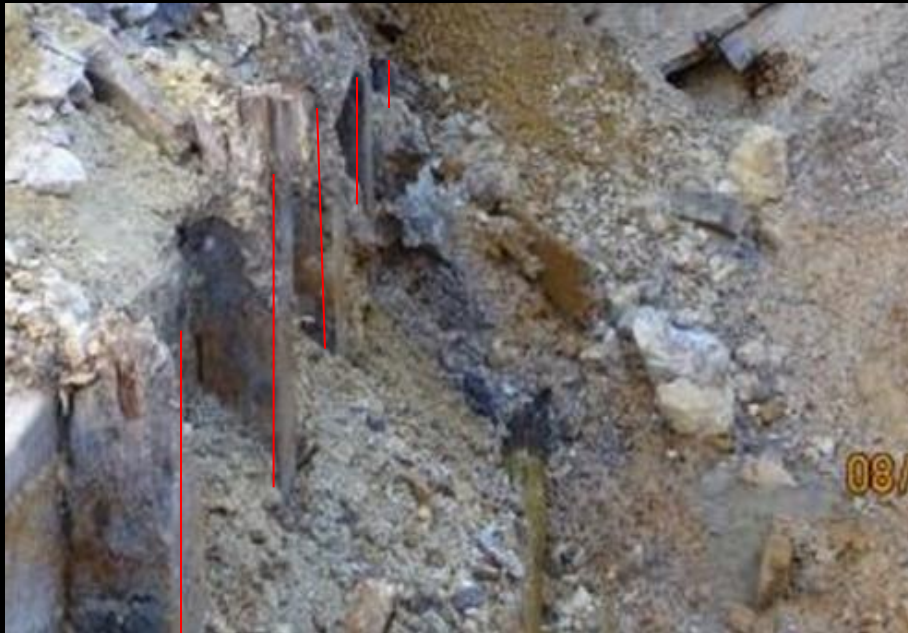
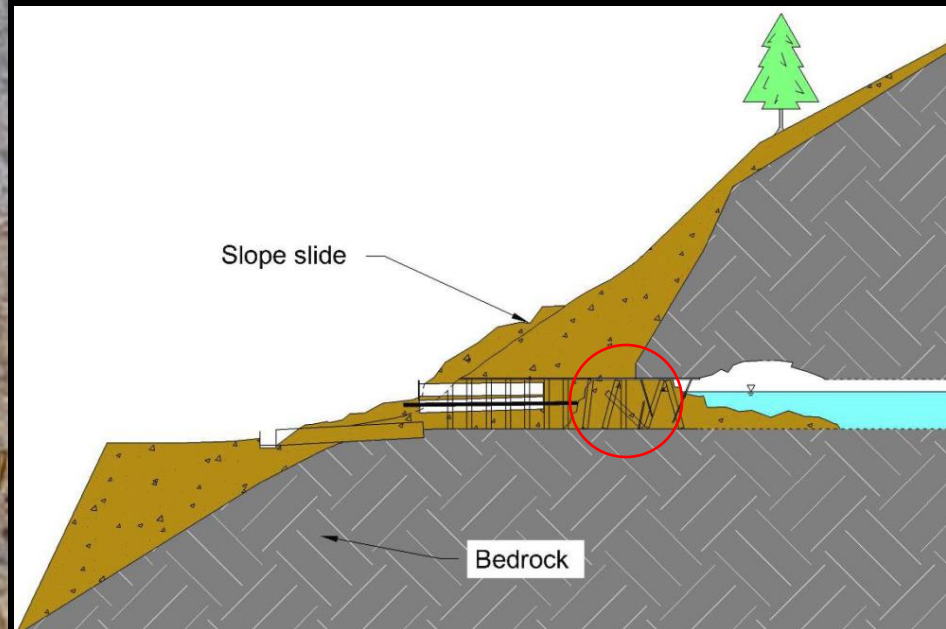
Right: EPA OSC explained the events of August 5 on an EPA video: "So we cleared all that out to about where these posts are (*gestures to timbers at adit portal*). You see they're leaning in, they were straight up then."¹

Lower right: DOI's *Technical Evaluation* consistently depicted the vertical timbers in the sets nearest the adit opening as collapsing.²

Below: Upright timbers are revealed as the excavation approached the adit portal.³

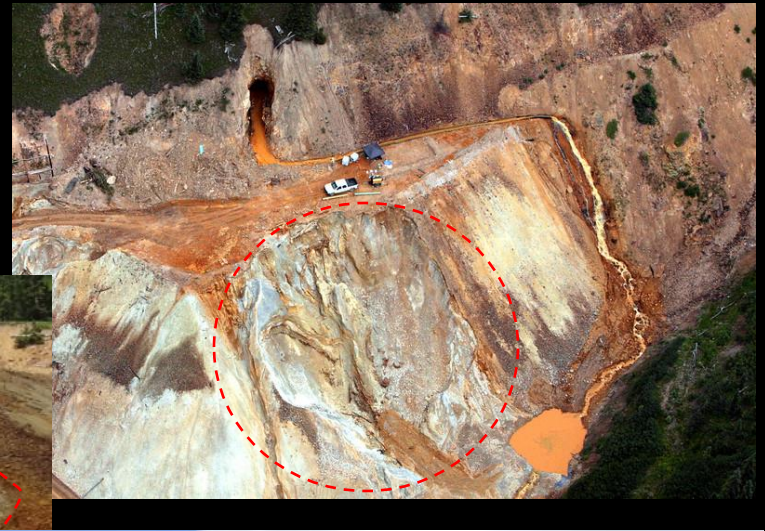
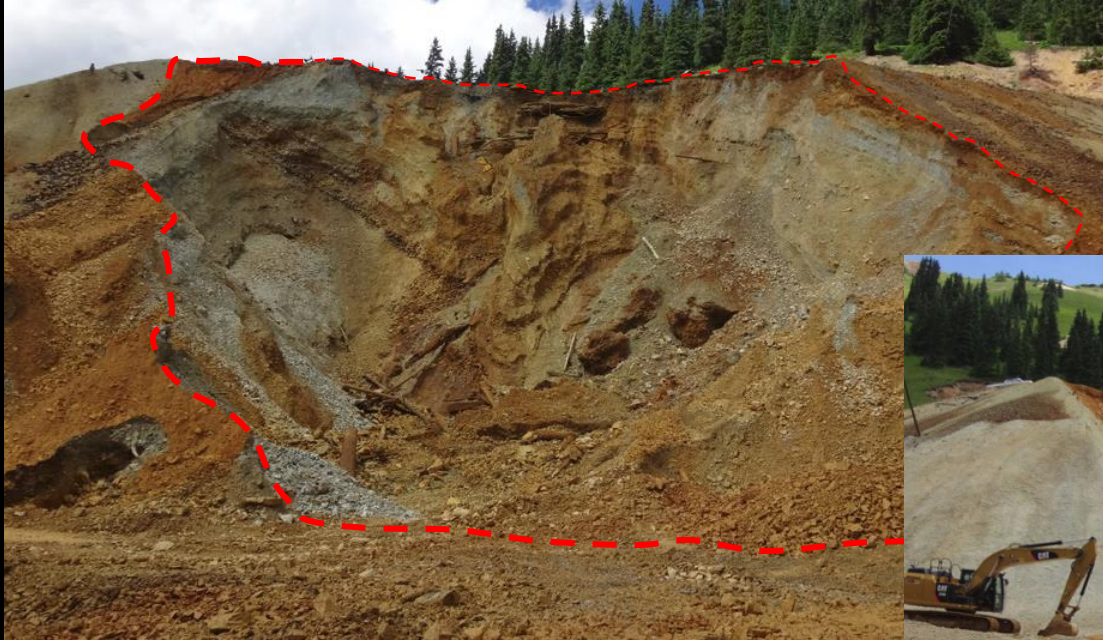
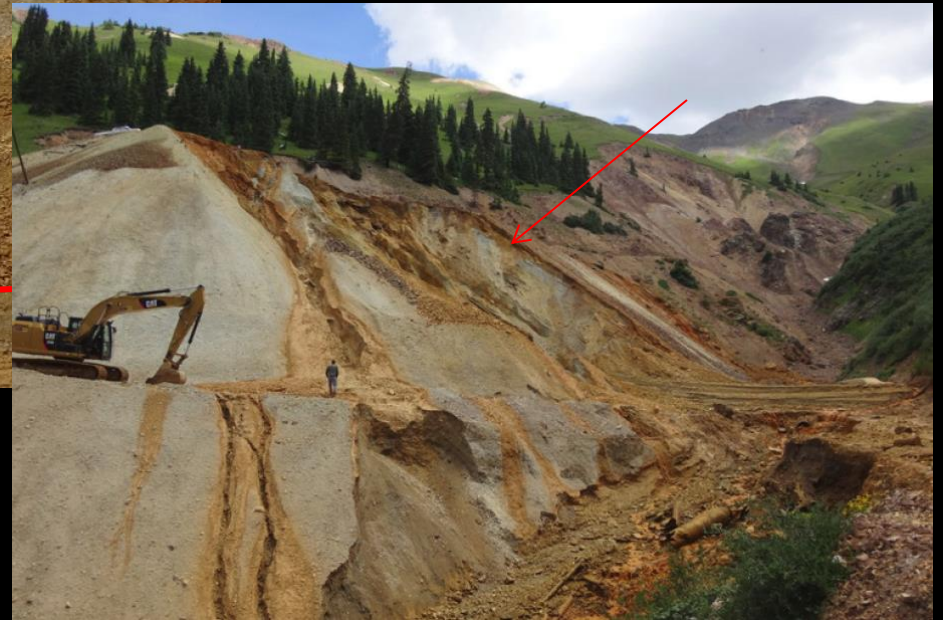
When three million gallons of contaminated water blew out of the mine, it washed away a mountainside of mine waste.¹

DOI's *Technical Review* has no discussion of the pollution from a waste pile that a DRMS official advised Committee Investigators was referred to as "hot."² By rough estimate between 4,000 and 7,000 cubic yards may have been washed out and carried into the watershed.
