Metallurgical & Corrosion Testing, Failure Analysis and Consulting

Report No. 0091-10-19492R
Examination of Three Failed Inconel 718 Studs

March 1, 2010

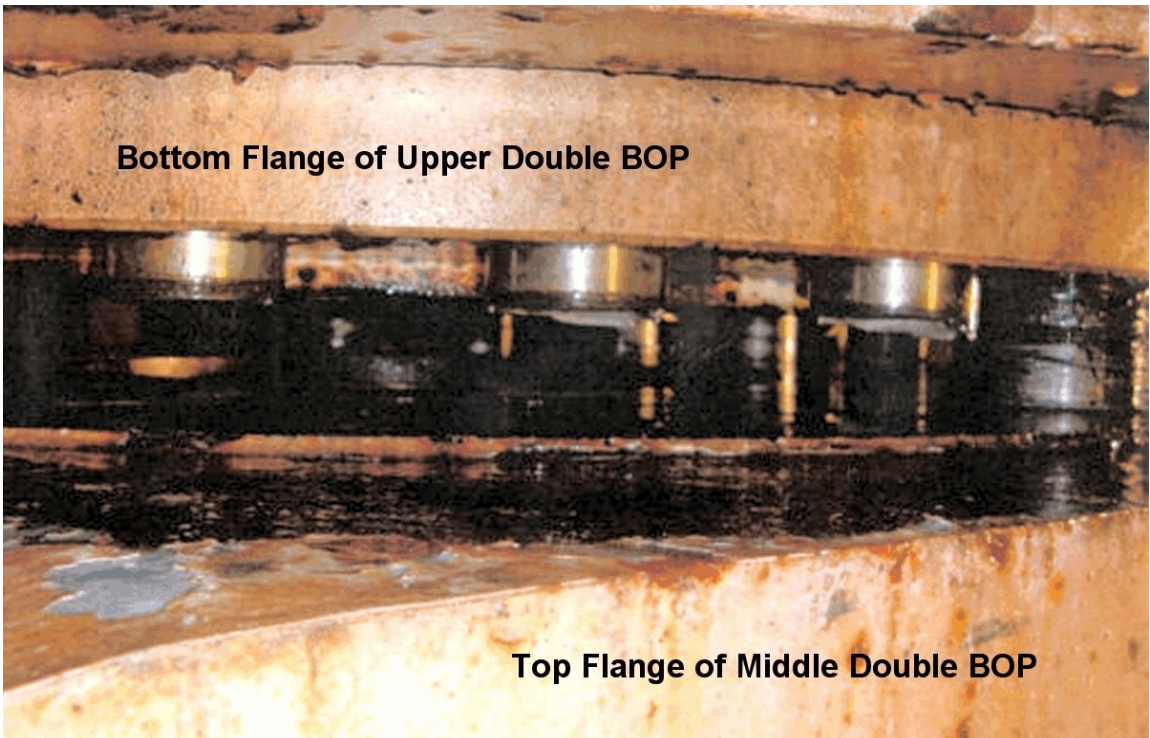
Figure 1 is a view of fractured studs shortly after the failure. Figure 2 is a view of studs with stripped threads shortly after the failure. Figure 3 shows a view of the nuts on the ends of the studs on the top side of the bottom flange of the upper double BOP, before they were cut to remove the failed studs. Figure 4 shows the

View of fractured studs shortly after the failure.

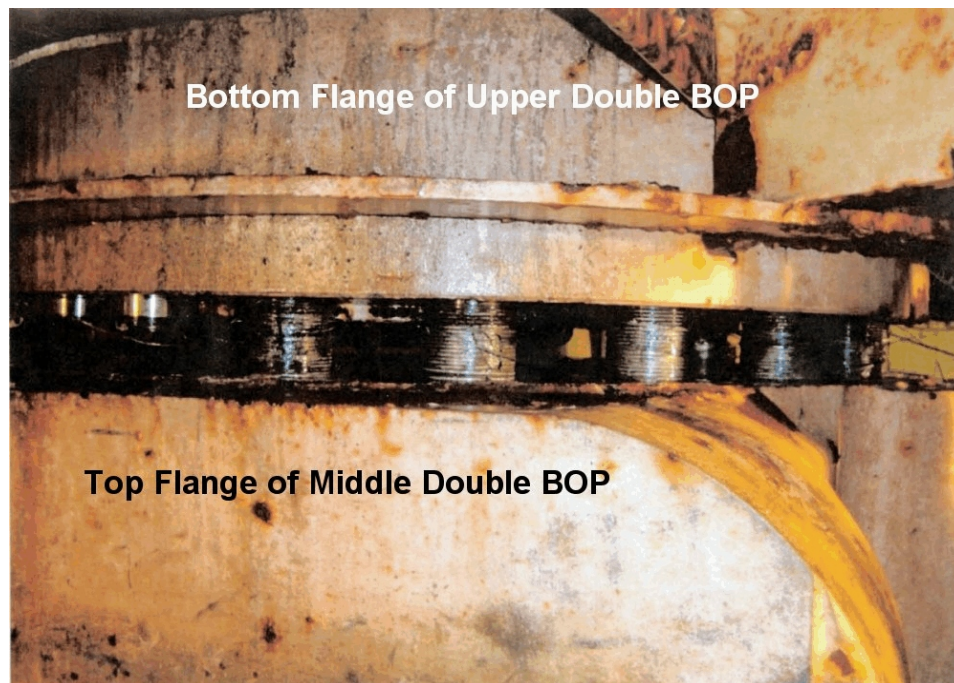
Figure 2

View of studs with stripped threads shortly after the failure.

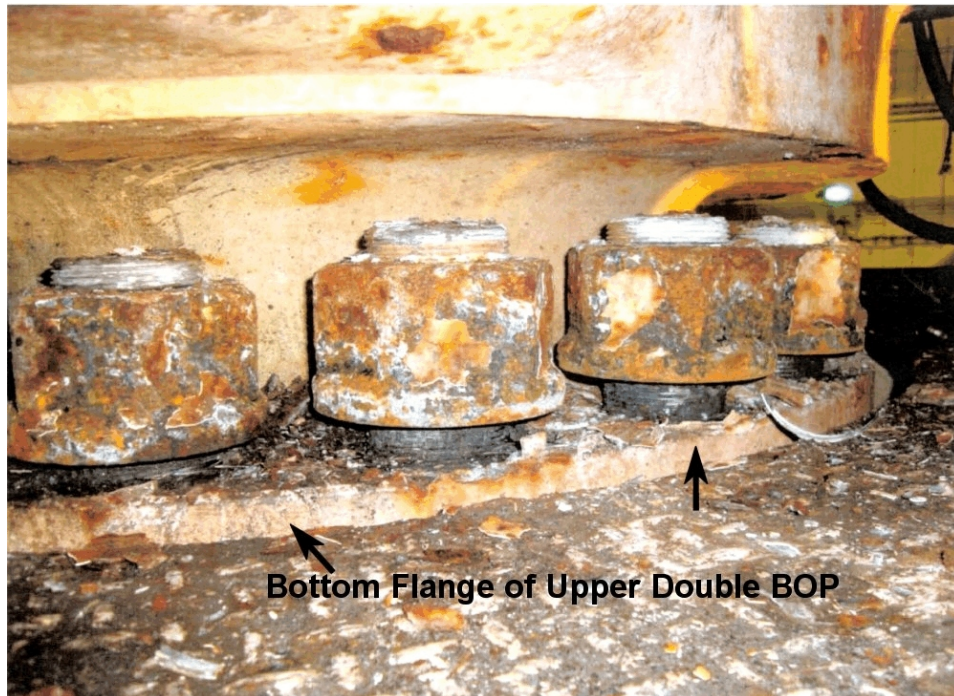
Figure 3

View of the nuts on the top ends of the studs on the top side of the bottom flange of the upper double BOP, before they were cut to remove the failed studs.

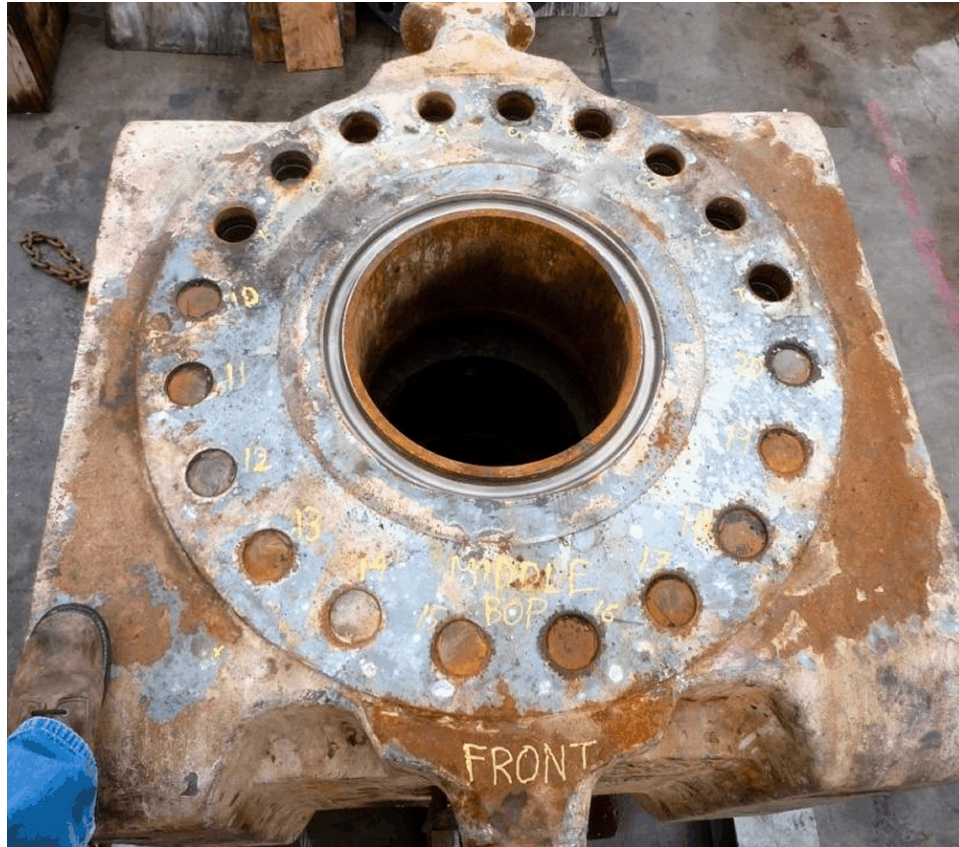
Figure 4

upper surface of the top flange of the middle BOP, after disassembly of the BOP and before the pieces of the failed studs had been removed. Figure 5 shows the nine studs that pulled out of the threaded holes in the top flange of the middle BOP, with the stripped threads still attached.

View of the top flange of the middle BOP showing the ends of fractured Studs 10 through 20, before removal.

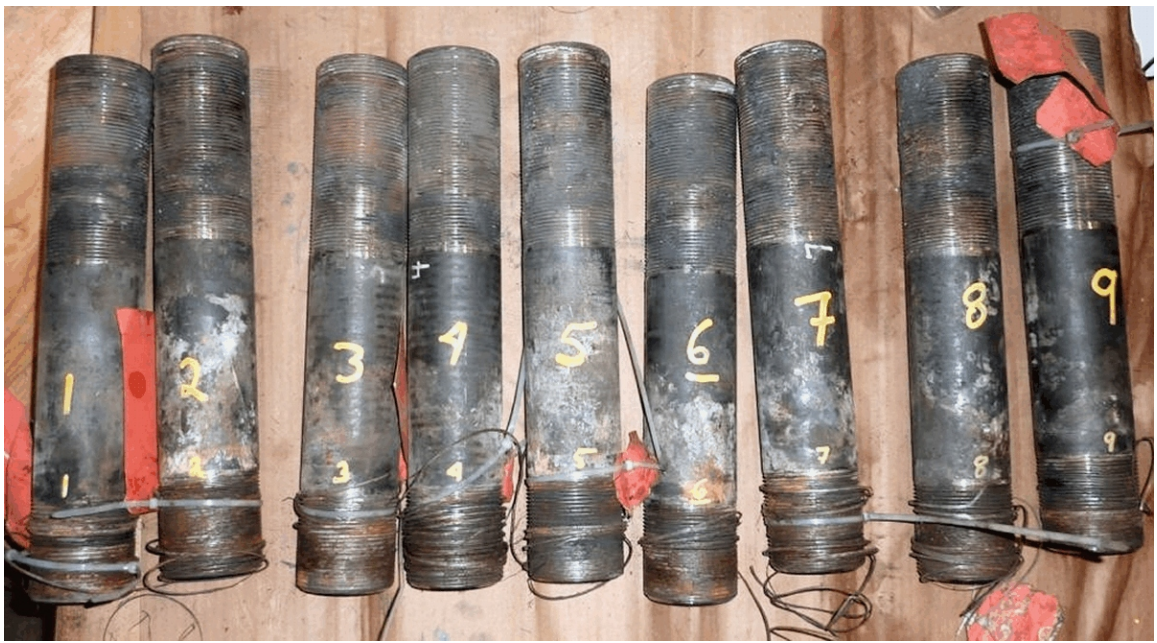
Figure 5

View of the nine studs that pulled out of the top flange of the middle BOP, stripping the female threads.

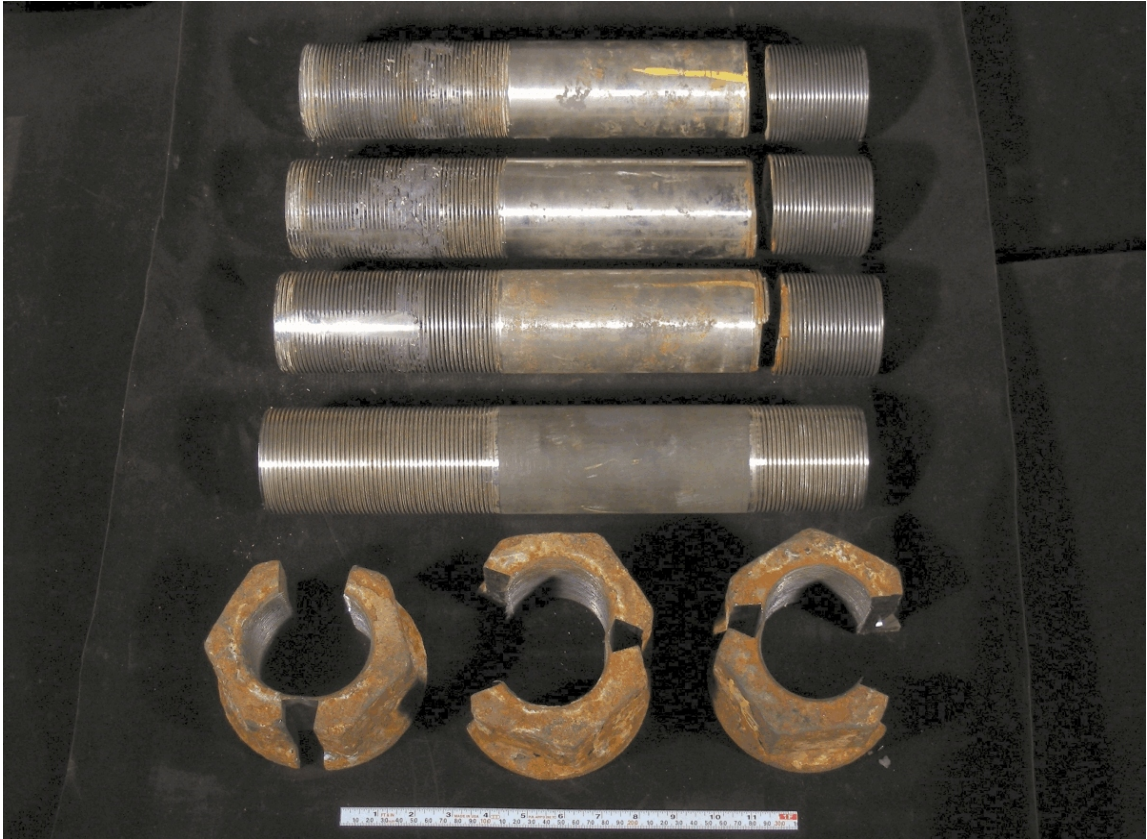
Figure 6 is a view of failed Studs 14, 15 and 16, as received, along with the new stud and the nuts that had to be cut in order to remove the longer stud sections from the bottom flange of the upper BOP.

View of failed Studs 14, 15 and 16, three nuts and a new stud, as received.

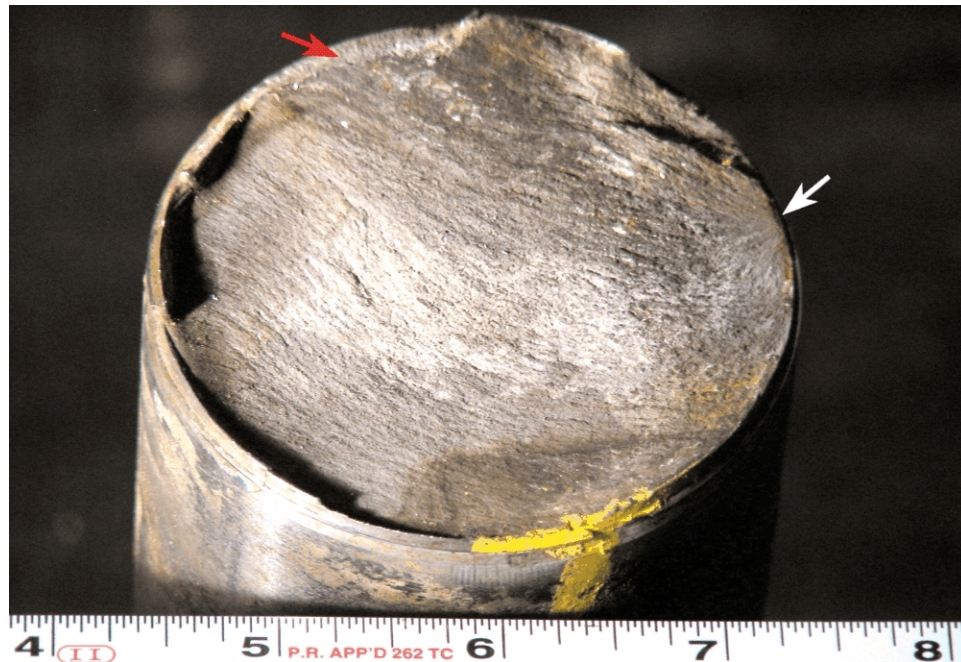
Figure 7

Figures 7 and 8 are views of the fracture surfaces on Stud 14. The red arrows indicate the location of the cracked threads shown later in Figure 11. Figures 9 and 10 are views of the fracture surfaces on Studs 15 and 16, respectively. The white arrows in Figures 7, 9 and 10 indicate the locations of the apparent fracture origins. Figure 11 is a view of cracked threads at the location indicated in Figures 7 and 8. The arrow indicates the location where a metallographic specimen was subsequently taken.

Even though the fractures were relatively flat and perpendicular to the longitudinal axis of the studs, which are characteristics of fatigue crack surfaces, none of the fracture surfaces on the three failed studs exhibited any of the other features typical of fatigue crack surfaces, such as ratchet marks around the edges or concentric progression marks across the surface.

View of the upper fracture surface on Stud 14. The white arrow indicates the apparent fracture origin location. The red arrow indicates the location of the cracked threads shown in Figure 11.

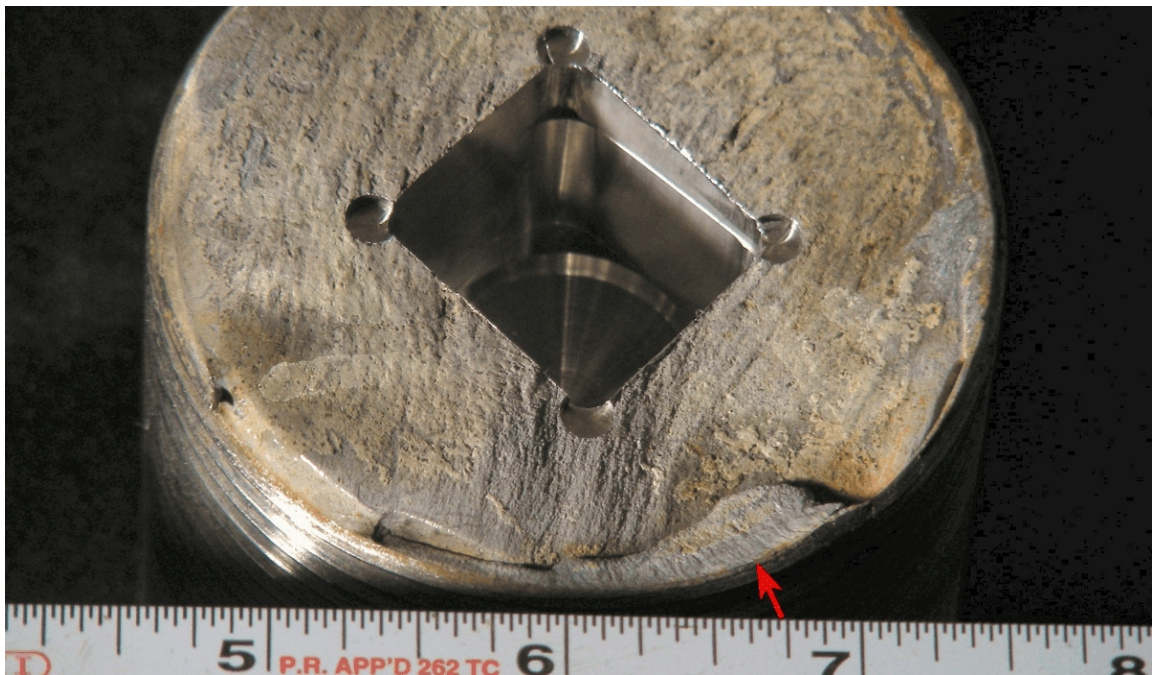
Figure 8

View of the lower fracture surface on the short section of Stud 14. The red arrow indicates the location of the cracked threads shown in Figure 11. The square hole was made to extract the stud section from the top flange of the middle BOP.

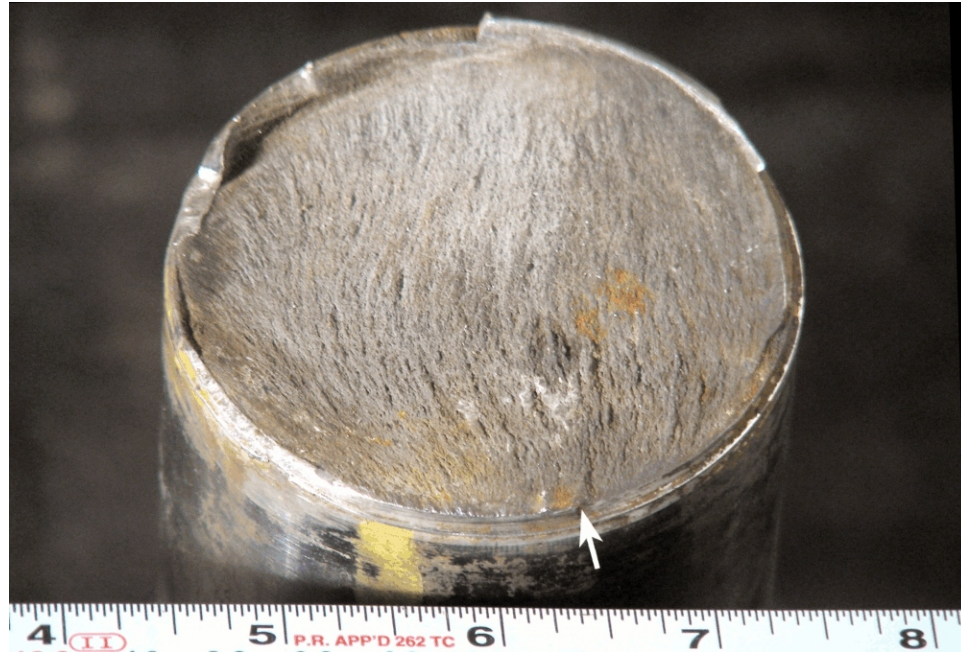
Figure 9

View of the upper fracture surface on Stud 15. The white arrow indicates the apparent fracture origin location.

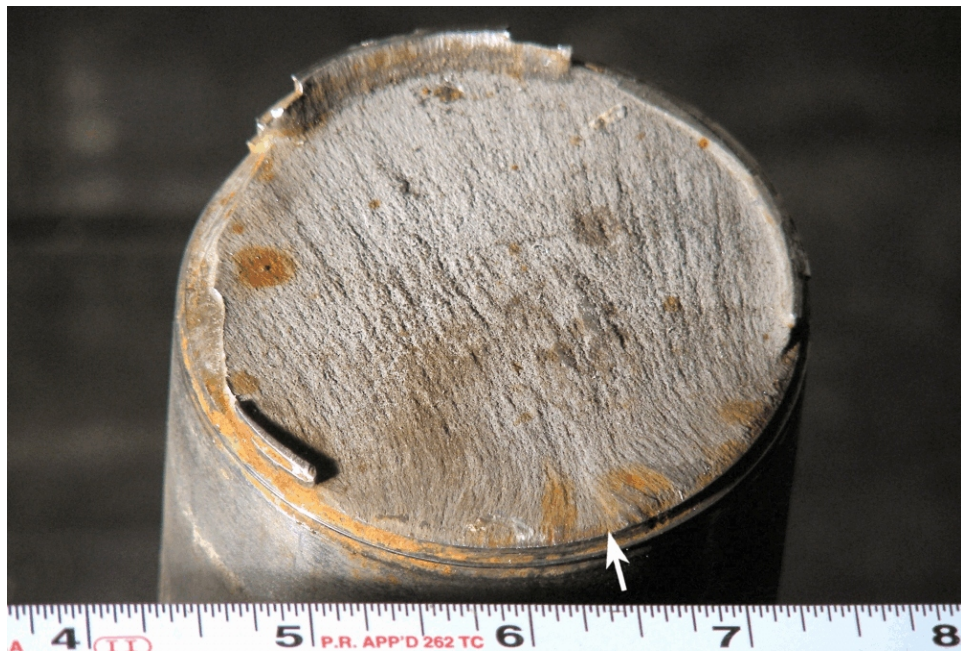
Figure 10

View of the upper fracture surface on Stud 16. The white arrow indicates the apparent fracture origin location.

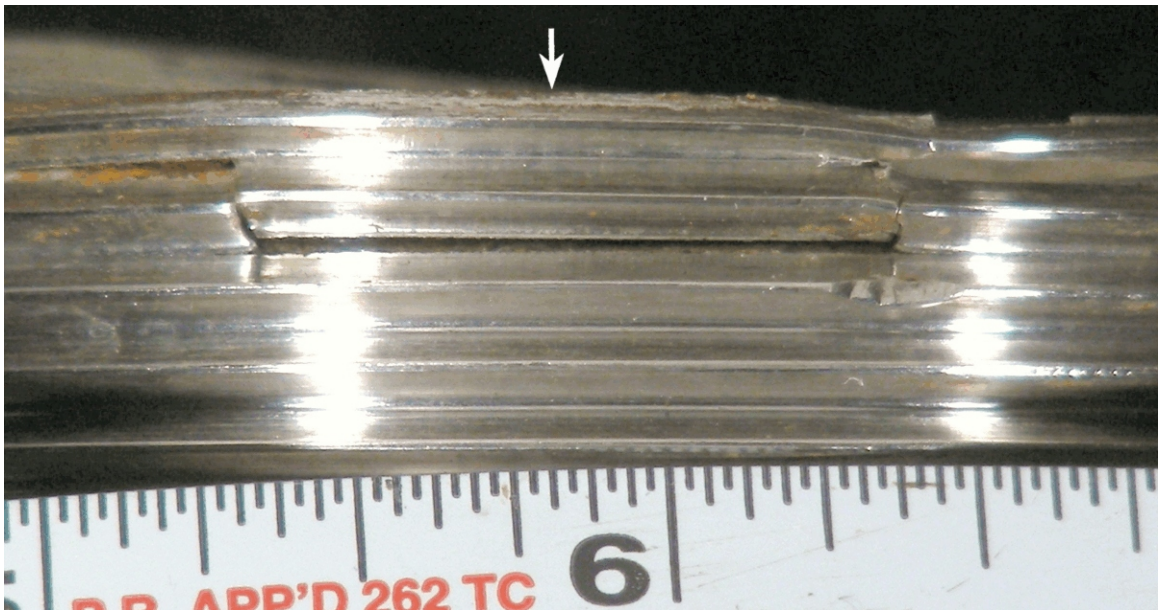
Figure 11

The threads on the short sections of the failed studs were checked with a thread gauge just beyond the fracture surfaces. No evidence of stretching was found, except at the location shown in Figure 11.

View of cracked threads on Stud 14, at the location indicated in Figures 7 and 8. The arrow indicates the location where a metallographic specimen was subsequently taken.

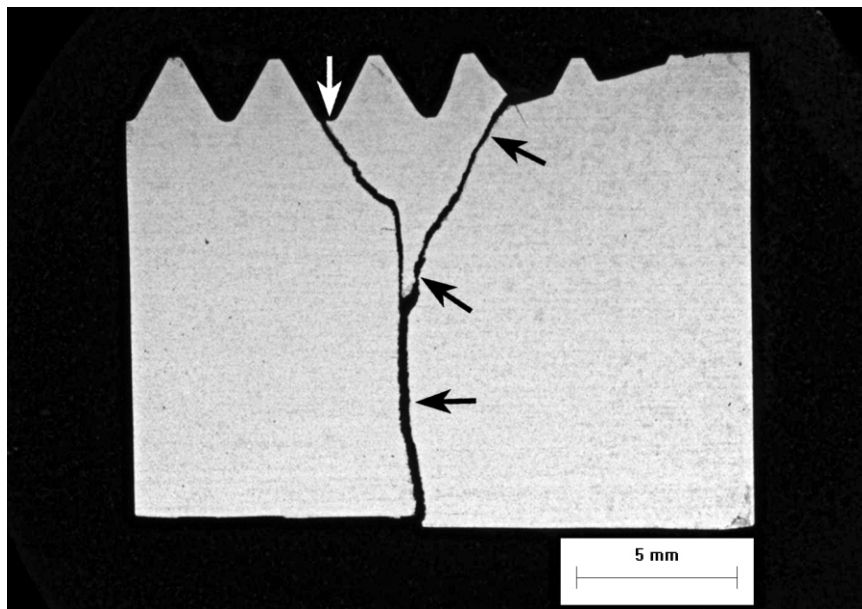
Figure 12 Kalling's No. 2 Etch Approx. 4X

A metallographic specimen was taken across the cracked threads shown in Figure 11, at the location indicated by the arrow. Figure 12 is a photomicrograph of the section of the cracked threads, with arrows indicating the cracked thread and the fracture surface, shown in Figures 7 and 8. Figure 13 is a photomicrograph showing the cracked threads at a higher magnification. Arrows indicate the locations of smaller cracks.

Photomicrograph of the section of the cracked threads shown in Figure 11. A section of the fracture surfaces shown in Figures 7 and 8, is indicated by the black arrows. The cracked thread shown in Figure 11, is indicated by a white arrow.

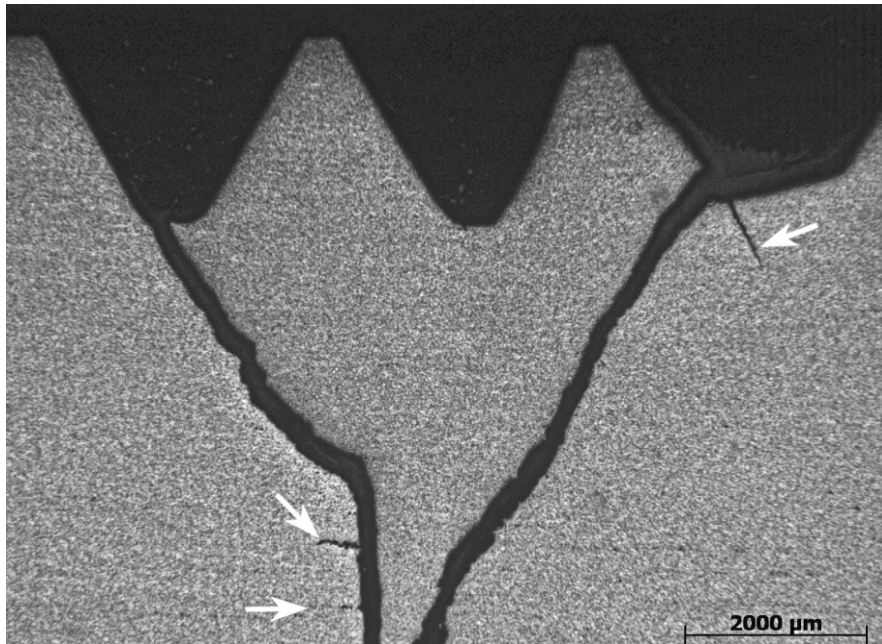
Figure 13 Kalling's No. 2 Etch 12X

Photomicrograph of a higher magnification view of the cracked threads showing small cracks, indicated by arrows.

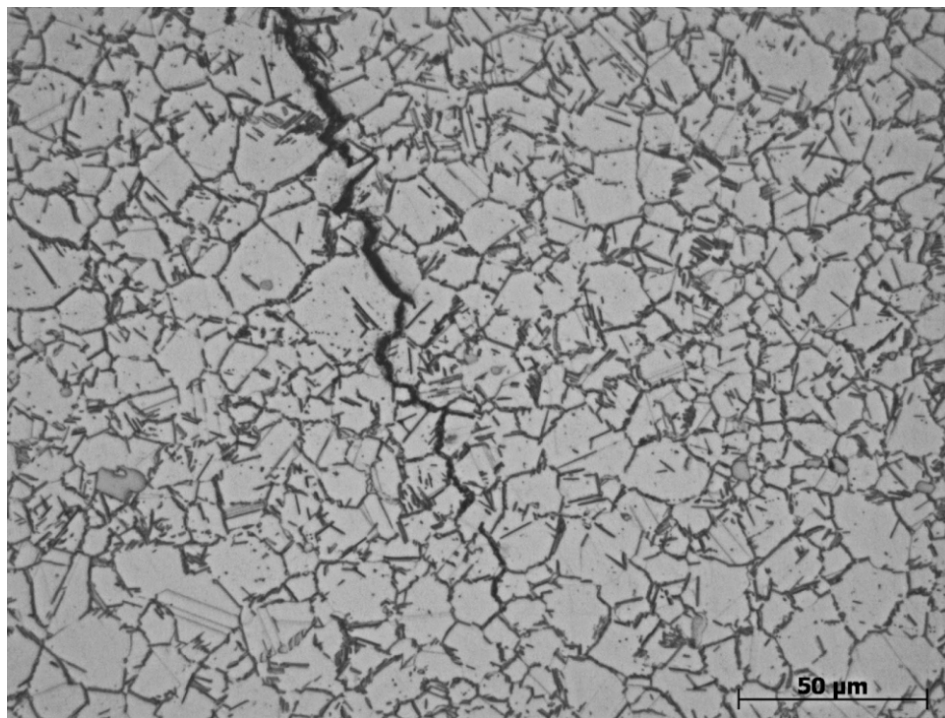
Figure 14 Kalling's No. 2 Etch 500X

Figure 14 is a photomicrograph showing the tip of the upper right hand crack shown in Figure 13. The crack is intergranular with acicular δ -phase present along grain boundaries and intragranular. This morphology is characteristic of cracks in some Inconel 718 after HSC.

Photomicrograph showing the tip of the upper right hand crack shown in Figure 13. Acicular δ -phase is shown along the grain boundaries and at intragranular locations.

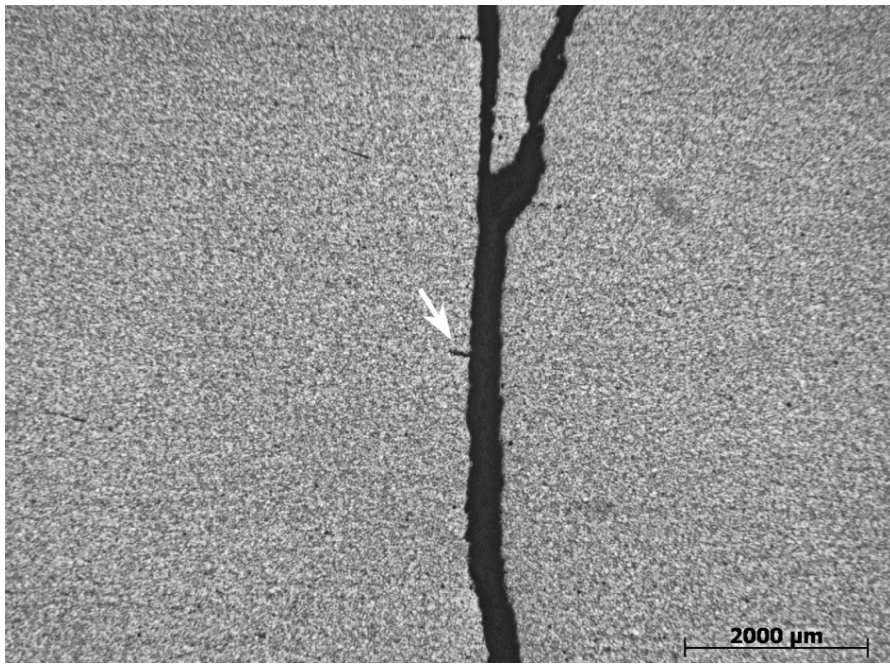
Figure 15 Kalling's No. 2 Etch 12X

Photomicrograph showing a small longitudinal crack, indicated by an arrow, originating at the transverse fracture surface.

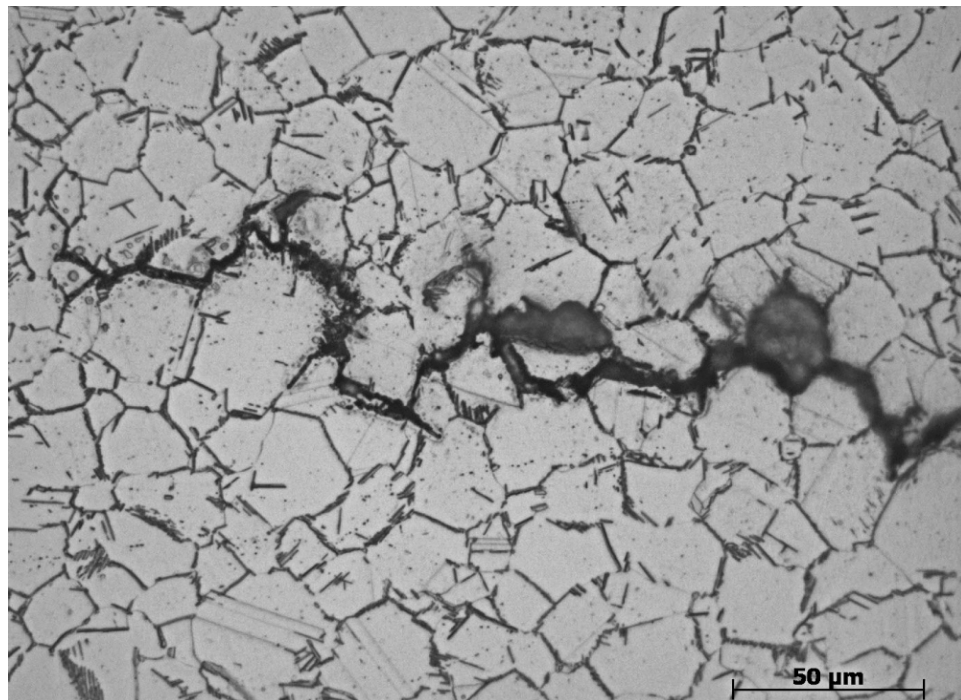
Figure 16 Kalling's No. 2 Etch 500X

Figure 15 is a photomicrograph of another section of the fracture showing a small longitudinal crack. Figure 16 shows the tip of the small crack, which is intergranular with acicular δ -phase present along grain boundaries and intragranular. Again, these features are typical of HSC in Inconel 718.

Photomicrograph showing the tip of the small crack indicated by the arrow in Figure 15. Acicular δ -phase is shown intragranular and along the grain boundaries.

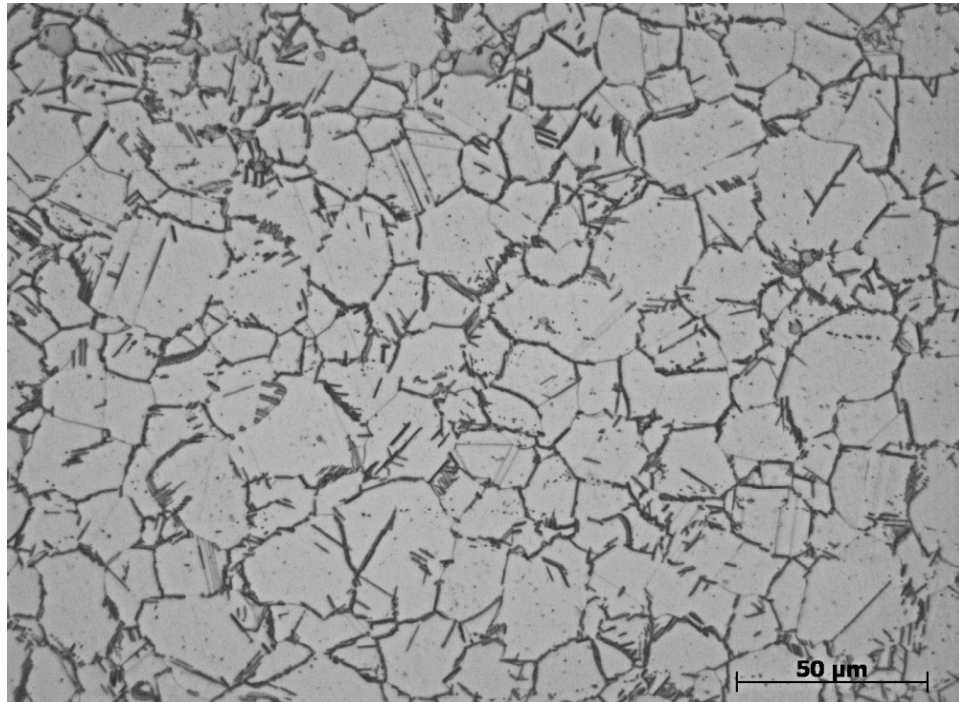
Figure 17 Kalling's No. 2 Etch 500X

Figure 17 is a photomicrograph showing representative microstructure of Stud 14 with acicular δ -phase along the grain boundaries and through grains.

Representative microstructure of Stud 14, showing the presence of acicular δ -phase along the grain boundaries and through grains.
