Investigation of November 20, 2014, Explosion and Fatality Lease OCS-00842, West Delta Block 105 Platform E

Gulf of Mexico Region, New Orleans District
Off Louisiana Coast

October 26, 2016

U.S. Department of the Interior
Bureau of Safety and Environmental Enforcement

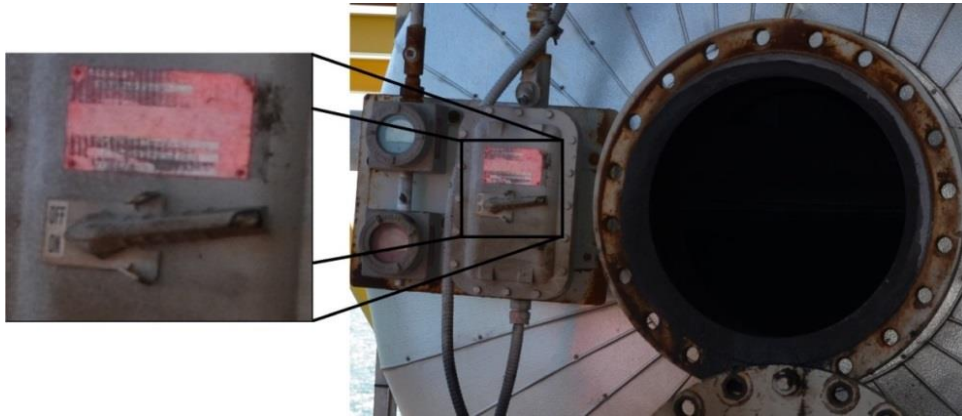
Figure 12 - Open Manway and Transformer Disconnect switch (November 21, 2014)

During the assessment of the heater treater, BSEE Investigators observed that the transformer disconnect switch, mounted directly adjacent to the still-open manway, was in the 'On' position (Figure 12). This switch was systematically located along the electrical circuit travelling from a main transformer breaker in the MCC building to the electrical grid inside the coalescing section of the heater treater.

The BSEE Investigators identified the potential hazard of the disconnect switch in the 'On' position, as it indicated an unrestricted electrical energy pathway at this point within the circuit to the electrical grid. The BSEE Investigators then checked the "TR-5 Feeder 15kVA NBK-600 Heater/Electrostatic Treater" breaker (hereafter identified as the 'heater treater breaker') in the nearby MCC building and also observed it to be in the 'On' position (Figure 13). With the breaker and disconnect switch both 'On,' there was no apparent restriction in the flow of electrical energy from the power source to the heater treater grid. The BSEE Investigators stopped work and directed Fieldwood personnel contact a field electrician to ensure the system was safe and fully isolated.

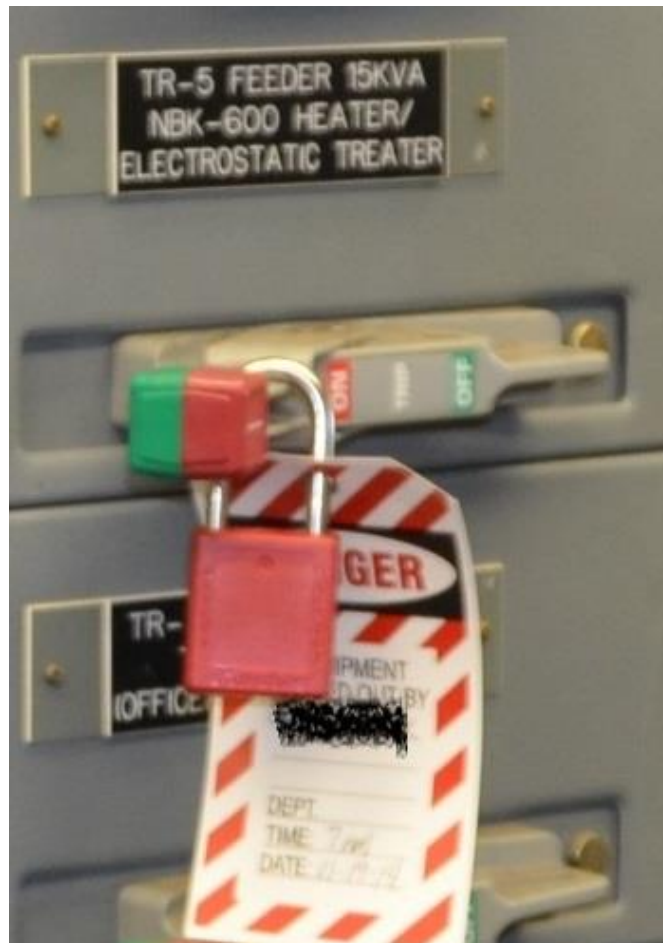
Figure 13 - Heater treater breaker in MCC Building, as observed by BSEE Investigators on November 21, 2014 (Name Redacted by BSEE)

The BSEE Investigators observed the heater treater breaker affixed with a key-type lock that was fed through the breaker handle and clasped,¹⁰ and a tag displaying the Island Acting PIC's name, date and time of when it was installed. The configuration of this breaker handle was such that it could be locked out or tagged out of service if it were turned 'Off' by positioning the handle entirely to the right and aligning it with corresponding holes on the breaker switch, and a lock were fed through the holes and clasped. It then could not be turned 'On' without unlocking and removing the lock.

The BSEE Investigators then brought the Island Acting PIC into the MCC building and asked him to look at the heater treater breaker. He indicated that he had locked the breaker out and demonstrated to the BSEE Investigators that he had the key to the heater treater breaker lock in his pocket. When BSEE Investigators explained that this was not a safe condition, the Island Acting PIC asked if he should move the breaker to the 'Off' position, which he was informed to do by the Fieldwood A-Hitch Field Foreman. The Island Acting PIC then used the same key to unlock the lock, move the breaker to the 'Off' position, and apply the lock and tag to secure the breaker handle in the 'Off' position correctly.

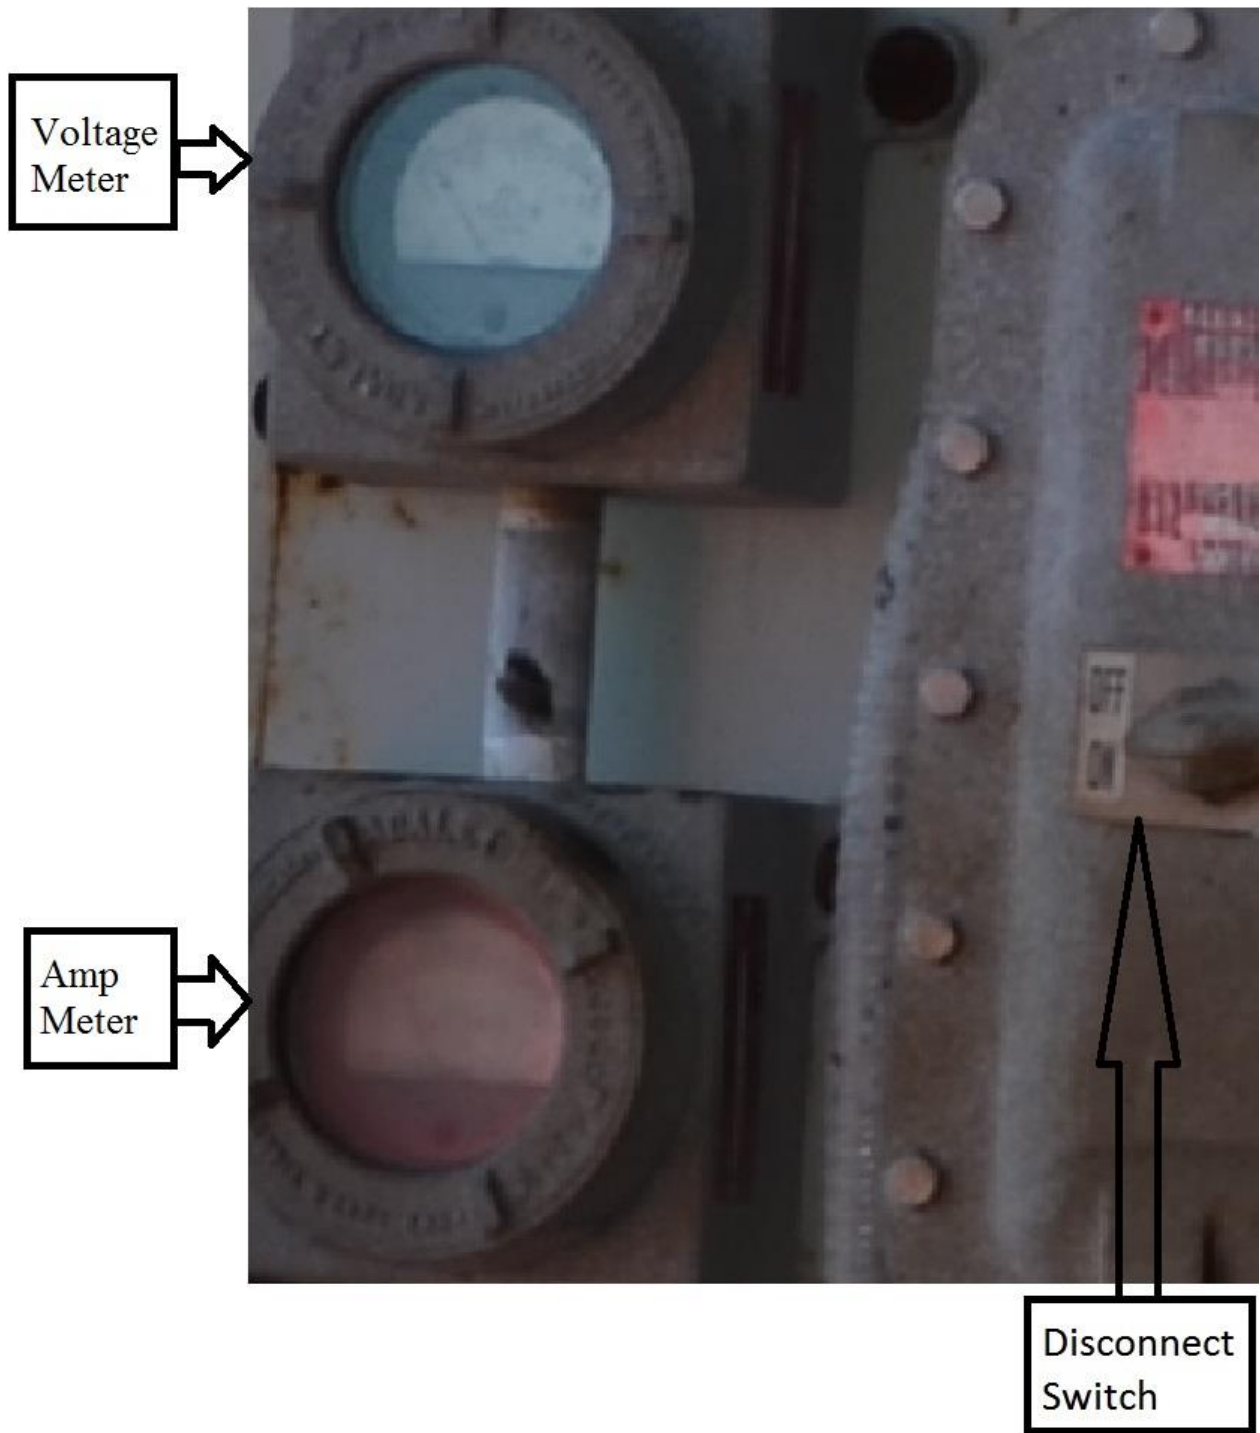
Figure 14 - Disconnect Switch, Volt and Amp Meters Prior to Turning the Heater treater breaker Off (November 21, 2014)

The BSEE Investigators also took photos during the initial onsite investigation on November 21, 2014. In particular, a close-up view of a photo taken of the volt and amp meters located on the heater treater adjacent to the disconnect switch and manway before the heater treater breaker was turned 'Off' (Figure 14), appeared to show the volt and amp meter readings¹¹ greater than the readings observed on those meters after the heater treater breaker had been turned 'Off' (Figure 15). This indicated that electricity appeared to have been present up to that point in the electrical circuit prior to turning off the heater treater breaker on November 21, 2014.

¹¹ This volt and amp output also appeared similar to those taken during post-incident investigation testing when third-party experts turned the heater treater breaker 'On,' which is discussed later in this report.

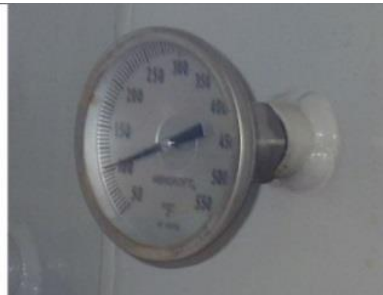
Figure 16 - Temperature Gauge on Transformer (November 21, 2014)

Additionally, hours after the heater breaker was turned 'Off' on the afternoon of November 21, 2014, BSEE Investigators observed the temperature gauge on the transformer at slightly over 100 degrees Fahrenheit (Figure 16), which was higher than the outside temperature,¹² and of the same gauge taken the following day (Figure 17).

¹² The National Oceanic and Atmospheric Administration's National Data Buoy Center identified air temperature at on November 21, 2014 never went above approximately 67.2 degrees Fahrenheit at the nearby Louisiana Offshore Oil Port.

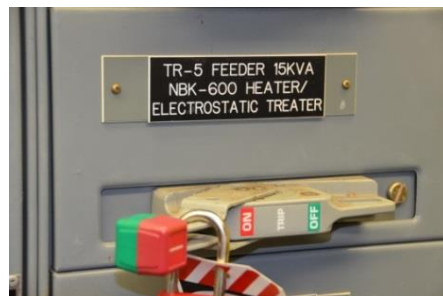
Figure 19 - Heater treater breaker 'On' (November 21, 2014)

The heater treater breaker controlled the electrical power supply to the transformer located on top of the WD 105 E heater treater, which powered the electrical grid inside the coalescing section of the heater treater outside of where Turnkey employees were working at the time of the incident. The heater treater breaker handle was labeled such that it could have been in one of three positions through a horizontal range of motion: On (left), Trip (middle) or Off (right). If the breaker were to be in the 'Off' position, then the circuit of electricity would not have reached the transformer; as also would likely have been true if in the 'Trip' position. However, BSEE Investigators observed the handle in the 'On' position when observed on November 21, 2014.

²¹ When in the 'On' position, the breaker was to the left of the panel wall and with the color Red outward facing (Figure 19).

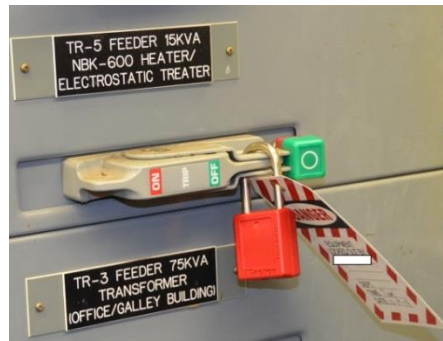
Figure 20 - Heater treater breaker 'Off' (November 21, 2014) (Name Redacted by BSEE)

To properly lock out the heater treater breaker, prior to affixing a lock to the breaker handle, the handle would first be pushed all the way to the right, or 'Off,' position on the panel wall, in which the color Green would be outward facing.²¹ The lock would then be fed through the openings on the breaker handle as well as the breaker panel wall, and then clasped (Figure 20).

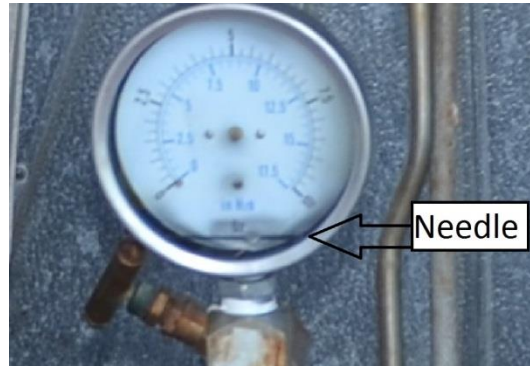
Figure 23 - Main Fuel Gas Gauge (November 21, 2014)

In addition, the pressure gauge associated with the main fuel gas piping was observed as without an attached needle (Figure 23).

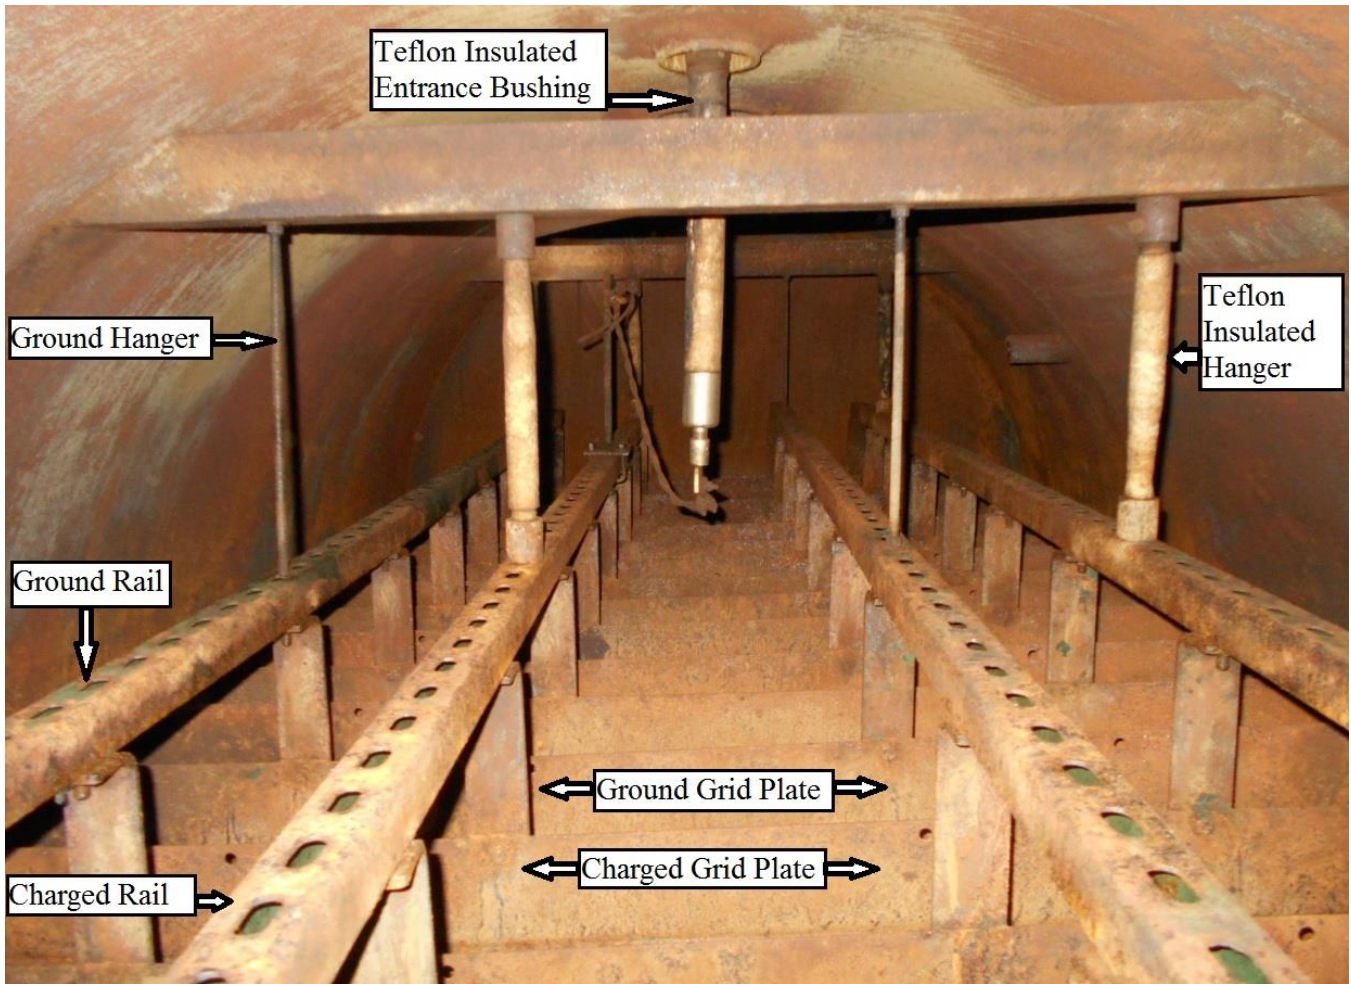
Figure 24 - Internal View of Grid (April 25, 2015)

Upon a post-incident evaluation of the grid in April 2015, a third-party technician identified normal signs of arcing on four of the Teflon insulators, and tracking (a failure mechanism for insulation breakdown) on the entrance bushing and two of the Teflon insulators (Figures 25, 26 and 27). He indicated that the metal grids and hardware were found to be in good condition.

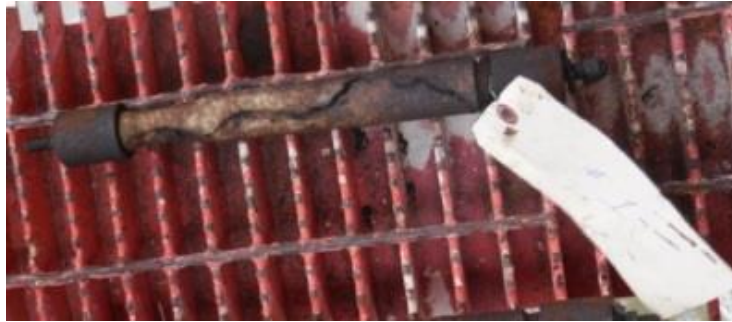
Figure 26 - Insulated Hanger #1 with arcing evident (April 27, 2015)

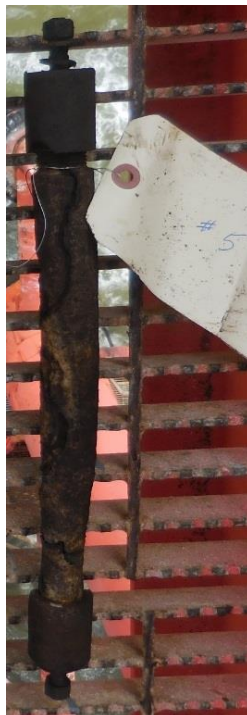
Figure 27 - Insulated Hanger #5 with arcing evident (April 27, 2015)

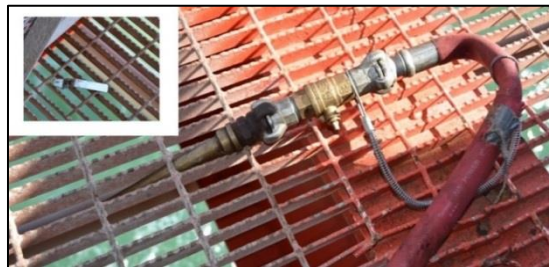
Figure 28 - Hose Nozzle and Handle (November 21, 2014)

The BSEE Panel also evaluated the composition of the water hose, nozzle and connections identified at the incident scene on November 21, 2014. BSEE Investigators noted finding the ball valve in the 'On' position, the handle lying in another location (Figure 28), and the water supply valve closed at its source.

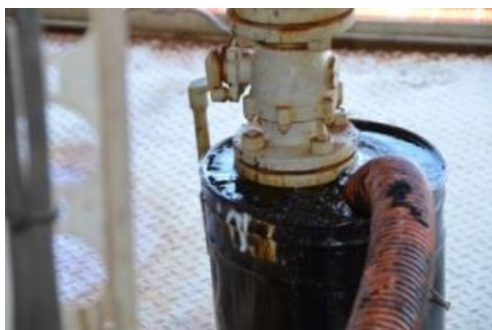
Figure 29 - Vacuum Hose Inside Bucket (November 21, 2014)

Accounts regarding the status of the vacuum pump and location of the vacuum hose in the minutes leading up to the incident differed among the individuals in the vicinity of the heater treater, ranging from witnessing a hose inside the vessel before the incident, to removing the vacuum hose from the manway to the bucket under the heater treater shortly before the incident, to never having seen the vacuum hose enter the vessel. The vacuum hose was found by BSEE Investigators on November 21, 2014, in the bucket under the middle of the heater treater (Figure 29). In this position, it was not believed to have been a potential source of ignition for inside of the heater treater.

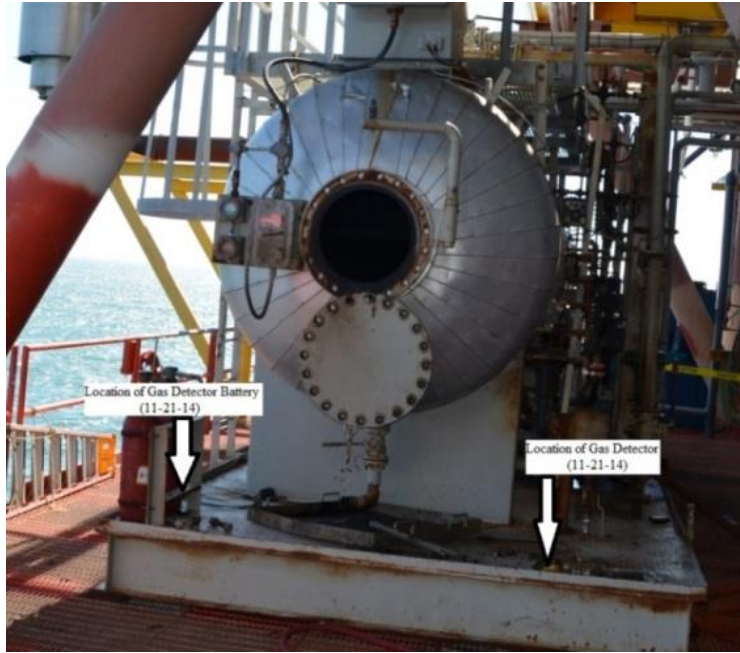
Figure 30 - Gas Detector Unit and Battery Locations (November 21, 2014)

On November 21, 2014, BSEE Investigators discovered a gas detector unit at the incident scene. The unit had been separated from its battery, both of which were located on the heater treater skid, but with the gas detector unit to one side of the hatch and the battery to the other (Figure 30). The BSEE investigators collected the two items and retained them for investigative purposes. Also included in the gas detector unit was a media card, on which data usage would be maintained. The gas detector was leased to Turnkey, with the last reliable calibration date of October 31, 2014.

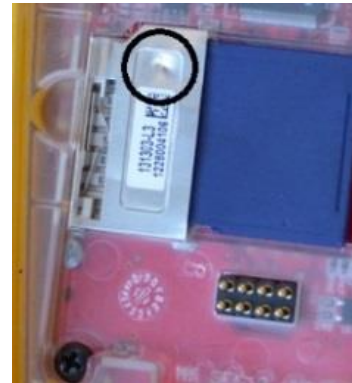
Figure 32 - Impression in Gas Detector's Media Card Holder (November 21, 2014)

The BSEE Panel attempted to retrieve data from the media card through Department of the Interior resources, as well as through the gas detector manufacturer. However, both attempts to recover data were unsuccessful. The manufacturer believed the reason for the inability to read the data was because of extensive damage to the main unit (Figure 31), as well as physical damage to the card believed to be from an impression in the metal socket of the gas detector unit (Figure 32).

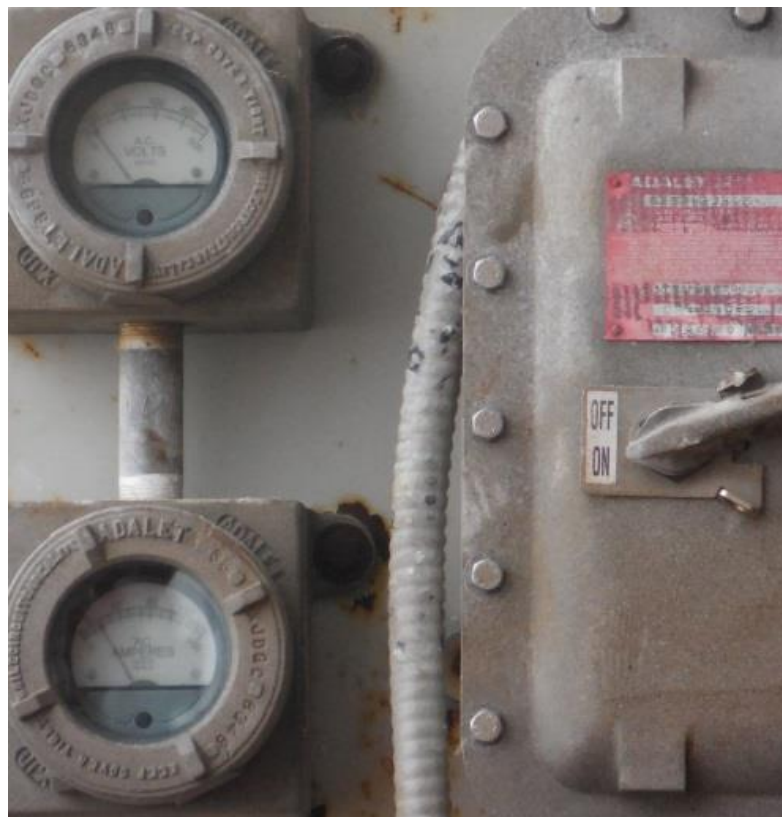
Figure 34 - Volt and Amp Meters When Transformer Energized (April 26, 2015)

The results of these electrical tests on the grid and transformer indicated that it could be expected that the grid inside the heater treater would be energized with approximately 2,000 volts when power to the transformer was turned 'On;' which would occur when both the heater treater breaker and disconnect switch were 'On.'
