**EPA, THE DEPARTMENT OF THE INTERIOR,
AND THE GOLD KING MINE DISASTER**

February 11, 2016
Majority Staff Report
Committee on Natural Resources
Chairman Rob Bishop
U.S. House of Representatives
114th Congress

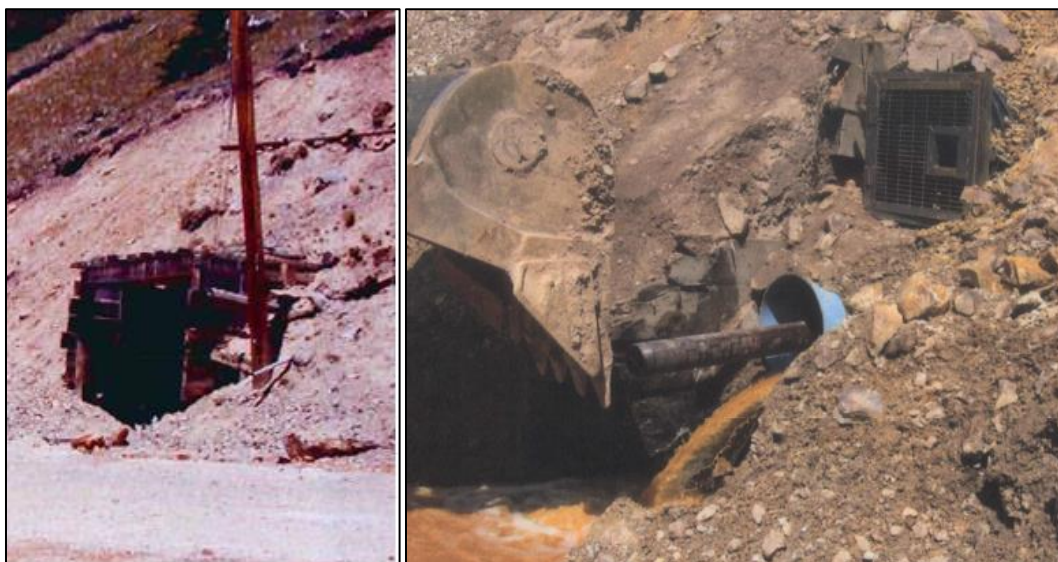
The adit portal (left) prior to DRMS's work in 2009 (right). Source: DRMS.

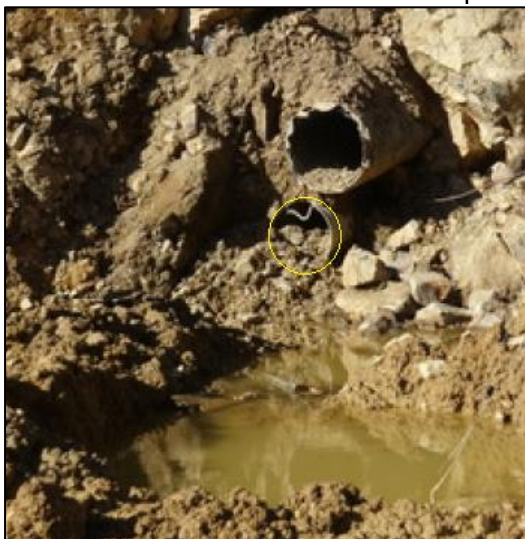
During its brief excavation of the portal in 2014, EPA appears to have misinterpreted the conditions in the adit and incorrectly concluded that the adit floor was six feet below the surface of the waste rock dump. The EPA crew observed “timbers . . . on the sides,” and an EPA contractor reportedly saw “a cap timber.”⁷ Presumably, the EPA crew took into account the adit’s 10 foot maximum height, saw what they assumed were the sides and roof of the portal structure extending about four feet above the waste dump, and concluded that the floor of the adit must have been six feet below the surface of the waste rock dump.⁸ They also assumed that the drainage and observation pipes that DRMS had installed in 2009, which EPA noted were each 24 inches in diameter and were stacked one on top of the other, occupied the top four feet of the

The drainage pipe, highlighted in yellow, is revealed during EPA’s 2014 excavation of the adit. Water is pooling on the waste rock dump surface, just below the drainage pipe. Source: Environmental Restoration.

Having made these unfounded conclusions, EPA then misinterpreted the conditions inside of the adit. The EPA crew observed water pooling near the level of the drainage pipe where it discharged onto the waste dump.⁹ EPA then assumed that the water pooling on the waste rock dump was essentially reaching equilibrium with the impounded water behind the blockage.¹⁰ Given EPA’s assumption that the floor of the adit was six feet below the drainage pipe at the elevation of the waste rock dump surface, EPA mistakenly believed that the pooling water indicated that there was only about six feet of water impounded inside of the adit.¹¹

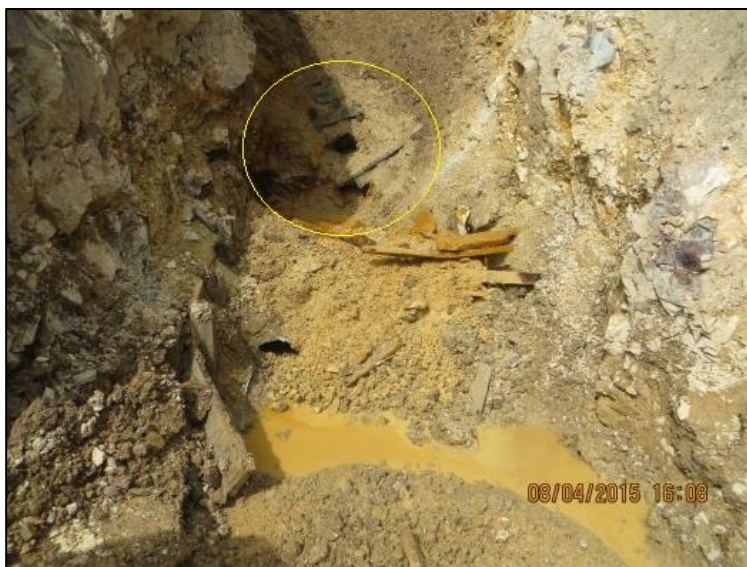
On August 4, 2015, the EPA crew excavated at approximately the level of the drainage and observation pipes until they exposed the plug at about 4:00 p.m. Photographs of the site taken around that time show that the adit plug, composed of compacted clay, sand, and

In this photo from 4:08 p.m. on August 4, the EPA crew has unearthed the plug (highlighted in yellow). The end of a section of pipe is visible in the mound in front of the plug. Source: EPA.

other materials, as well as visible remnants of the portal structure, was *above* the excavated pipes that EPA believed occupied the top four feet of the adit. In other words, the crew discovered that the adit plug was higher than where they thought the roof of the adit was located. At this point, the EPA crew should have realized that their assumptions about the elevation of the adit floor and the location of the pipes were dangerously inaccurate.

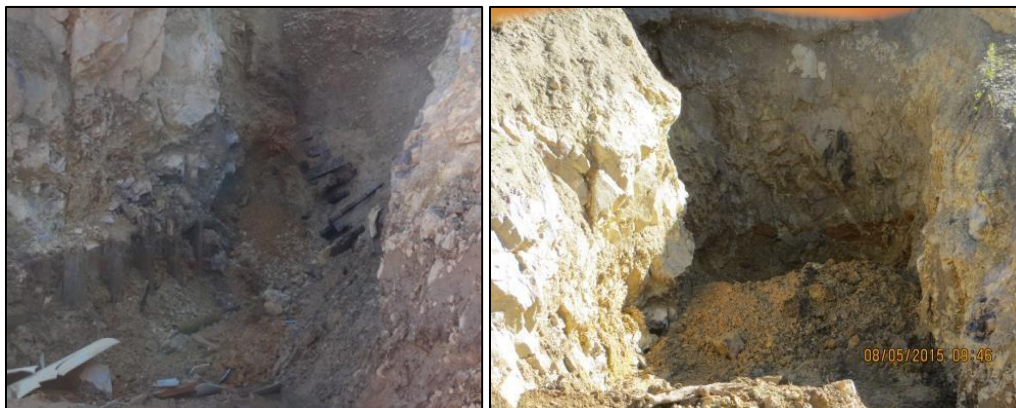
On morning of August 5, 2015, the plug is still visible (left). Shortly thereafter, it was buried with backfill (right). Source: Environmental Restoration/EPA.

After revealing the plug on the afternoon of August 4, the EPA crew paused overnight to consider the situation. The following day, they continued excavating. Photographs of the work performed at the site on the morning of August 5 appear to show that EPA removed the remaining portions of the DRMS pipes closest to the portal and then backfilled the excavated area until the plug they had exposed the day before was hidden behind a mound of backfilled earth.

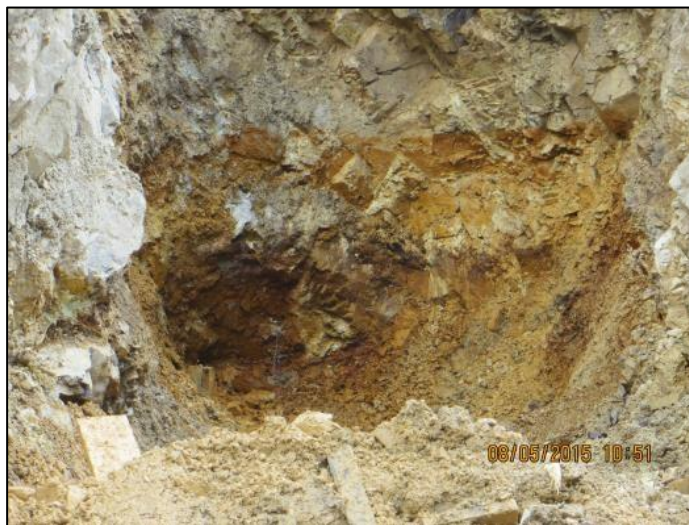
The initial spurt of water from the adit appears in the excavated area, just below a white mark on the rock face. The plug is no longer visible because EPA backfilled the excavation. Source: EPA.

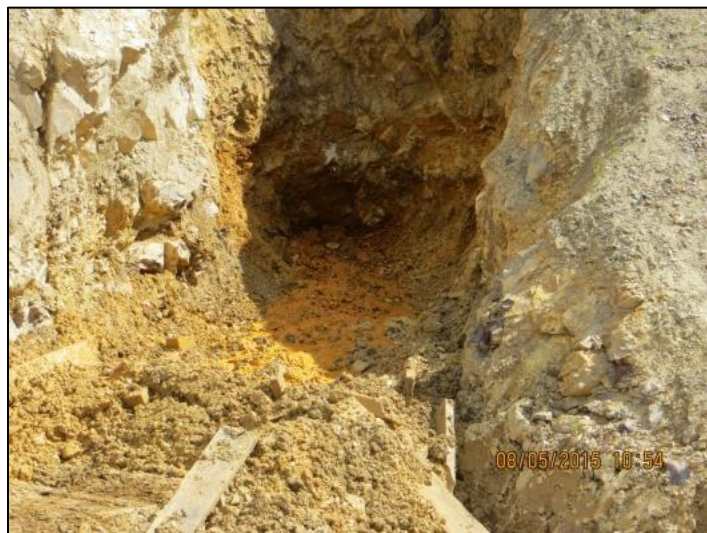
The flow of water escaping from the adit has increased and turned orange. Wood planks, placed to direct water towards the channel on the right side of the adit, are also visible. Source: EPA.

In a photograph time-stamped at 10:51 a.m. on the morning of the spill, none of the crew or machinery is visible in the excavated adit area, there are no equipment tracks on top of the berm, and the initial spurt of water from the adit is perfectly captured. The spurt began to erode the plug, and by 10:54 a.m., orange water had begun to pool behind the berm and flow toward the drainage channel on the right.

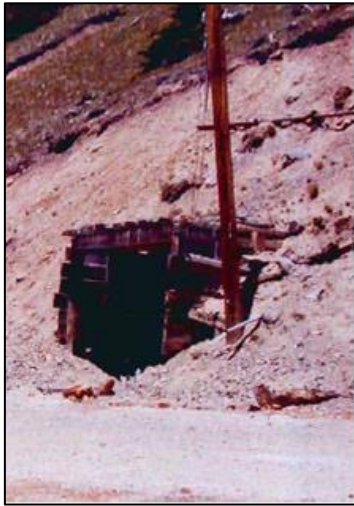
The portal structure, prior to DRMS's work. Source: DRMS.

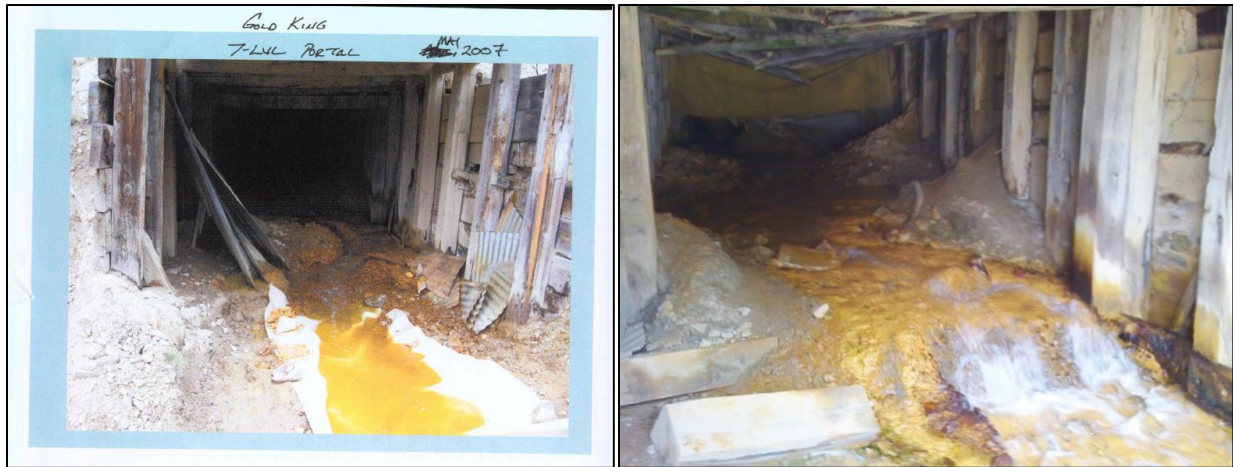
Photographs showing the adit in 2007 (left) and 2009 (right). Source: DRMS (left), Todd Hennis (right).

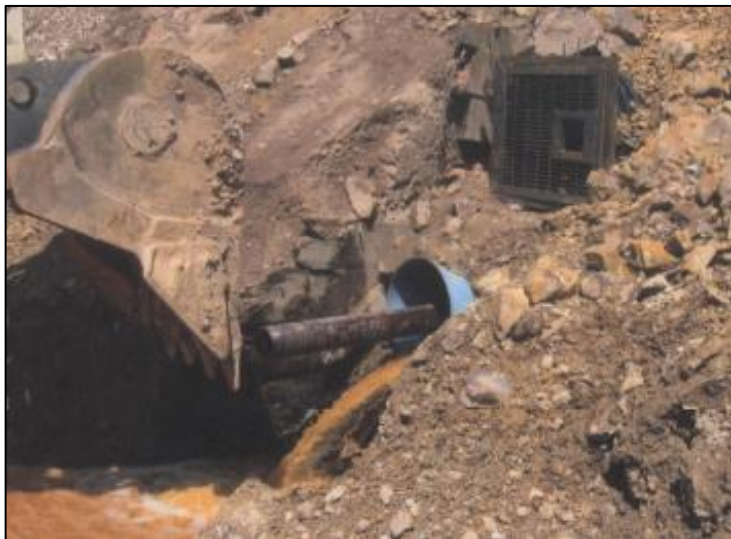
The “well point” DRMS inserted through the drainage pipe was a 6-inch diameter perforated steel pipe called a stinger.¹¹² According to contemporaneous DRMS records, the stinger was 44 feet long and extended roughly 14 feet past the end of the 30 foot drainage pipe.¹¹³ Another DRMS report differed indicating that the stinger penetrated at least some of the 12 feet of collapsed material.¹¹⁴ Although the 2009 DRMS project summary report notes that the stinger “was unable to penetrate through any of the original collapse in the tunnel,” DRMS stated that the adit continued to drain at approximately 200 gallons per minute, a rate similar to the drainage rate prior to the backfilling and installation of the stinger and the two pipes.¹¹⁵

DRMS drives the stinger through the drainage pipe in 2009.
Source: DRMS.

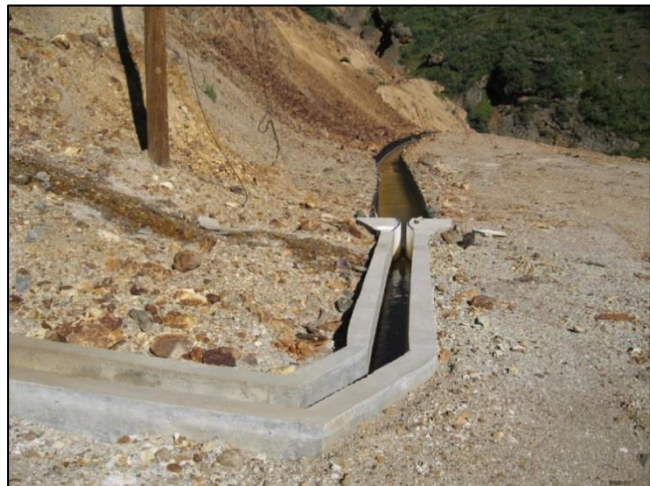
The concrete channel installed by DRMS in 2009.
Source: Environmental Restoration.

In addition to backfilling the adit, in 2009 DRMS also constructed a concrete channel and installed a flume on the surface of the waste dump.¹¹⁶ (See App. 16) The flume and channel were located in front of the adit and connected to the drainage ditch DRMS had installed in 2008.¹¹⁷

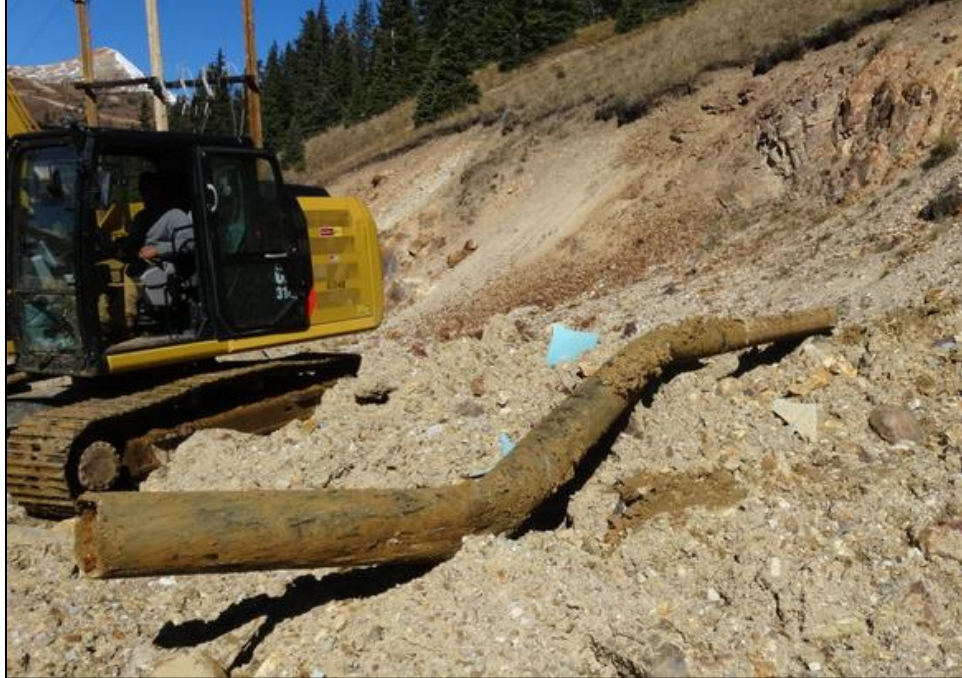
¹²⁴ Email from [redacted], to [redacted] (Oct. 16, 2014, 03:01 p.m.) ("I had [redacted] pull the stinger out of the muck pile and, as you can see, it is trashed.").

Part of the stinger, following removal in 2014. Source: Environmental Restoration.

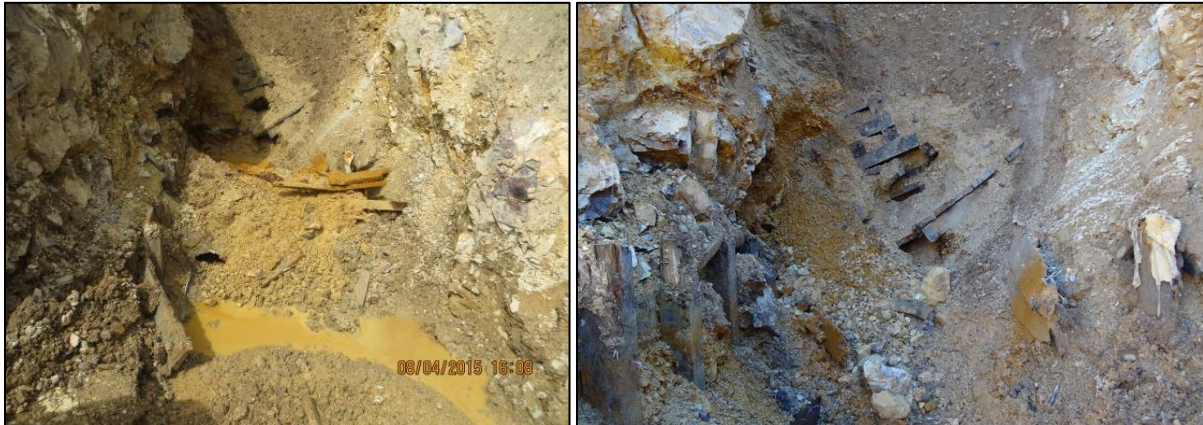
The plug on the afternoon of August 4 (left) and the morning of August 5 (right). Source: EPA (left) and Environmental Restoration (right).

Photographs of the excavated adit show what appears to be wooden debris from the portal structure embedded in the plug. The top of the plug is clearly visible above the level of the drainage and observation pipes. When the crew discovered that the plug was above where EPA's 2014 conclusions indicated it would be, it should have been a clear warning to the EPA crew that their assumptions were incorrect. It also removed the crew's basis for assuming the adit was not pressurized, since that assumption rested primarily on the EPA's (now disproved) beliefs about the location of the adit floor.

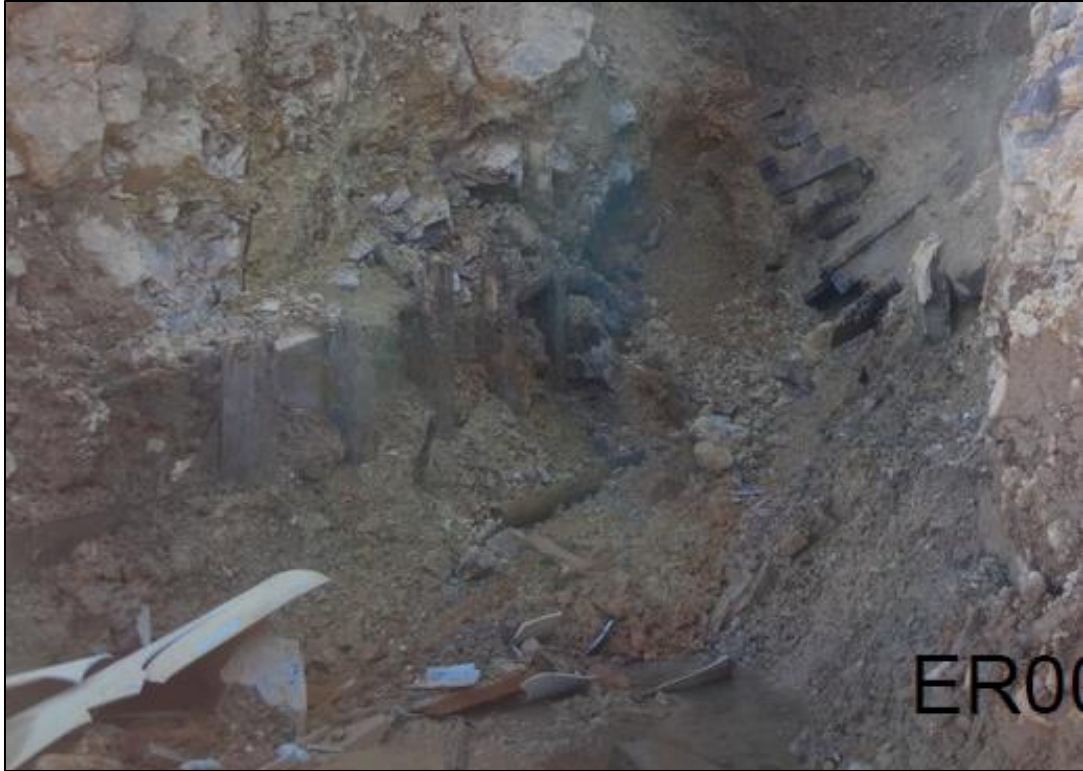
Shards of the removed drainage pipe (lower left) in front of the excavated adit. Source: Environmental Restoration.

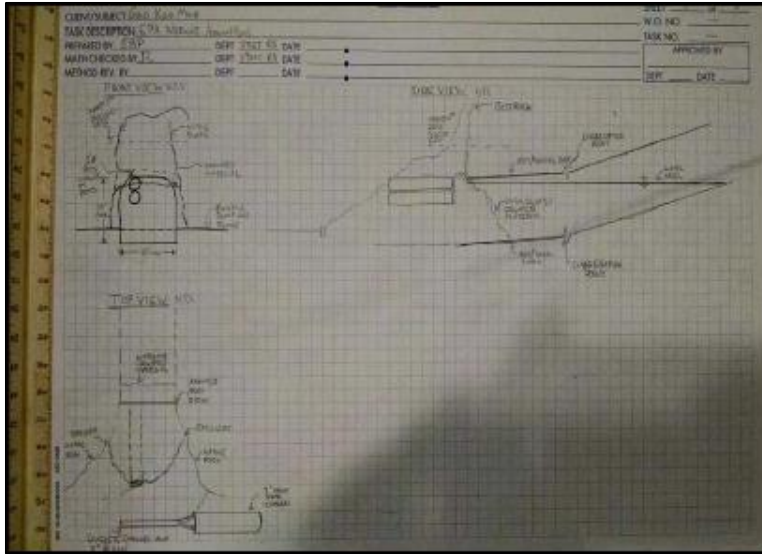
The contractor's August 11, 2015, drawing of EPA's "working assumptions" about the Gold King Mine, included in the *Internal Review* as Attachment D. Source: EPA.

Despite EPA's conclusion that the adit floor was six feet below the surface of the waste dump, and EPA's reassertion of this conclusion in its *Internal Review*, the drawing that EPA attached to illustrate the crew's working assumptions is curiously ambiguous regarding the elevation of the adit floor. The line depicting the adit floor fades away well before the point at which it would connect to the waste dump surface.

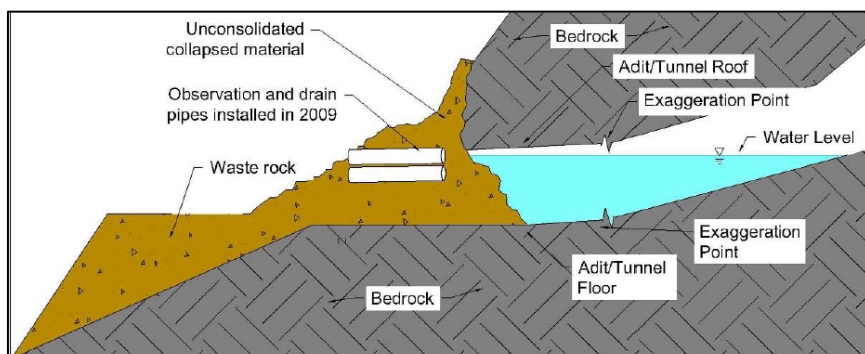
Figure 40.—Cross-section illustration showing the condition of the adit that was assumed by the EPA OSC and the abandoned mine experts from DRMS for use in planning to open the adit (not to scale). The "exaggeration point" means the right side of the drawing has an exaggerated vertical scale in order to show the 1% uphill slope of the adit. If drawn without exaggeration, the uphill slope of the adit would not be obvious on the drawing.

DOI's depiction of EPA's assumptions about the condition of the adit does not reflect EPA's conclusion that the adit floor was 6 feet below the surface of the waste rock dump.

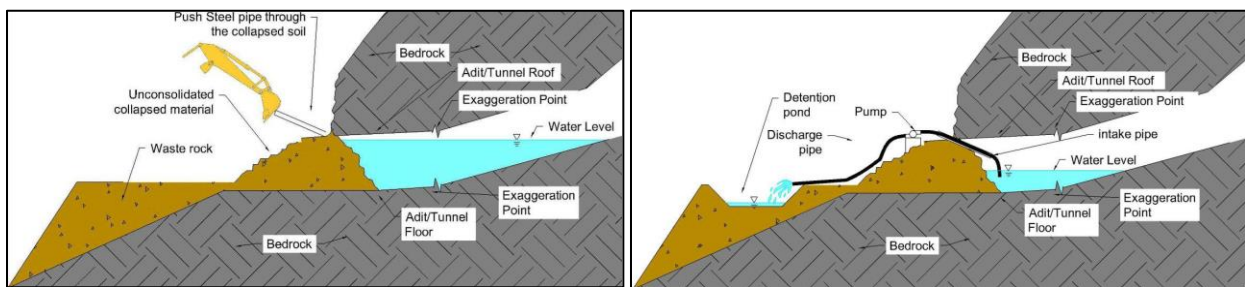
Quite simply, the EPA crew could not have been executing the plan described in the *Technical Evaluation* because the stinger and pump needed to dewater the mine were not on-site on August 5, 2015,¹⁸³ and it is unclear why the crew would have dug into the plug (thus destabilizing it) without having the necessary equipment to proceed with the plan immediately. Out of the five steps in the plan DOI illustrates, only the first step would have even been feasible for the EPA crew on August 5, 2015. DOI's failure to include this information in the *Technical Evaluation* demonstrates DOI's carelessness in ascertaining the facts. (See App. 13)

Figures 42 (left) and 44 (right) in DOI's *Technical Evaluation* depict steps 2 and 4 of the plan EPA was supposedly implementing when the blowout occurred. EPA could not have been following this plan, because the steel pipe (stinger) and pump were not on-site on August 5, 2015.

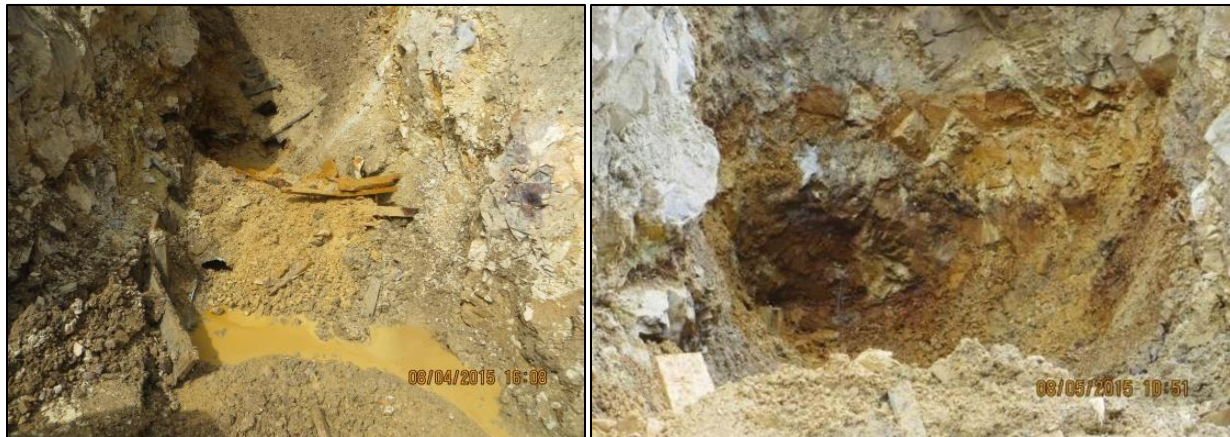
As a caption from the *Technical Evaluation* noted, “[t]he fill derived from the excavation had now covered the timbers, lagging, and seep visible in the previous photograph.”²²⁷ Mr. Griswold gave a video account of what happened the day of the blowout stating, “There’s pictures of that, that we have.”²²⁸ Following are two of the pictures Mr. Griswold refers to.

Plug exposed on August 4 (left), and buried by backfill at the time of the initial spurt (right). Source: EPA.
