M/V CONNECTED
Coral Reef Restoration Monitoring Report
Monitoring Events 2004-2005
Florida Keys National Marine Sanctuary
Monroe County, Florida

December 2006

Joe Schittone
Erik C. Franklin
J. Harold Hudson
Jeff Anderson

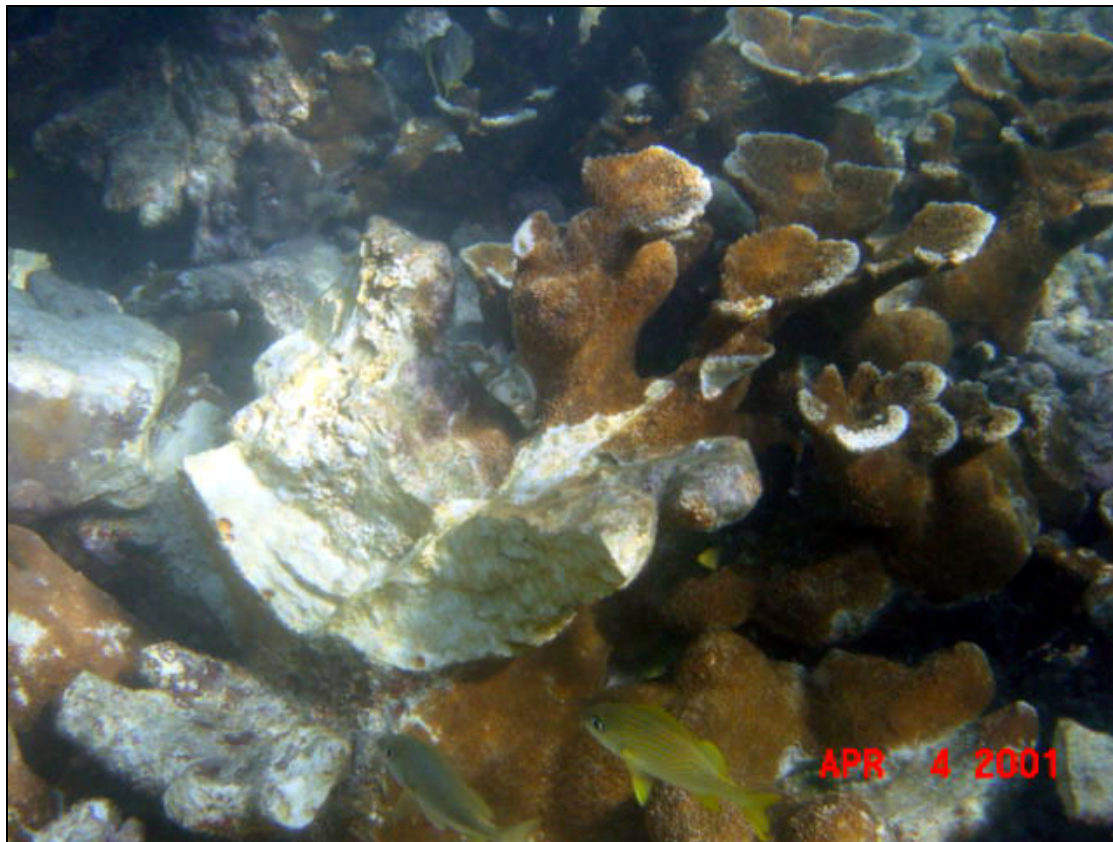
Figure 2. Elkhorn coral, *Acropora palmata*, the predominant coral species of the shallow reef crest habitat, damaged by the M/V *Connected* grounding at Western Sambo Reef (photo credit: Bill Goodwin, FKNMS).

The most prominent feature of the injury site consisted of a wide grounding track plowed through an elkhorn coral stand (Figure 2). The width of the injury swath varied between 3-7 m along the inbound path and widened at the final resting place to 9 m (Figure 3). The latitude and longitude of the beginning of the inbound track were recorded as 24° 28.811' N and 81° 43.105' W and the end of the inbound track as 24° 28.822' N and 81° 43.091' W (datum GRS80). During removal, the vessel was pivoted and extracted to the south (Figure 3). The area of damaged reef framework and live coral colonies from the inbound path and resting place was 189.58 m². In addition, small intermittent areas of injury were documented in front of the

inbound path (4.02 m²), near the bow resting place (0.64 m²), and adjacent to the pivot point (8.24 m²). The total length of injury was 81.2 m and the total area of injury was 202.48 m² of reef framework and corals, predominately the elkhorn coral *Acropora palmata*.

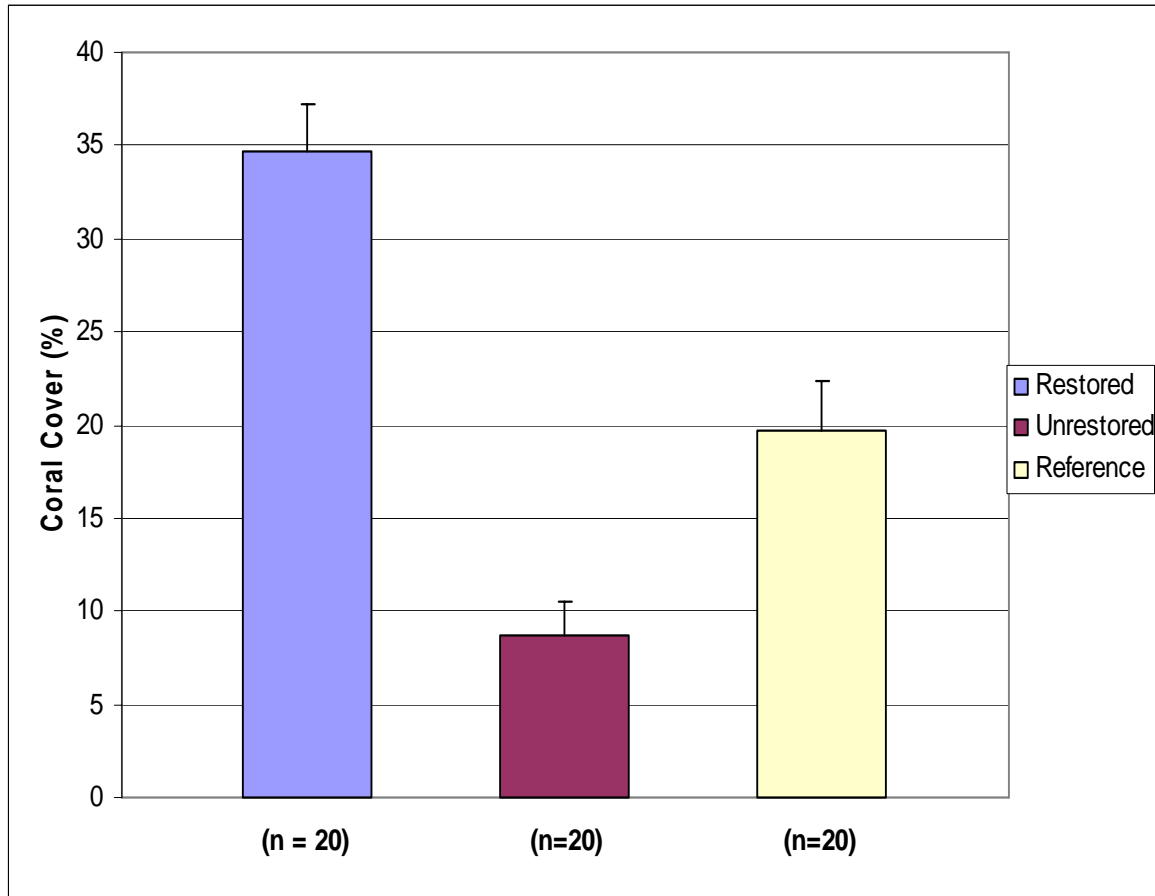
Figure 7. 2004 — mean (\pm SE) coral cover (%) among the restored (reef crown) area, the damaged unrestored area, and the reference area of the *Connected* grounding site.

The *Connected* restoration site contained a matrix of solitary live *Acropora palmata* colonies, live *A. palmata* thickets, dead *A. palmata* skeletons, and reef rubble. Coral species observed within quadrats included *Acropora palmata*, *Agaricia agaricites*, *Diploria clivosa*, *Favia fragum*, *Millepora alcicornis*, and *Porites asteriodes*. *Acropora palmata* was the dominant coral species and represented 96% of the reported coral cover. Reflecting the habitat matrix of the reef flat, samples of coral cover within areas were heterogeneous; cover ranged from 0% to 59% in the restoration area and from 0% to 58% in the reference area. Unfortunately the contractor who did the restoration in 2001 did not establish a reference area, so there was no possibility of determining the trajectory of corals surrounding the grounding site, at least as of the time of the baseline monitoring. In 2004, mean coral cover was approximately 8% in the damaged unrestored area and 19.5% in the reference area. The coral cover of the reef crowns was estimated as 34% (Figure 7). Accompanying vertical growth, representing increased topographic complexity, can be assessed from the photos (see photos in APPENDIX).

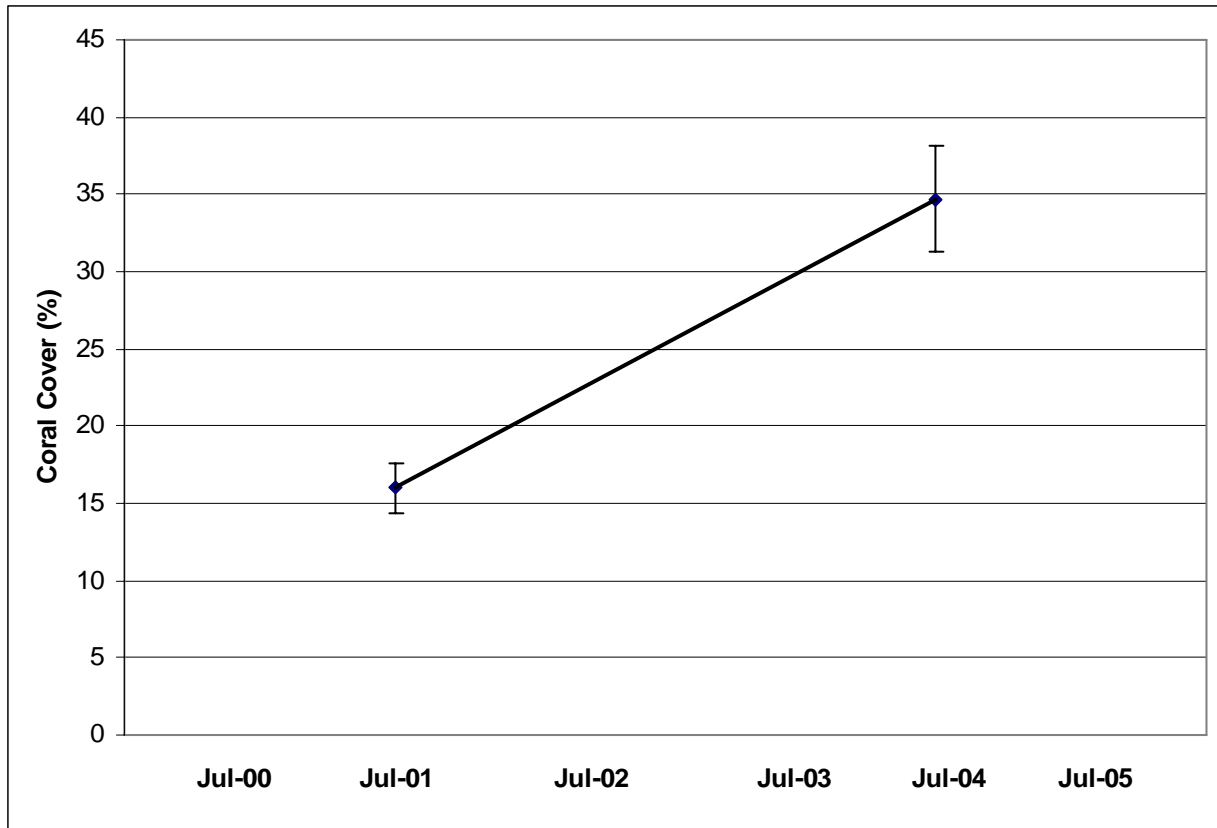
Figure 8. Trend in mean (\pm SE) coral cover (%) of the reef crowns of the *Connected* grounding site from 2001 to 2004.

In August 2001, shortly after the restoration was completed, a series of near-vertical underwater digital photographs were taken of the reef crowns. Using a random point count method software (Kohler 2004), coral cover was estimated as 16% in 2001 from 50 points per photo frame. Therefore, utilizing the 2004 monitoring data, the coral cover of the reef crowns had increased approximately 6% per year (absolute coverage) since the restoration in 2001 (Figure 8).

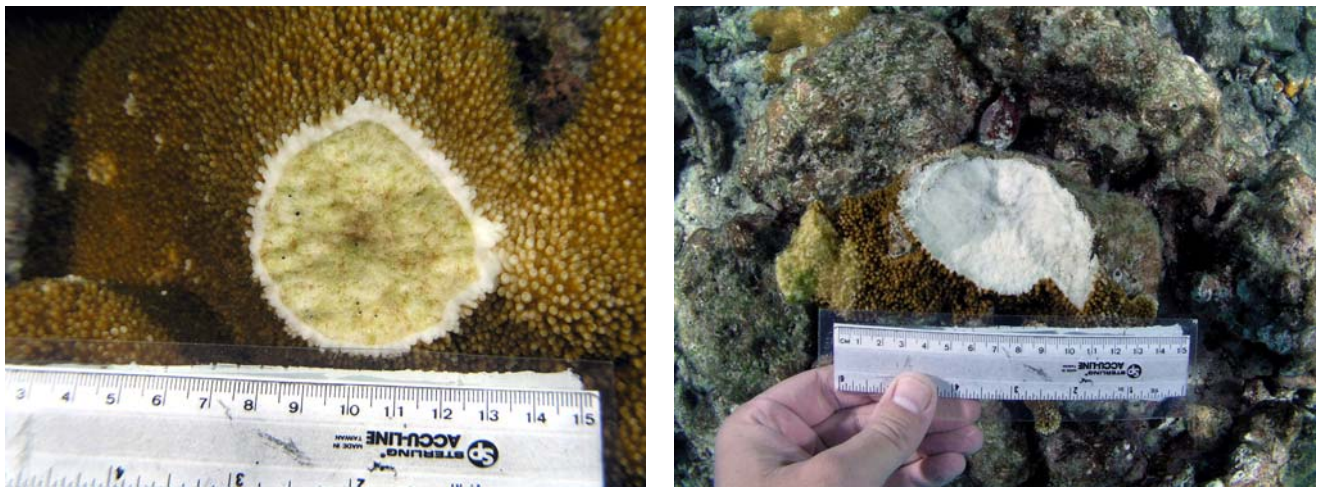
Figure 9. Broken branches on *Acropora palmata* colonies on reef crown #86 (left) and #87 (right).

Despite the near passage of hurricane Charley, the stability and surface of all 20 restoration modules were found to be visually and tactilely sound. However, as can be expected in a storm event, there was slight noticeable physical damage to a few reattached coral colonies. The tips of some fragments appeared to have been recently broken (e.g. reef crown #86; APPENDIX and Figure 9). Notice, at the time of this monitoring event, the “wound” is already being covered with algae and some coral tissue growth.).

Additional, non-storm-related structural damage was also documented (attributable to a boat strike), highlighting the multiple challenges faced at this site. The reef crown (#87; APPENDIX and Figure 9) is in relatively shallow water (~ 1.5 m), and the damage was very recent; perhaps a day or less old. This opinion is based on the fact that the wound did not have any signs of algae overgrowth, and fresh bottom paint was visible in the vicinity. The good news concerning the

incident is that there was no visible damage to the reef crown module; thus the remaining living *Acropora palmata* tissue had a good chance to recover, absent intervening causes.

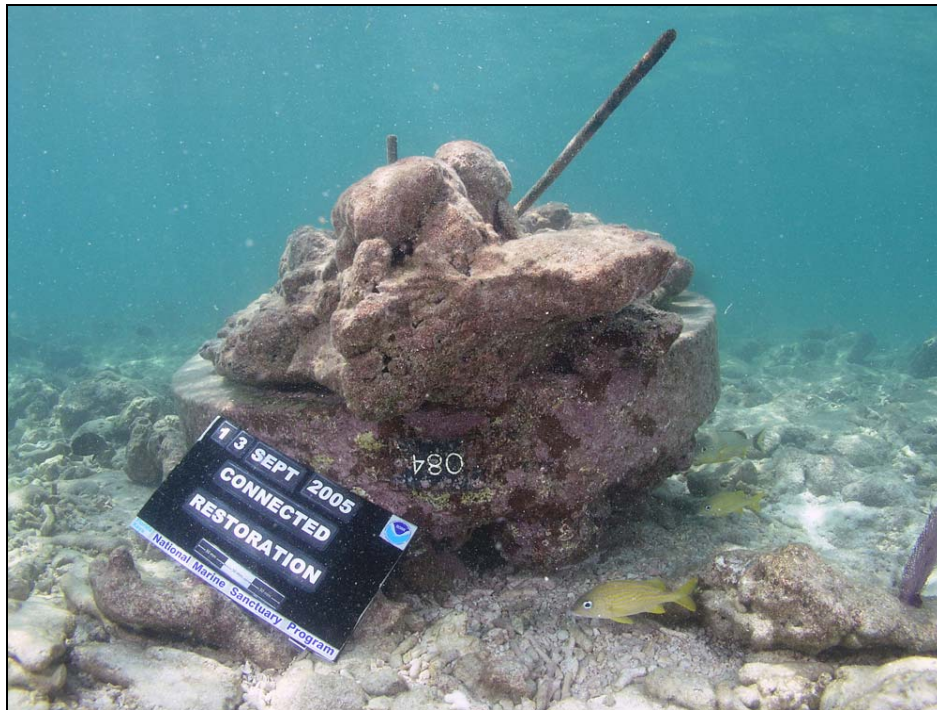
Figure 10. Reef crown (#84) uprooted and overturned by storm-generated waves.

The stability and surface of 19 of the twenty restoration modules were found to be visually and tactilely sound. One reef crown was dislodged from the substrate (Figure 10). Close inspection by the Sanctuary biologist, Harold Hudson, who was also present during the restoration of the

site, determined that the module had been incorrectly installed with too few and too short sections of rebar securing it to the substrate. Other reef crowns (e.g. modules 83, 85, and 99 photos in APPENDIX), while still securely affixed, did have loose substrate eroded from their bases. This erosion can be directly traced to instability of the underlying substrate. Close inspection of the site revealed that instead of a well-cemented reef framework, the reef underpinning there was composed of loose *Acropora palmata* debris held in place by tightly-packed sediment. Washout of the stabilizing sediment by hurricane-driven waves resulted in the observed erosion at the bases of these reef crowns. Two other reef crowns (e.g. modules 91 and 92 photos in APPENDIX), still securely affixed to their locations in a natural depression in the reef, were completely buried by unconsolidated reef rubble.

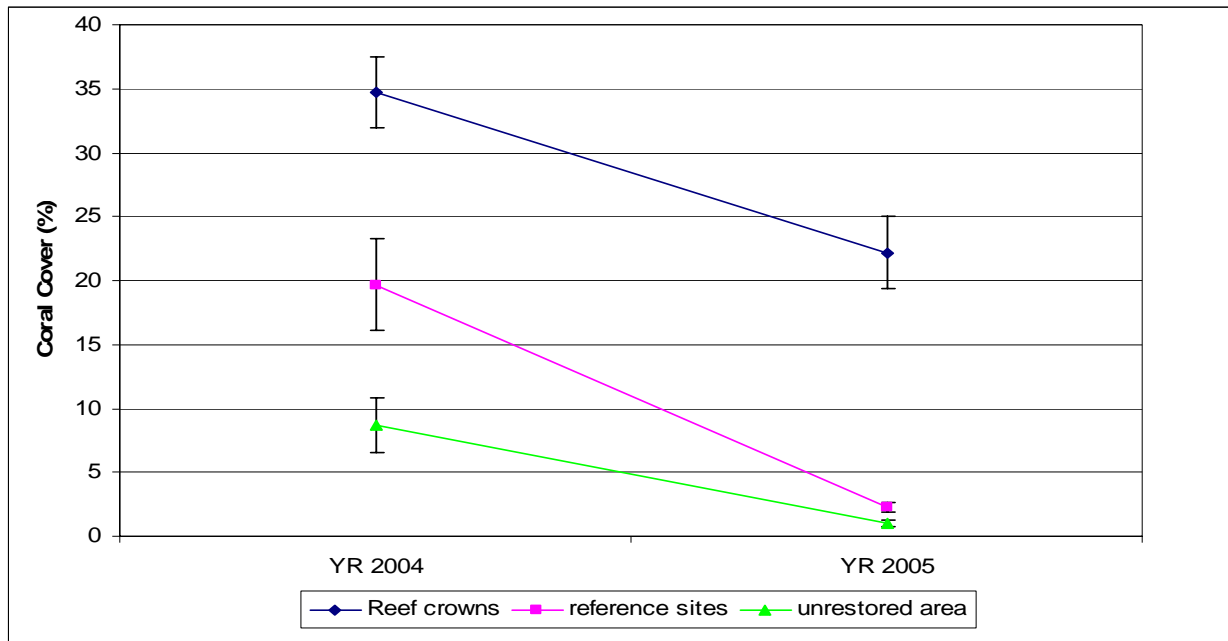
Figure 11. Trends in mean (\pm SE) coral cover (%) of the reef crowns, reference sites, and unrestored areas from 2004 to 2005.

At the time of the 2005 monitoring, coral cover of the reef crowns was 22.2%. This was down approximately 36% from what cover had been the summer before (about 12% in terms of absolute cover). However, this pales in comparison to the damage done at the reference site, where cover was found to be 2.2%. This was reduced almost 89% (relatively) from the previous monitoring event (a reduction of $\approx 17.5\%$ in absolute terms). A very similar degradation trend

was observed at the damaged, unrestored site, where relative cover likewise decreased 88% (Table 2 and Figure 11).

The much greater reduction in coral cover in the reference zone can probably be attributable to the fact that most of the site lies below the bathymetry of the reef crowns; thus it served as a natural repository for the rubble and sediment which blanketed the whole area. This view is buttressed by the fact that damage (almost exclusively as a result of burial by storm-generated sediment) was differentially experienced among the reef crowns according to their elevation. For example, crowns which lay in a natural depression or “channel” were wholly smothered (e.g. reef crowns 91 and 92 in APPENDIX; these were buried in rubble which had to be excavated to ID the crowns for the photos.).
