BSEE Panel Report 2013-002

# **Investigation of November 16, 2012, Explosion, Fire and Fatalities at West Delta Block 32 Platform E**

**Gulf of Mexico Region, New Orleans District  
Lease No. OCS 00367**

**November 4, 2013**

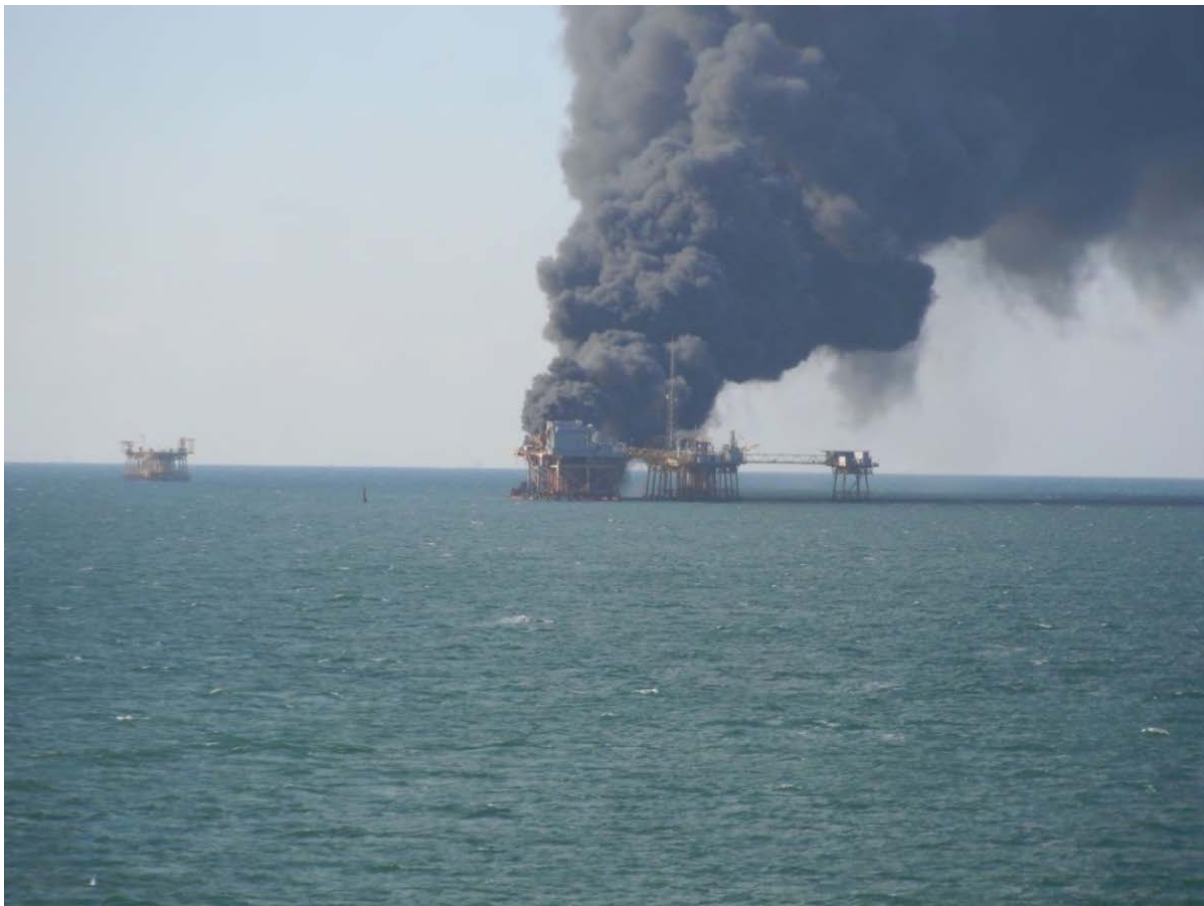
***Figure 1 – WD 32 E platform after explosion***

The ignition started a chain reaction that caused the wet oil tank and two connected dry oil tanks to explode. These explosions caused the three tanks to separate at their bases, launching the wet oil tank and the first dry oil tank into the Gulf of Mexico and blowing the second dry oil tank into the air. The second dry oil tank then struck the platform crane and

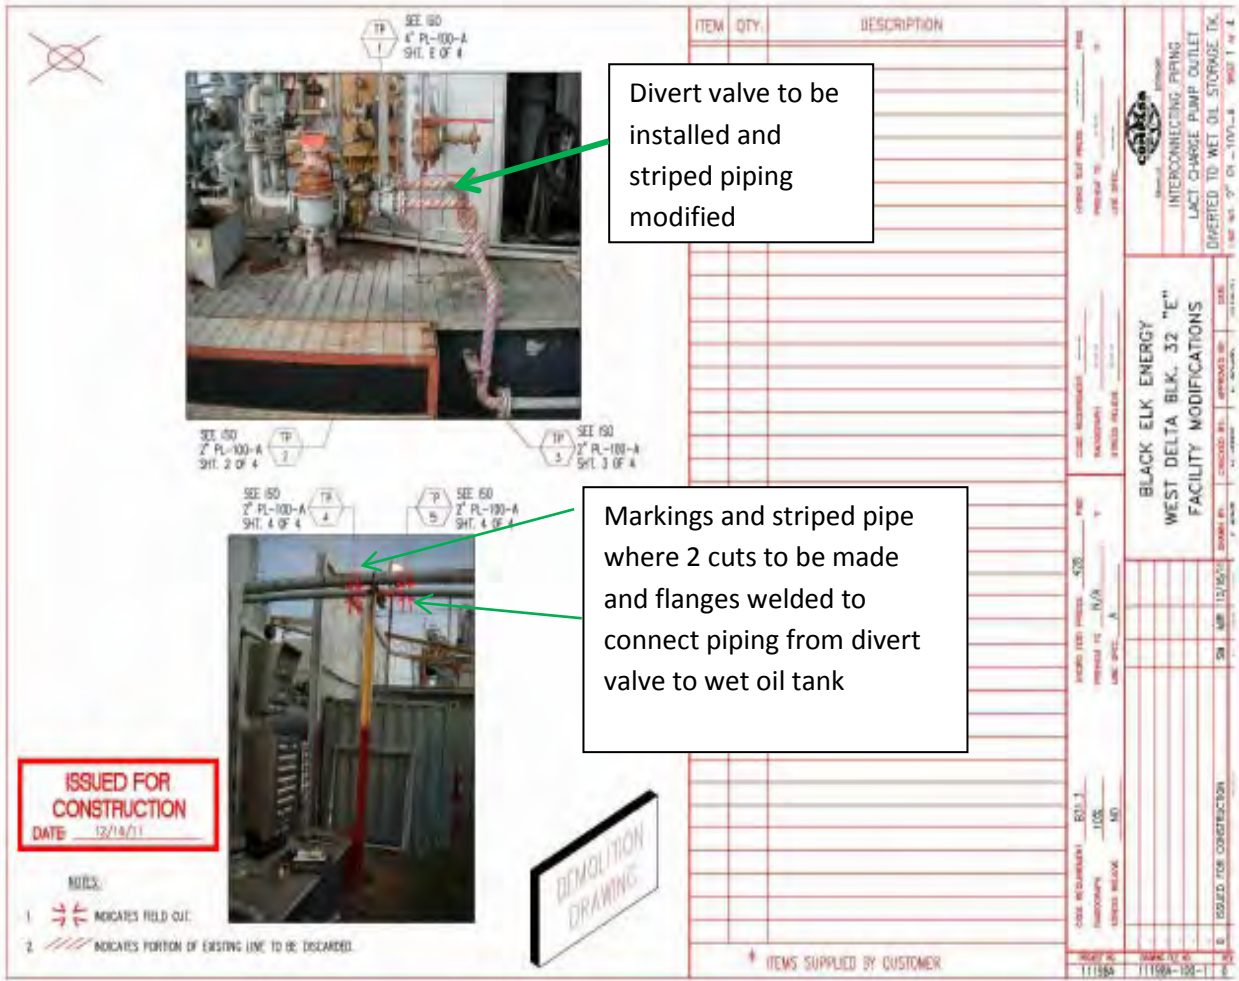
**Figure 3 – Photo illustration submitted with MOC to install divert valve and make two cuts in line, weld flanges, and install piping from divert line on LACT unit to wet oil tank**

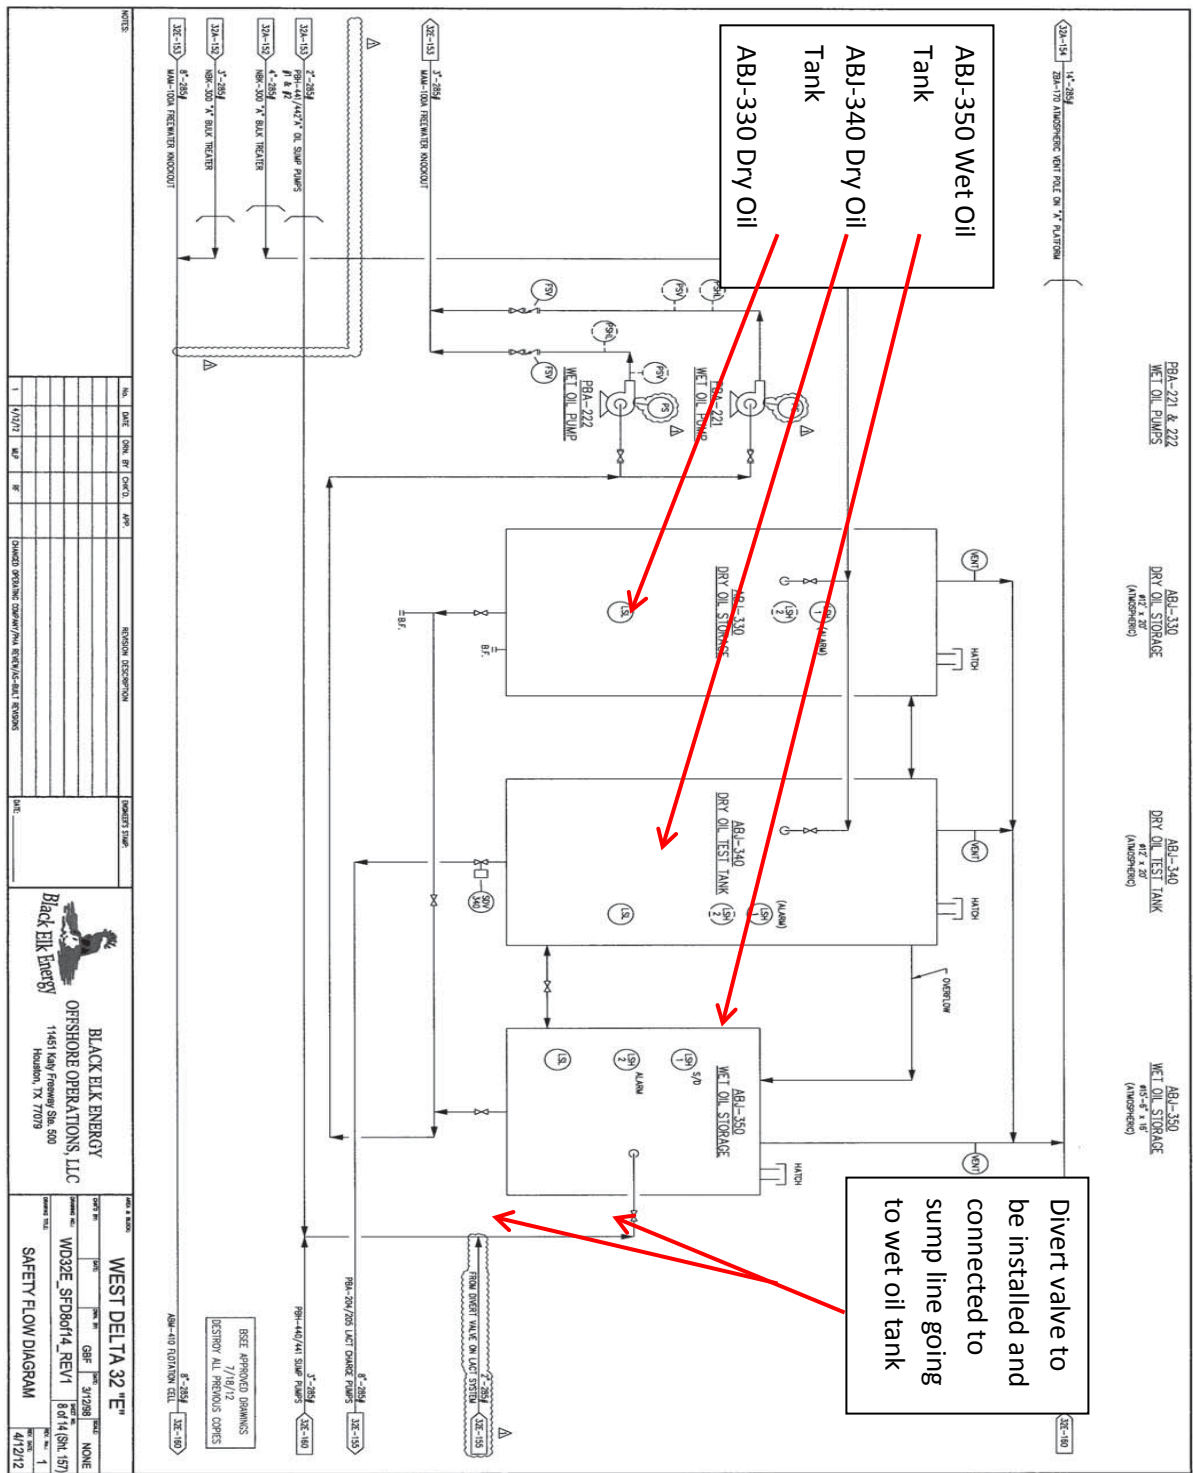
WEST DELTA 32 "E"  
 W032E\_SF080614\_REV11 8/14/12 (S) 197  
 SAFETY FLOW DIAGRAM 4/12/12

Figure 4 – Schematics for LACT MOC to install divert valve, showing the wet oil tank and both dry oil tanks

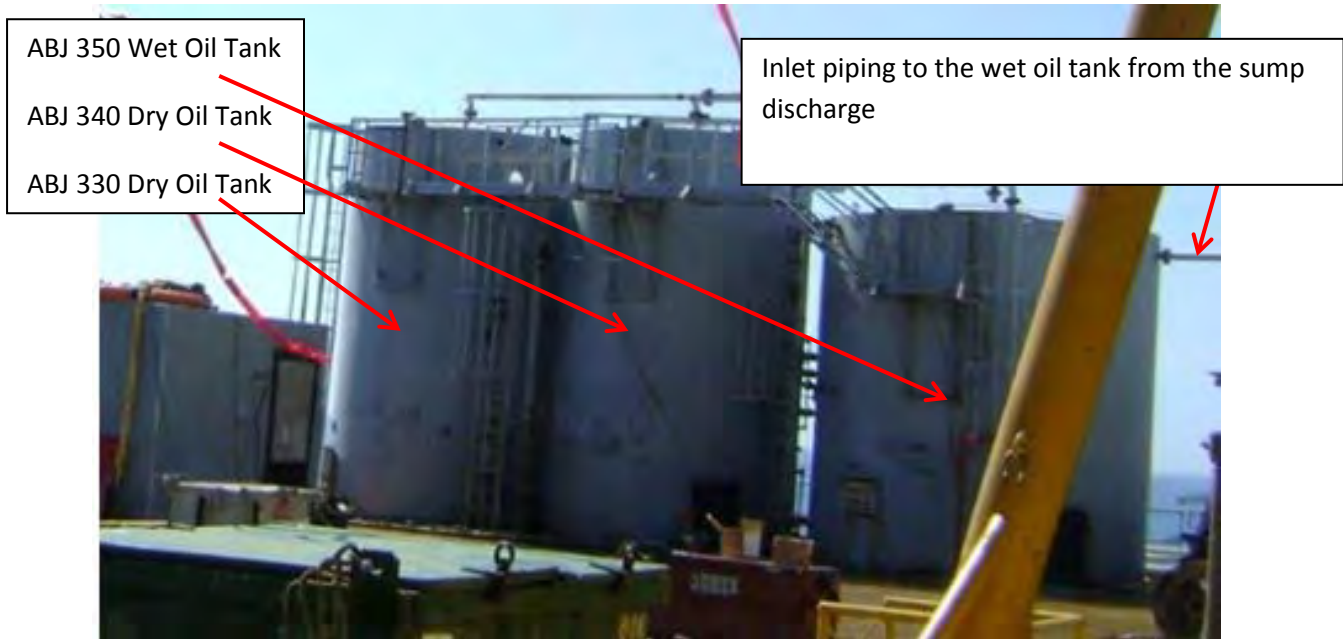
***Figure 5 – Illustration showing the wet oil and dry oil tanks along with the inlet piping from the sump discharge***

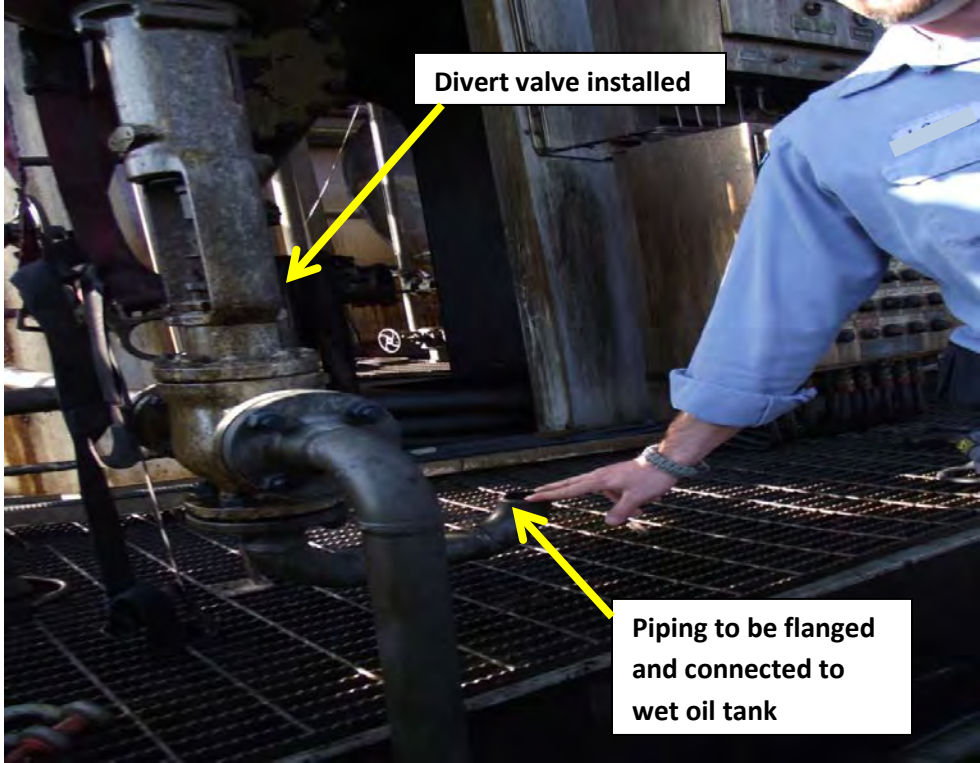
*Figure 6 – Divert valve installed on LACT unit, and from there will go to the wet oil tank*

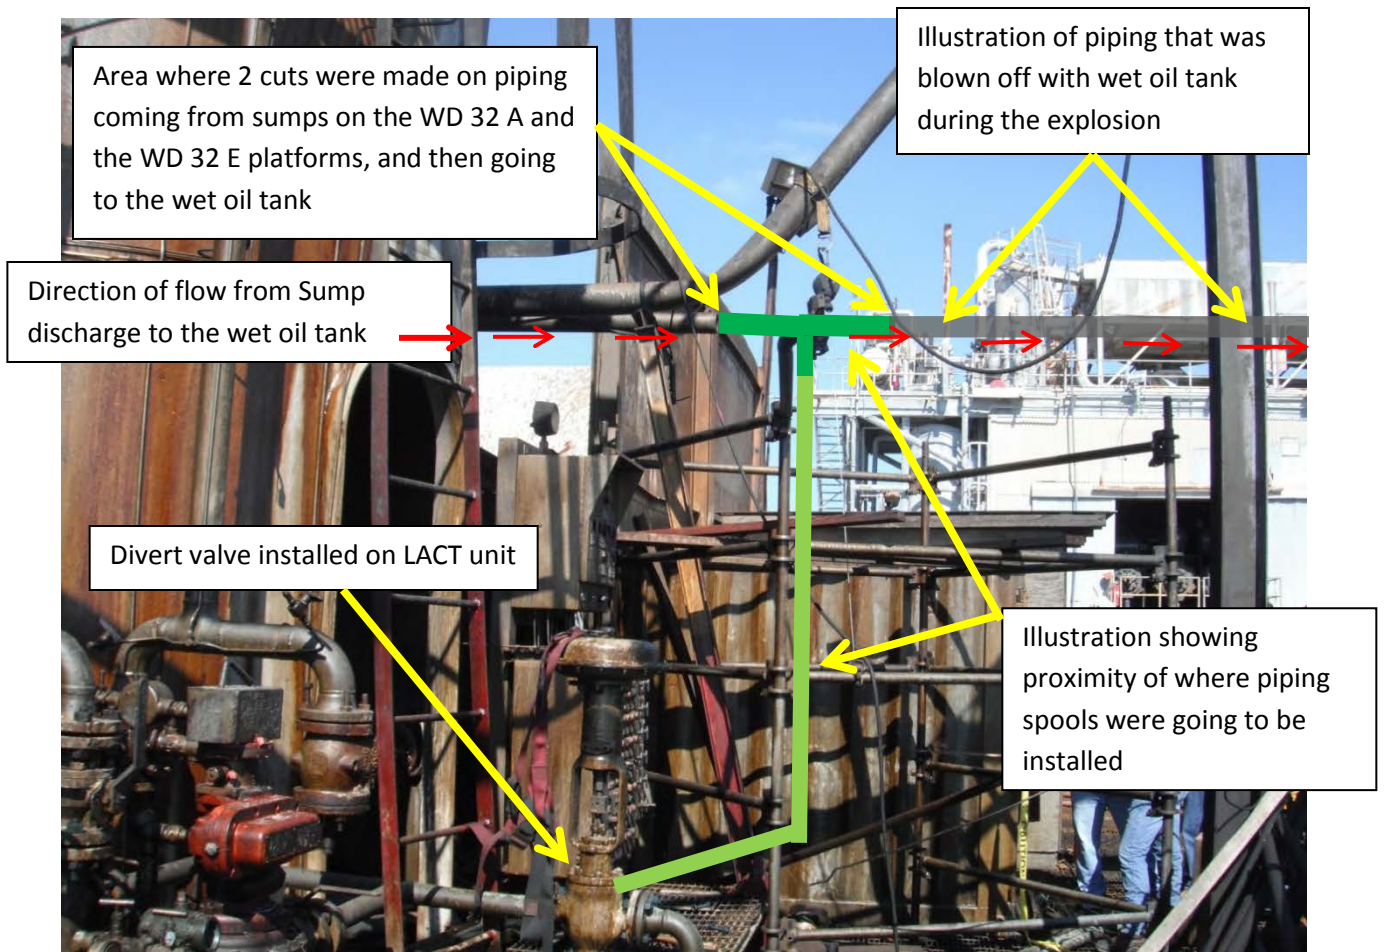
**Figure 7 – Illustration showing proximity of piping to be installed on LACT unit divert valve work**

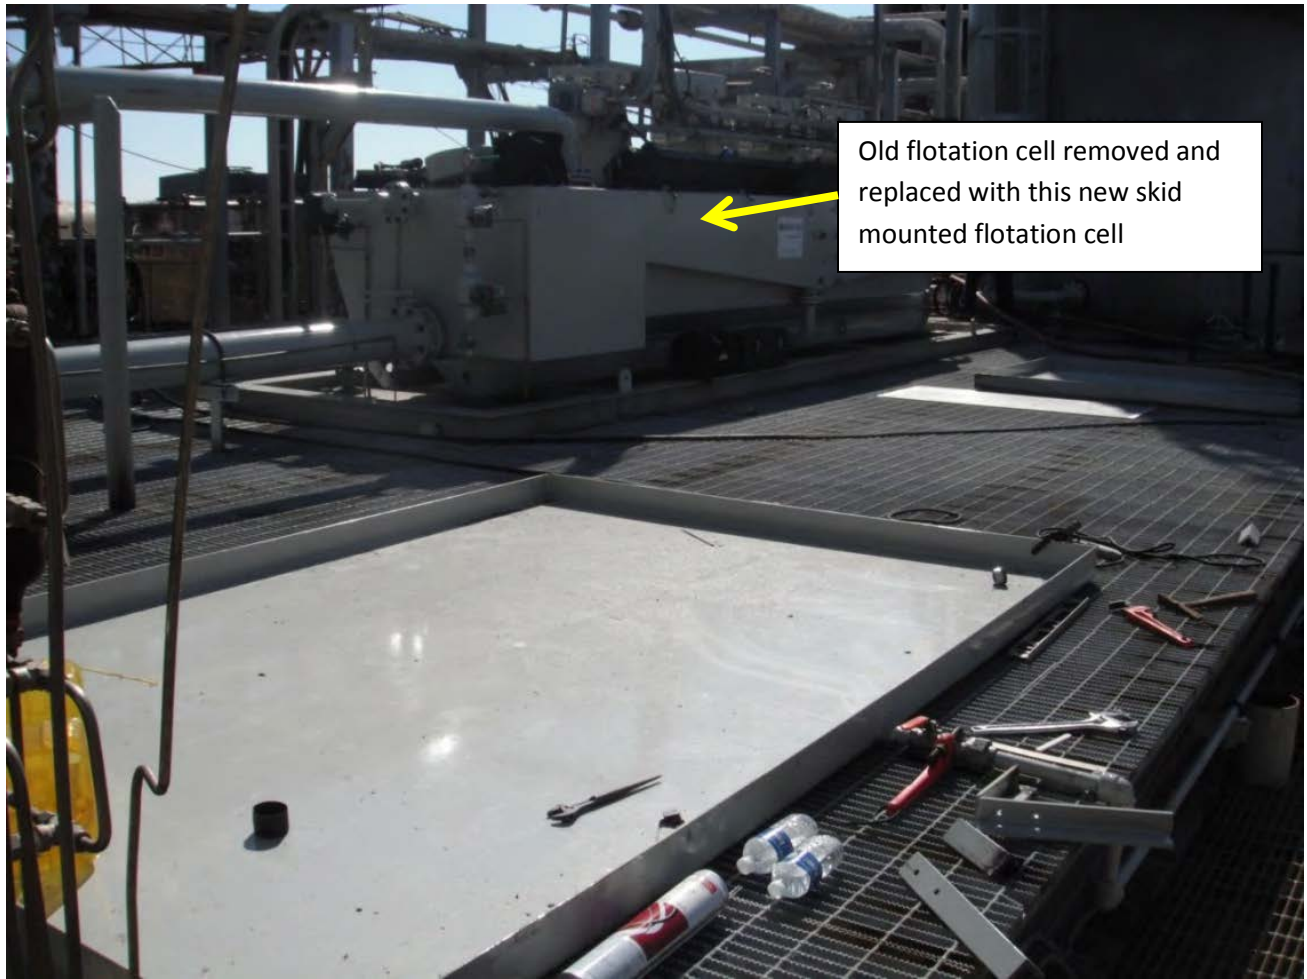
Old flotation cell removed and replaced with this new skid mounted flotation cell

***Figure 8 – Replaced old flotation cell with a reconditioned flotation cell on WD 32 E***

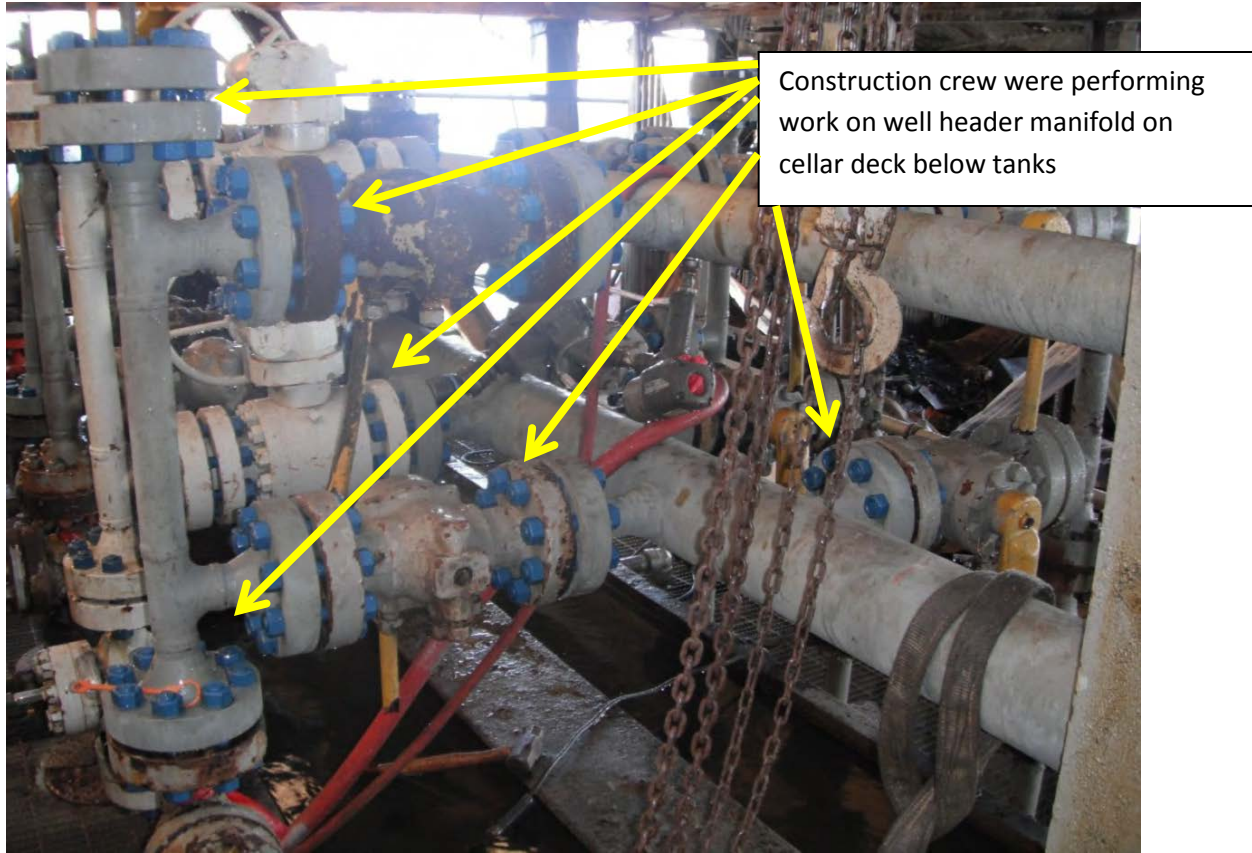
***Figure 9 – Construction crew installed flowlines and performed work on manifold system on cellar deck***

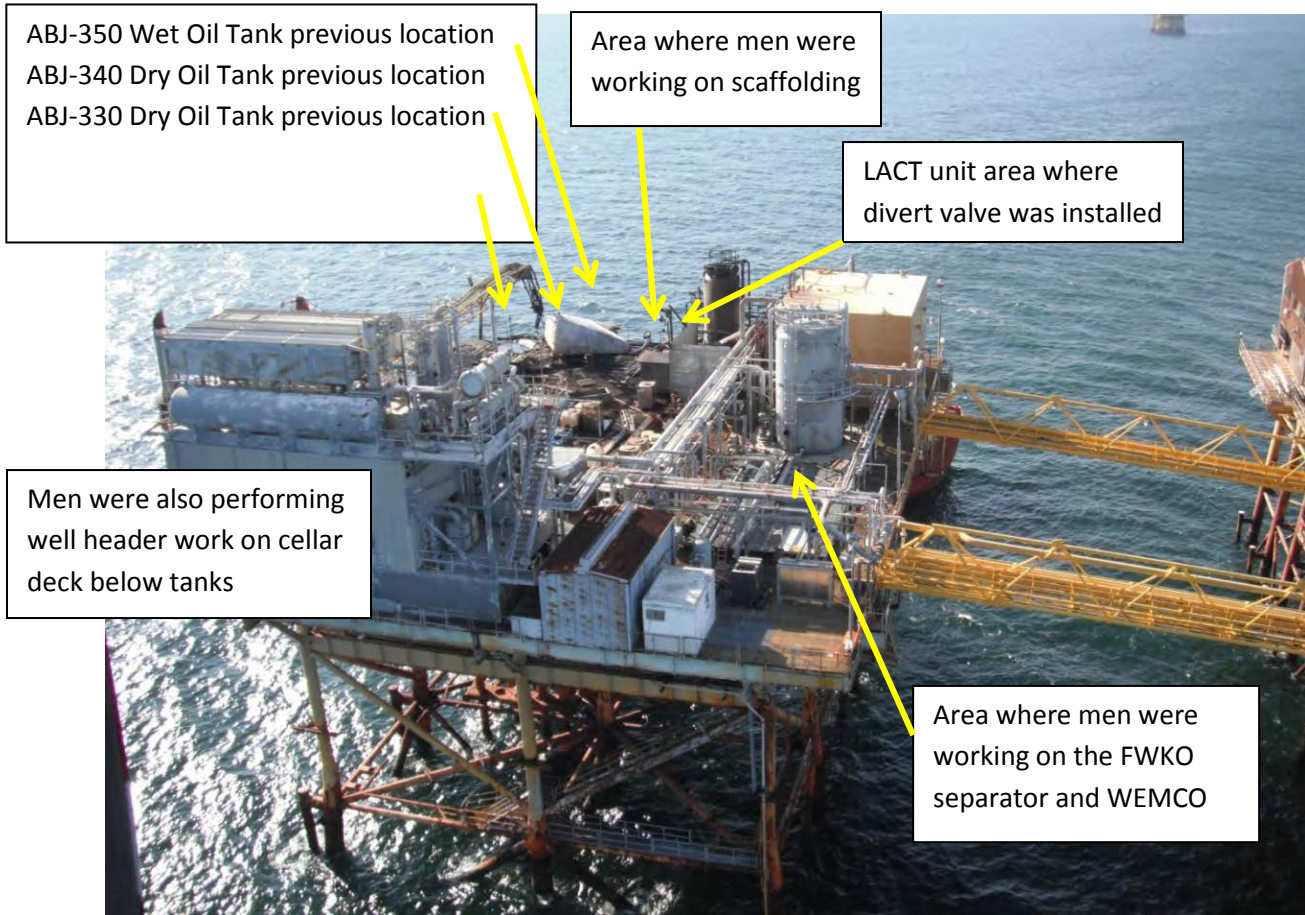
**Figure 10 – Areas where work was performed on WD 32 E platform**

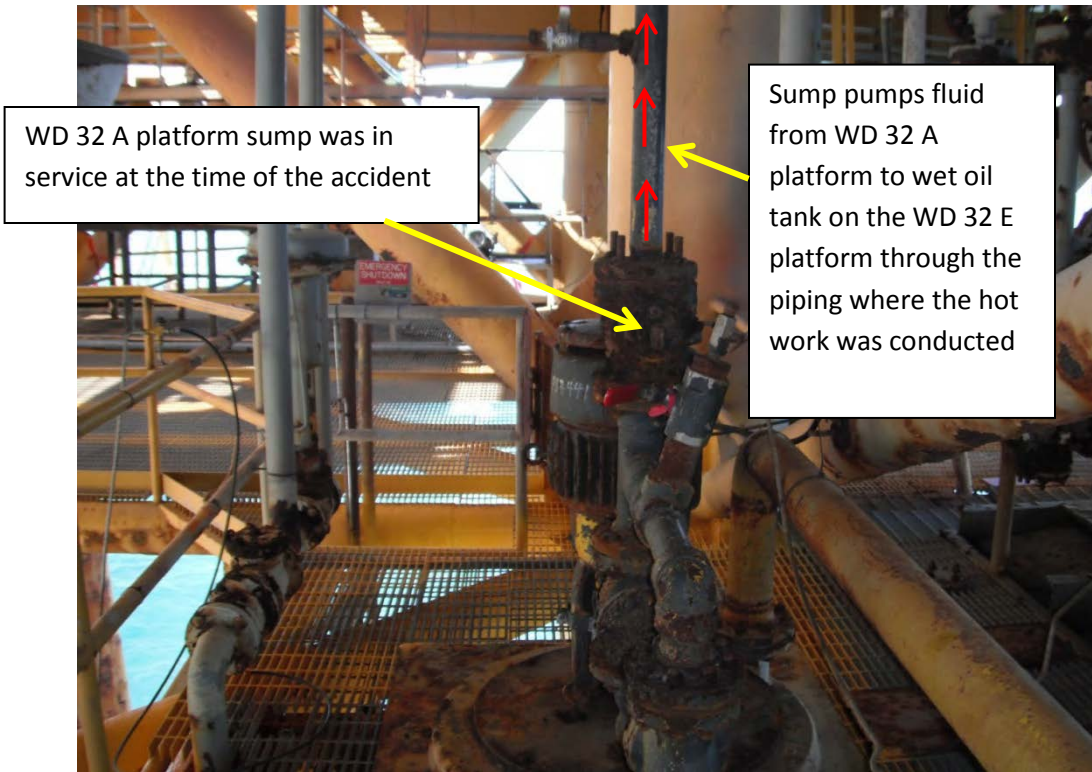
The BSEE investigation identified that the sump systems on both the WD 32 A and E platforms were still in service the day after the explosion/fire (see figures 11 and 12). The Panel concluded that having both sump pumps in service at the time of the incident posed a significant risk. However, based on the evidence gathered, the sump pumps did not contribute to the cause of the incident.

**Figure 11 – The WD 32 A platform sump was in service while the construction crew performed hot work**

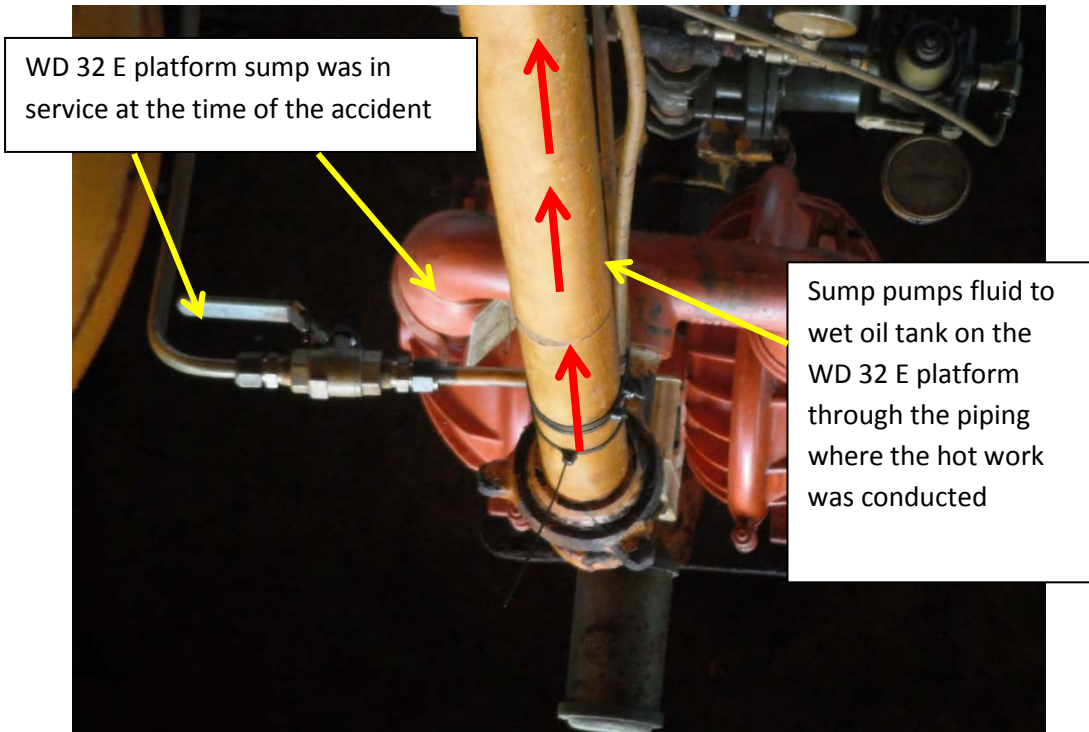
**Figure 12 – The WD 32 E platform sump was in service while the construction crew performed hot work**

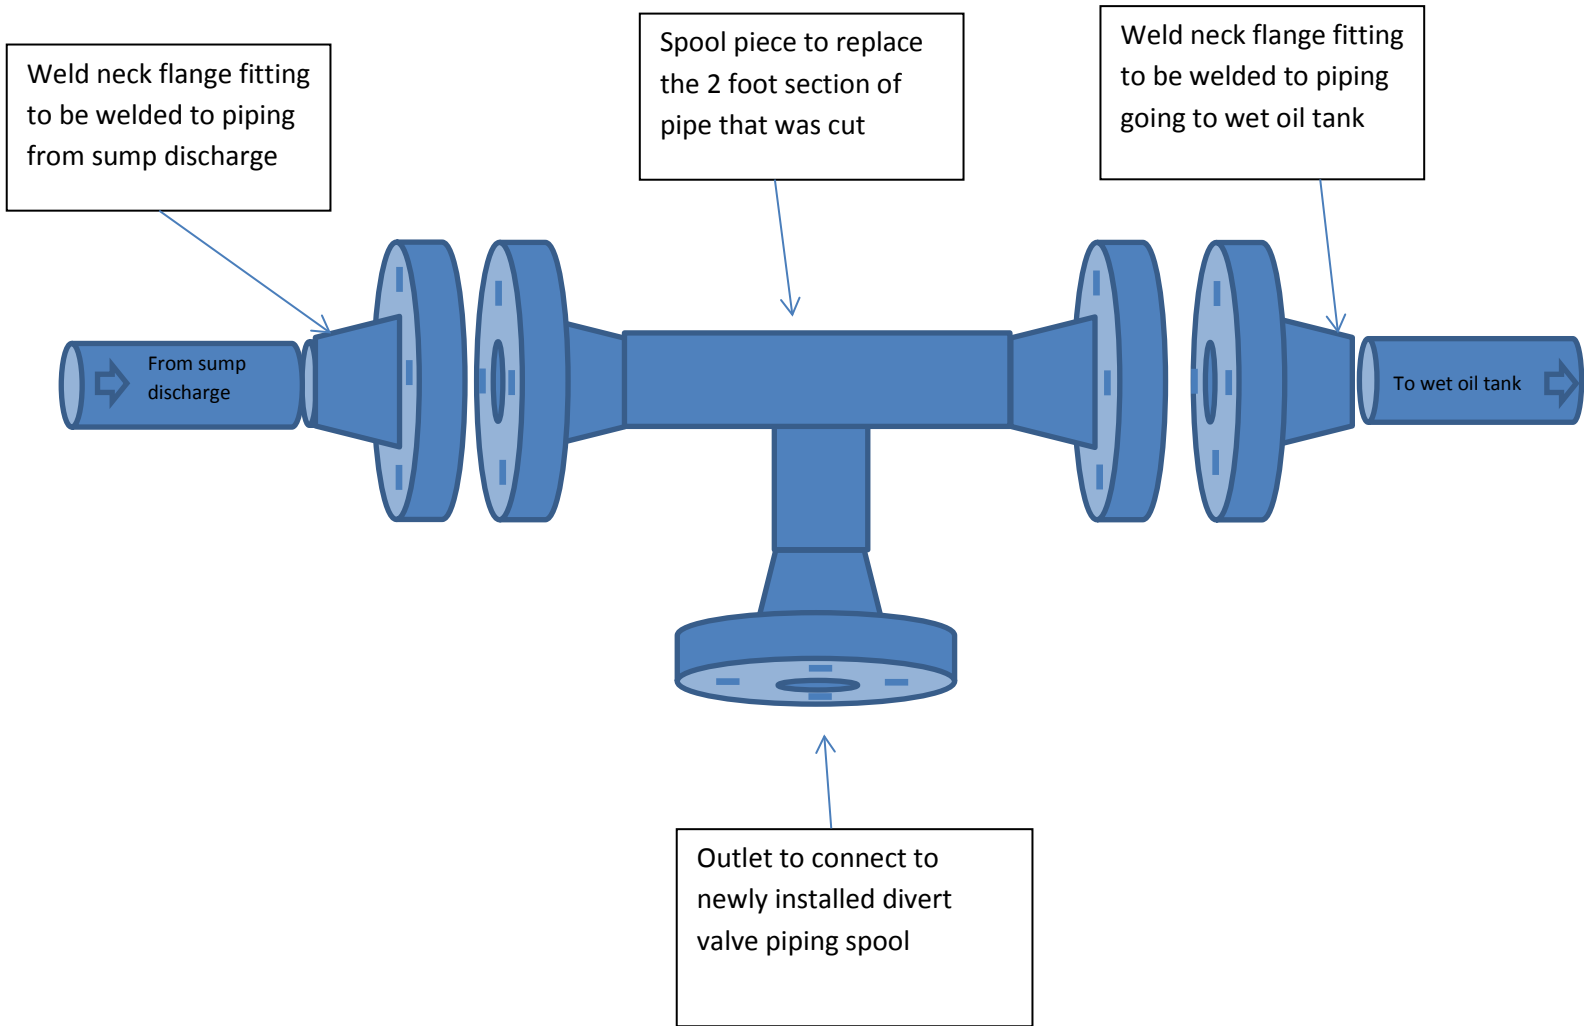
According to the GIS/DNR supervisor, he returned to the main office located on WD 32 D platform where the Compass consultant was also located. The GIS/DNR construction workers located in the LACT unit work area continued to make the necessary cold cuts until a two foot section of pipe had been removed. After the two feet of piping had been removed, a GIS/DNR construction worker used an electric powered grinder to smooth and prep the exposed piping edges for the welding of the two flanges (see figure 7). This grinding is considered hot work and according to witnesses produced a significant amount of sparks. Around 9:00 a.m., the GIS/DNR construction worker completed all of the grinding work and was joined on the scaffolding by two other GIS/DNR construction workers. These three workers were all standing on the scaffolding, preparing to start welding work. One of the GIS/DNR workers held the flange in place while another worker squared the flange and the third GIS/DNR worker was set to weld the flange into place. The welder was supposed to place several tack welds on the flange. These tack welds would be used to hold the flange in place as the welder completed the permanent welds. In an interview with Panel members, one GIS/DNR worker stated that it is at this point in time, just before the tack welding began, another GIS/DNR worker asked the other two workers if they smelled a gas like odor and received no response. The GIS/DNR welder then started to make the first tack weld, which ignited the flammable vapors present.

**Figure 13 – Illustration of the fabrication, assembly, and tack welding location**

The failure to properly secure the oil tanks, purge their pipelines, and follow established hot work procedures allowed the flammable vapors to reach a hot work area. The flammable vapors originating from these oil tanks reached the area where the GIS/DNR workers were tack welding a flange. Once the vapors were ignited by the welding work, the flame traveled from tank to tank due to the tanks' piping configuration. Due to the headspace in each tank, a combustible atmosphere inside each tank was created. Once this combustible atmosphere ignited, the increased pressures created inside each of the tanks could not be released fast enough through the vent system. These increased pressure levels exceeded the structural strength of the tanks and caused the tanks to fail at their base welds. This increased pressure and failure at the base welds resulted in two of the tanks breaking away from their base and launching off of the WD 32 E platform, eventually landing in the GOM. The third tank also broke away at its base weld and launched from the platform, however this tank struck the platform crane and landed back on the WD 32 E platform. The liquid contents of all three tanks were released from the bottom of each tank onto the platform and into the GOM. The flames that traveled through the tanks also ignited these hydrocarbons as they were released onto the platform and into the GOM.

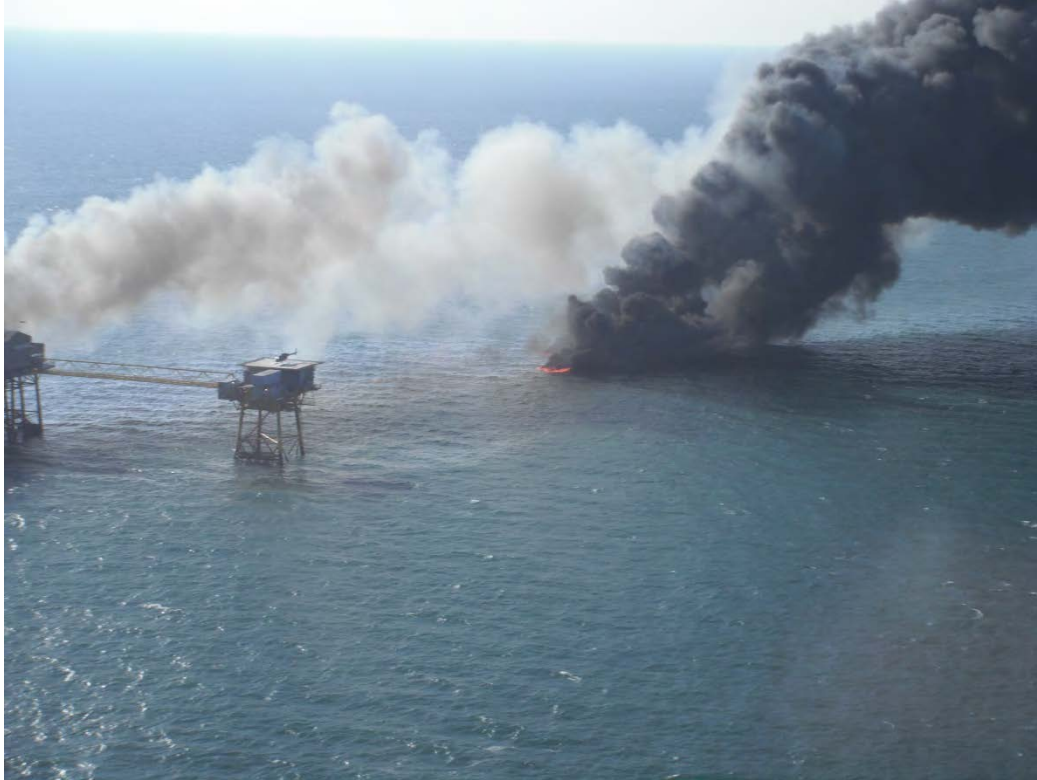
conclusions discussed in this report. According to ABSG modeling, in a matter of seconds the flame propagated through the piping into the wet oil tank, and then into the two dry oil tanks. All three of these tanks were connected by a common vent line, which allowed the ignition to continue from one tank to the next without obstruction. Based on ABSG flame propagation modeling, it took less than two seconds from the ignition of these hydrocarbon vapors for a chain reaction to occur that caused the wet oil tank and two connected dry oil tanks to explode. Due to the explosive pressure inside each tank, all three tanks separated at their base welds. After the tanks separated, the wet oil tank and one dry oil tank were launched by this force from the platform into the GOM (see figure 14). The second dry oil tank was launched into the air striking the platform crane causing it to land back onto the platform. The released liquid hydrocarbons ignited on the platform. These explosions contributed to the death of three workers, injured multiple other workers, created an oil sheen approximately one half mile by 200 yards, and caused platform damage. Based on the volumes of liquid present in each tank at the time of the incident, the Panel estimated that a total of 500 barrels of liquid hydrocarbons were contained in the tanks at the time of the explosion.

**Figure 14 – One of the tanks that landed in the GOM**

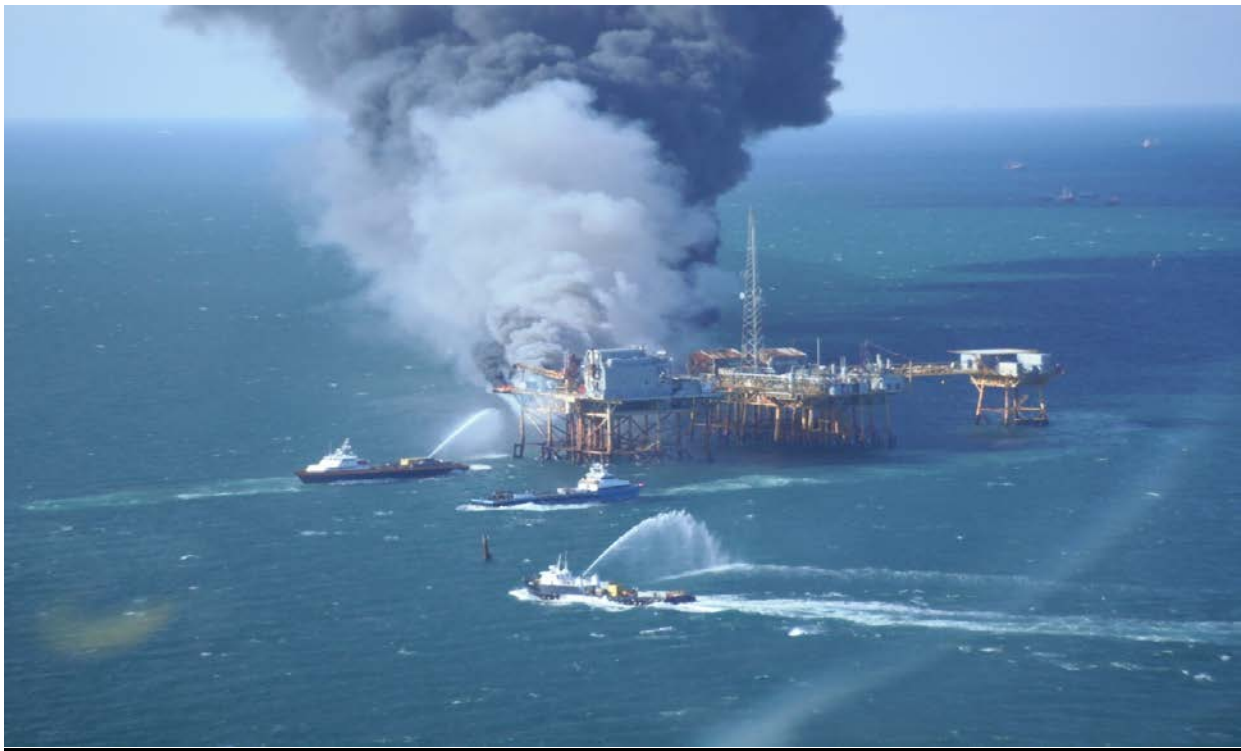
The fire was eventually extinguished by the WGPSN operators along with several boats in the area (see *figure 15*). BSEE and the USCG responded quickly to the scene to investigate the explosion/fire. BSEE observed an oil sheen approximately one half mile by 200 yards. (see *figure 16*).

***Figure 15 – Work boats in the area helping to extinguish fire on WD 32 E platform***

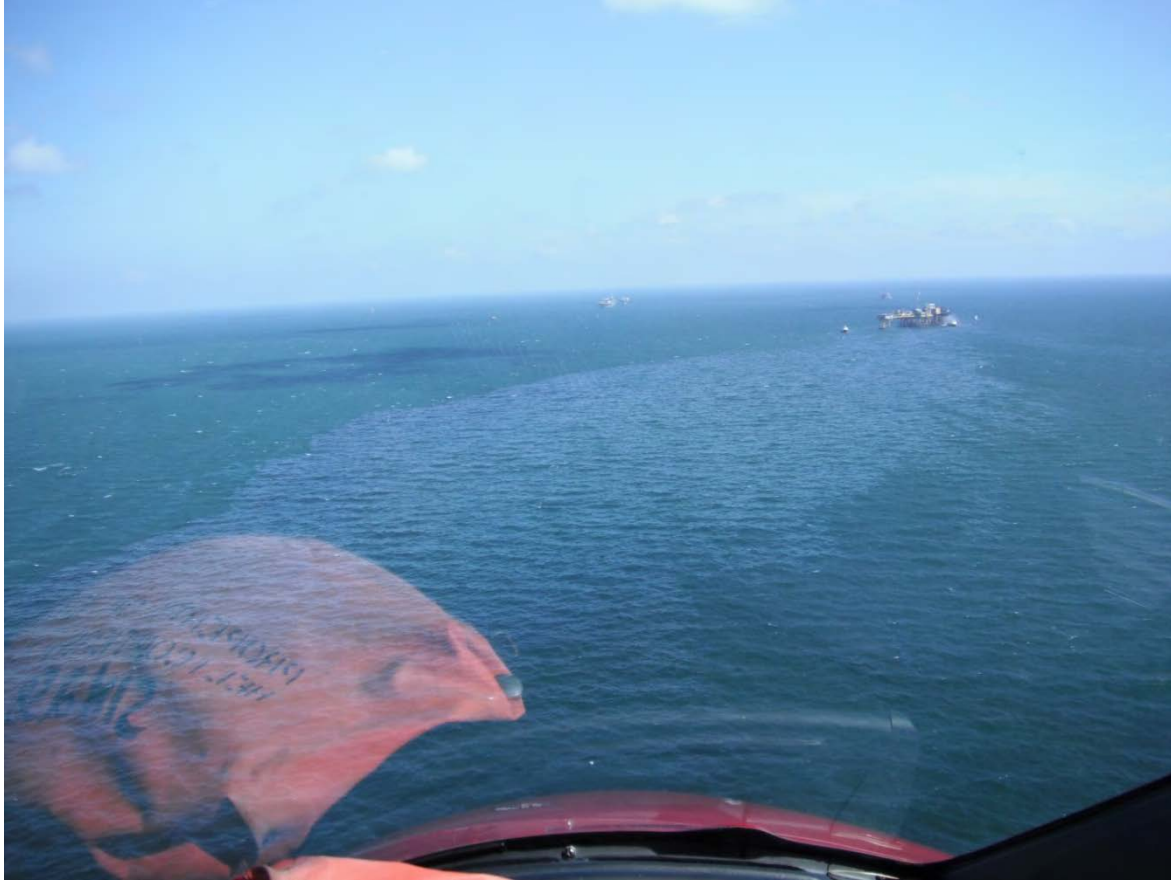
***Figure 16 – Sheen from Black Elk Energy WD 32 E platform after explosion and fire***
