PNNL New Jersey WindSentinel

Monthly Report #1 November 2015

Ocean Tech Services, LLC

December 17, 2015

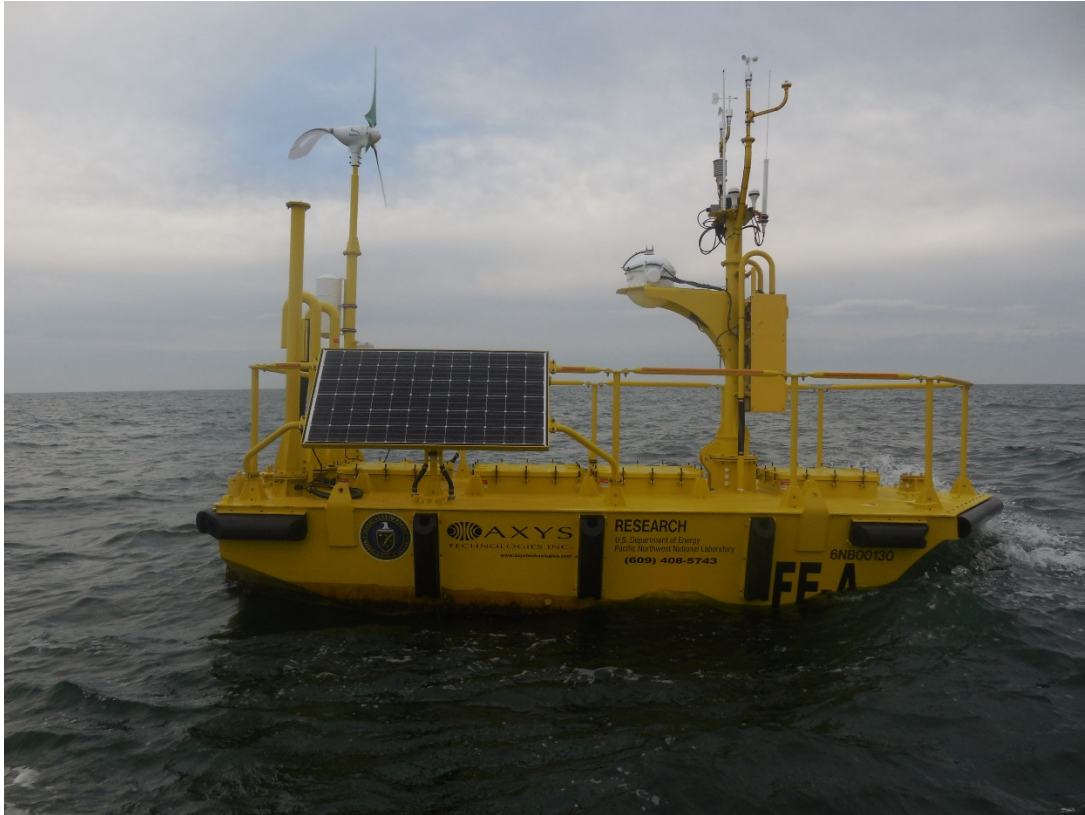
The WindSentinel on the day of inspection

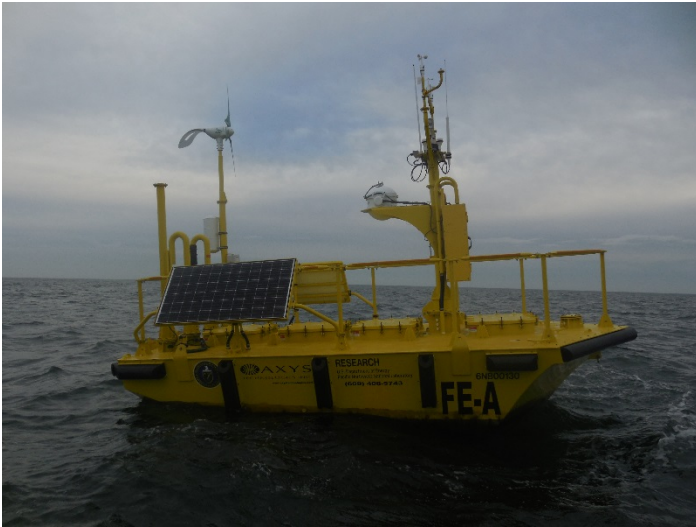
WindSentinel and conditions at arrival

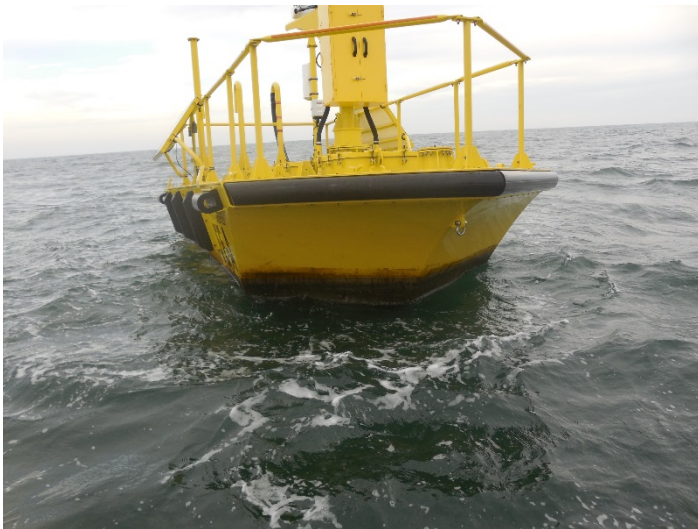
Additional Comments	
WHAT ADDITIONAL MAINTENANCE TASKS WERE PERFORMED?	
1	LOTS OF PICTURES
2	OPENED TURBINE JUNCTION BOX, INSPECTED.
3	
4	
5	
6	
7	
8	
COMMENTS OR NOTES FOR THE NEXT MONTHLY INSPECTION OR MAINTENANCE TRIP	
1	RAISE / CLEAN MOONPOOL SENSORS
2	
3	
4	
5	
6	
7	
8	
ADDITIONAL COMMENTS OR NOTES	
• BIOFOULING / GROWTH ON HULL AT / BELOW WATER LINE BEGINNING

Bow eye and hull biofouling
