Leadville Mine Drainage Tunnel Risk Assessment

Leadville Mine and Drainage Tunnel Project, Colorado
Great Plains Region

The Bureau of Reclamation has completed a study to evaluate the stability and assess the risk associated with the Leadville Mine Drainage Tunnel (LMDT) in Leadville, Colorado. The risk assessment consists of the following four sections:

Existing Condition of the Leadville Mine Drainage Tunnel

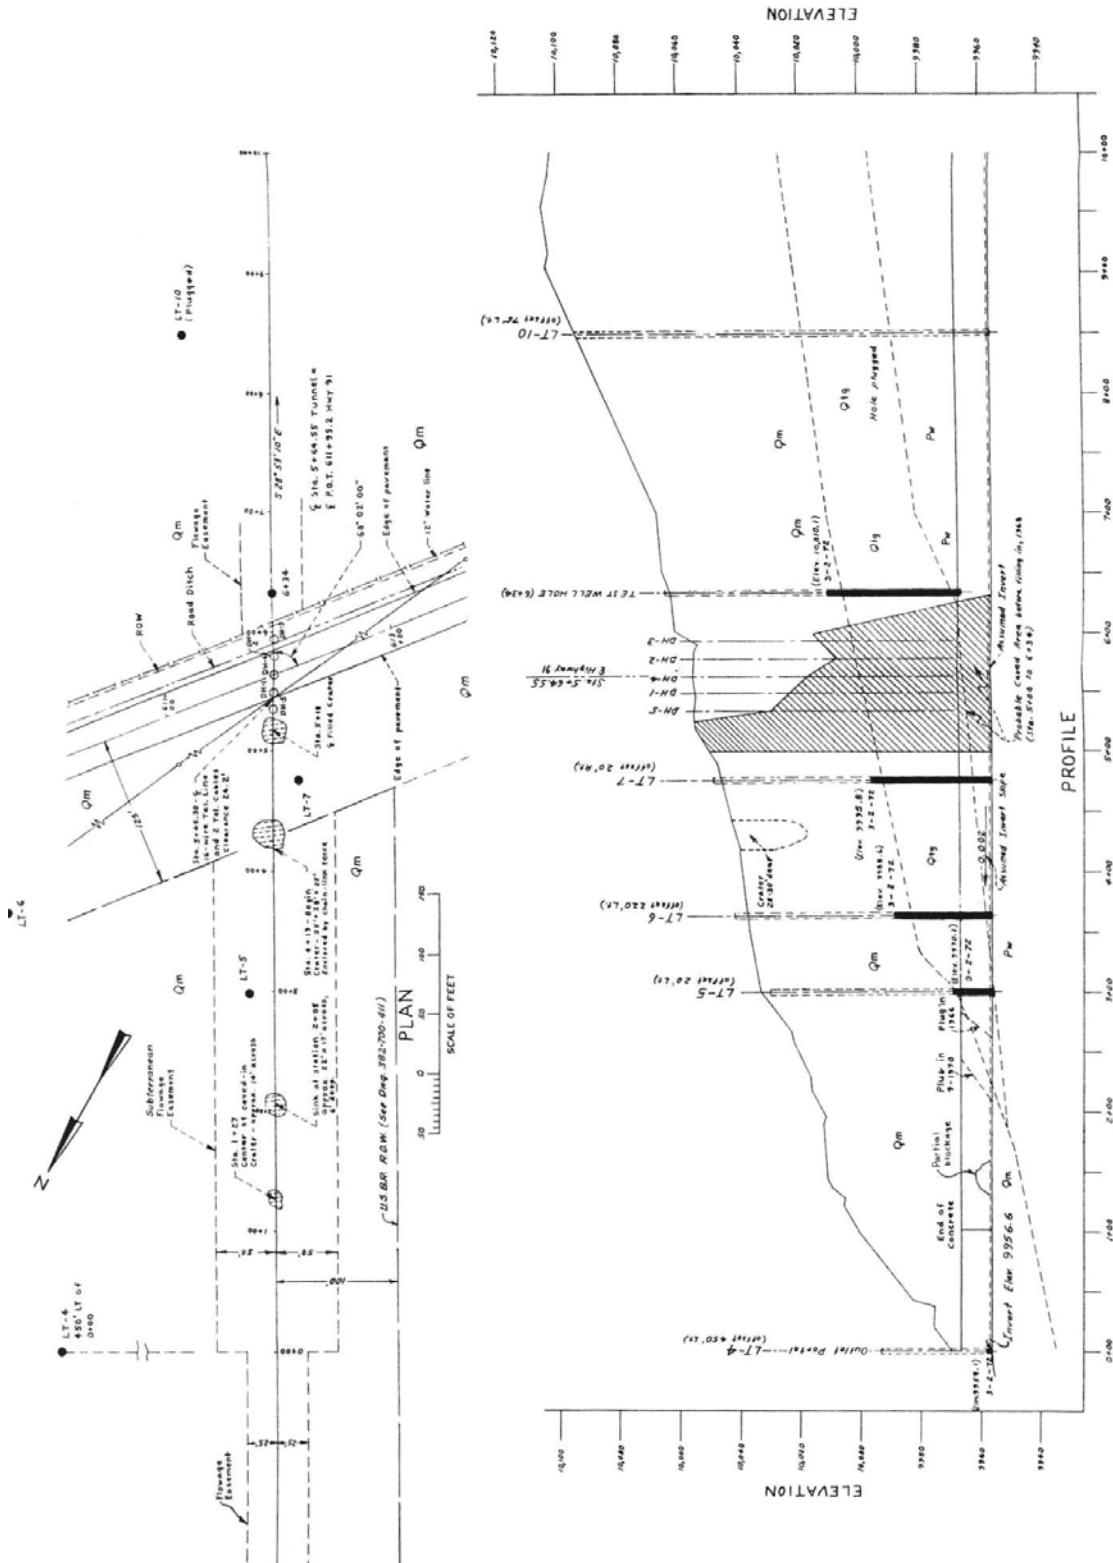
Figure 14. Plan and section showing condition of the LMĐT in 1972 including the location of sinkholes, 1968 injection drill holes, and monitoring wells installed in 1968, taken from (Reclamation, 1976).

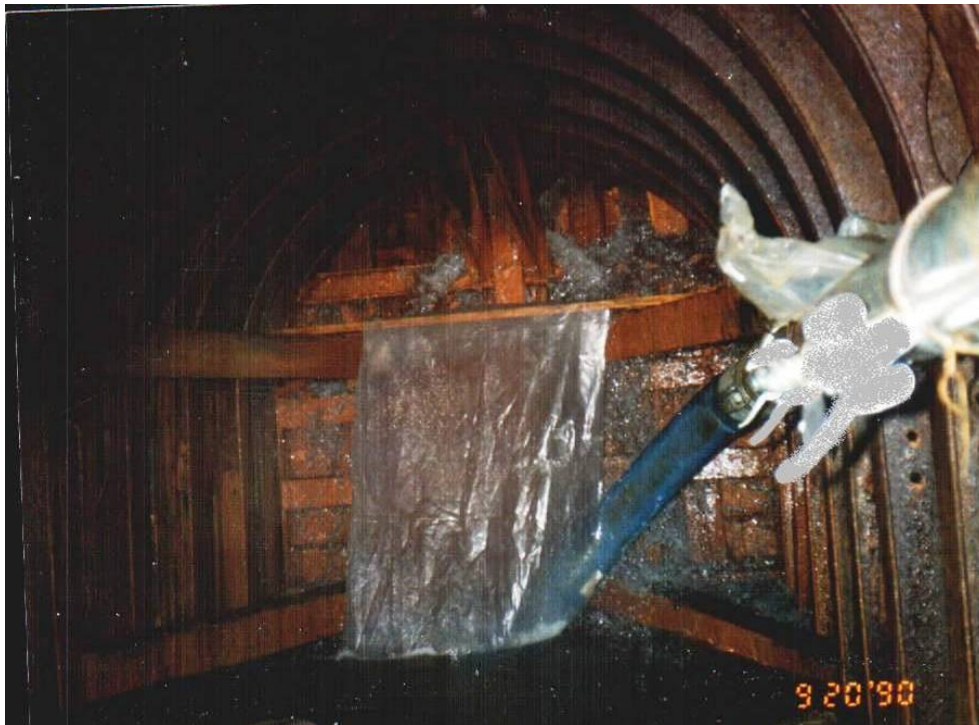
Figure 15. Photograph of the bulkhead located at Station 4+66.

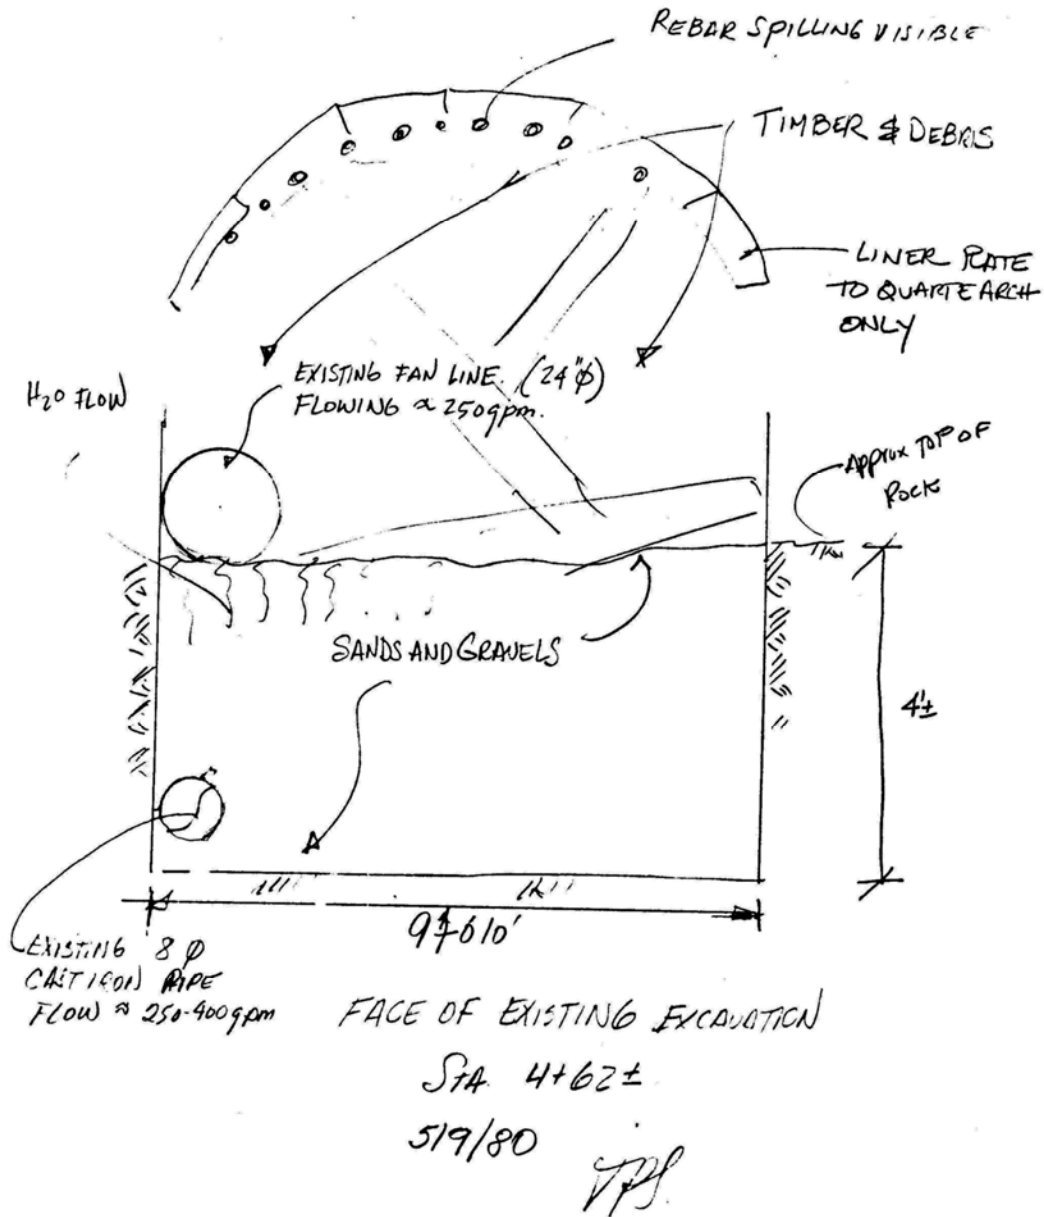
Figure 16. Sketch showing flows from vent pipe and compressed air pipe which extend through collapsed material in the LMDT, taken from (Smirnoff and Allen, 1980).

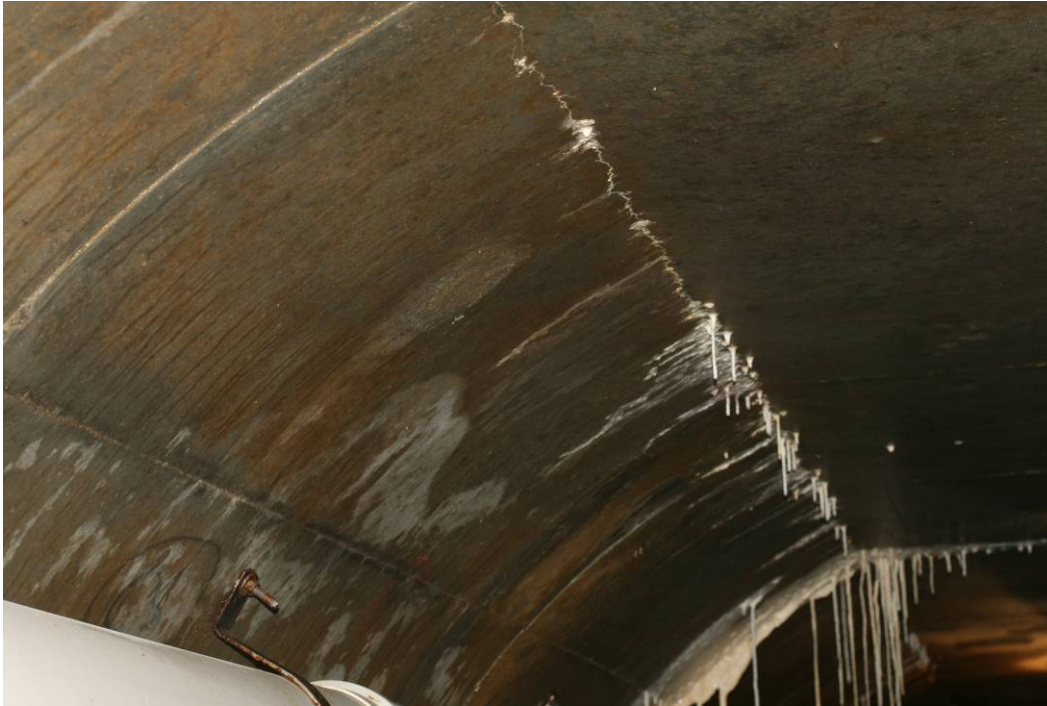
The inside surface of the reinforced concrete tunnel liner in the downstream portion of the tunnel has been coated with a bright white reflective material. The presence of this coating obscures the condition of the concrete. The upstream portion of the reinforced concrete liner (where the liner is under higher soil and water loading) has not been coated. Approximately ten cracks were observed in the concrete lining. The cracks varied from hairline to about 1/16 of an inch wide. The two most significant cracks were found on the left side of the tunnel (looking downstream), one in the crown, (see Figure 20), and one along the wall about 4 feet above the floor. Both of these cracks were about 20 feet long and 1/16-inch wide. A small amount of calcium bearing mineral precipitates are forming from the seepage coming through the cracks. The seepage rates are very slow; at most locations the cracks are wet, but not dripping. The cracks are of little structural concern. Probing with an ice pick it was not possible to dig open the cracks. The concrete is sound and very hard, even right at the edge of the crack. Only one crack near the lattice bulkhead showed minor offsetting of the tunnel lining; at all other cracks, the lining is smooth and even across the crack.

Figure 20. Photograph taken on March 25, 2008 looking downstream from about midway inside the reinforced concrete lined segment of the LMDT. Note the calcium carbonate stalactites forming from the slow seepage along a thin roof crack and at a joint in the concrete lining.

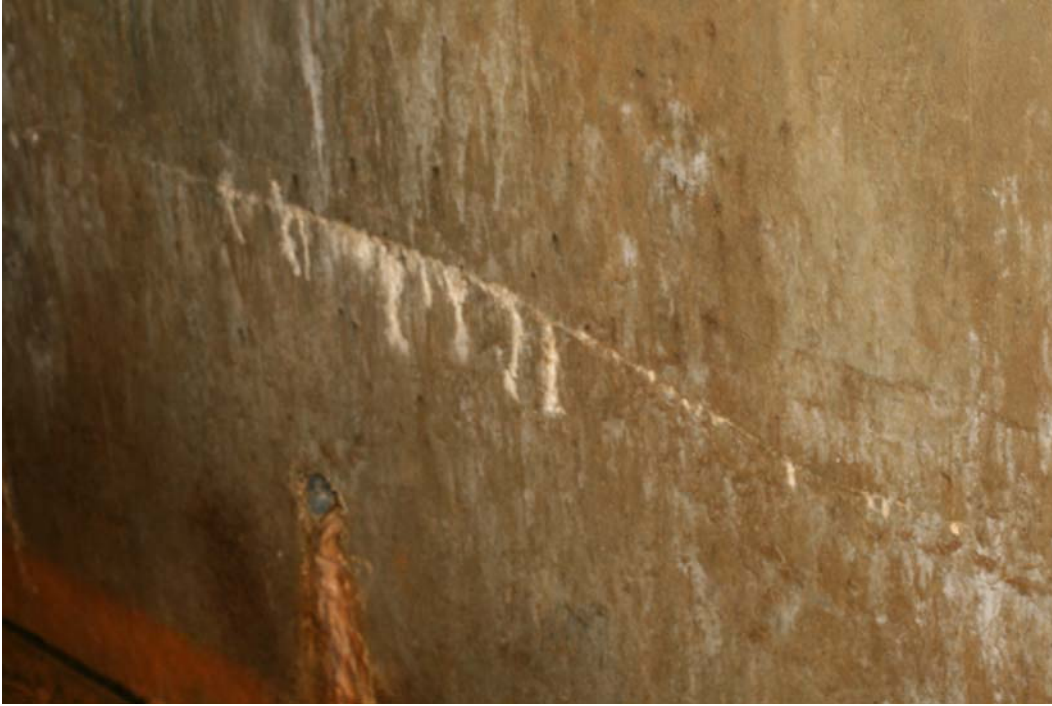
Figure 21. This crack located about 3 feet above the LMDT floor is the only one that showed offsetting of the concrete. The offset is about 1/8 inch.

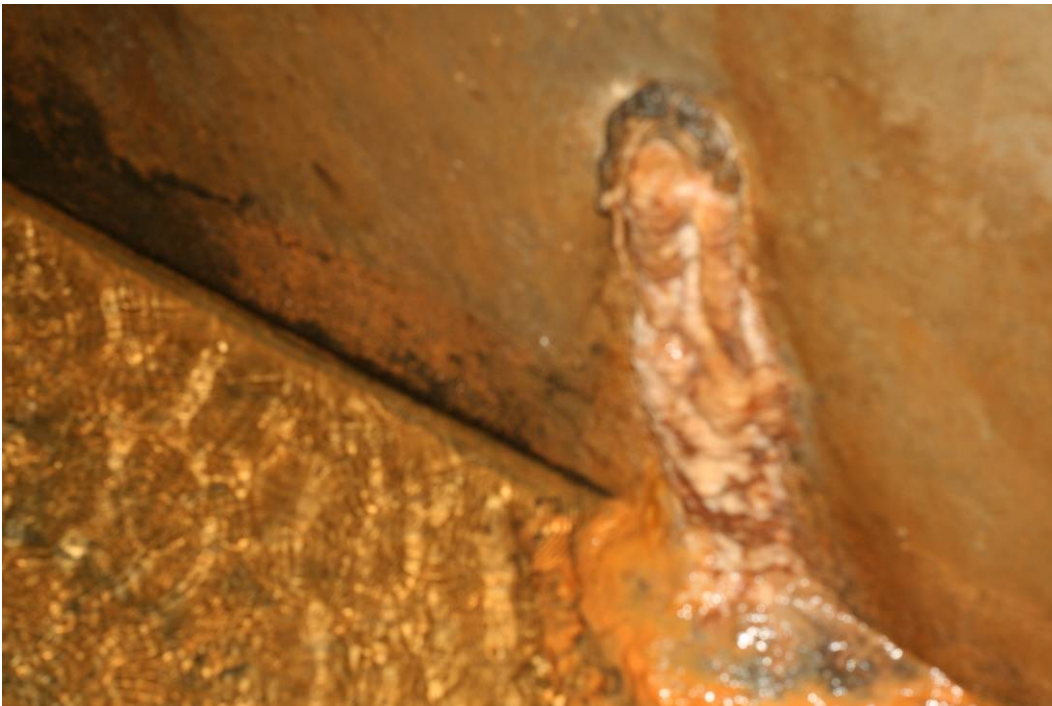
Figure 22. Photograph of a weep hole in the reinforced concrete lining which is almost completely blocked by calcium carbonate precipitates.

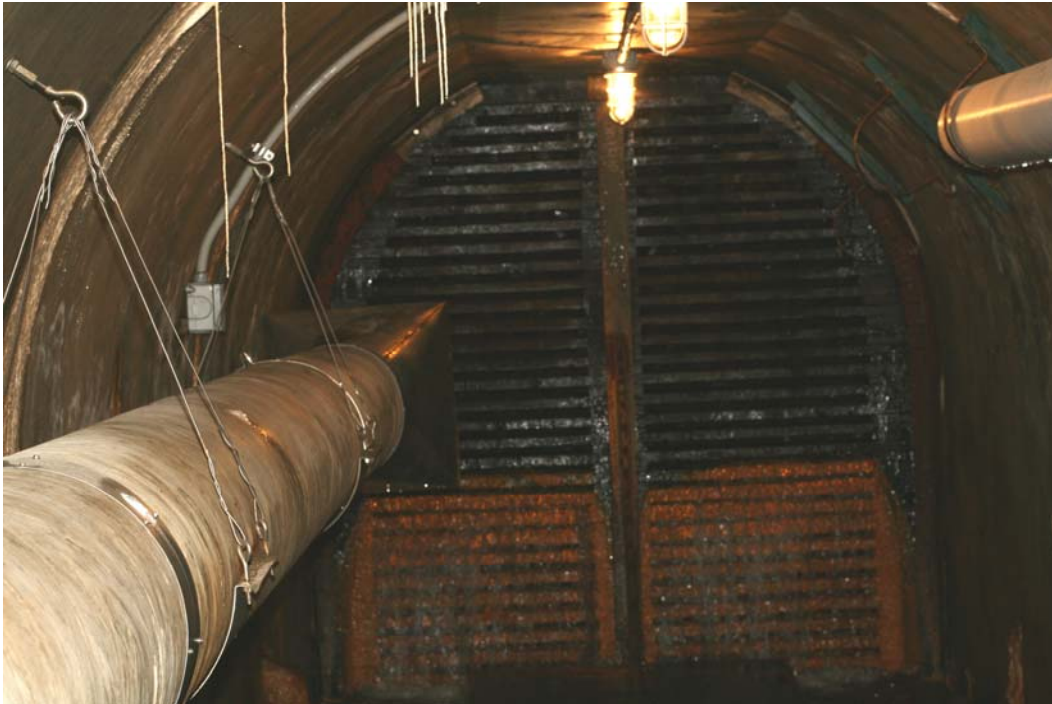
Behind the bulkhead are 3- to 12-inch cobbles behind which is a vertical zone of 1 ½ to 2 ½-inch gravel. During construction, finer sized gravel was used for the gravel fill, but when the timber lattice support was installed, it was found that the smaller gravel was carried into the lattice openings by the water flow and it resulted in constricting the drainage flow rate through the timber structure. A change was made to install a vertical zone of cobbles to lie in immediate contact with the timber lattice which is what was observed to be the case.

Figure 23. Photograph taken on March 25, 2008 of the cobble and gravel-filled timber-lattice bulkhead at Station 4+61 of the LMDT. At left is the intake end of the ventilation pipeline.

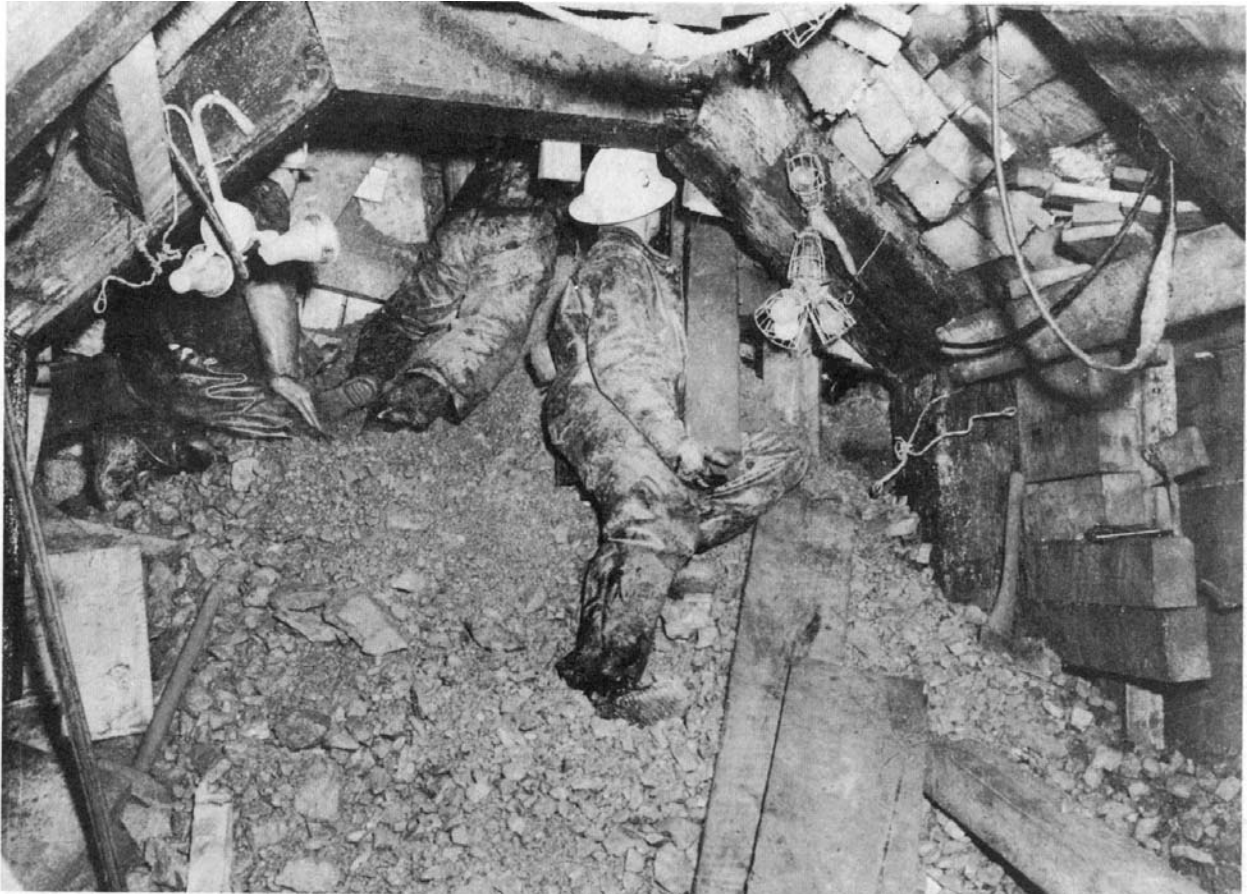
Figure 2. Excavating to remove a boulder at the top of a collapse zone of shattered quartzite in the LMDT, note the mix of material sizes, taken from (Salsbury, 1956).

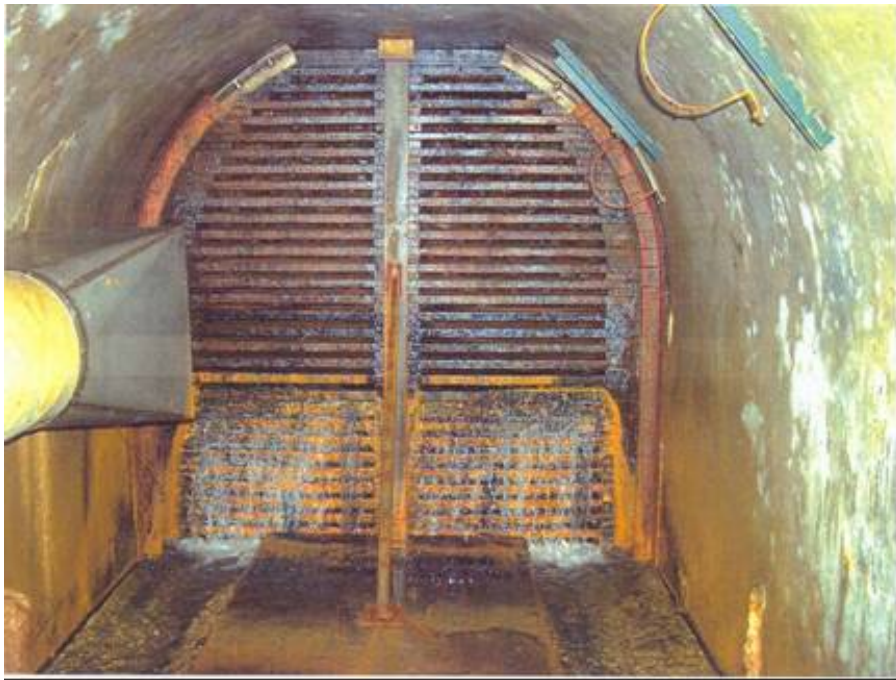
Figure 4. - Photograph taken in 2001 of the existing Timber Lattice Bulkhead installed in 1991 at Station 4+60 to 4+61. Note clarity of water outflow and 2.5-foot high flow with has been typical since post construction.

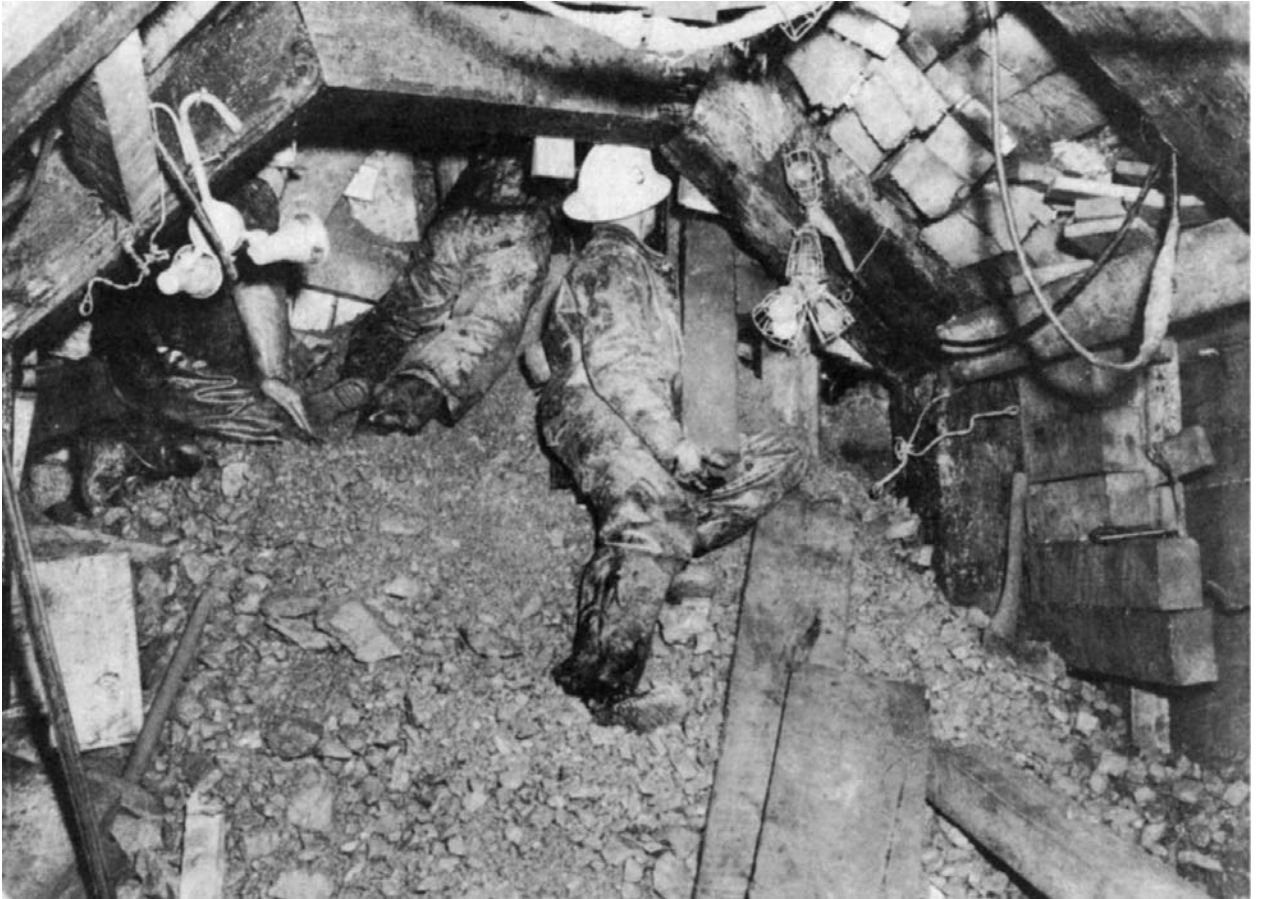
Figure 5. Running Ground in the Parting quartzite (approximate date August/September 1951)
