# **JOINT U.S.-CANADA POWER SYSTEM OUTAGE TASK FORCE**

**UTILITY VEGETATION MANAGEMENT INITIAL REPORT  
December 2003**

# INITIAL REPORT UTILITY VEGETATION MANAGEMENT

## FAULT CHRONOLOGY, OBSERVATIONS AT FIELD SITES AND COMMENTS

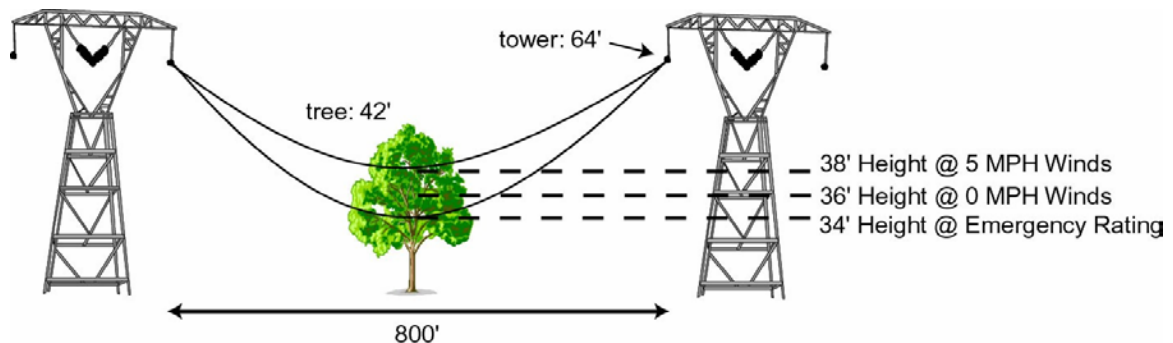
The following graphic provides an example of how conductor height can vary depending on load and wind velocity.

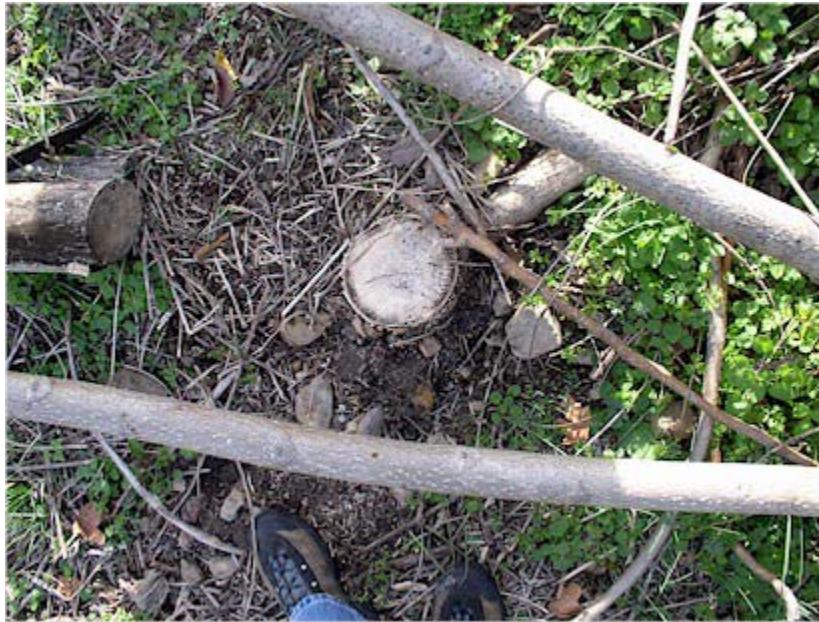
Evidence of tree contact was observed between towers 222 and 223. Conductor height of north phase measured 39 feet at tree location and point of contact. Center phase measured 41 feet and south phase measured 47 feet.

Two ailanthus trees showed evidence of significant fault current damage and were debarked. One measured 2.5" diameter at ground line, and the other measured 6" diameter at ground line.

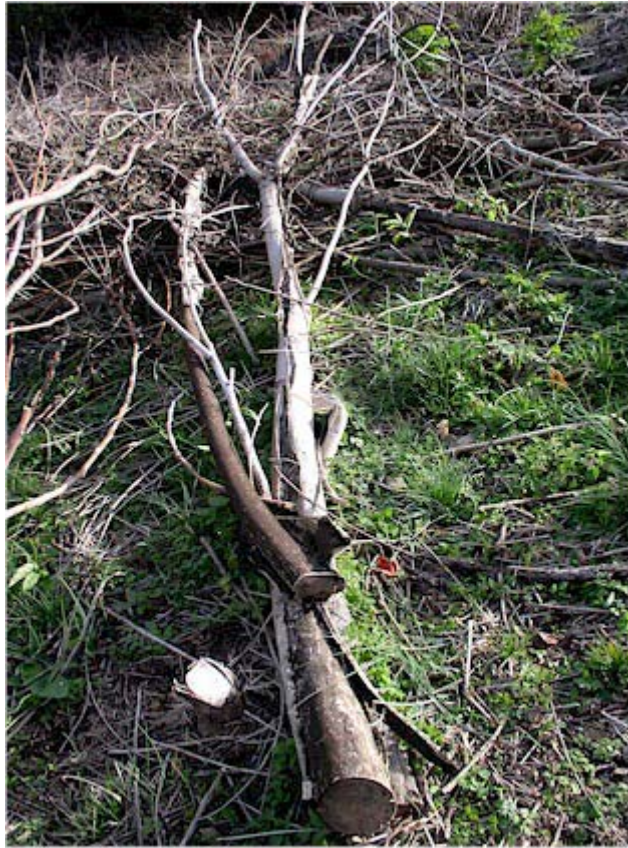
Both trees estimated to be 30 to 35 feet tall. Other trees in the area showed evidence of fault current damage as well.

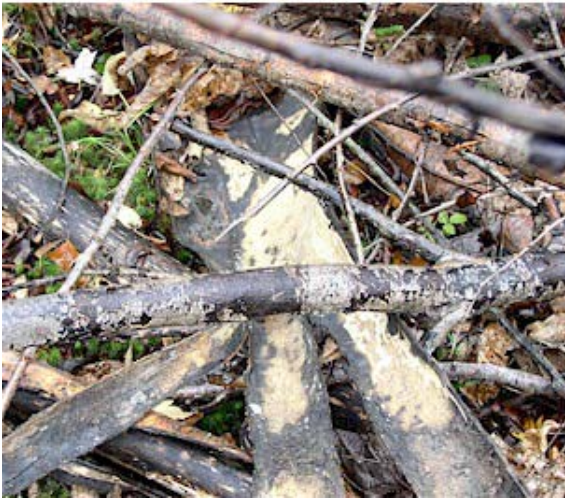
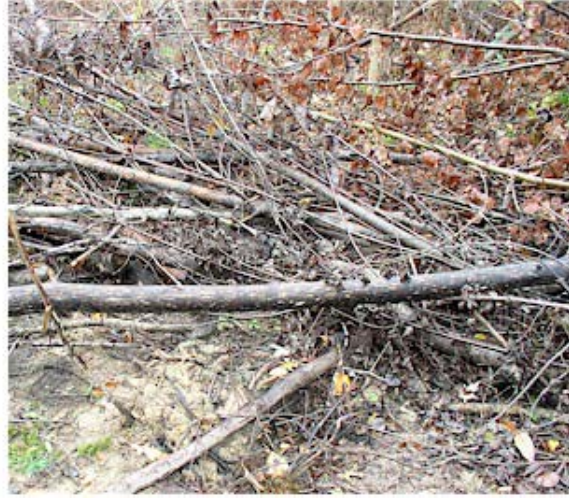
Inspected tree conditions at structure 40376 (20.5%) between towers 40375 and 40376. Trees and vegetation were felled on or after August 14<sup>th</sup>. Debris and tree parts were inspected on site.

Conductor height measured 44' 9". Tree height measured at 30 feet, although we could not verify location of the stump, or missing section of tree. Obvious significant fault damage to clustered trees. Charred limbs, and de-barked by fault current.

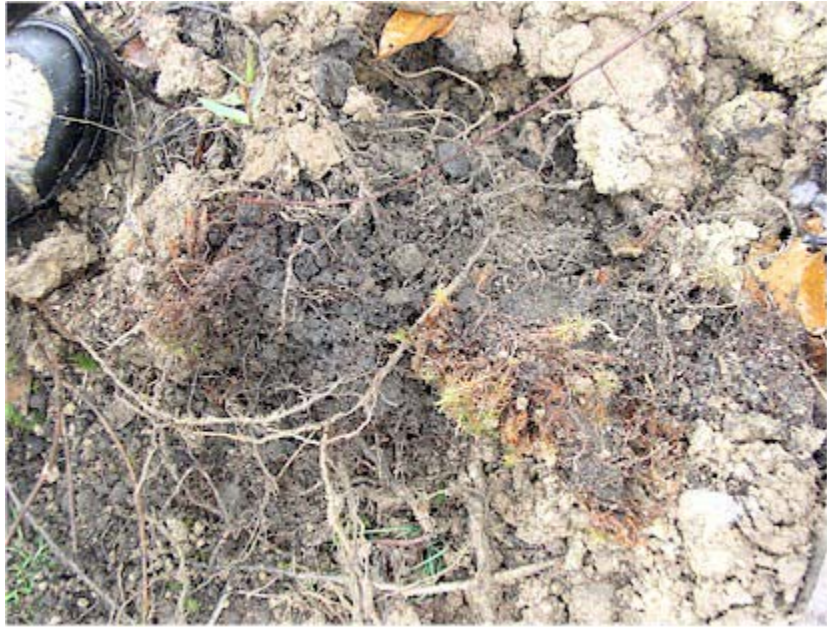
Topsoil in the area of trunk was disturbed, discolored and broken up at site. This would be indicative of a higher magnitude fault or multiple faults.

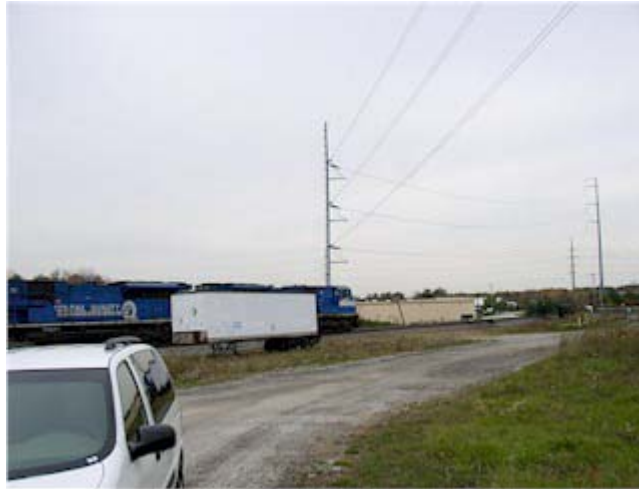
No evidence of vegetation at calculated fault location (11.3%). See photo below.

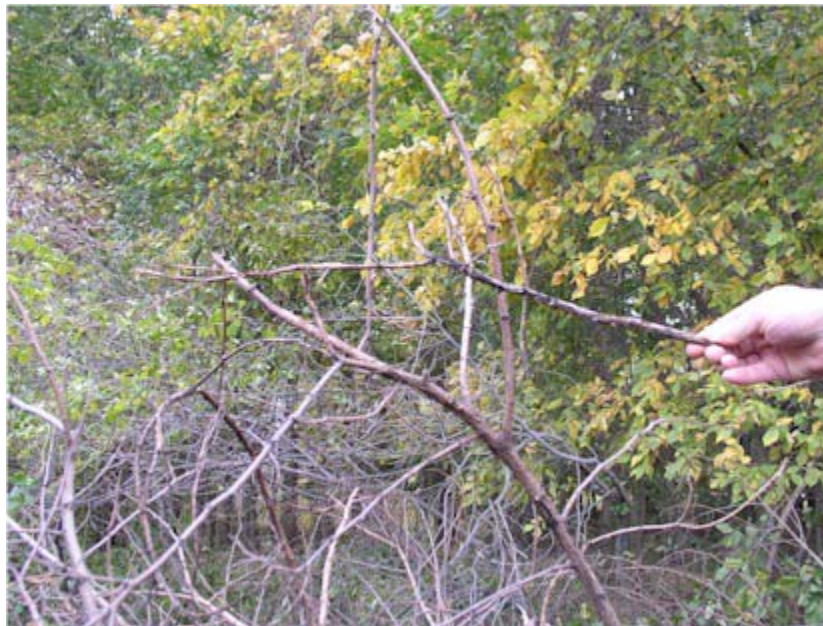
At 17.7%, between towers 42861 and 42860 we inspected vegetation. Trees and brush were felled on or after August 14<sup>th</sup>. Conductor height measured at 46' 7", tree height measured at 42'. Locust tree showed evidence of fault current damage. Tree damage indicated a lower level of fault current.

Burn marks were observed at 35' 8" up tree. Portions of the tree had been removed from the site making it difficult to determine exact height of contact, implying that the height is a minimum, and likely 3-4 feet higher than verifiable.

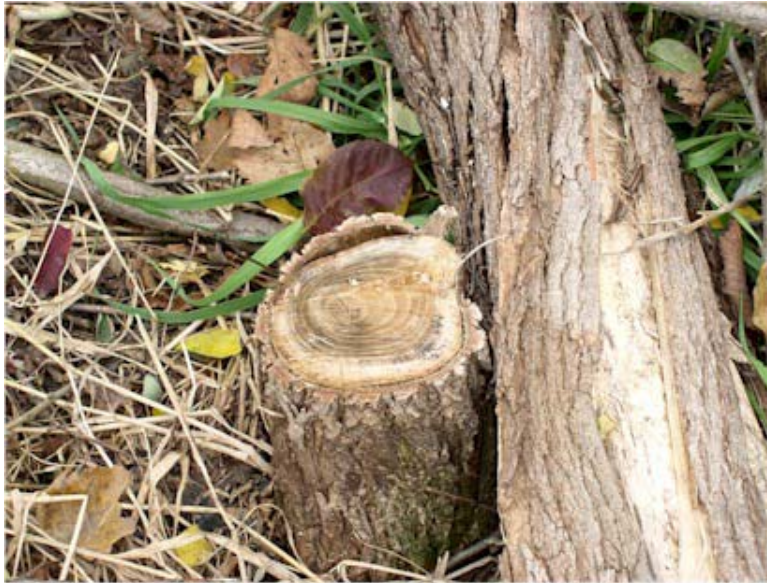
Other vegetation along the right-of-way measured between two and five inches in diameter at ground line. The following photo depicts a tree located in the right-of-way that was over six years old, as indicated by the growth rings.

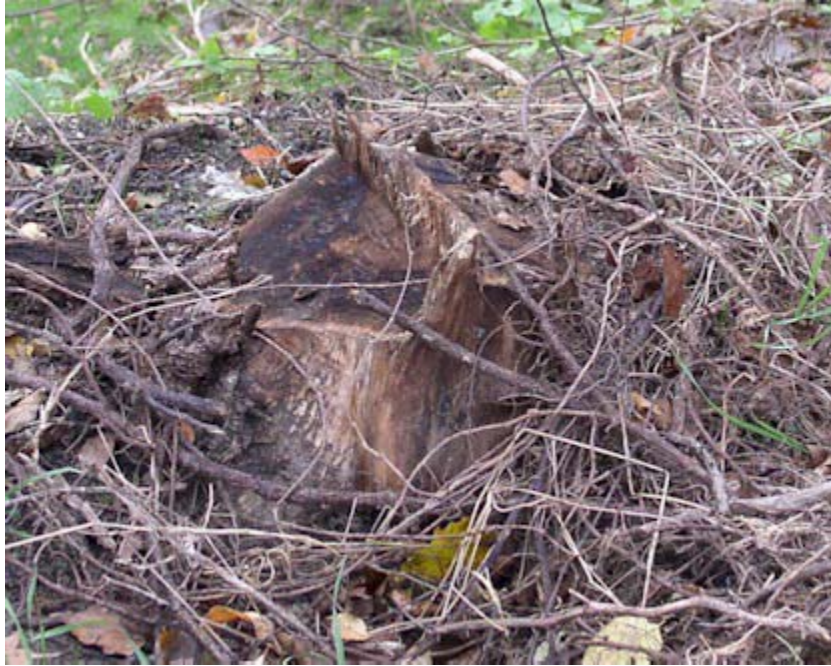
Conductor height measured 48' 9" at fault location. No evidence of tree debris at site. Walnut tree stump measured 14" diameter at ground line.

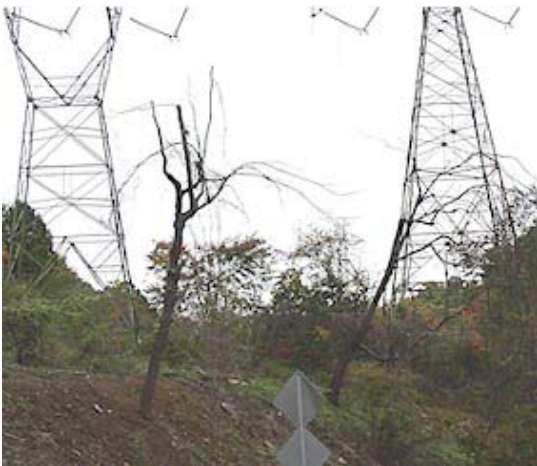
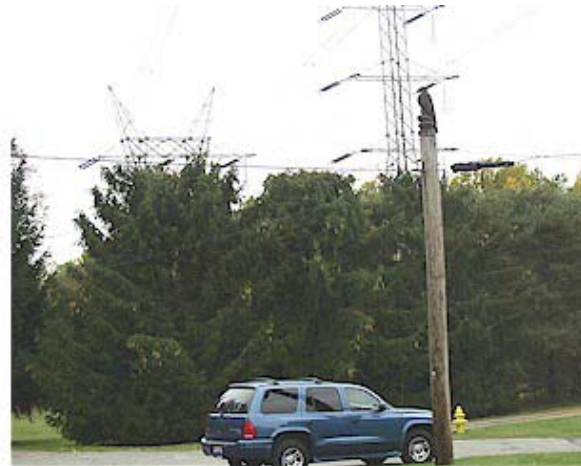
Subsequent clearing left trees and brush that, in our opinion, could have been removed as indicated by the photo below on the left. This photo was taken in the same span as the fault occurred. Other trees were pruned and left in the right-of-way as part of a landscaped area as indicated by the photo on the right. This photo was taken within one span of the fault.

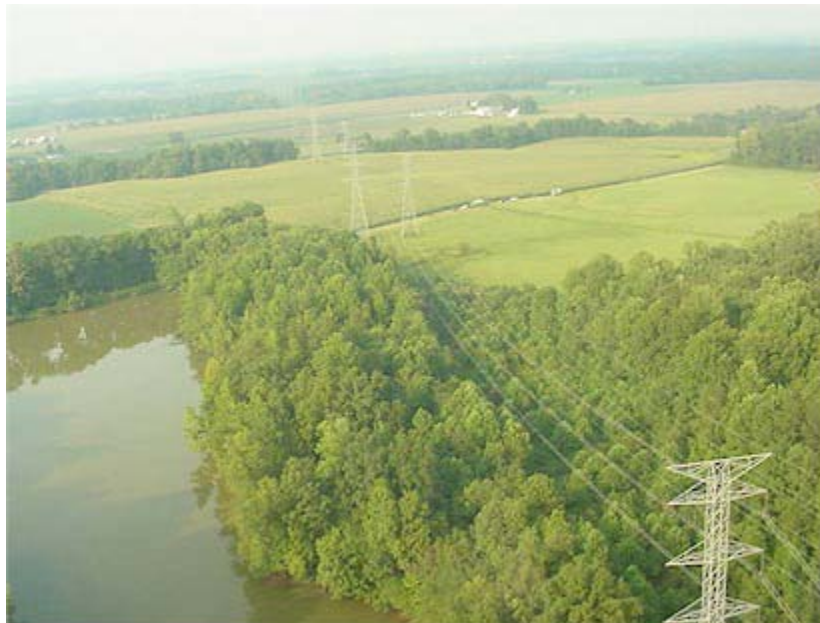
Based on discussions with Cinergy, this transmission line fault occurred as a result of tree contact in one span of the Columbus – Bedford circuit. See photo below.

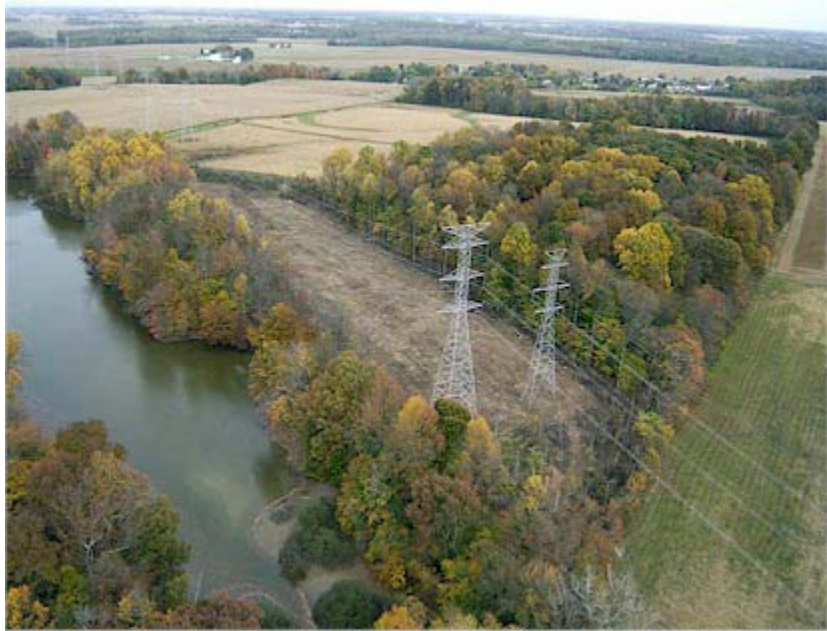
Apparently work on this span had been halted various times by the owner of the property. The owner of the property had severely limited the ability to achieve necessary clearances, and apply subsequent herbicides to control future growth. While Cinergy does, in fact, have documented rights to perform this work (documented easement), this landowner has successfully halted work from proceeding on several occasions. This included the homeowner obtaining a court granted temporary injunction halting work by Cinergy. Note: the required work was finally completed on October 9, 2003 as depicted in the photo below.
