# Instrumentation Failure and Embankment Breach Taum Sauk, Missouri

## FERC Response to the Taum Sauk Embankment Breach

**Daniel J. Mahoney, Deputy Director  
Division of Dam Safety and Inspections**

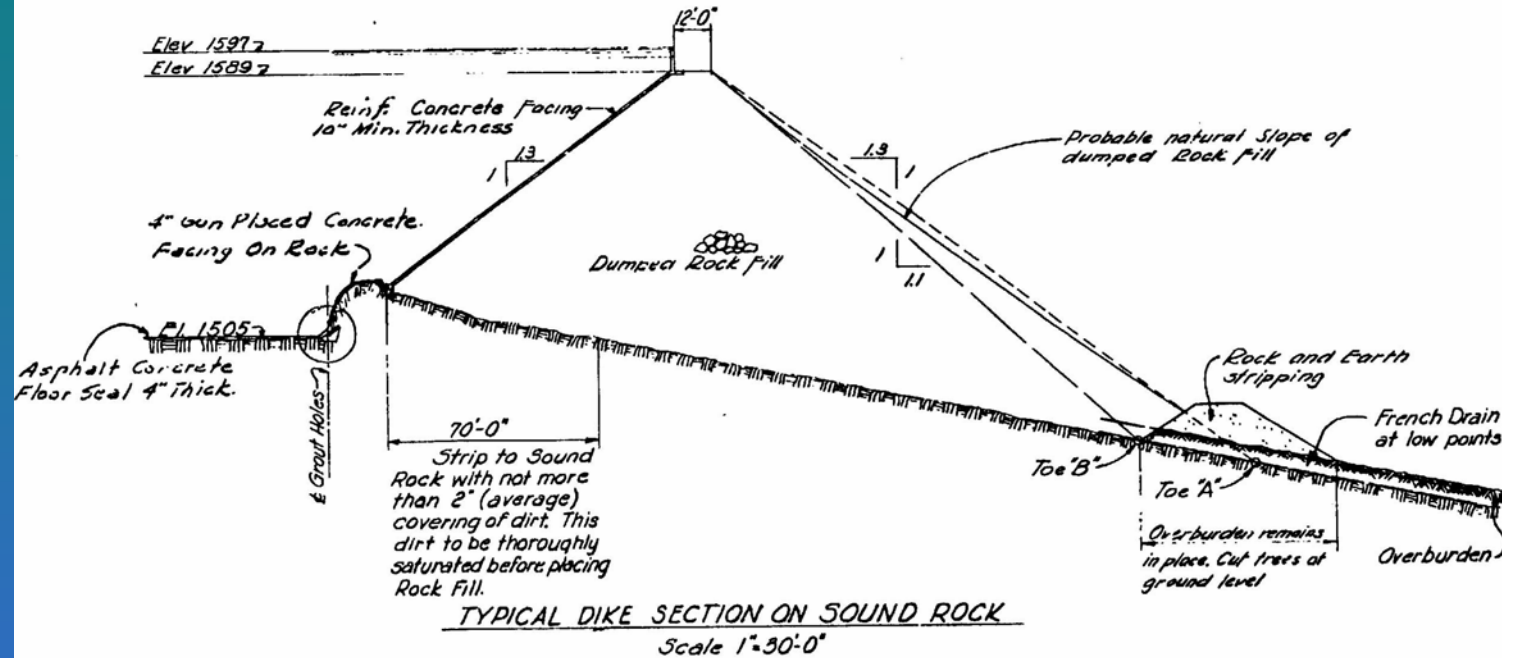
## Cross Section from Original Design Drawings

- 100-Foot High Concrete Faced Rock Fill Embankment
- 10-Foot High Parapet Wall
- Operation – 2-Foot of Freeboard

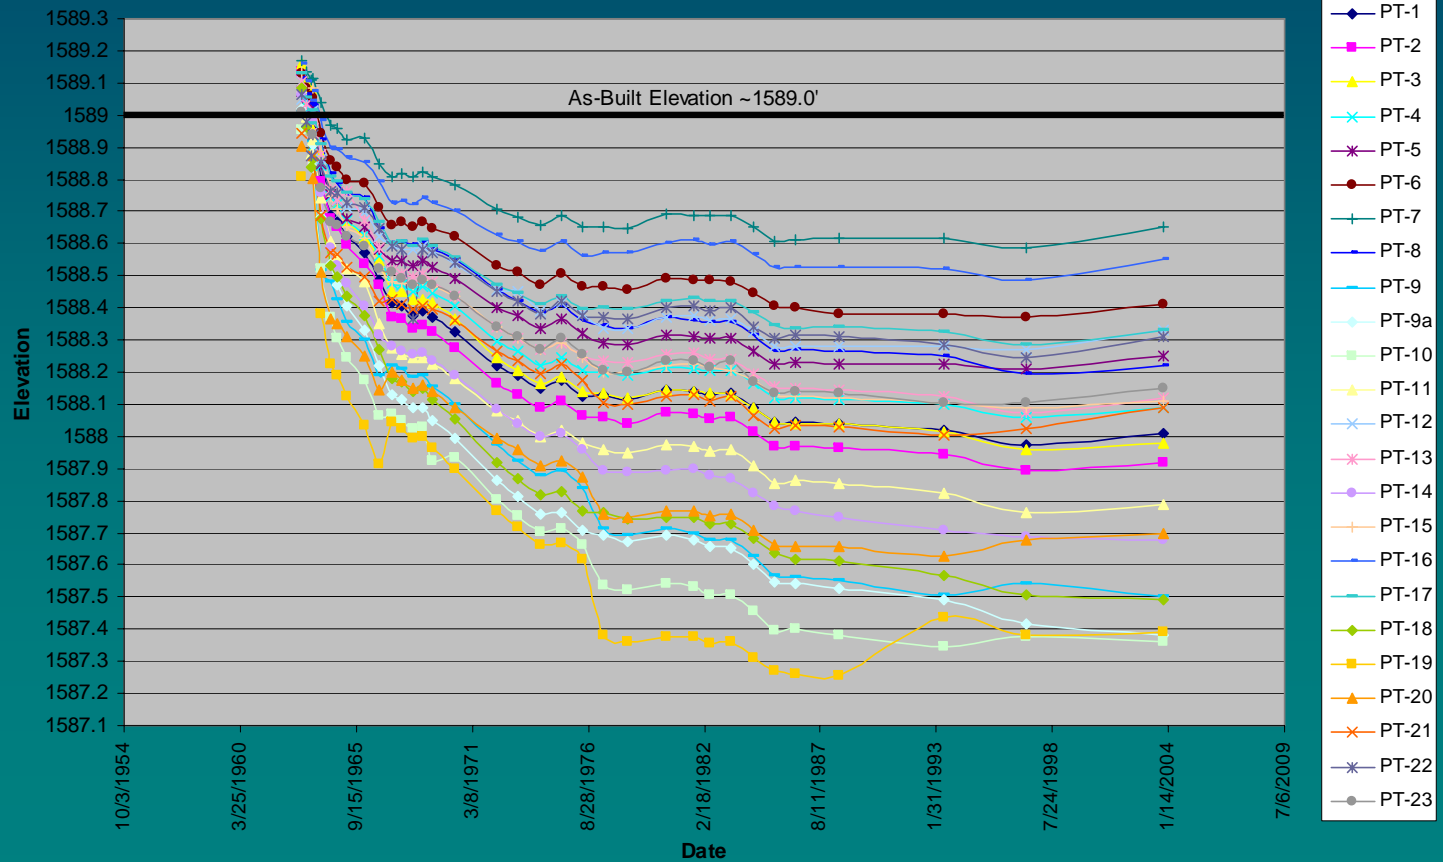
Total History  
Taum Sauk Pin Elevations

# Long Term Settlement of CFRF Dam

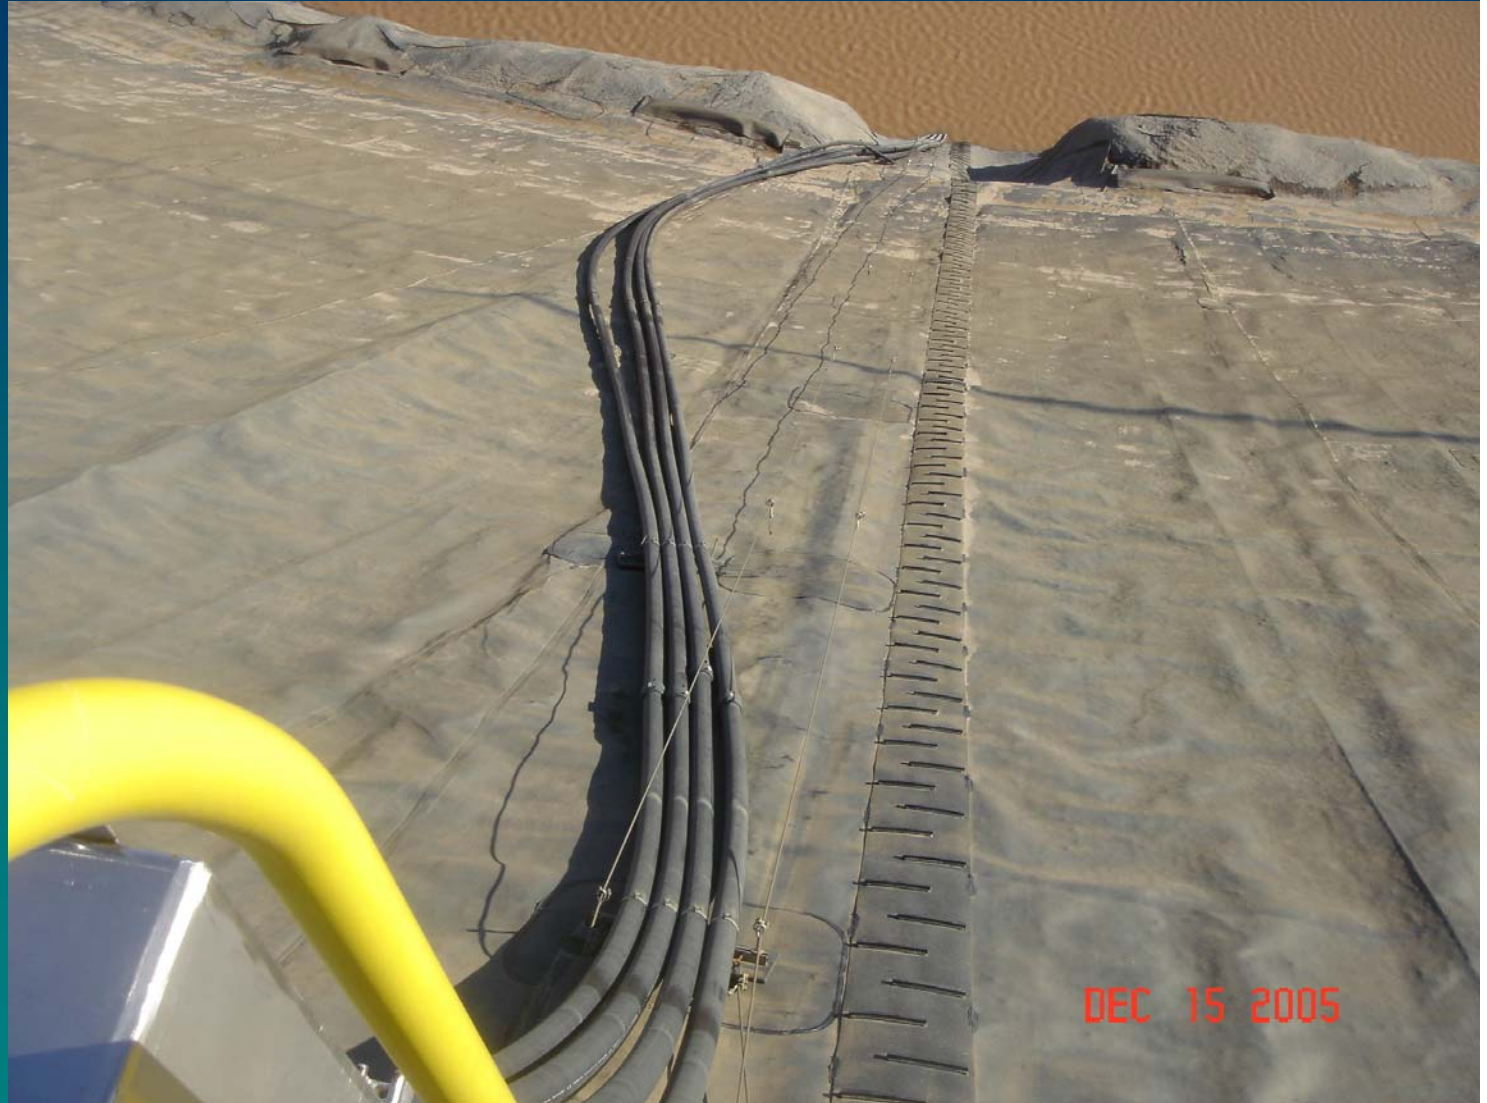
DEC 15 2005

- The Pressure Transducers that Monitored Reservoir Water Levels Became Unattached From Their Supports Causing Erroneous Water Level Readings

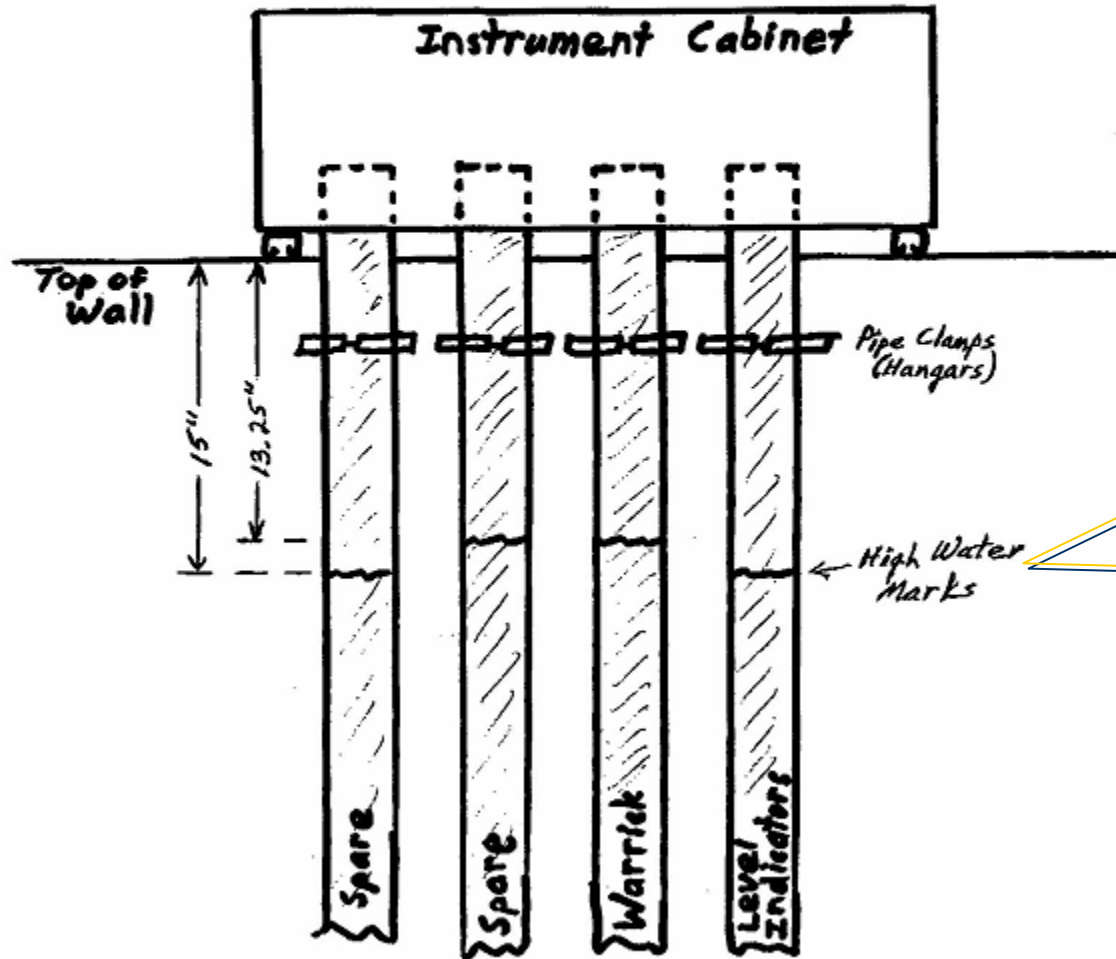
- The Emergency Backup Level Probes Were Set at an Elevation above the Lowest Points Along the Parapet Wall; Thus, They Failed Their Protection Role Because This Enabled Overtopping to Occur Before the Probes Could Trigger Shutdown

1596.90

1596.75

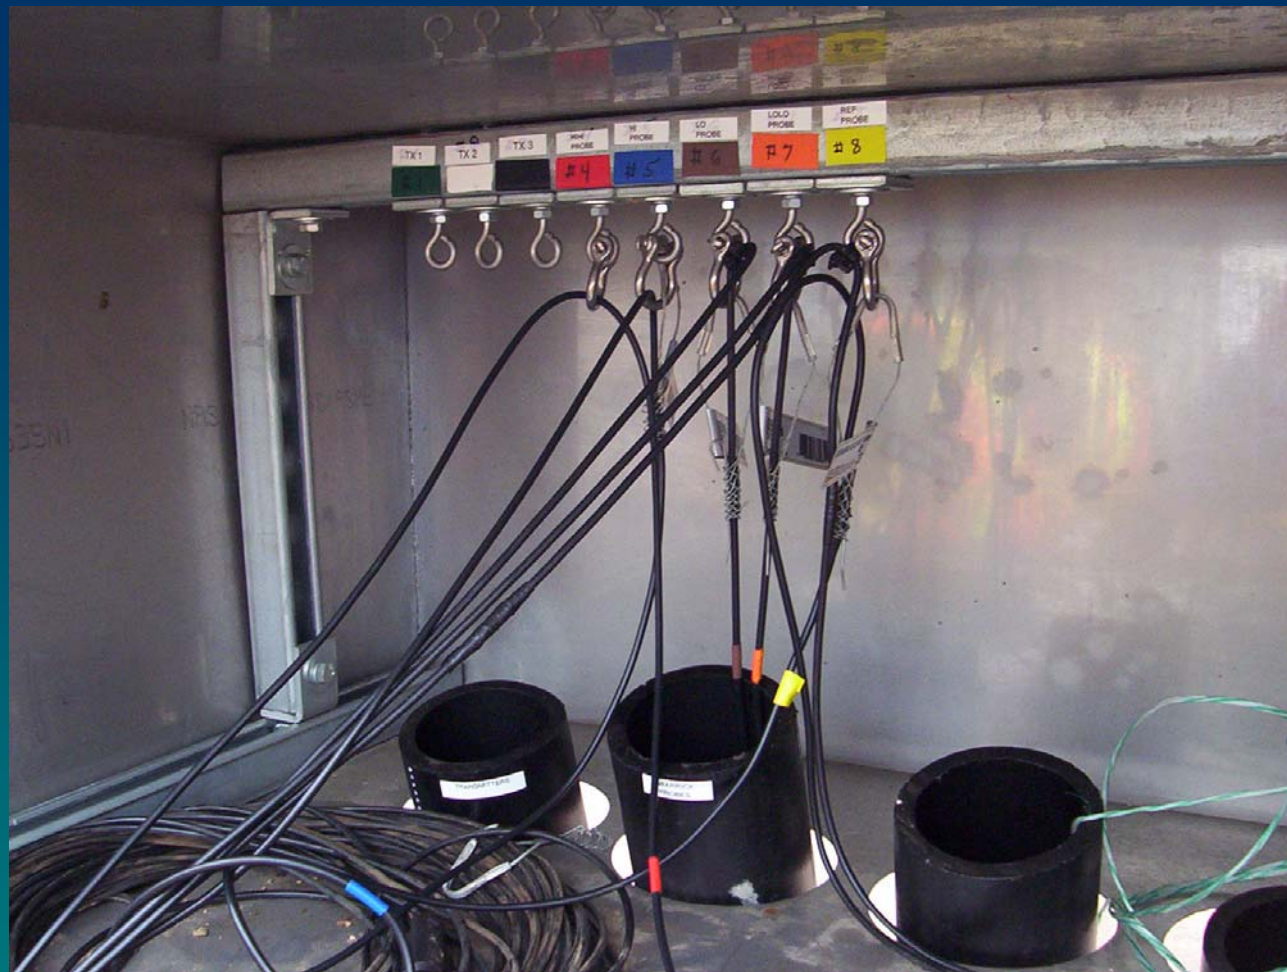
Upper Ends of Protective Pipes With Instrument Cables in Enclosure on Parapet

Pressure Transducers Use Left Pipe and Conductivity Probes Use the Second Pipe From Left

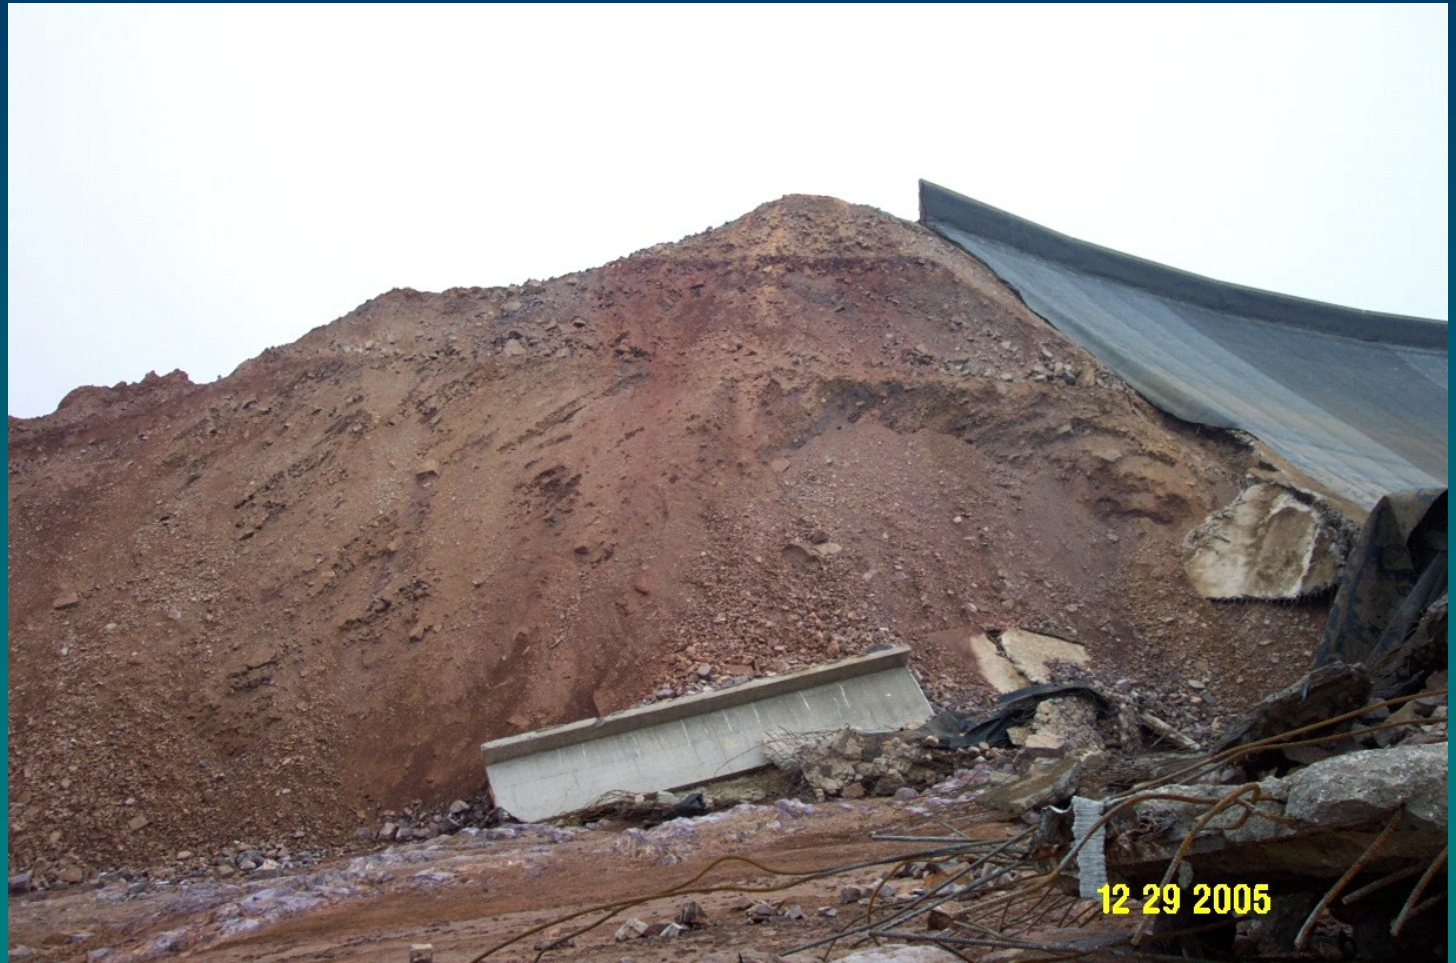
The Marginally Stable Dumped “Dirty” Rockfill Constituted An Unforgiving Containment Structure.

It Could Not Tolerate the Additional Pore Pressures and Erosive Effects of the Overtopping Water Plunging Over the Top of the Parapet Wall onto the Narrow Dam Crest and Cascading Down the Steep 1.3:1 Slope

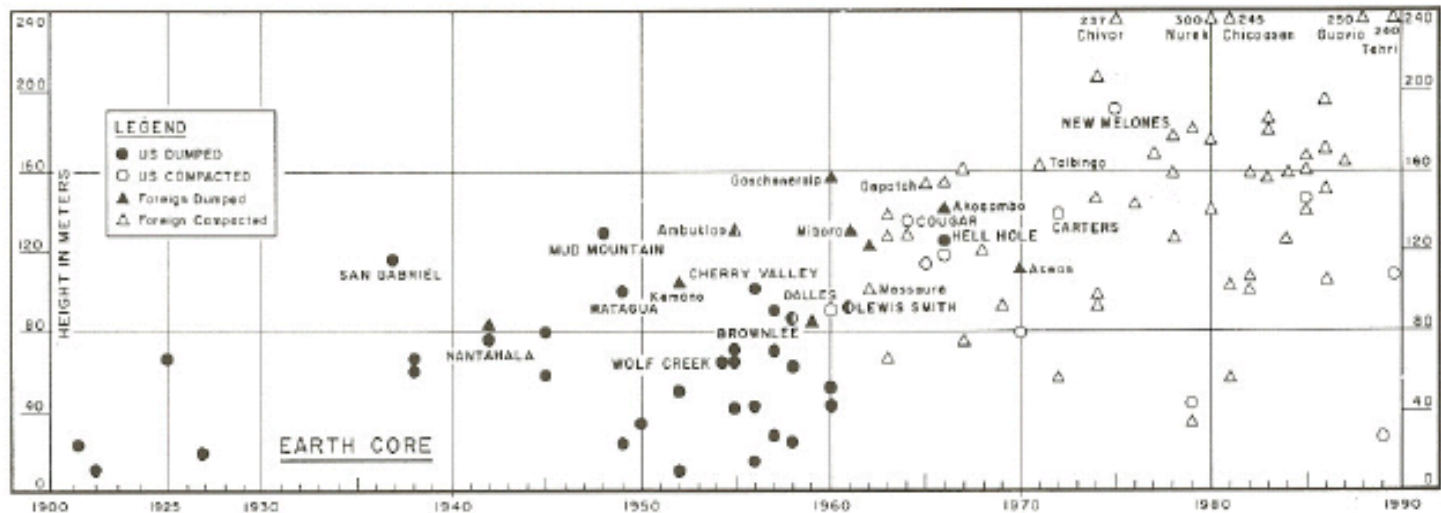
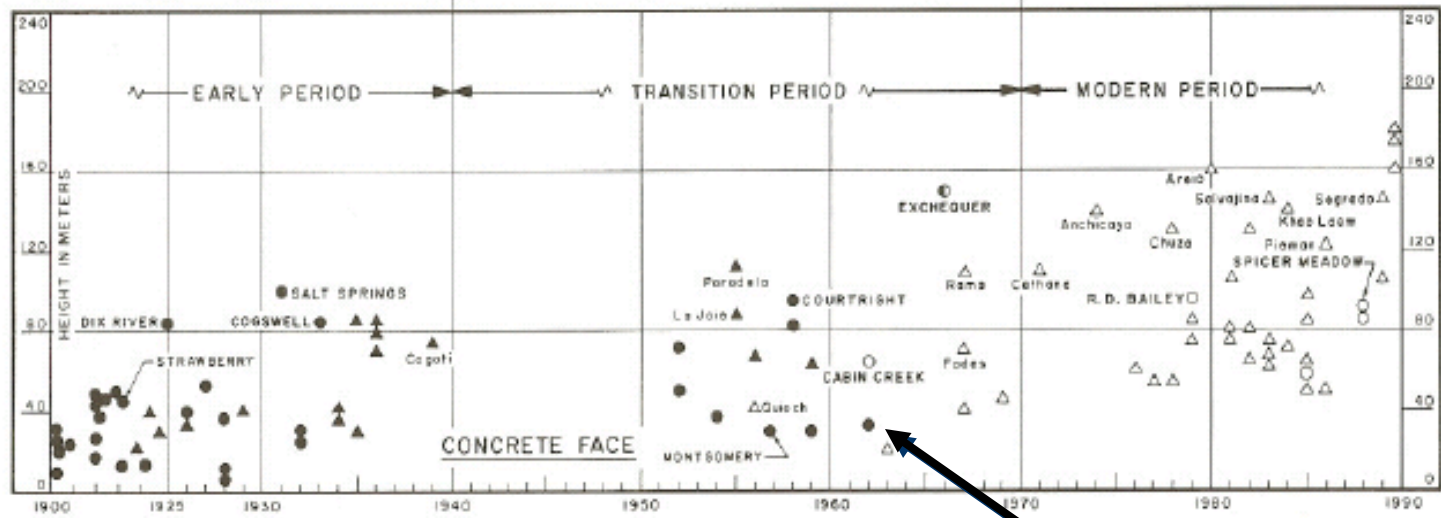
## Trends in Type and Height of Rockfill Dams

Taum Sauk U.R.
